**REPORT  
GEOLOGICAL STUDY  
LOTS 46, 47, AND 48, THE SUMMIT AT SKI LAKE  
PHASE 12  
WEBER COUNTY, UTAH  
(PARTS OF SECTION 24, TOWNSHIP 6 NORTH,  
RANGE 1 EAST, SALT LAKE BASE AND MERIDIAN)**

November 10, 2016

Job No. 2077-02N-16

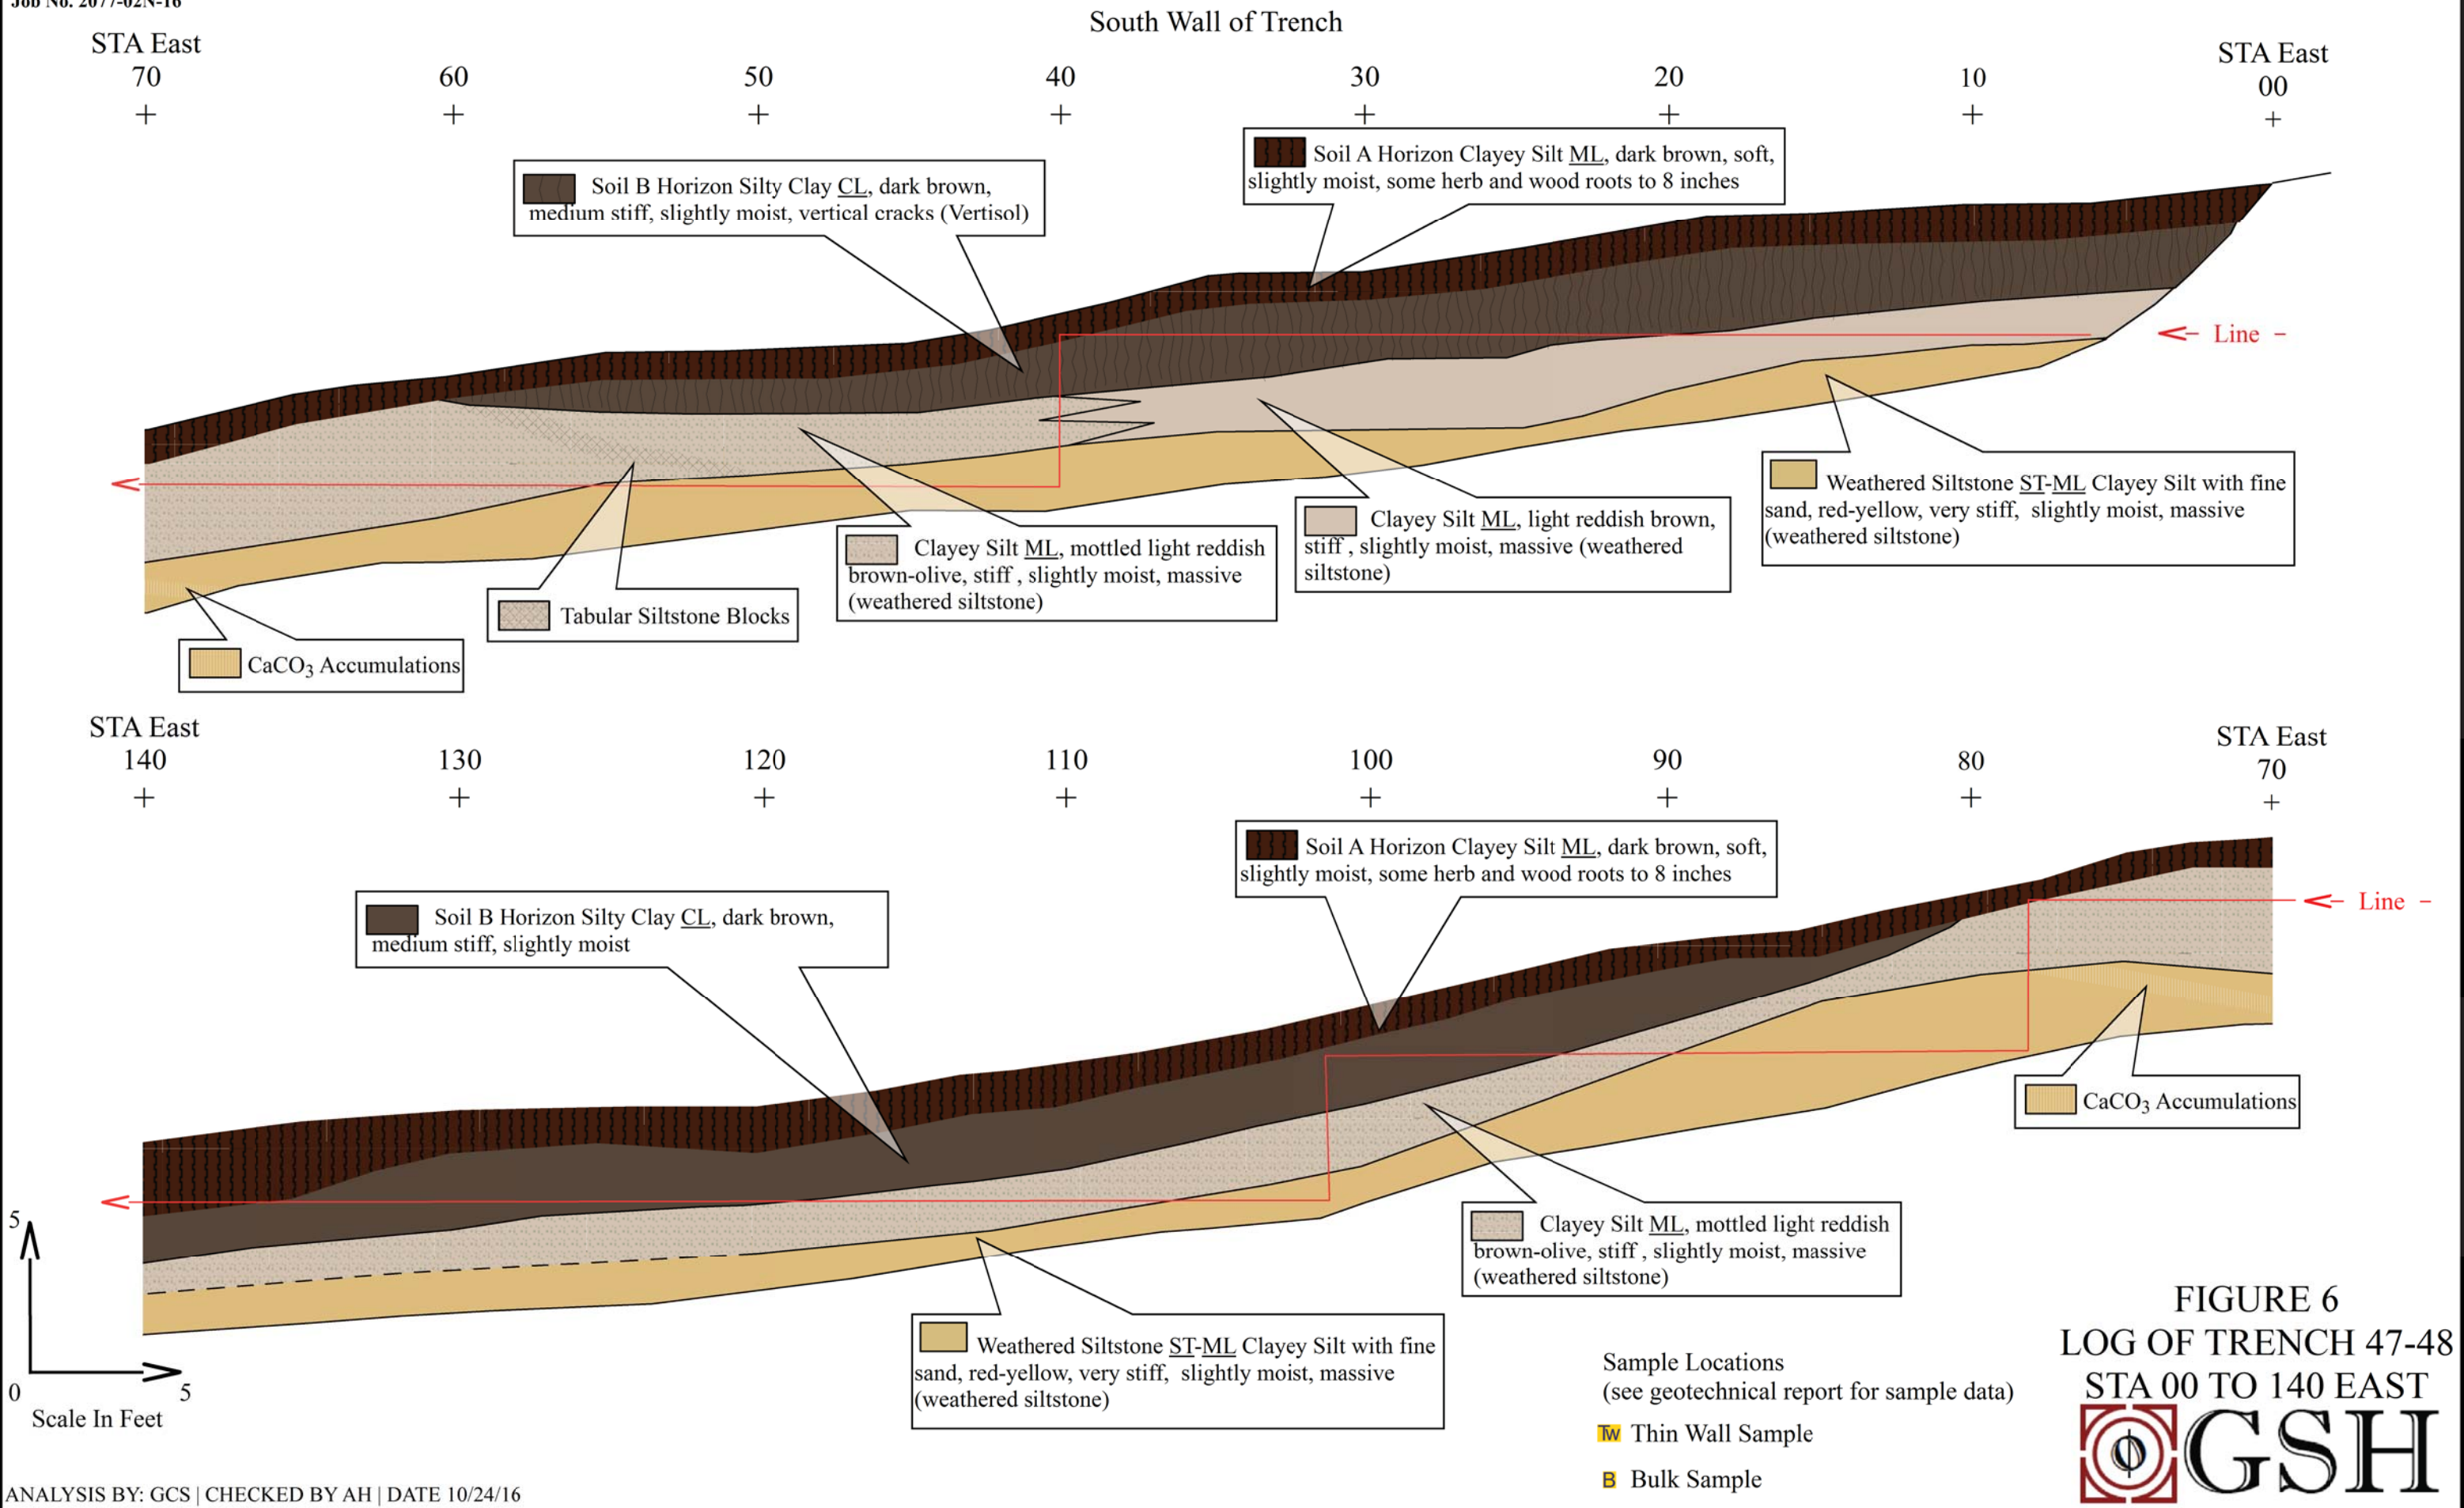
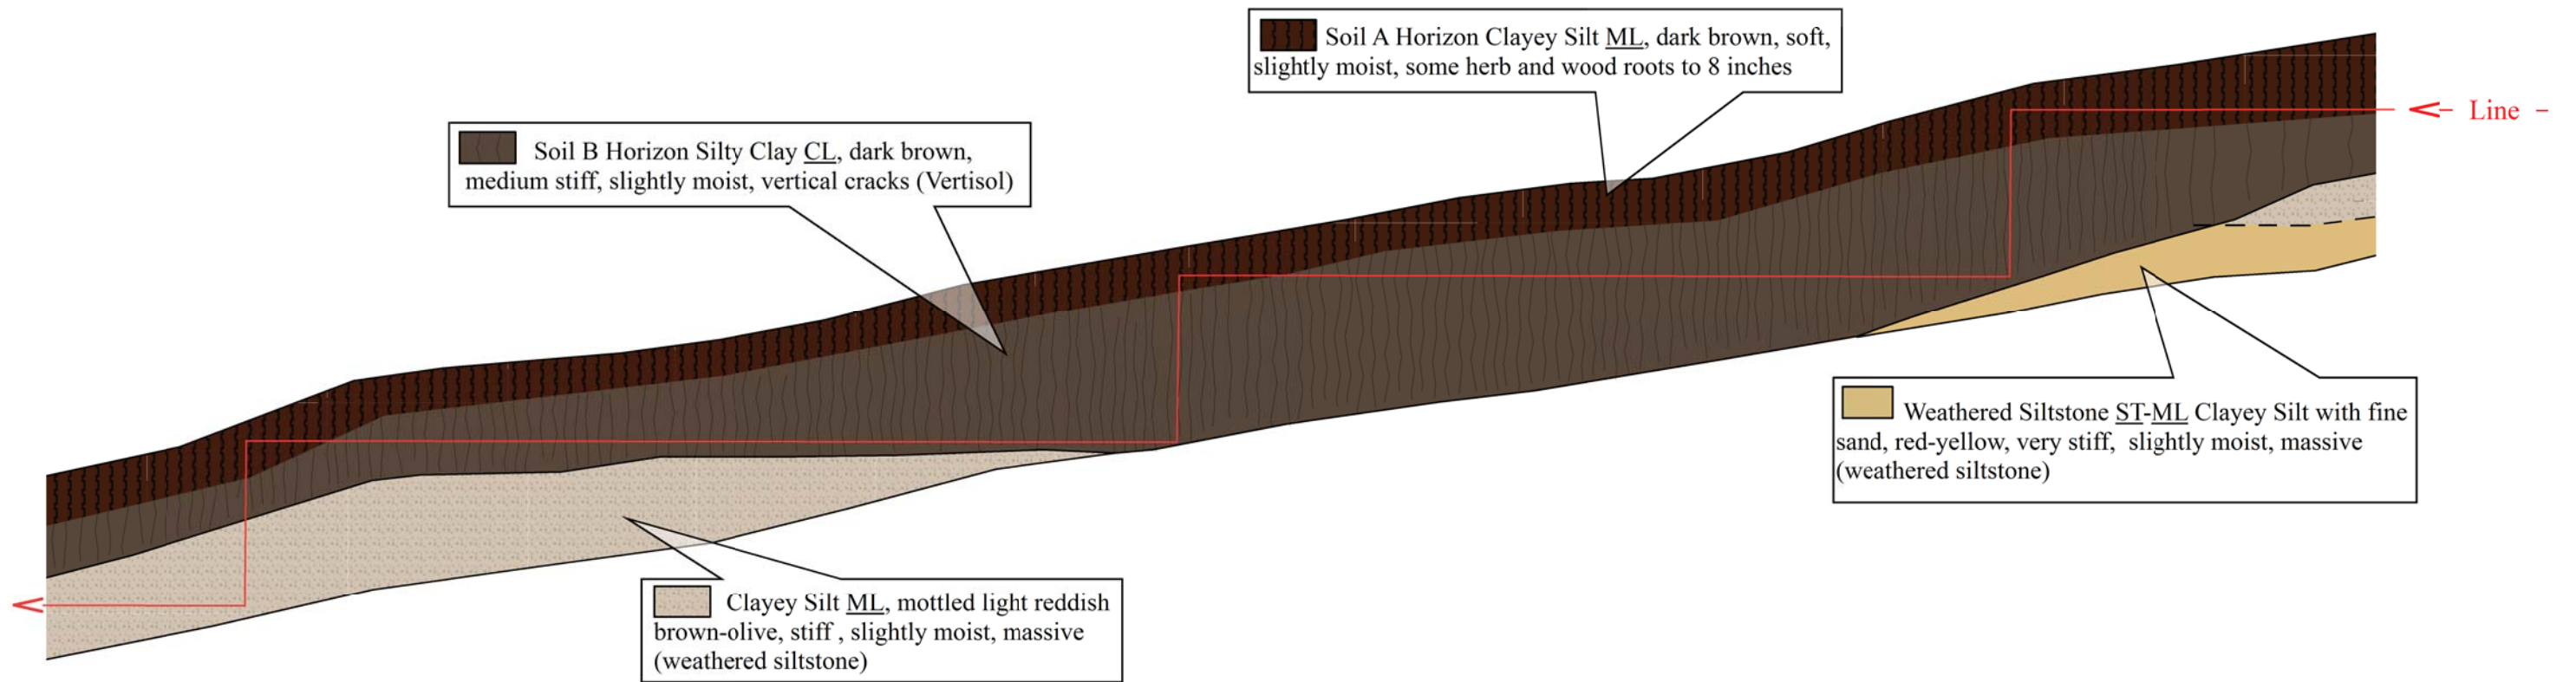
**FIGURE 6**  
**LOG OF TRENCH 47-48**  
**STA 00 TO 140 EAST**

Soil B Horizon Silty Clay CL, dark brown, medium stiff, slightly moist, vertical cracks (Vertisol)
