**Geotechnical Investigation
Cobabe Ranch Development
Eden, Utah**

March 9, 2022

**Geotechnical Investigation
Cobabe Ranch Development
Approximately 2720 North 5100 East
Eden, Utah
CG Project No.: 133-015**

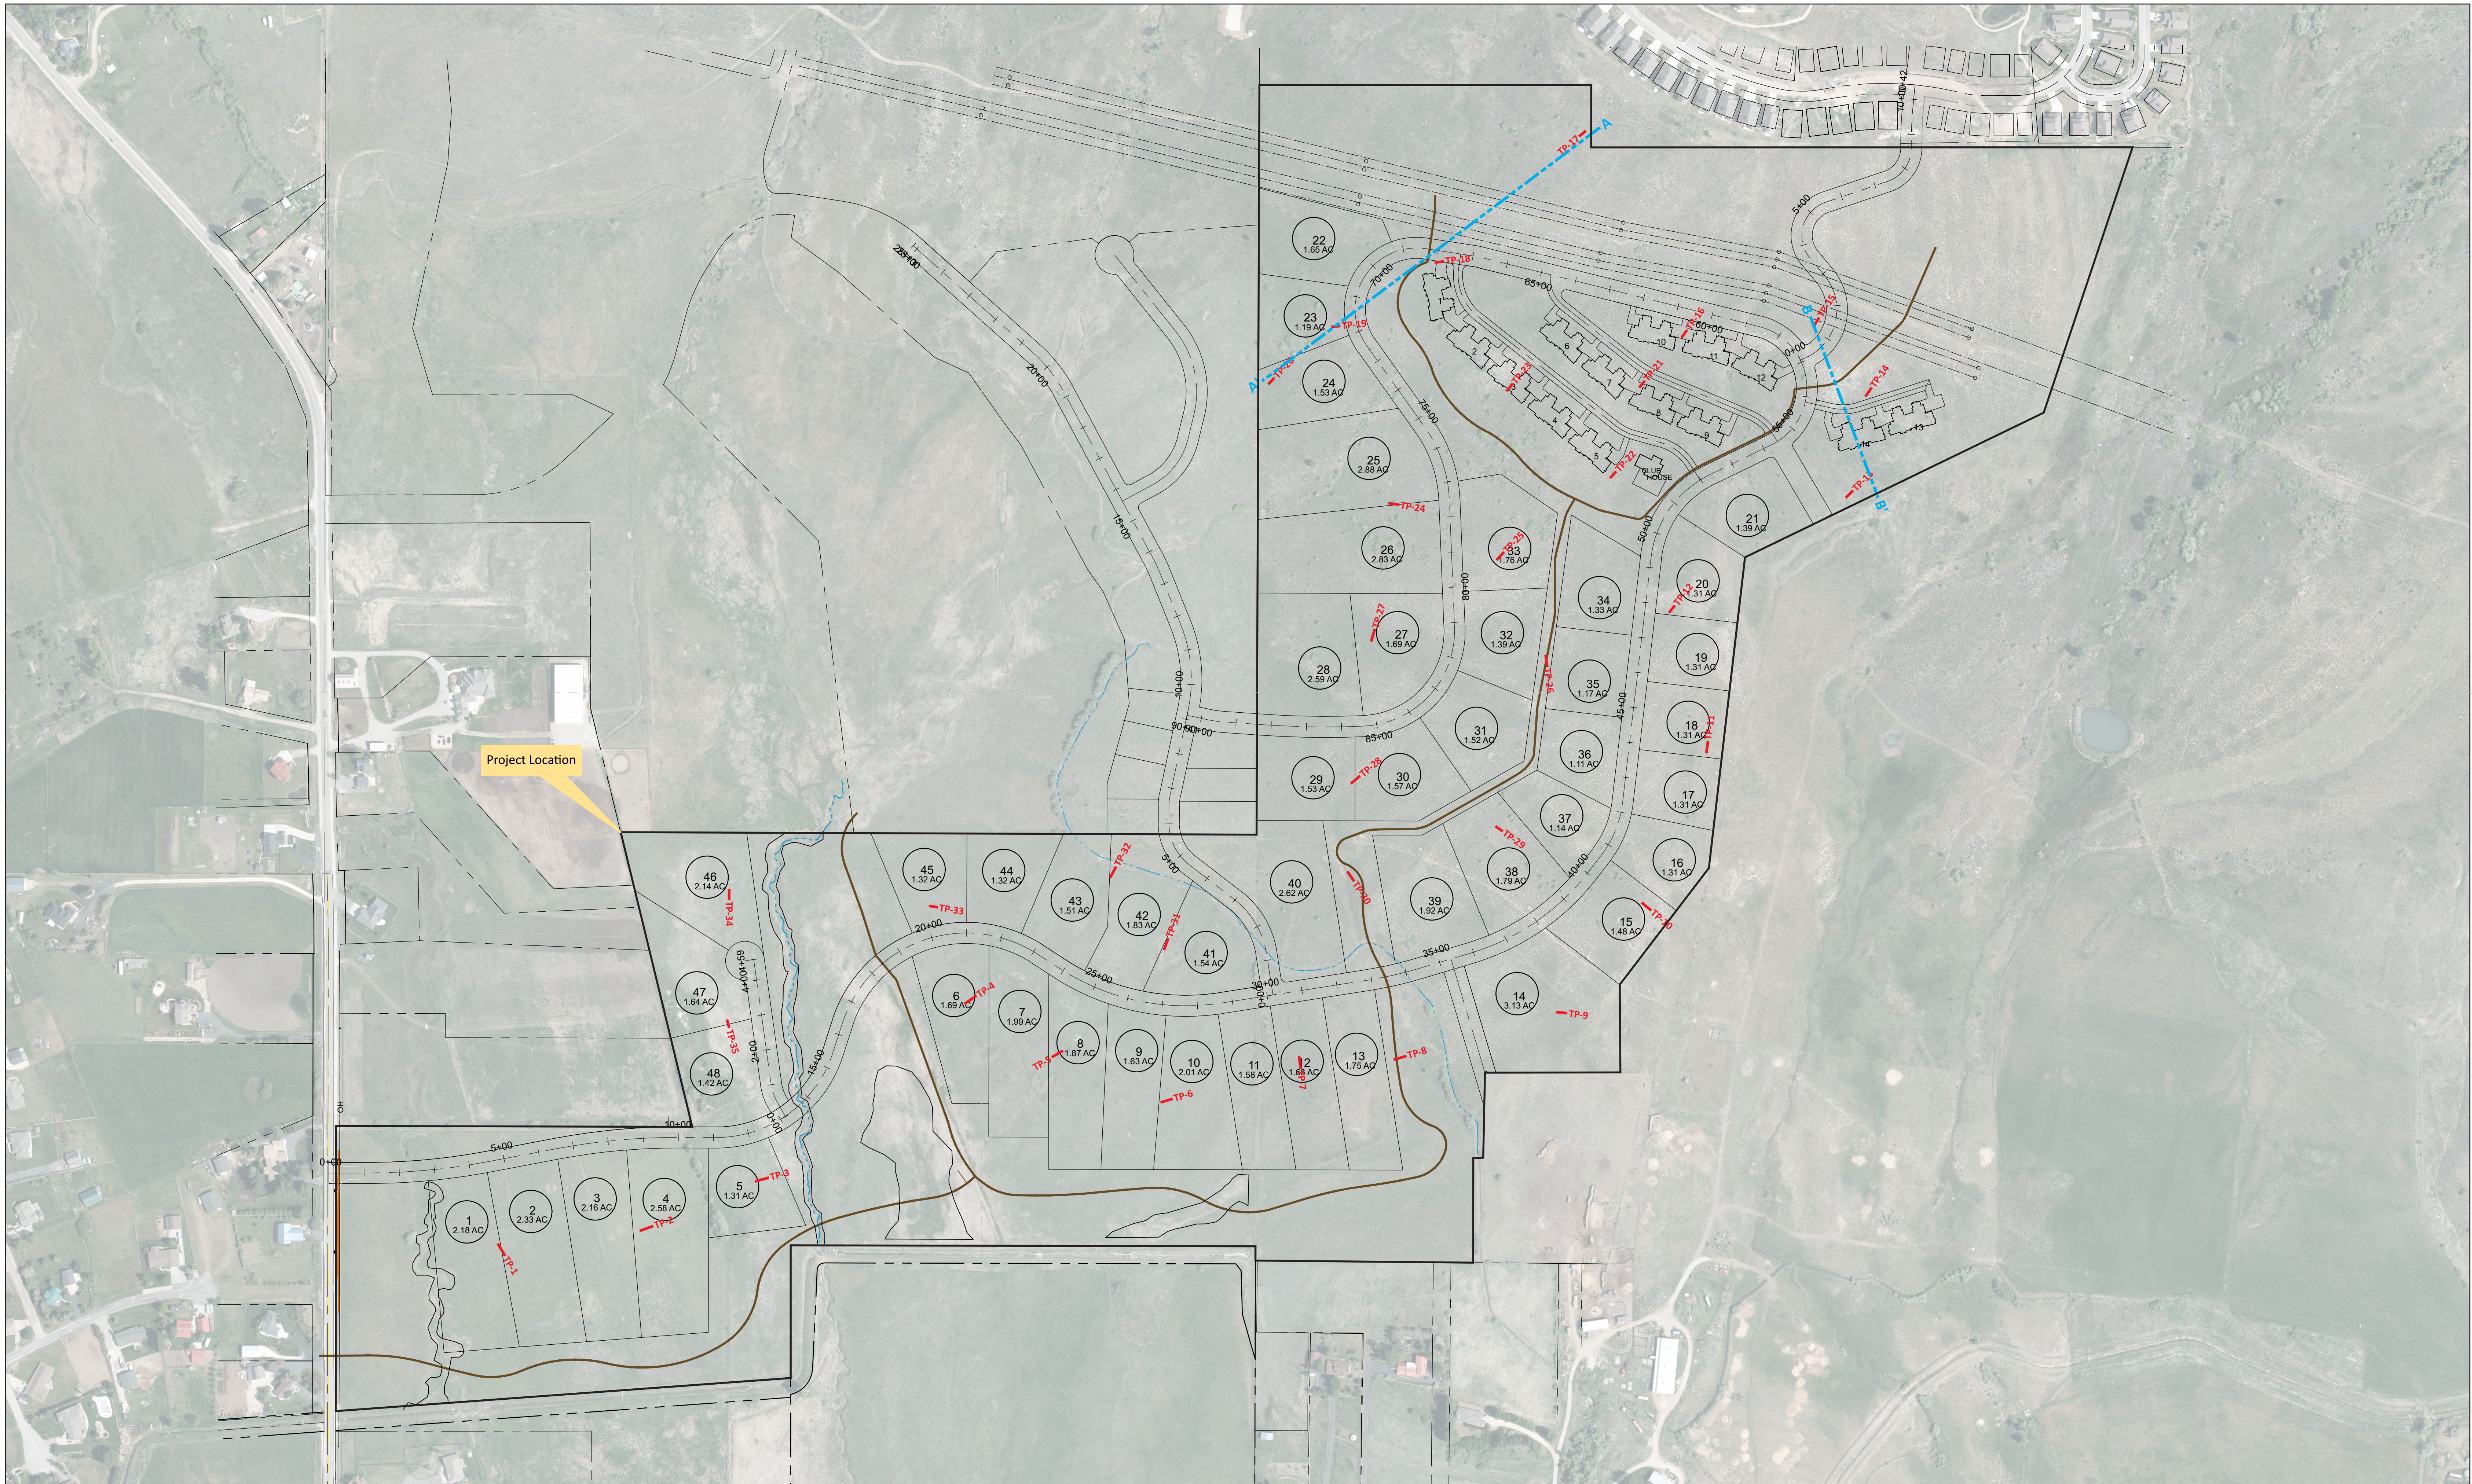
Base: Utah Geographic Resource Center, 2012 high resolution orthophoto, 12.5 cm resolution. Site plan modified from Gardner Engineering preliminary plan sheet SP1 dated 06-15-2021.

The subsurface conditions at the site were explored by excavating 35 test pits to depths of 10 to 14 feet below the existing site grade. The approximate test pit locations are shown on the Exploration Location Map, Plate 2. The subsurface conditions as encountered in the test pits were recorded at the time of excavation and are presented on the attached Test Pit Logs, Plates 3 to 37. A key to the symbols and terms used on the Test Pit Logs may be found on Plate 38.
