July 1, 2025
Job No. 3361-007-25

Re: Report
Geological Site Reconnaissance and Review
Base Area Sprung Structure
Snowbasin Resort, 3925 East Snowbasin Road
Huntsville, Utah (41.2163°, -111.8583°)

Base Area Sprung Structure
GSH Job No. 3361-007-25

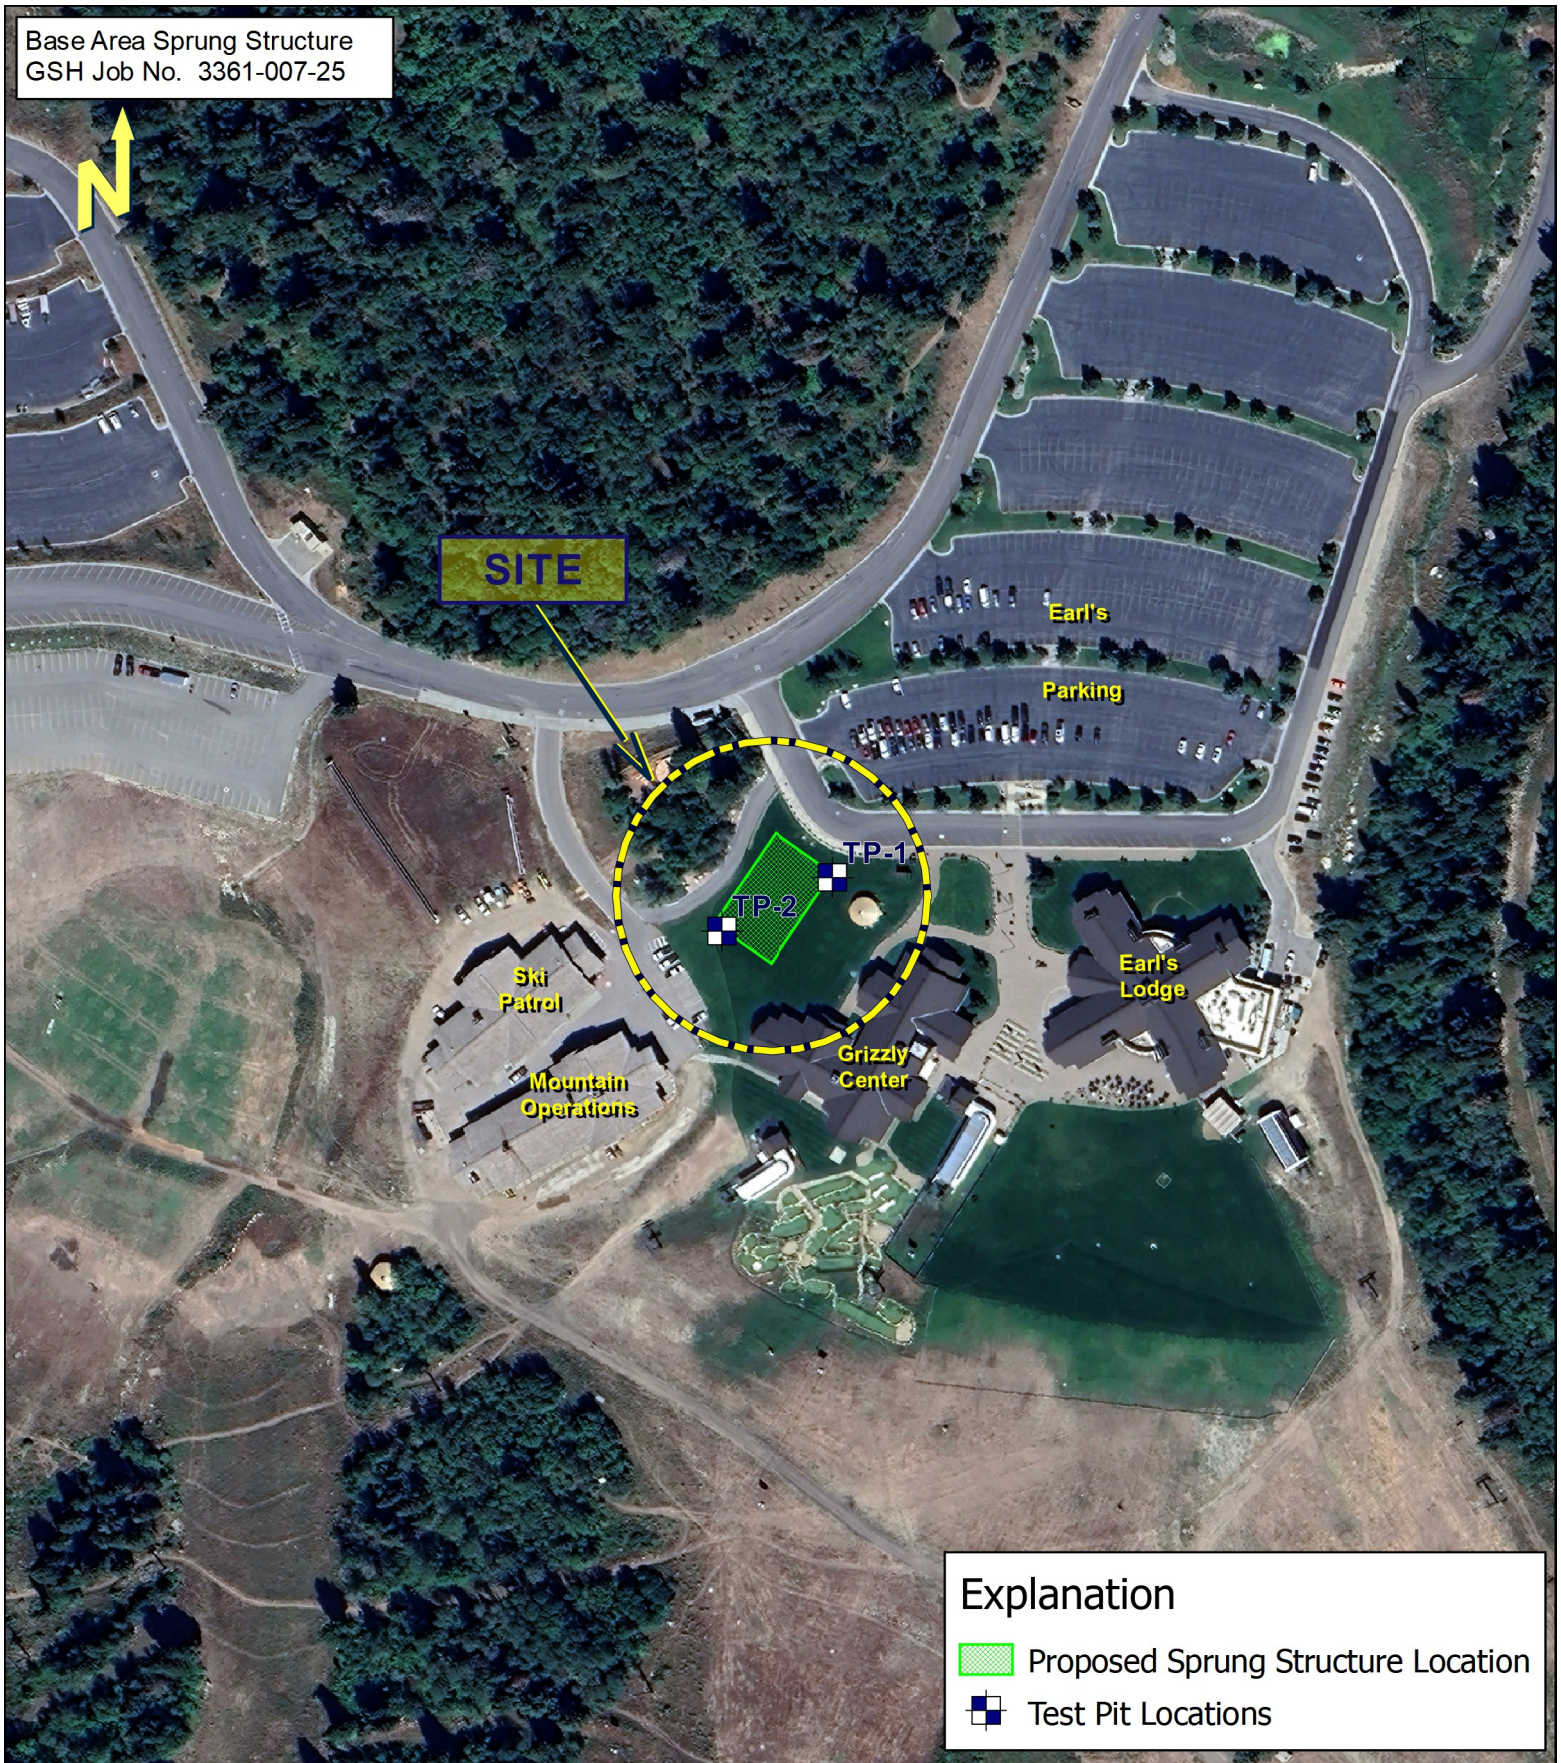
FIGURE 2
SITE PLAN

and, the analysis of 2012 5.0-inch digital HRO orthoimagery coverage, and a 2024 0.6-meter digital NAIP orthoimagery coverage of the site, and review of the contemporary Google Earth® orthoimagery coverage of the site as shown on Figure 2.

As shown on Figure 2, the proposed structure location includes a landscaped area within the developed base facilities area of the resort. Elevation on the proposed structure is approximately 6,396 feet. Slope gradients range from near-level to substantially steeper than the 25-percent on nearby slopes. Surface vegetation consists of maintained turf.
