January 16, 2025

**Geotechnical Investigation
Bitton-Herrick Property
Approximately 800 South 4100 West
Ogden, Utah
CG Project No.: 145-027**

Mark I. Christensen, P.E.
Principal

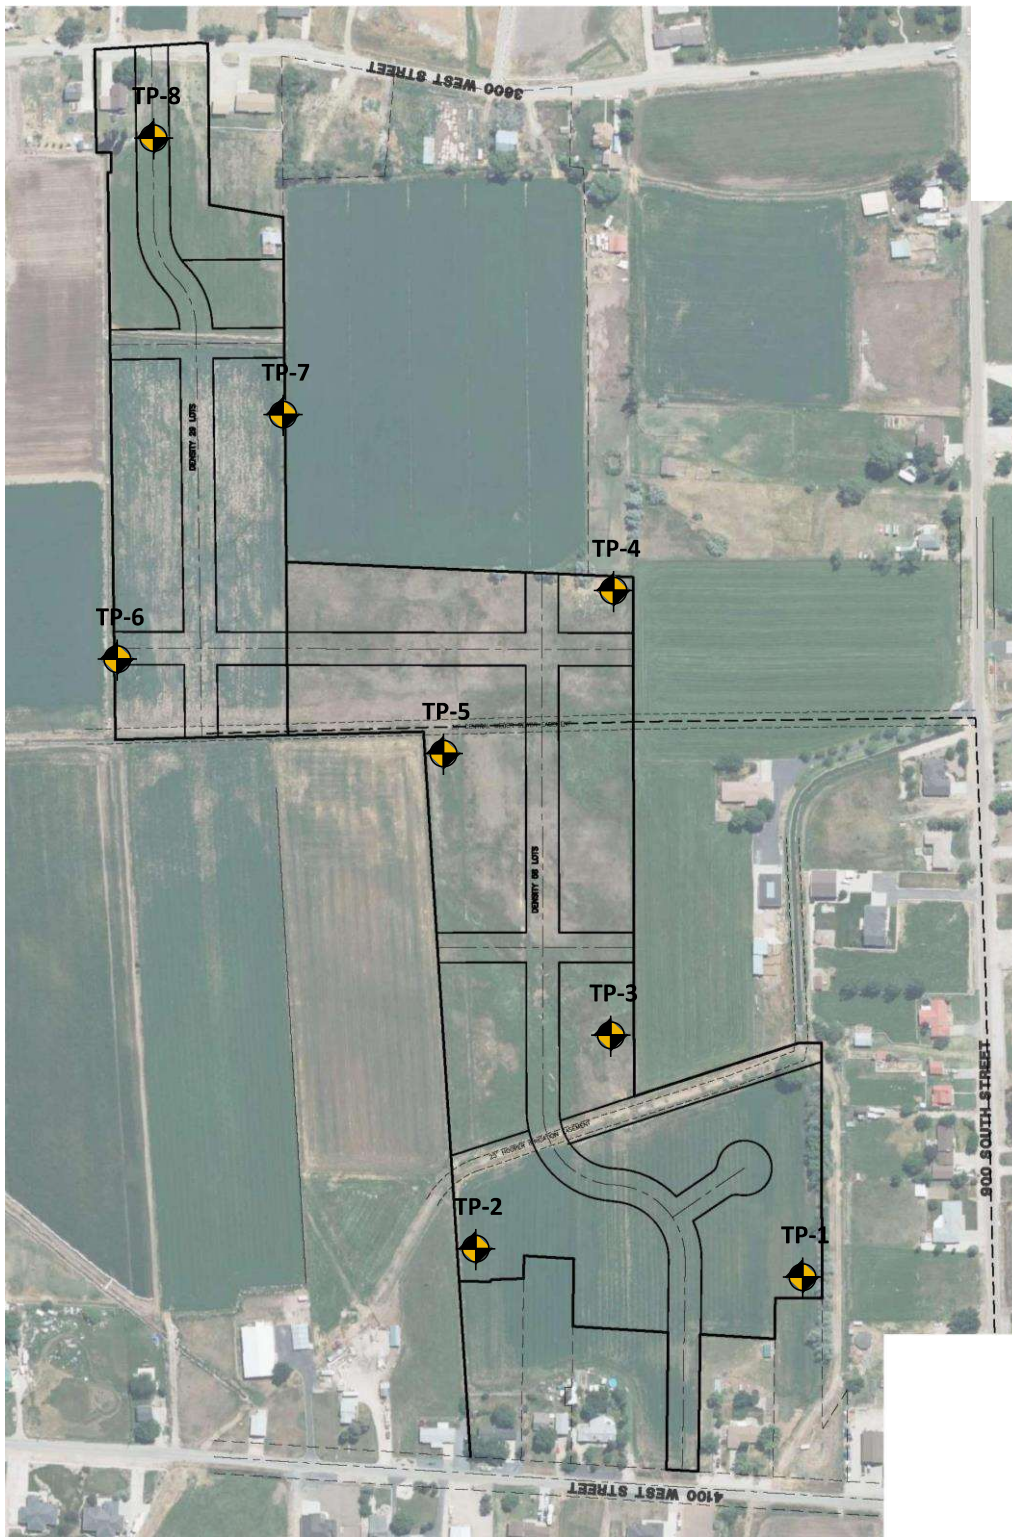
Plate
 2

Approximate Test Pit Location

Exploration Location Map

The subsurface conditions at the site were explored by excavating eight test pits to depths of 8 to 9 feet below the existing site grade. The approximate test pit locations are shown on the Exploration Location Map, Plate 2. The subsurface conditions as encountered in the test pits were recorded at the time of excavation and are presented on the attached Test Pit Logs, Plates 3 to 10. A key to the symbols and terms used on the Test Pit Logs may be found on Plate 11.

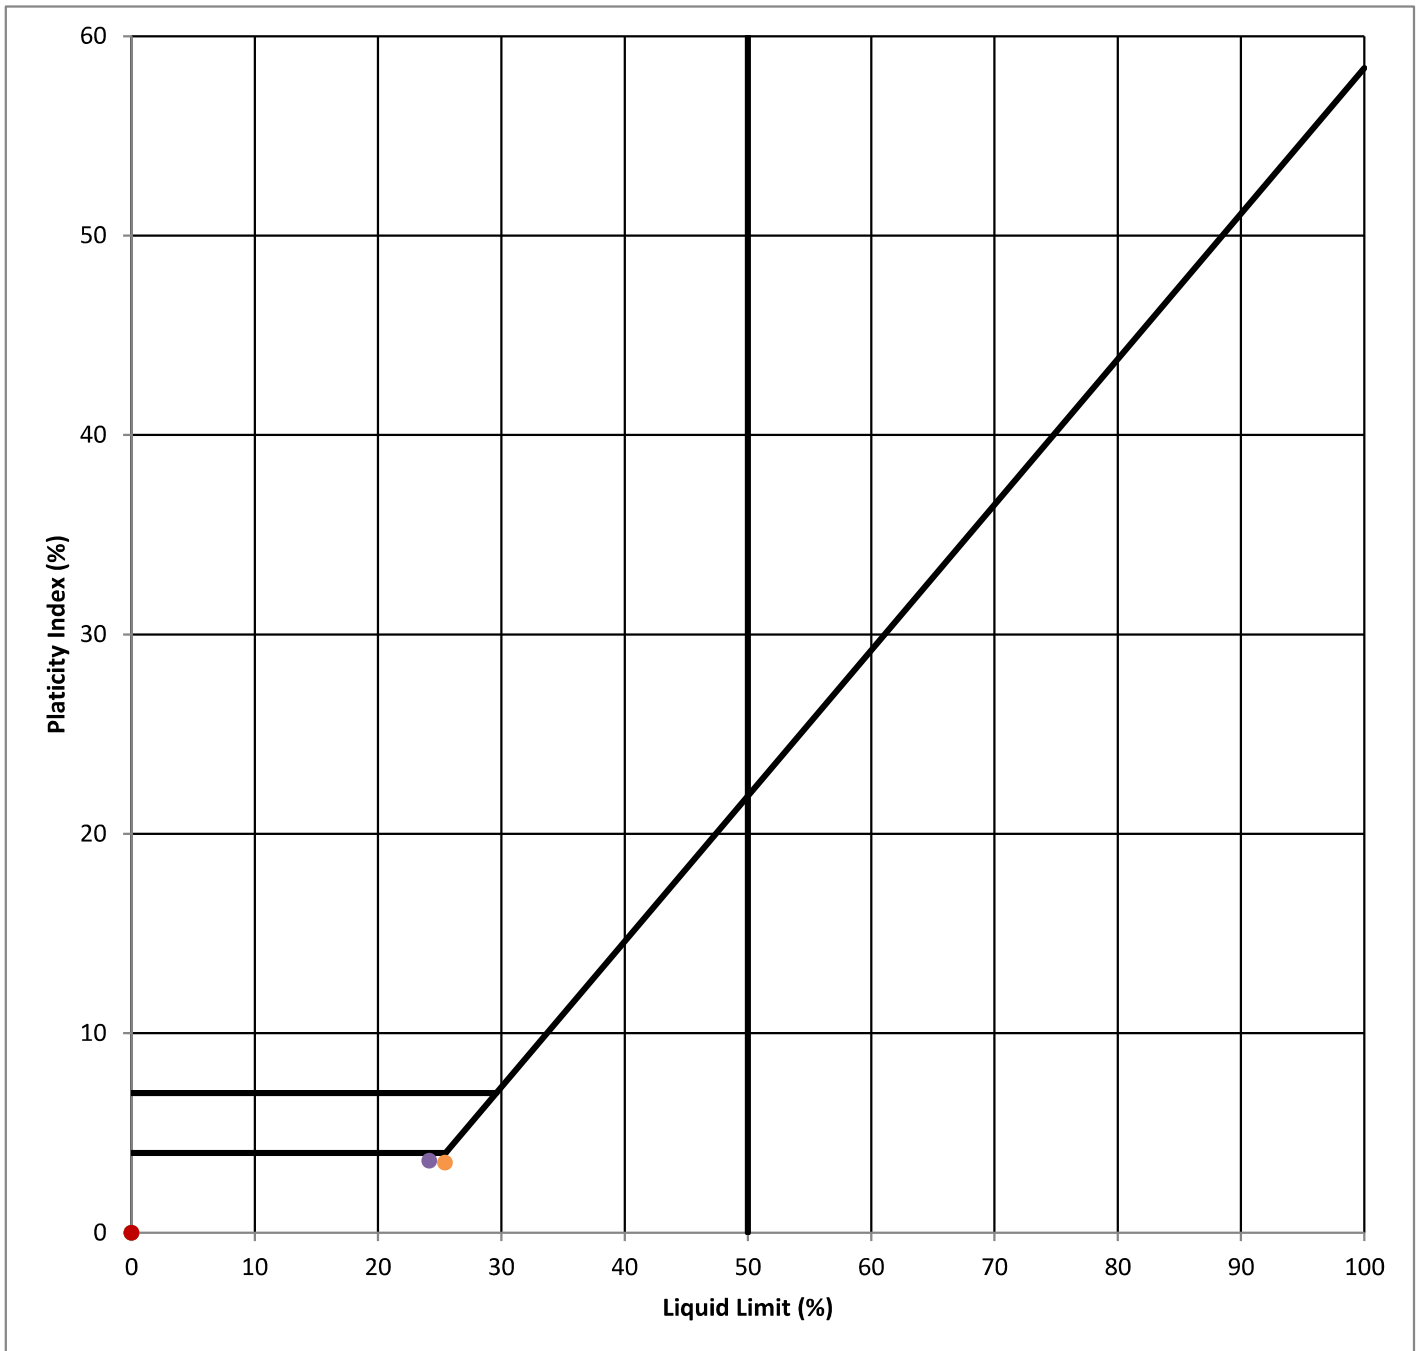
<p>Lync Construction Bitton-Herrick Property Ogden, Utah Project No.: 145-027</p>	<p>Plate 12</p>
---	--	-----------------------------

Atterberg Limits

Location	Depth (ft)		Classification	Liquid Limit	PI
TP-1	6	●	Poorly Graded SAND	NP	NP
TP-2	2	●	SILT with sand	25	4
TP-3	7	●	Silty SAND	NP	NP
TP-4	2	●	Sandy SILT	24	4
TP-5	6	●	Silty SAND	NP	NP

The results of our laboratory tests are also presented on the Test Pit Logs, Plates 3 through 10, and more detailed laboratory results are presented on the laboratory testing plates, Plates 12 through 16.

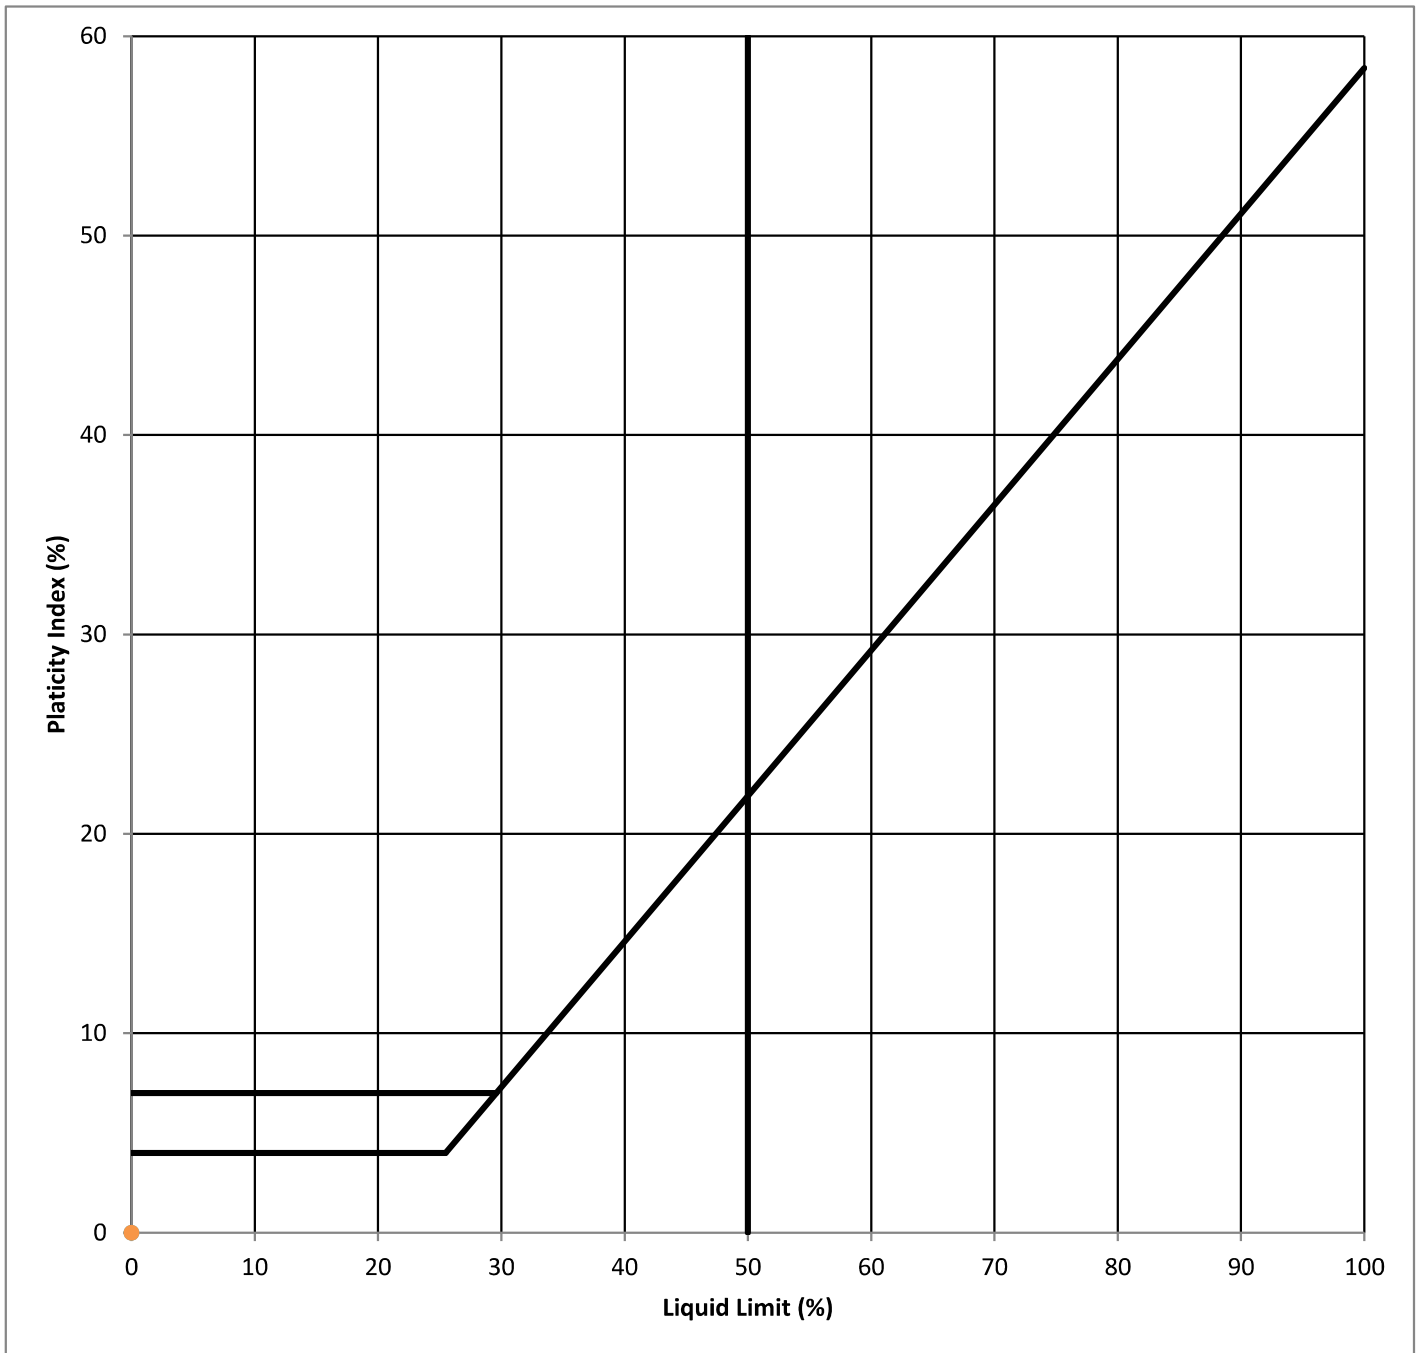
<p>Lync Construction Bitton-Herrick Property Ogden, Utah Project No.: 145-027</p>	<p>Plate 13</p>
---	--	-----------------------------

Atterberg Limits

Location	Depth (ft)		Classification	Liquid Limit	PI
TP-6	7	●	Poorly Graded SAND with silt	NP	NP
TP-7	2	●	Silty SAND	NP	NP

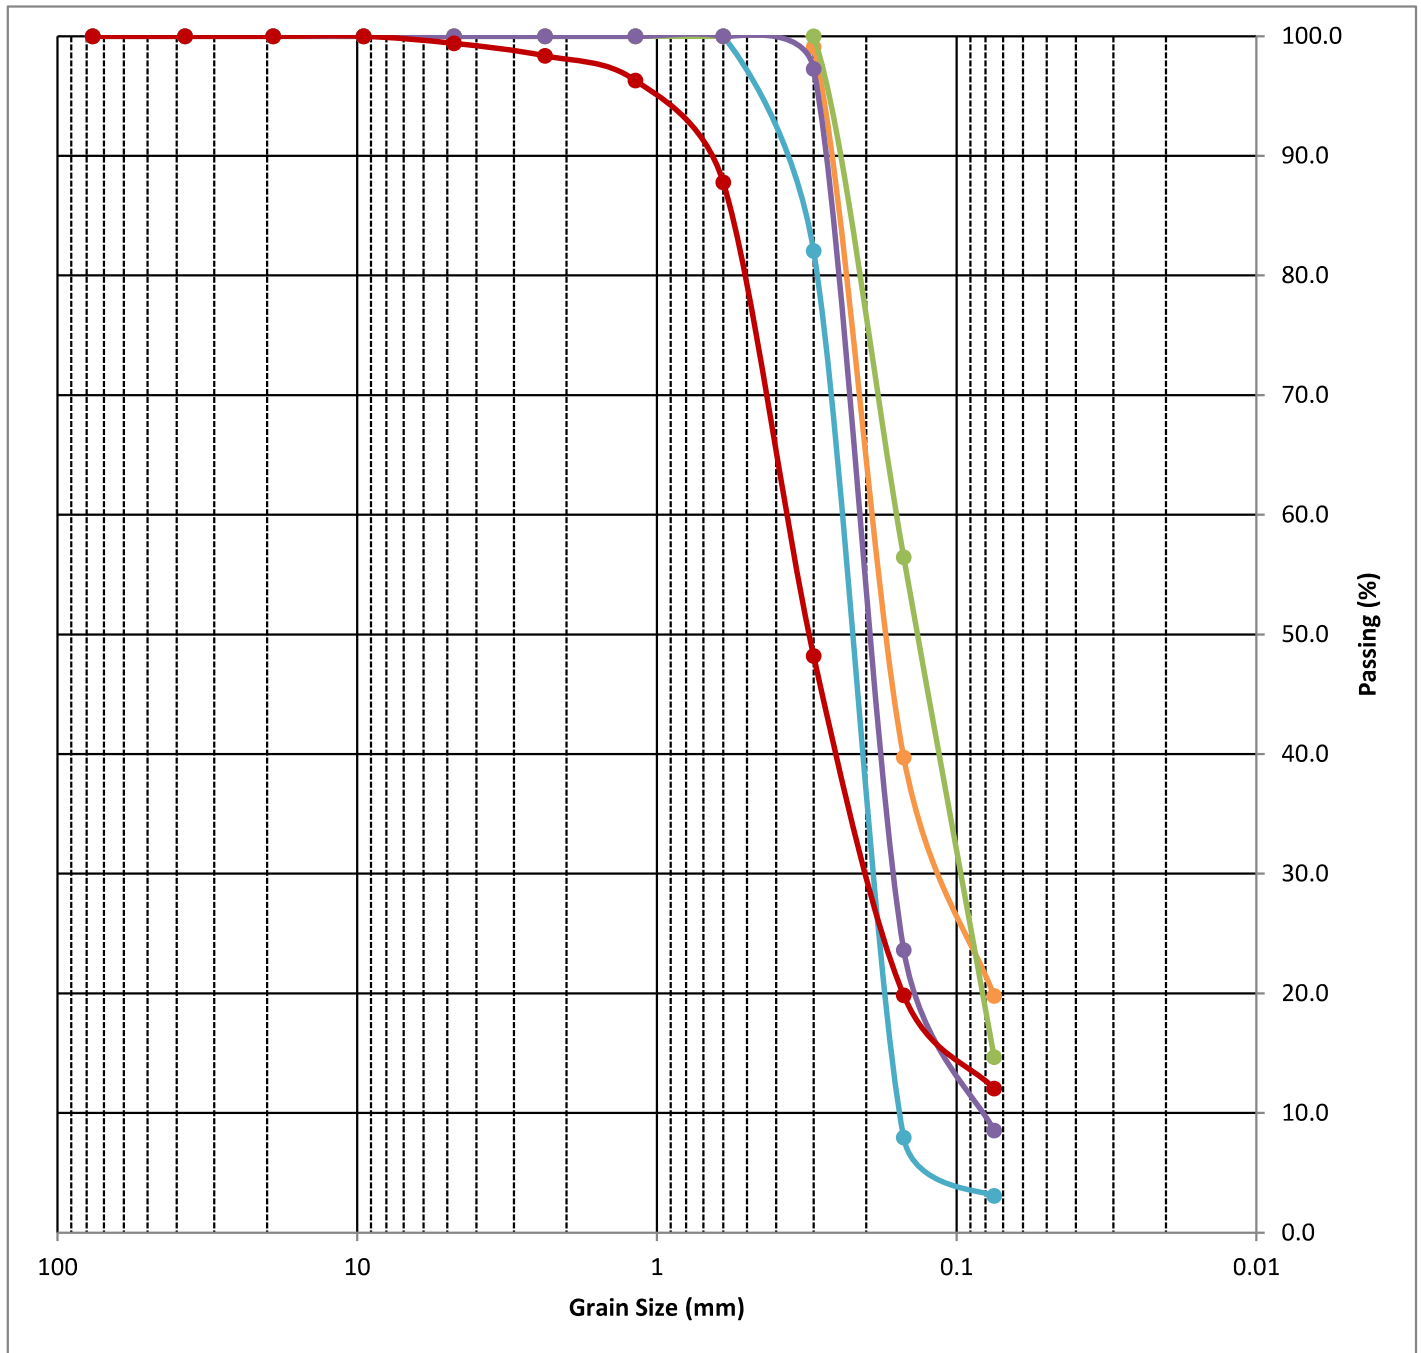
Grain Size Distribution

Location	Depth		Classification	% Gravel	% Sand	% Silt and Clay
TP-1	6	●	Poorly Graded SAND	0.0	96.9	3.1
TP-3	7	●	Silty SAND	0.0	80.2	19.8
TP-5	6	●	Silty SAND	0.0	85.3	14.7
TP-6	7	●	Poorly Graded SAND with silt	0.0	91.5	8.5
TP-7	2	●	Silty SAND	0.6	87.4	12.0

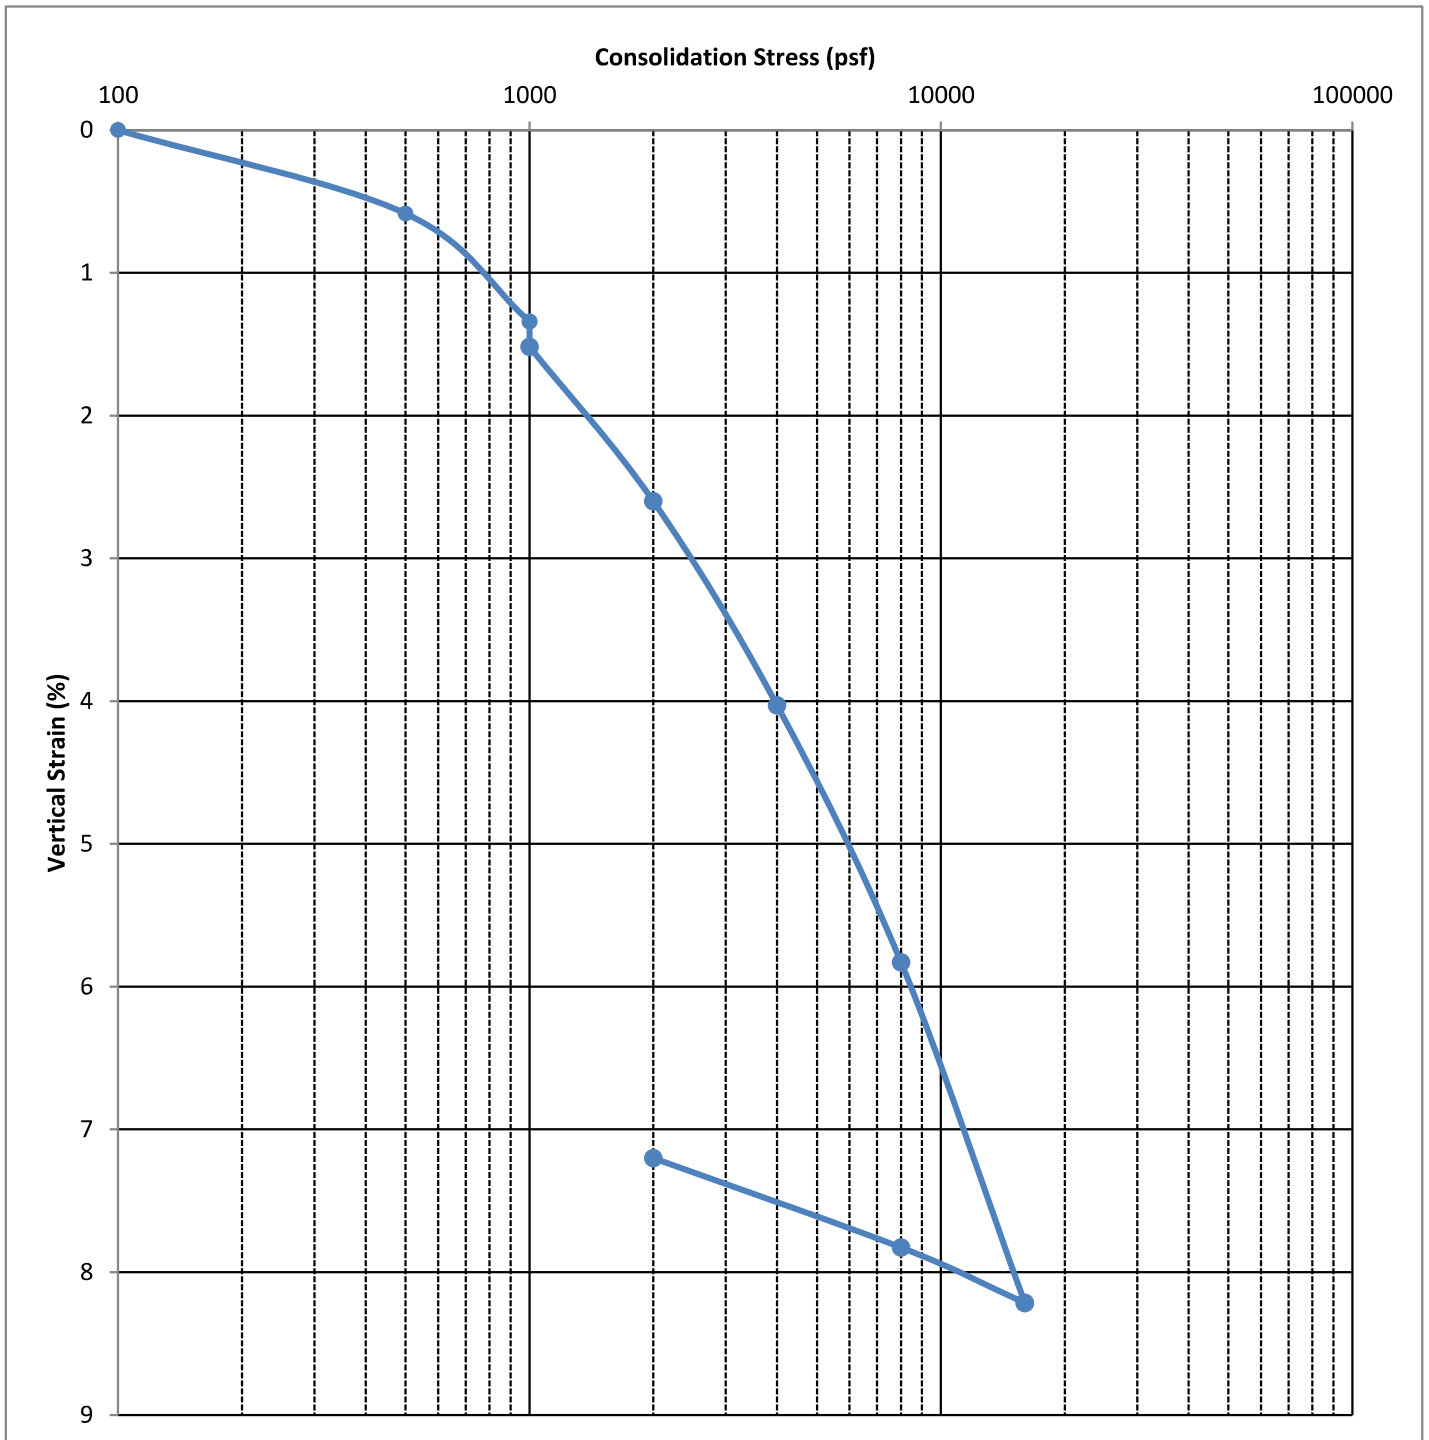
1-D Consolidation

Location	Depth (ft)	Dry Density (pcf)	Moisture Content (%)	σ_o (psf)	σ_p (psf)	C_c	C_r	OCR
TP-2	2	106.1	19.6	300	2,000	0.070	0.011	6.7

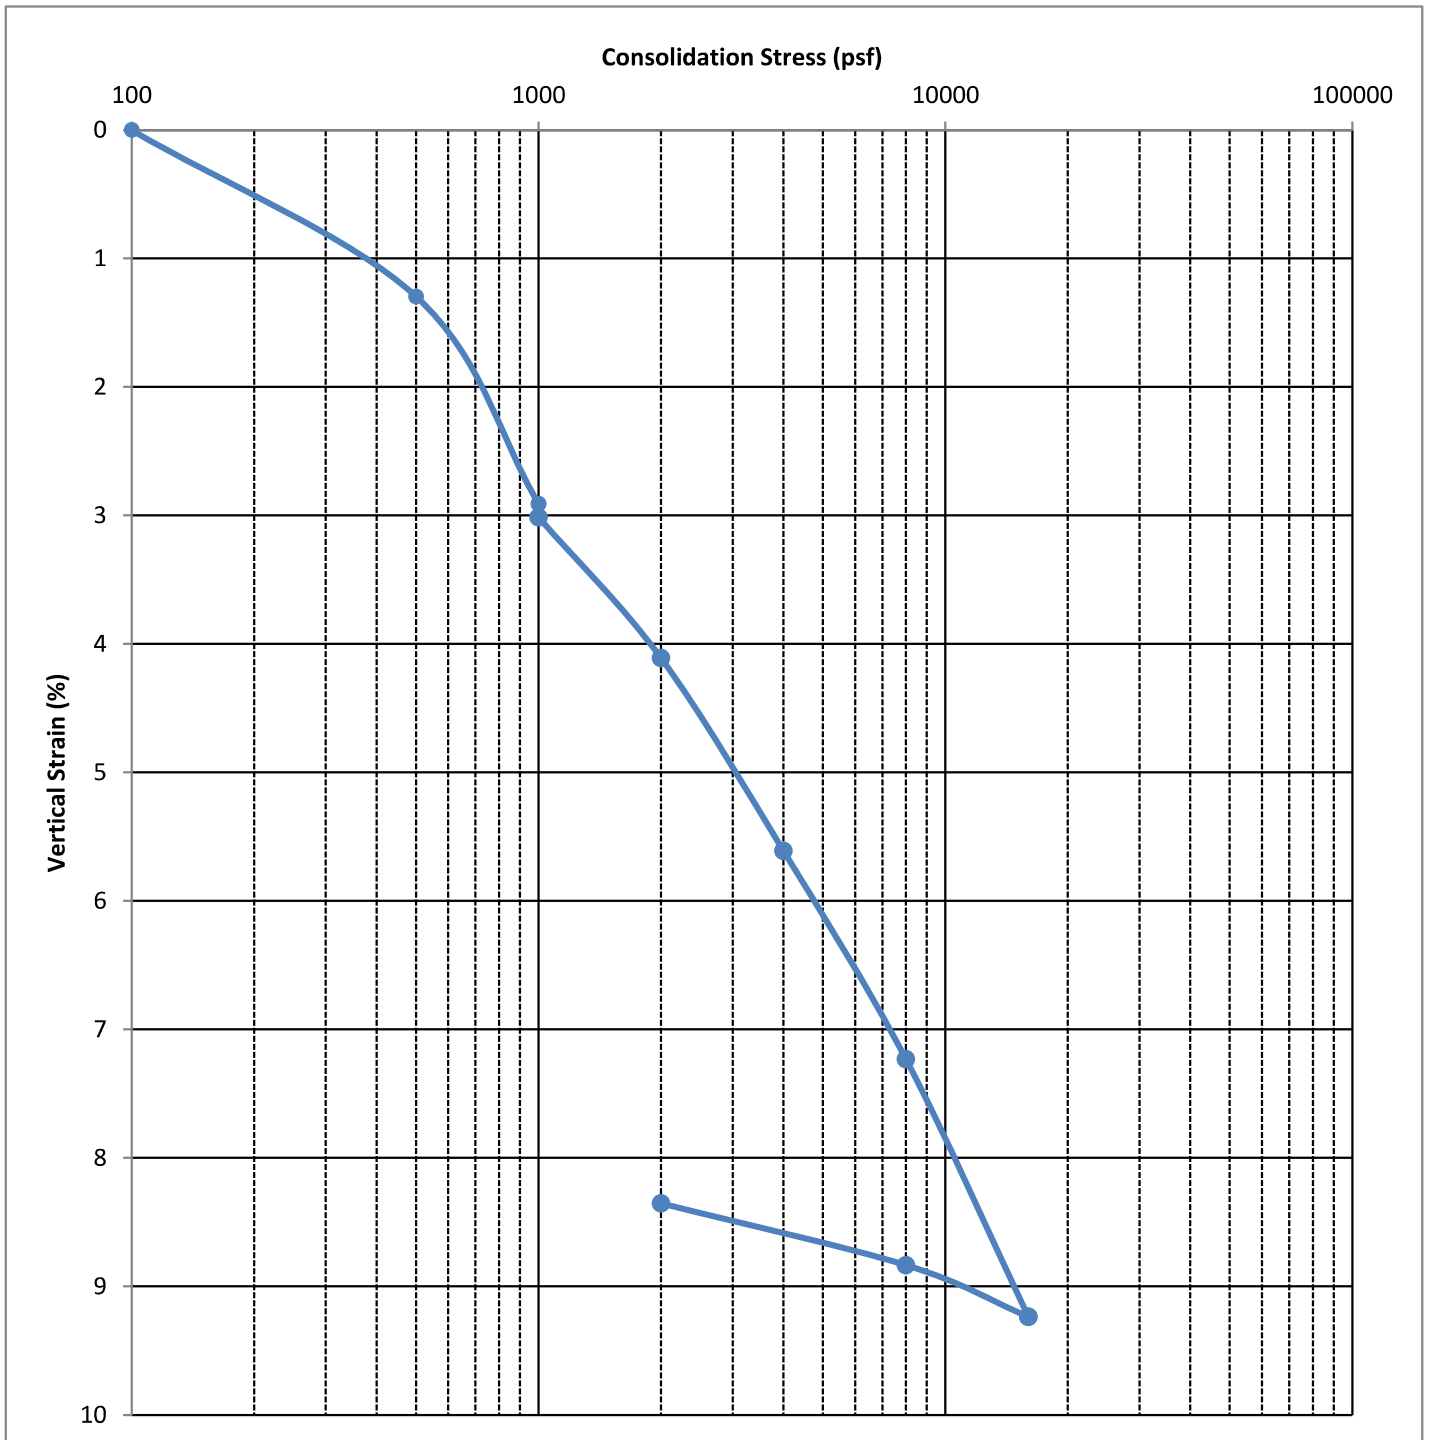
1-D Consolidation

Location	Depth (ft)	Dry Density (pcf)	Moisture Content (%)	σ_o (psf)	σ_p (psf)	C_c	C_r	OCR
TP-4	2	104.5	22.9	300	1,900	0.060	0.010	6.3
