**GEOLOGIC-HAZARD STUDY
PROPOSED HANNOY RESIDENCE
3563 PINEVIEW COURT
EDEN, UTAH**

**BIG CANYON HOMES, INC.
1925 SW HOYTSTVILLE ROAD
WANSHIP, UTAH 84017**

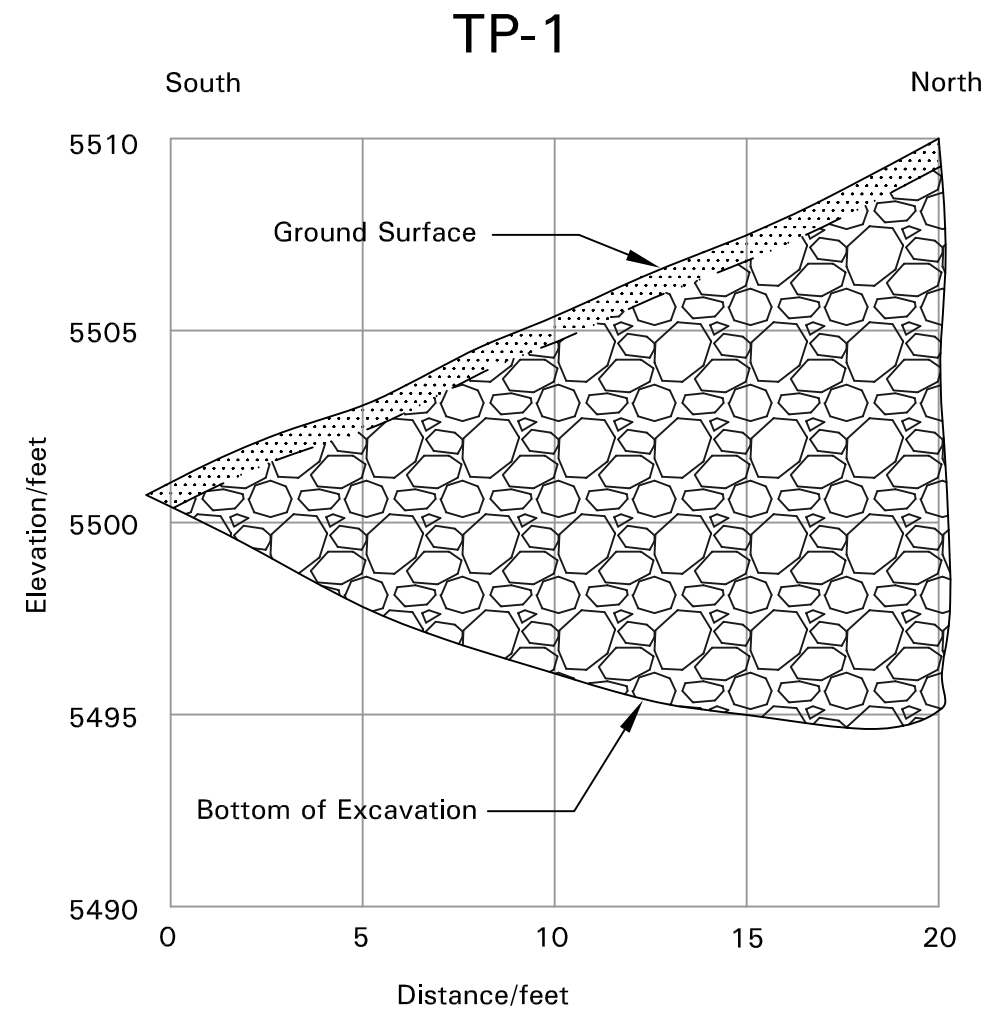
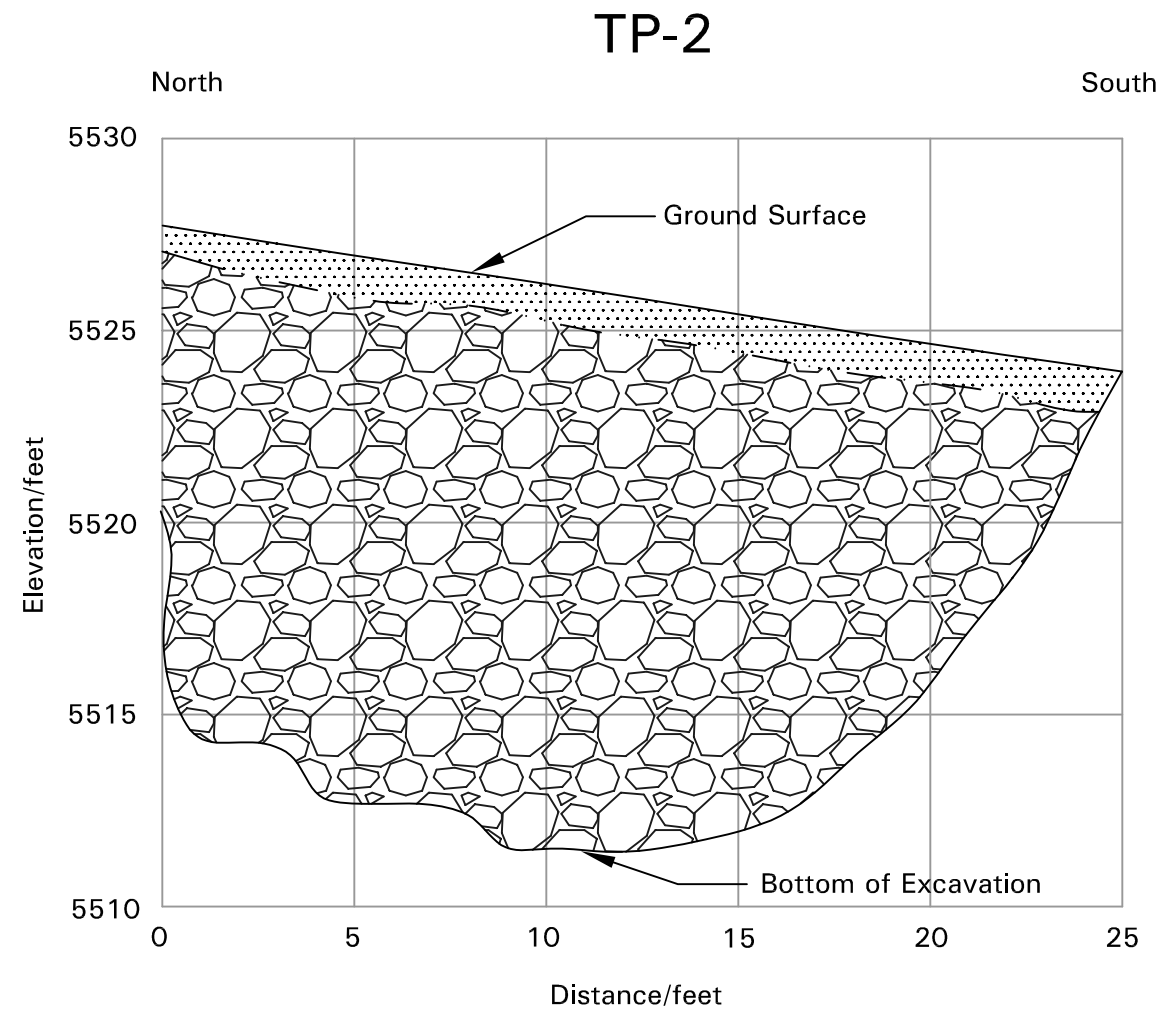
Topsoil; clayey gravel with sand, cobbles, occasional boulders up to approximately 3 feet in size, very moist, dark brown, roots, organics.

Clayey Gravel with Sand (GC); cobbles, occasional boulders up to approximately 3 feet in size, dense to very dense, moist to very moist, brown, iron oxide staining. (Colluvium)

Two test pits and a boring were used to determine subsurface conditions at the site. Test Pits TP-1 and TP-2 were extended to depths of approximately 26 and 21 feet, respectively. Clayey gravel with sand, cobbles and boulders up to approximately 3 feet in size was encountered the full depths of the test pits and the lower 5 feet of the boring, where practical auger refusal was met. The gravel is primarily matrix to clast-supported and represents colluvial deposits. No evidence of faults or landslide slip planes were found in the test pits. Logs for the upper 15 feet of the test pits are presented on Figure 3. Photographs of the upper 15 feet of the test pits are presented in the appendix.
