**REPORT
RECONNAISSANCE LEVEL GEOLOGICAL STUDY
PROPOSED SINGLE LOT KEO HOMESTEAD
SUBDIVISION
APPROXIMATELY 5600 EAST HIGHWAY 39
WEBER COUNTY, UTAH**

Job No. 1675-02N-15

Re: Reconnaissance Level Geological Study
Proposed Single-Lot KEO Homestead Subdivision
Approximately 5600 East Highway 39
(Part of Section 14, Township 6 North, Range 1 East, Salt Lake base and meridian)
Weber County, Utah

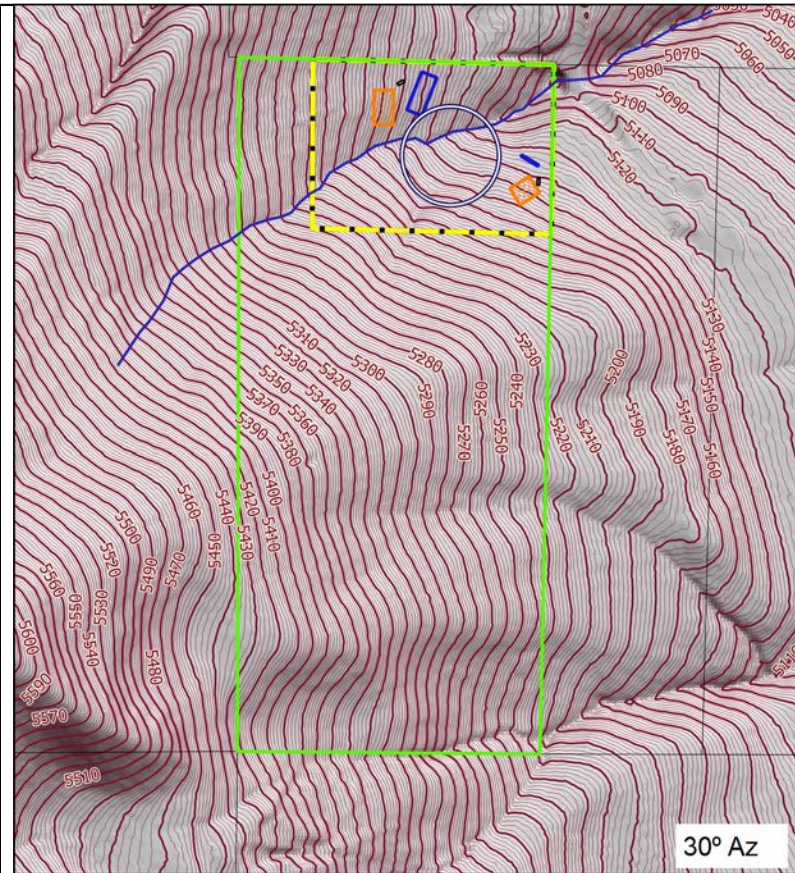
APPENDIX A FIGURE 1 CONTOUR AND SHADED RELIEF ANALYSIS

GDAL Contour Utility - Extracts contour lines from any GDAL-supported elevation raster.

GRASS r.shaded.relief Utility Creates a raster shaded relief map based on current resolution settings and on sun altitude, azimuth, and z-exaggeration values entered by the user. Top left to lower right, sun angle azimuth 300°, 30°, 120° and 210° respectively.

GDAL Contour Utility - Extracts contour lines from any GDAL-supported elevation raster.
