# Staff Report for Administrative Approval Hillside Review – Notice of Conditional Approval

**Application Request:** Consideration and action on a request to approve a Hillside Review for the LaStayo residence located on Lot 44 in the Big Sky Estates No. 1.  
**Applicant:** Paul and Linda LaStayo  
**Authorized Representative:** Bill Arthur  
**File Number:** HSR 2016-10

**A NEW RESIDENCE  
FOR  
Paul and Linda LaStayo  
4015 Bluebell Drive  
Liberty, UT**

**GEOLOGIC HAZARDS EVALUATION**

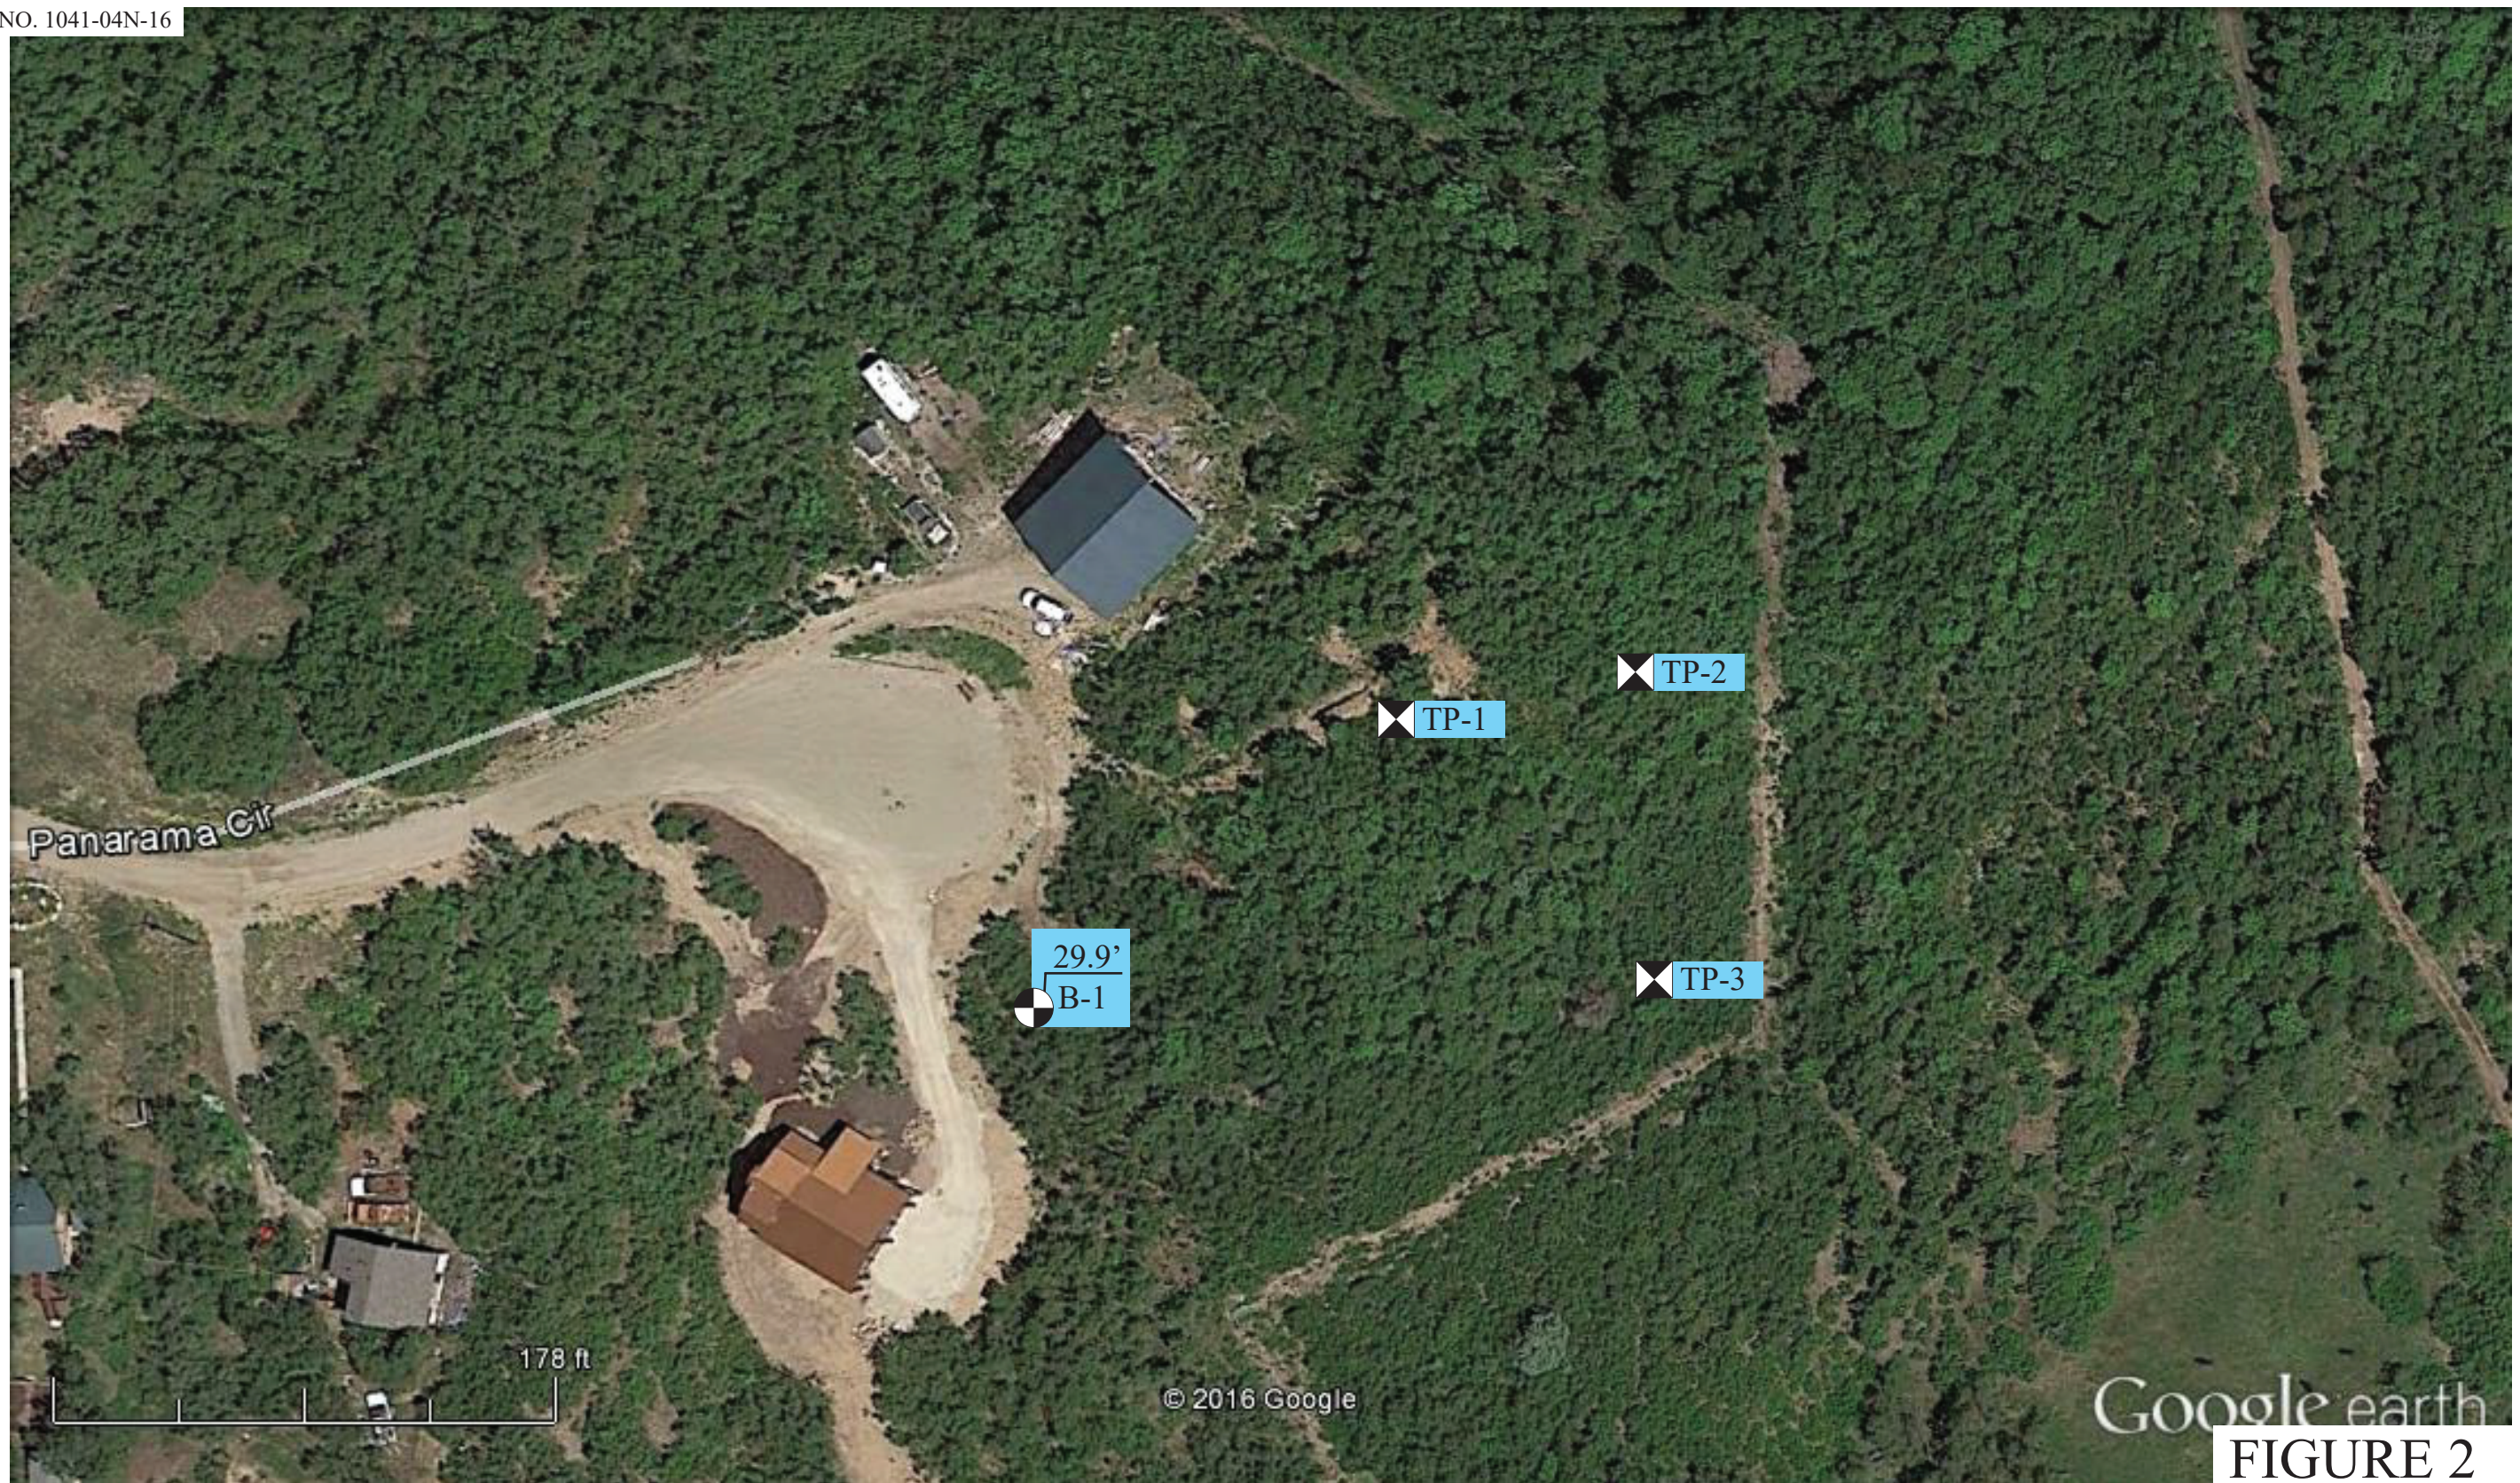
KEY:  
Measured Groundwater depth (feet)

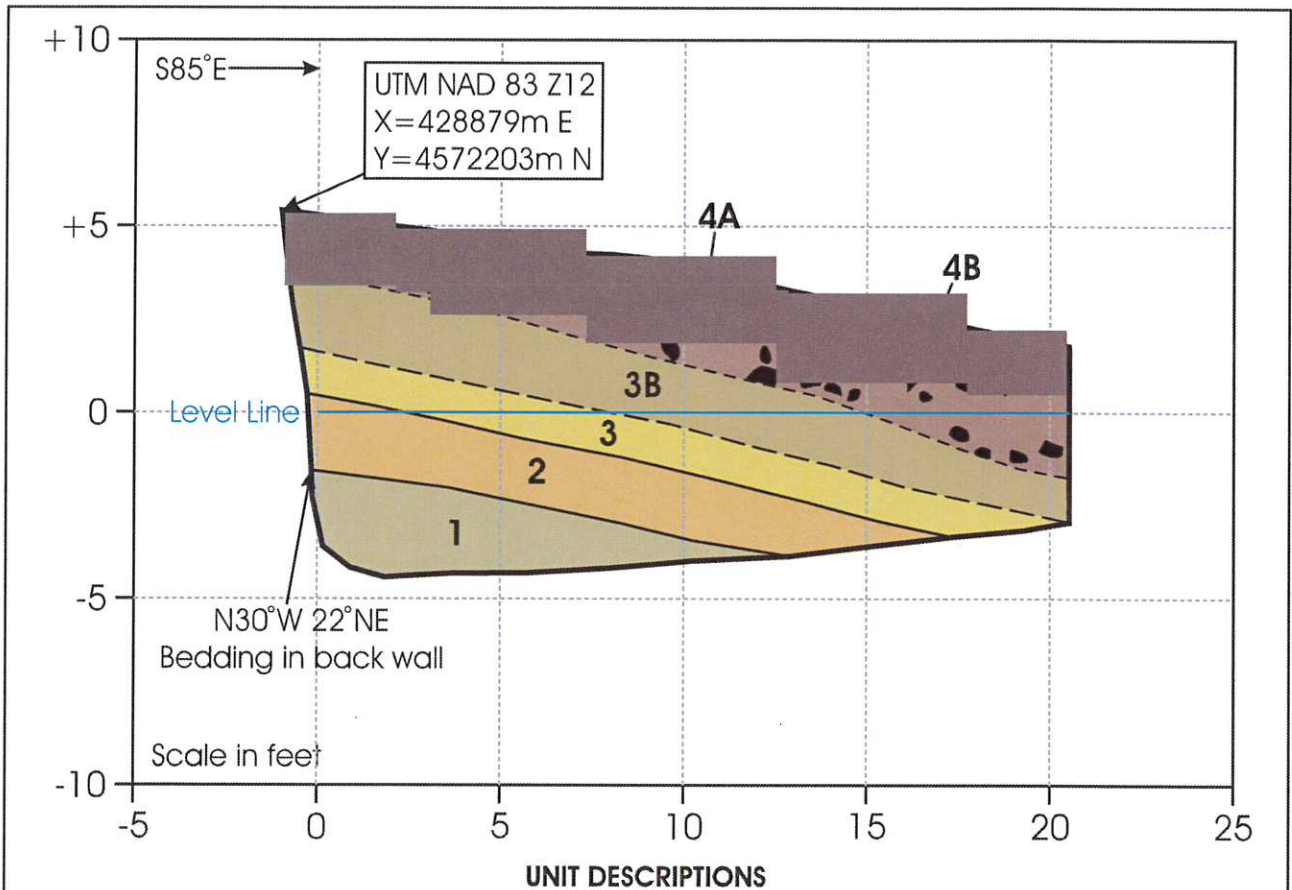
**Unit 1.** *Tertiary Norwood Formation* - Weathered tuffaceous claystone comprised of olive- to reddish-brown, moderate to high density, poorly bedded, lean to fat clay (CL/CH).

**Unit 2.** *Tertiary Norwood Formation* - Weathered tuffaceous siltstone comprised of pale-brown to pink, moderate density, poorly bedded, carbonate-enriched, silt (ML).

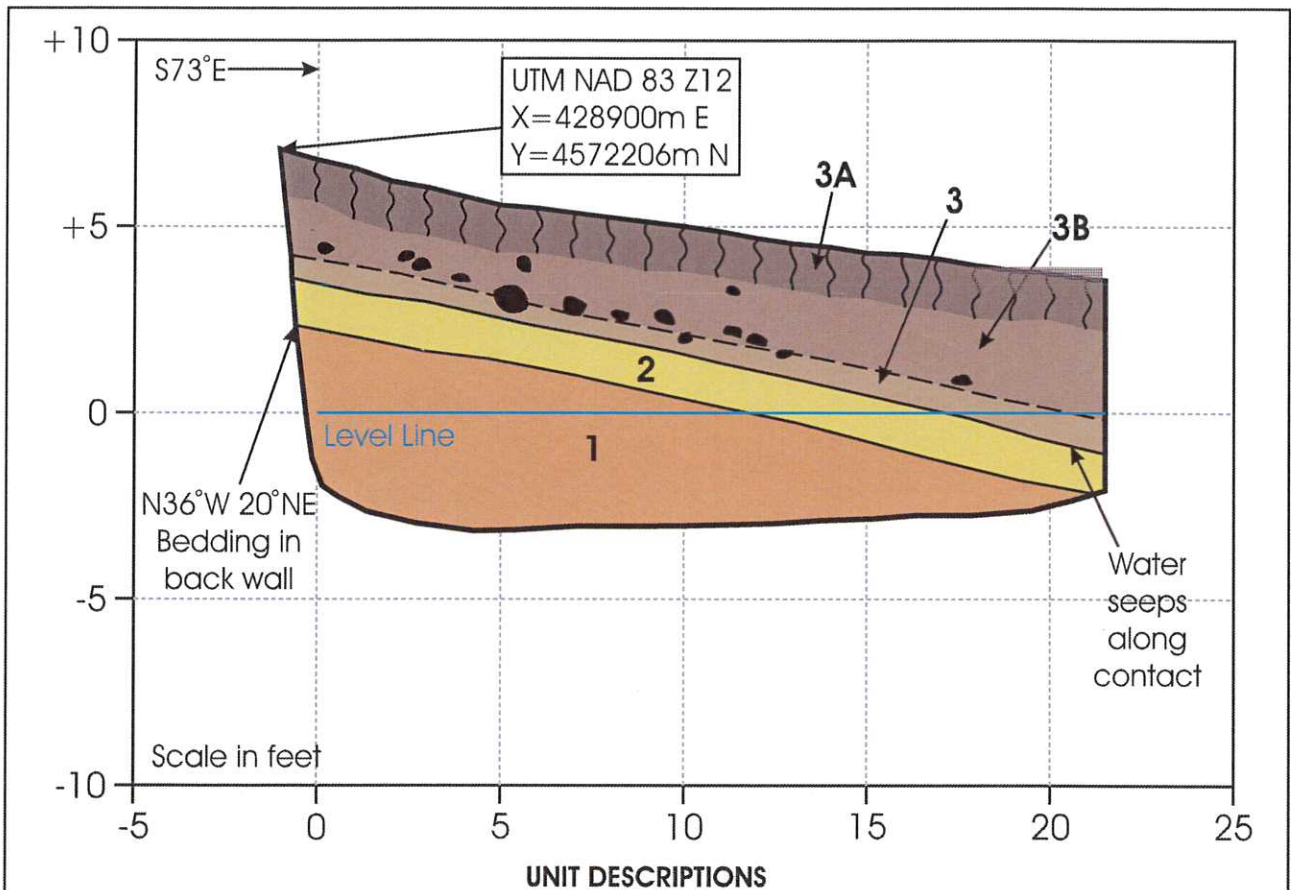
**Unit 1.** *Tertiary Norwood Formation* - Weathered tuffaceous siltstone to claystone comprised of reddish-brown, moderate to high density, poorly bedded, carbonate-enriched silt to lean clay (ML/CL).

**Unit 2.** *Tertiary Norwood Formation* - Weathered tuffaceous claystone comprised of olive- to brownish-olive, moderate to high density, poorly bedded, lean to fat clay (CL/CH).
