Staff Report for Administrative Approval
Hillside Review – Notice of Conditional Approval
Weber County Planning Division

Application Request: Consideration and action on a request to approve a Hillside Review for the Mariani residence located on Lot 5 in the Big Sky No. 1 Subdivision.
Applicant: David and Gayle Mariani
File Number: HSR 2016-09

GEOLOGIC HAZARDS EVALUATION

SUBJECT: Geologic Hazards Evaluation
Lot 5 Big Sky Estates No. 1
2337 North Panorama Circle
Liberty, Weber County, Utah

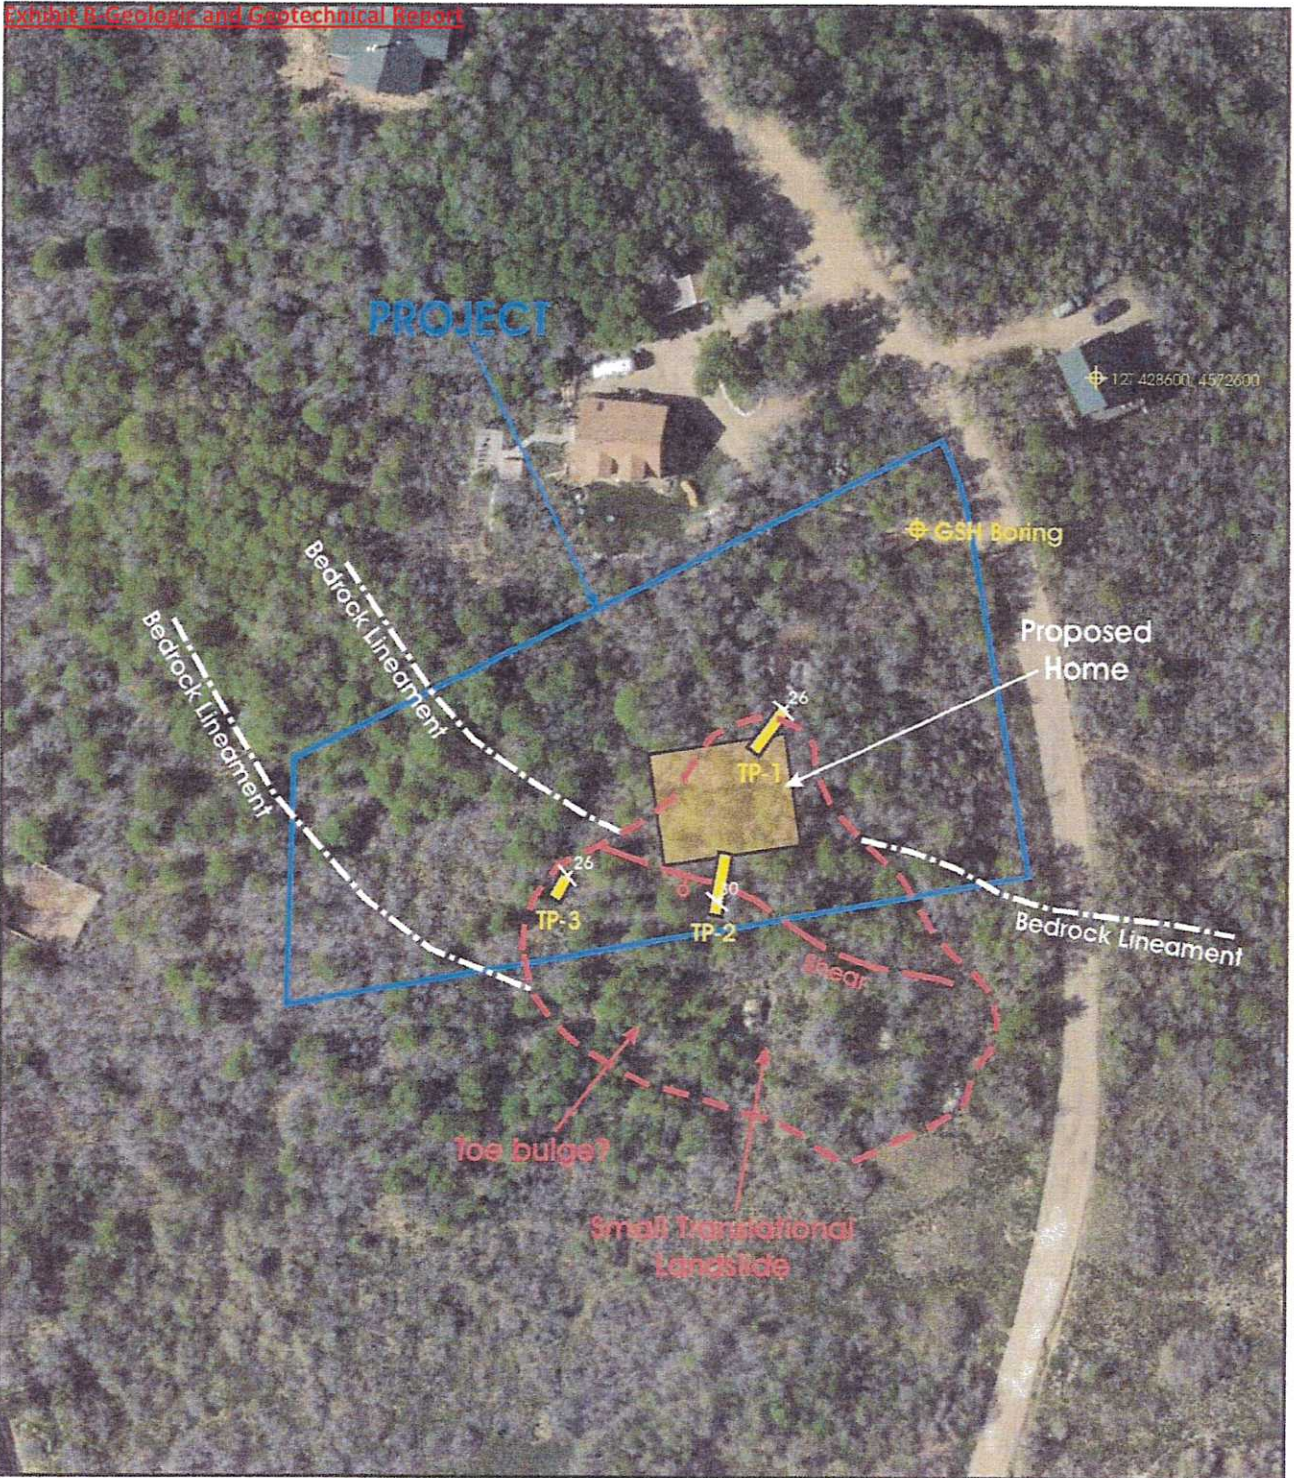
FIGURE 3A

Source: Utah AGRC, 2012 High-Resolution Orthophoto, 6-inch resolution.

High-resolution orthophotography from 2012 and 1-meter bare earth DEM LIDAR from 2011 available from the Utah AGRC (Figures 3A and 3B) were reviewed to obtain information about the geomorphology of the site area. Several bedrock lineaments (presumably contacts between subunits in the Norwood Formation) are evident of Figures 3A and 3B that are obscured across the Project by what appears to be a small landslide. The landslide head is slightly north of the proposed home; the failure then widens and descends downslope to the southwest to about 85-90 feet southwest of the home. A slight bulge is evident on both the 2012 aerial photo and 2011 LIDAR image in the toe area (Figures 3A and 3B). We note that this bulge is not evident on the surveyed topography on Figure 3C, which may be just an anomaly of the surveying methodology. Morphology of the landslide appears subdued or obscured, suggesting it may be an older feature (possibly latest Pleistocene to early Holocene in age). No evidence of other geologic hazards were observed on the air photos in the site area.

Three test pits were excavated at the property in April 2016 to evaluate subsurface conditions. Test pit locations are shown on Figures 3A-3C, and were measured using a

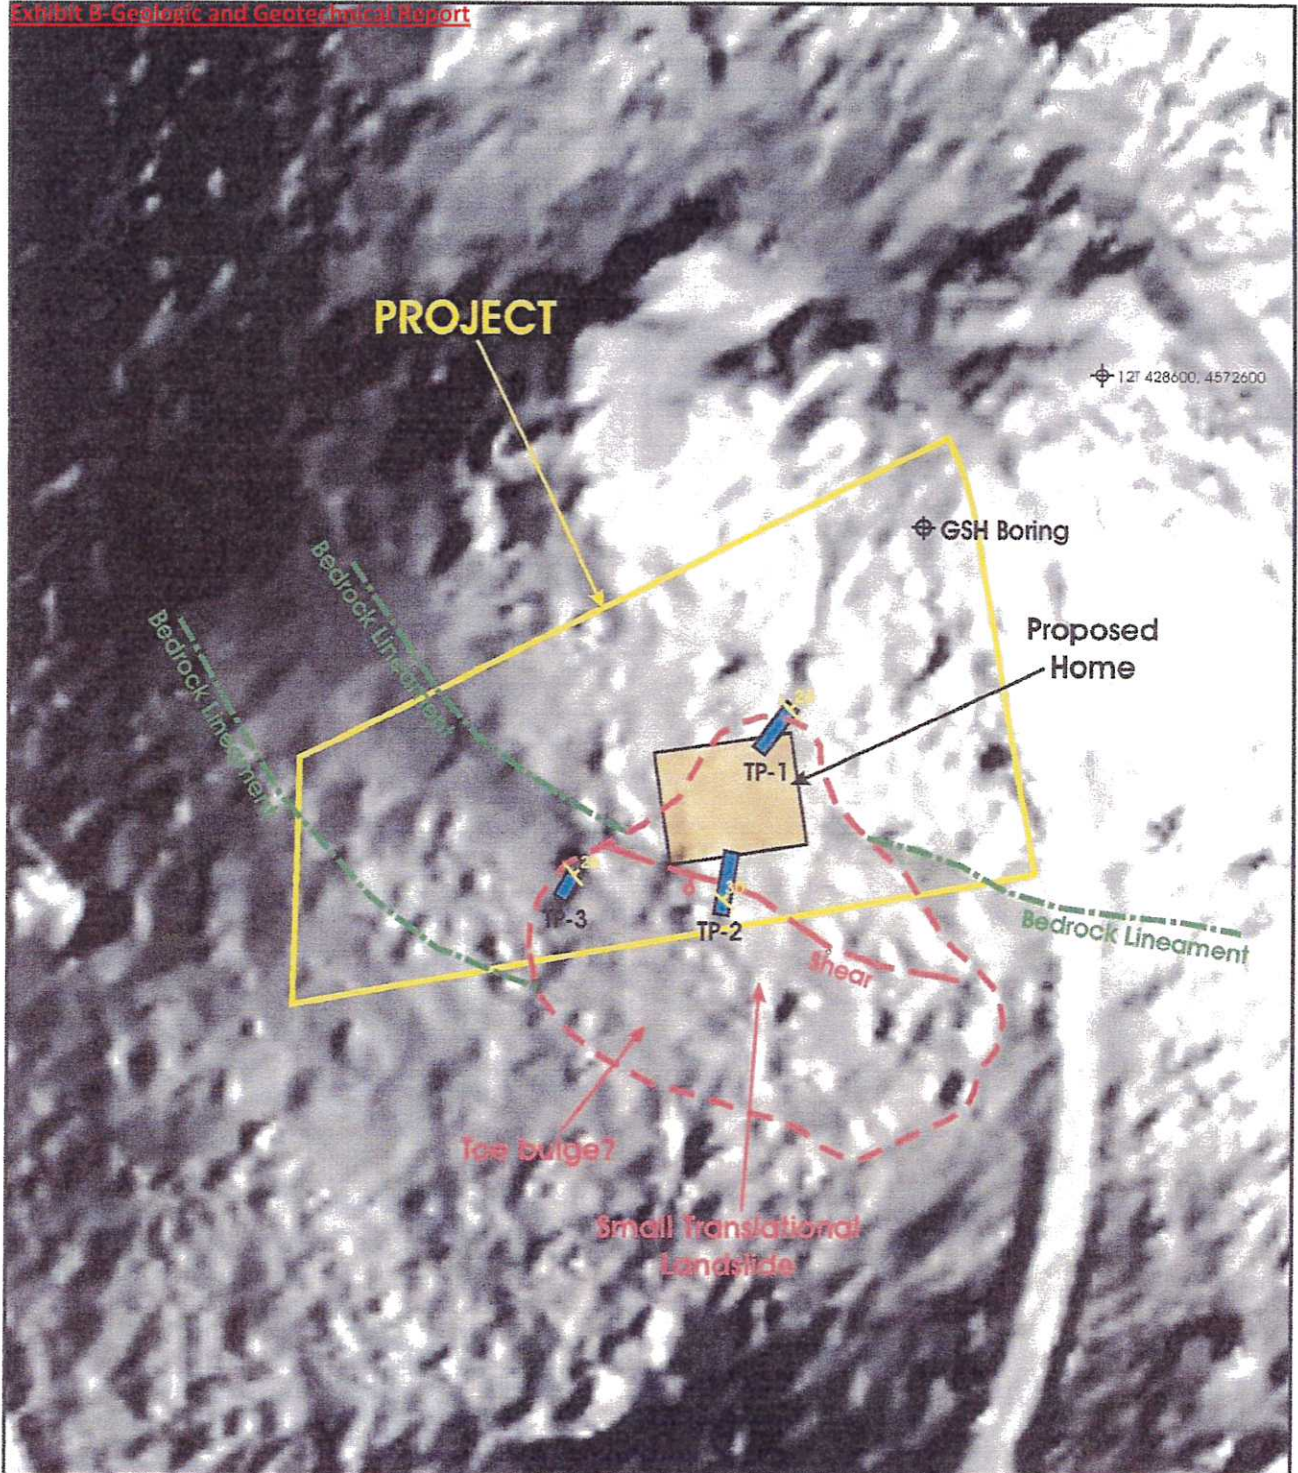
FIGURE 3B

Source: Utah AGRC, 2011 LIDAR Bare Earth DEM.

Test pit 2 (Figure 4B) exposed fractured and sheared sandstone bedrock (units 1 and 2) overlain by landslide colluvium (unit 3). Bedding in unit 1 near 9 feet horizontal (Figure 3B) showed a strike/dip of N50°W 30° NE, which suggests only a few degrees of backtilting and horizontal rotation. Many of the shears appeared to die out slightly above the trench floor, although several showed down-to-the-southwest displacements of up to several feet and continued below the test pit bottom. Trend of the shears ranged between N63° W to N76° W, generally similar to topographic contour trends.

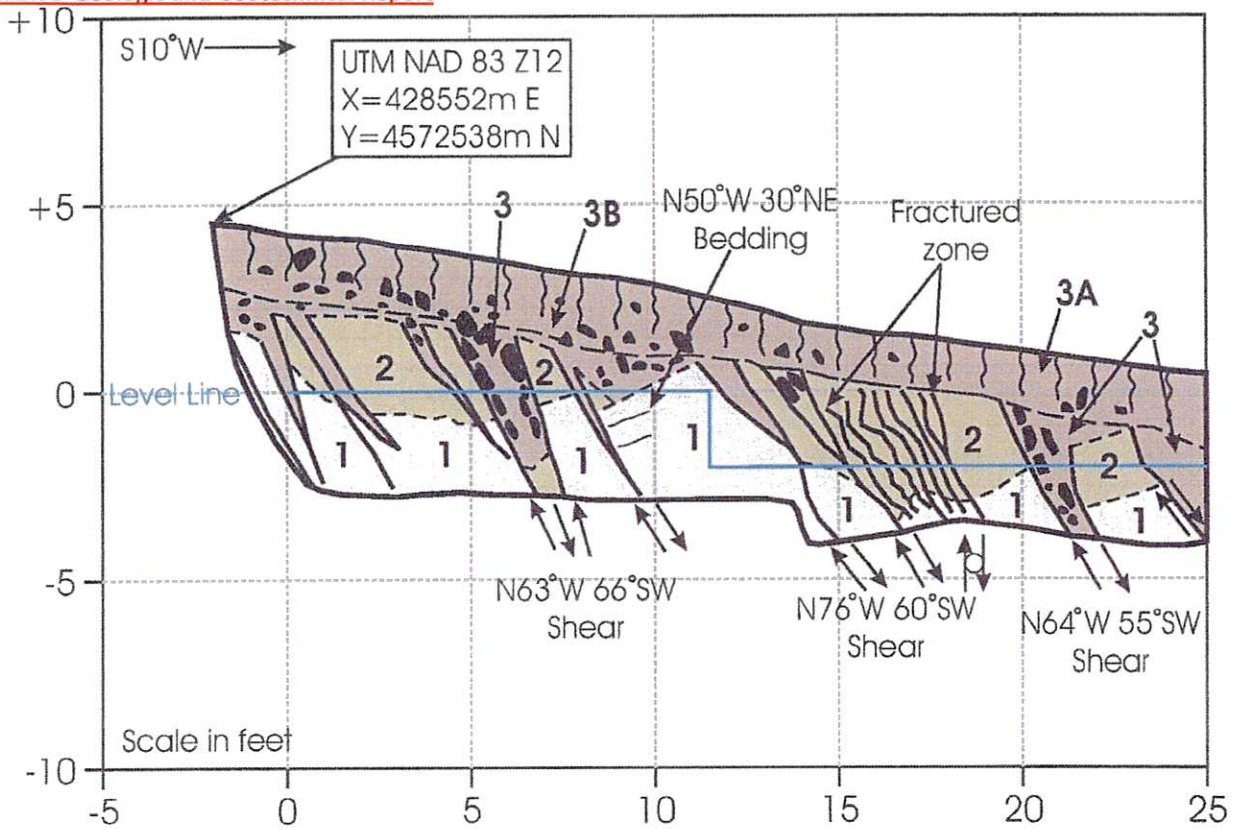
FIGURE 4B

UNIT DESCRIPTIONS

Unit 1. Tertiary Norwood Formation - Fractured, very dense, pale-gray, carbonate-enriched, well-bedded tuffaceous sandstone.

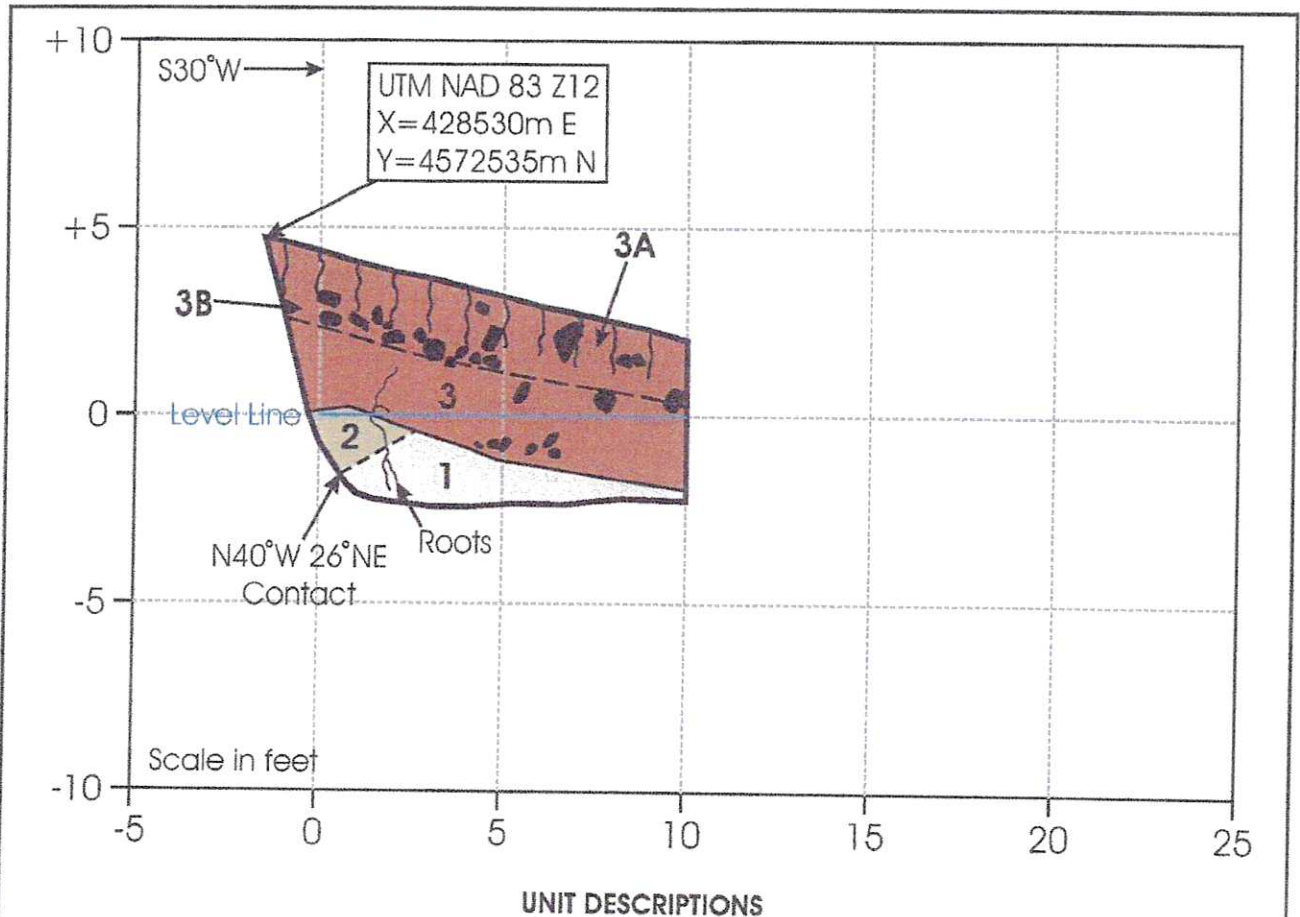
UNIT DESCRIPTIONS

Unit 1. Tertiary Norwood Formation - Fractured, very dense, pale-gray, carbonate-enriched, well-bedded tuffaceous sandstone.

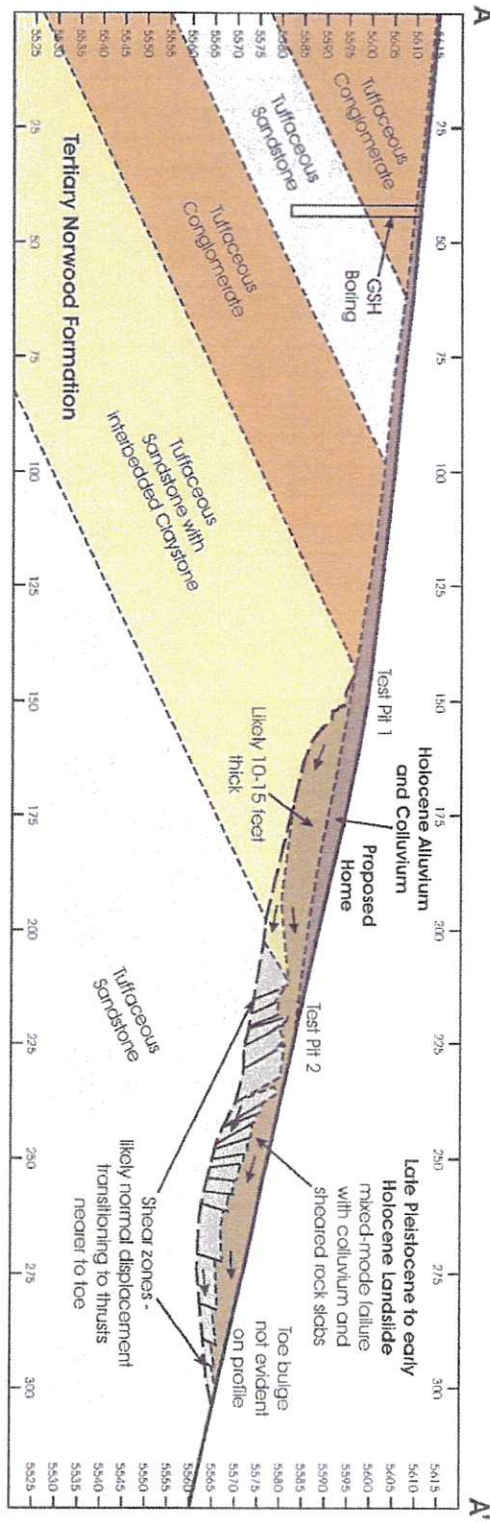
CROSS SECTION

SCALE: 1 inch = 25 feet
 No vertical exaggeration
 Contacts based on subsurface data and are inferred in unexplored areas and/or depth

A portion of the site, and particularly the area of the proposed home, is on what appears to be an older (late Pleistocene to early Holocene) landslide that is likely shallow and involved both shallow rotational and translational movement. Deformation from and colluvial deposits of the landslide are exposed in all the test pits at the site, although the low degree of deformation suggests it did not move very far. However, given the above we rate the risk from landsliding as high. We recommend stability of the slopes be evaluated in a geotechnical engineering evaluation prior to building based on site specific data and subsurface information included in this report. Recommendations for reducing the risk from landsliding should be provided if factors of safety are determined to be unsuitable. The stability evaluation should take into account possible perched groundwater and fluctuating seasonal levels. Care should also be taken that site grading does not destabilize slopes in this area without prior geotechnical analysis and grading plans, and that proper drainage is maintained.

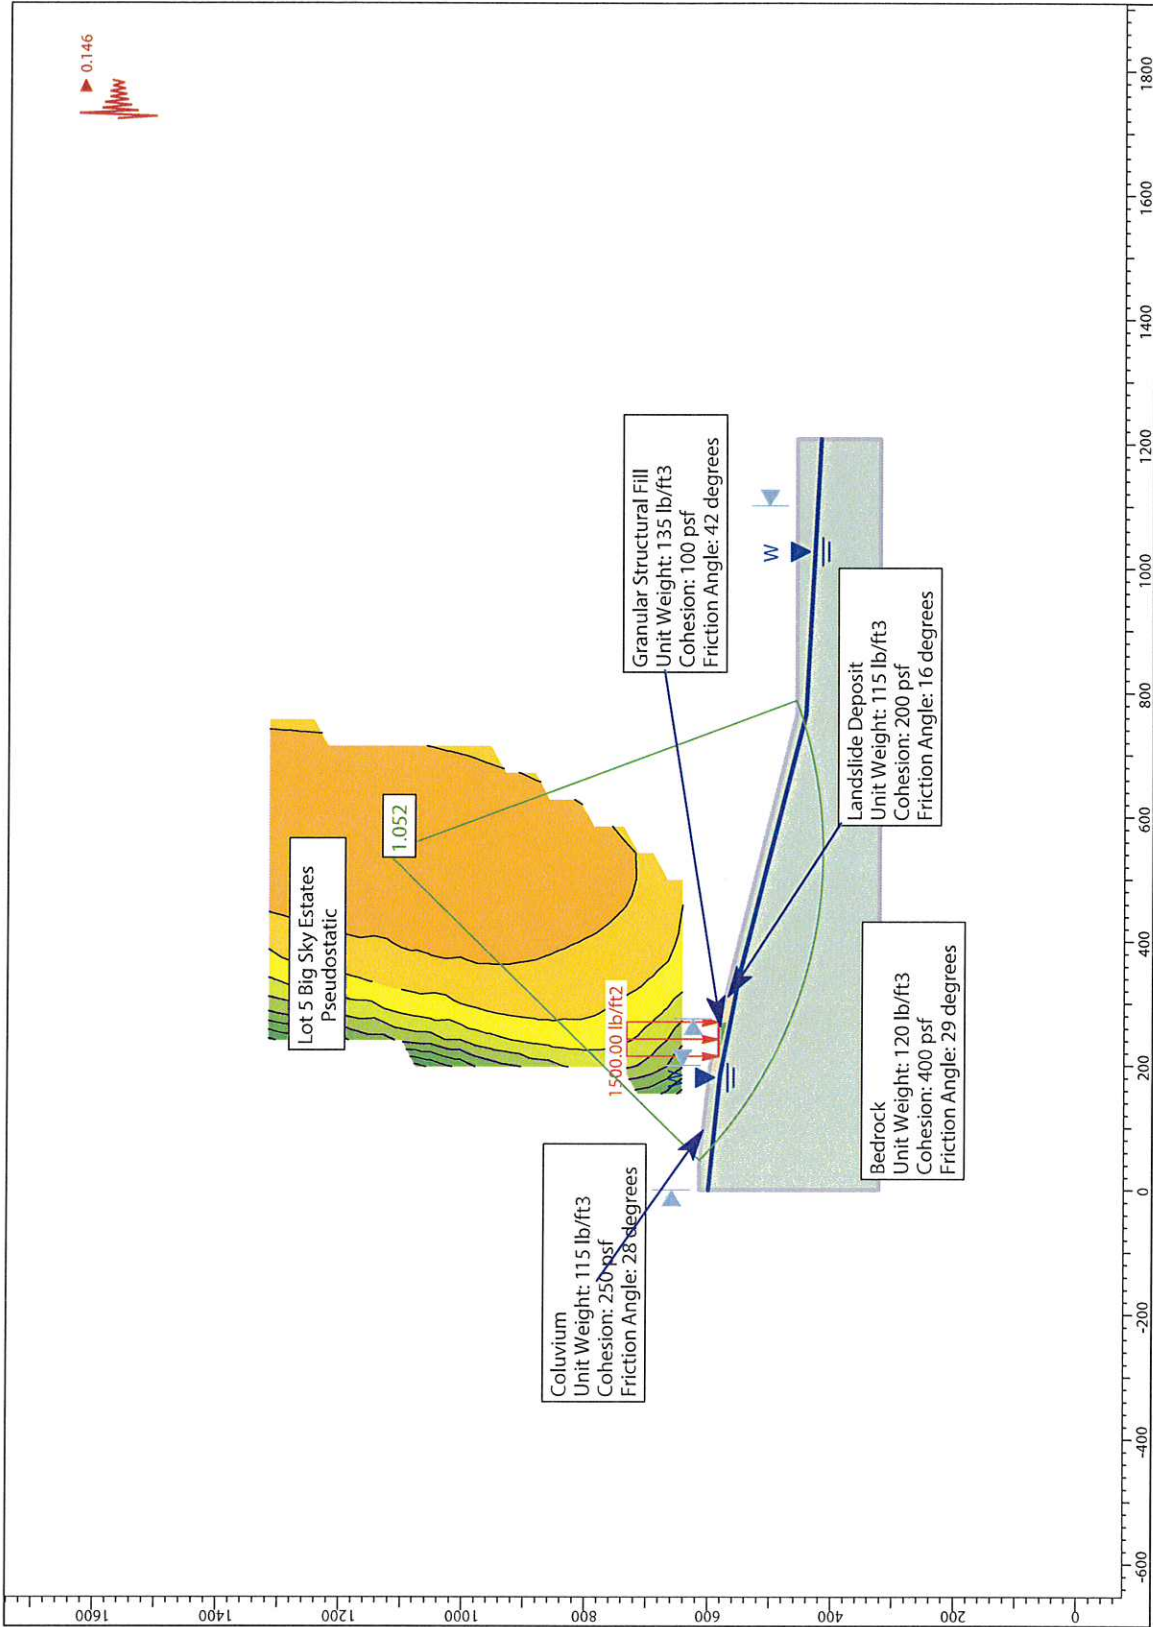
STABILITY RESULTS

LOT 5 BIG SKY ESTATES
