**REPORT
GEOLOGICAL HAZARDS STUDY
LOTS 22 AND 23
THE LEGENDS AT HAWKINS CREEK
6564 AND 6585 EAST CHAPARRAL ROAD
NEAR EDEN, WEBER COUNTY, UTAH**

Job No. 2129-01N-16

RE: Geological Study
Lots 22 and 23 The Legends at Hawkins Creek
Huntsville Area, Weber County, Utah
(Parts of the SW 1/4 Section 24, Township 6 North, Range 1 East, Salt Lake base and
meridian)

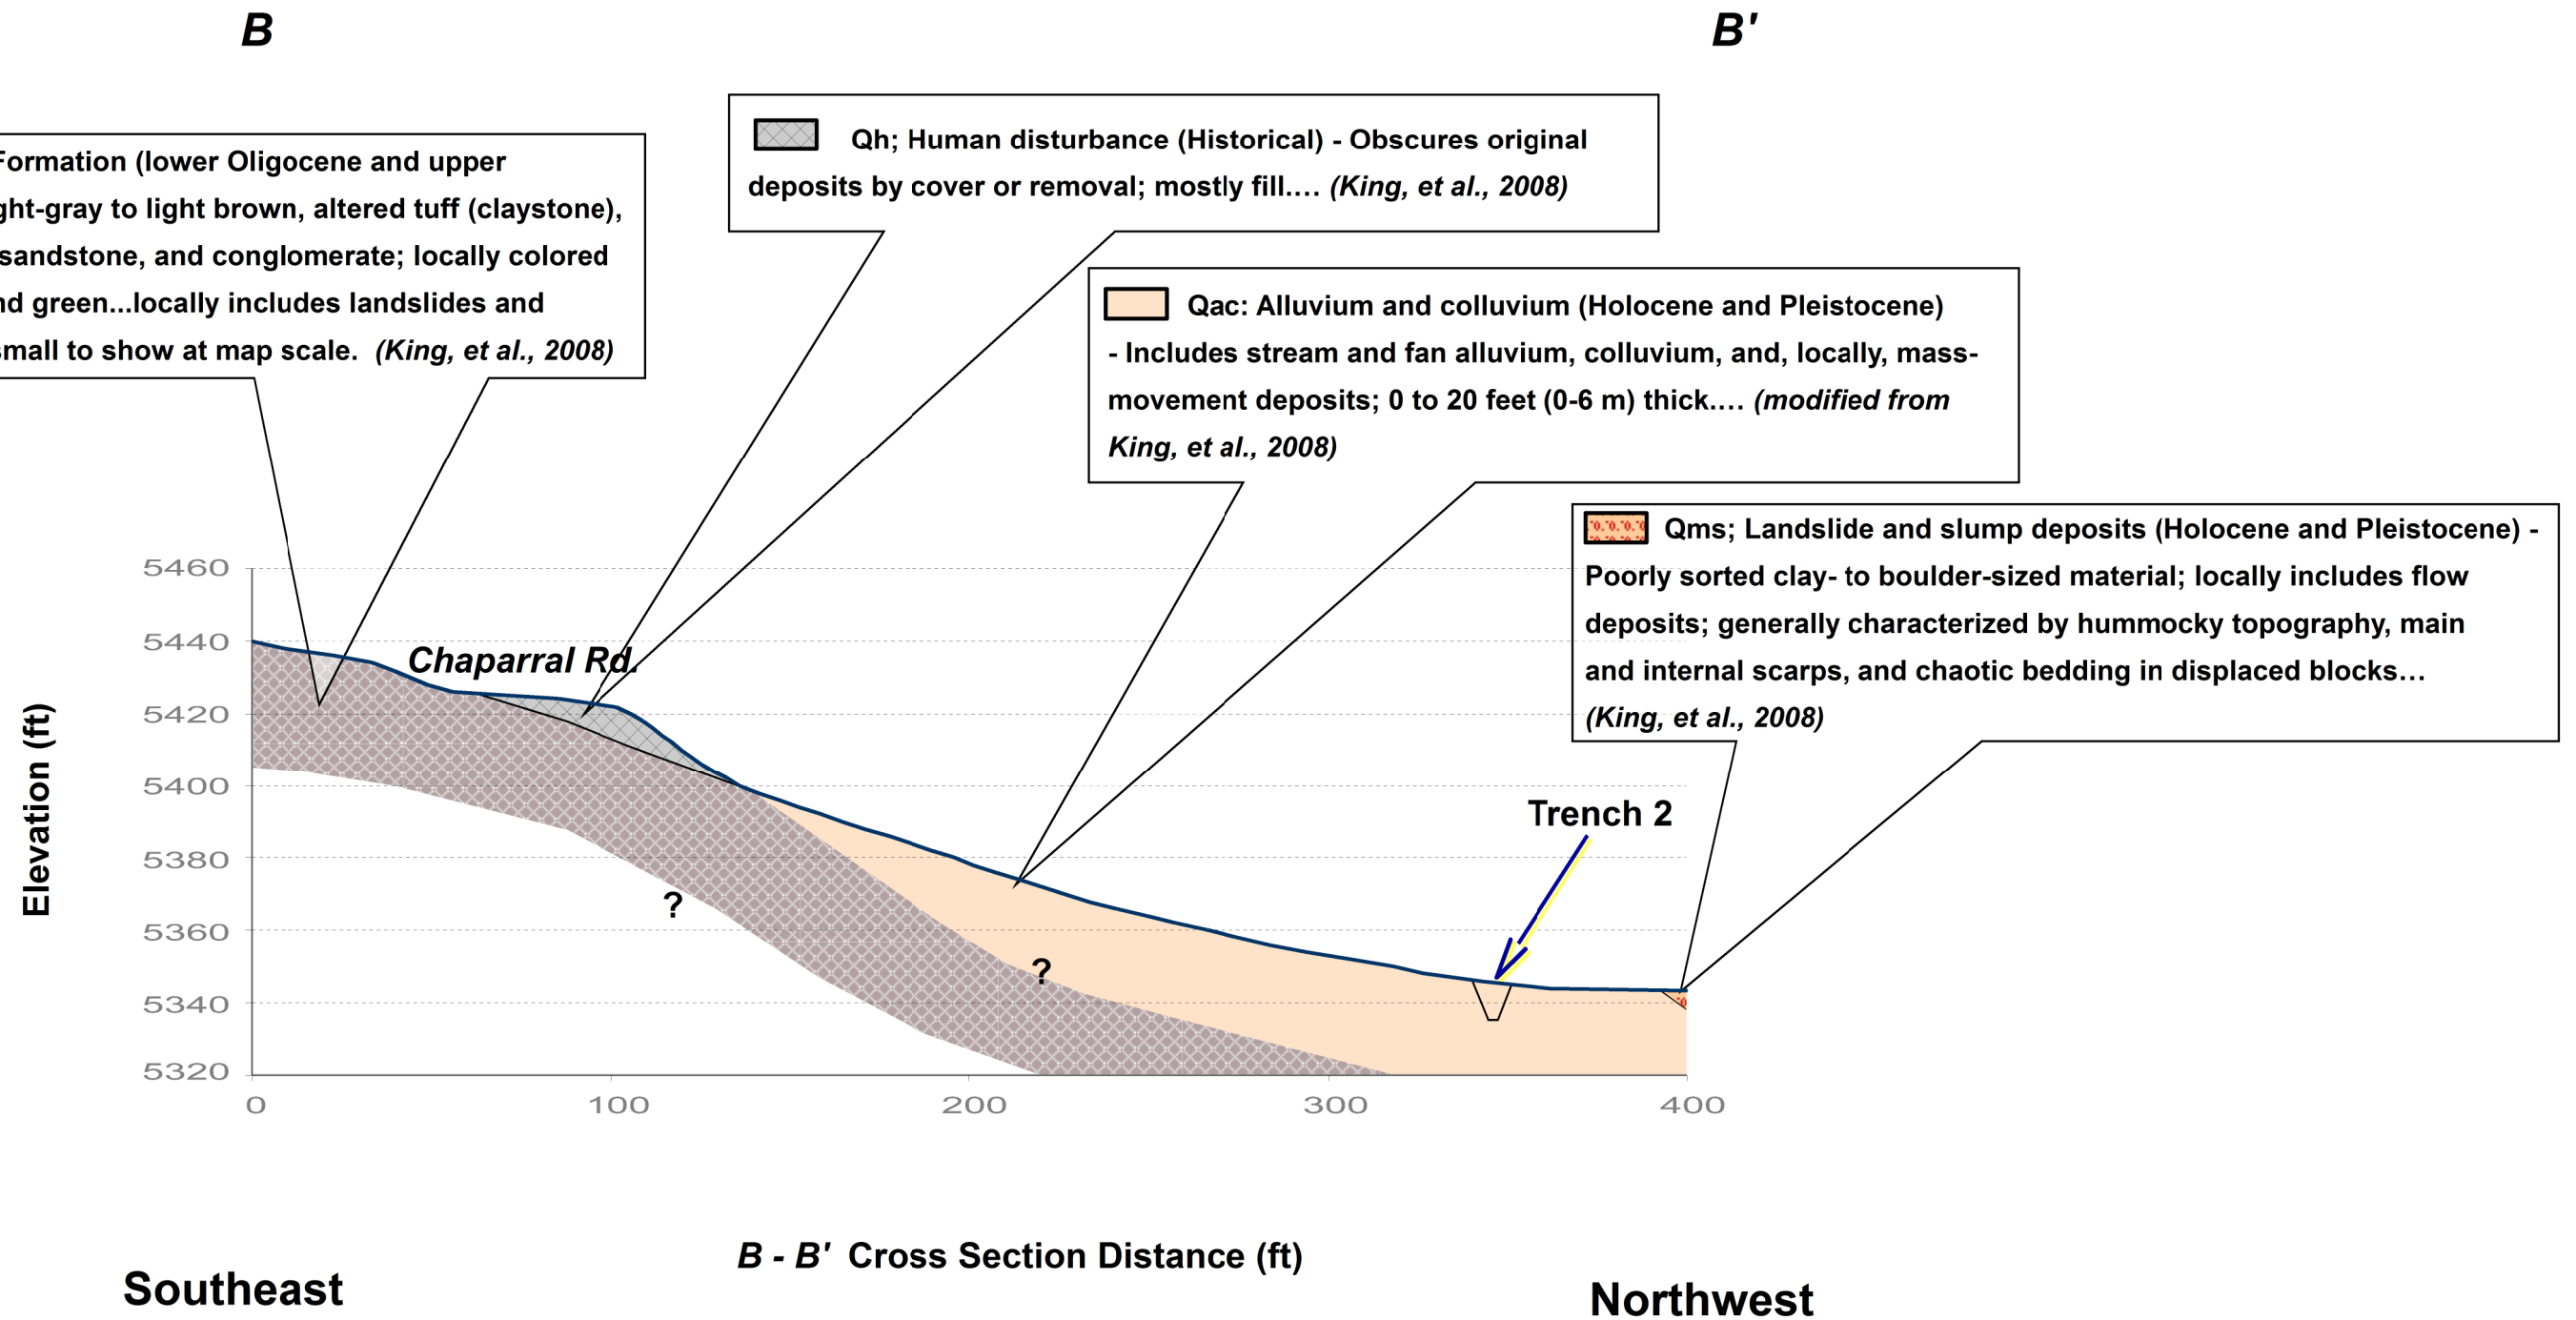
FIGURE 17
 SLOPE CROSS
 SECTION B-B'

* From Section Shown on Figure 4 and 15
