Staff Report for Administrative Approval
Hillside Review – Notice of Conditional Approval
Weber County Planning Division

Application Request: Consideration and action on a request to approve a Hillside Review for Lots 50R, 51R, 52R, 53R & 54R in the Summit at Ski Lake No. 13.
Applicant: Valley Enterprise Investment Company, LLC
Authorized Representative: Ray Bowden
File Number: HSR 2016-11

**REPORT
GEOLOGICAL STUDY
LOTS 50R TO 54R SUMMIT AT SKI LAKE NO. 13
EAST CLAIRETINA COURT
HUNTSVILLE, UTAH**

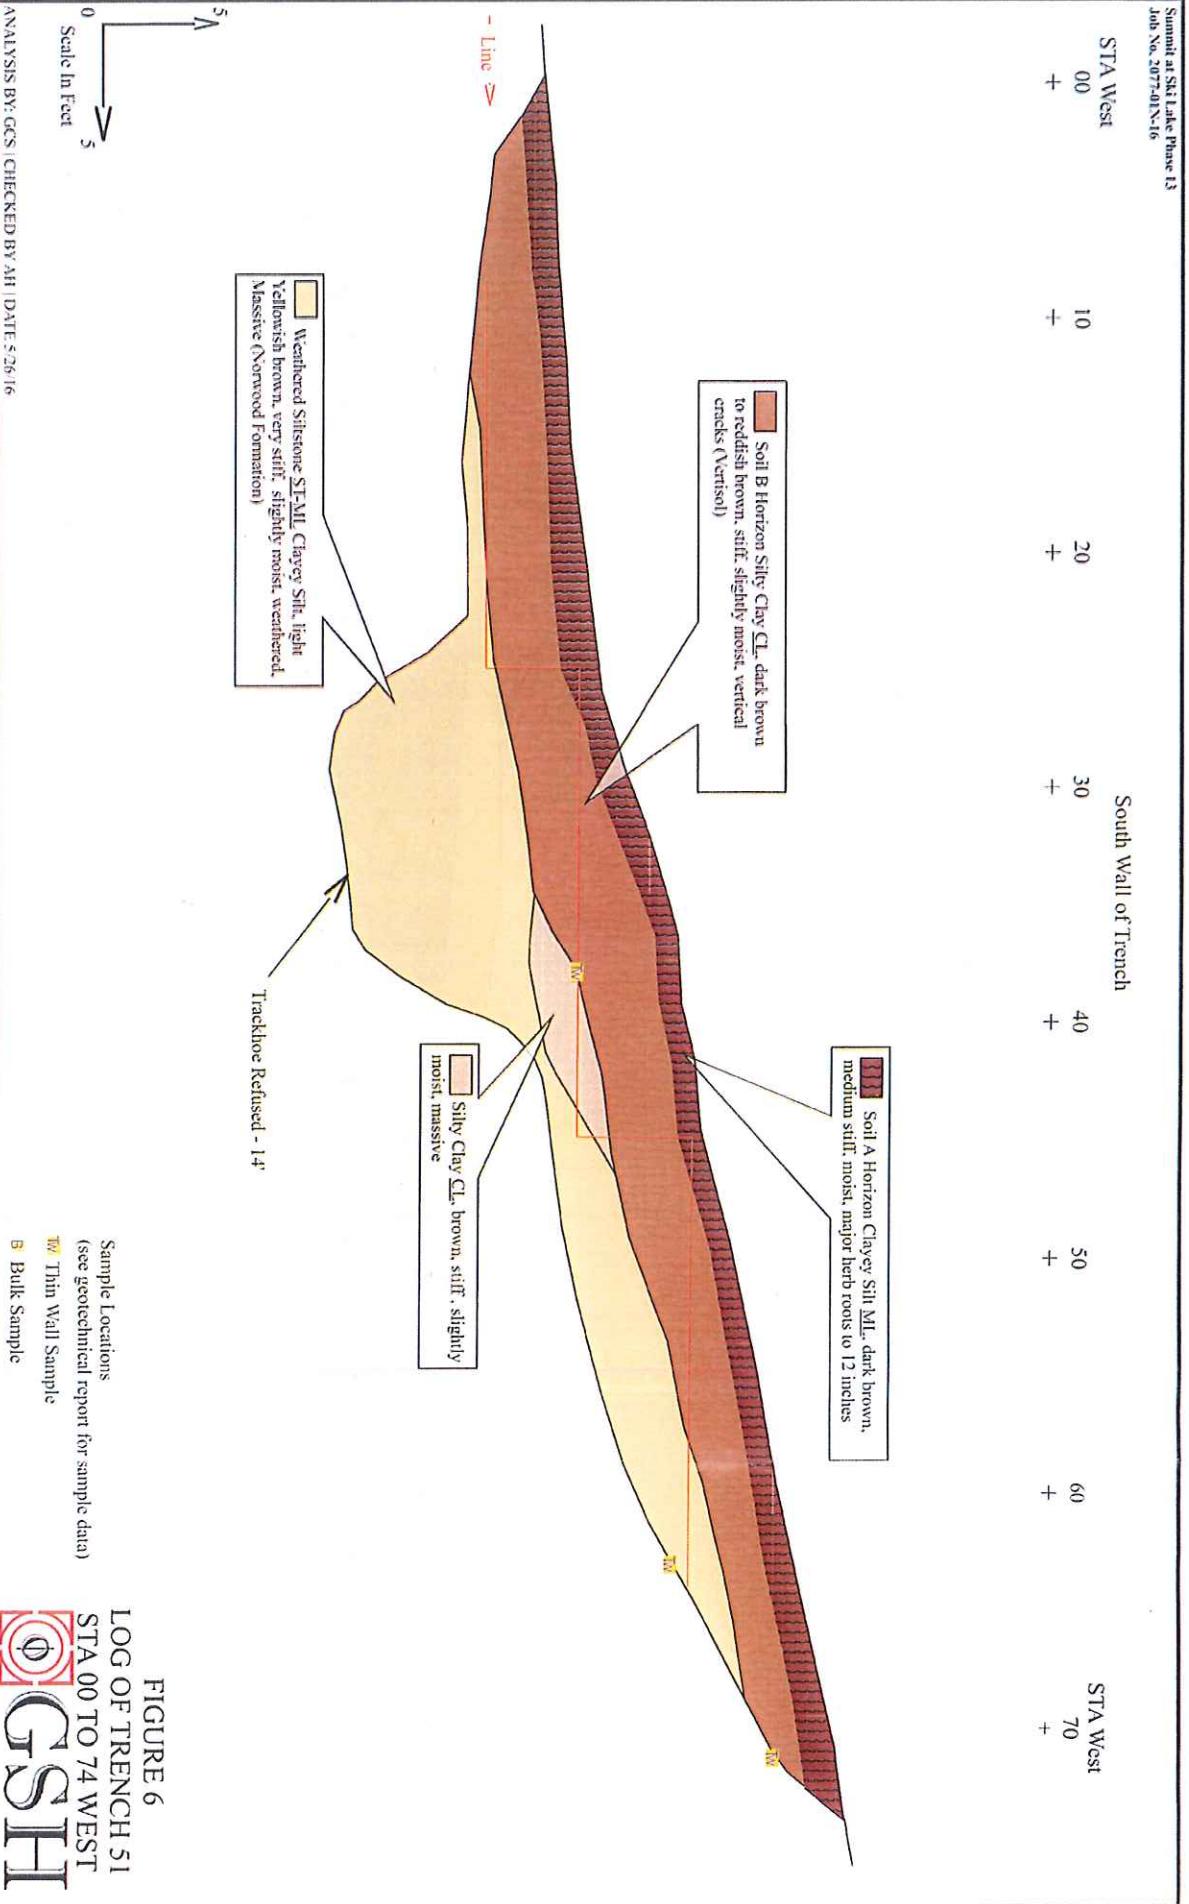
FIGURE 6
 LOG OF TRENCH 51
 STA 00 TO 74 WEST
 GSH

Sample Locations
 (see geotechnical report for sample data)

The natural rock and soils observed in the trenches and test pits and illustrated on our logs, Figures 5 to Figure 9, Logs of Trenches, and Figure 10 and Figure 11, Logs of Test Pits, generally consisted, from bottom to top of:

Landslide movement was observed in Trench 50 and Trench 51, and evidence of movement within the same feature was observed during our previous 2015 study in test pits GSH-2, GSH-3 and GSH-4 and on the Logged Roadway Geology Cut (GSH, 2015). This landslide feature is mapped on Figure 14, as Qms-2015. The landslide deformation and movement was observed beginning at the Logged Roadway Geology Cut on the Via Cortina roadway with movement detected in the trenches and test pits downslope from the cut in a northward direction, extending beyond the north property boundary, and joining a larger mapped landslide feature (King et al., 2008) north of the property boundary. The axial north-south length of the feature to the north property boundary is approximately 325 feet, and the east-west width is approximately 245 feet. The observed thickness of the landslide feature was from 10.0 feet in Trench 50, and possibly as thick as 15.0 feet in Test Pits GSH-2 and GSH-3 from our 2015 study (GSH 2015). The soils observed in Trench 51, appear to apical landslide flank soils on the western margin of the slide feature. The slide plane surface feature observed in the trenches displayed nominal deformation along the plane surface, with some oxidation accumulations (Fe Oxides) observed along the base of the movement in the trenches.

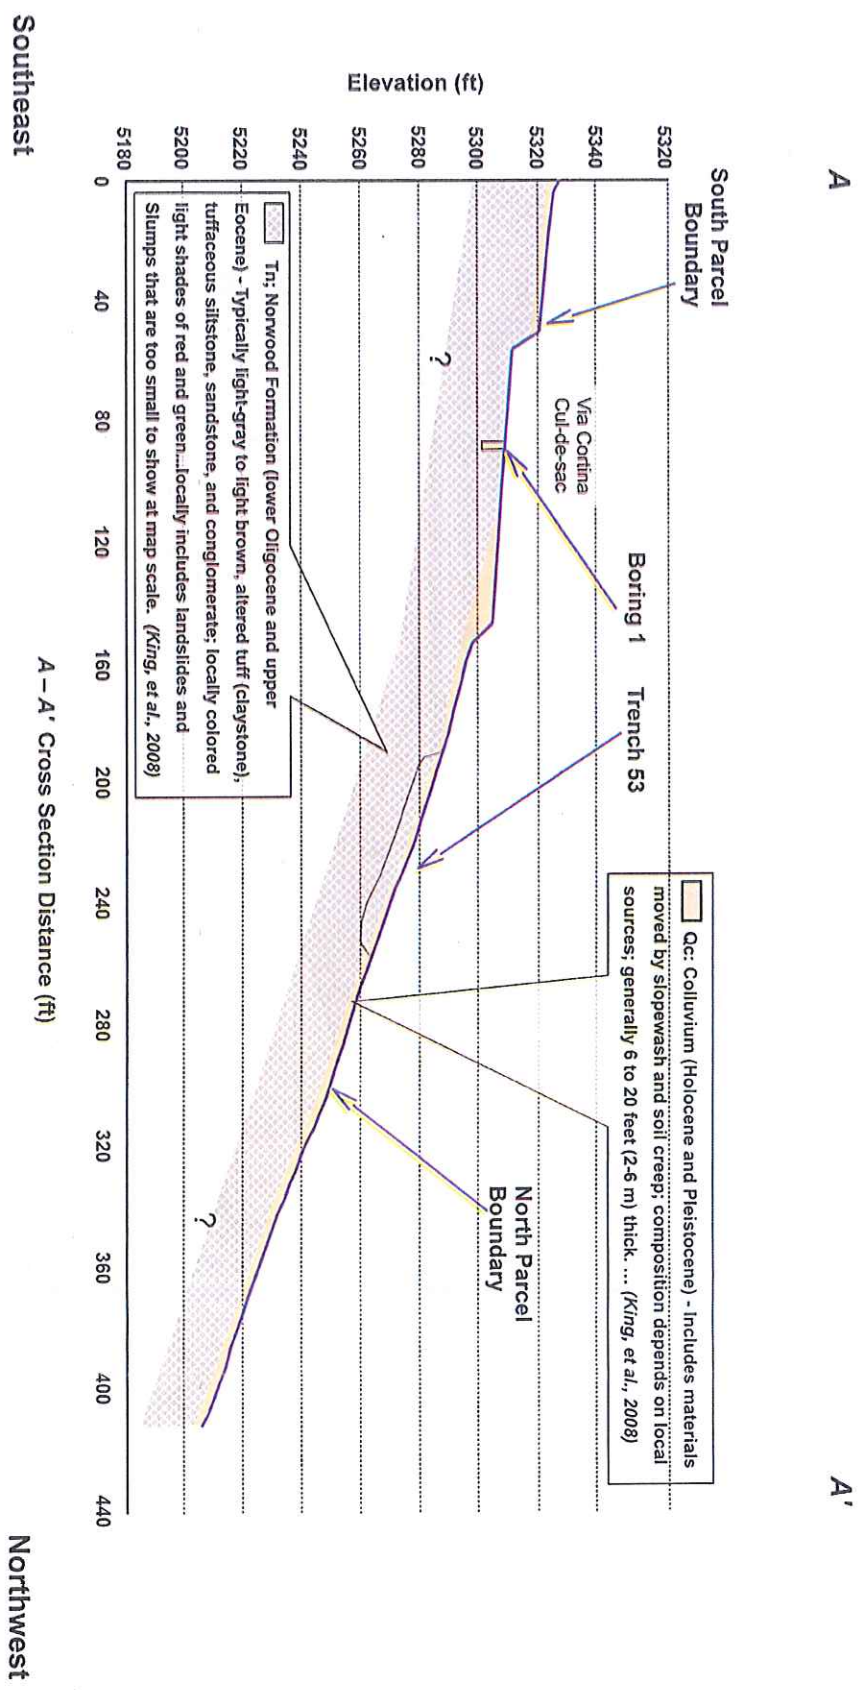
*Elevation data for the cross section were developed from 2.0 meter 2006 LIDAR digital elevation data. Elevations for the Via Cortina cut slopes were recorded using a hand-held GPS receiver device during our field program.
