**REPORT  
GEOLOGICAL STUDY  
LOTS 50R TO 54R SUMMIT AT SKI LAKE NO. 13  
EAST CLAIRETINA COURT  
HUNTSVILLE, UTAH**

Job No. 2077-01N-16

RE: Report  
Geological Study  
Five Residential Development Lots  
Lots 50R, 51R, 52R, 53R, and 54R  
The Summit at Ski Lake Phase 13  
Weber County, Utah  
(Parts of Section 24, Township 6 North, Range 1 East, Salt Lake base and meridian)

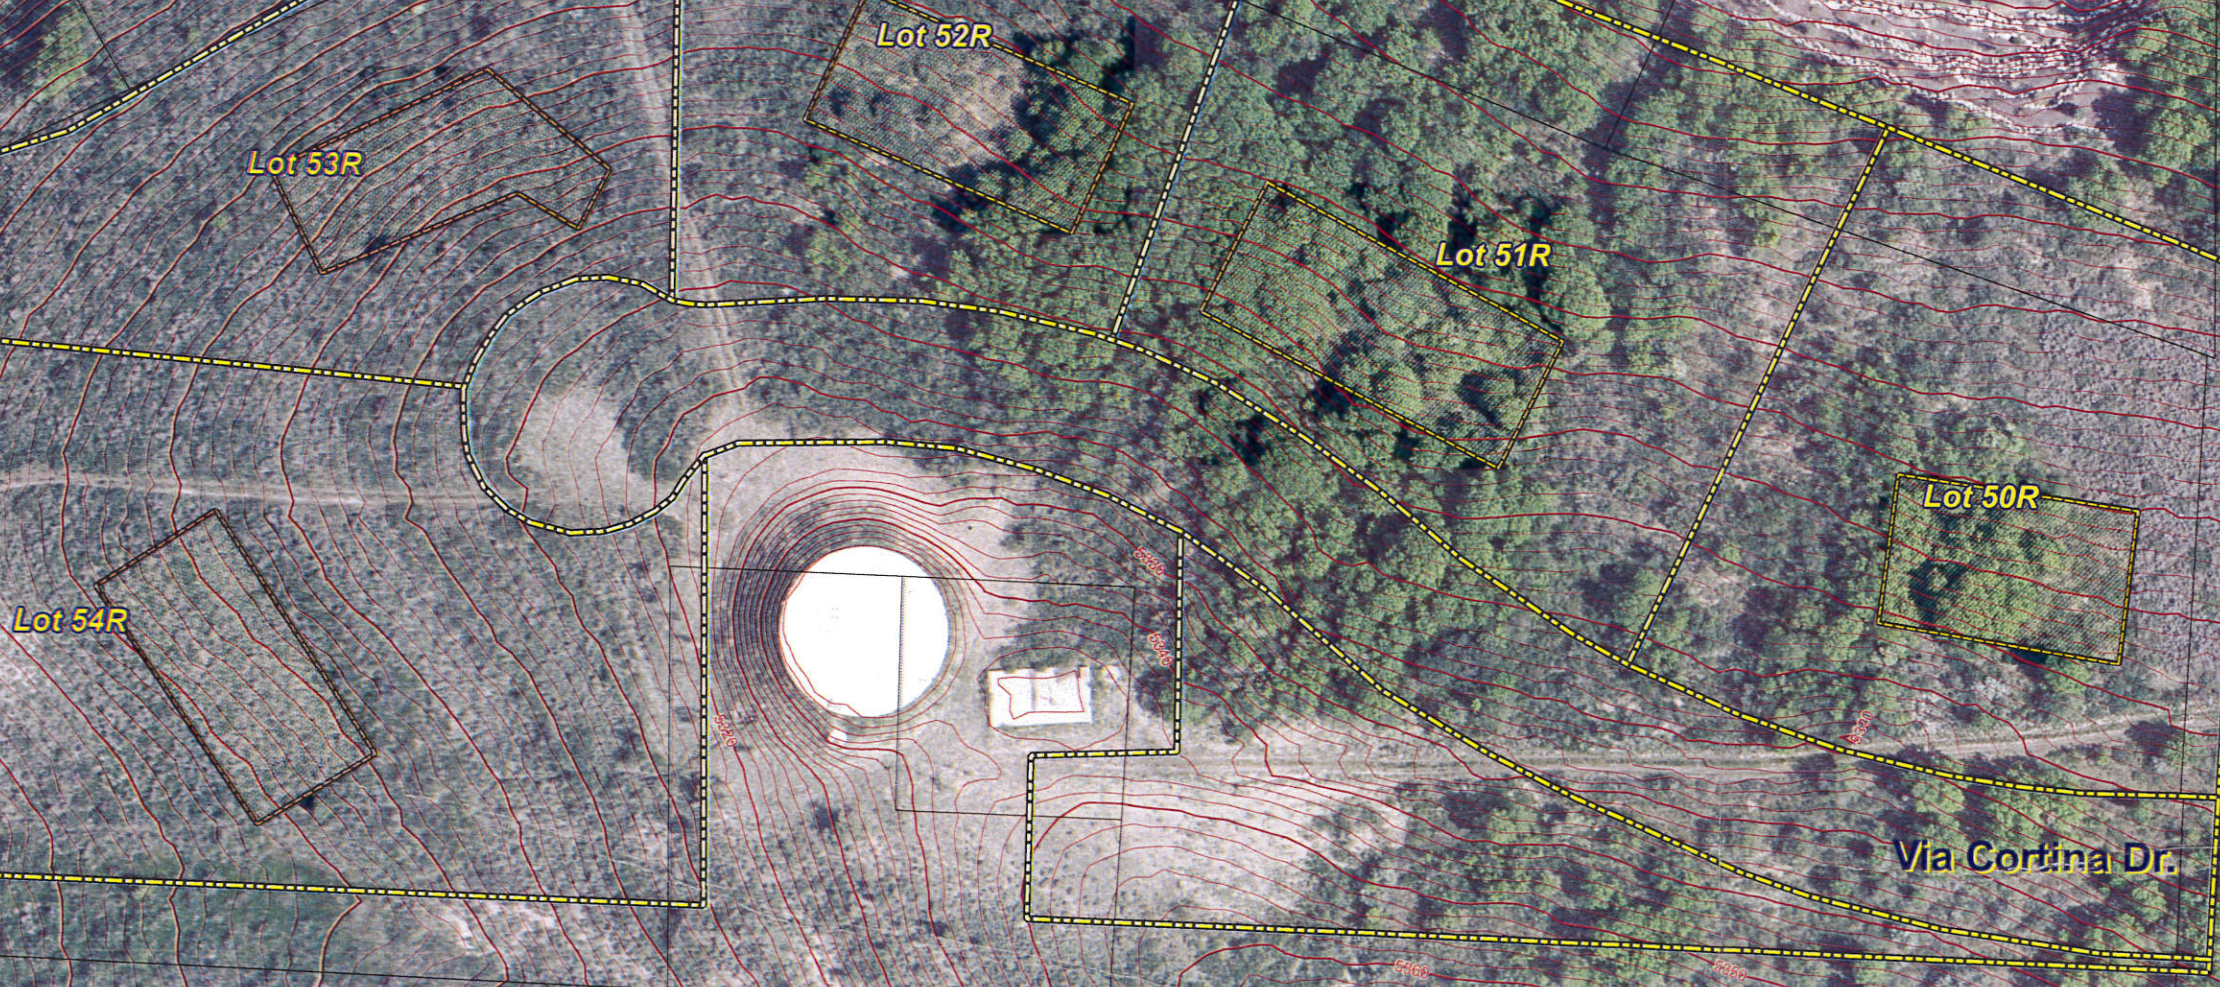
**FIGURE 2**  
**SITE PLAN**

As shown on Figure 2 and Figure 4, the site consists of an area of approximately 9.3 acres in size that is currently vacant and undeveloped. At the time of our 2016 field program, general grading for the Via Cortina roadway Clairtina Court had taken place. Surface vegetation consists of open areas of grasses, weeds and sage brush with clustered wooded areas of scrub oak, alder, box elder and maple tree cover. The topography of the site consists of a north facing hillslope with slopes on the property generally facing downward toward the north and northwest toward Ogden Valley.

shown on Figure 2 and Figure 4, and historical stereoscopic imagery flown in 1946. GIS analyses of elevation and geoprocessed DEM terrain data as discussed in the previous section (LiDAR-Slope Analysis) and shown on Figure 14, field reconnaissance of the general site area, and the interpretation of the trenches, test pits and borings excavated and drilled on the site as part of our field program. Seismic hazards information was developed from United States Geologic Survey (USGS) databases (Peterson, et al., 2008).

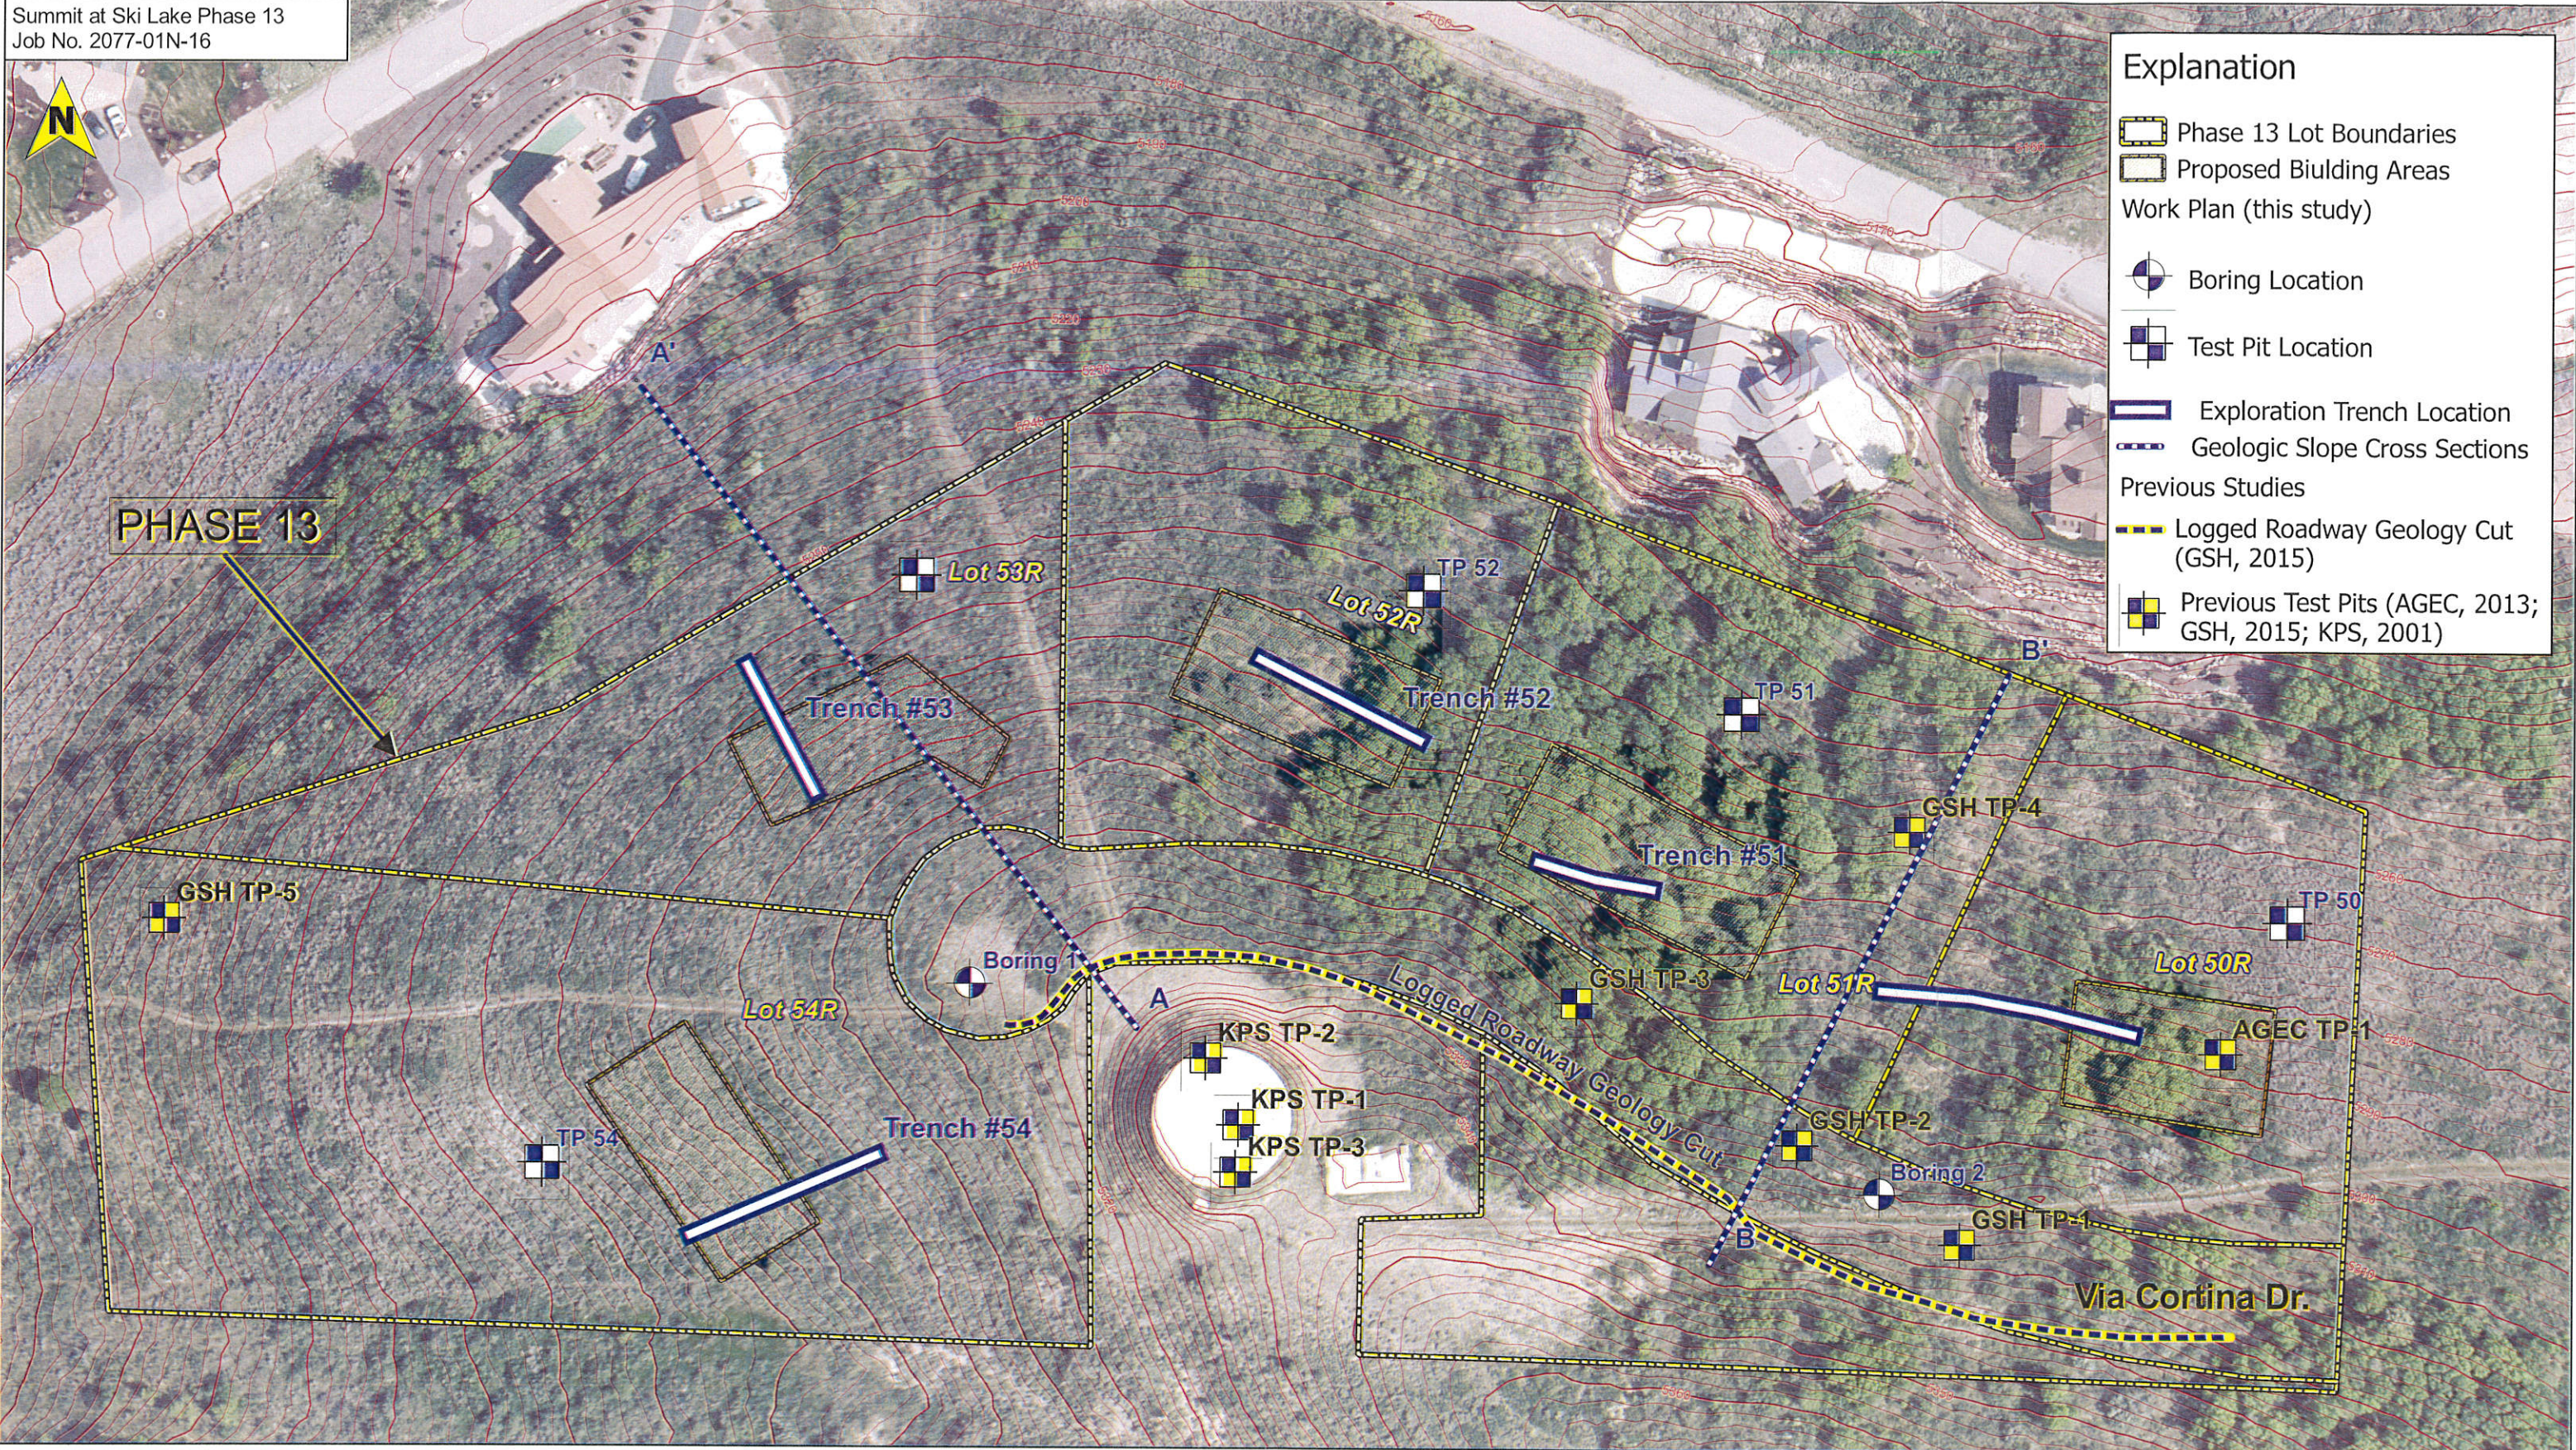
KPS and Associates, Inc., 2001; King, et al., 2008; Applied GeoTech, 2013; and GSH Geotechnical Inc., 2015, were reviewed. The KPS and Associates study involved a geotechnical evaluation and test pit excavations for a water tank constructed on the south side of the Parcel. The King, et al , 2008 document is an Open-file UGS geological mapping project of the Snow Basin and Huntsville, Utah quadrangles, which includes the location of the Phase 13 Parcel. The 2013 Applied GeoTech study was a geotechnical evaluation conducted for surrounding Phases 12 and 13 of the Ski Lake development that included four test pit explorations. The 2015 GSH Geotechnical Inc., study was a geological investigation conducted for the extension of the Via Cortina roadway on the south side of the Parcel site. The GSH Study included the geological logging of approximately 700 feet of vertical cut exposure made for the roadway extension, and four "walk-in" test pits. The locations of the test pits and cut exposure walls investigated in the previous studies are included on Figure 4, Work Plan.

The logs of the two borings shown on Figure 4 that were made for our concurrent geotechnical study and included in this reporting, are included on Figure 12 and Figure 13. The borings were completed using a CME 55 truck-mounted drill rig using hollow-stem auger/rotary wash equipment and methods. Soil and rock samples were recovered at 2.5-foot intervals using driven 2.42-inch inside diameter drive Dames & Moore sampler. The borings were also logged in accordance with the Unified Soil Classification System (USCS).

Based on our observations, the area of movement, Qms-2016 shown on Figures 4 and 14 consists of a relatively shallow, approximately 10.0 to 15.0 feet in thickness, block of soil that appears to have moved or "creeped" downslope in response to inherent weak and expansive soil characteristics, and the moderately steep slope conditions in this area. Based upon our observations of evident topographic surface expression of this feature, we believe that this movement is presently active.

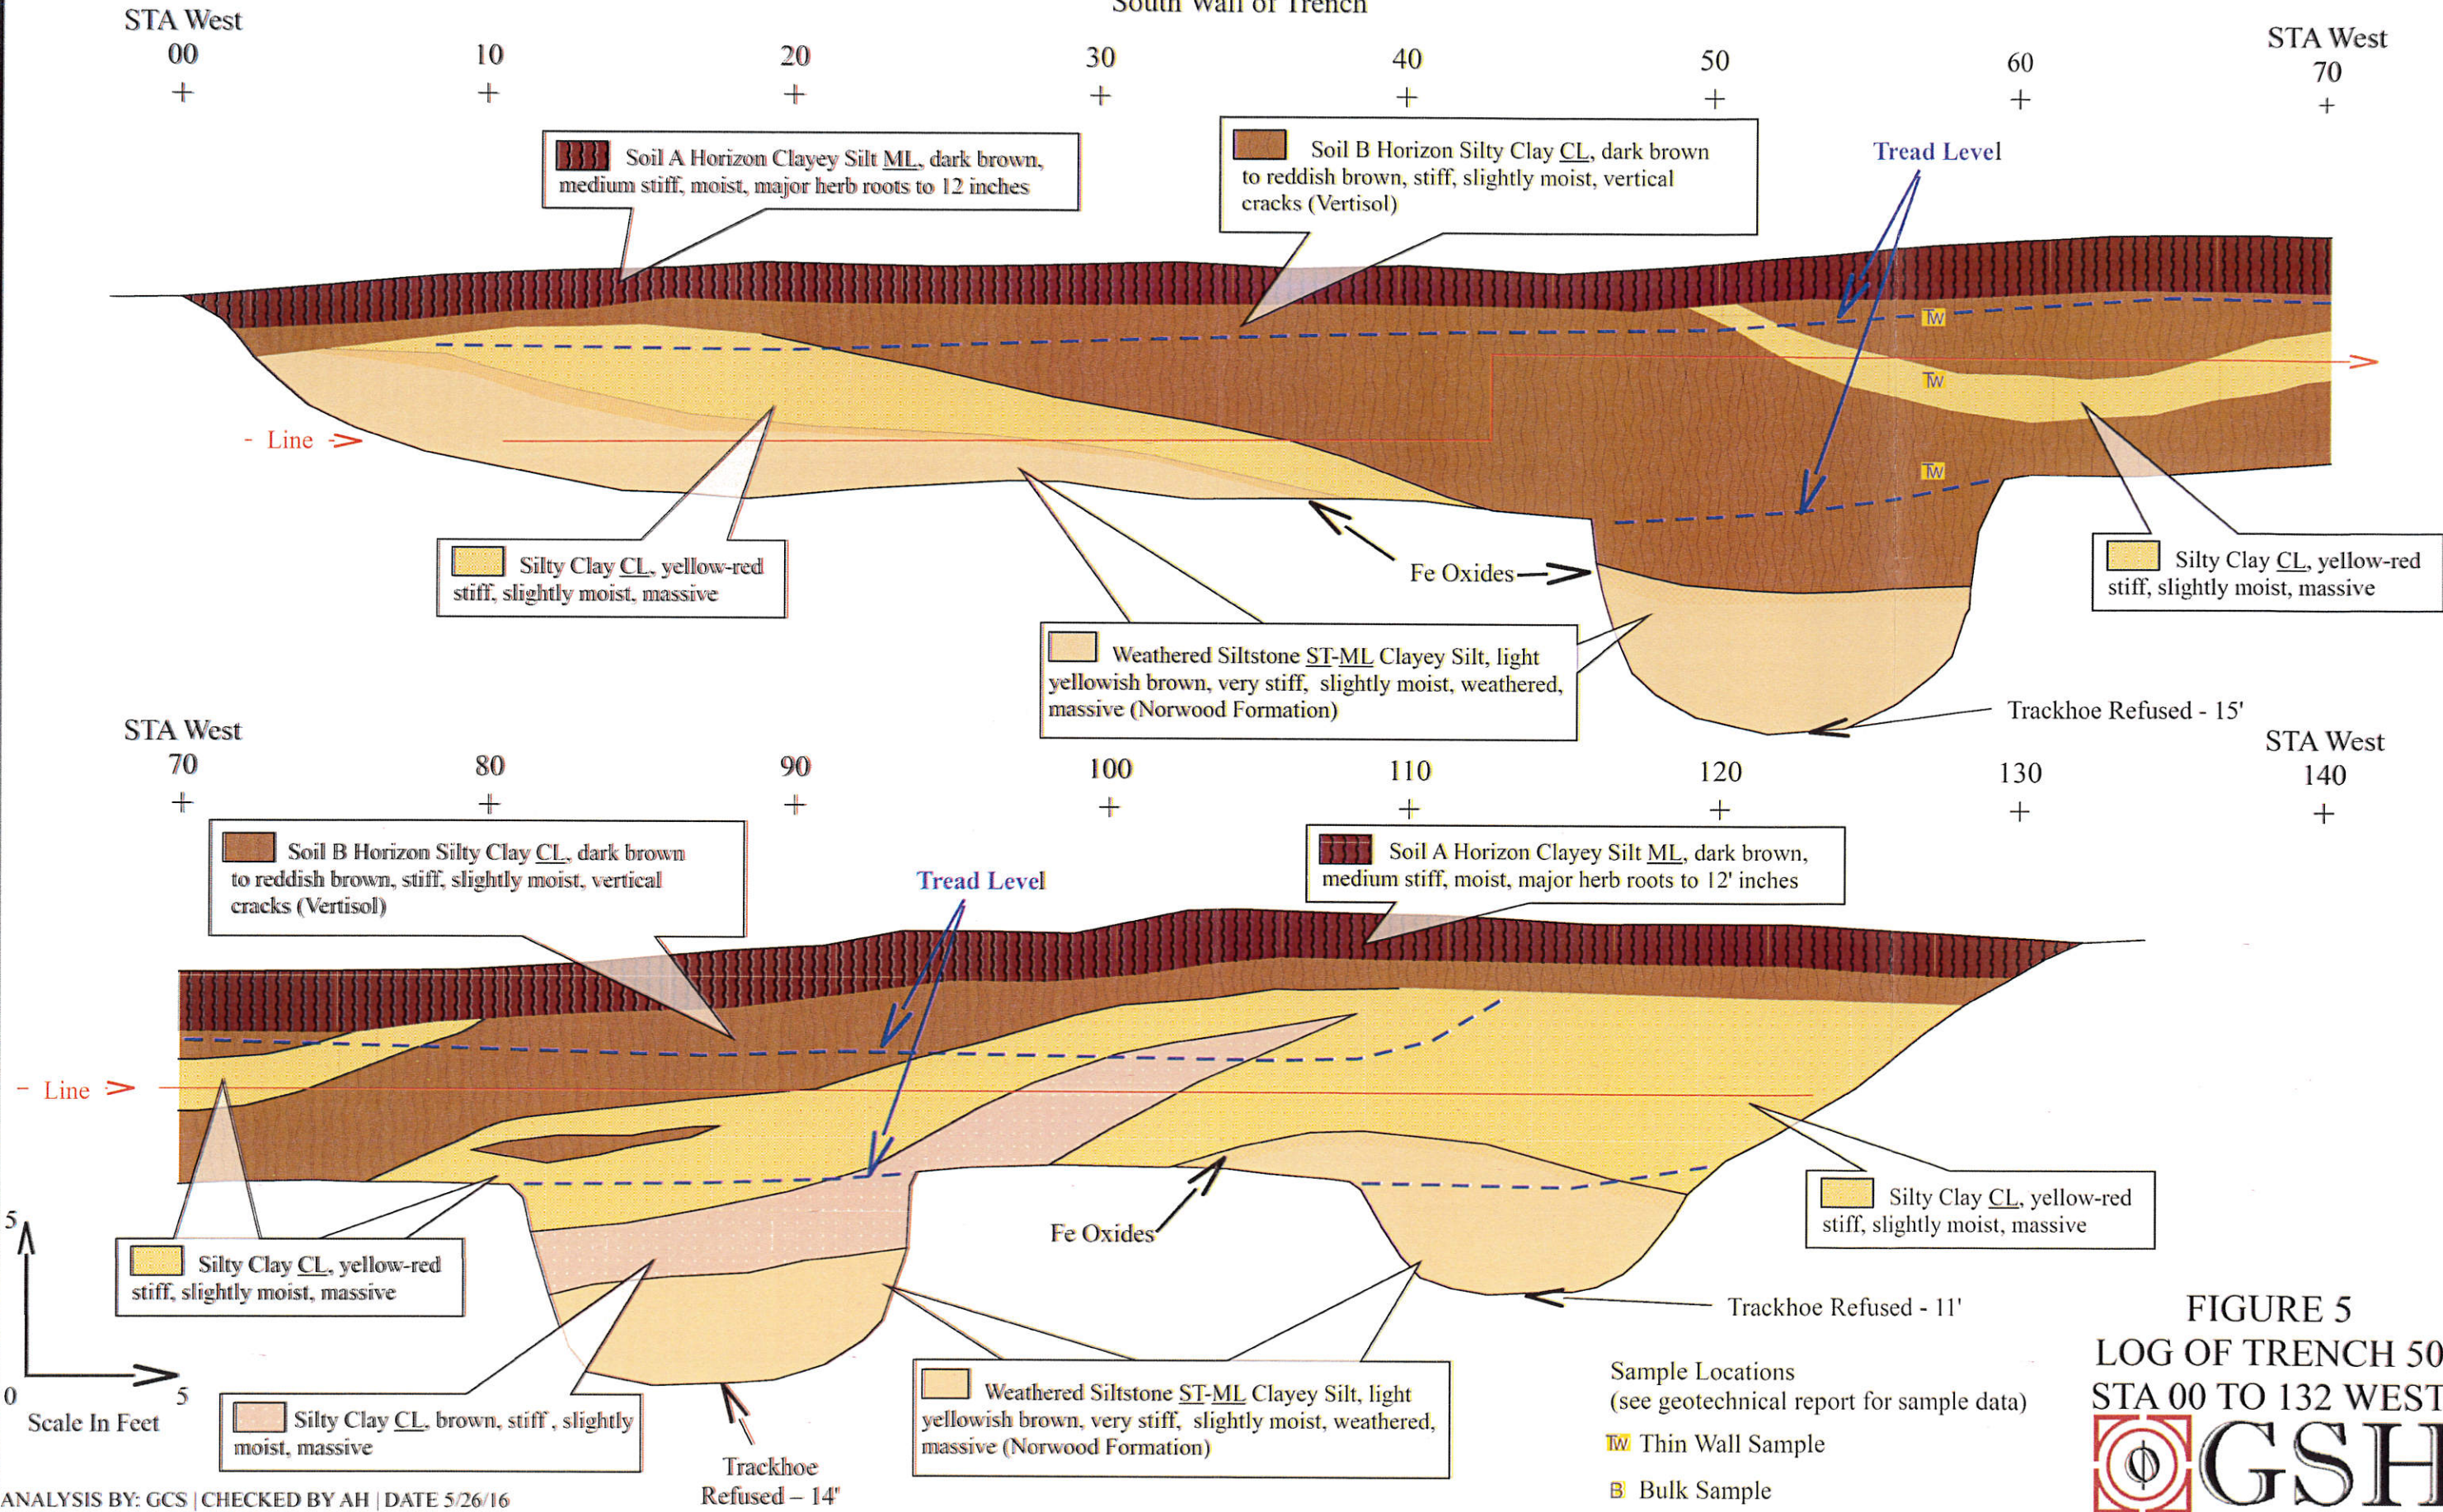
FIGURE 5  
LOG OF TRENCH 50  
STA 00 TO 132 WEST  
**GSH**

Landslide movement was observed in Trench 50 and Trench 51, and evidence of movement within the same feature was observed during our previous 2015 study in test pits GSH-2, GSH-3 and GSH-4 and on the Logged Roadway Geology Cut (GSH, 2015). This landslide feature is mapped on Figure 14, as Qms-2015. The landslide deformation and movement was observed beginning at the Logged Roadway Geology Cut on the Via Cortina roadway with movement detected in the trenches and test pits downslope from the cut in a northward direction, extending beyond the north property boundary, and joining a larger mapped landslide feature (King et al., 2008) north of the property boundary. The axial north-south length of the feature to the north property boundary is approximately 325 feet, and the east-west width is approximately 245 feet. The observed thickness of the landslide feature was from 10.0 feet in Trench 50, and possibly as thick as 15.0 feet in Test Pits GSH-2 and GSH-3 from our 2015 study (GSH 2015). The soils observed in Trench 51, appear to apical landslide flank soils on the western margin of the slide feature. The slide plane surface feature observed in the trenches displayed nominal deformation along the plane surface, with some oxidation accumulations (Fe Oxides) observed along the base of the movement in the trenches.

South Wall of Trench

The natural rock and soils observed in the trenches and test pits and illustrated on our logs, Figures 5 to Figure 9, Logs of Trenches, and Figure 10 and Figure 11, Logs of Test Pits, generally consisted, from bottom to top of:

**1. Landslide and slump deposits:** Presence of mass-movement landslide and slump deposits (**Qms-2015**) is based upon developed field observations including; deformation of soils and rock beds observed in Trench 50, Trench 51, and Test Pits GSH-2, GSH-3 and GSH-4, and location of the topographic features evident on the LiDAR imagery on Figure 14 indicating the planform area of movement observed in the trenches and test pits.

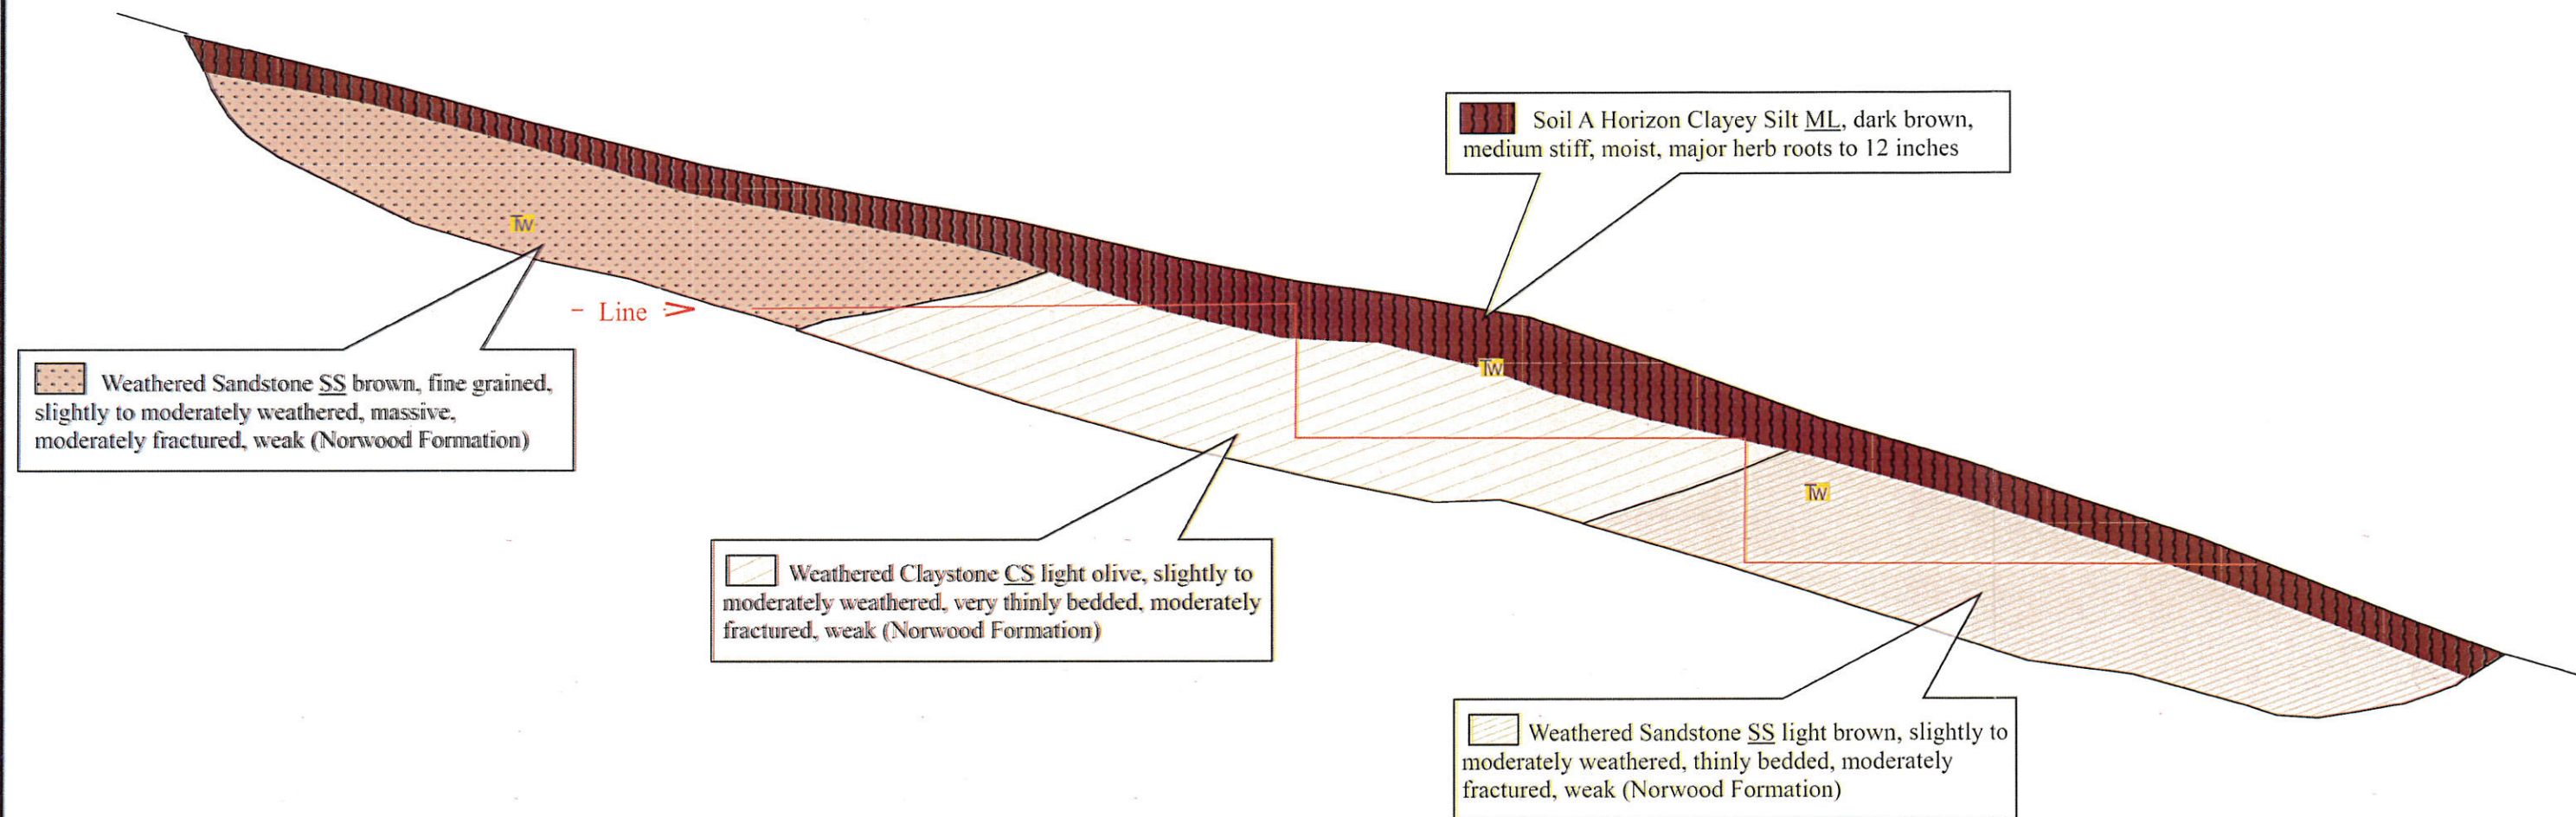
FIGURE 8  
 LOG OF TRENCH 53  
 STA 00 TO 72 WEST  
 GSH

Weathered Sandstone SS brown, fine grained, slightly to moderately weathered, massive, moderately fractured, weak (Norwood Formation)

Soil A Horizon Clayey Silt ML, dark brown, medium stiff, moist, major herb roots to 12 inches

Weathered Claystone CS light olive, slightly to moderately weathered, very thinly bedded, moderately fractured, weak (Norwood Formation)

Weathered Sandstone SS light brown, slightly to moderately weathered, thinly bedded, moderately fractured, weak (Norwood Formation)

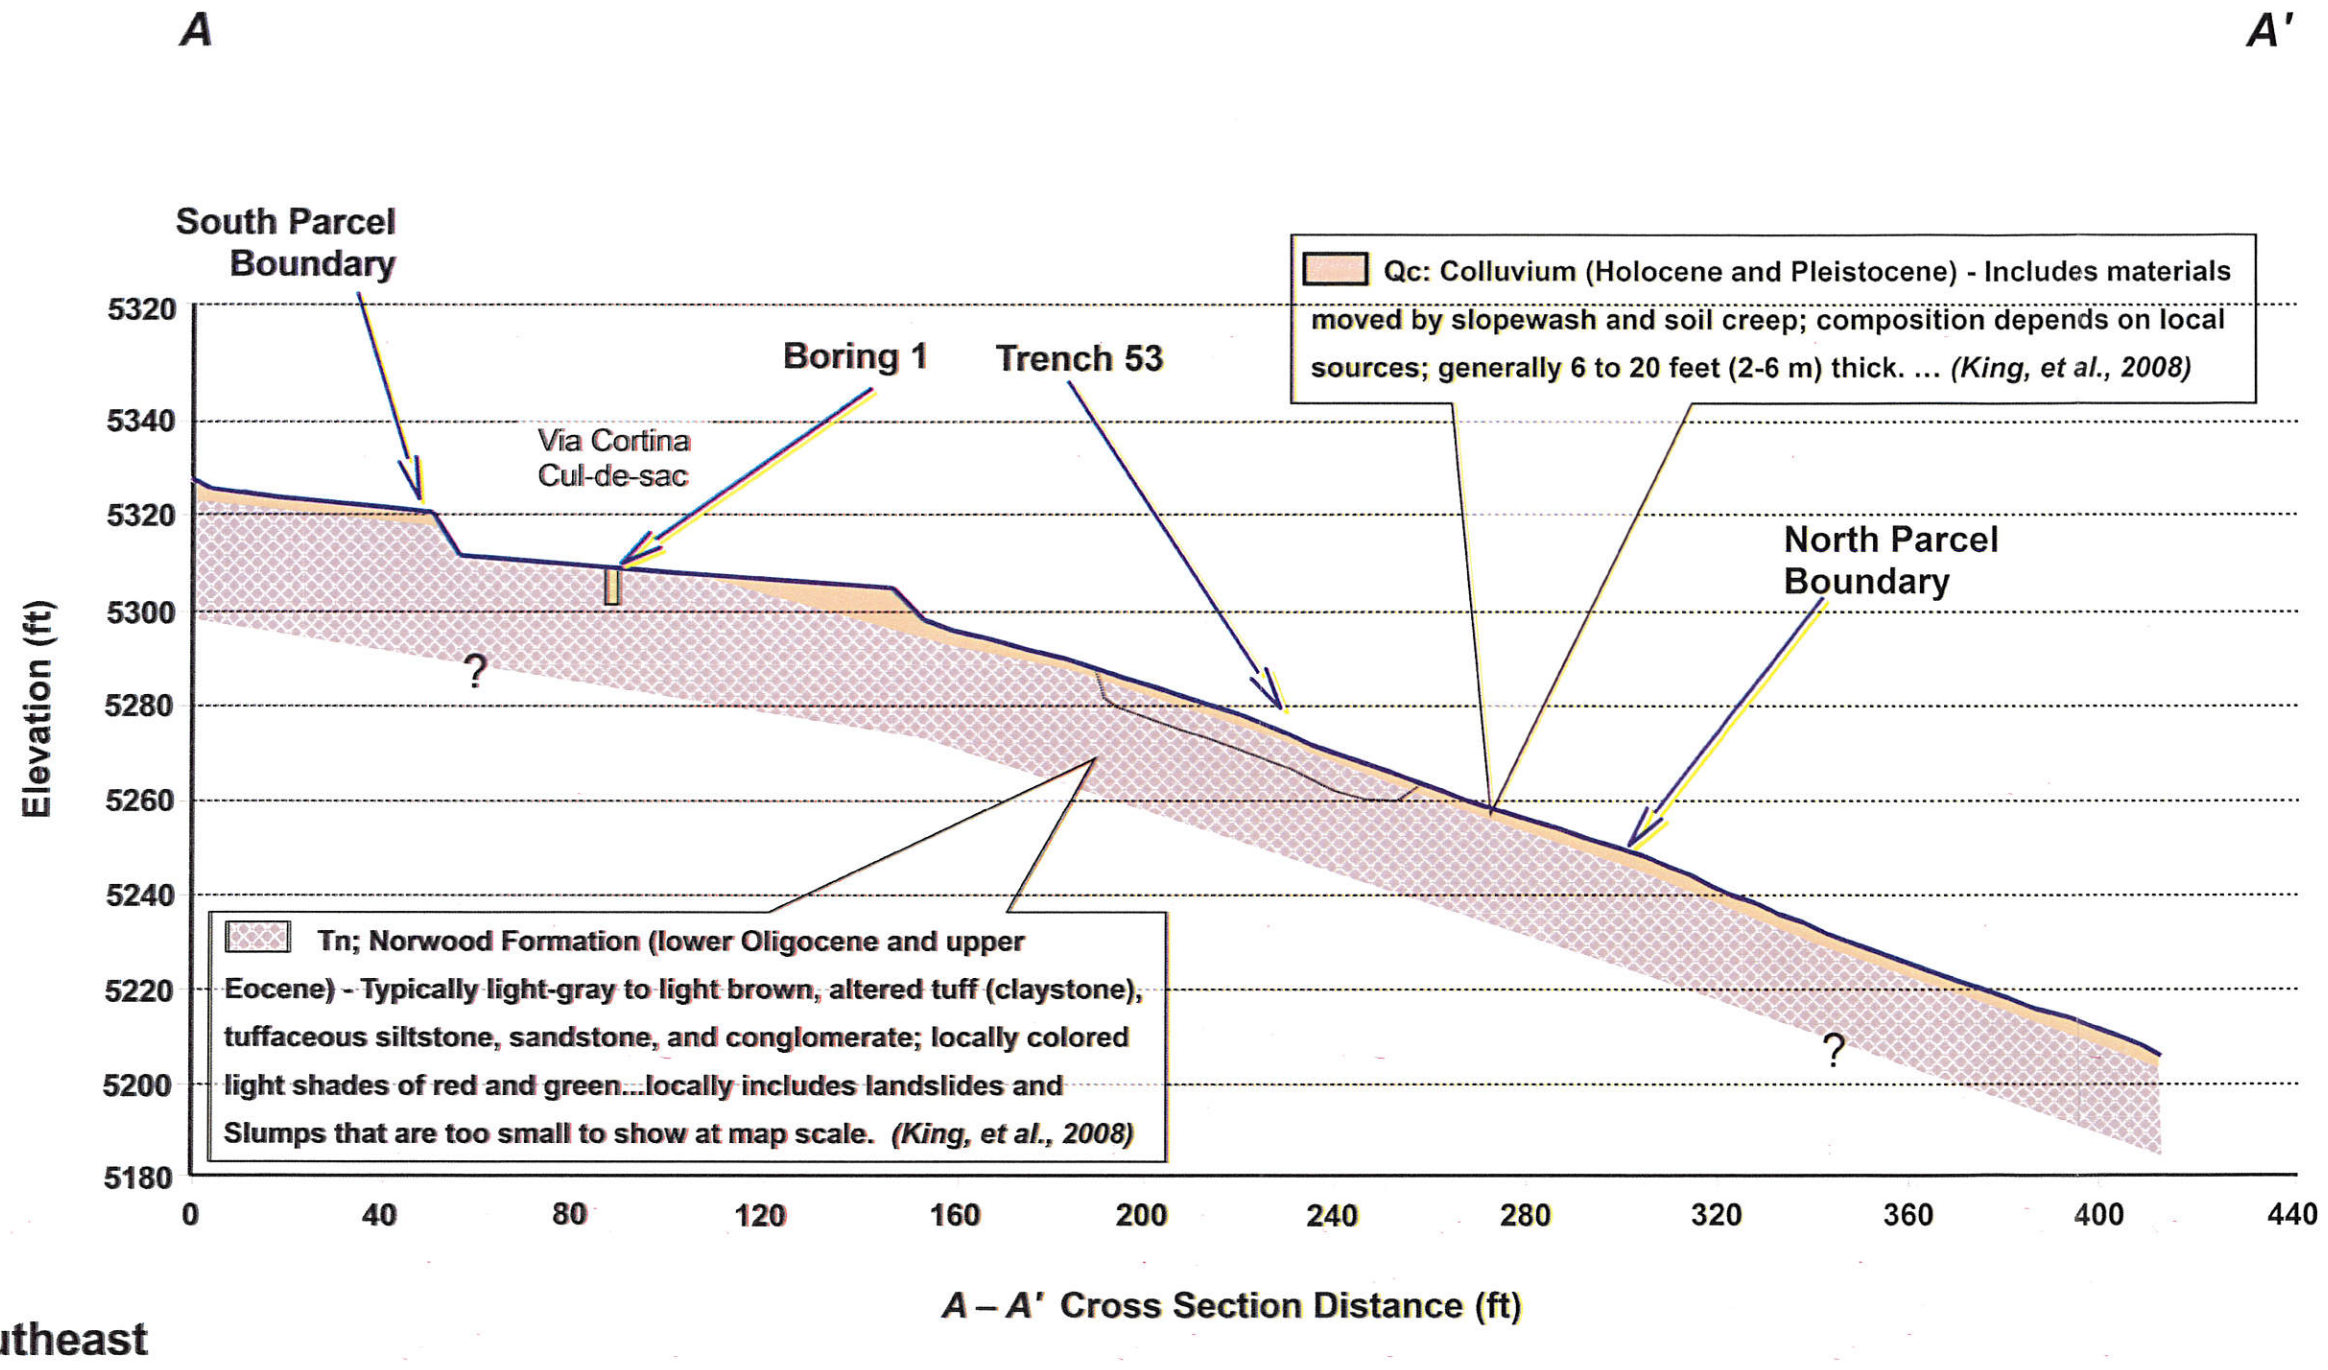
\*Elevation data for the cross section were developed from 2.0 meter 2006 LiDAR digital elevation data. Elevations for the Via Cortina cut slopes were recorded using a hand-held GPS receiver device during our field program.

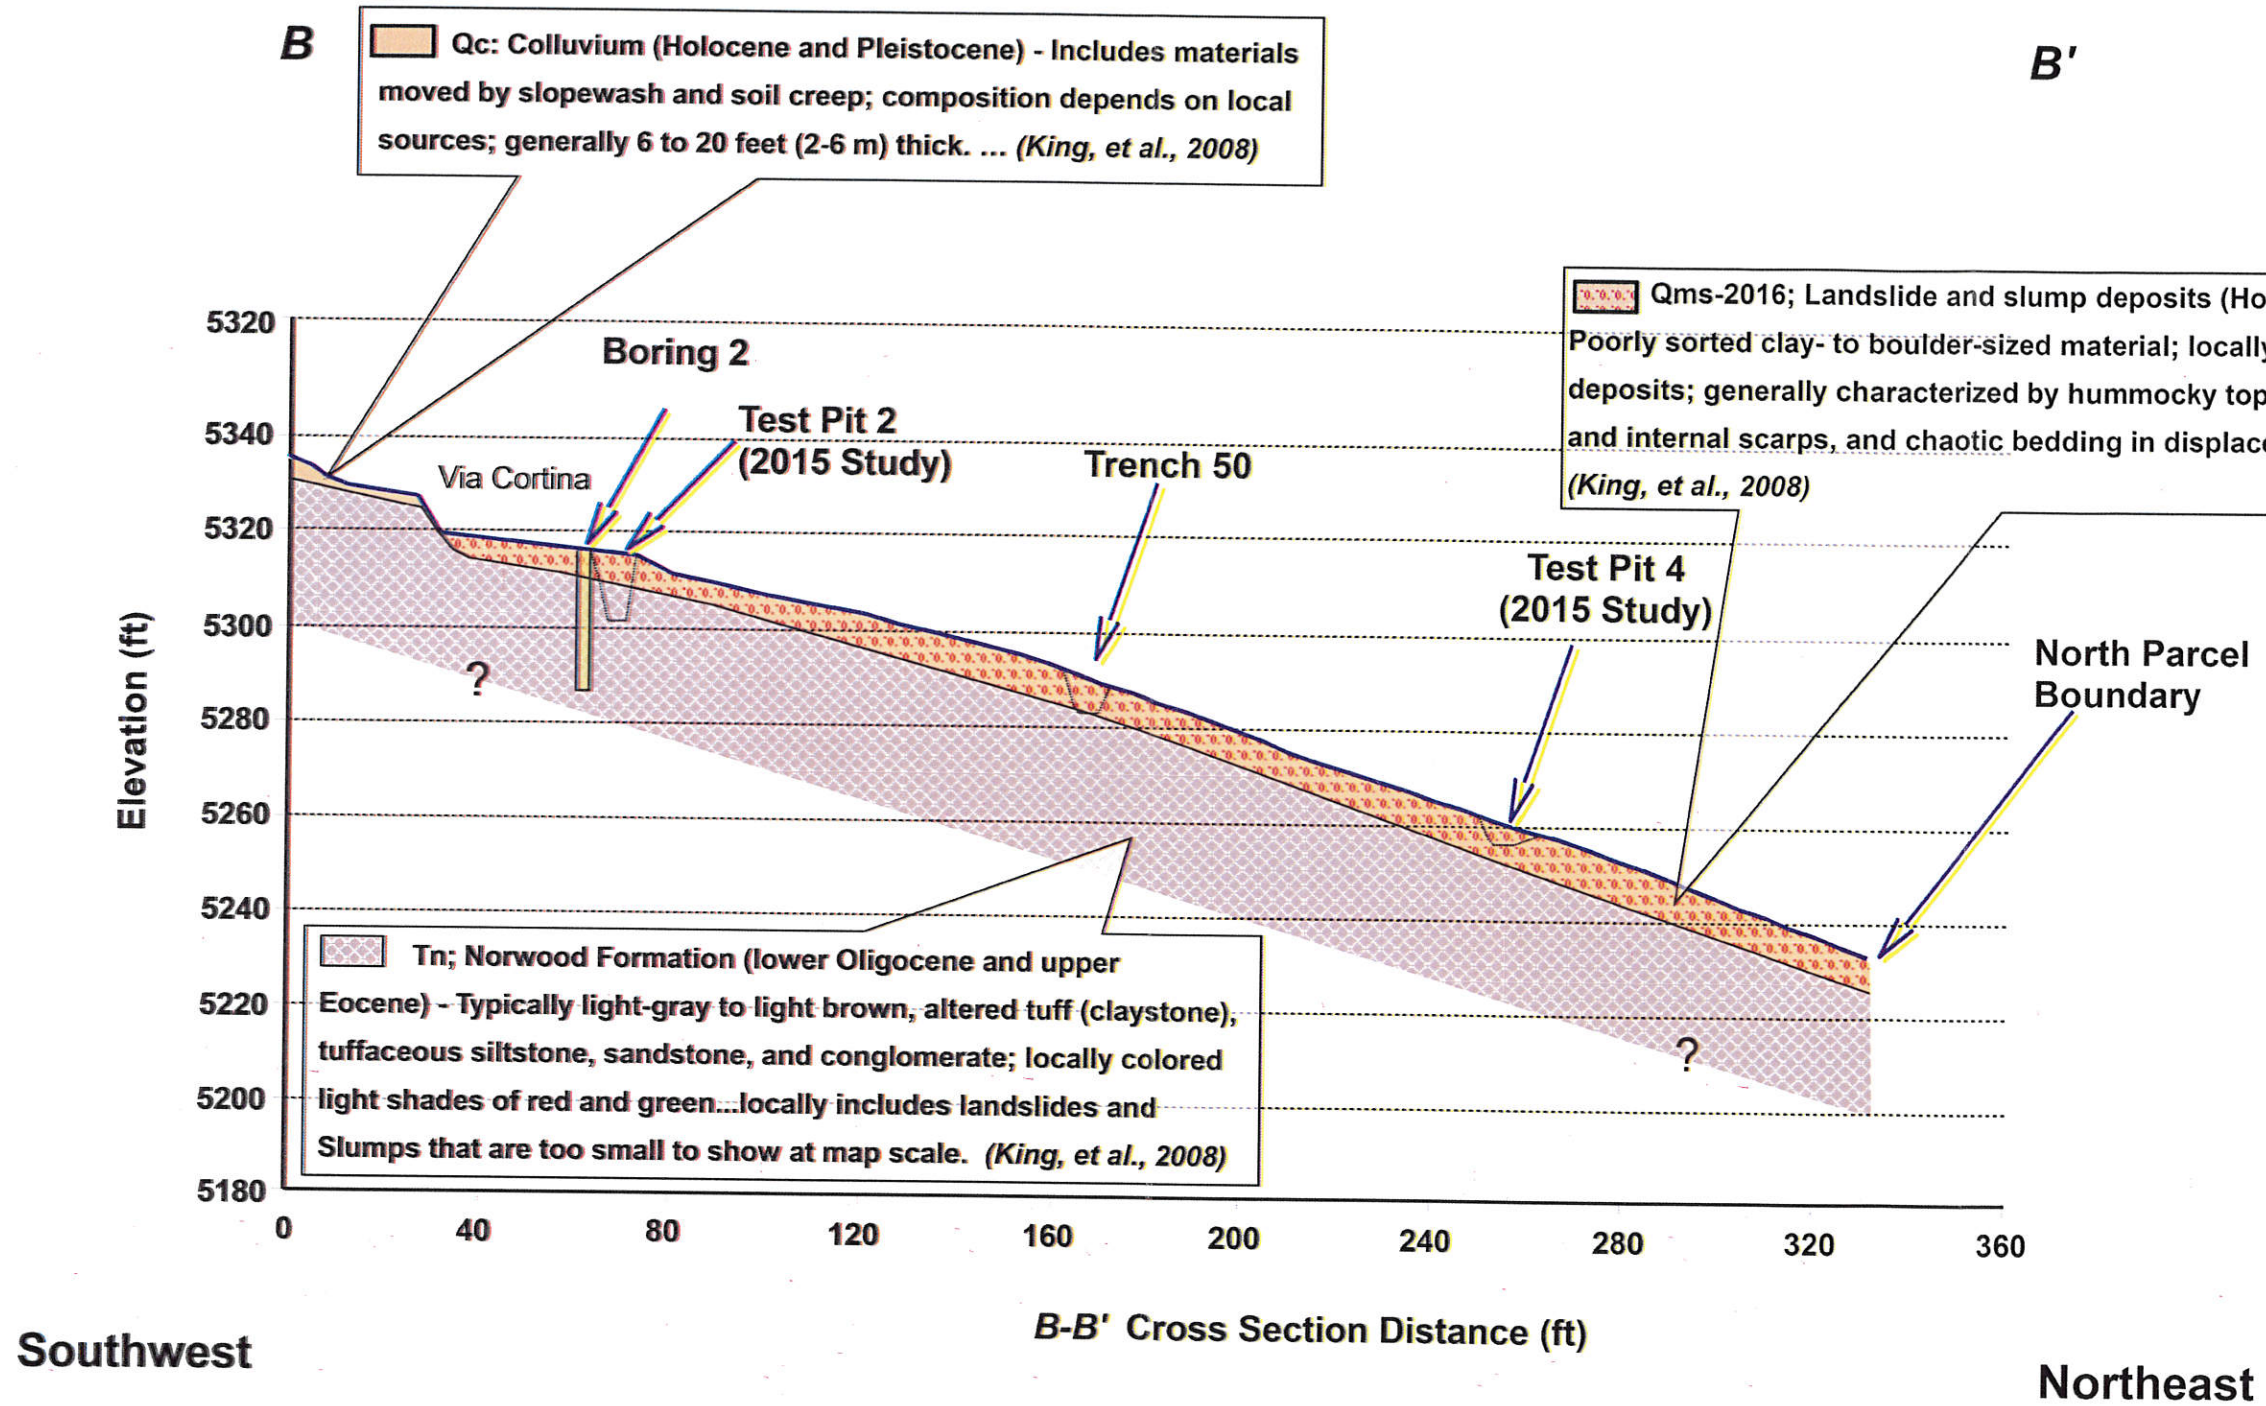
\*Elevation data for the cross section were developed from 2.0 meter 2006 LiDAR digital elevation data. Elevations for the Via Cortina cut slopes were recorded using a hand-held GPS receiver device during our field program.
