Staff Report for Administrative Approval

Application Request: Consideration and action on a request for approval of Conditional Use Permit CUP 2016-09 an amendment to include a caretaker's home at Camp UTABA a private campground, located at 7005 North North Fork Road, Liberty.

File Number: CUP 2016-09

**Subject: Professional Geologist Site Reconnaissance and Review
Camp UTABA Caretakers Home
Weber County Parcel #17-092-0015
7005 N Fork Road, (Liberty Area)
Eden, Weber County, Utah**

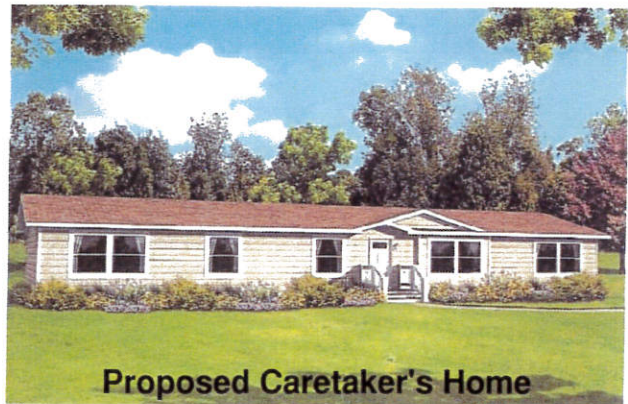
Proposed Caretaker's Home

Additional design standards and requirements: The amendment to the site plan includes the addition of one 2,305 square foot (76 foot by 30.33 foot) building. The building will be a one story manufactured home. The building will have light tan wood siding (horizontal), white windows and trim, and a brown metal roof. The home will be just east of the main road in the camp about 350 feet back from the entry. Currently there is an old manager's cabin near by this site that will be removed.
