**GEOTECHNICAL & GEOLOGIC
HAZARD INVESTIGATION
Horizon Neighbourhood Development
Summit Powder Mountain Resort
Weber County, Utah**

IGES Project No. 01628-013

August 3, 2016

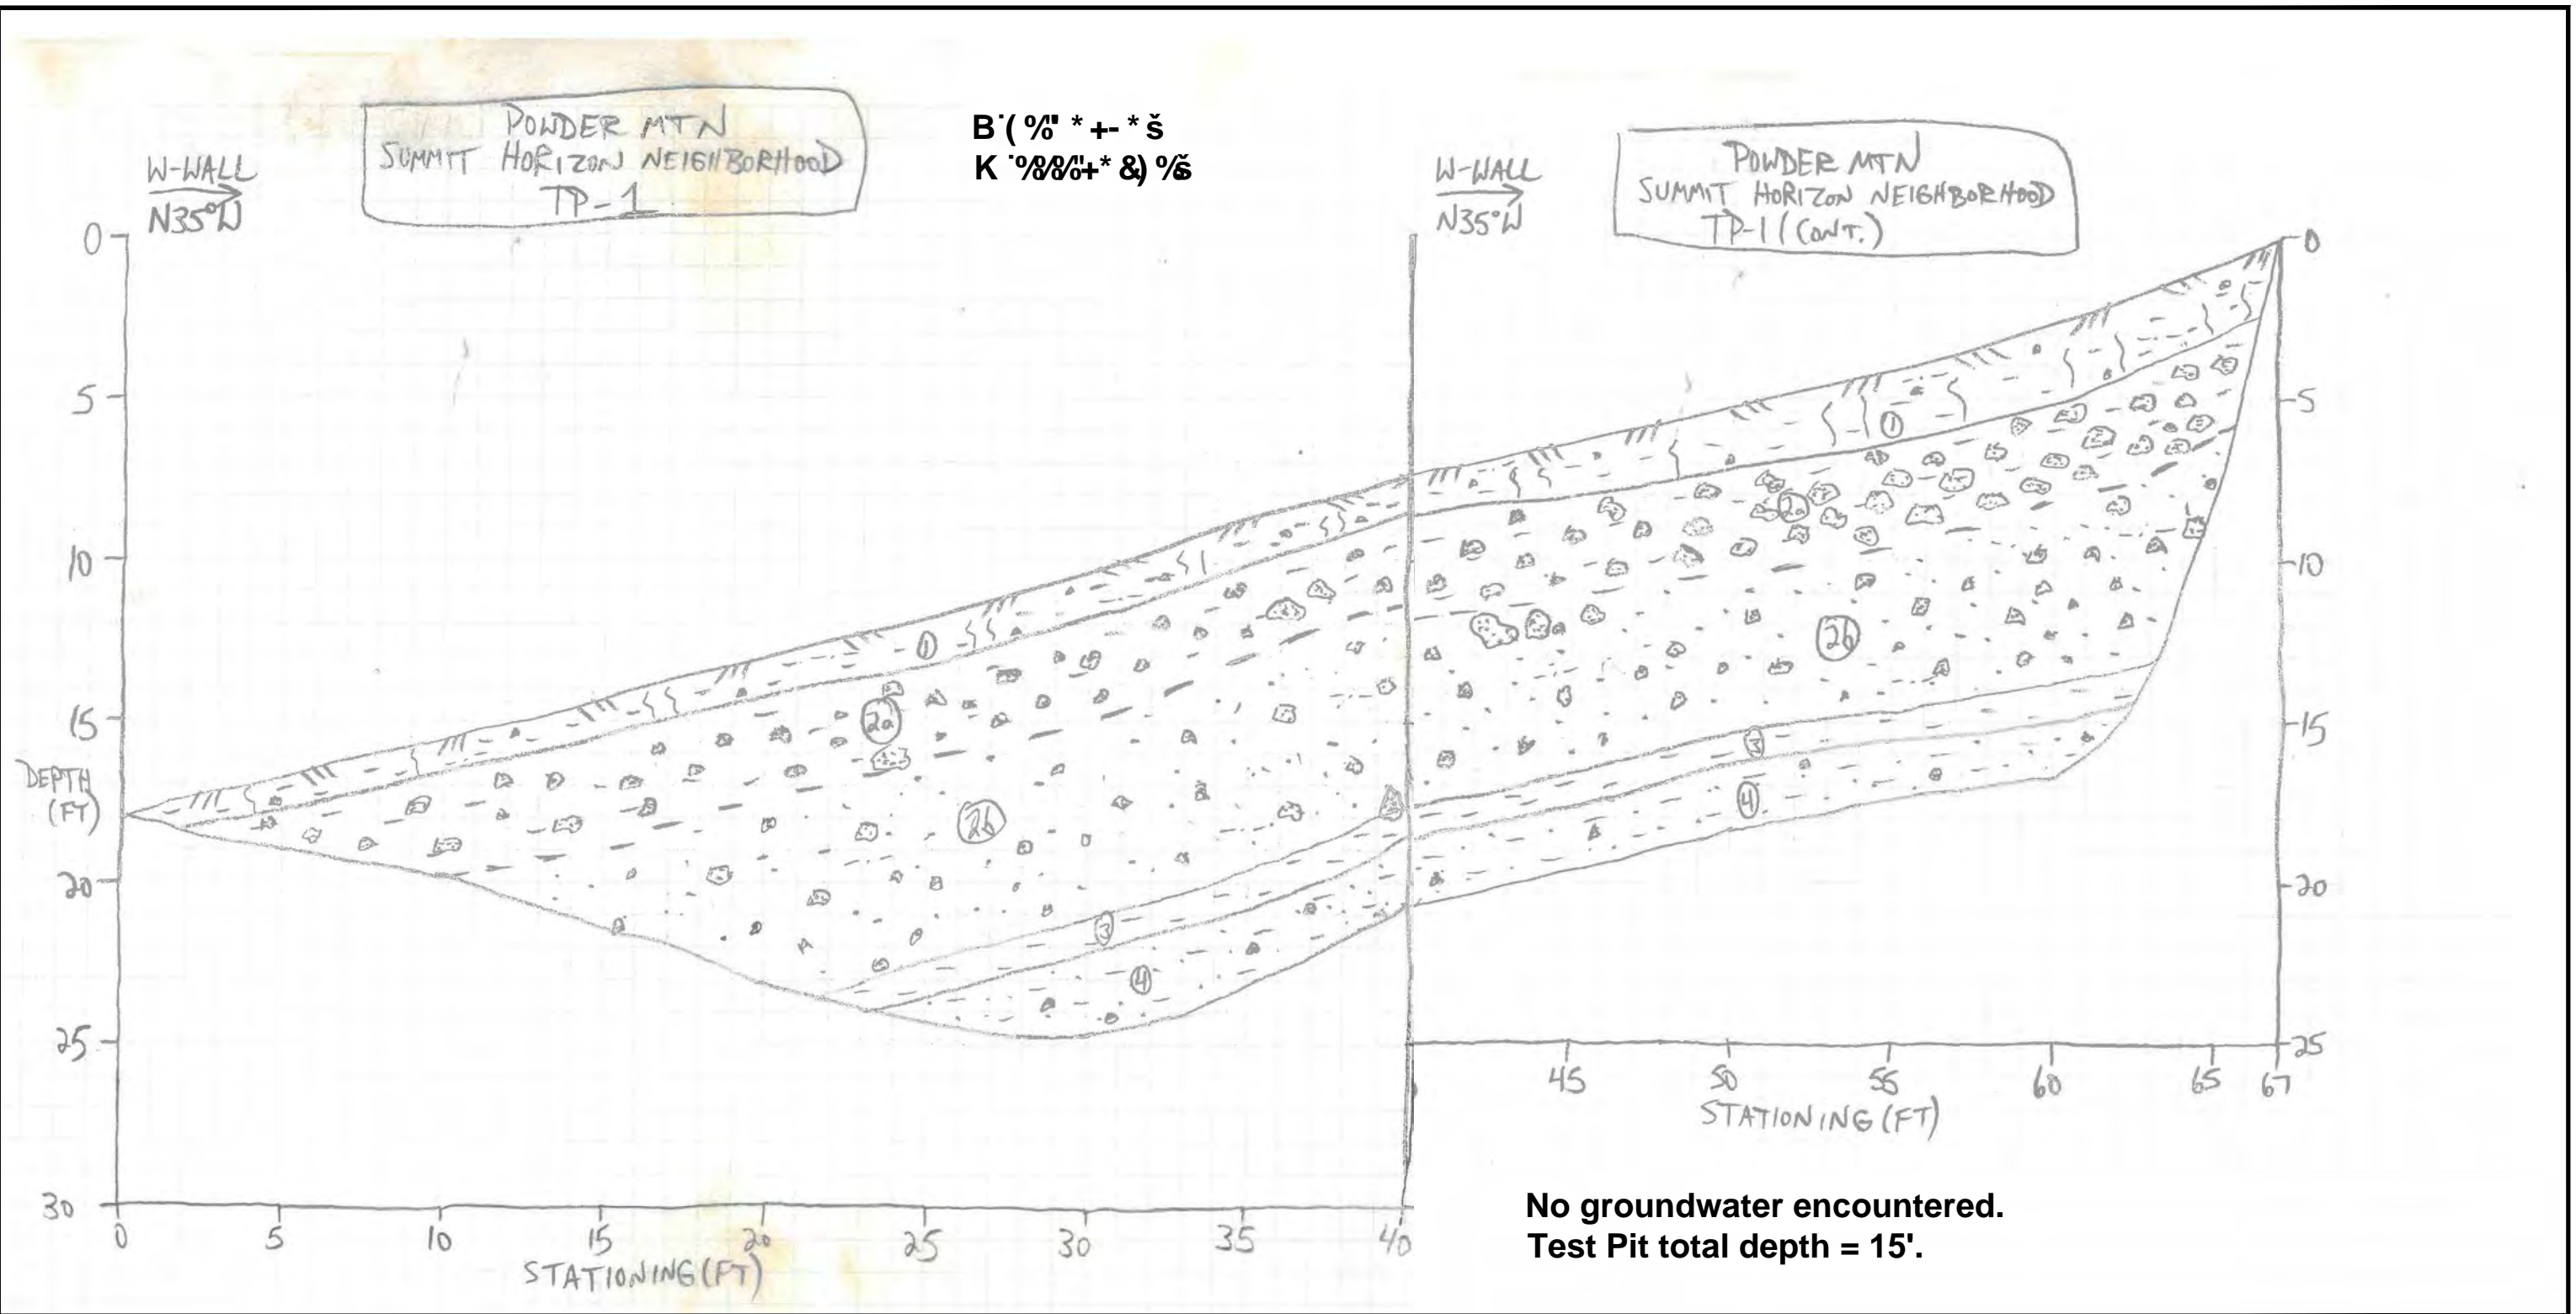
LITHOLOGIC UNIT DESCRIPTIONS:

1. A/B Soil Horizon: ~1.5-2' thick; dark yellowish brown (10YR 4/2); lean CLAY, medium stiff, slightly moist, low plasticity, massive; some silt and occasional to common quartzite clasts up to 3" thick, though some boulders several feet in diameter noted on ground surface; clasts are subrounded to rounded, all white to pink quartzite; gravel and larger sized clasts comprise ~5% of unit; abundant plant and tree roots, though much more concentrated in uppermost 6" of unit.

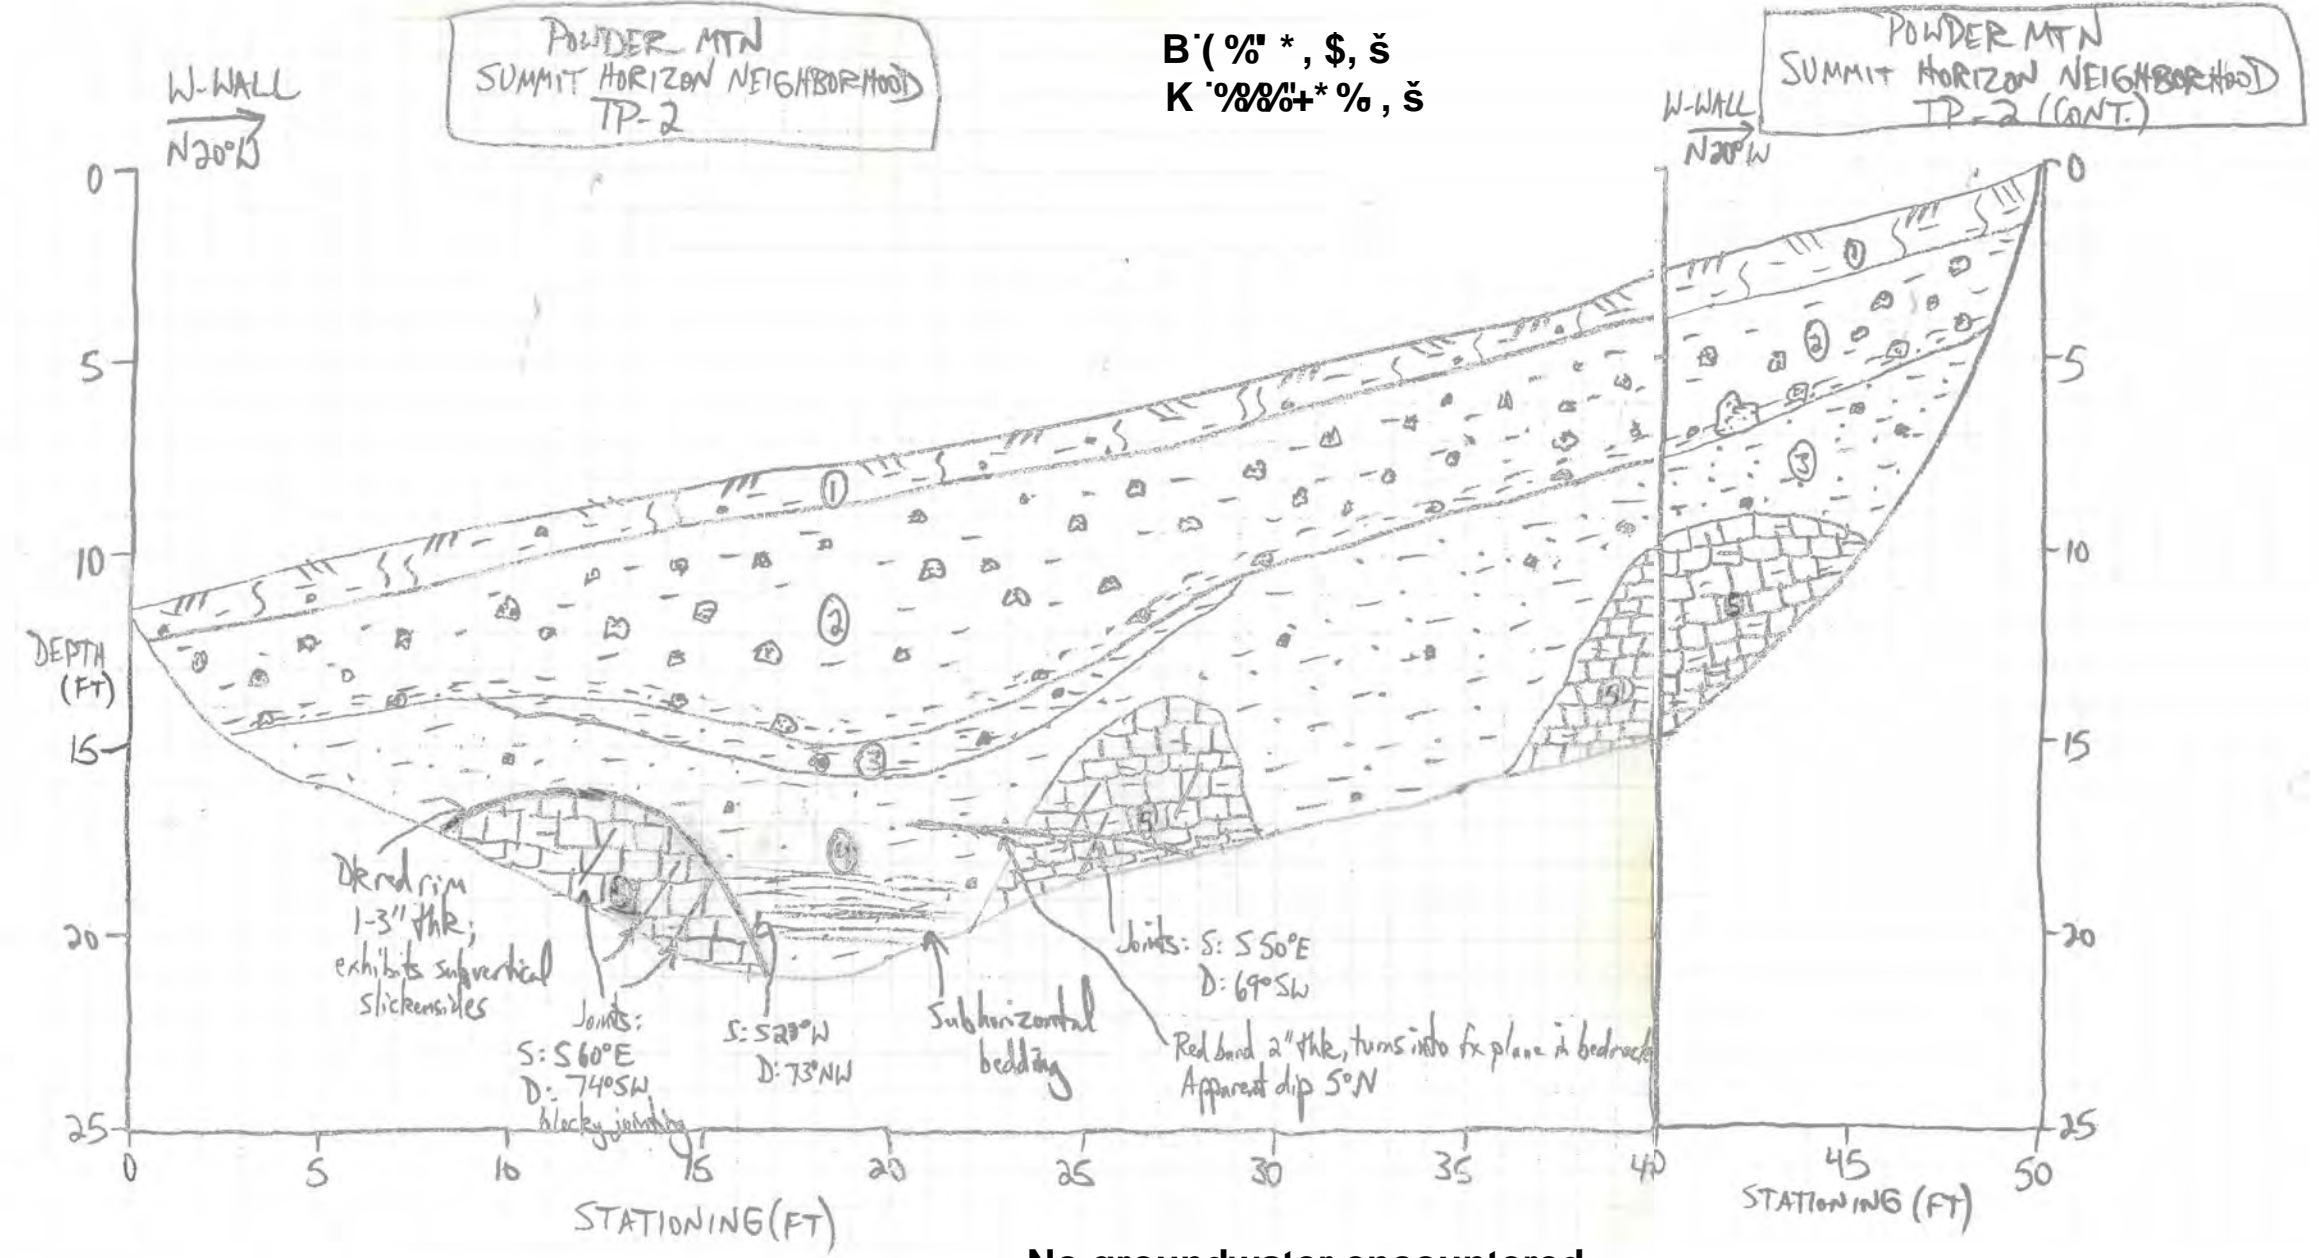
No groundwater encountered.
 Test Pit total depth = 14'.

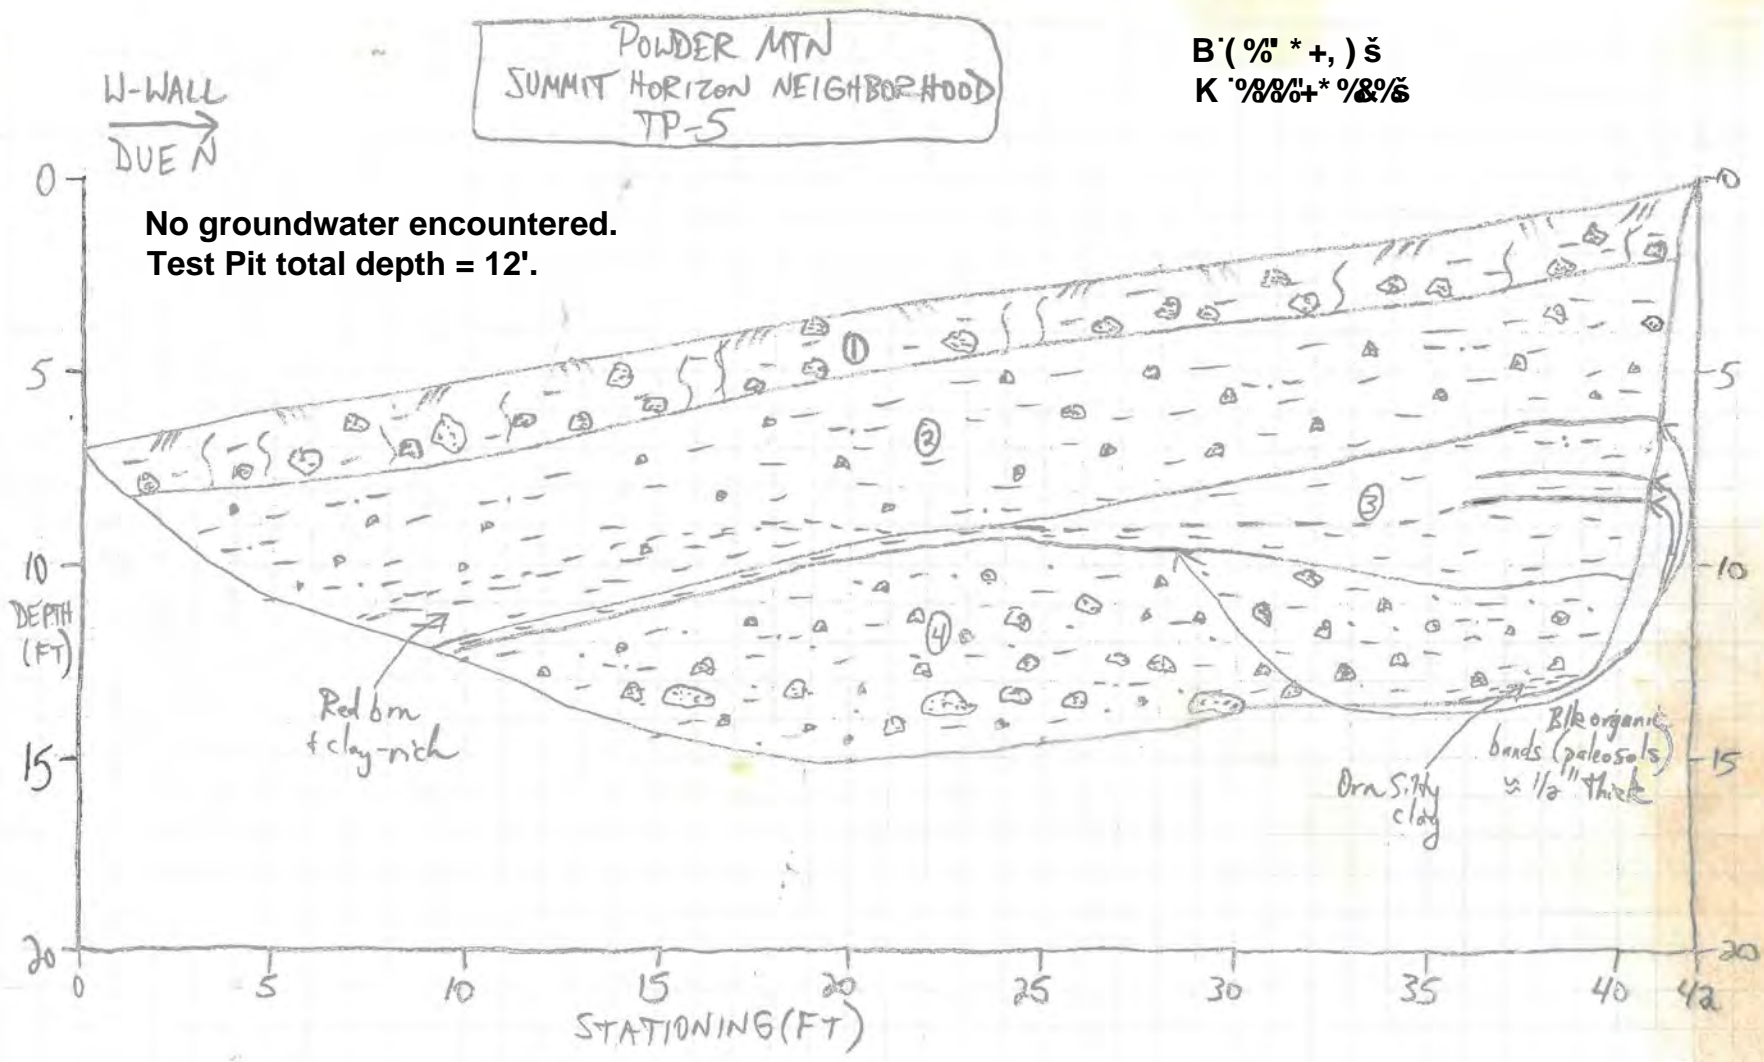
POWDER MTN
SUMMIT HORIZON NEIGHBORHOOD
TP-5

No groundwater encountered.
Test Pit total depth = 12'.

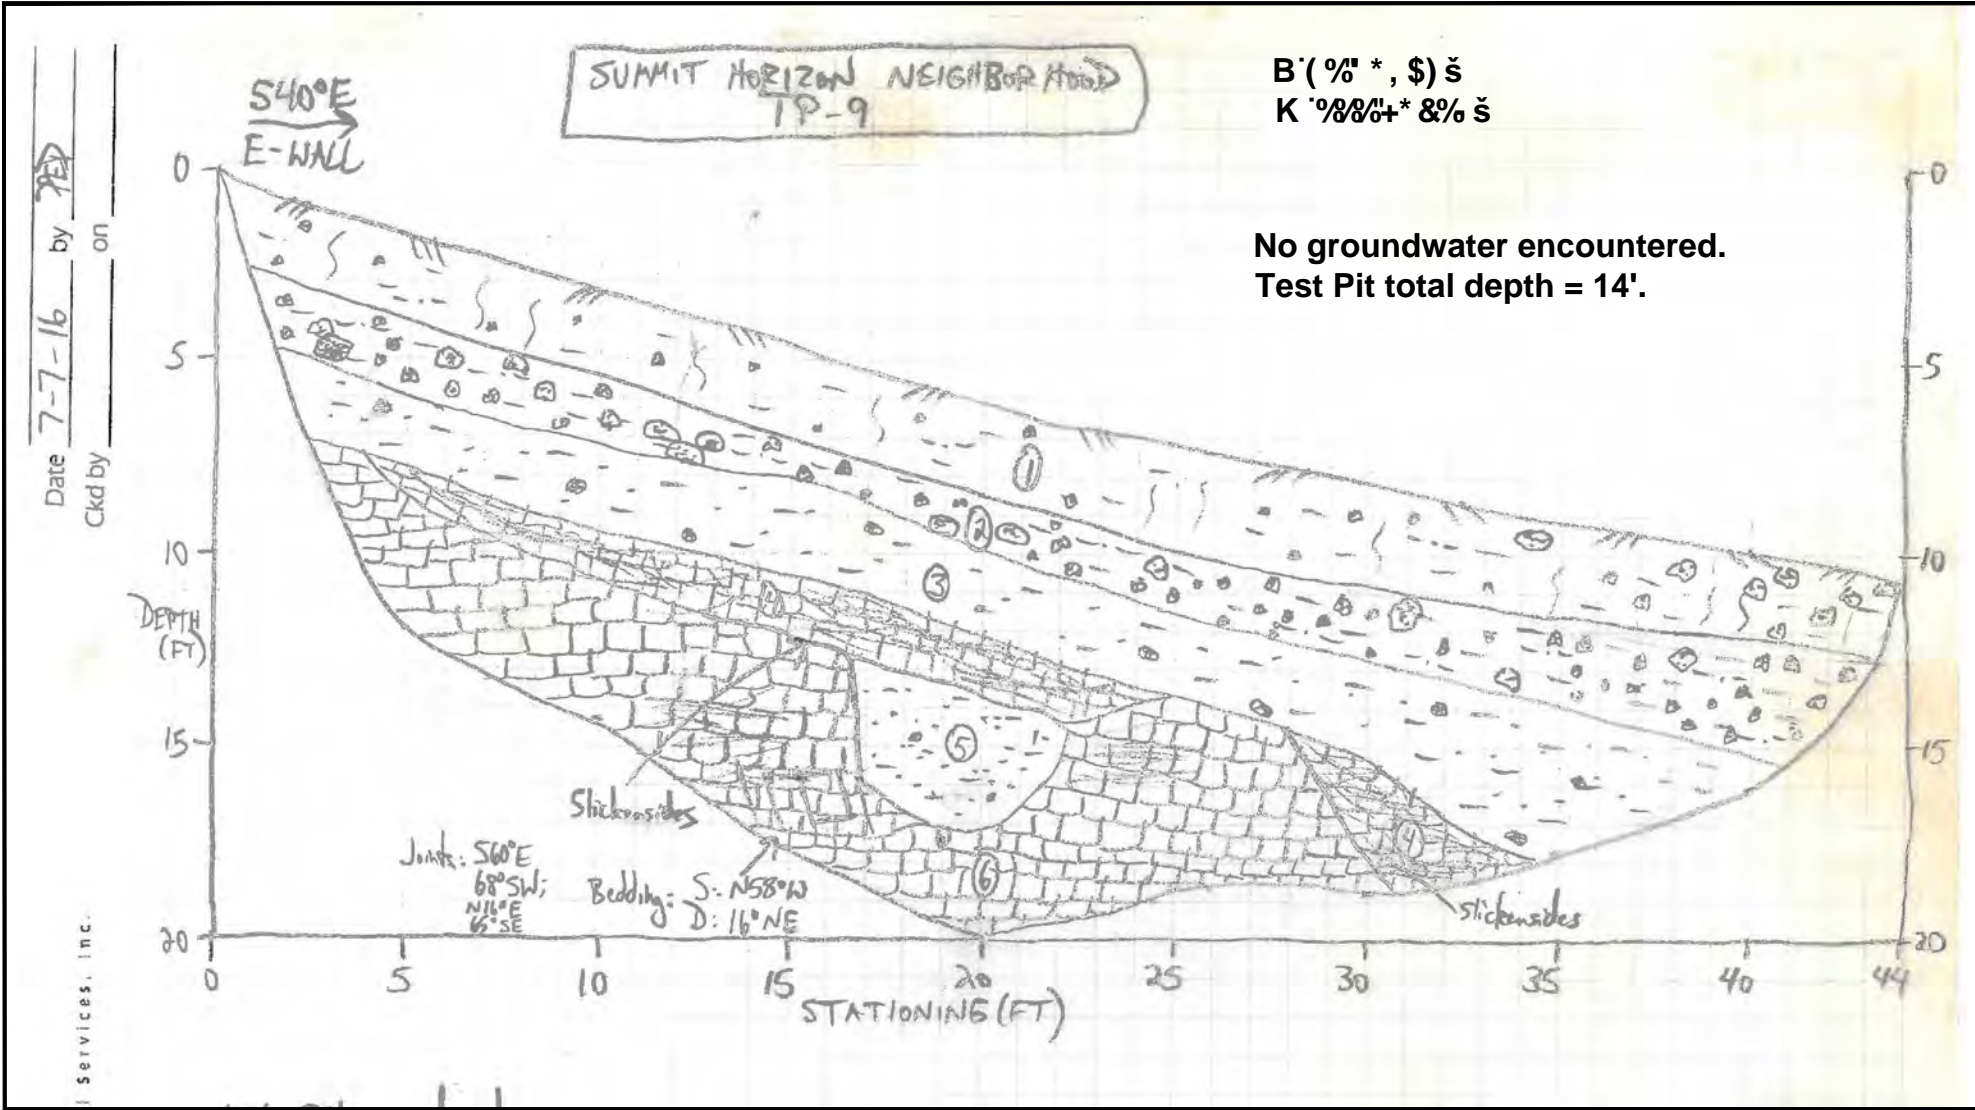
- 1. A/B Soil Horizon:** ~1.5-2' thick; dark yellowish brown (10YR 4/2); silty lean CLAY with gravel, medium stiff, dry, low plasticity, massive; gravel and larger sized clasts comprise ~15-20% of unit; clasts are entirely subrounded to subangular medium gray (N5) quartzite up to 1.5' diameter, though mode average <1" diameter; abundant plant and tree roots; planar, gradational basal contact.

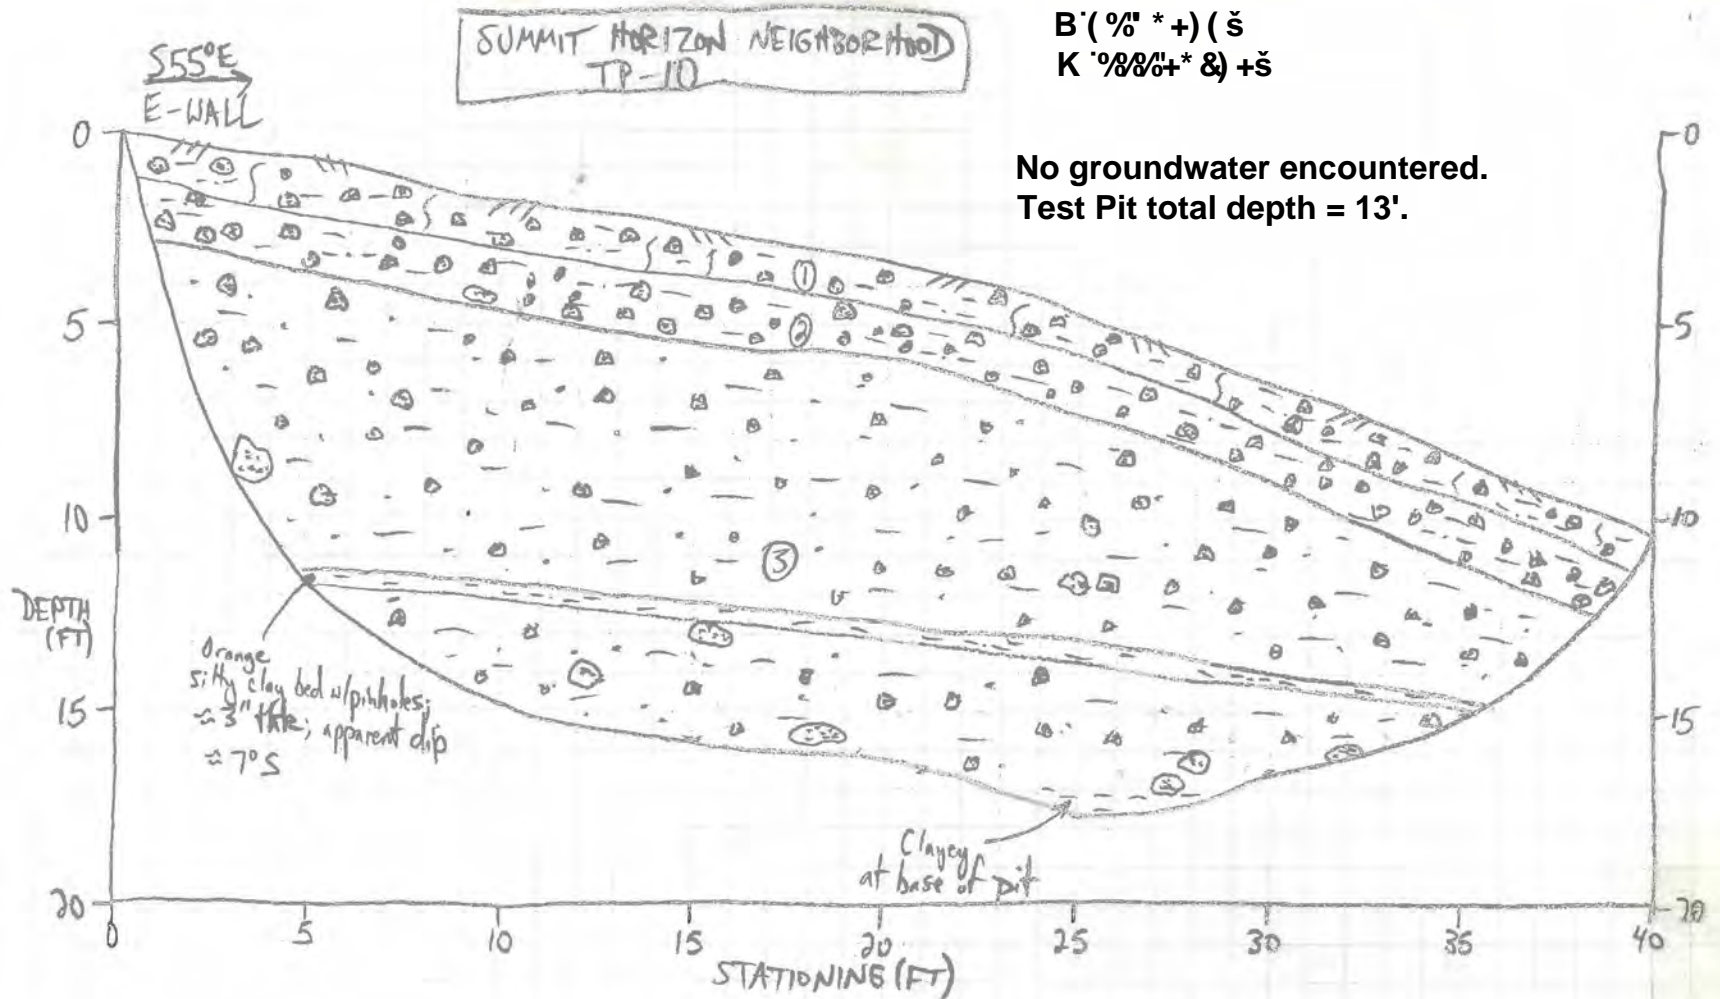
SUMMIT HORIZON NEIGHBORHOOD
TP-10

No groundwater encountered.
Test Pit total depth = 12' (refusal).

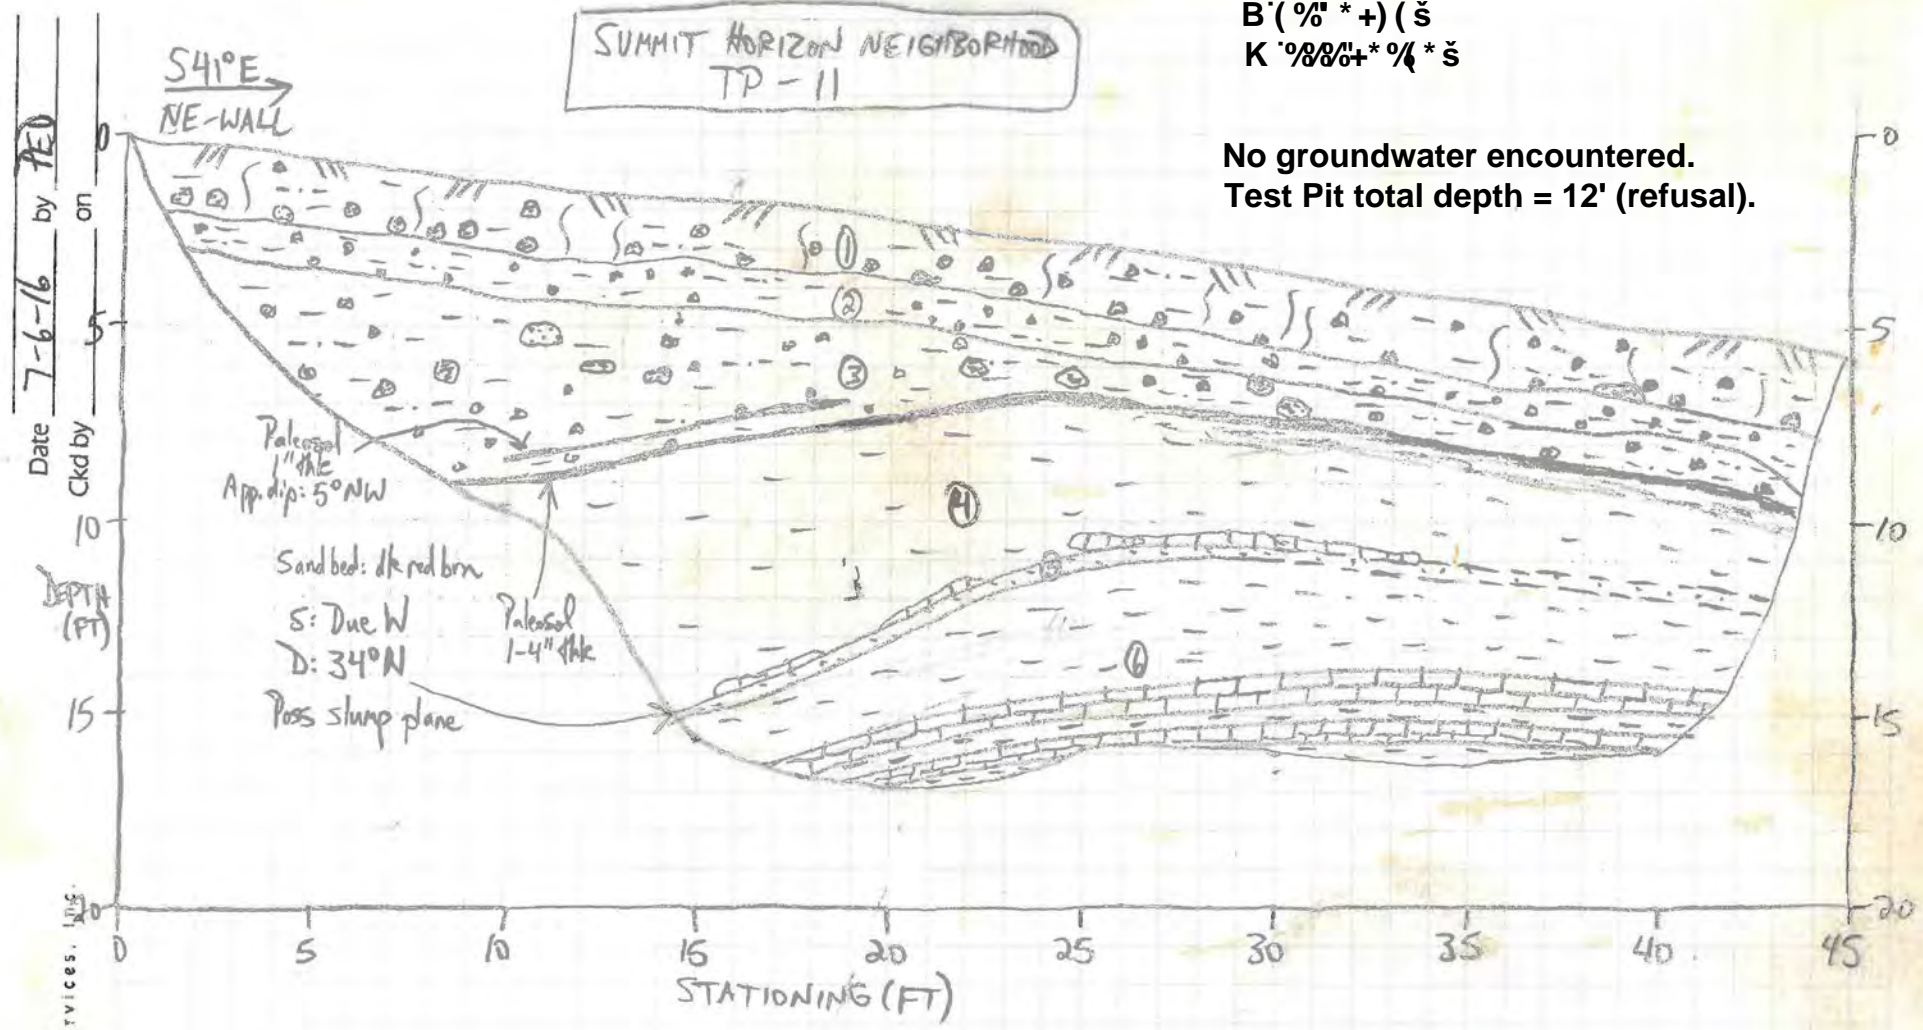
- 1. A/B Soil Horizon:** ~1.5-2' thick; dark yellowish brown (10YR 4/2); silty lean CLAY with gravel, stiff, slightly moist, low plasticity, massive; gravel and larger sized clasts comprise ~35-40% of unit; clasts are entirely subrounded to subangular medium gray (N5) quartzite up to 1' diameter, though mode average 2-4" diameter; abundant plant and tree roots; planar, gradational basal contact.

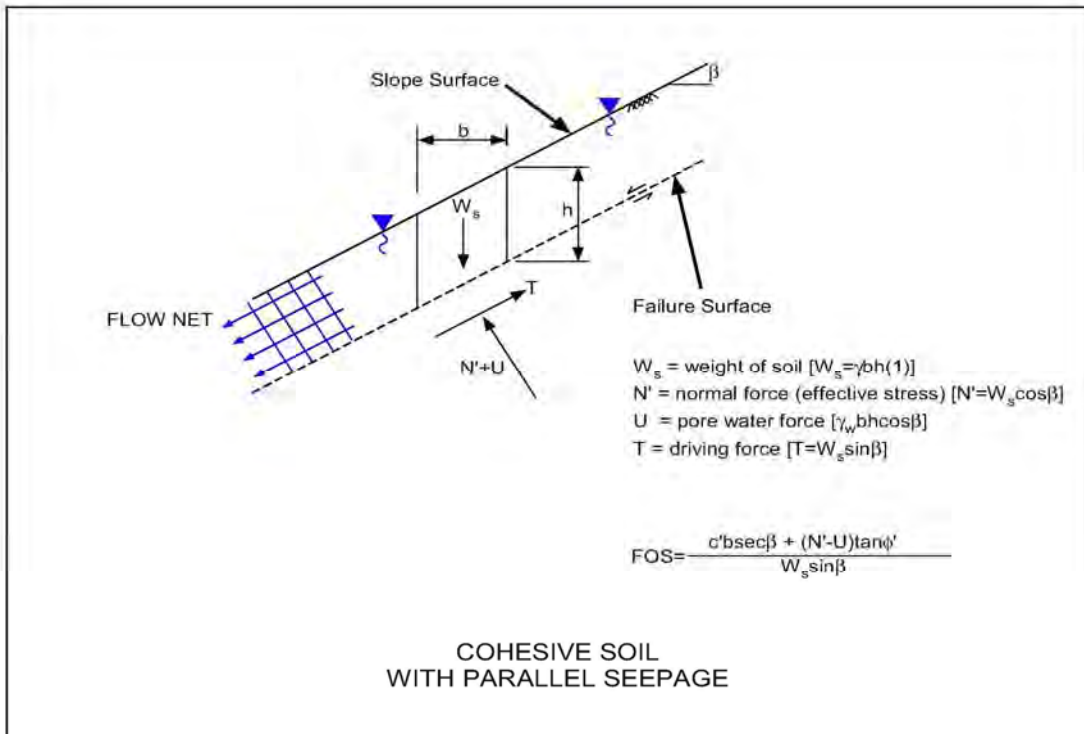
Figure C-2

This model assumes $c > 0$ and the face of the slope is saturated to depth h
