# Staff Report for Administrative Approval Hillside Review – Notice of Conditional Approval

**Application Request:** Consideration and action on a request to approve a Hillside Review for the Anderson residence located on Lot 2-R in The Reserve at Crimson Ridge Cluster Subdivision Phase 1.

**File Number:** HSR 2016-18

## GEOLOGIC HAZARDS EVALUATION THE RESERVE AT CRIMSON RIDGE, LOT 2-R 1013 NORTH VALLEY VIEW DRIVE LIBERTY, WEBER COUNTY, UTAH

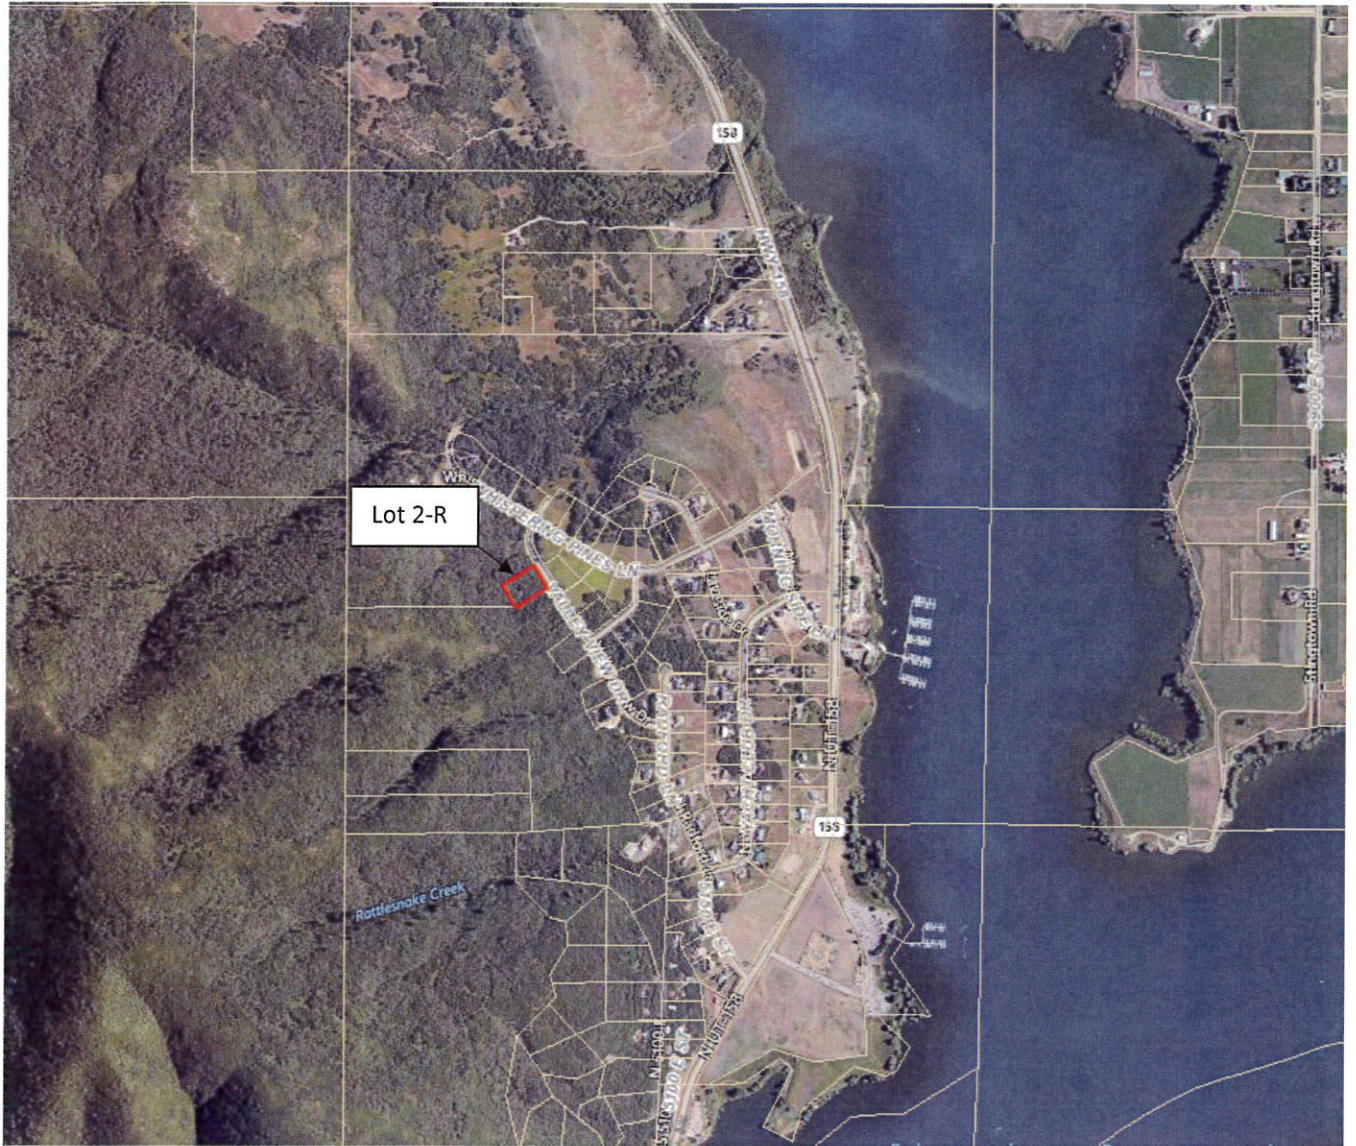
**Map 1**

**SITE PLAN**  
 103 N VALLEY VIEW DRIVE  
 LOT 2-R  
 THE RESERVE AT CRIMSON RIDGE SUBDIVISION  
 EDEN CITY, WEBER COUNTY, UTAH

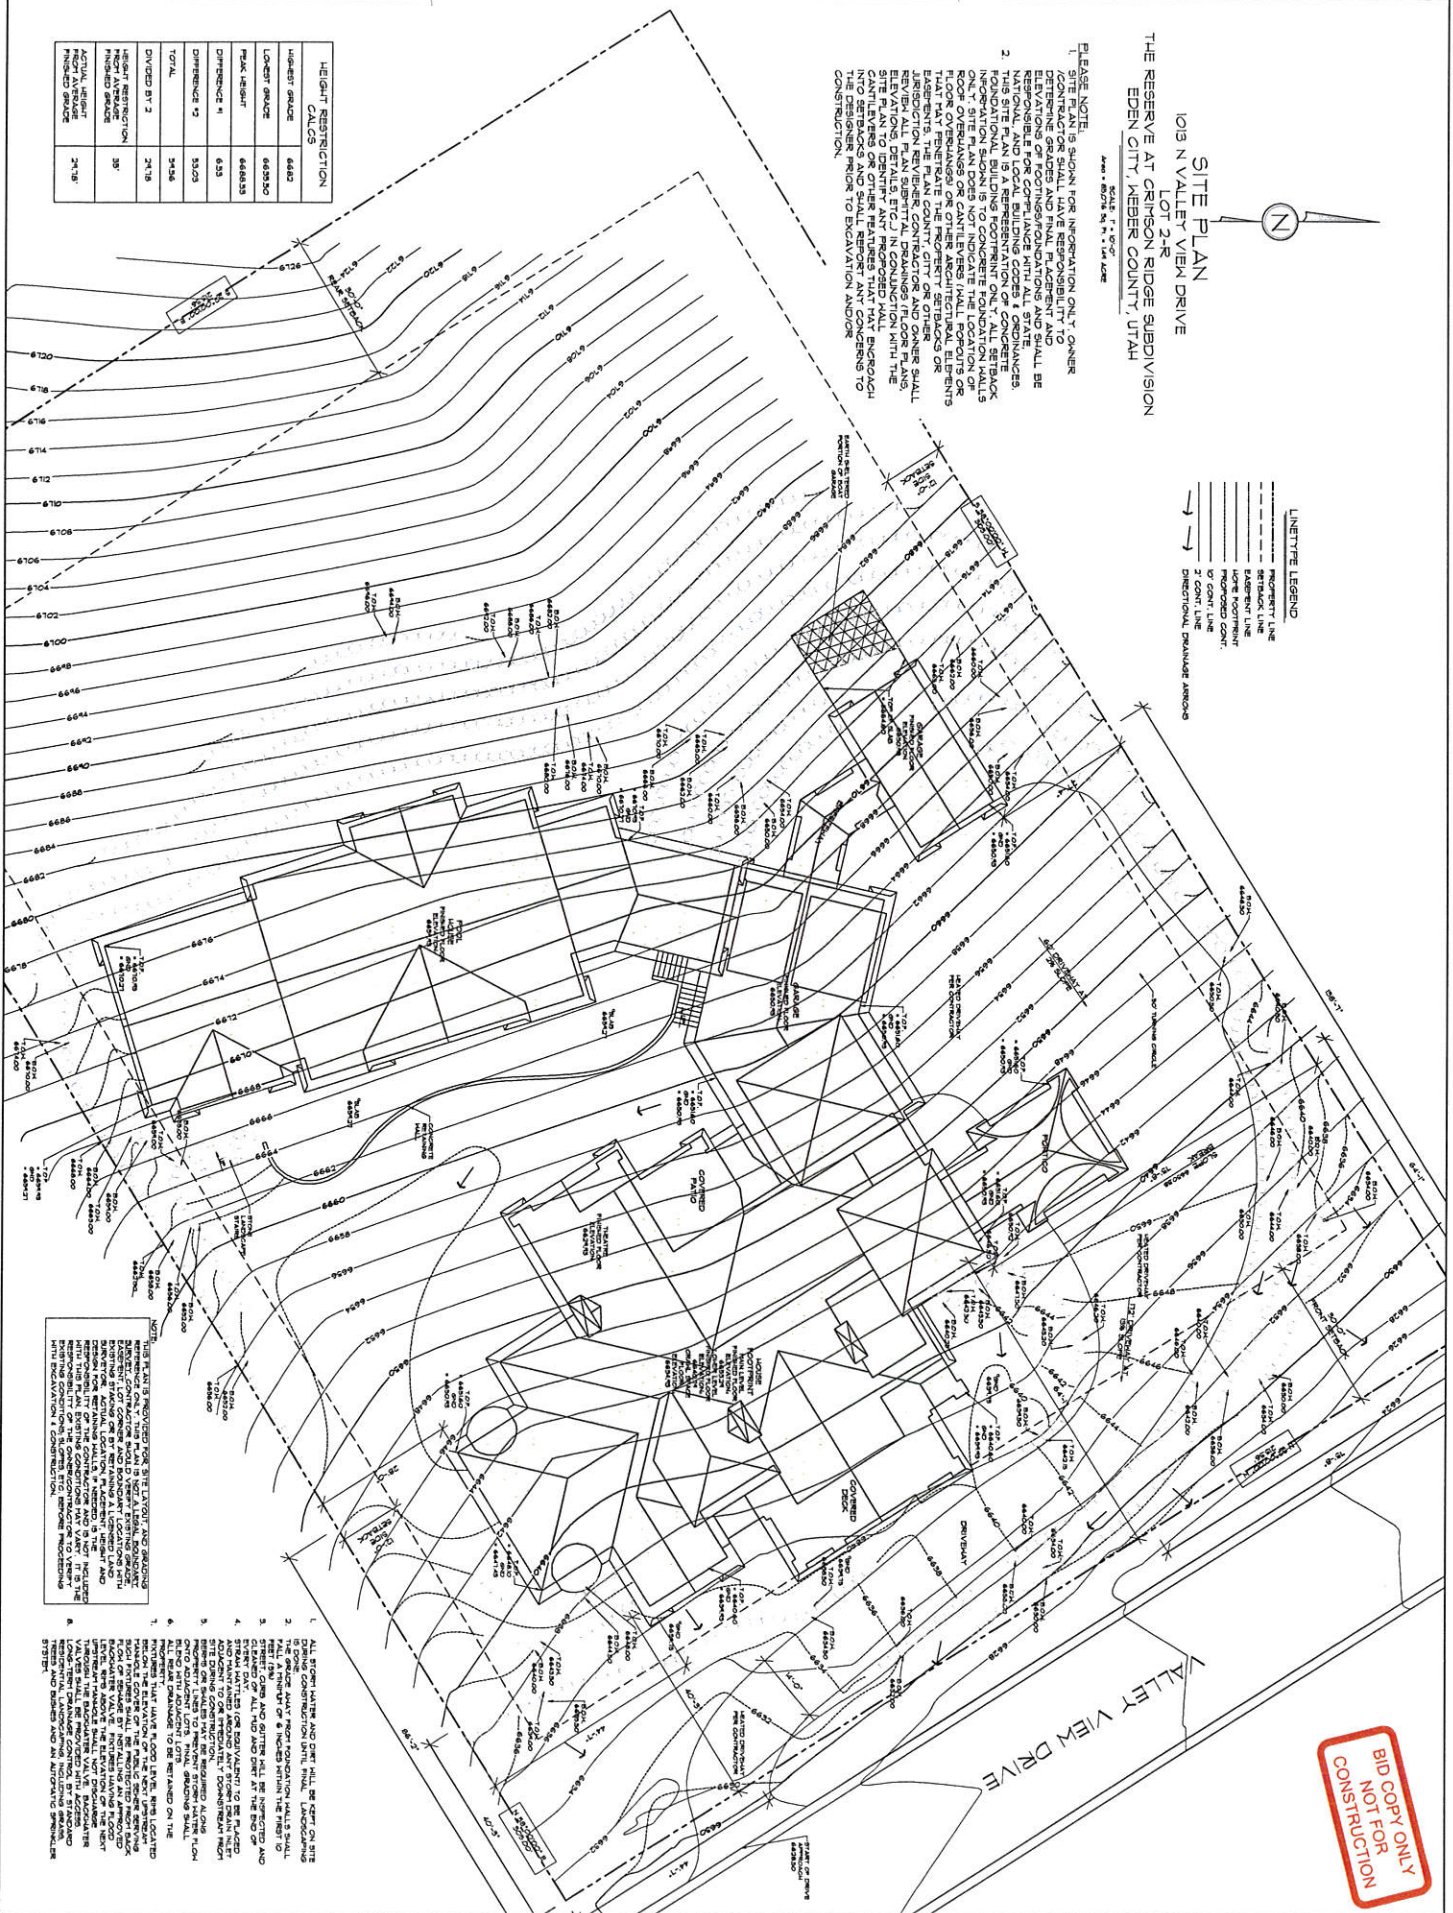
**NOTE:**  
 1. THE SETBACKS SHOWN ON THIS PLAN ARE BASED ON THE ASSUMPTION THAT THE EXISTING GRADE IS AS SHOWN ON THE TOPOGRAPHIC MAP. THE ARCHITECT SHALL BE RESPONSIBLE FOR VERIFYING THE EXISTING GRADE AND FOR OBTAINING THE NECESSARY PERMITS AND APPROVALS FROM THE LOCAL AUTHORITIES. THE ARCHITECT SHALL BE RESPONSIBLE FOR THE DESIGN OF THE FOUNDATIONS AND SHALL REPORT ANY CONCERNS TO THE DESIGNER PRIOR TO EXCAVATION AND/OR CONSTRUCTION.

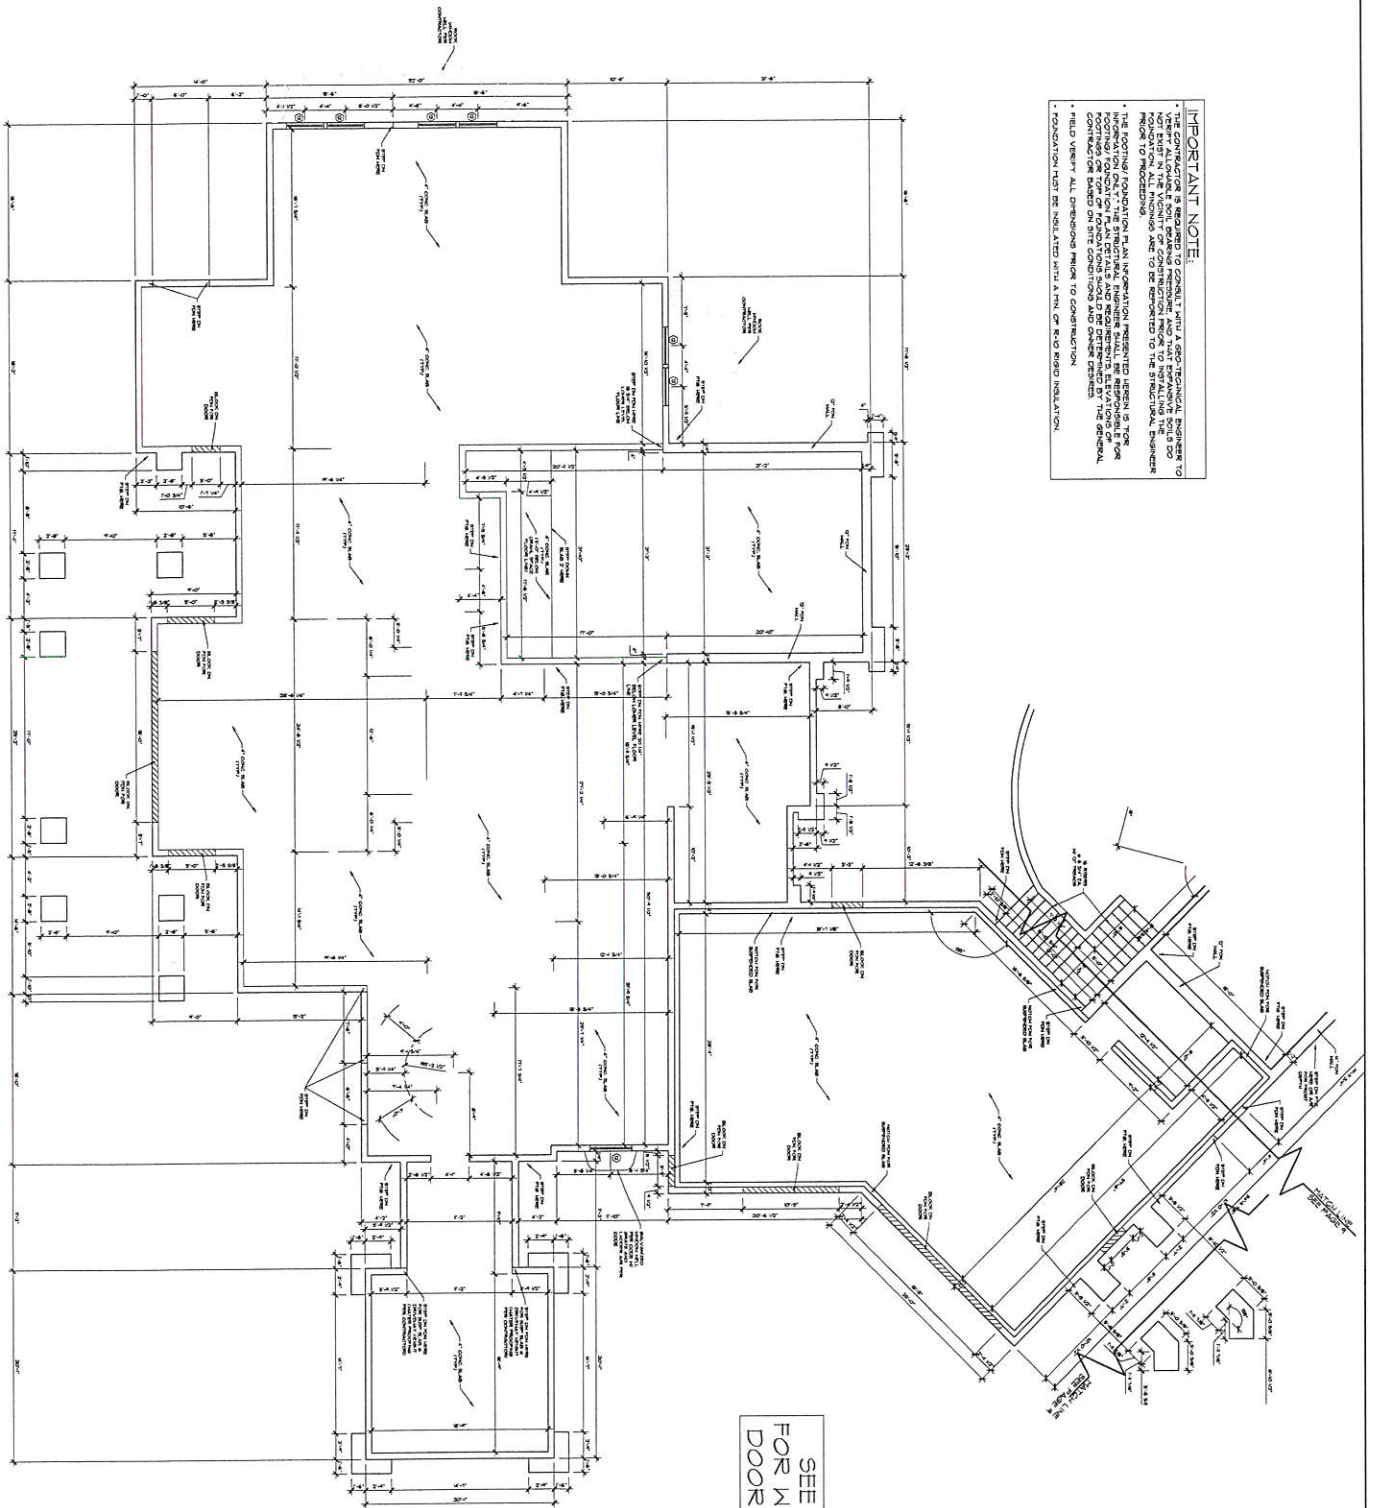
SHEET TITLE:  
**MAIN HOUSE  
FOOTING / FOUNDATION PLAN**

- THE CONTRACTOR IS REQUIRED TO CONSULT WITH A GEO-TECHNICAL ENGINEER TO VERIFY ALL GRADE, SOIL BEARING CAPACITY, AND TYPICAL FOUNDATION SOILS TO BE USED. ALL FOUNDATIONS ARE TO BE REFERRED TO THE STRUCTURAL ENGINEER FOR PROCEEDING.
- THE LOCATION OF ALL FOUNDATIONS, INCLUDING ALL EXISTING AND NEW FOUNDATIONS, SHALL BE REPRESENTED BY THE FOUNDATION PLAN. ALL FOUNDATIONS SHALL BE REPRESENTED BY THE FOUNDATION PLAN. ALL FOUNDATIONS SHALL BE REPRESENTED BY THE FOUNDATION PLAN. ALL FOUNDATIONS SHALL BE REPRESENTED BY THE FOUNDATION PLAN.
- FIELD VERIFY ALL DIMENSIONS PRIOR TO CONSTRUCTION.
- FOUNDATION MUST BE INSULATED WITH A MIN. OF R-10 INSULATION.

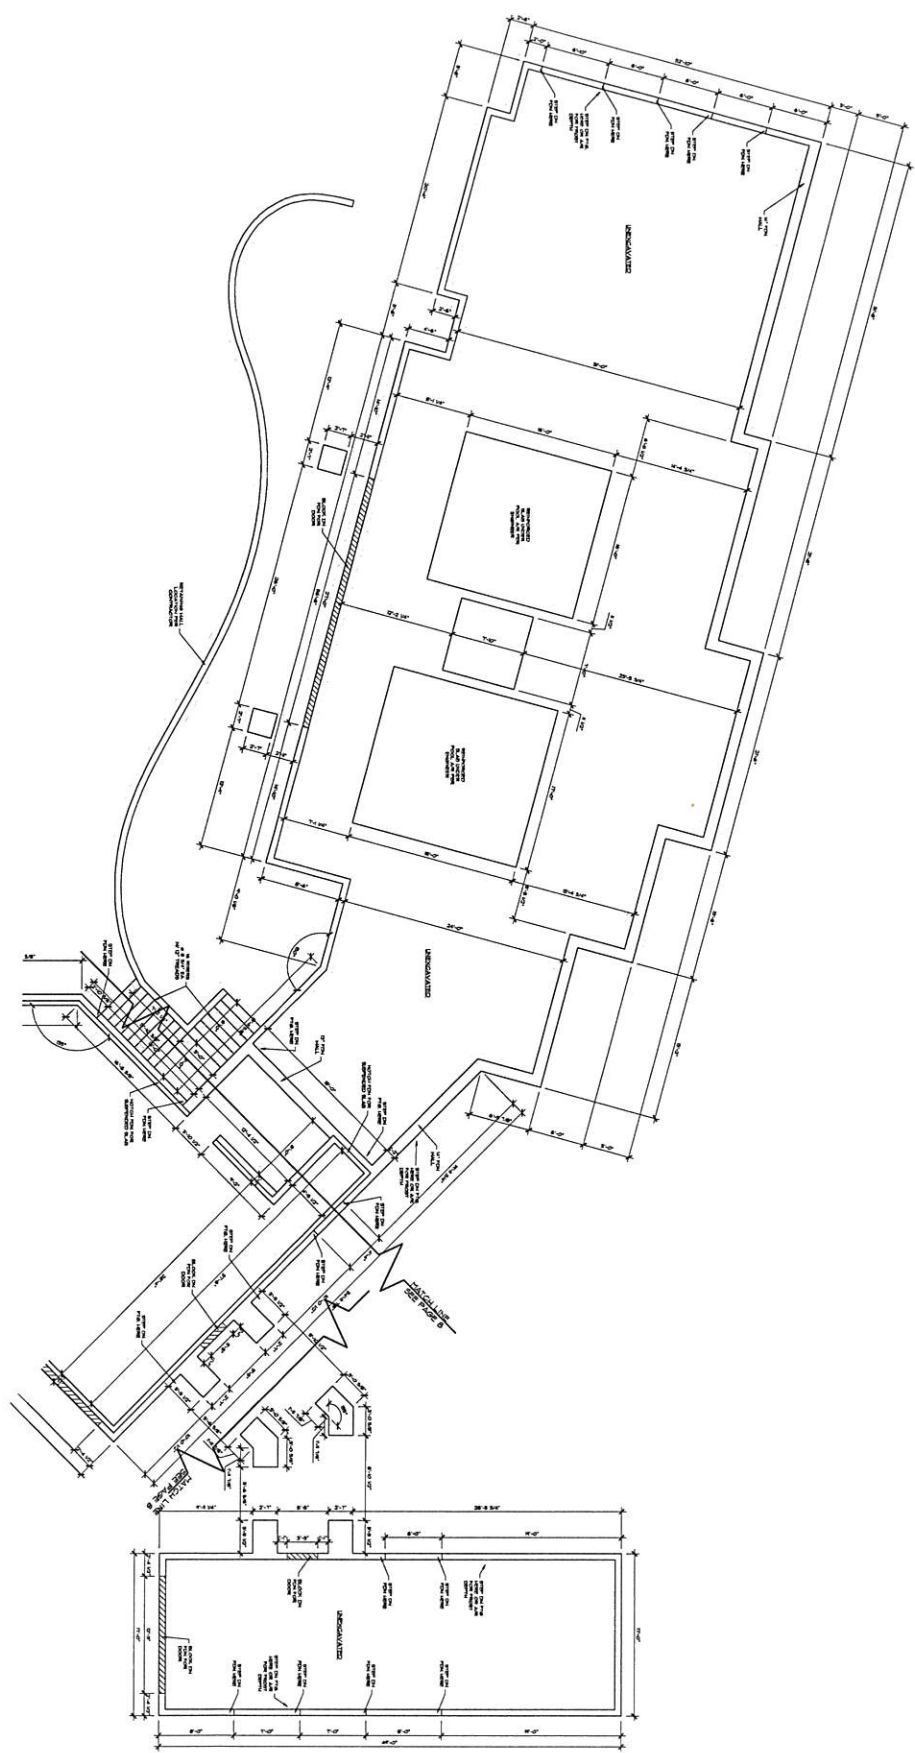
SHEET TITLE: POOL HOUSE & BOAT GARAGE FOOTING / FOUNDATION PLAN

- THE CONTRACTOR IS REQUESTED TO CONSULT WITH A GEO-TECHNICAL ENGINEER TO OBTAIN SOIL TESTS AND A FOUNDATION DESIGN TO BE INSTALLED IN THE VICINITY OF CONSTRUCTION PRIOR TO INSTALLING THE FOUNDATION.
- THE FOUNDATION PLAN INFORMATION PRESENTED HEREIN IS FOR INFORMATION ONLY. THE CONTRACTOR SHALL BE RESPONSIBLE FOR OBTAINING ALL NECESSARY PERMITS AND APPROVALS FROM THE LOCAL GOVERNMENT. ALL DIMENSIONS SHOULD BE DETERMINED BY THE GENERAL CONTRACTOR.
- FIELD VERIFY ALL DIMENSIONS PRIOR TO CONSTRUCTION.
- FOUNDATION TO BE INSTALLED WITH A MIN. OF R-10 RIGID INSULATION.

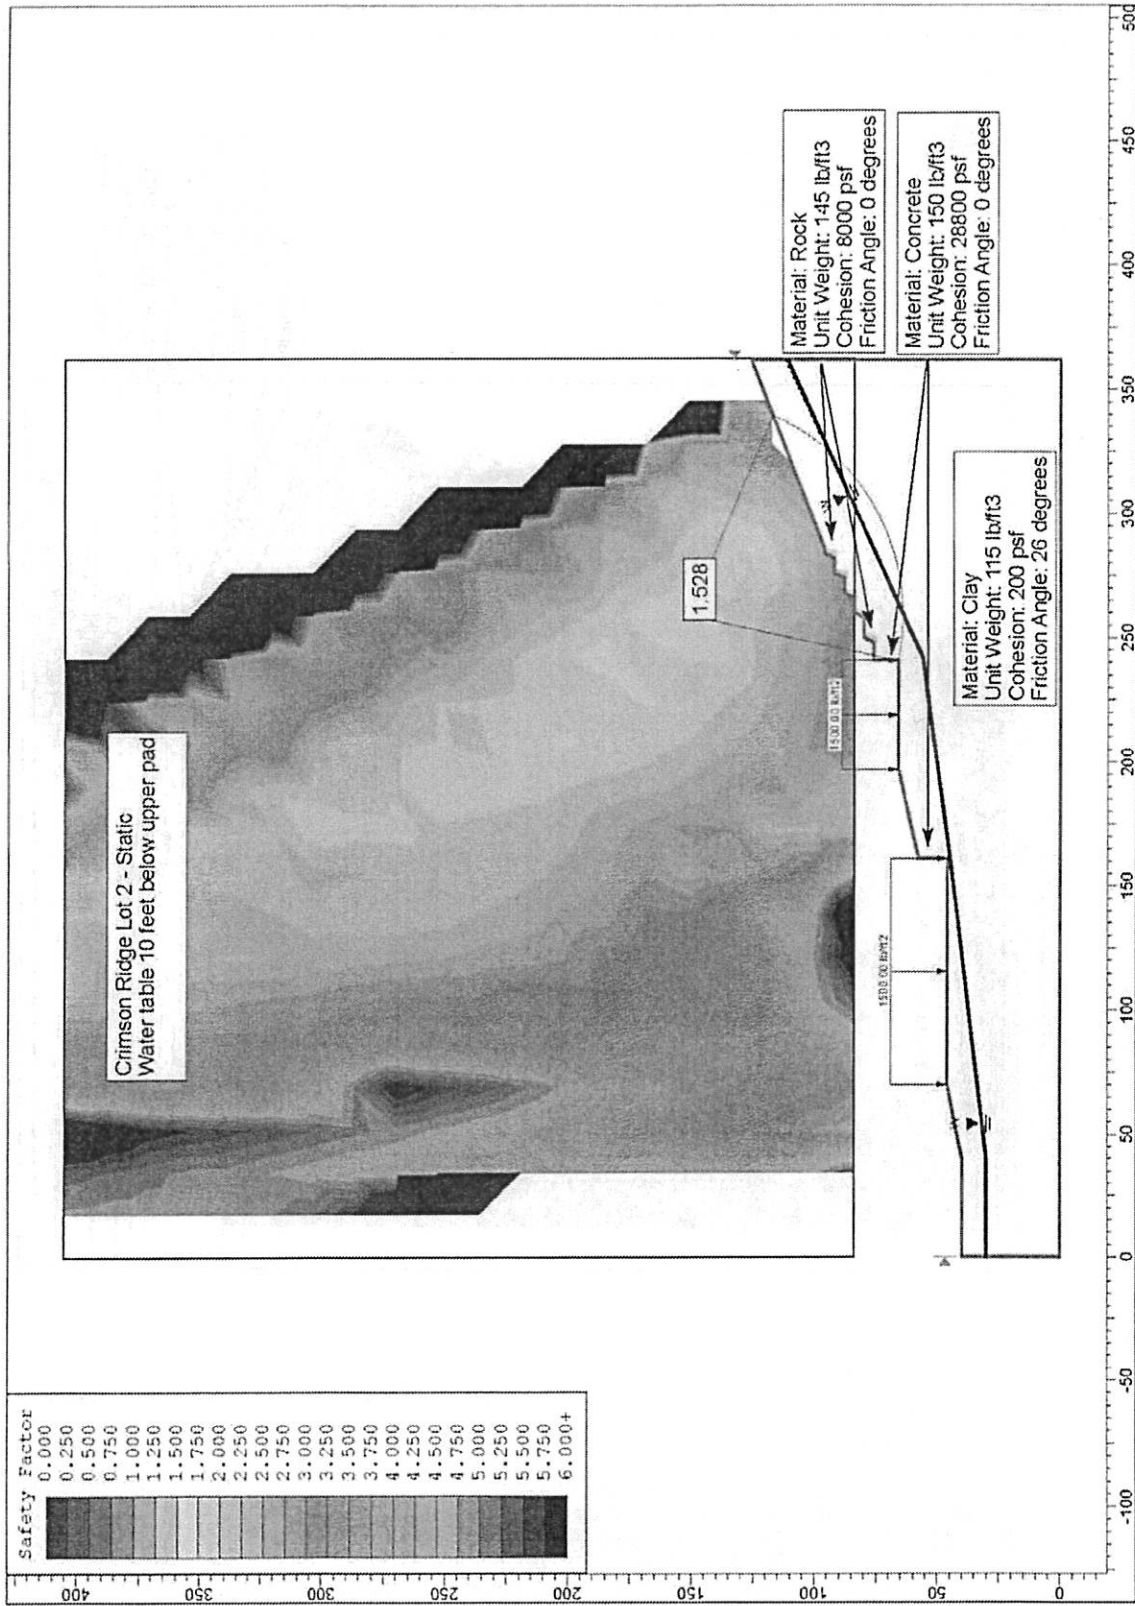
# STABILITY RESULTS

## LOT 2 CRIMSON RIDGE SUBDIVISION

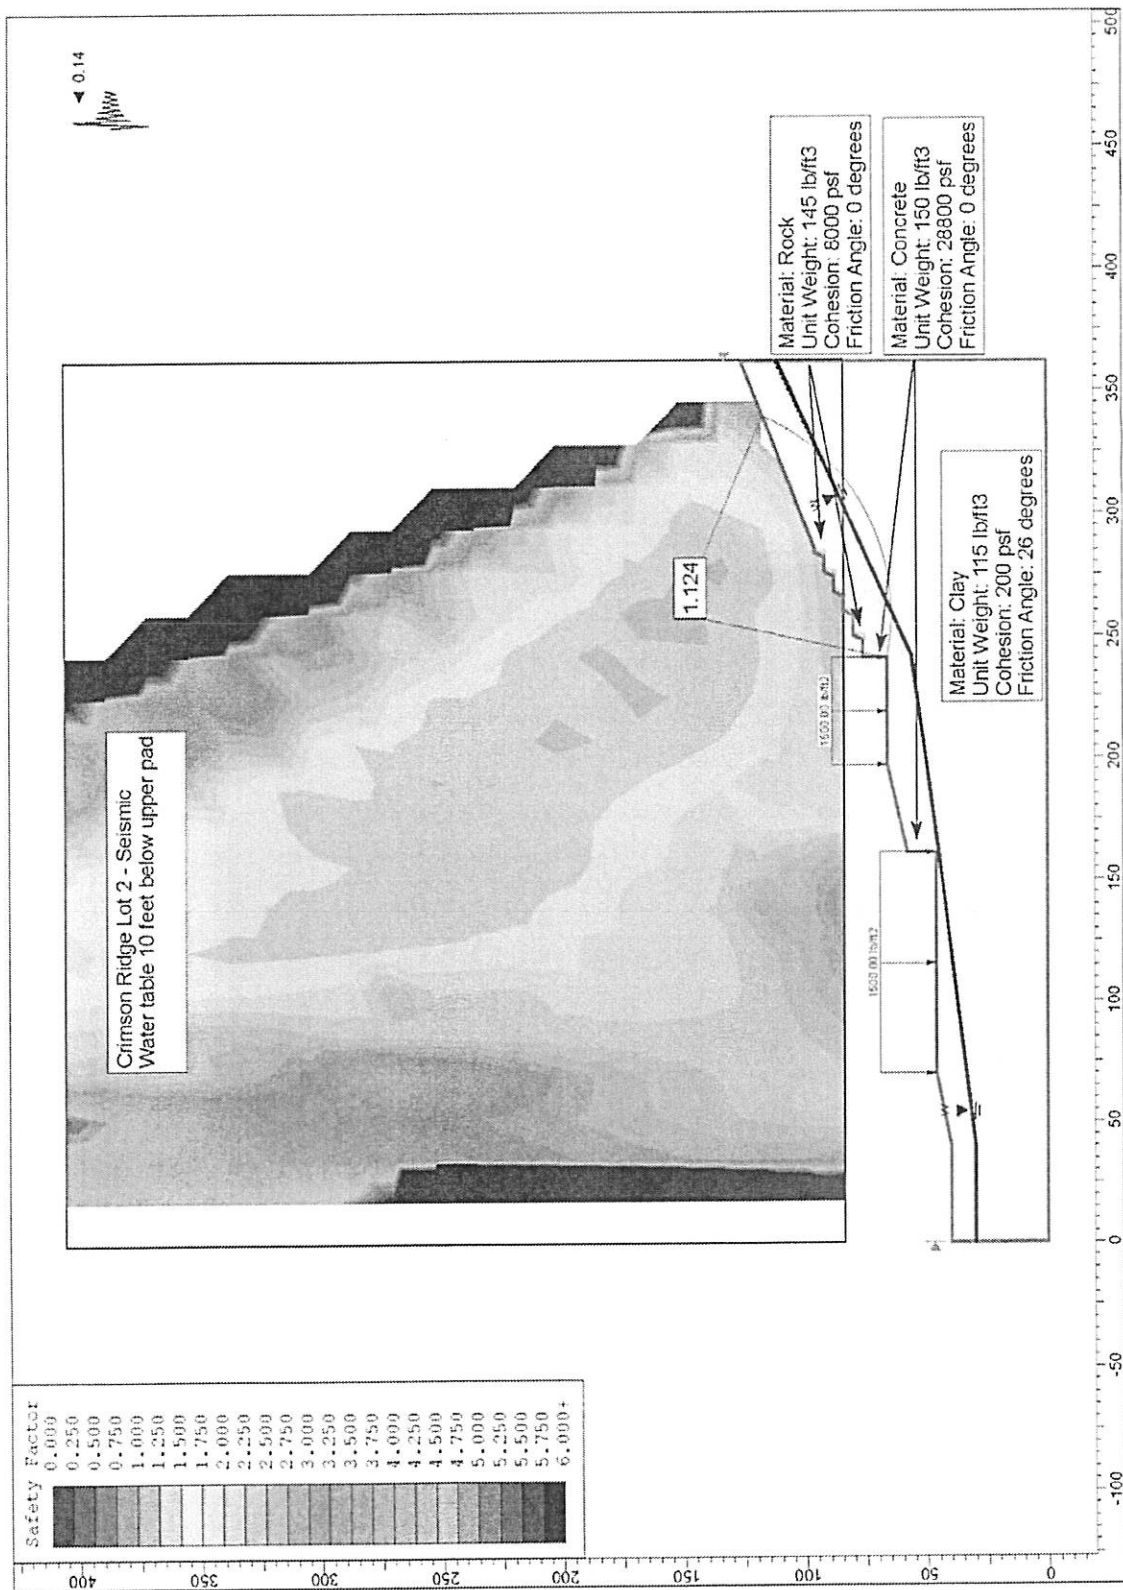
# STABILITY RESULTS

## LOT 2 CRIMSON RIDGE SUBDIVISION

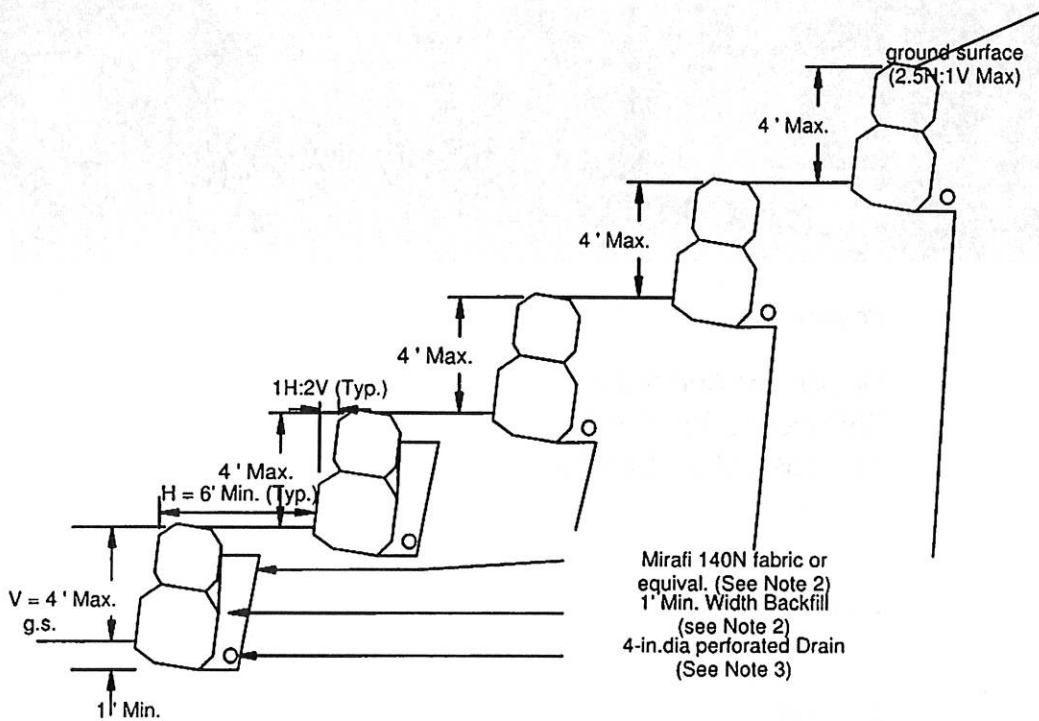
1. BACKFILL SOILS SHOULD BE PLACED IN LOOSE LIFTS NOT EXCEEDING A THICKNESS OF 12 INCHES, MOISTURE CONDITIONED TO WITHIN 2% OF OPTIMUM, AND COMPACTED TO A MINIMUM 95% OF THE MAXIMUM DRY DENSITY AS DETERMINED BY ASTM D1557.
2. FREE-DRAINING BACKFILL SHALL CONSIST OF GRAVEL HAVING LESS THAN 5% PASSING No. 200 SIEVE, OR MAY USE MIRADRAIN (OR EQUIVALENT) INSTEAD OF GRAVEL & FABRIC.
3. PERFORATED DRAIN SHALL BE WRAPPED WITH FABRIC, SLOPED A MINIMUM 2% TO SIDE OF WALL, AND DISCHARGED TO APPROPRIATE DRAINAGE DEVICE.
4. BOULDER SIZES SHALL BE A MINIMUM 36 INCHES FOR THE BOTTOM ROW AND A MINIMUM 24 INCHES FOR THE UPPER ROW FOR EACH TIER.

Mirafix 140N fabric or  
equival. (See Note 2)  
1' Min. Width Backfill  
(see Note 2)  
4-in. dia perforated Drain  
(See Note 3)

A subdrain system must be installed upslope of the home, pool house, boat house and rockery landscape walls to reduce the potential for surface water infiltration, as discussed further within this report. A foundation subdrain must be constructed for all exterior foundations. Additionally, a subdrain system with lateral tie-ins must be constructed beneath/around the proposed pool.

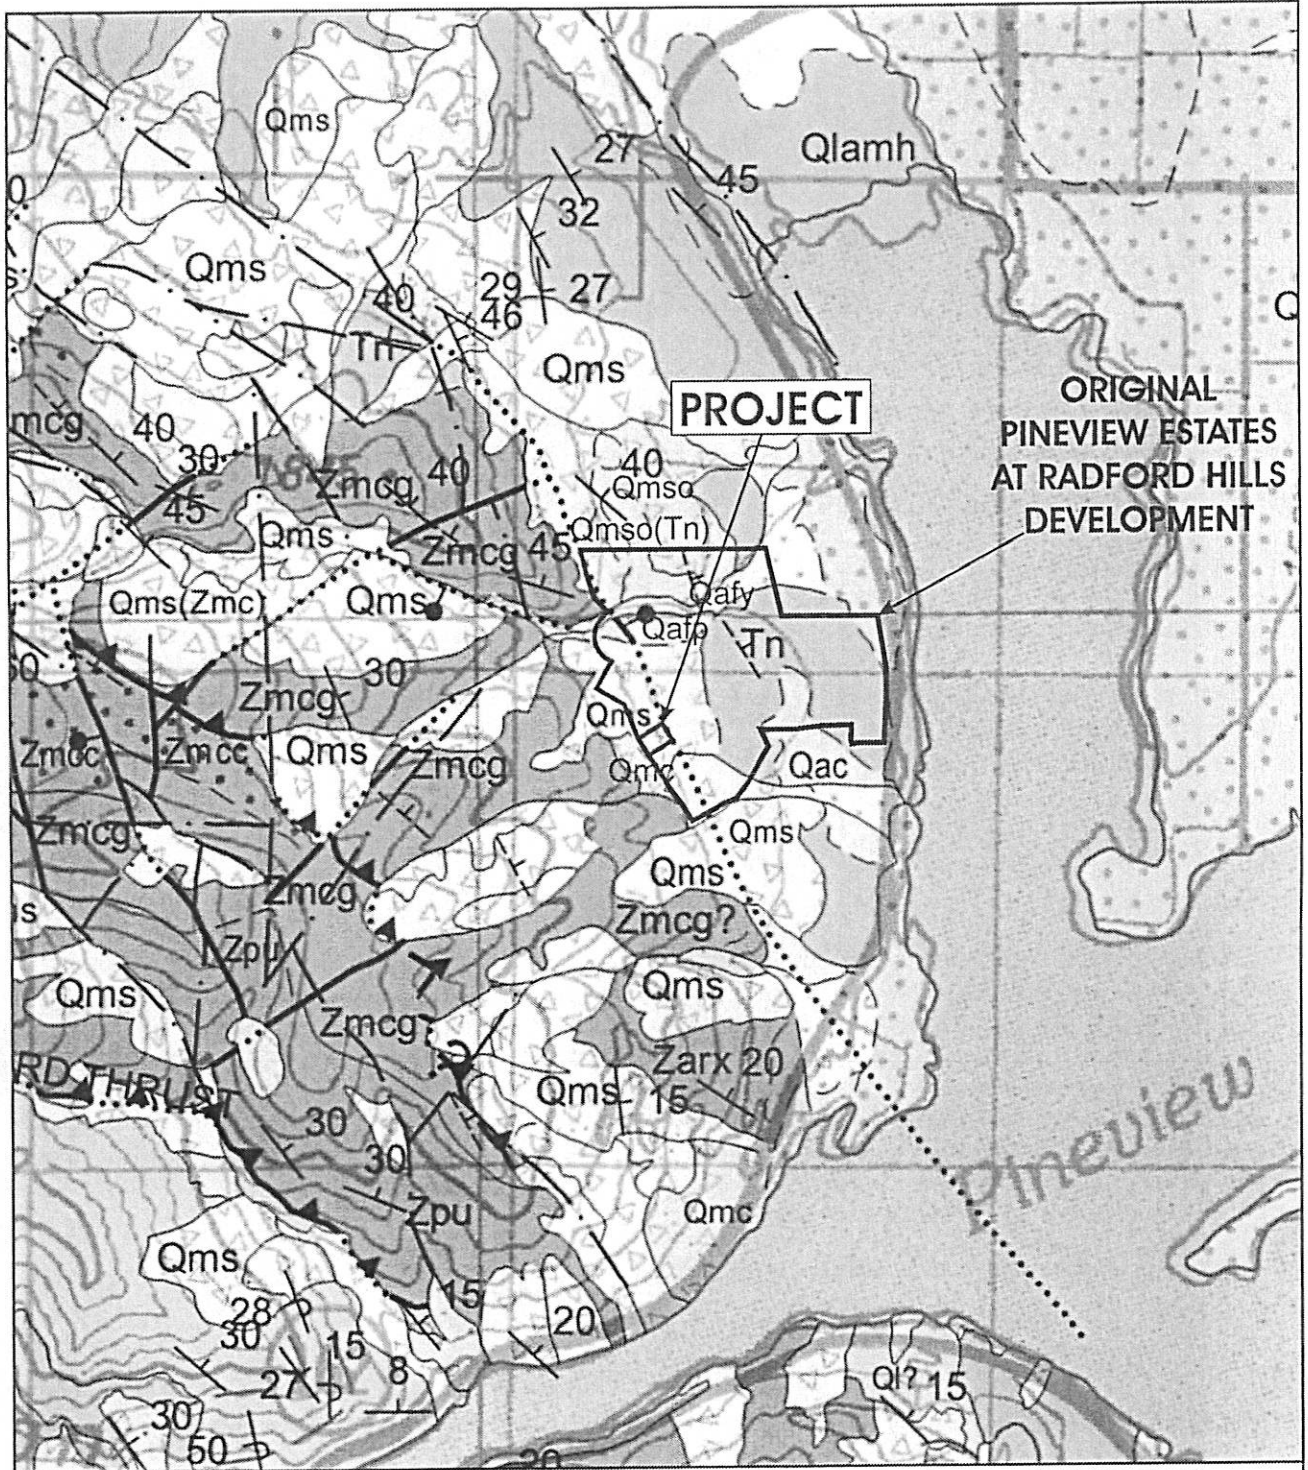
**FIGURE 2**

Source: Coogan and King (2016); original map scale 1:100,000. See text for explanation of nearby surficial geologic units.

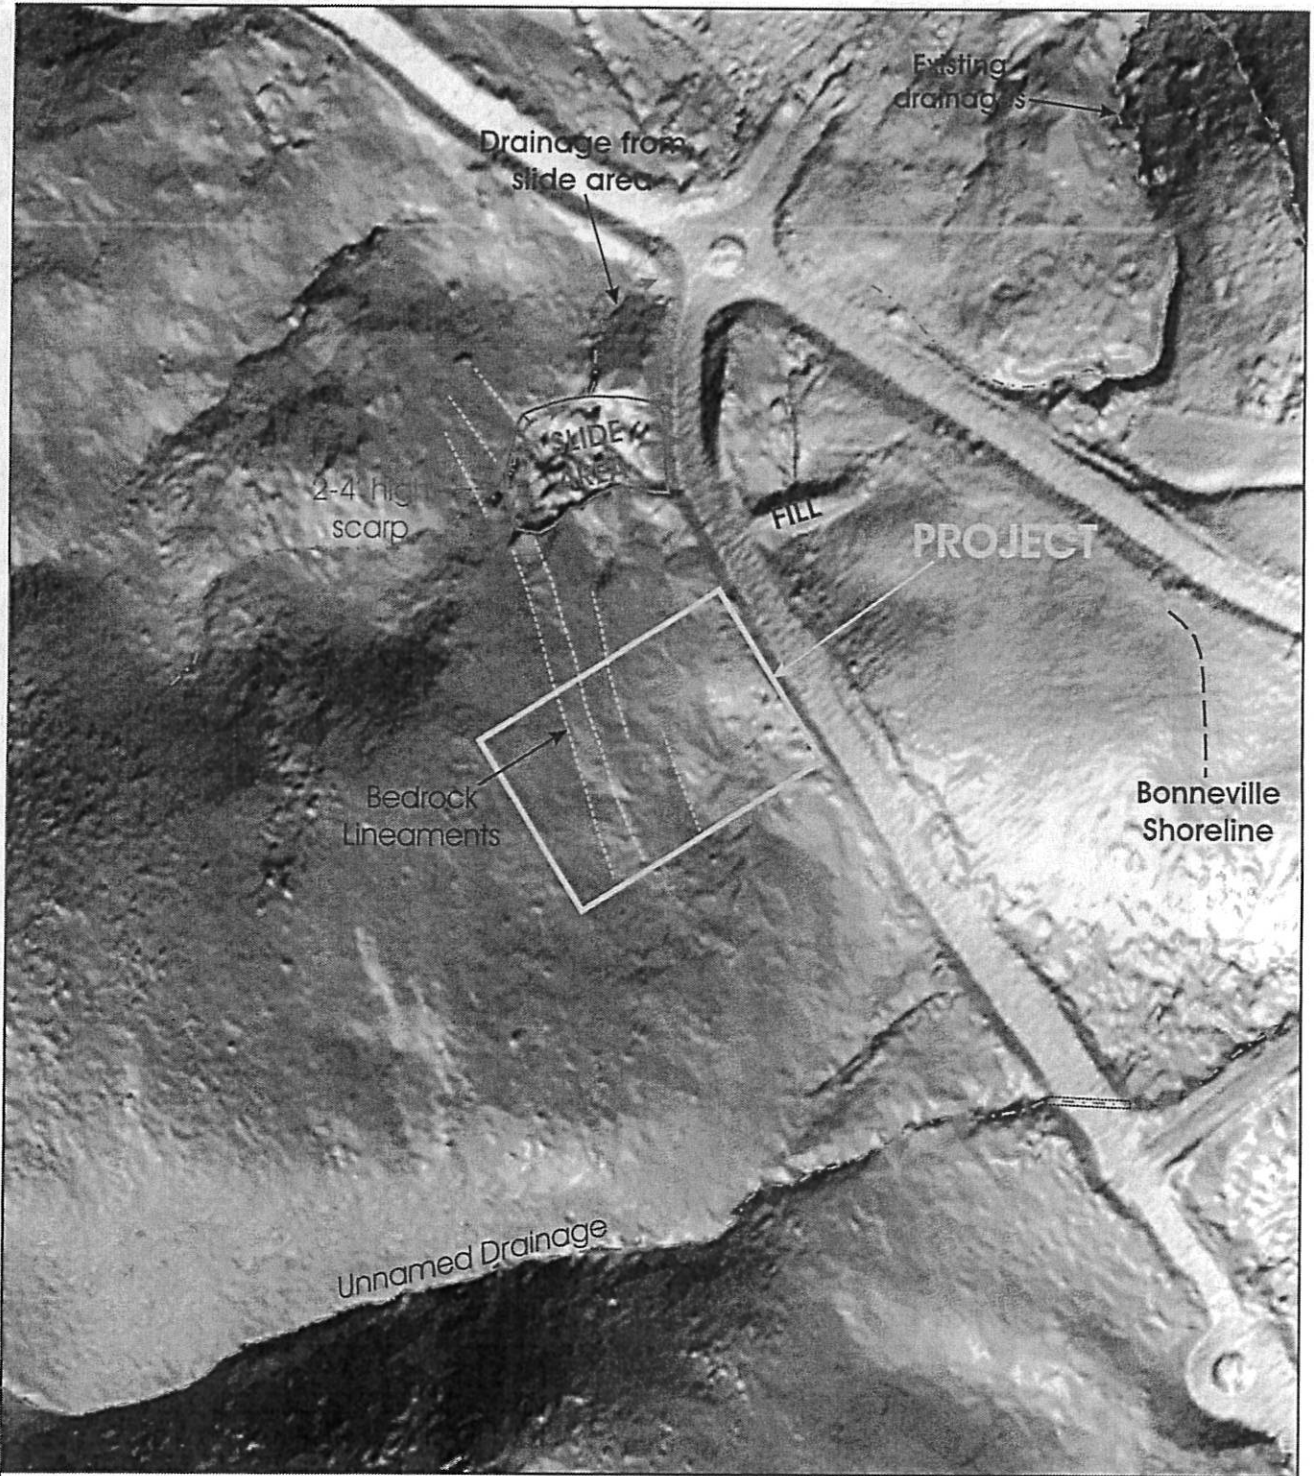
2011 LIDAR IMAGE

Source: Utah AGRC, 1-meter LIDAR Bare Earth DEM, 2011.

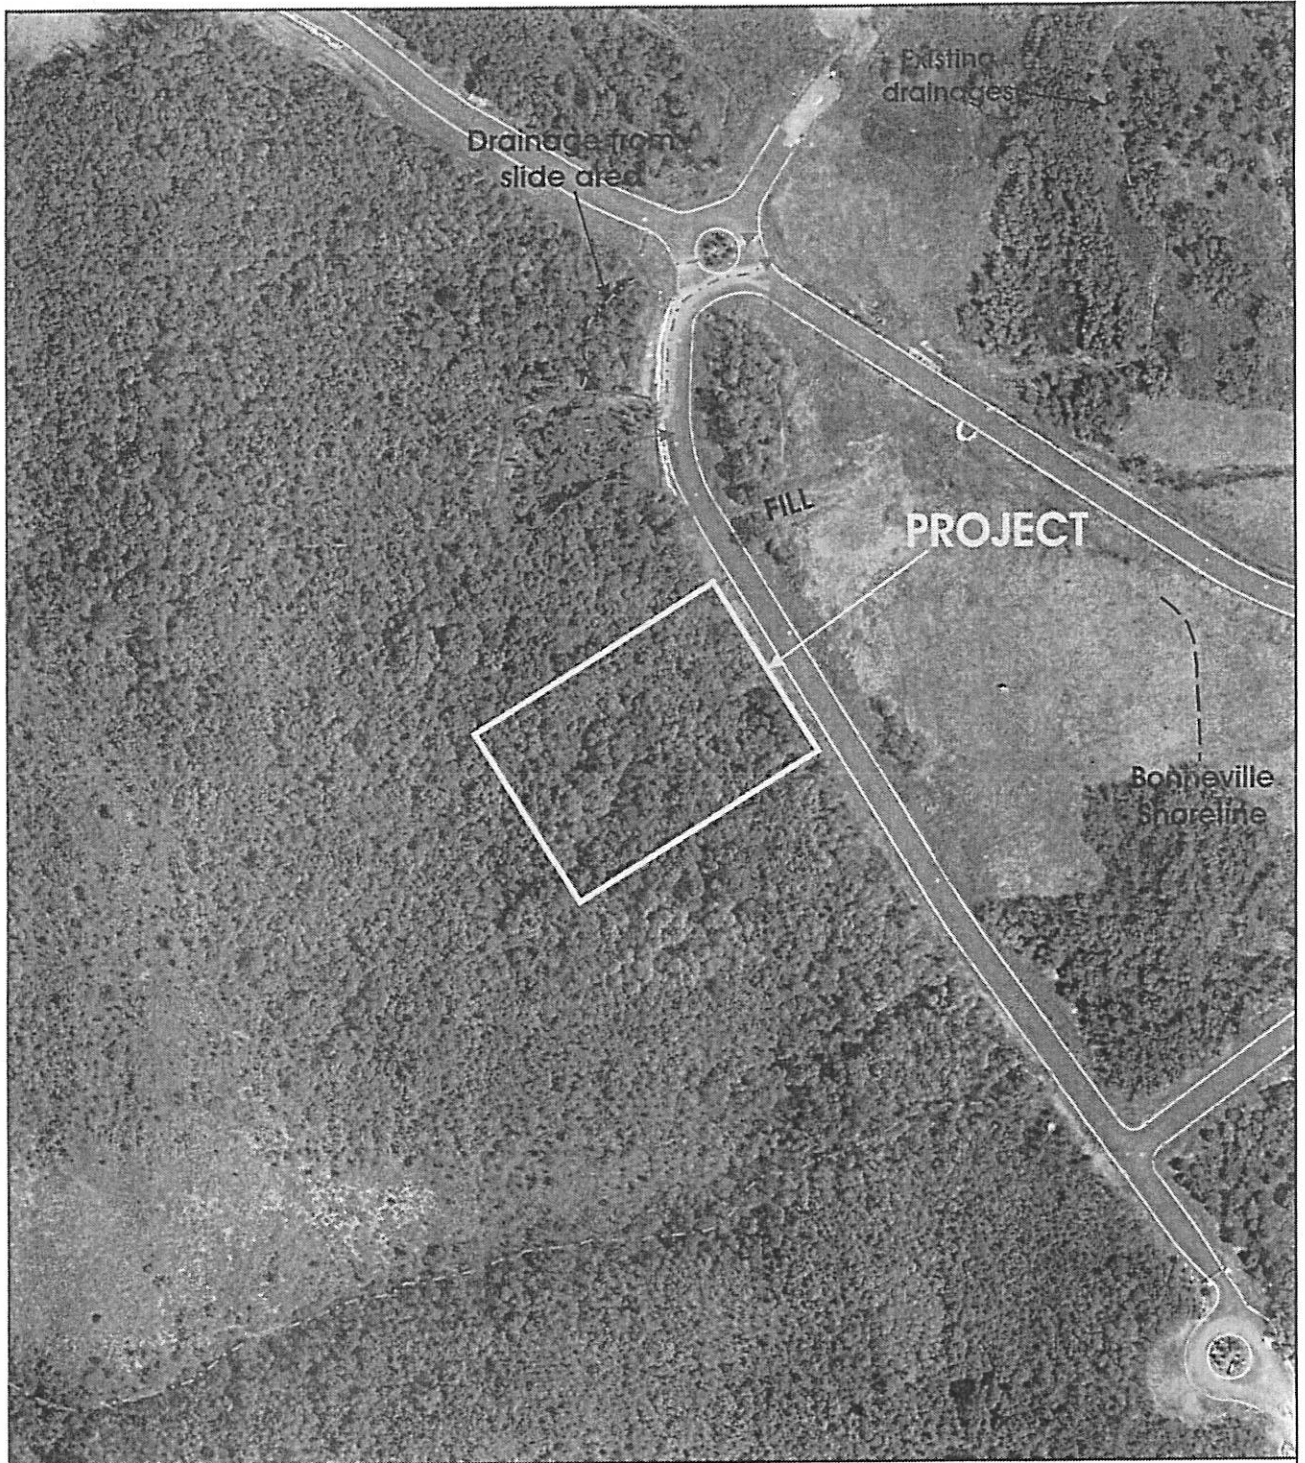
**FIGURE 3B**

Source: Utah AGRC, High Resolution Orthophoto, 6-inch resolution, 2012.

- Figure 1. Location Map (8.5"x11")
- Figure 2. Geologic Map (8.5"x11")
- Figure 3A. 2011 LIDAR Image (8.5"x11")
- Figure 3B. 2012 Air Photo (8.5"x11")
- Figure 4. Site Plan (8.5"x11")
- Figures 5A-D. Trench Log (four 11"x17" sheets)
- Figures 6A-C. Test Pit Logs (three 8.5"x11" sheets)
- Figure 7. Cross Section (11"x17")

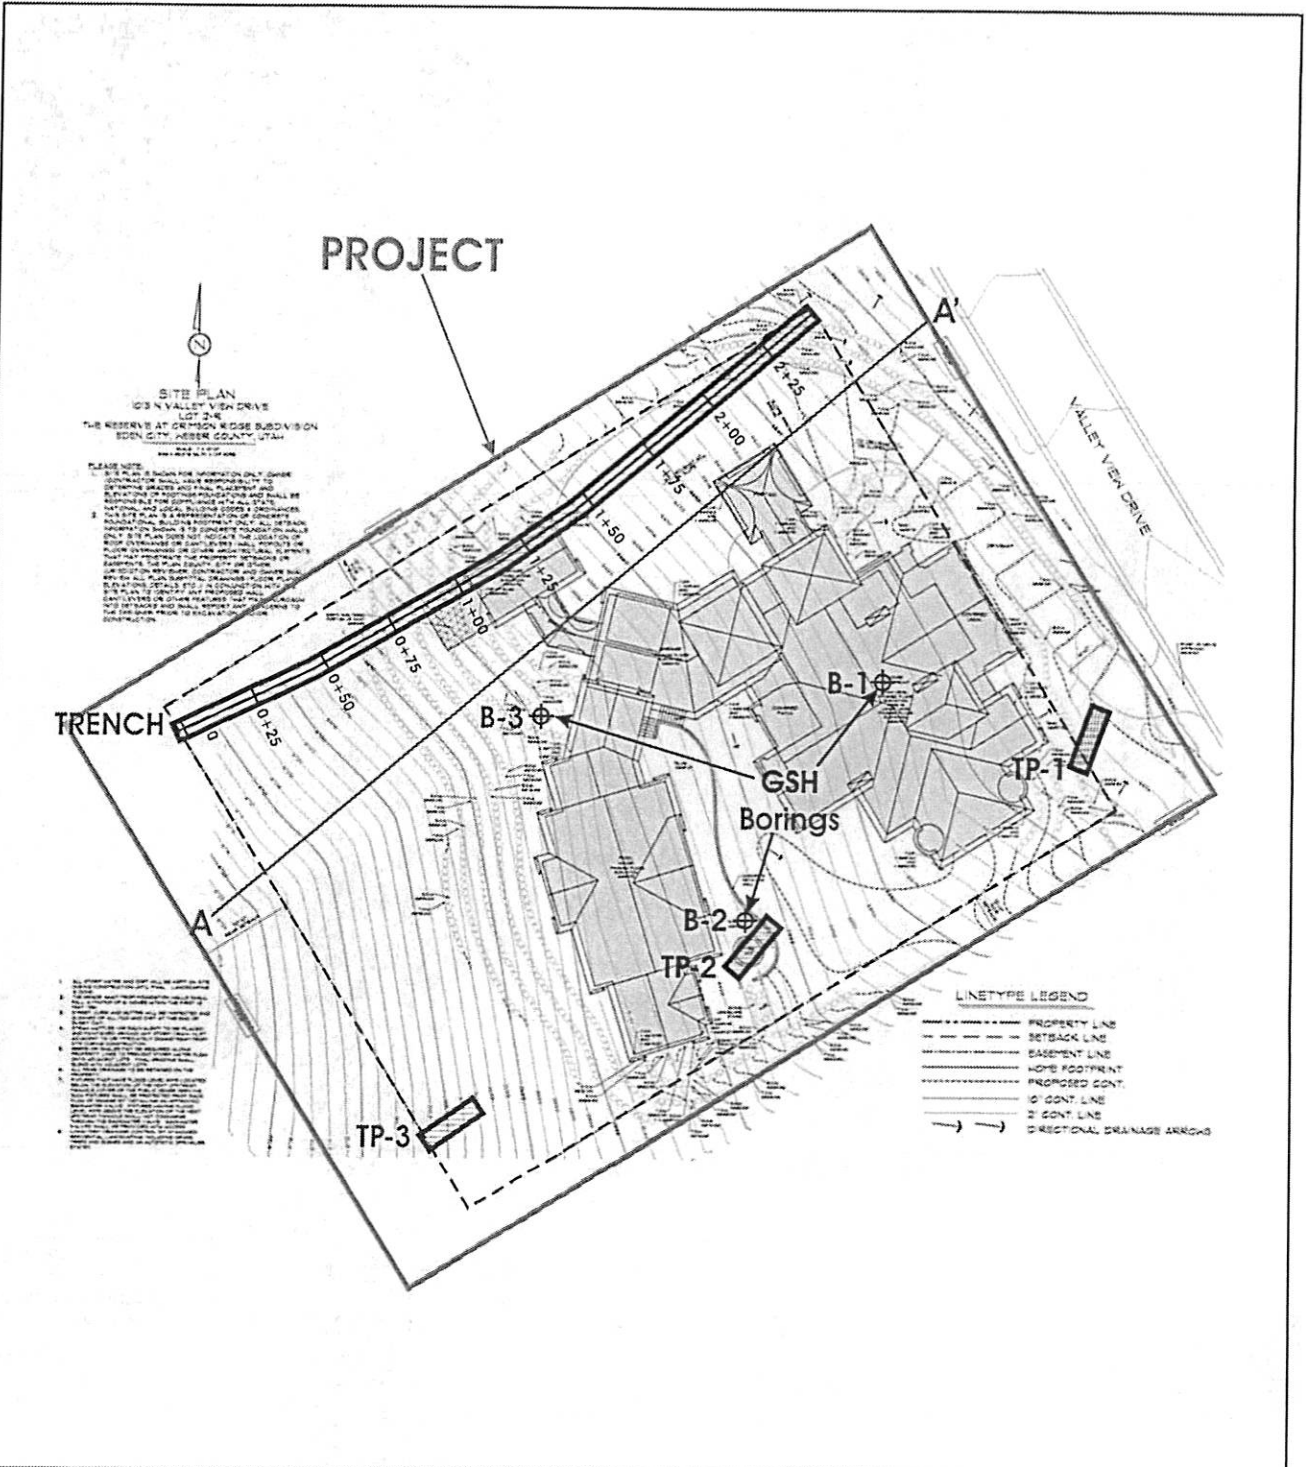
**FIGURE 4**

One trench and three walk-in test pits were excavated at the property between June 30 and July 2, 2016 to evaluate subsurface conditions. Figure 4 is a site plan at a scale of one inch equals 60 feet (1:720) showing the site boundaries, surveyed topography, the proposed home location and footprint, locations of the trench and test pits, and approximate locations of the borings conducted by GSH. Figures 5 and 6A-C are logs of the trench and test pits at a scale of 1 inch equals five feet (1:60). Due to the length of the trench and scale, Figure 5 occupies four 11"x17" sheets (A-D). The trench and test pit locations were measured using a hand-held GPS unit and by trend and distance methods from known points. Trench logging generally followed methodology in McAlpin (1996). The trench and test pit exposures were also digitally photographed at 5-foot intervals to document subsurface conditions. The photos are not provided herein, but are available on request. No complications were encountered that substantially impacted the subsurface investigation, except for groundwater seepage in test pit TP-1, which caused this test pit to rapidly fill with water to a depth of several feet during and following the logging.

The trench at the site was excavated generally along the north site boundary and extended an overall N34°E for a total distance of 247 feet (Figure 4). The trench exposed a sequence of inclined bedrock units of the Tertiary Norwood Formation in which the modern A-horizon soil and a Bt to Bw horizon was forming. The exposed bedrock sequence showed strikes ranging from N40°W to N42°W and dips of from 37° to 42° to the northeast (Figures 5A-D), which appears similar to nearby measurements (discussed above). Unit descriptions are provided on Figure 5D. No evidence of landsliding was exposed in the trench, except for one suspect iron-oxide stained crack near station 1+61 feet (Figure 5C) that may be related to slow slope creep. One seep was also observed near station 0+67 feet (Figure 5B), although this seep was weak and only caused a muddy area in the trench floor.

Figure 7 shows a cross section across the slope at the site at a scale of 1 inch equals 30 feet with no vertical exaggeration. The profile location is shown on Figure 4. Units and contacts are inferred based on the subsurface data discussed above. We use an overall dip of 40 degrees for contacts within the Norwood Formation. Presumed existing groundwater levels are also indicated based on the GSH field logs for the borings, although we note that future levels may fluctuate seasonally and in response to landscape irrigation.
