# Staff Report for Administrative Approval Hillside Review – Notice of Conditional Approval

**Application Request:** Consideration and action on a request to approve a Hillside Review for the Anderson residence located on Lot 2-R in The Reserve at Crimson Ridge Cluster Subdivision Phase 1.

**File Number:** HSR 2016-18

## GEOLOGIC HAZARDS EVALUATION THE RESERVE AT CRIMSON RIDGE, LOT 2-R 1013 NORTH VALLEY VIEW DRIVE LIBERTY, WEBER COUNTY, UTAH

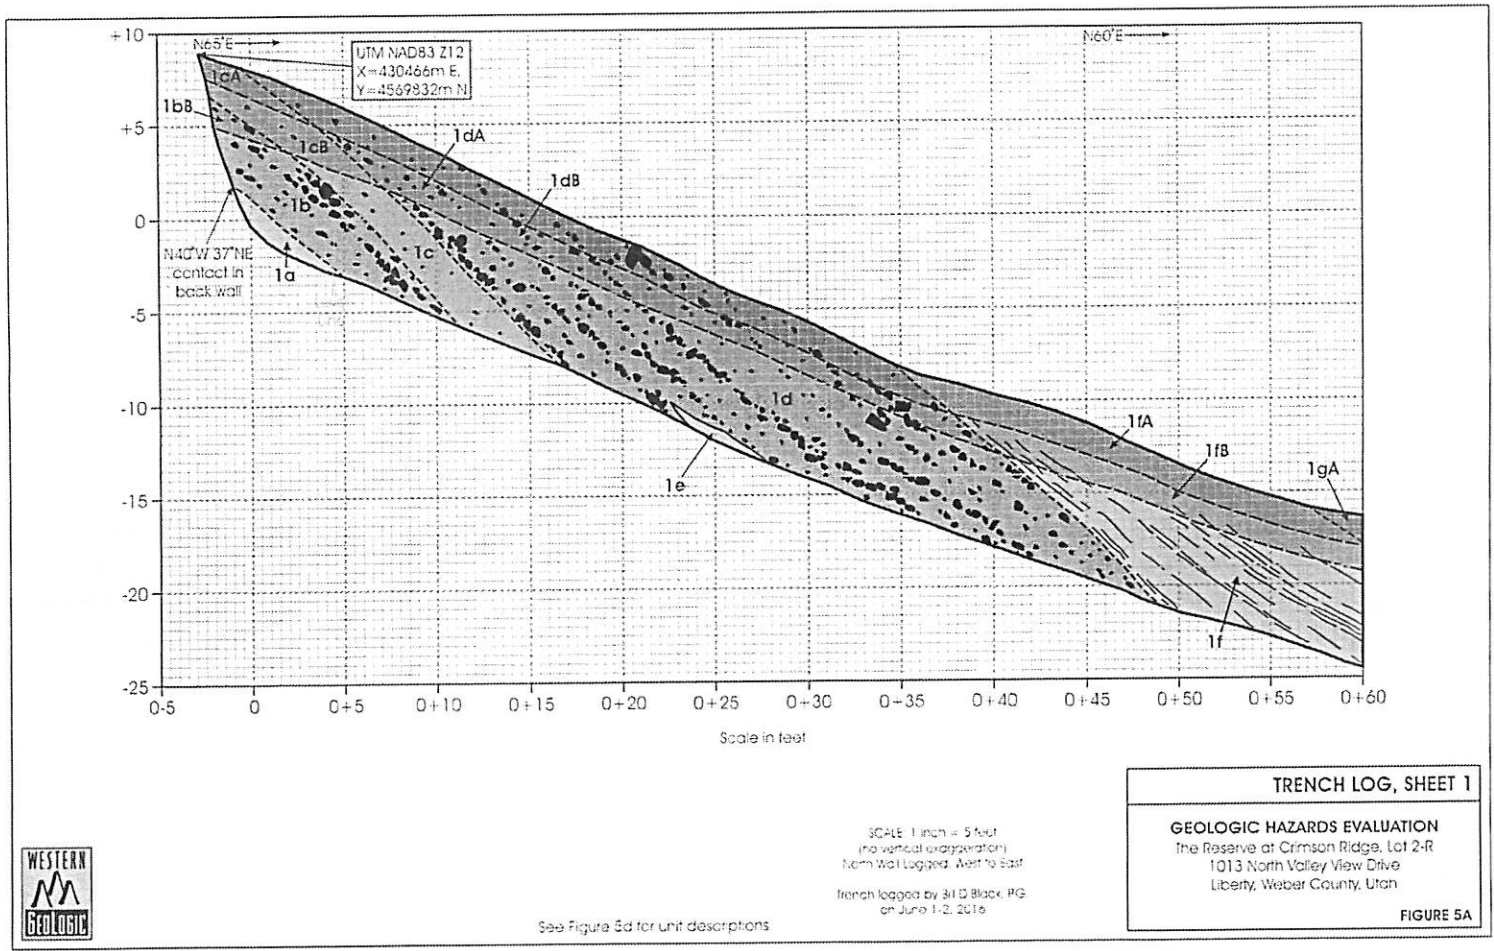
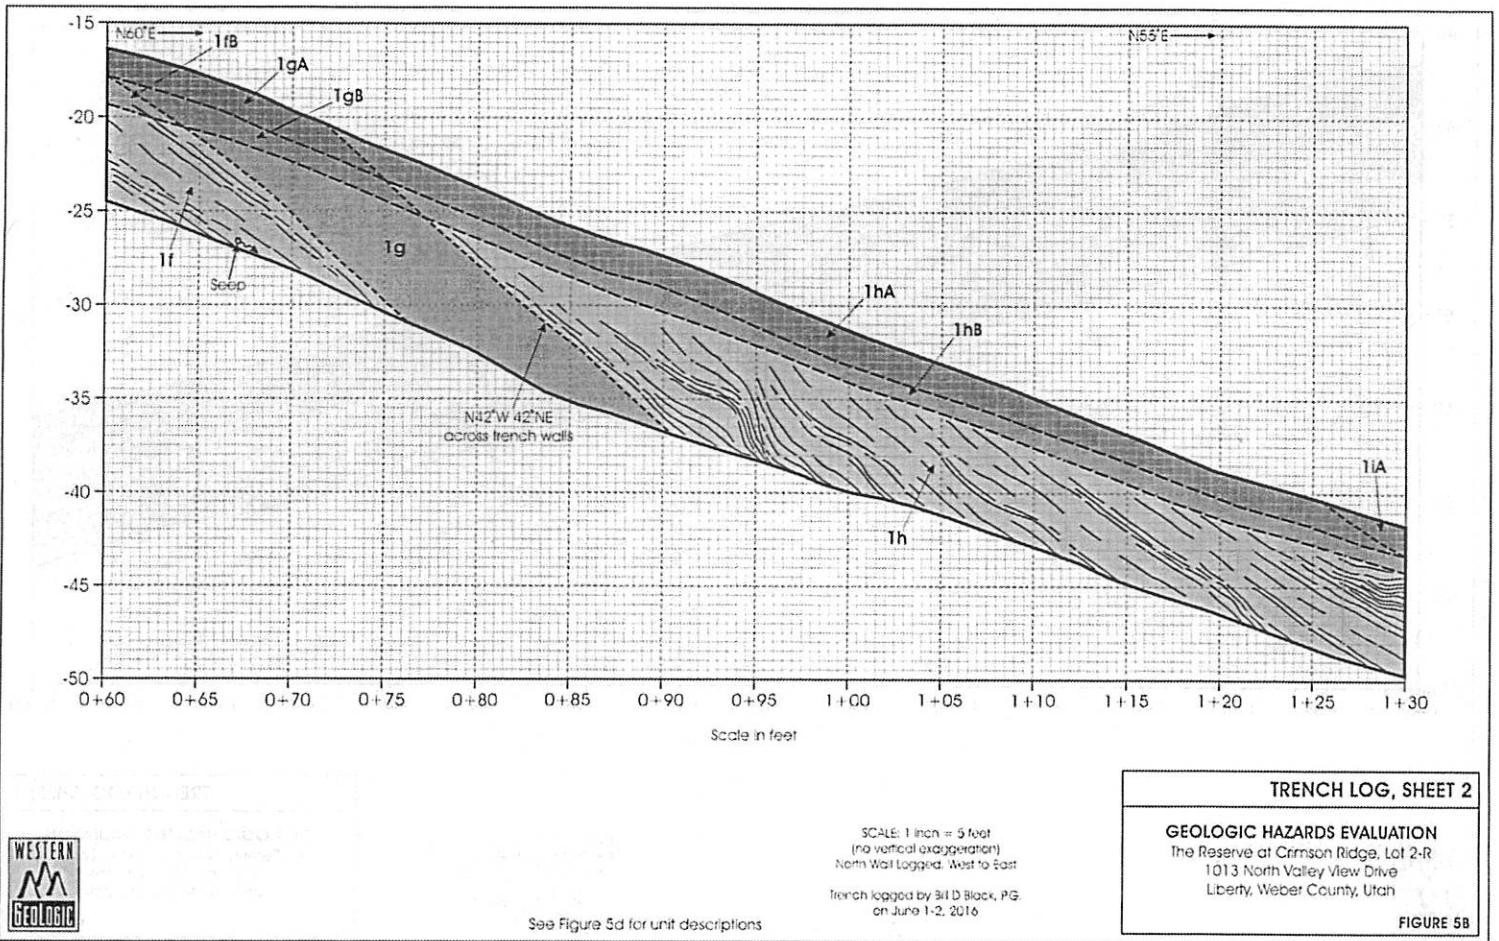
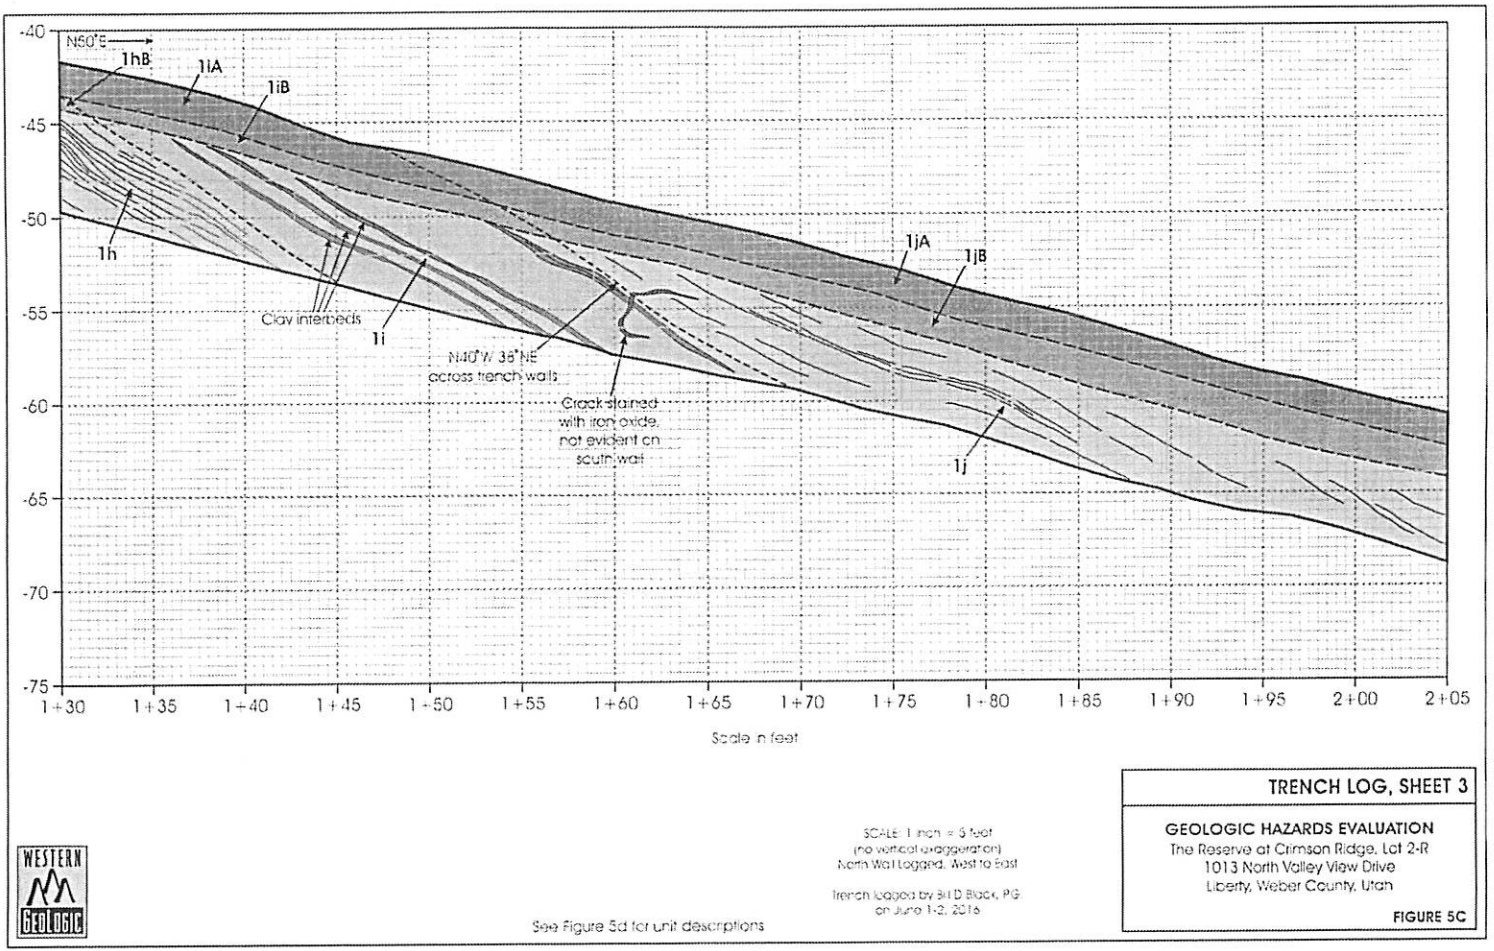
The trench at the site was excavated generally along the north site boundary and extended an overall N34°E for a total distance of 247 feet (Figure 4). The trench exposed a sequence of inclined bedrock units of the Tertiary Norwood Formation in which the modern A-horizon soil and a Bt to Bw horizon was forming. The exposed bedrock sequence showed strikes ranging from N40°W to N42°W and dips of from 37° to 42° to the northeast (Figures 5A-D), which appears similar to nearby measurements (discussed above). Unit descriptions are provided on Figure 5D. No evidence of landsliding was exposed in the trench, except for one suspect iron-oxide stained crack near station 1+61 feet (Figure 5C) that may be related to slow slope creep. One seep was also observed near station 0+67 feet (Figure 5B), although this seep was weak and only caused a muddy area in the trench floor.

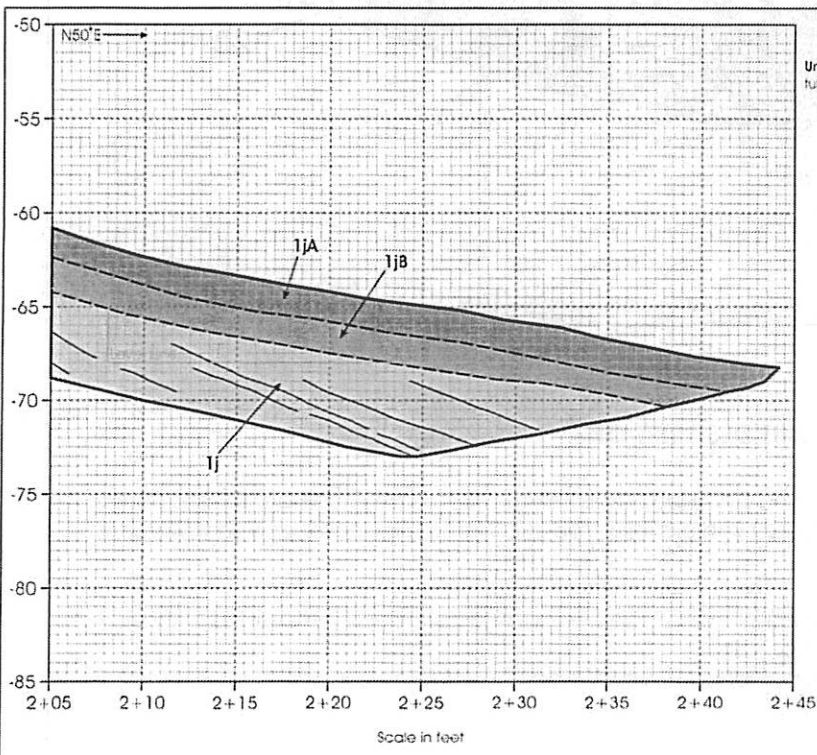
**FIGURE 5D**

- Unit 1. Tertiary Norwood Formation** - sequence of moderate to high density, poorly to well bedded, tuffaceous bedrock units striking northwesterly and dipping to the northeast.

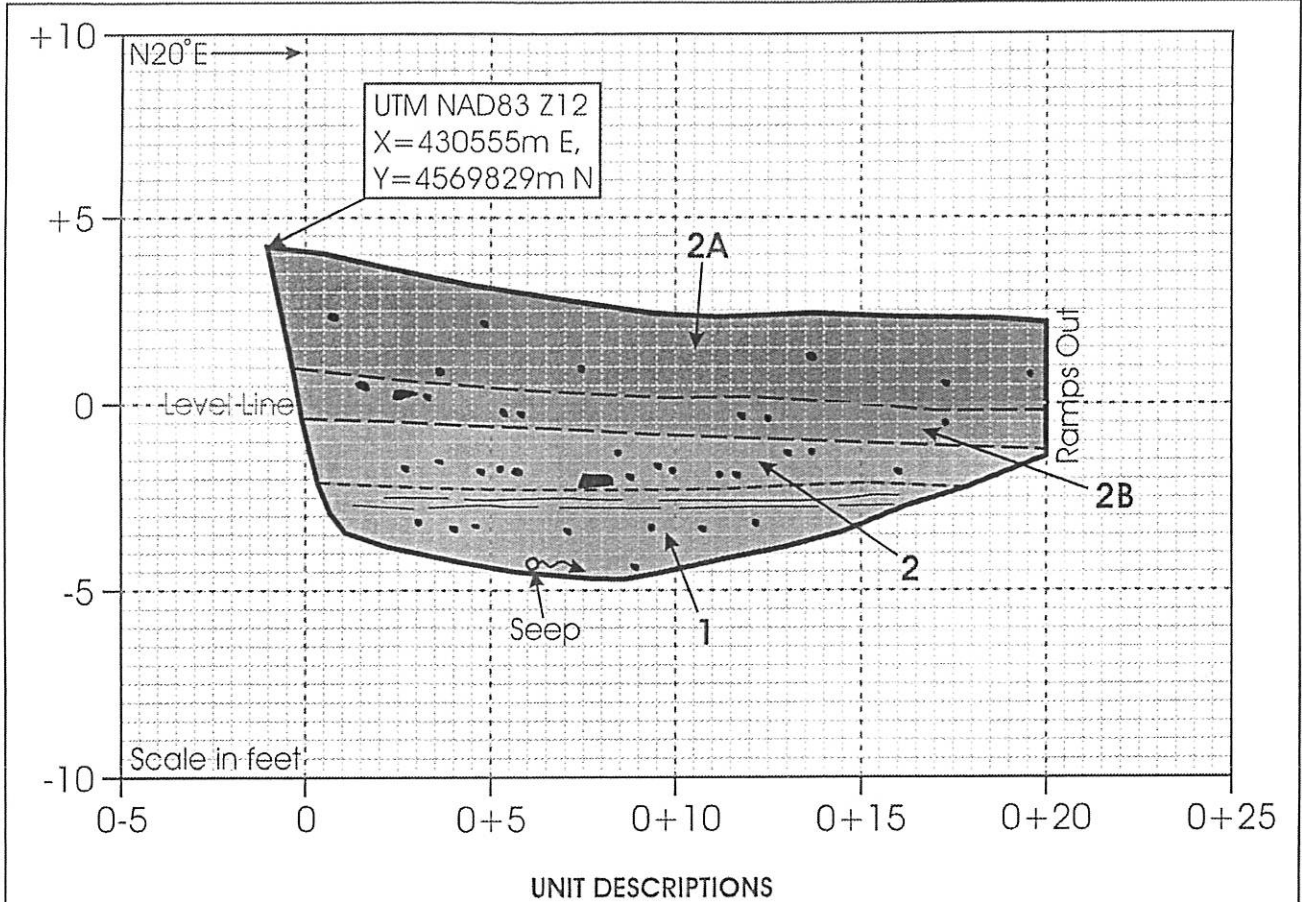
**Unit 1.** Latest Pleistocene to Holocene Alluvium and Colluvium - Reddish-brown to gray, moderate to high density, poorly bedded to massive, bedded, sandy clay (CL) with gravel; topset lean to fat clay lense; likely shallow slump deposits.

**Unit 2.** Holocene Alluvium and Colluvium - Reddish-brown to dark-brown, moderate density, massive, sandy clay with gravel and trace cobbles (CL); likely slope colluvium.

SCALE: 1 inch = 5 feet  
 (no vertical exaggeration)  
 North Wall Logged, West to East

Logged by Bill D. Black, P.G.  
 on May 31, 2016  
 Reviewed by  
 Craig V. Nelson, P.G.

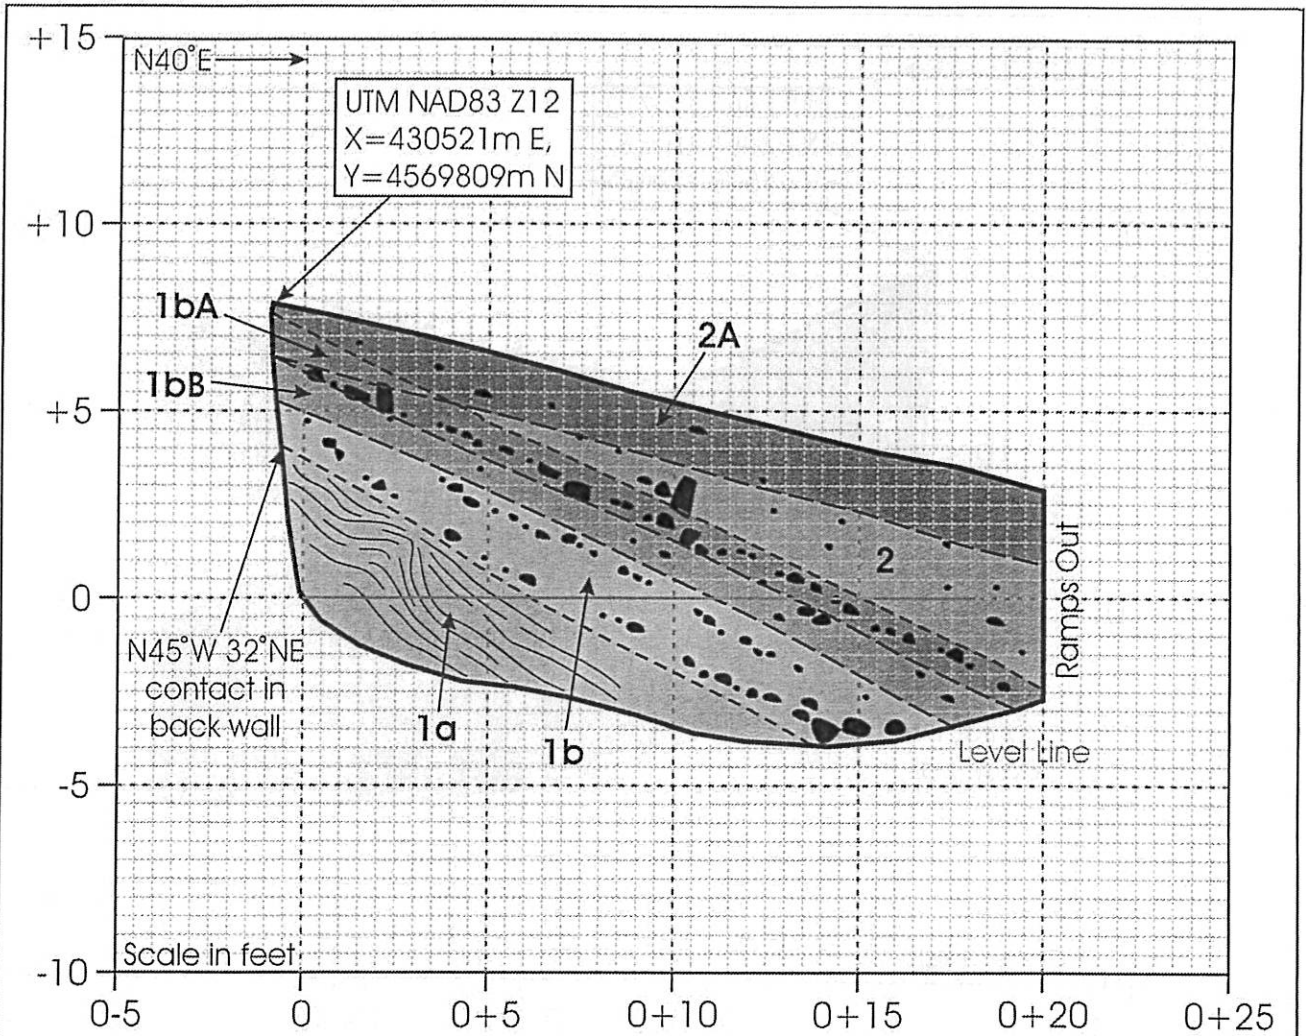
**FIGURE 6B**

- Unit 1. Tertiary Norwood Formation** - Sequence of weathered, poorly to well-bedded, moderate to high density, tuffaceous claystone, sandstone, and conglomerate.
- 1a. Claystone to sandstone comprised of sandy clay to clayey sand (CL-CH/SC), iron-oxide staining along bedding; likely corresponds to unit 1h in trench (Figure 5).
  - 1b. Conglomerate comprised of reddish-brown clayey sand with gravel, cobbles, and trace boulders (SC).
    - 1bA. Paleosol A horizon formed in unit.
    - 1bB. B-horizon soil formed in unit.
- Unit 2. Holocene Alluvium and Colluvium** - Reddish-brown to dark-brown, moderate density, massive, sandy clay with gravel and trace cobbles (CL); clasts with stage II carbonate, mainly quartzite.
- 2A. Organic-rich, very-dark-grayish-brown, root penetrated, A-horizon soil formed in unit.

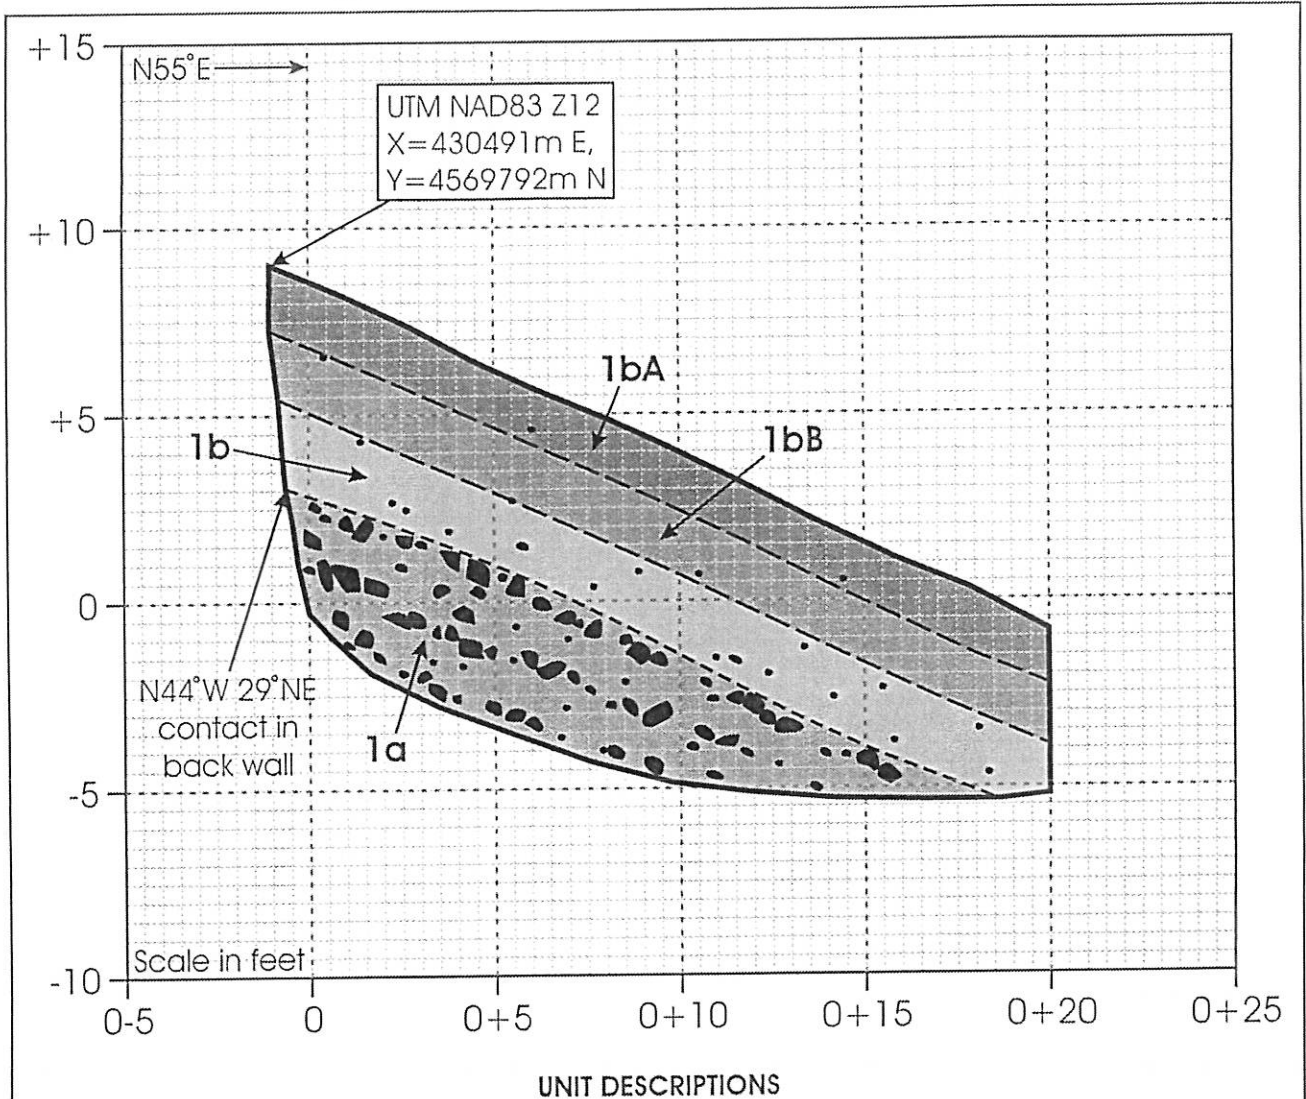
**FIGURE 6C**

**Unit 1. Tertiary Norwood Formation** - Sequence of weathered, moderate density, poorly bedded, tuffaceous conglomerate and sandstone.

- 1a. Tuffaceous conglomerate comprised of reddish-brown clayey gravelly sand to sandy gravel (SC/GW) with cobbles and trace boulders.
- 1b. Highly weathered tuffaceous sandstone (?) comprised of clayey sand with gravel (SC).
  - 1bA. Modern A-horizon soil formed in unit.
  - 1bB. B-horizon soil formed in unit.

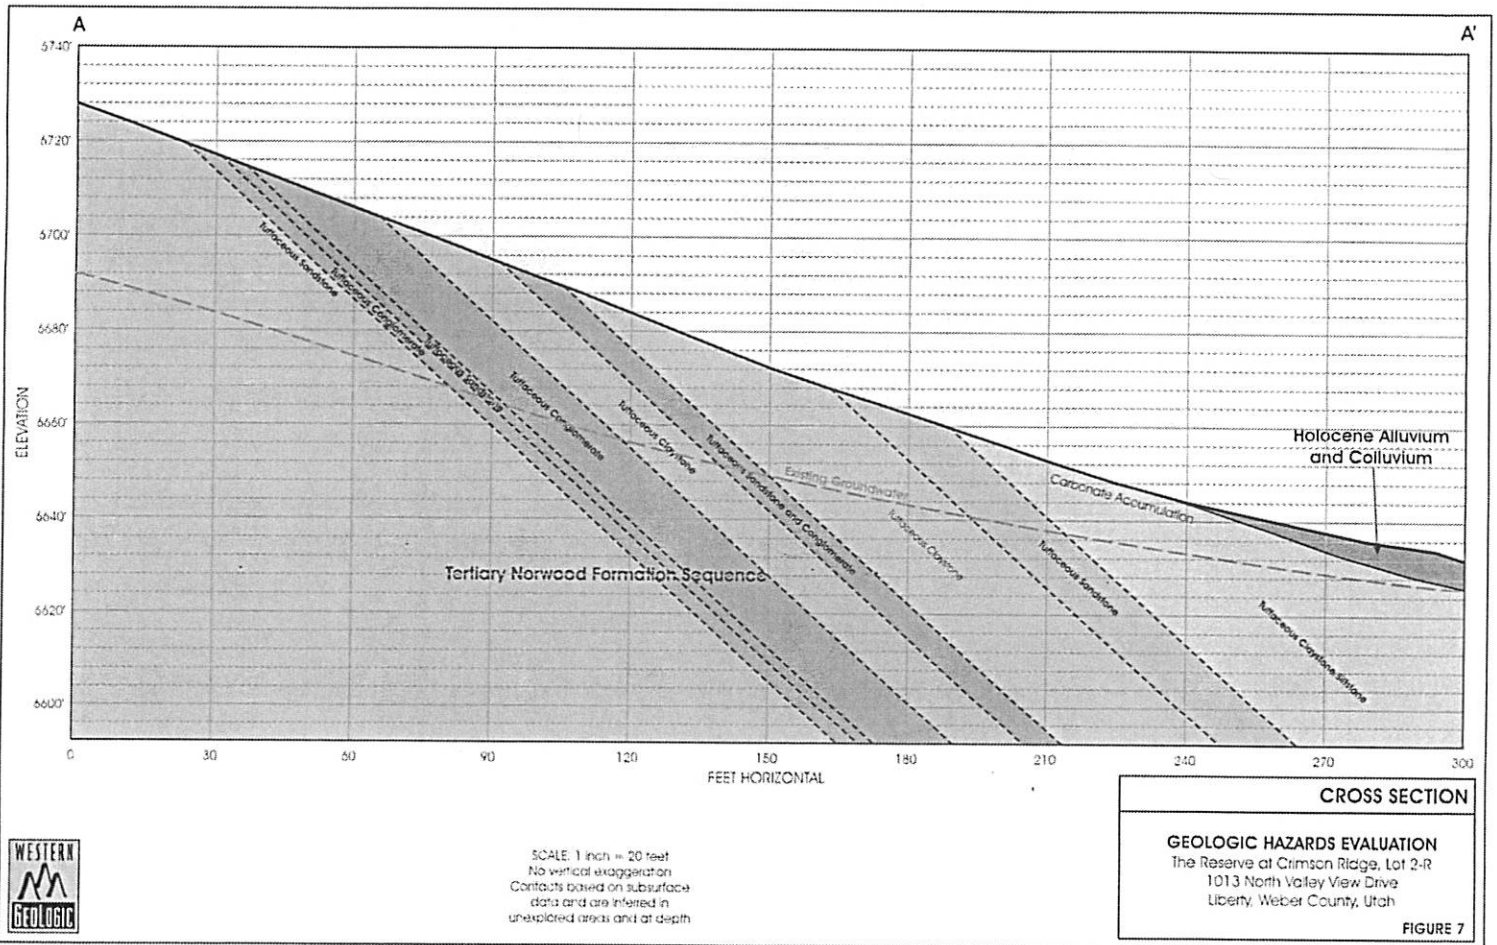
Test pit TP-1 at the site (Figures 4 and 6A) exposed a sequence of alluvium and colluvium in which the A- and B-horizon soils were forming. The lowermost unit in this test pit appeared to be a shallow slump deposit, whereas the overlying unit (1b) appeared to be a mix of slope colluvium (Figure 6A). No source area for this slump was evident on Figures 3A-B, suggesting it was either small or has been eroded away (and therefore is old). Test pit TP-2 (Figures 4 and 6B) exposed a sequence of colluvium overlying tuffaceous conglomerate and claystone bedrock of the Norwood Formation. We infer the latter correlates to unit 1h in the trench (Figure 5B), although no overlying conglomerate unit was observed in the trench and may reflect a lateral variation between the trench and TP-1. Such variations are commonly found in the Norwood Formation. Test pit TP-3 (Figures 4 and 6C) exposed a sequence of tuffaceous conglomerate and sandstone that we infer correlates to units 1b and 1c in the trench (Figure 5A), although the measured strike/dip in TP-3 differed slightly (N44°W 29°NE).
