JIM & ALLY DEPIANO

SQUARE FOOTAGE CALCULATIONS	CLIENT:	JIM & ALLY DEPIANO
UPPER FLOOR	TYPE:	RESIDENTIAL PLAN
MAIN FLOOR	ISSUE DATE:	XXX/XX/2016
LOWER FLOOR	REV. DATE:	
BASMENT	LOCATION:	ASPEN DRIVE
GARAGE	LOT #42-R	FOUNDER MOUNTAIN WEST PHASE 2
	EDEN CITY MEMBER COUNTY UTAH	
	PLAN NUMBER	SHEET NUMBER
	454465	1 OF 15

SITE PLAN
ASPEN DRIVE
FOUNDER MOUNTAIN WEST PHASE 2
LOT #42-R
EDEN CITY, WEBER COUNTY, UTAH

GEOLOGIC HAZARDS EVALUATION

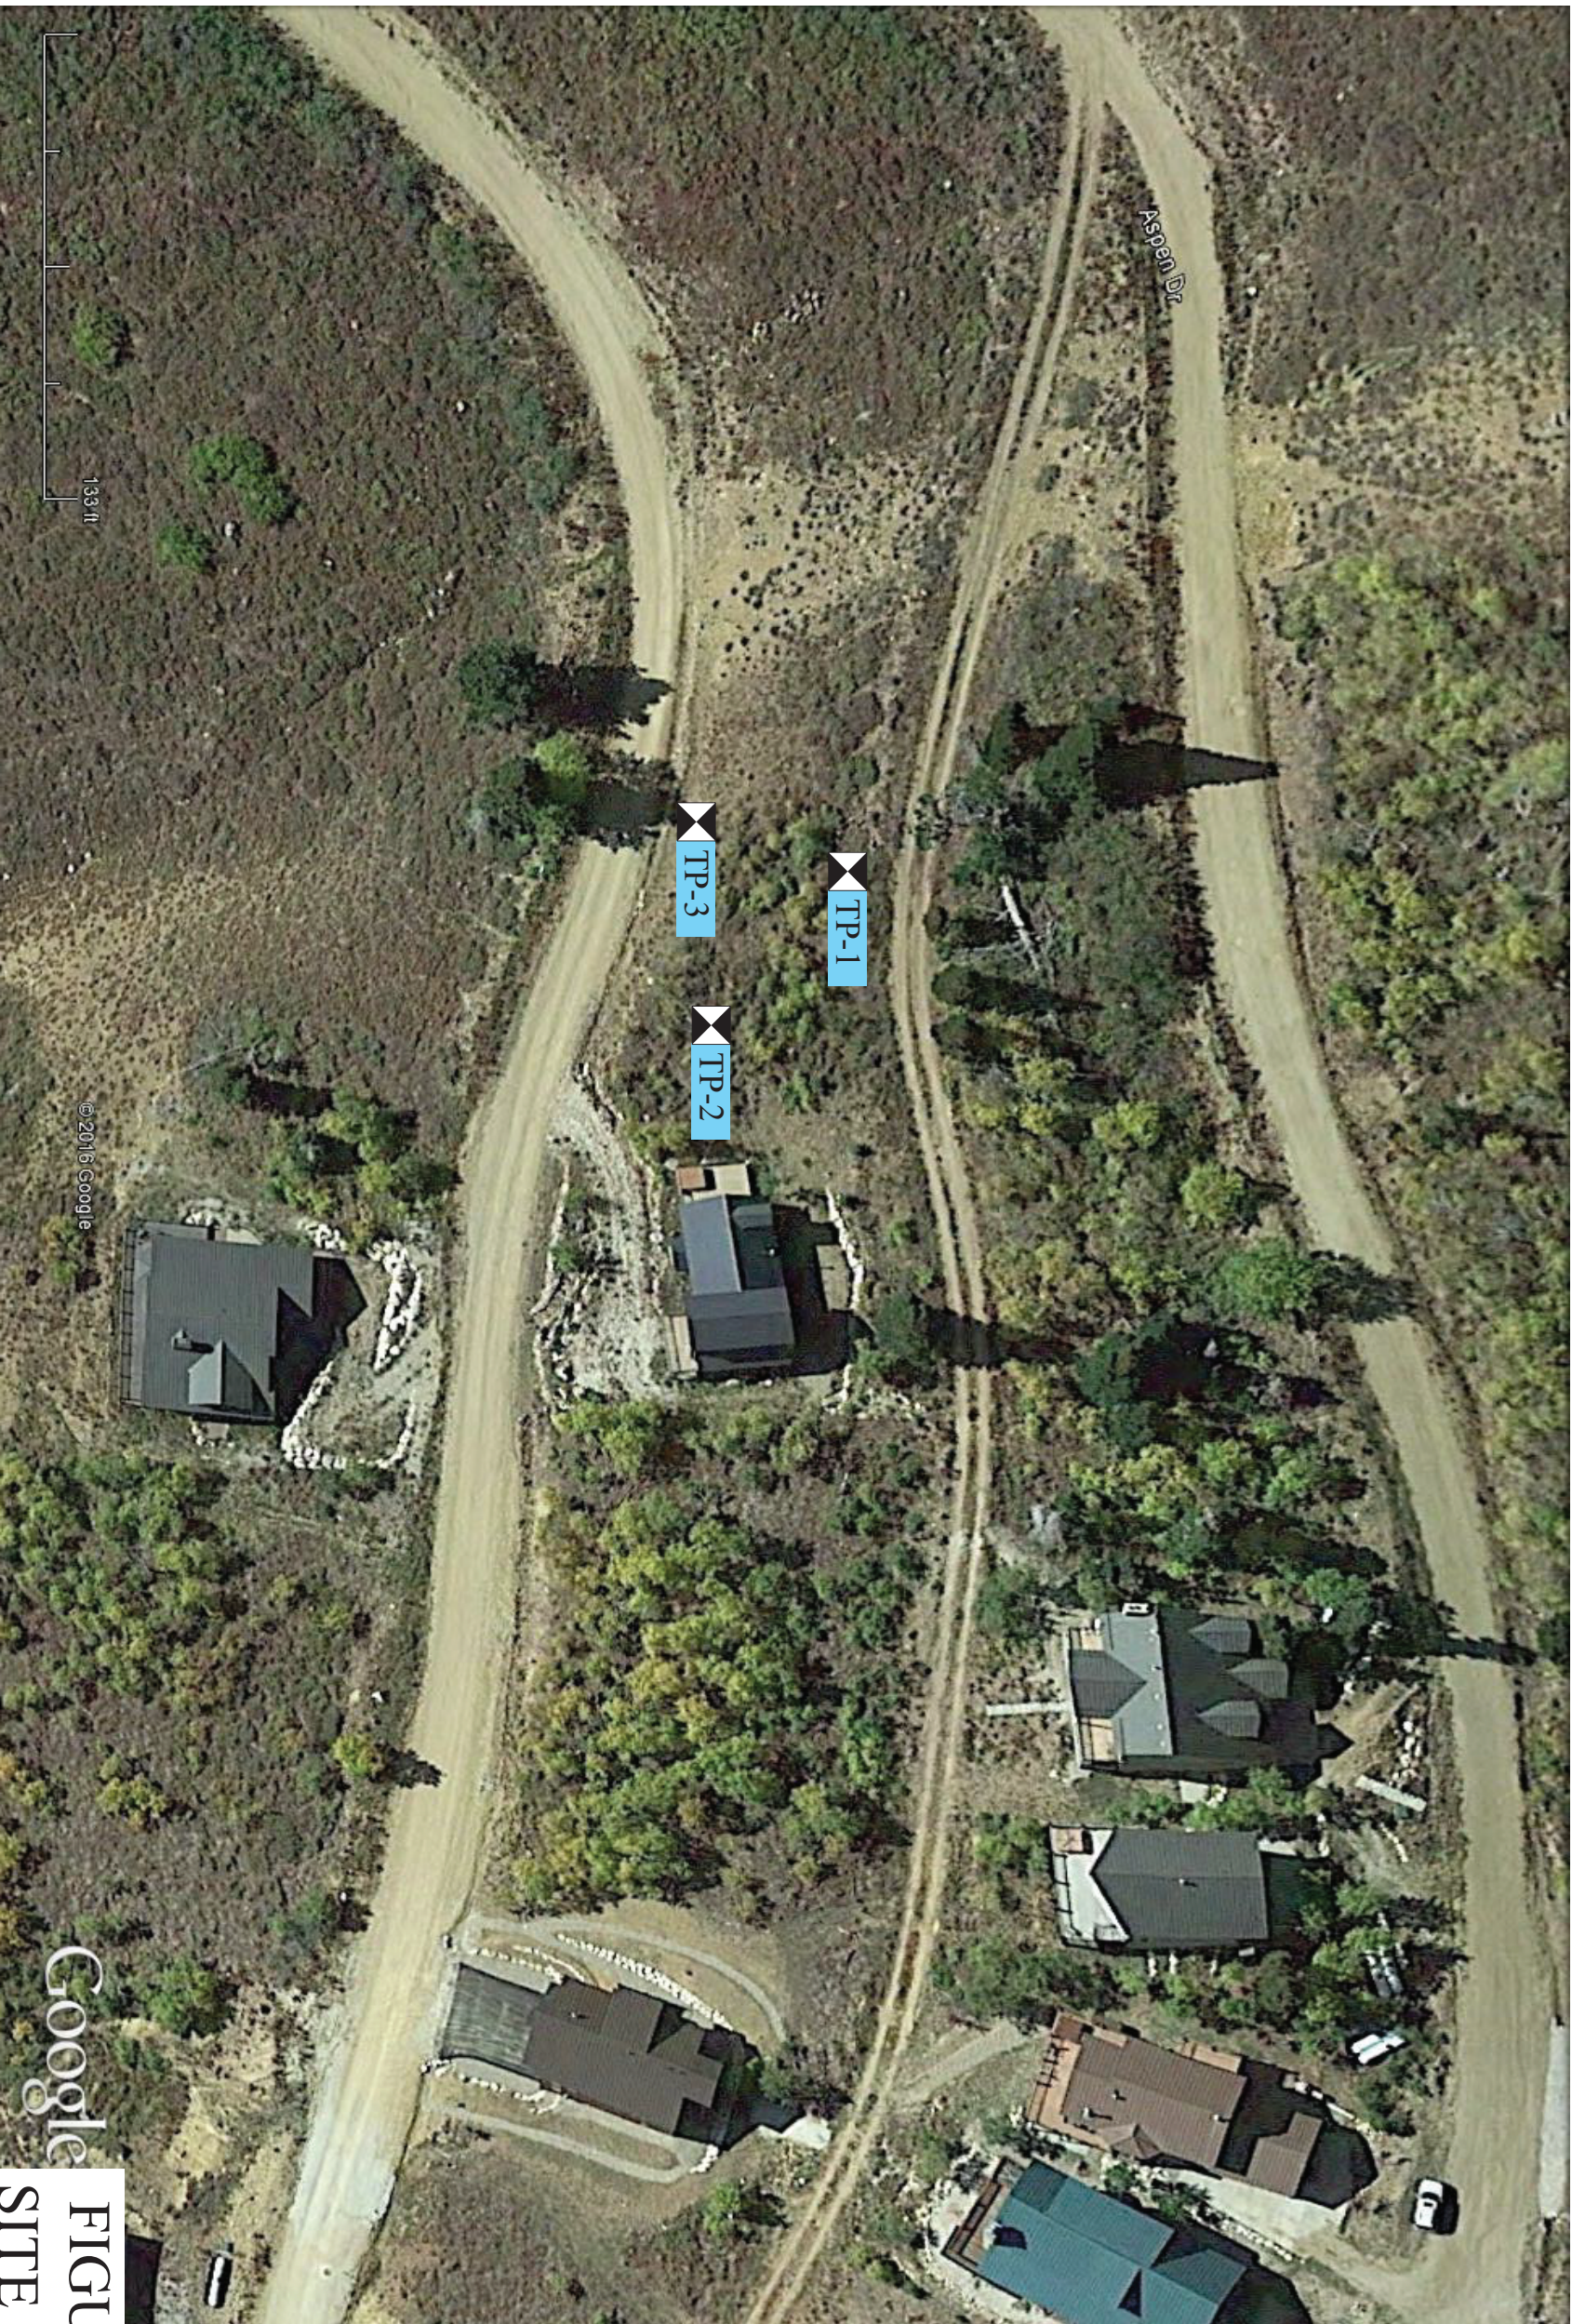
FIGURE 1
VICINITY MAP
  **GSH**
Page 37 of 73

REFERENCE:
ADAPTED FROM AERIAL PHOTOGRAPH
DOWNLOADED FROM GOOGLE EARTH
IMAGERY DATE: JUNE 16, 2015

This report presents the results of our geotechnical study performed for Lot 42R of the Powder Mountain West Subdivision located at 6706 Aspen Drive in Weber County, Utah. The general location of the site with respect to major roadways, as of 2014, is presented on Figure 1, Vicinity Map. A more detailed layout of the site showing the existing improvements is presented on Figure 2, Site Plan. The locations of the test pits excavated in conjunction with this study are also presented on Figure 2.

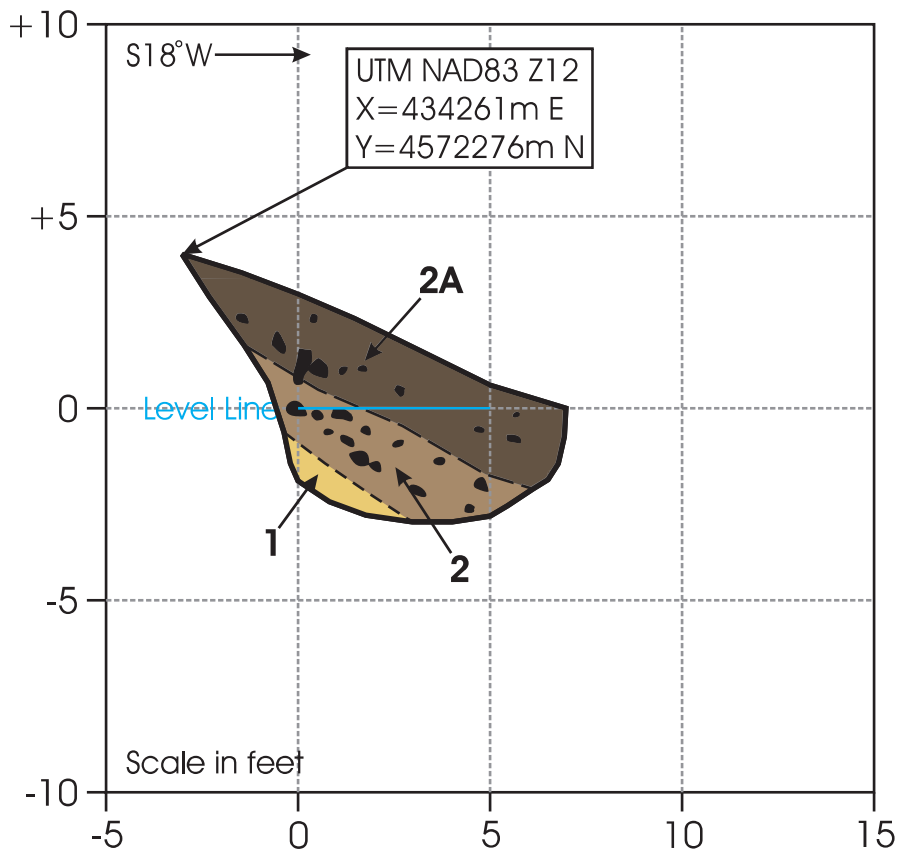
FIGURE 5A

UNIT DESCRIPTIONS

Unit 1. *Precambrian Mutual Formation* - Weathered, dense, massive, buff-colored quartzite; caused backhoe refusal at about 4.7 feet deep.

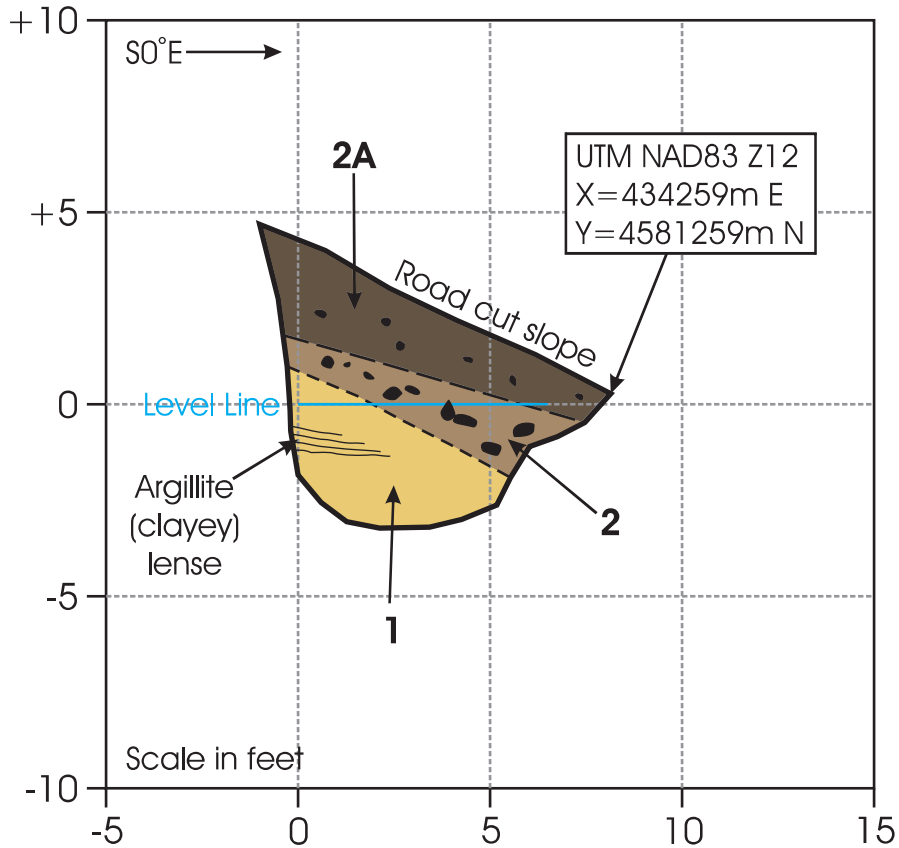
UNIT DESCRIPTIONS

Unit 1. *Precambrian Mutual Formation* - Weathered, dense, massive, buff-colored quartzite with discontinuous argillate (indurated clay) lense; caused backhoe refusal at about 6.1 feet deep.

SCALE: 1 inch = 5 feet
(no vertical exaggeration)
East Wall Logged, North to South

Logged by Bill D. Black, P.G.
on July 1, 2016
Reviewed by
Craig V. Nelson, P.G.
