**REPORT  
GEOLOGIC RECONNAISSANCE STUDY  
BUILDABLE AREA EXPANSION  
EMERSON HILLS SUBDIVISION LOT #12  
LIBERTY, UTAH**

Job No. 406-01A-16

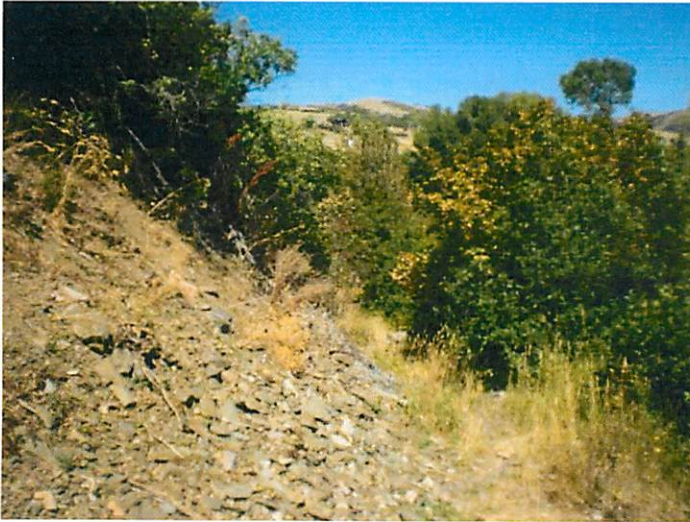
Our review of geologic maps, indicate that the surficial geology in this area consists of primarily alluvial terrace and floodplain deposits from the Pleistocene era. The site is situated within an alluvial valley associated with the North Fork of the Ogden River. The geologic materials consist of predominantly rounded sand and gravel with numerous cobbles and small boulders.

#1 View of roadcut exposed geologic materials comprising the slopes at the site.

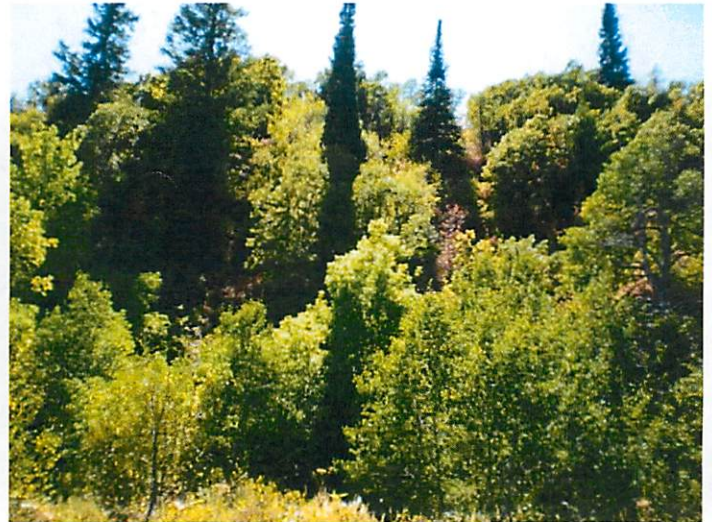
#2 Facing southwest from the buildable area expansion toward the heavily vegetated slope.

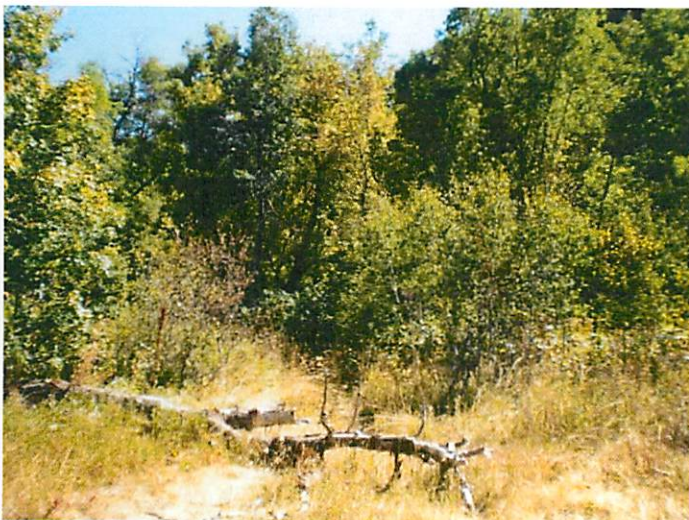
The surface of the proposed buildable area expansion is mostly flat and heavily vegetated with shrubs and large trees.

#3 Facing southeast across the proposed building area expansion.

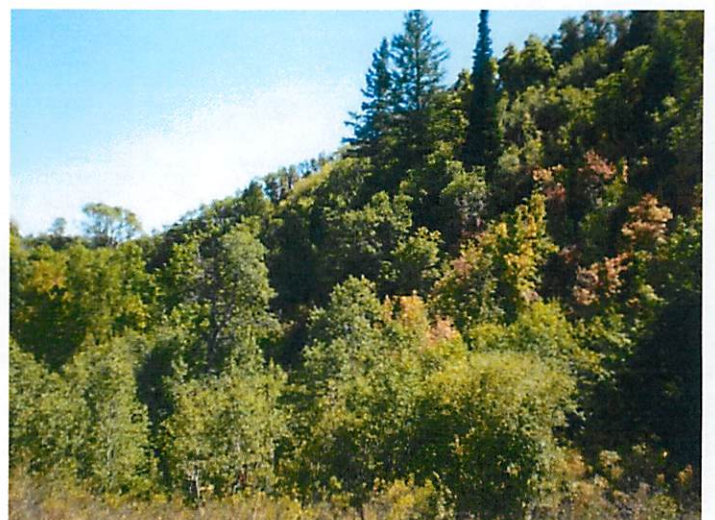
#4 Facing southeast, overall buildable area.

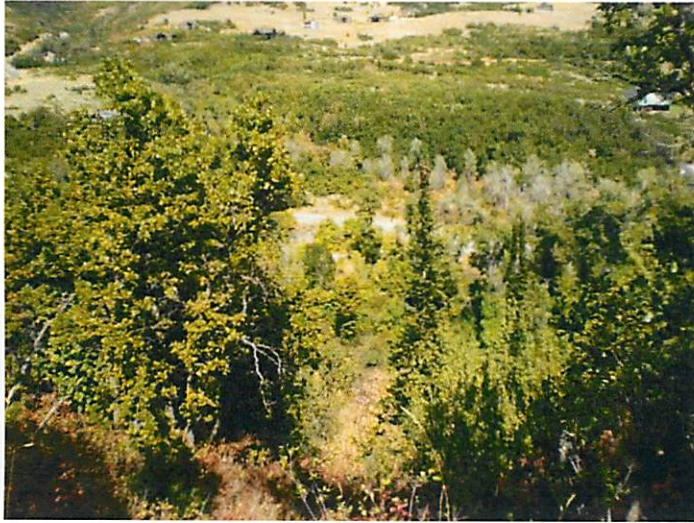
The overall topography in the area slopes down to the east/southeast with a total relief of approximately 130 feet across the site. The slopes vary significantly across the lot from nearly flat, to a grade of approximately 25 percent in the buildable area, and approximately 64 percent along the 130+ foot tall river-carved slope on the southern portion of the lot.

#5 Facing northeast from the top of the 130+ foot slope.

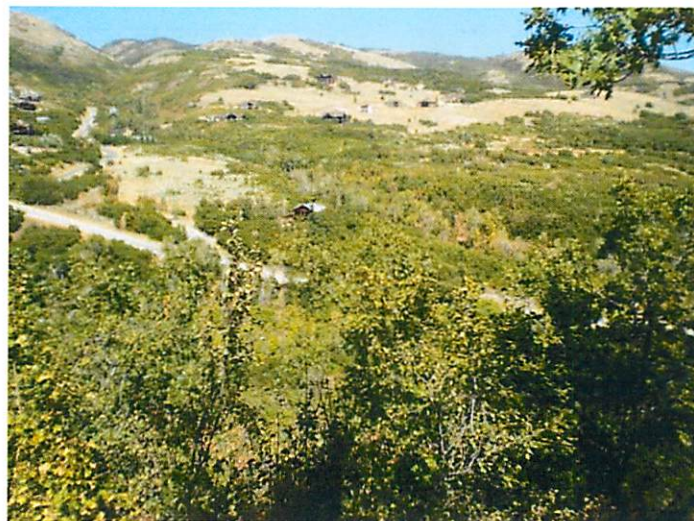
#7 Facing northeast from the top of the large slope across the rest of the subdivision.
