January 11, 2017
Job No. 406-01A-16

Re: Professional Geologist Review and Supplemental Addendum

Geologic Reconnaissance Study
Buildable Area Expansion
Emerson Hills Subdivision Lot #12
Liberty, Utah
September 23, 2016

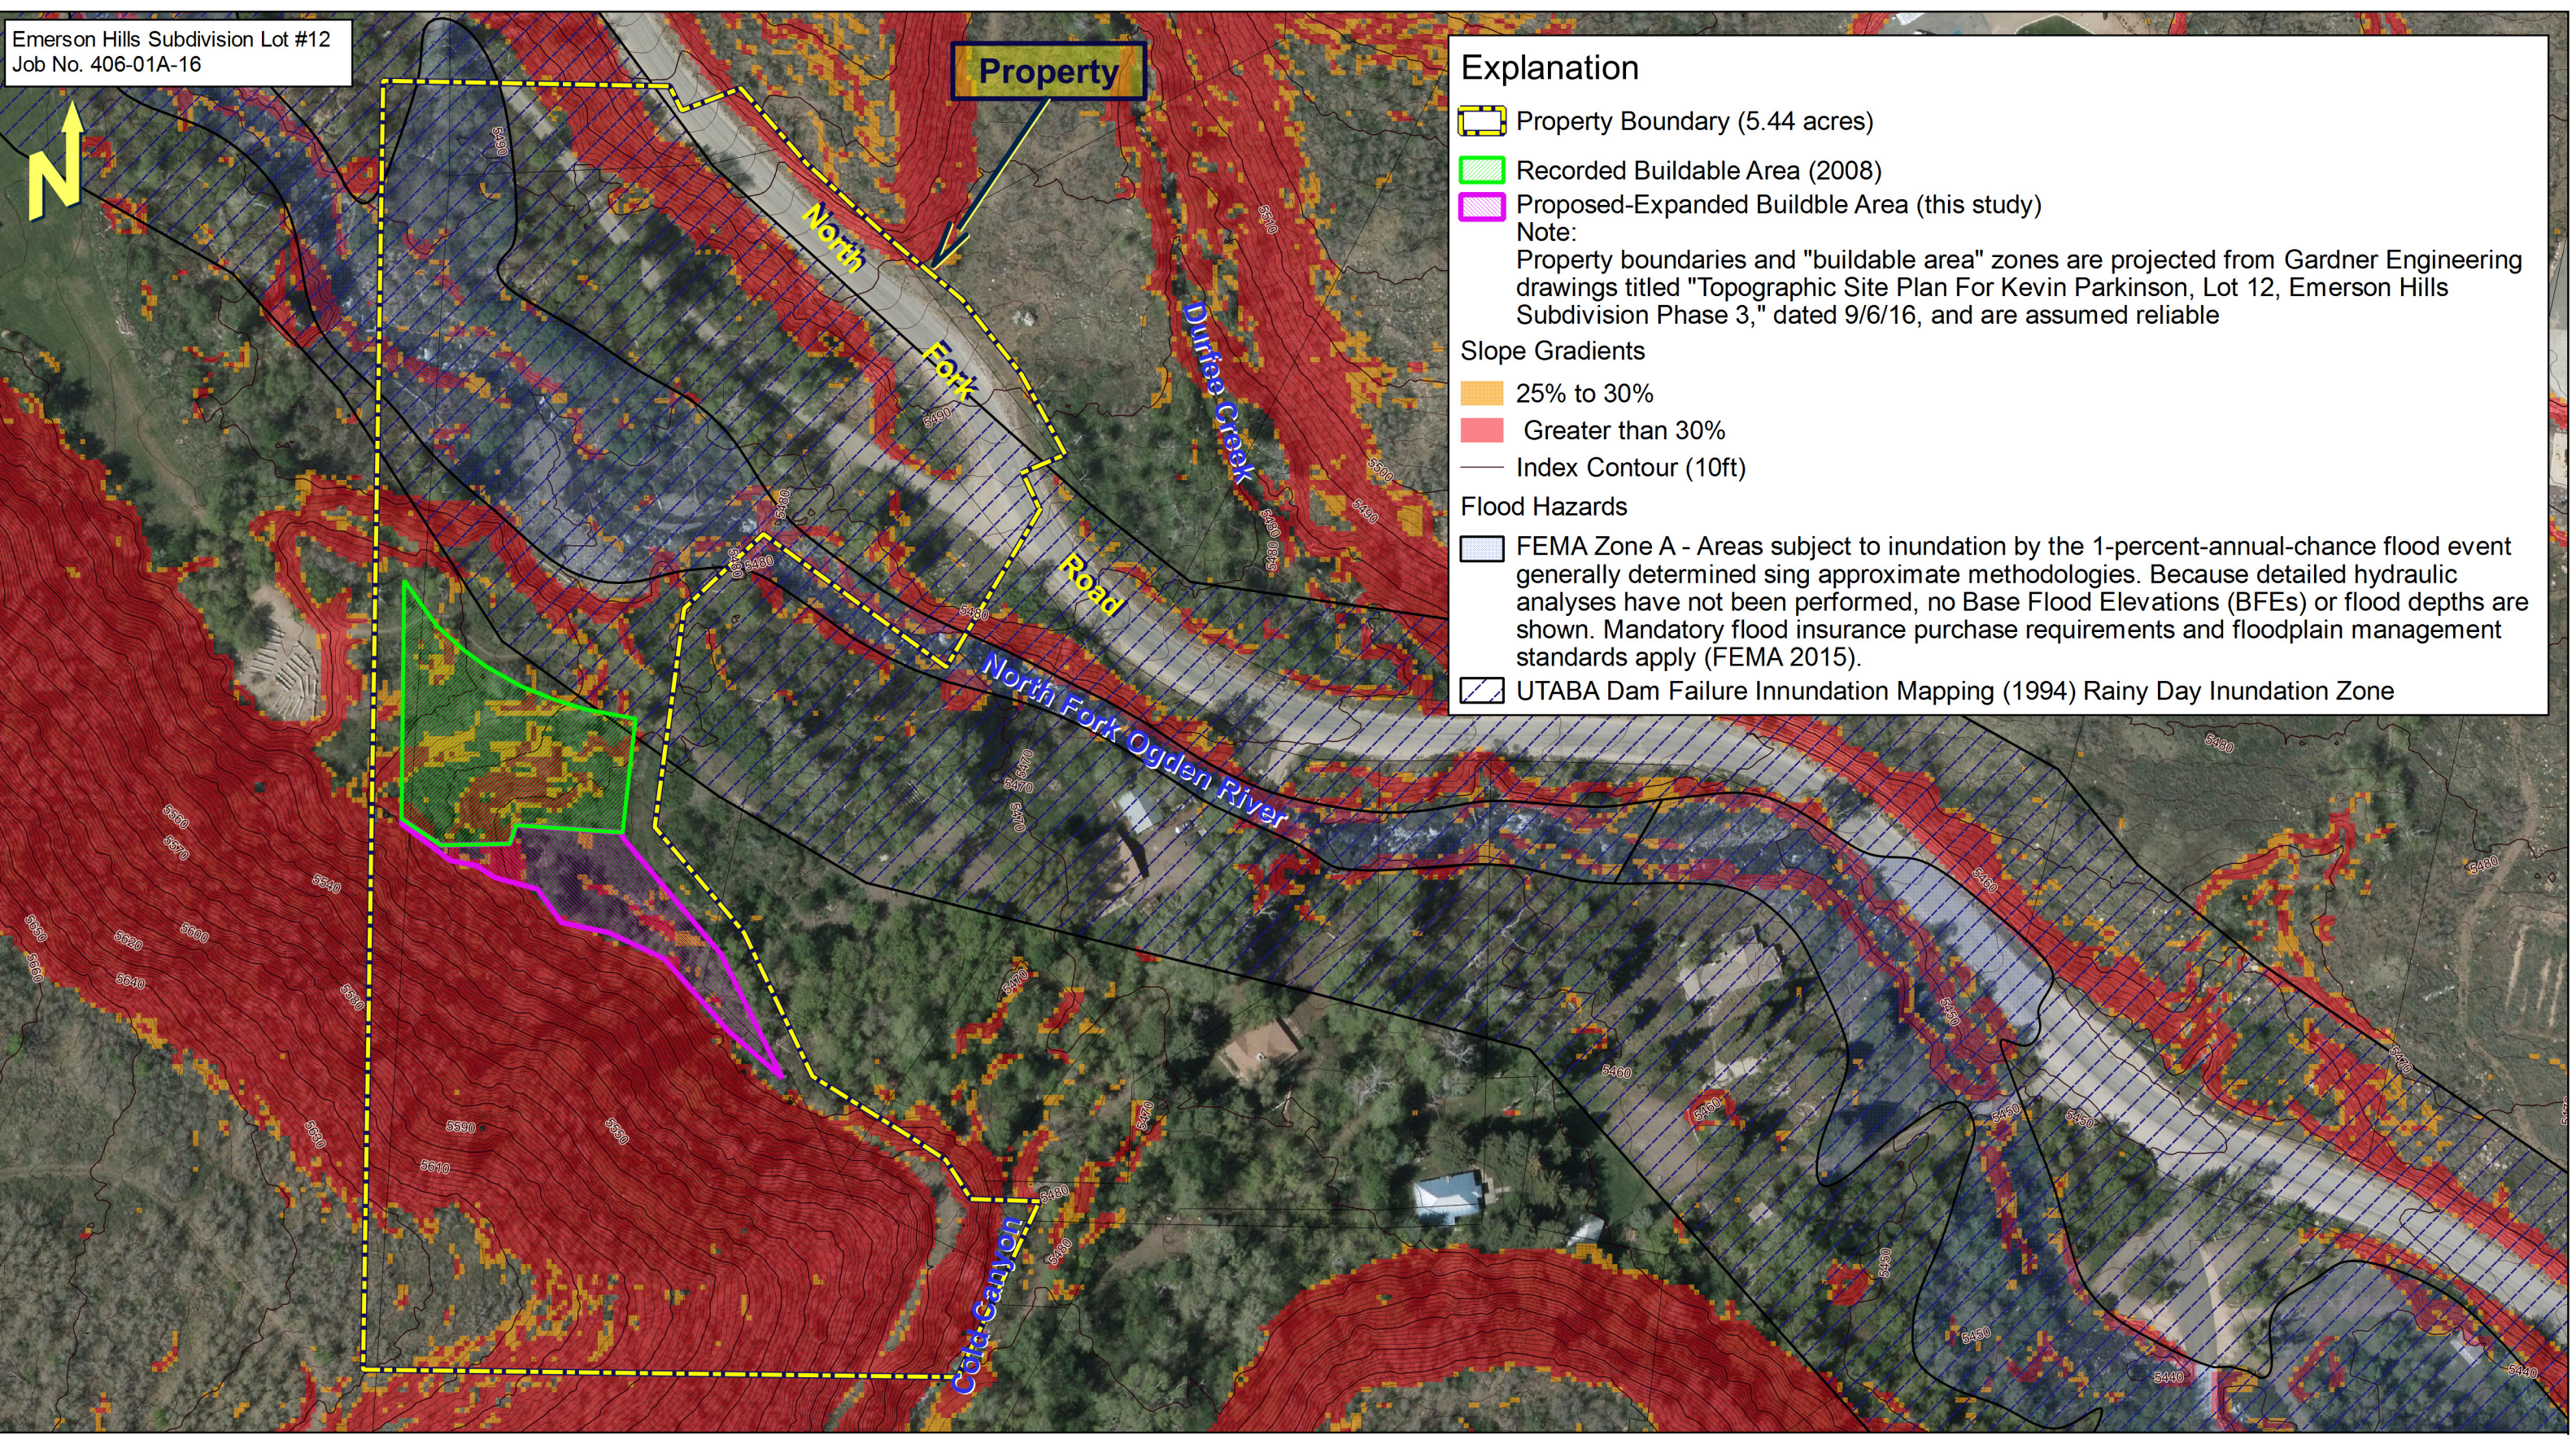
FIGURE 1
GEOLOGIC
HAZARDS REVIEW

The summation of our review is presented on Figure 1, Geologic Hazards Review, which presents the site layout and limiting geoenvironmental conditions. Also shown on Figure 1, are property boundaries and "buildable area" zones that were projected from Gardner Engineering drawings titled "Topographic Site Plan For Kevin Parkinson, Lot 12, Emerson Hills Subdivision Phase 3," dated September 6, 2016, and assumed as reliable.

6. Flooding: Mapping by Federal Emergency Management Agency (FEMA, 2015) is shown on Figure 1. The Zone A shown on Figure 1, includes the 100-year flood hazard zone as delimited by recent FEMA studies conducted in the Ogden Valley area. On the basis of the FEMA determination *...mandatory flood insurance purchase requirements and floodplain management standards apply...for improvements made in the Zone A area shown on Figure 1.* Shown on Figure 1, the Zone A FEMA mapping for the North Fork Ogden River does not appear to contact the "buildable area" parts of the site where the river crosses on the north side the site.

Also shown on Figure 1, is the UTABA Dam Failure Inundation mapping as prepared by Weber county to evaluate the area of inundation should dam failure occur at the UTABA Dam which is located approximately 1.3 miles up-stream from the site on the North Fork Ogden River (Bridges, 1977). The estimated inundation area from failure of the UTABA Dam is shown on Figure 1, and is presumed to be the worst-case scenario calculated by the County Engineers (Weber County Engineering, 1994), and probability of this occurrence is very low.

7. Sloping Surfaces: The surface of site slopes developed from our LiDAR analysis range from level to well over 50-percent as shown on Figure 1. For the overall 5.44-acre area of the site, slope gradients averaged 36.4 percent, with the slopes ranging from 0.0 to 100.0 percent. For the existing buildable area the slope gradient averaged 23.9 percent, and the proposed-expanded buildable area the slope gradient averaged 17.1 percent.

The steeper slope areas in excess of 25 percent are shown on Figure 1, with the steeper sloping surfaces on the site concentrated on a steep riser slope located immediately to the southwest of the existing and proposed-expanded buildable areas on the site. The threshold gradient for slope development considerations and hillside review according to the Weber County Section 108-14-3 (Weber County Code, 2016), includes slopes greater than 25-percent.

Based upon the findings of this review we believe that the proposed homesite development within the identified existing and proposed-expanded buildable areas located on the 5.44-acre property will not be excessively exposed to the geological hazards specified by the Weber County Natural Hazards Overlay District code (Weber County Code, Chapter 27) to preclude this development.
