GEOTECHNICAL AND GEOLOGIC HAZARD INVESTIGATION
Thomas Quinn Living Trust Property
Parcel No. 20-035-0033, Old Snowbasin Road
Unincorporated Weber County, Utah

IGES Project No. 02350-001

September 16, 2016

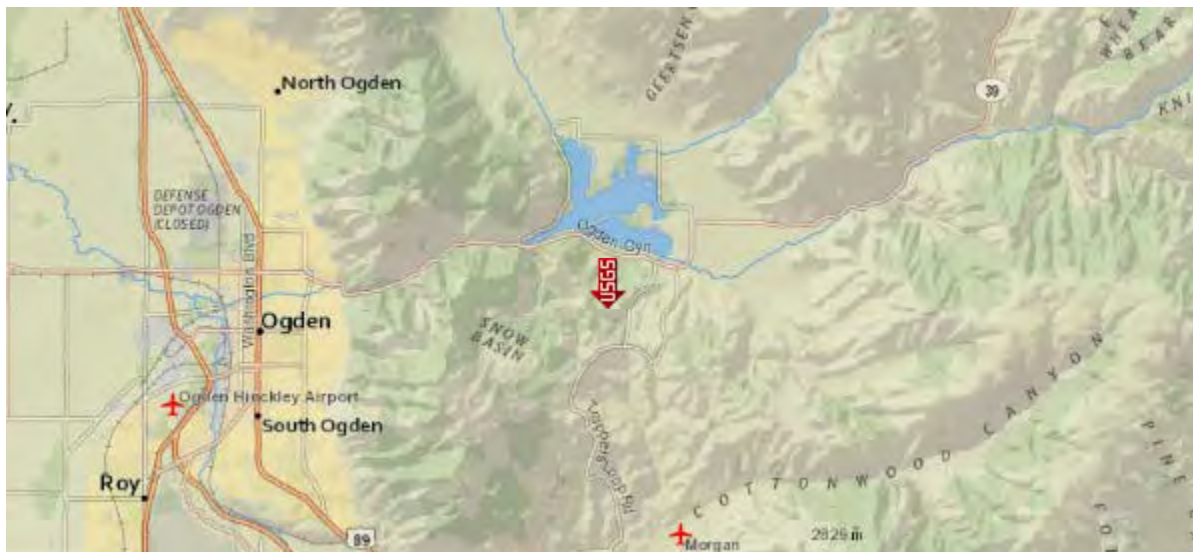
USGS-Provided Output

$S_s = 0.857 \text{ g}$	$S_{MS} = 0.906 \text{ g}$	$S_{DS} = 0.604 \text{ g}$
$S_1 = 0.289 \text{ g}$	$S_{M1} = 0.437 \text{ g}$	$S_{D1} = 0.291 \text{ g}$

Site Soil Classification Site Class C – “Very Dense Soil and Soft Rock”

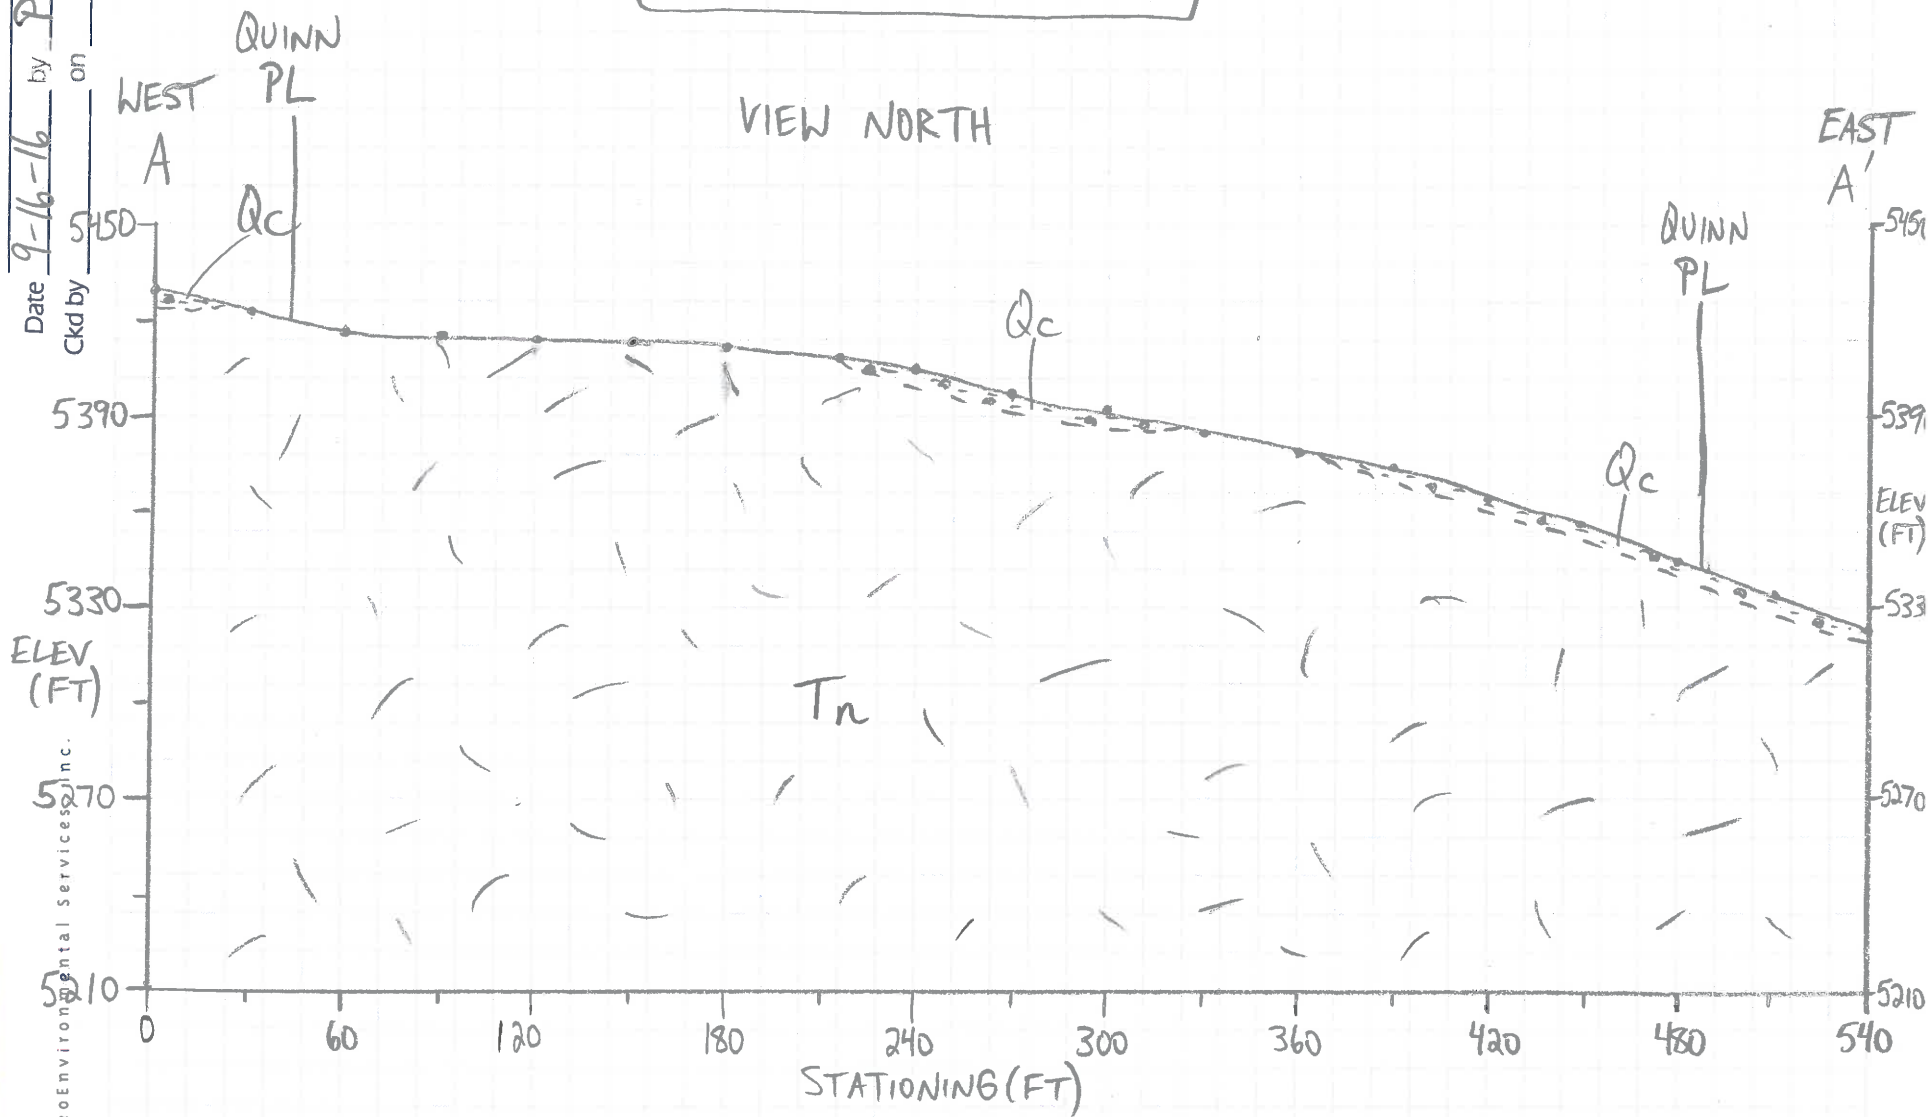
FIGURE D-1
CROSS-SECTION A-A'

Tn = NORWOOD TUFF

Based on our analysis, the existing slope meets the minimum factors-of-safety of 1.5 for static and 1.0 for seismic conditions. The results of the stability analyses are presented in Appendix D.

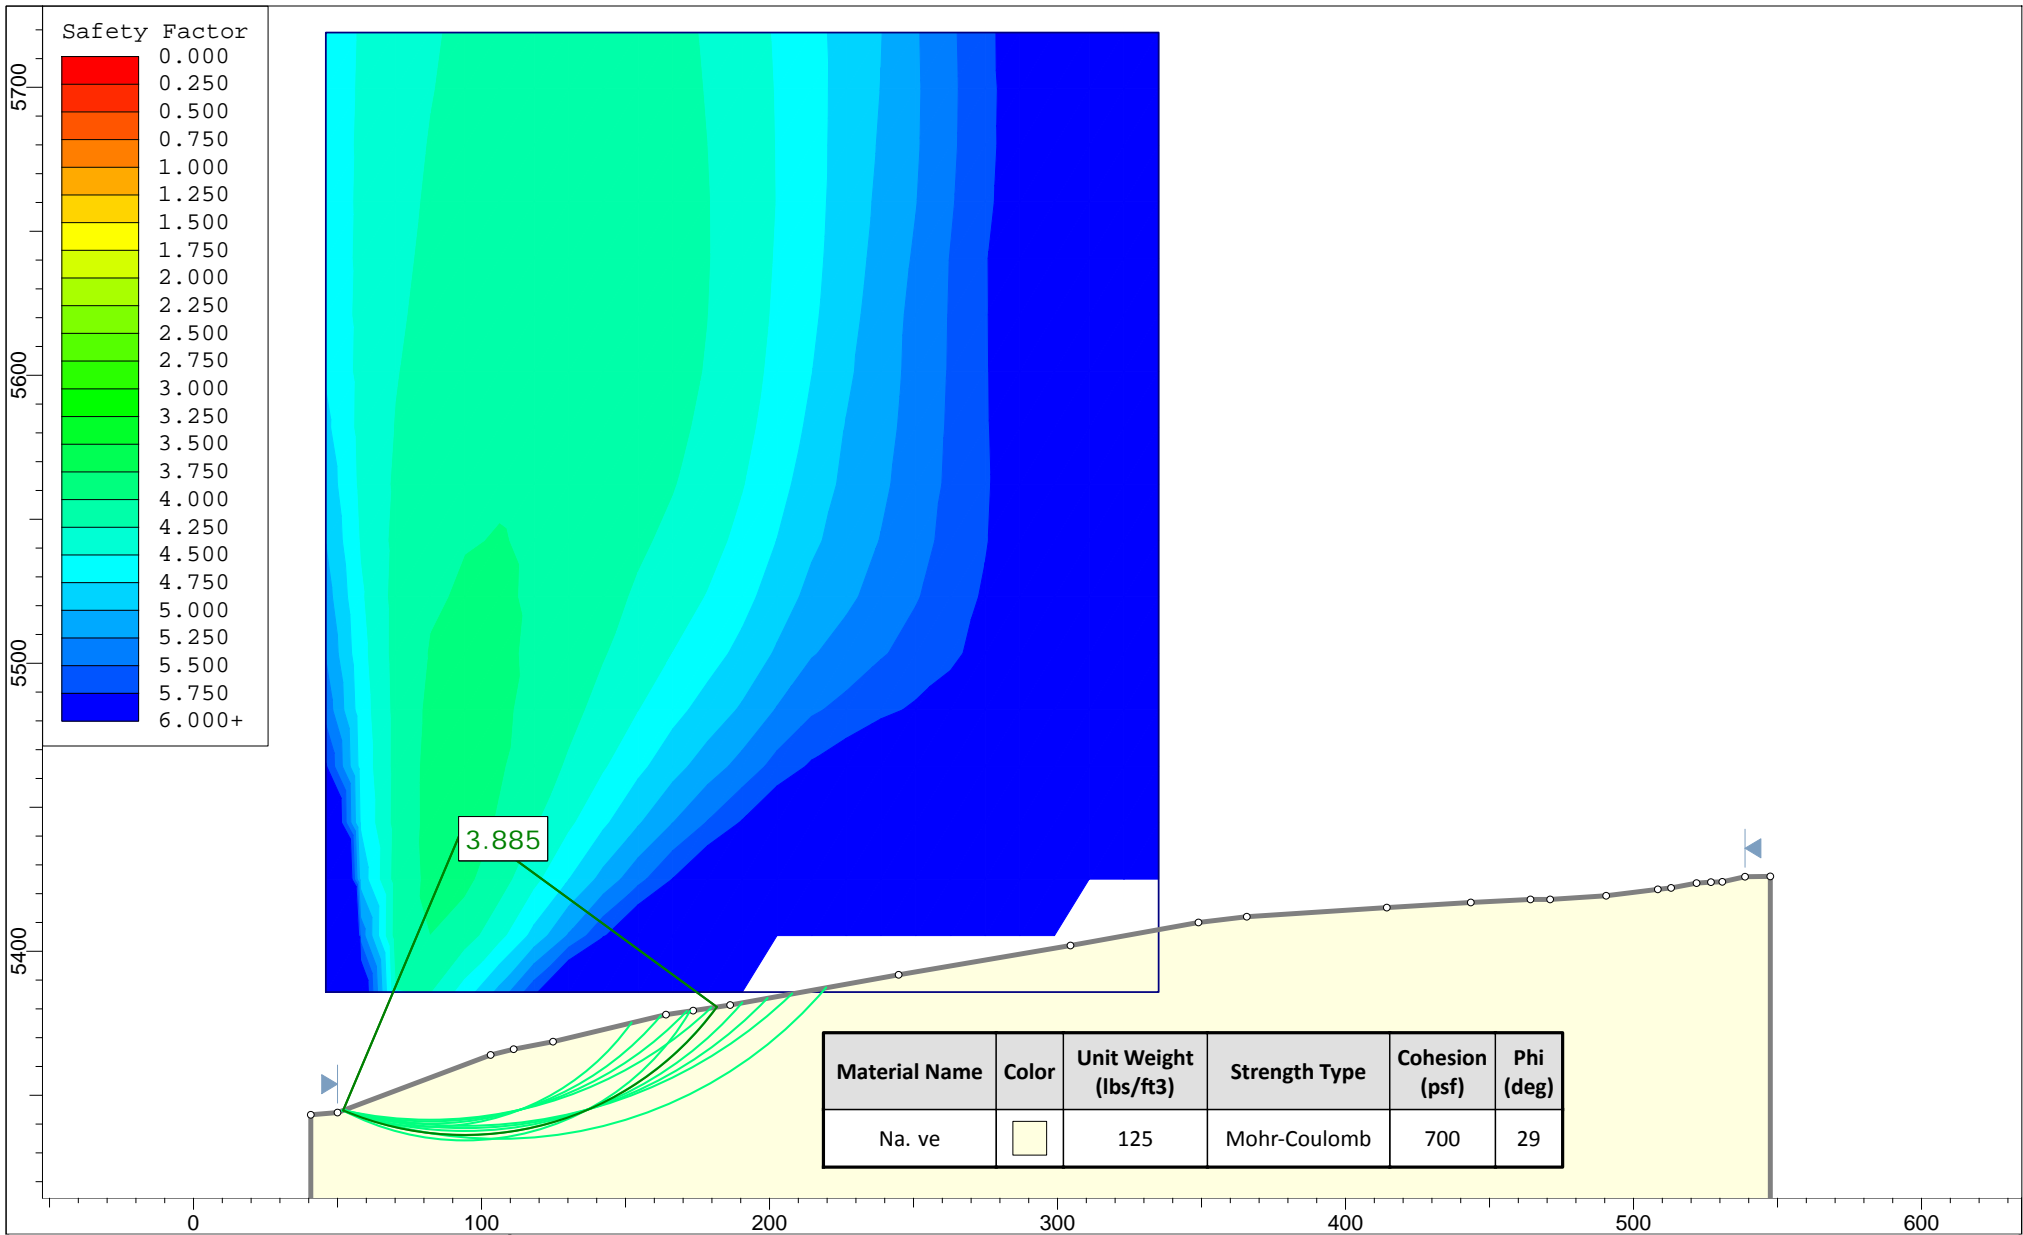
<i>Project</i> Thomas Quinn Property			
	<i>Analysis Description</i> Section A' : A Global Stability			
	<i>Drawn By</i> JKW	<i>Scale</i> 1:800	<i>Company</i> IGES, Inc.	
	<i>Date</i> 9-15-2016	<i>File Name</i> Section A_A.slim
