**GEOTECHNICAL AND GEOLOGIC HAZARD INVESTIGATION**  
**Main Street West**  
**Summit Powder Mountain Resort**  
**Weber County, Utah**

IGES Project No. 01628-023

January 18, 2017

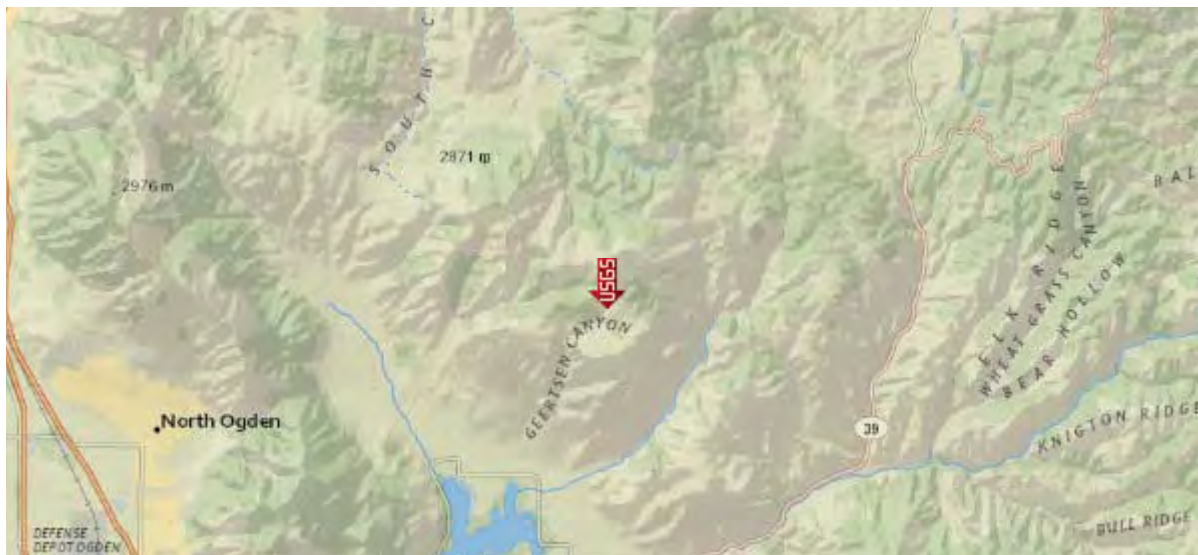
**Site Soil Classification** Site Class C – “Very Dense Soil and Soft Rock”

**Risk Category** I/II/III

## USGS-Provided Output

$S_S = 0.810 \text{ g}$	$S_{MS} = 0.872 \text{ g}$	$S_{DS} = 0.581 \text{ g}$
$S_1 = 0.269 \text{ g}$	$S_{M1} = 0.411 \text{ g}$	$S_{D1} = 0.274 \text{ g}$
