December 1, 2016

IGES Project No. 01628-015

Subject: Geologic Hazards Assessment
Village Nests Condominiums
Summit Powder Mountain Resort
Weber County, Utah

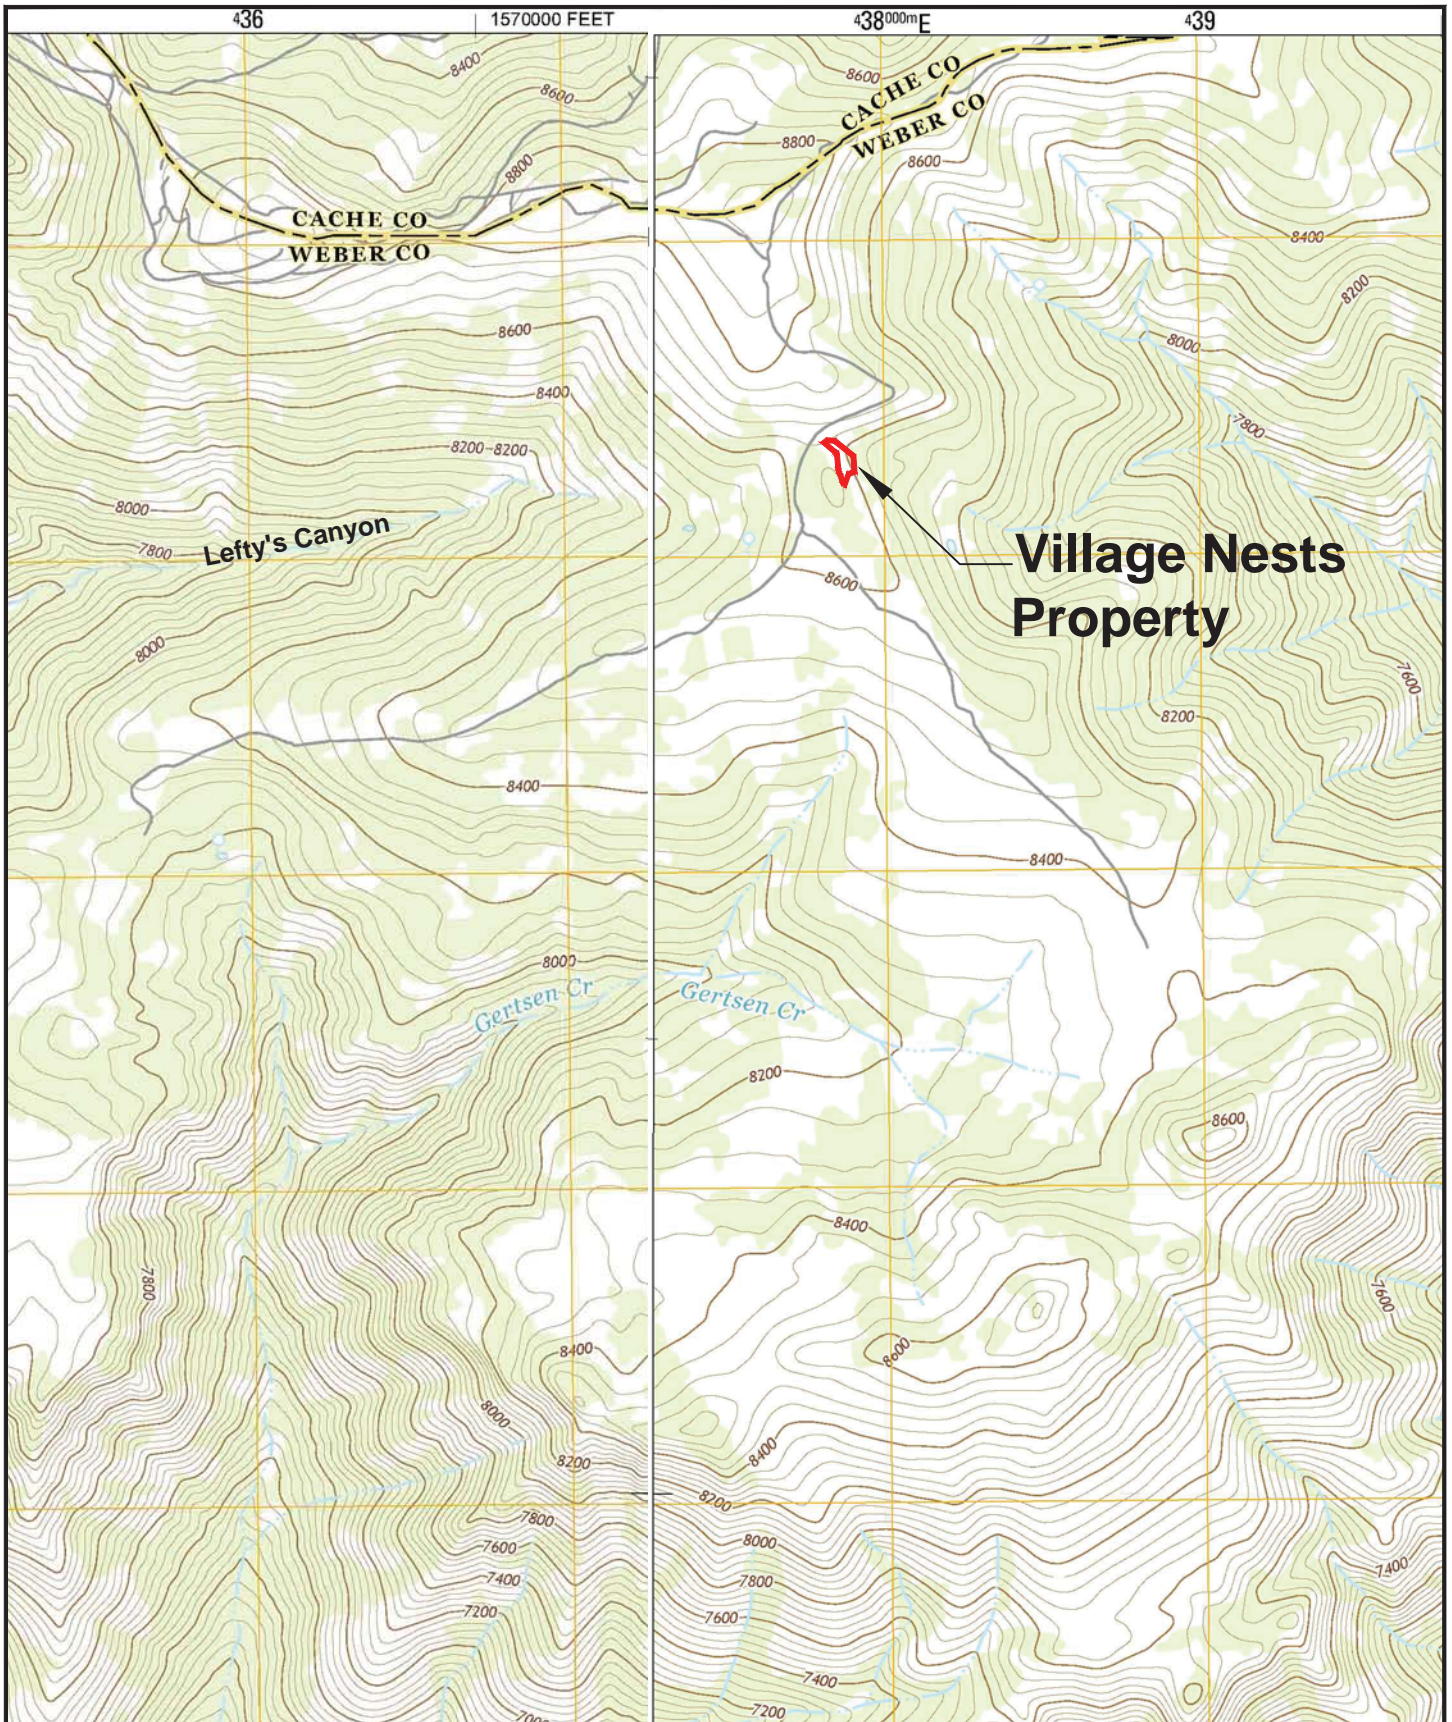
The USGS topographic maps for the Huntsville and Brown’s Hole Quadrangles (2014) show that the Village Nests project area is situated near the top of a ridge, with the topographic gradient down to the east (see Figure A-1). No active or ephemeral stream drainages are found on the property. No springs are known to occur on the property, though it is possible that springs may occur on various parts of the property during peak runoff.

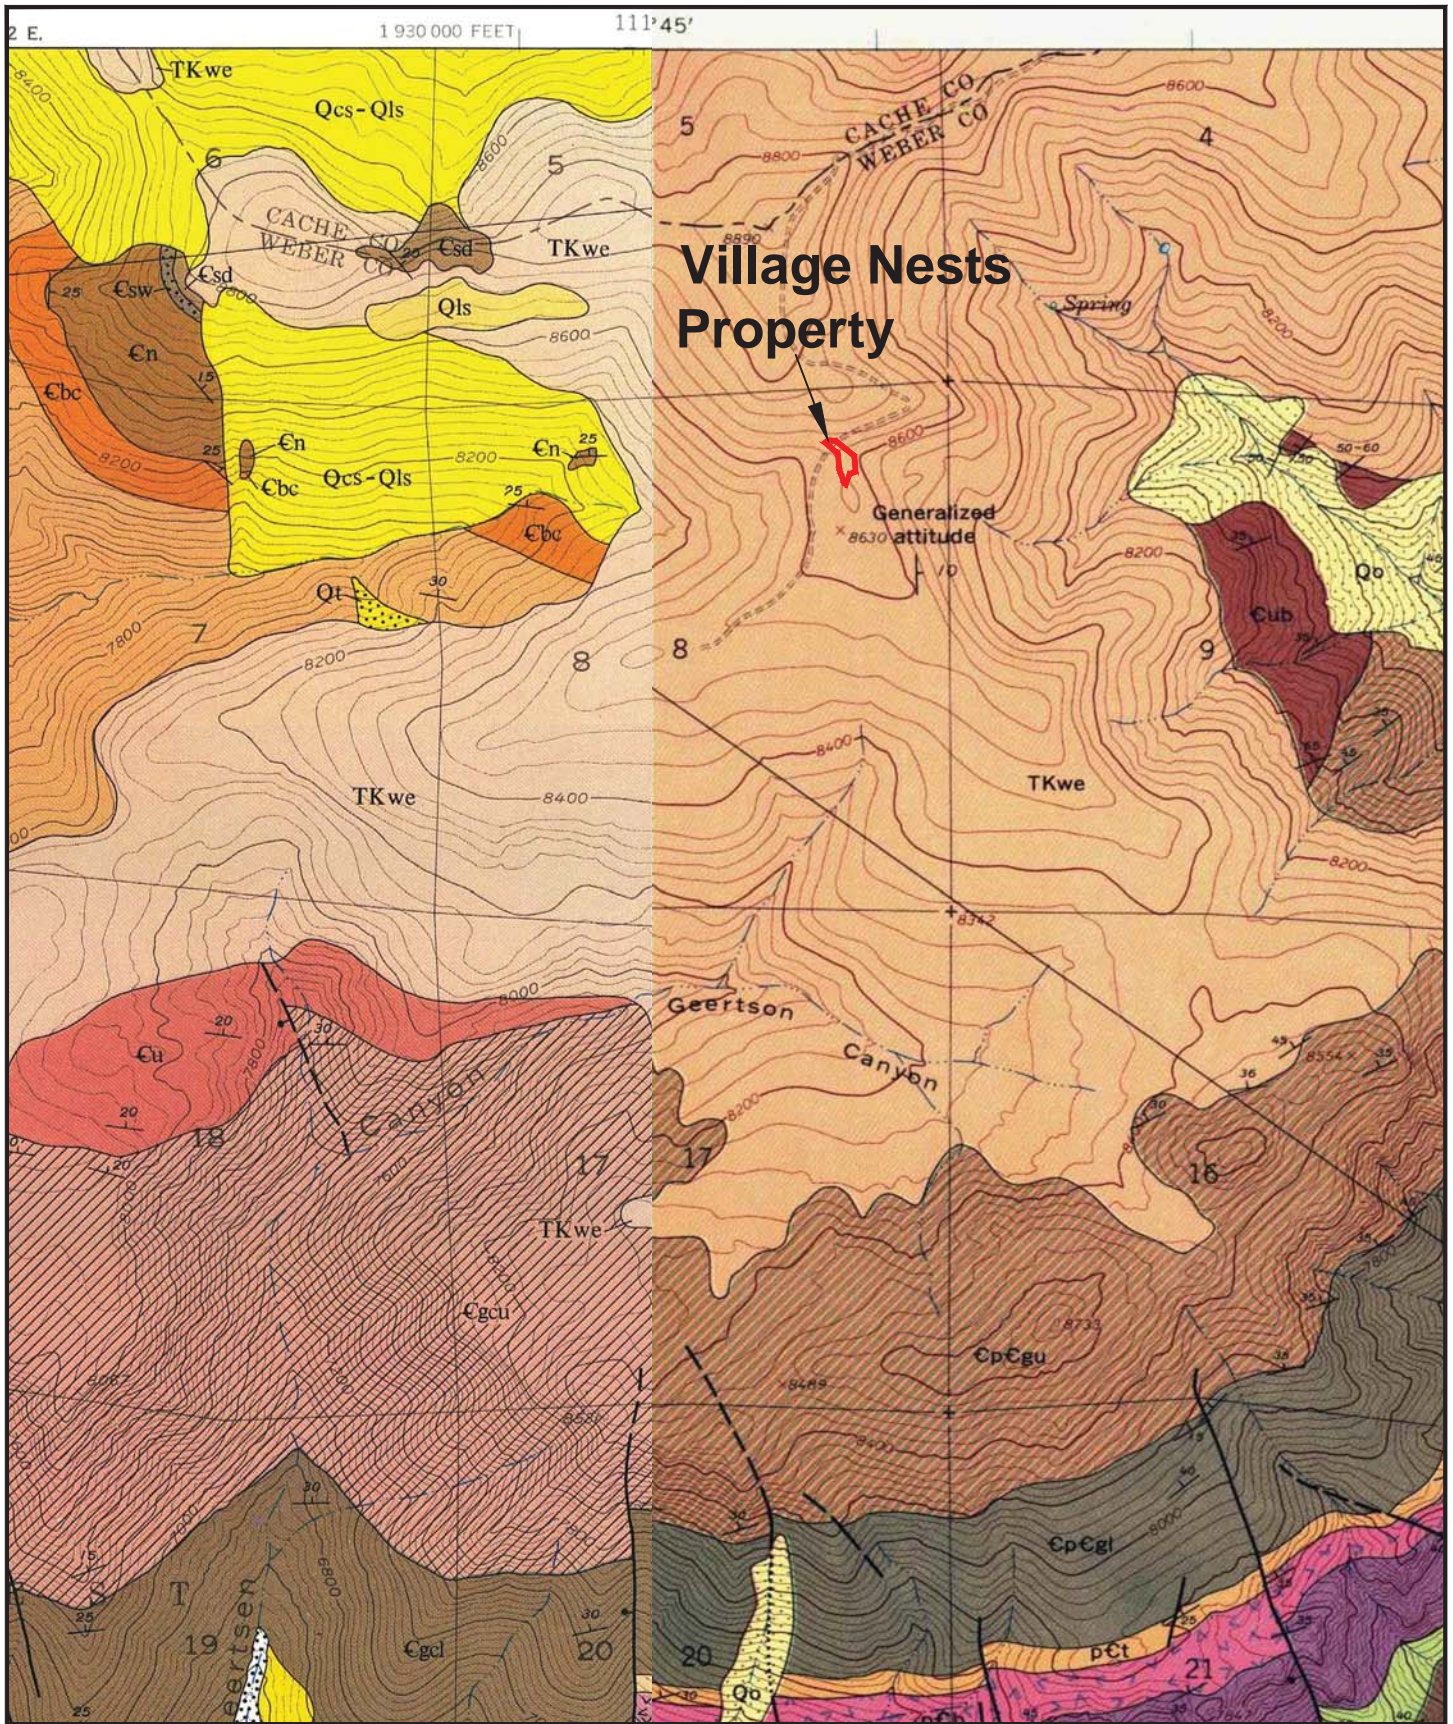
According to Crittenden, Jr. (1972), the property is entirely underlain by the undivided Tertiary/Cretaceous Wasatch and Evanston Formations (TKwe), described as “unconsolidated pale-red to greenish-red pebble, cobble, and boulder conglomerate. Forms boulder-covered slopes but does not crop out anywhere. Clasts are mainly Precambrian quartzite and are tan, gray, or purple; matrix is mainly poorly consolidated sand and silt.” A generalized bedding attitude shows this unit striking due north and dipping 10 degrees to the east; this map forms the basemap for the *Regional Geology Map 1* (Figure A-2). Coogan and King (2001) produced a regional-scale geologic map that covered the property; this map shows the property to be entirely underlain by the Wasatch Formation. Western Geologic (2012) identified a number of landslide deposits contained within the Powder Mountain Resort expansion area, though none of these were shown underlying the Village Nests area (Figure A-3). Finally, Coogan and King (2016) updated their 2001 map, which is generally consistent with the 2001 map and shows the Wasatch Formation bedrock in the area to be striking approximately to the north-northeast, and dipping between 3 and 6 degrees to the east-southeast; additionally, according to this map, the property abuts a north-south trending syncline¹ (Figure A-4).

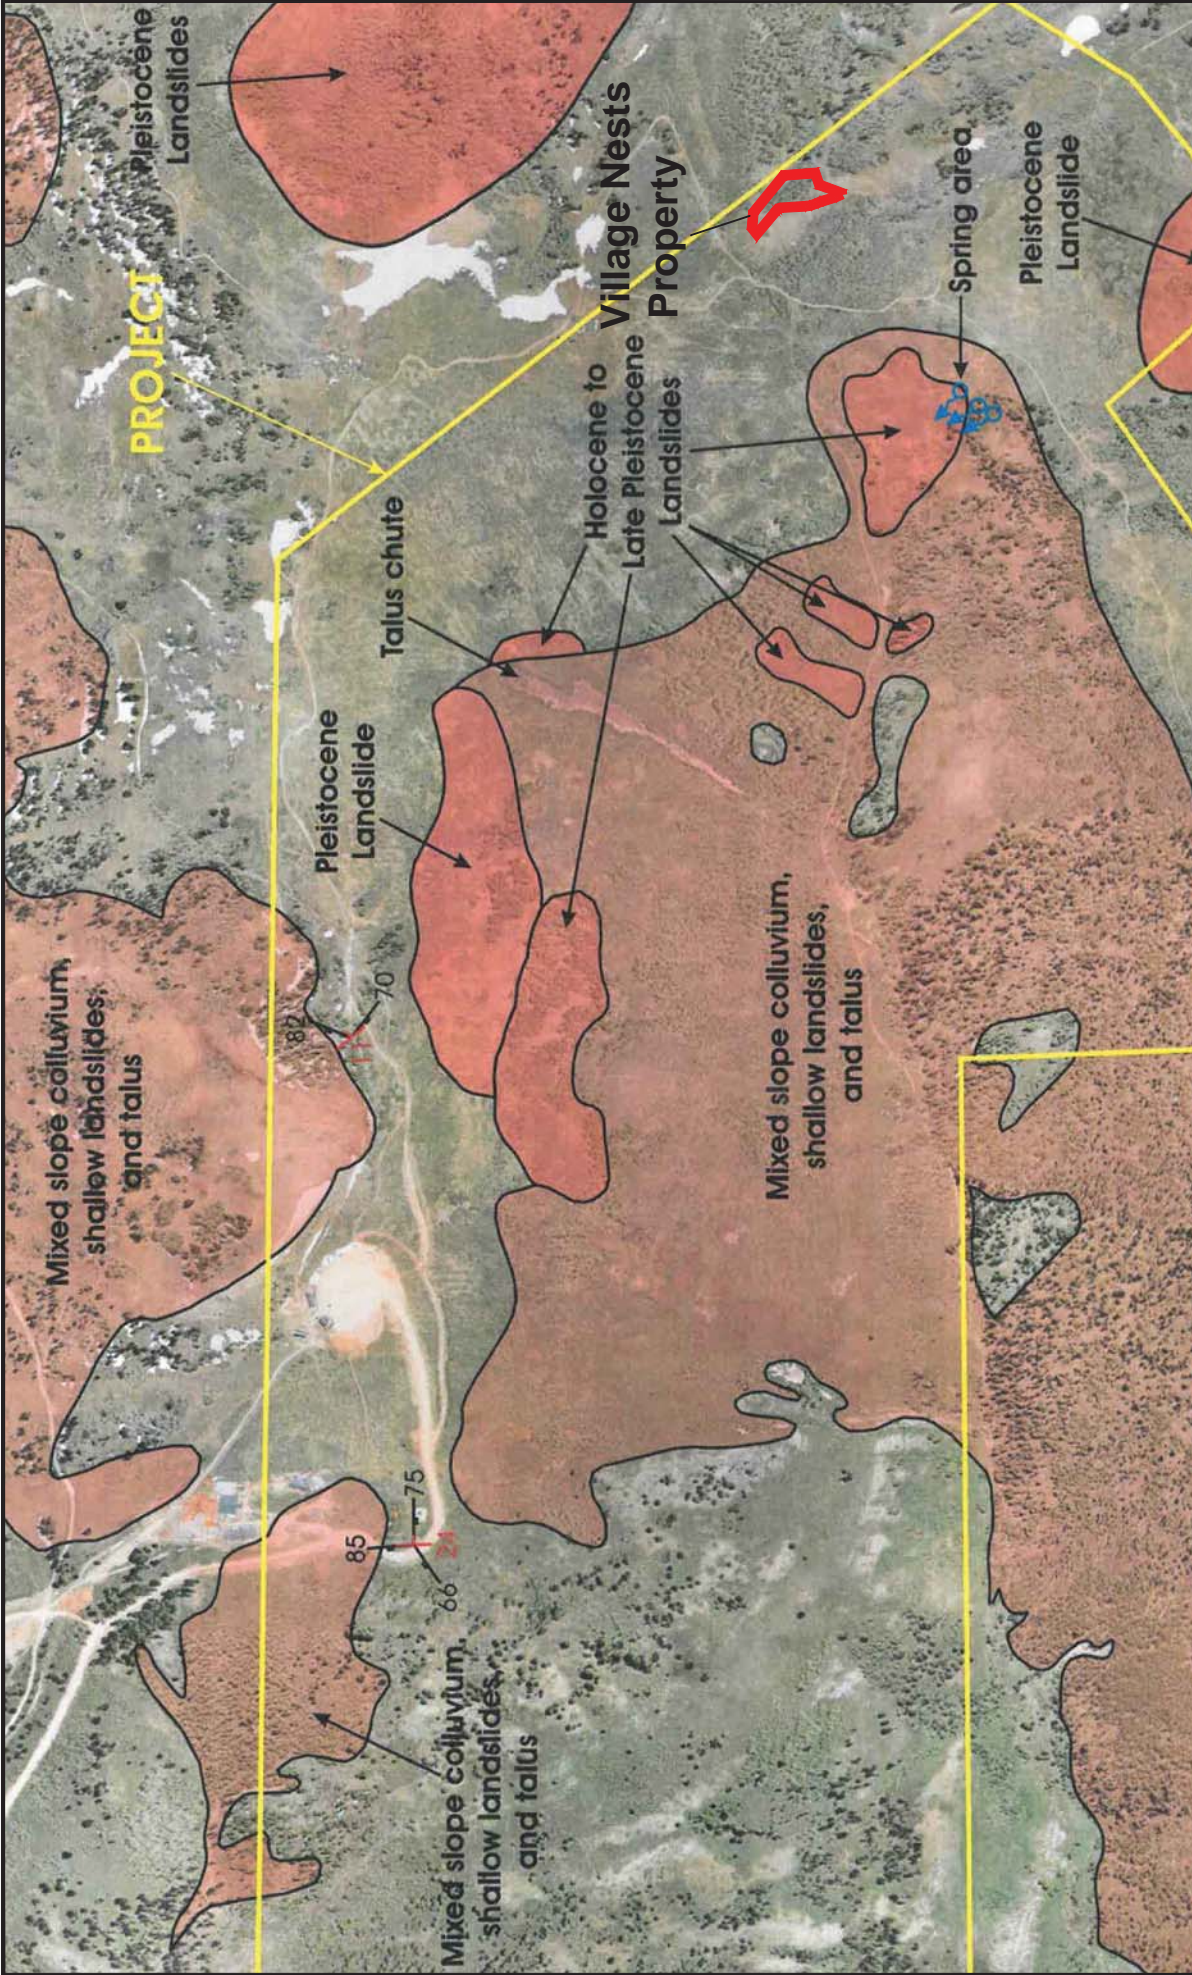
FIGURE A-3

deposits underlying the Village Nests property, though several landslide deposits are noted to the north and west of the property (see Figure A-3).

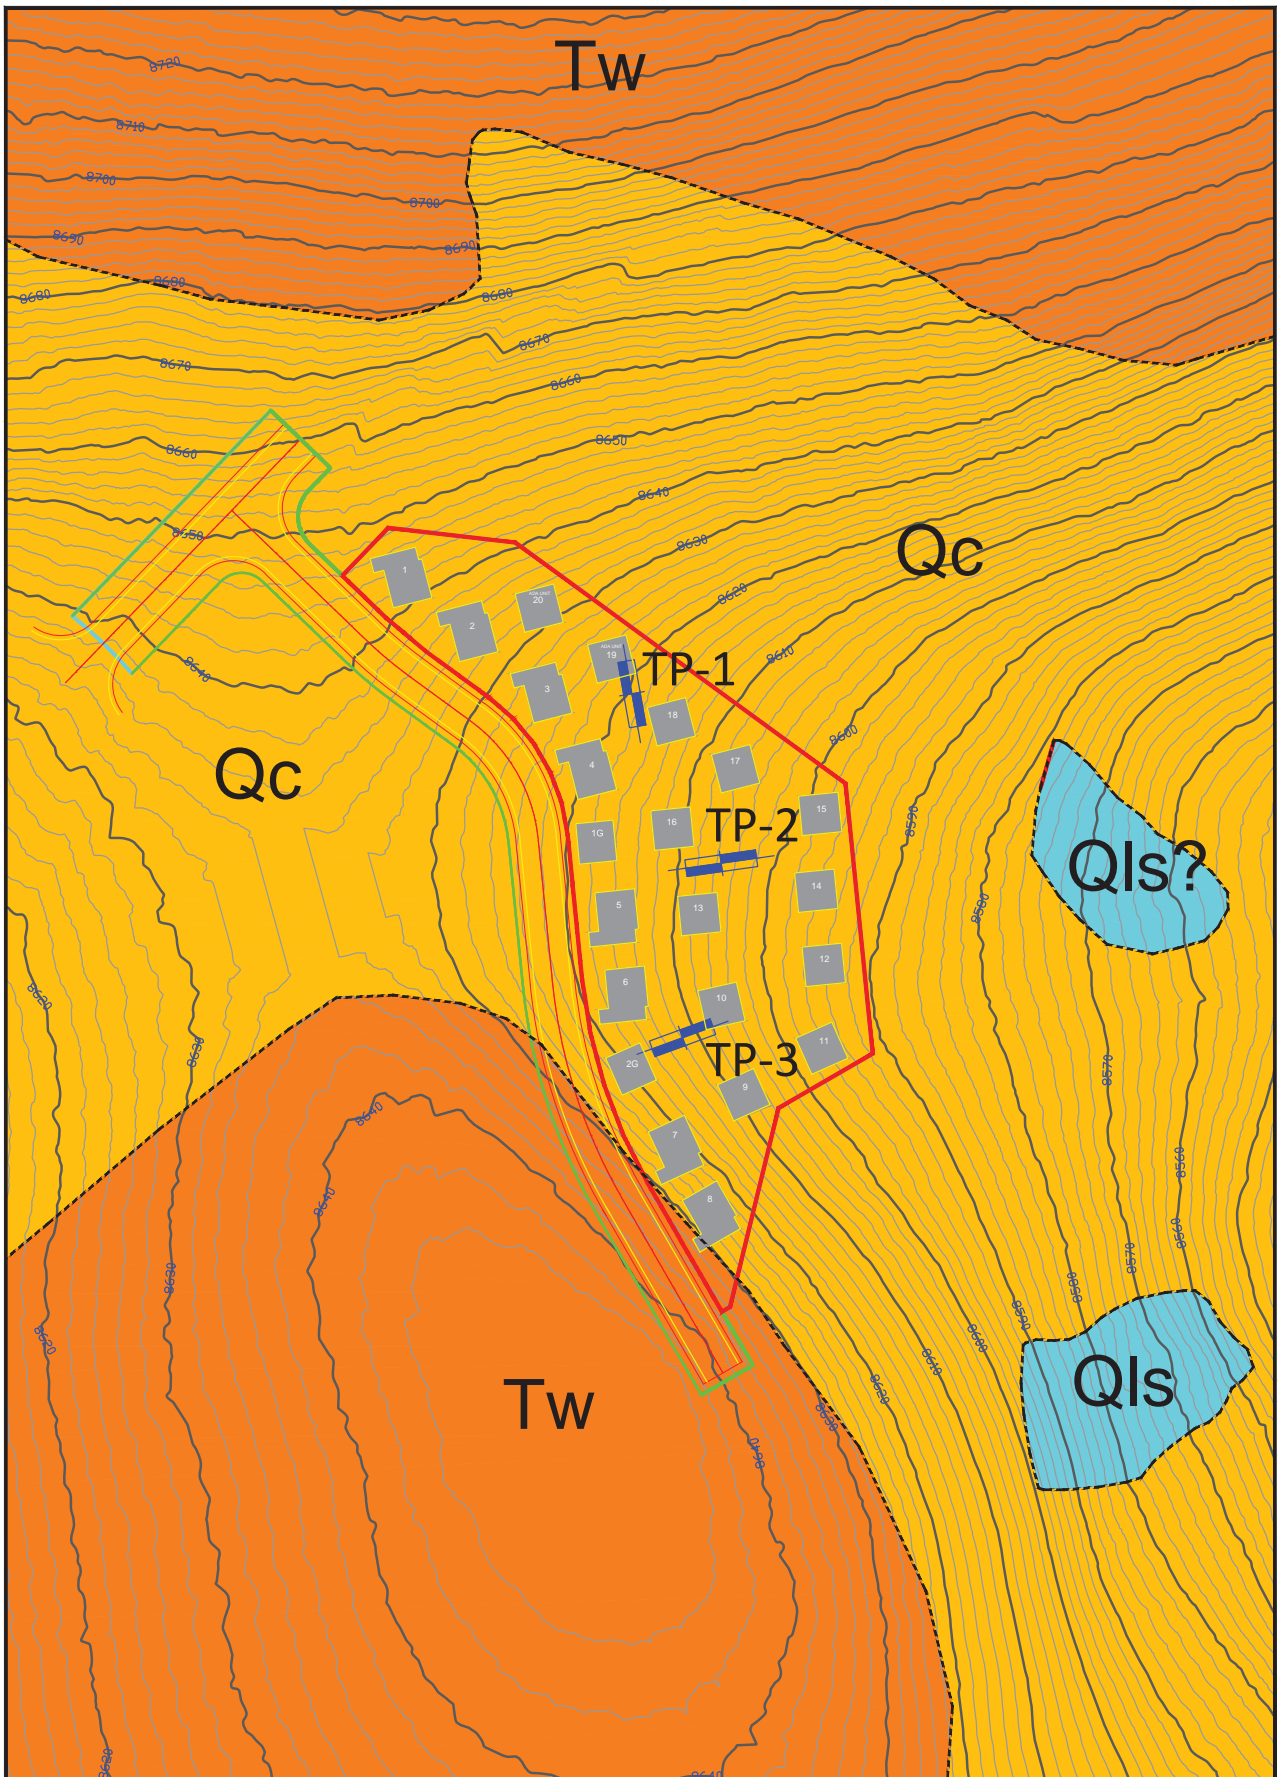
LOCAL GEOLOGY MAP
 VILLAGE NESTS
 GEOTECHNICAL AND GEOLOGIC
 HAZARD ASSESSMENT
 SUMMIT POWDER MOUNTAIN RESORT
 WEBER COUNTY, UTAH

geologically map the surficial geology of the area. Figure A-5 is a site-specific geologic map of the Village Nests property and adjacent areas.

The eastern side of the property was densely vegetated with aspen trees, which showed minor to no evidence of soil creep downslope to the east on a gentle, even slope. The western portion of the property had the steepest slopes, and was largely covered in grasses. No springs or ephemeral drainages were observed on the property, though abundant mule's ear plants (possibly indicative of shallow groundwater conditions), were observed approximately 150 feet south of the property. Additionally, no evidence of landsliding or other geologic hazards was observed on the property, though potential localized landslide features were observed to the south and east of the property (see Figure A-5).

On July 8, 2016, three exploration test pits were excavated at representative locations across the property (Figure A-5). The test pits were excavated with to depths ranging between 12 and 12.5 feet below existing grade with the aid of a Caterpillar 345C tracked excavator. Detailed logs for each of the test pits are displayed in Figures A-6 through A-8. The same three geologic units were encountered in the subsurface for each of the three test pits. These include the following:

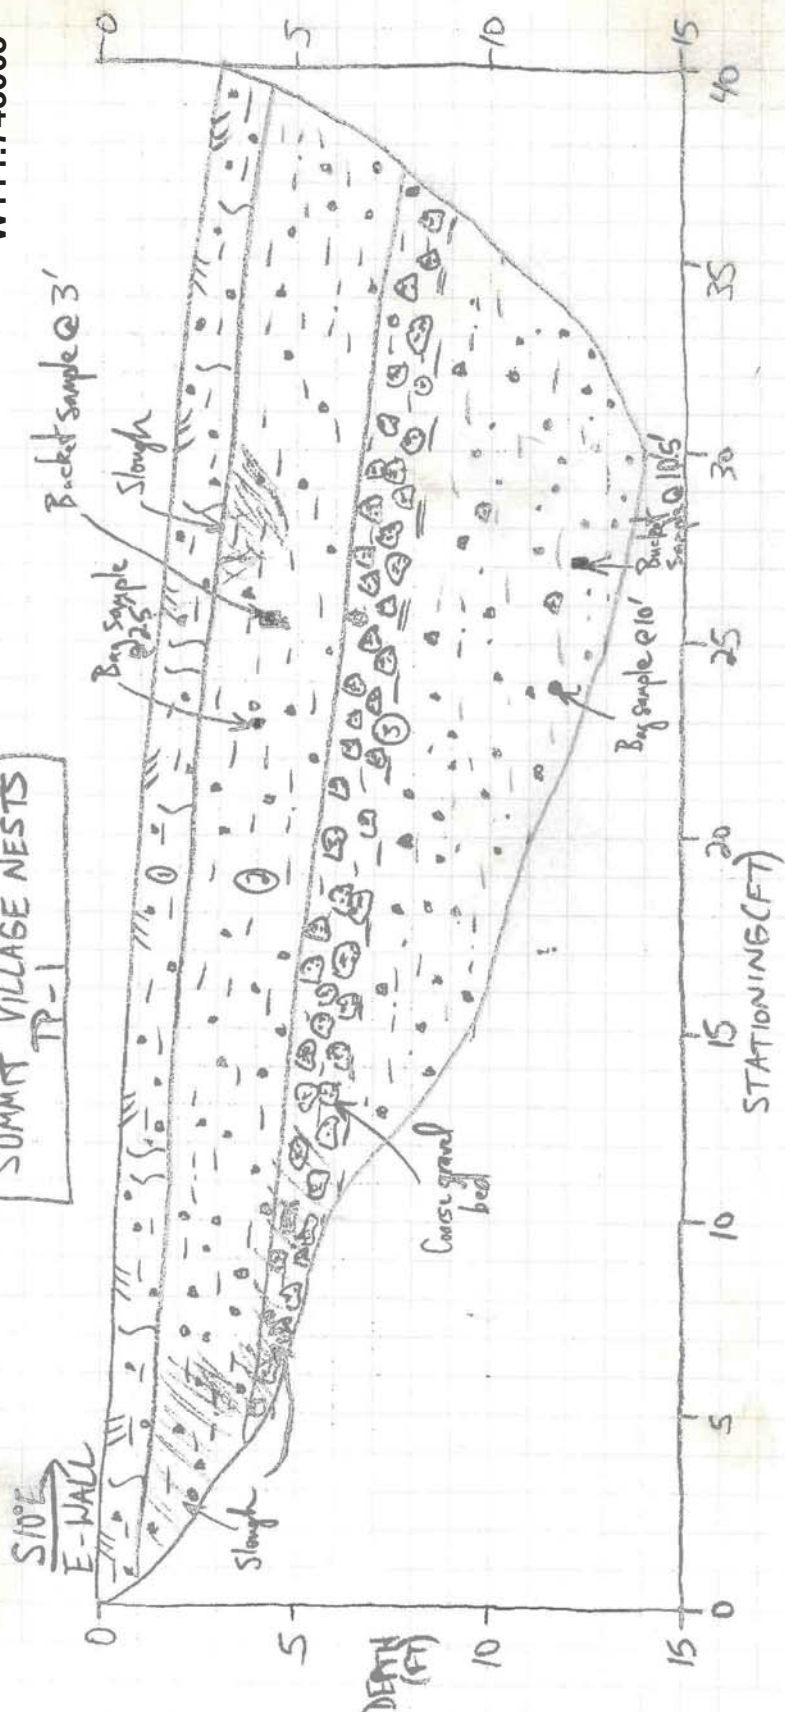
SUMMIT VILLAGE NESTS
TP-1

***No groundwater encountered.**

- 1. A/B Soil Horizon:** ~1-1.5' thick; dark yellowish brown (10YR 4/2) to moderate reddish brown (10R 4/6) gravelly lean CLAY (CL), medium stiff, slightly moist, low plasticity, massive; gravel and larger sized clasts comprise ~40% of unit; clasts entirely subrounded to subangular medium light gray (N6) quartzite up to 2" in diameter, though some boulders (1 to 2' in diameter) seen on surface; clasts are largely homogeneous in size, ranging between 1/2" and 2" in diameter; poorly sorted; abundant plant and tree roots; gradational, planar basal contact.

- 2. Colluvium:** ~2-3' thick; moderate reddish brown (10R 4/6) to dark yellowish brown (10YR 4/2) gravelly lean CLAY (CL) gradational to clayey GRAVEL (GC), medium stiff, slightly moist, low plasticity, massive; gravel and larger sized clasts comprise ~60% of unit; clasts entirely quartzite as above and up to 2" in diameter; matrix is largely topsoil; minor silt; abundant pinhole voids (1 mm) throughout; abundant plant and tree roots in upper half of unit, which become less common with depth; irregular, gradational basal contact.

- 3. Wasatch Fm:** ~At least 7.5' thick; dark reddish brown (10R 3/4) to moderate reddish brown (10R 4/6) to pale reddish brown (10R 5/4); weakly consolidated conglomerate bedrock, disaggregated to gravelly lean CLAY (CL) gradational to clayey GRAVEL (GC), stiff, moist, low to moderate plasticity, massive; gravel and larger sized clasts comprise ~50-70% of unit; clasts entirely subrounded to subangular light gray (N7) to grayish purple (5P 4/2) quartzite up to 1' in diameter, though mode size 1-2"; common silt and very fine-grained sand; uppermost ~2' contains coarsest material, with mode clast size ~6"; overall, unit appears somewhat reversely graded; poorly sorted except in upper coarse bed, which is moderately sorted; occasional to common pinhole voids (1-2 mm); rare plant and tree roots.

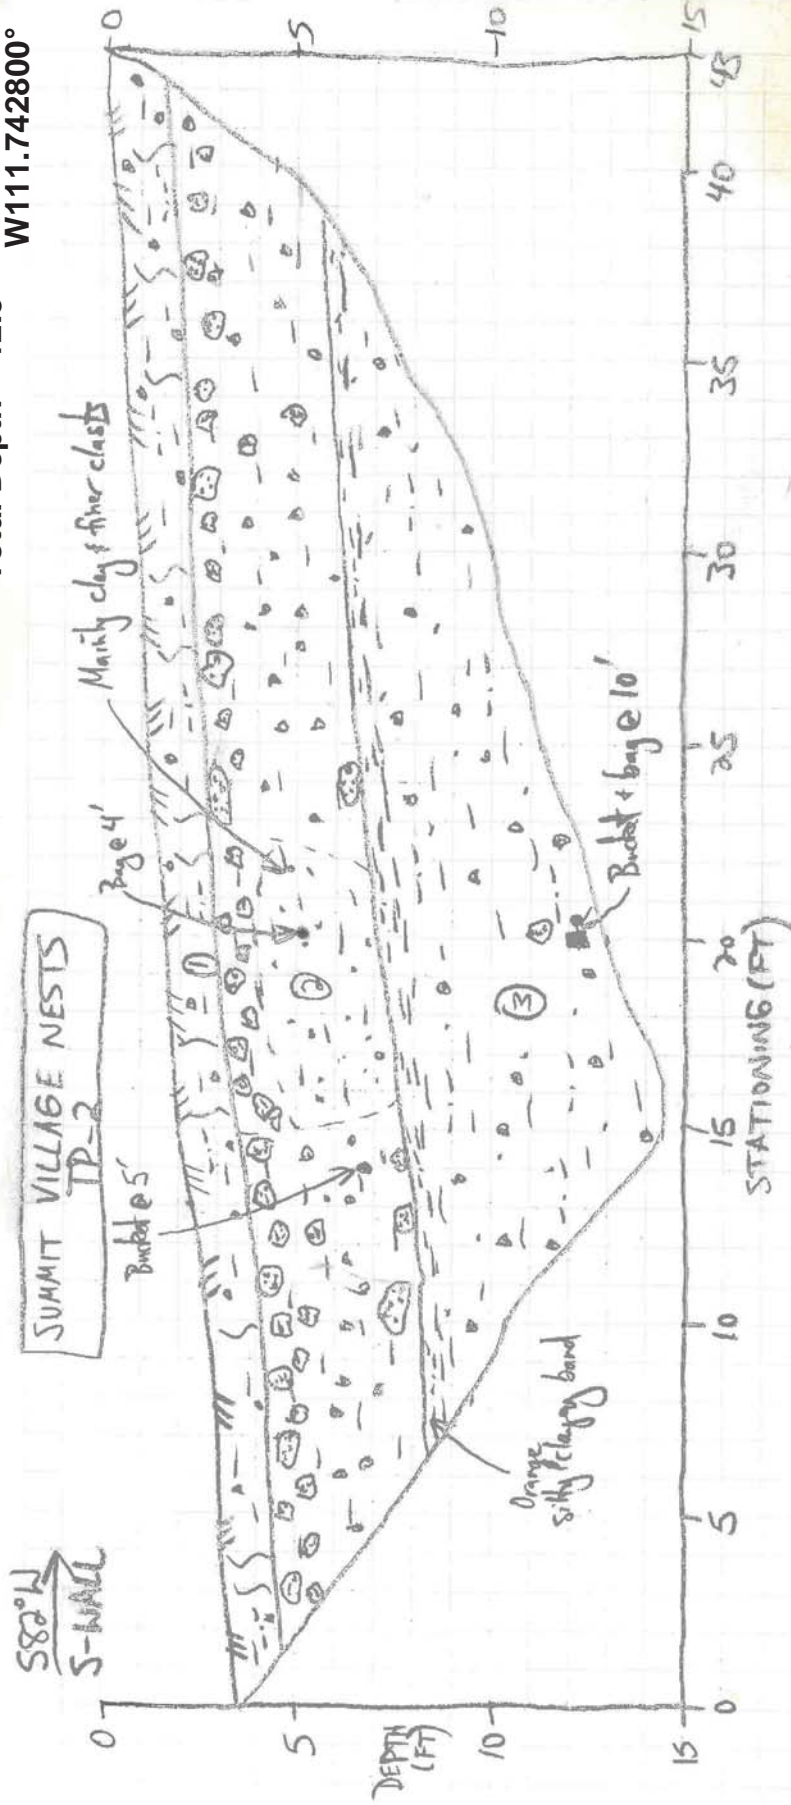
***No groundwater encountered.**

2. Colluvium: ~4' thick; dark yellowish brown (10YR 4/2) clayey GRAVEL (GC), medium dense, moist, low plasticity, massive; gravel and larger sized clasts comprise ~70% of unit; clasts entirely quartzite as above, subrounded to subangular, and up to 1.5' in diameter, though mode size ~4"; unit appears to be sorted by clast size: uppermost ~1' has coarsest material (mode size 6"), middle ~2' mode size 4", basal ~1' is mix of both larger and smaller clasts; middle of unit has an anomalously lower clast concentration (~15%), with small clasts (<1") that are largely subangular; clay component is lean; common pinhole voids throughout (1 mm); occasional plant and tree roots; sharp, planar basal contact.

3. Wasatch Fm: ~At least 7' thick; moderate reddish brown (10R 4/6) to dark yellowish orange (10YR 6/6); poorly consolidated conglomerate bedrock, disaggregated to clayey GRAVEL with sand (GC), medium dense to dense, moist, low plasticity, massive, though possibly weakly thickly bedded; gravel and larger sized clasts comprise ~50-60% of unit; clasts entirely subrounded to subangular quartzite as above up to 1' in diameter, though mode size 2-4"; minor silt component, and becomes sandier with depth; single clast of dark gray shaley dolomite found weathering out of unit in base of test pit; occasional pinhole voids (1 mm) in clayey parts of unit; orange clayey/silty band ~4" thick found at top of unit; rare plant and tree roots.

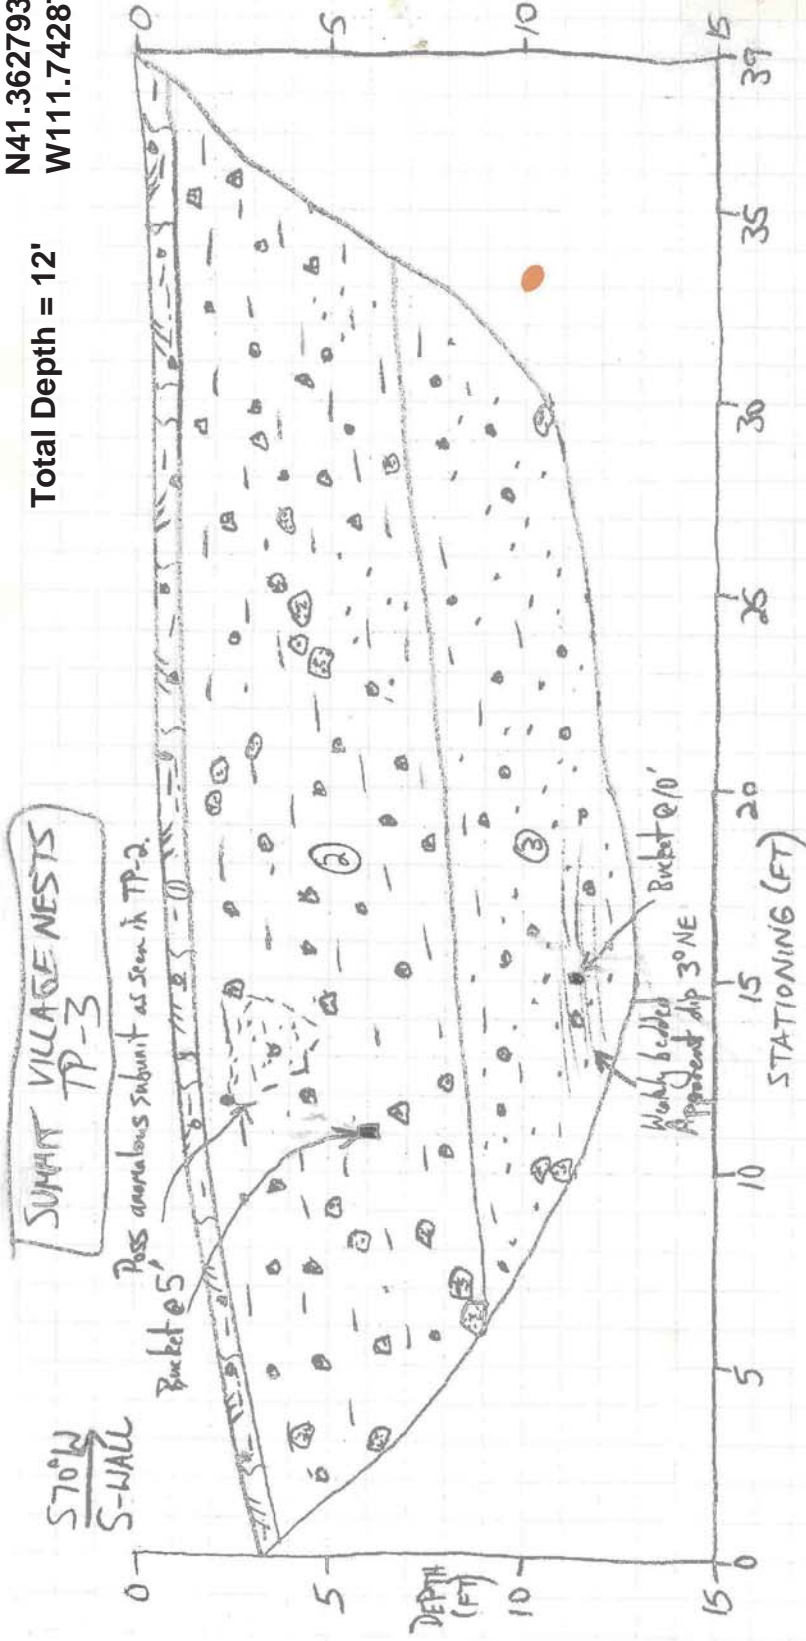
***No groundwater encountered.**

- 2. Colluvium:** -6.5' thick; dark yellowish brown (10YR 4/2) gravelly lean CLAY (CL) gradational to clayey GRAVEL (GC), medium stiff, moist, low plasticity, massive; gravel and larger sized clasts comprise ~40-50% of unit; clasts entirely subrounded to subangular quartzite as above up to 10" in diameter, though in a heterogeneous mixture of clast sizes (mode size ~1-3"); locally sandy; may contain middle portion with finer clasts, as seen in TP-2, though the subunit is less conspicuous and does not show clast size sorting; poorly sorted; common pinhole voids (1-2 mm) and plant and tree roots; planar, gradational basal contact.

- 3. Wasatch Fm:** -At least ~5' thick; dark reddish brown (10R 3/4) to moderate reddish brown (10R 4/6); weakly consolidated conglomerate bedrock, disaggregated to clayey SAND with gravel (SC), medium dense to dense, moist, low plasticity, thinly weakly bedded downslope to northeast; gravel and larger sized clasts comprise ~30-40% of unit; clasts entirely subrounded to subangular quartzite as above up to 8" in diameter, though mode size 1-2"; clay component is lean; sand component is medium-grained and includes predominantly quartz grains and some quartzite grains; minor silt; clayey near top and becomes sandier with depth; rare plant and tree roots.
