**Geologic Hazards Assessment**  
**Parcel# 21-071-0003**  
**4033 East Nordic Valley View Drive**  
**Liberty, Utah**

GeoStrata Job No. 1236-002

September 23, 2016

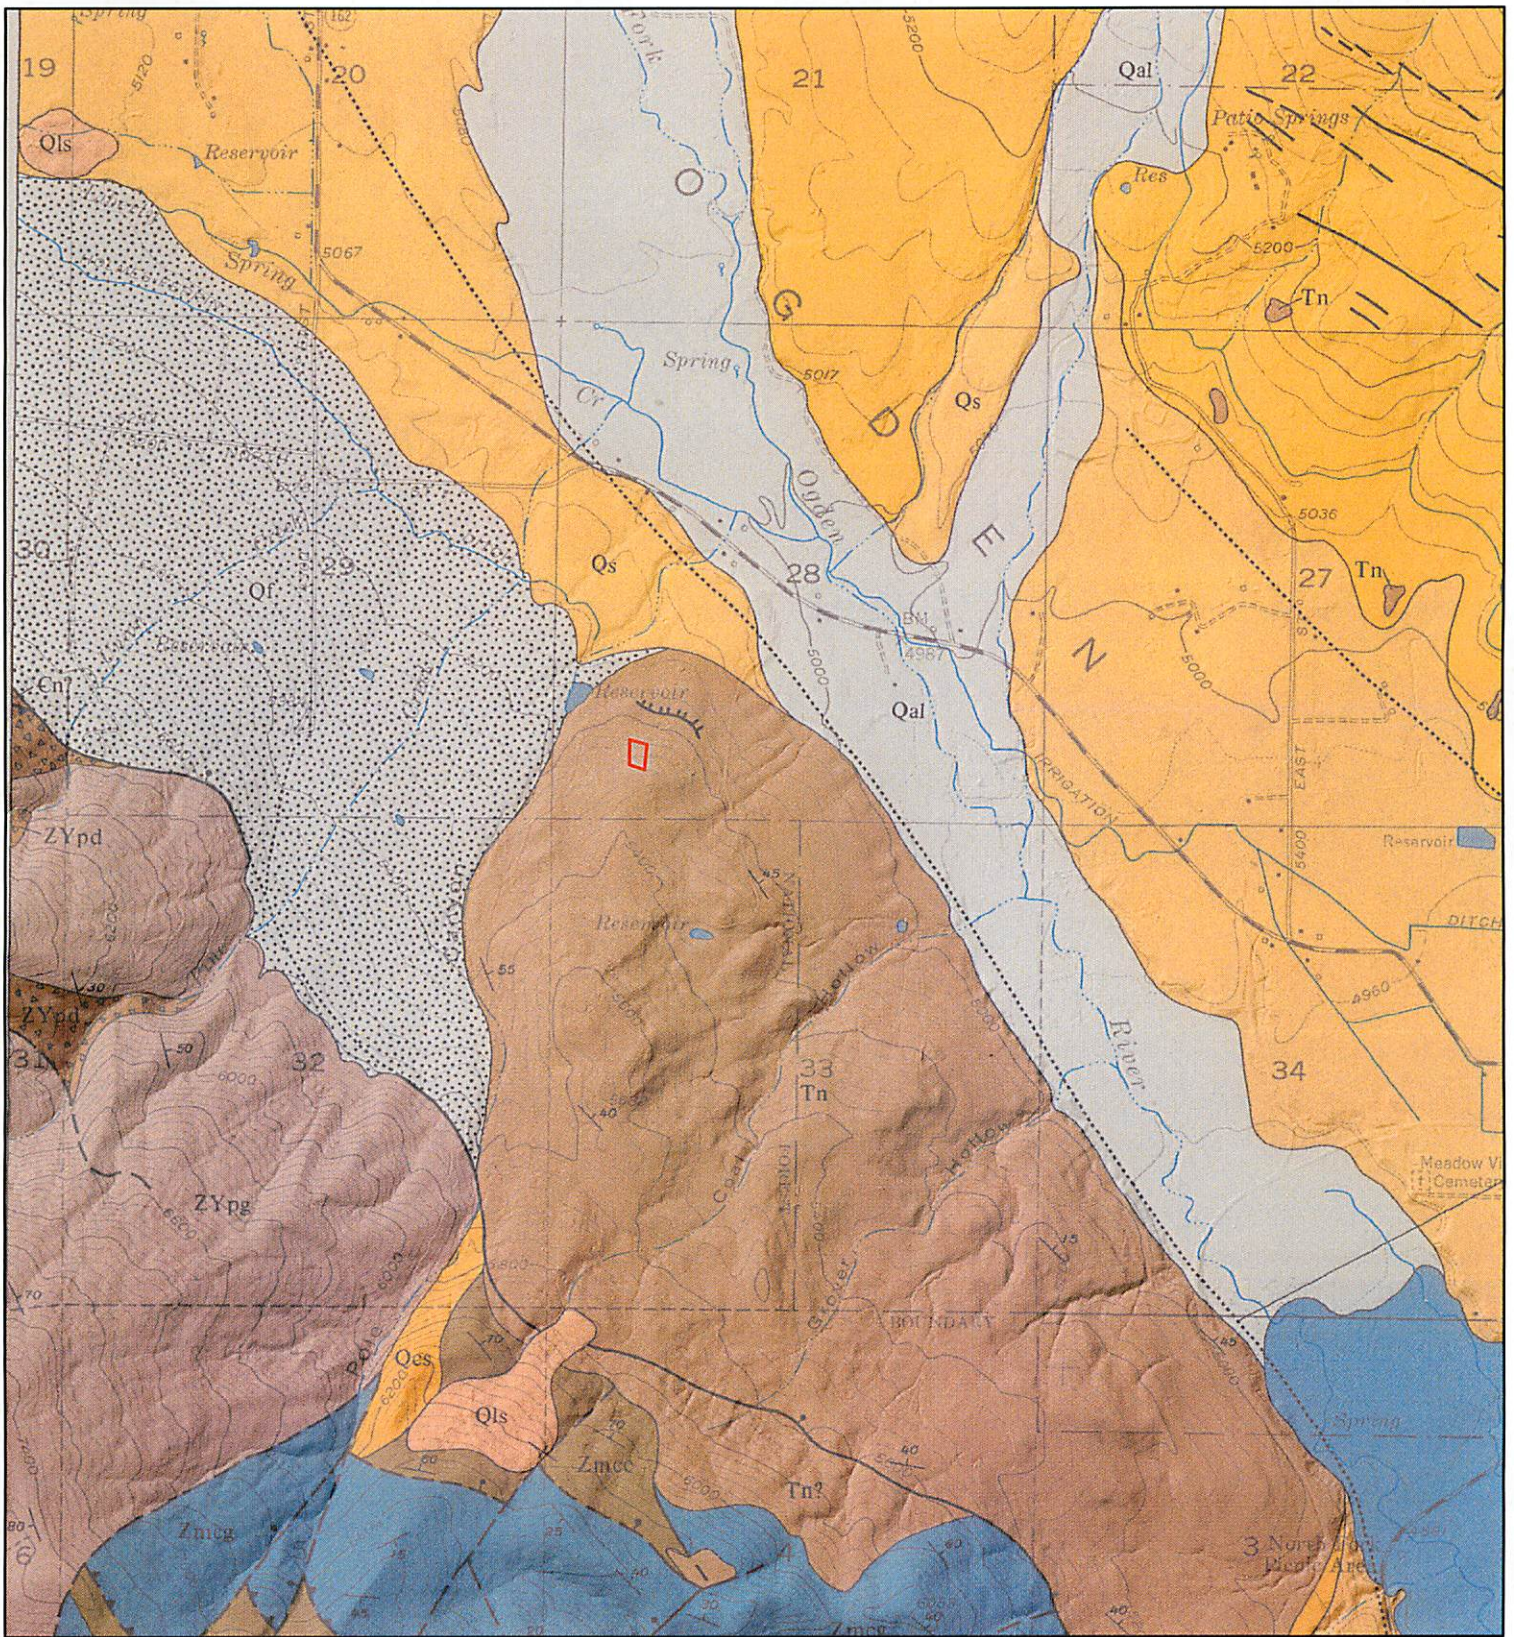
**Plate  
 3a**

Geologic Map of the Huntsville Quadrangle, Weber and Cache Counties, Utah, Sorensen and Crittenden, 1979. Hillshades derived from 2011 1 meter LiDAR provided by the State of Utah AGRC.

**Site Vicinity Geologic Map**

Surface sediments within the subject site, as shown on Plate 3a Site Vicinity Geologic Map and Plate 4 Site Vicinity 30' X 60' Geologic Map, are mapped as lower Oligocene and upper Eocene Norwood Formation (Tn). The Tertiary Norwood Formation is described as light-gray to light-brown, locally colored light shades of red or green in the west side of Ogden Valley, altered tuff (claystone), altered tuffaceous siltstone and sandstone, and conglomerate (Coogan and King, 2016).

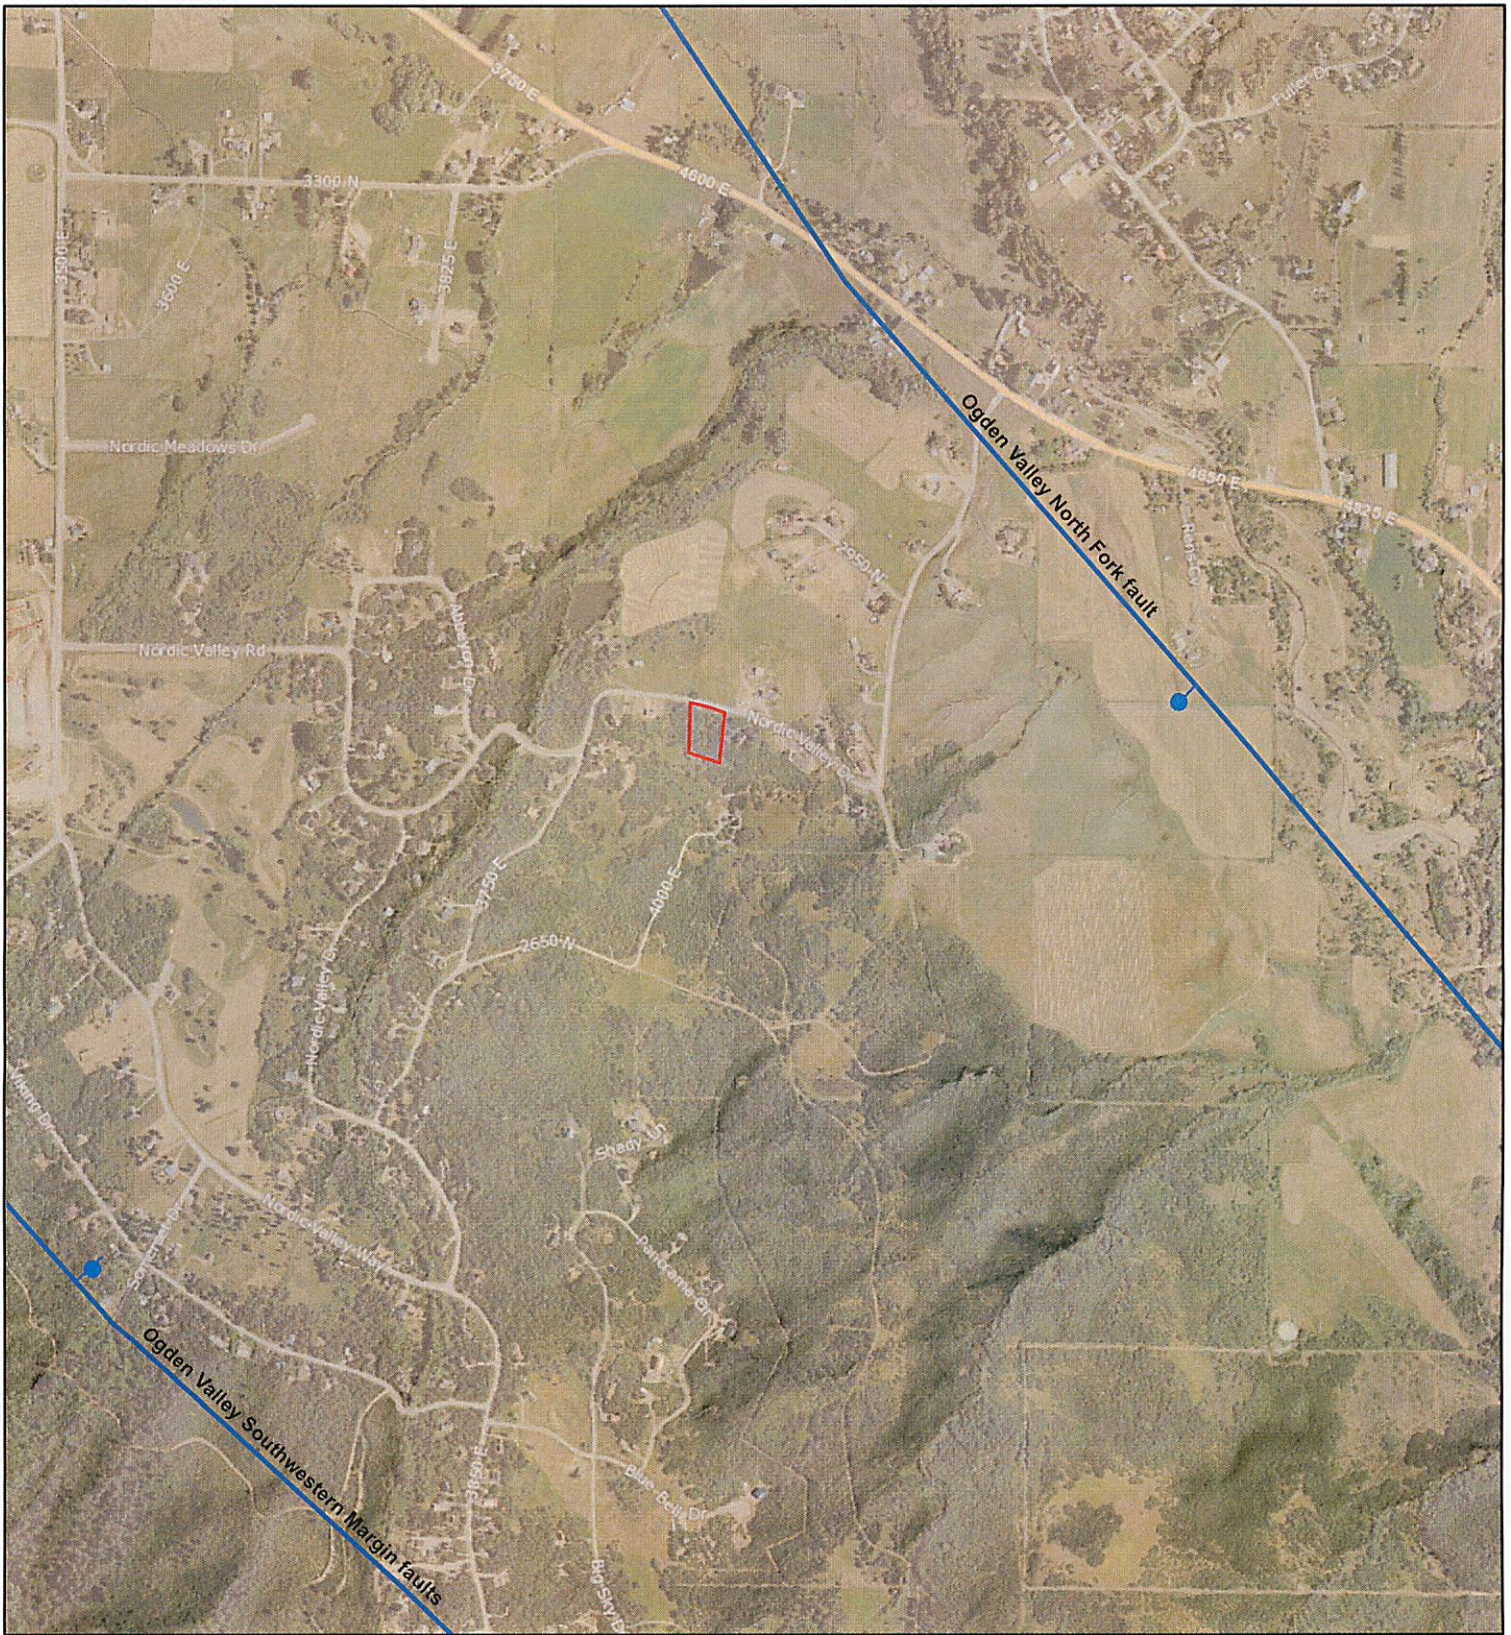
**Plate  
6**

**UGS Quaternary Fault Map**

Based on review of published geologic maps, our stereographic aerial photograph interpretation, our review of the hillshades derived from the 1 meter Bare Earth LiDAR elevation data (2011) and our field observations, no active surface ruptures are located near the subject site (Plate 6 UGS Quaternary Faults Map). The nearest faults are the northwest-southeast trending Ogden Valley North Fork Fault and the Ogden Valley Southwestern Margin Fault which are middle and late Quaternary in age (<750,000 years old) with an undetermined reoccurrence interval and a slip rate of less than 0.2 mm/yr (Black and others, 1999). These faults are located approximately 2,020 feet northeast of the subject site and 4,400 feet to the southwest of the subject site, respectively. Given our field and office investigations, the surface fault rupture hazard within the subject site is **considered low** and it is considered unlikely that surface fault rupture will impact
