# GEOTECHNICAL AND GEOLOGIC HAZARDS INVESTIGATION Bobcat Ridge Subdivision Summit Powder Mountain Resort Weber County, Utah

IGES Project No. 01628-028

July 26, 2018

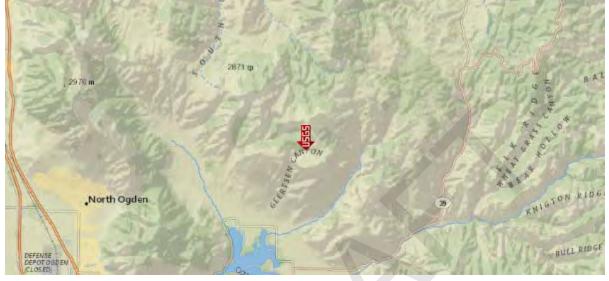
**User-Specified Input**

Report Title	Bobcat Fri July 20, 2018 20:16:05 UTC
Building Code Reference Document	2012/2015 International Building Code (which utilizes USGS hazard data available in 2008)
Site Coordinates	41.3578°N, 111.7496°W
Site Soil Classification	Site Class C – "Very Dense Soil and Soft Rock"
Risk Category	1/11/111

#### **USGS**–Provided Output

S <sub>s</sub> =	0.814 g	S <sub>MS</sub> =	0.874 g	S <sub>DS</sub> =	0.583 g
<b>S</b> <sub>1</sub> =	0.270 g	<b>S</b> <sub>M1</sub> =	0.413 g	<b>S</b> <sub>D1</sub> =	0.275 g
