**Geologic Hazards Assessment
Parcel No. 23-012-0082
Powder Ridge Road
Eden, Utah**

GeoStrata Job No. 1236-001

November 1, 2016

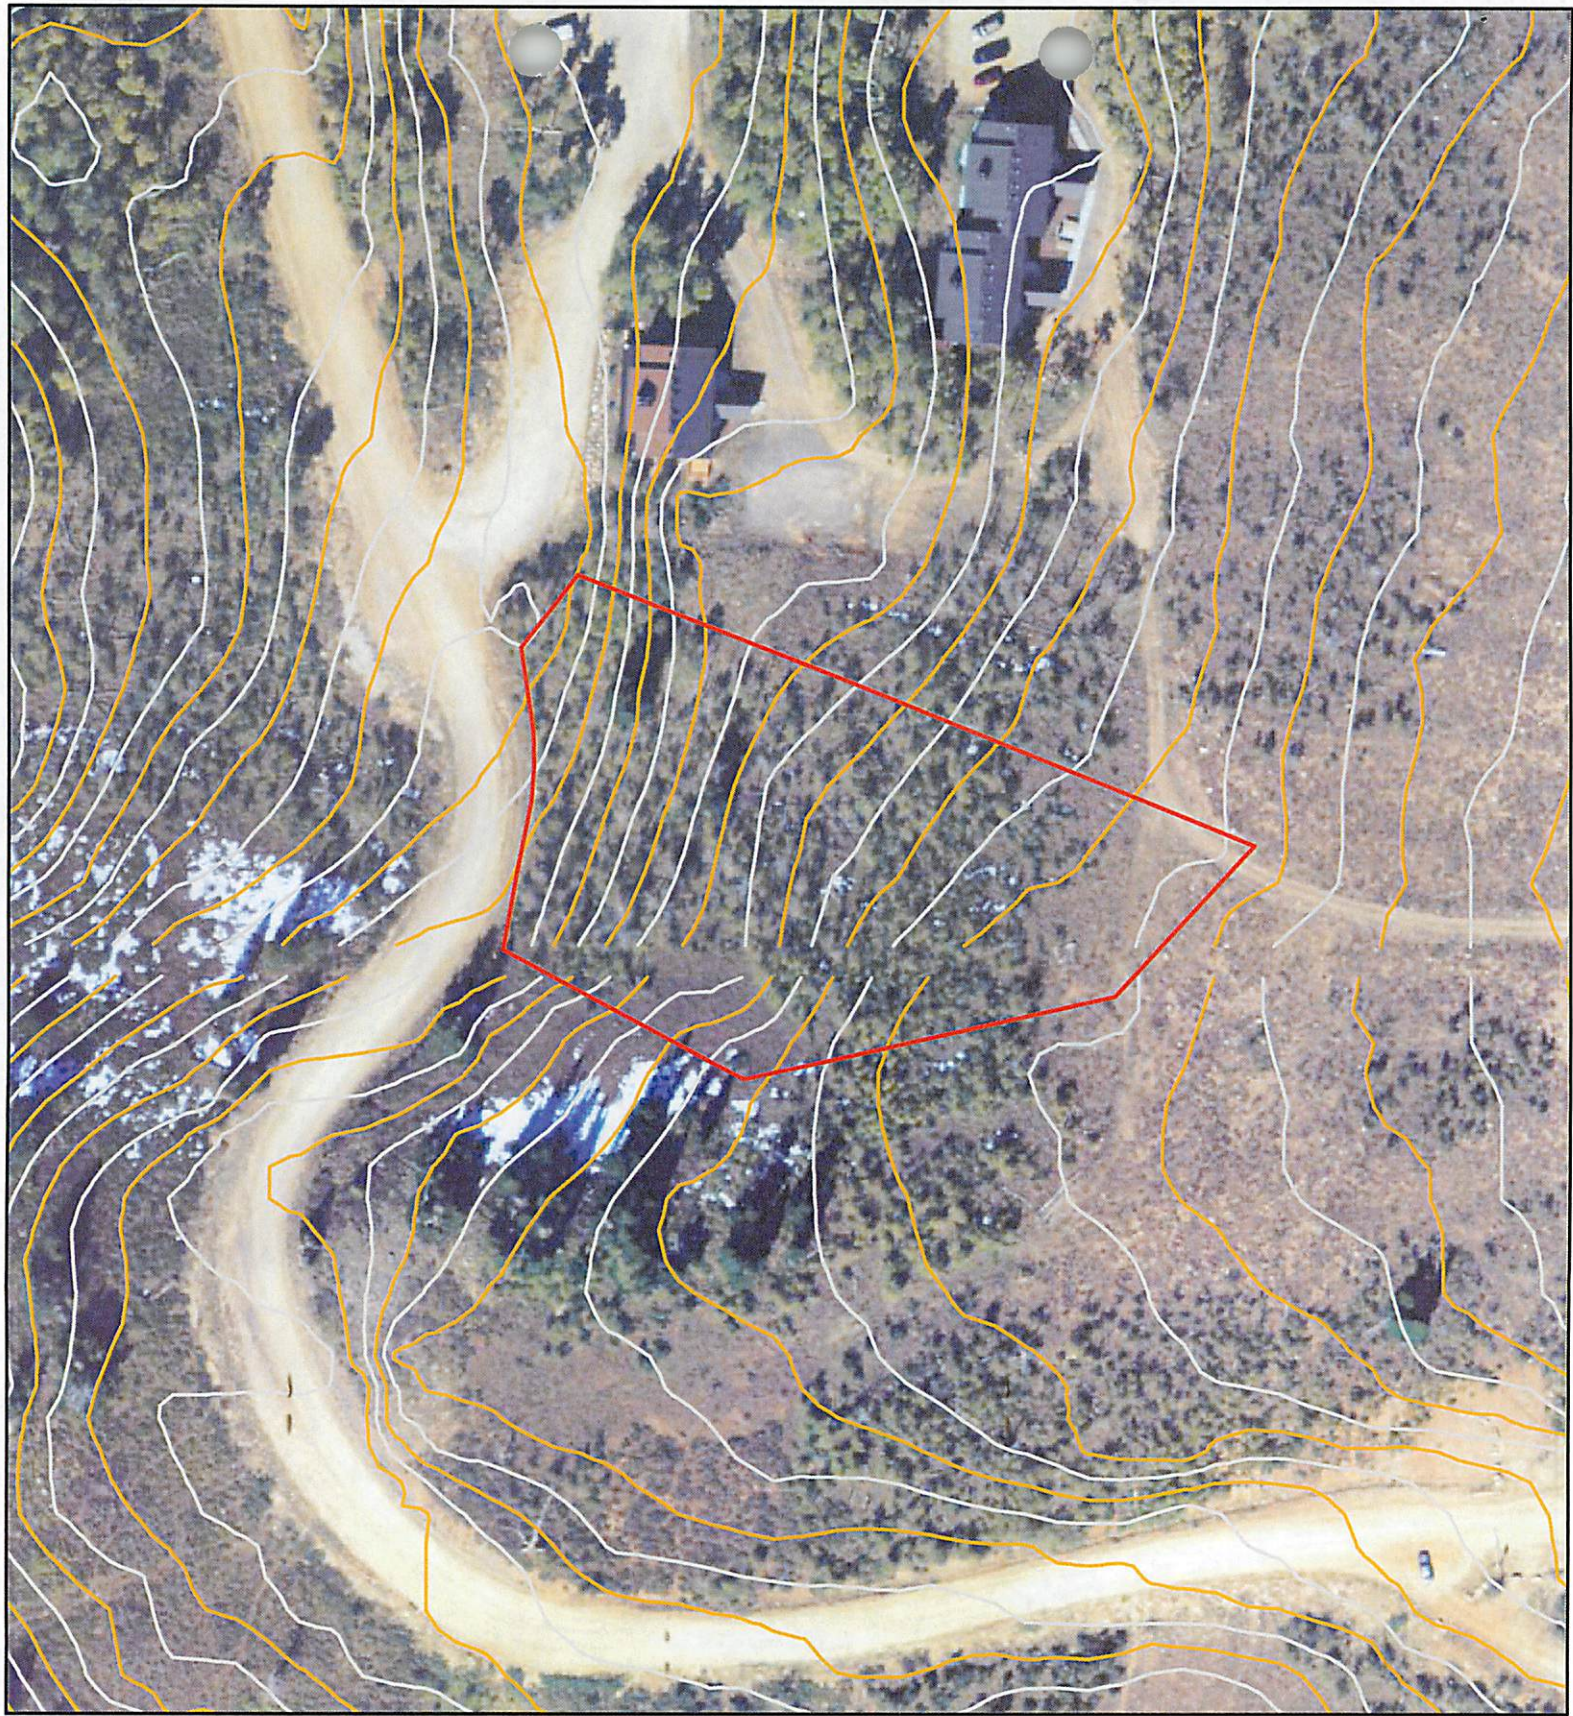
Plate
5

Geologic Hazards Assessment
 Parcel No. 23-012-0082
 Powder Ridge Road
 Eden, Utah
 Project Number: 1236-001
Contour Map

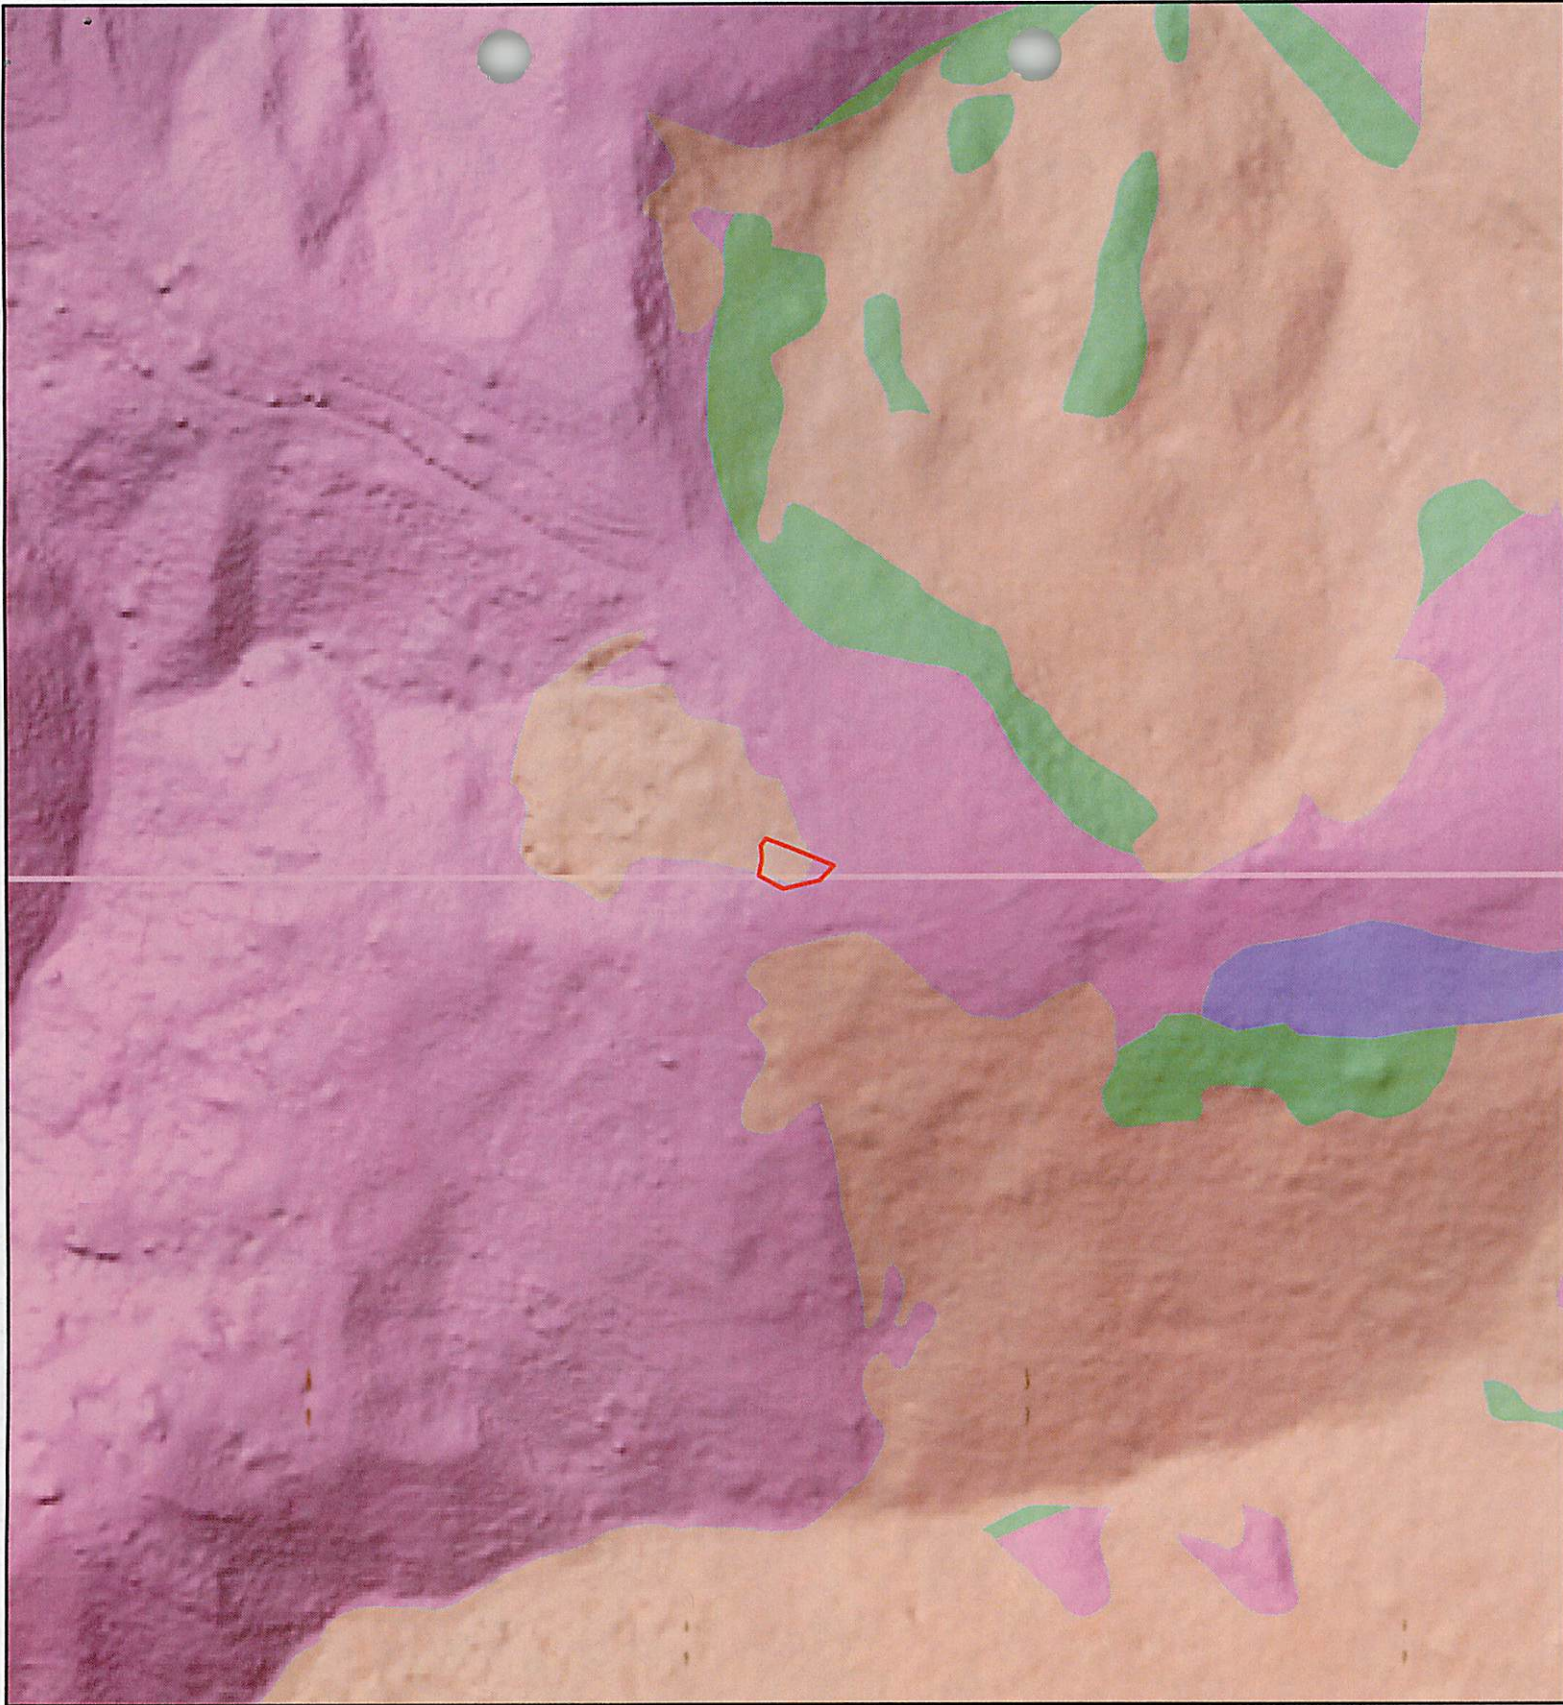
- Legend**
- Approximate Site Boundary
 - Landslide Scarp
 - Debris Flow Paths
 - deep or unclassified landslide
 - landslide and/or landslide undifferentiated from talus, colluvial, rock-fall, glacial, and soil-creep deposits
 - landslide undifferentiated from talus and/or colluvial deposits
 - lateral spread and/or flow failure
 - not classified
 - shallow landslide

Based on review of published geologic maps, undifferentiated landslide and colluvial deposits are mapped within the subject site (Plate 3a Site Vicinity Geologic Map, Plate 4 Site Vicinity 30' X 60' Geologic Map and Plate 6 Landslide Hazard Map). However, our stereographic aerial photograph interpretation, our review of the hillshades derived from 5 meter auto-corrected DEM from 2006 1 meter NAIP orthophotography and our field observations revealed no scarp features, hummocky topography, or other landslide related geomorphology features related to landslide deformation were observed. During our field investigation we did observe curved tree trunks which would suggest soil creep or snow loading within the subject site and is consistent with published geologic maps that include the area of the subject site. Based on our field observations and the location on the hillside of the subject site, it is the opinion of GeoStrata that the surficial deposits within the subject site are thin colluvial, slopewash or soil creep deposits. These deposits are mapped as overlying Nounan Dolomite which is dipping between 25 and 30 degrees to the west and into the hillside. Based on our office and field investigation, the landslide hazard within the subject site is considered low and it is considered unlikely that landslides will impact the proposed development.

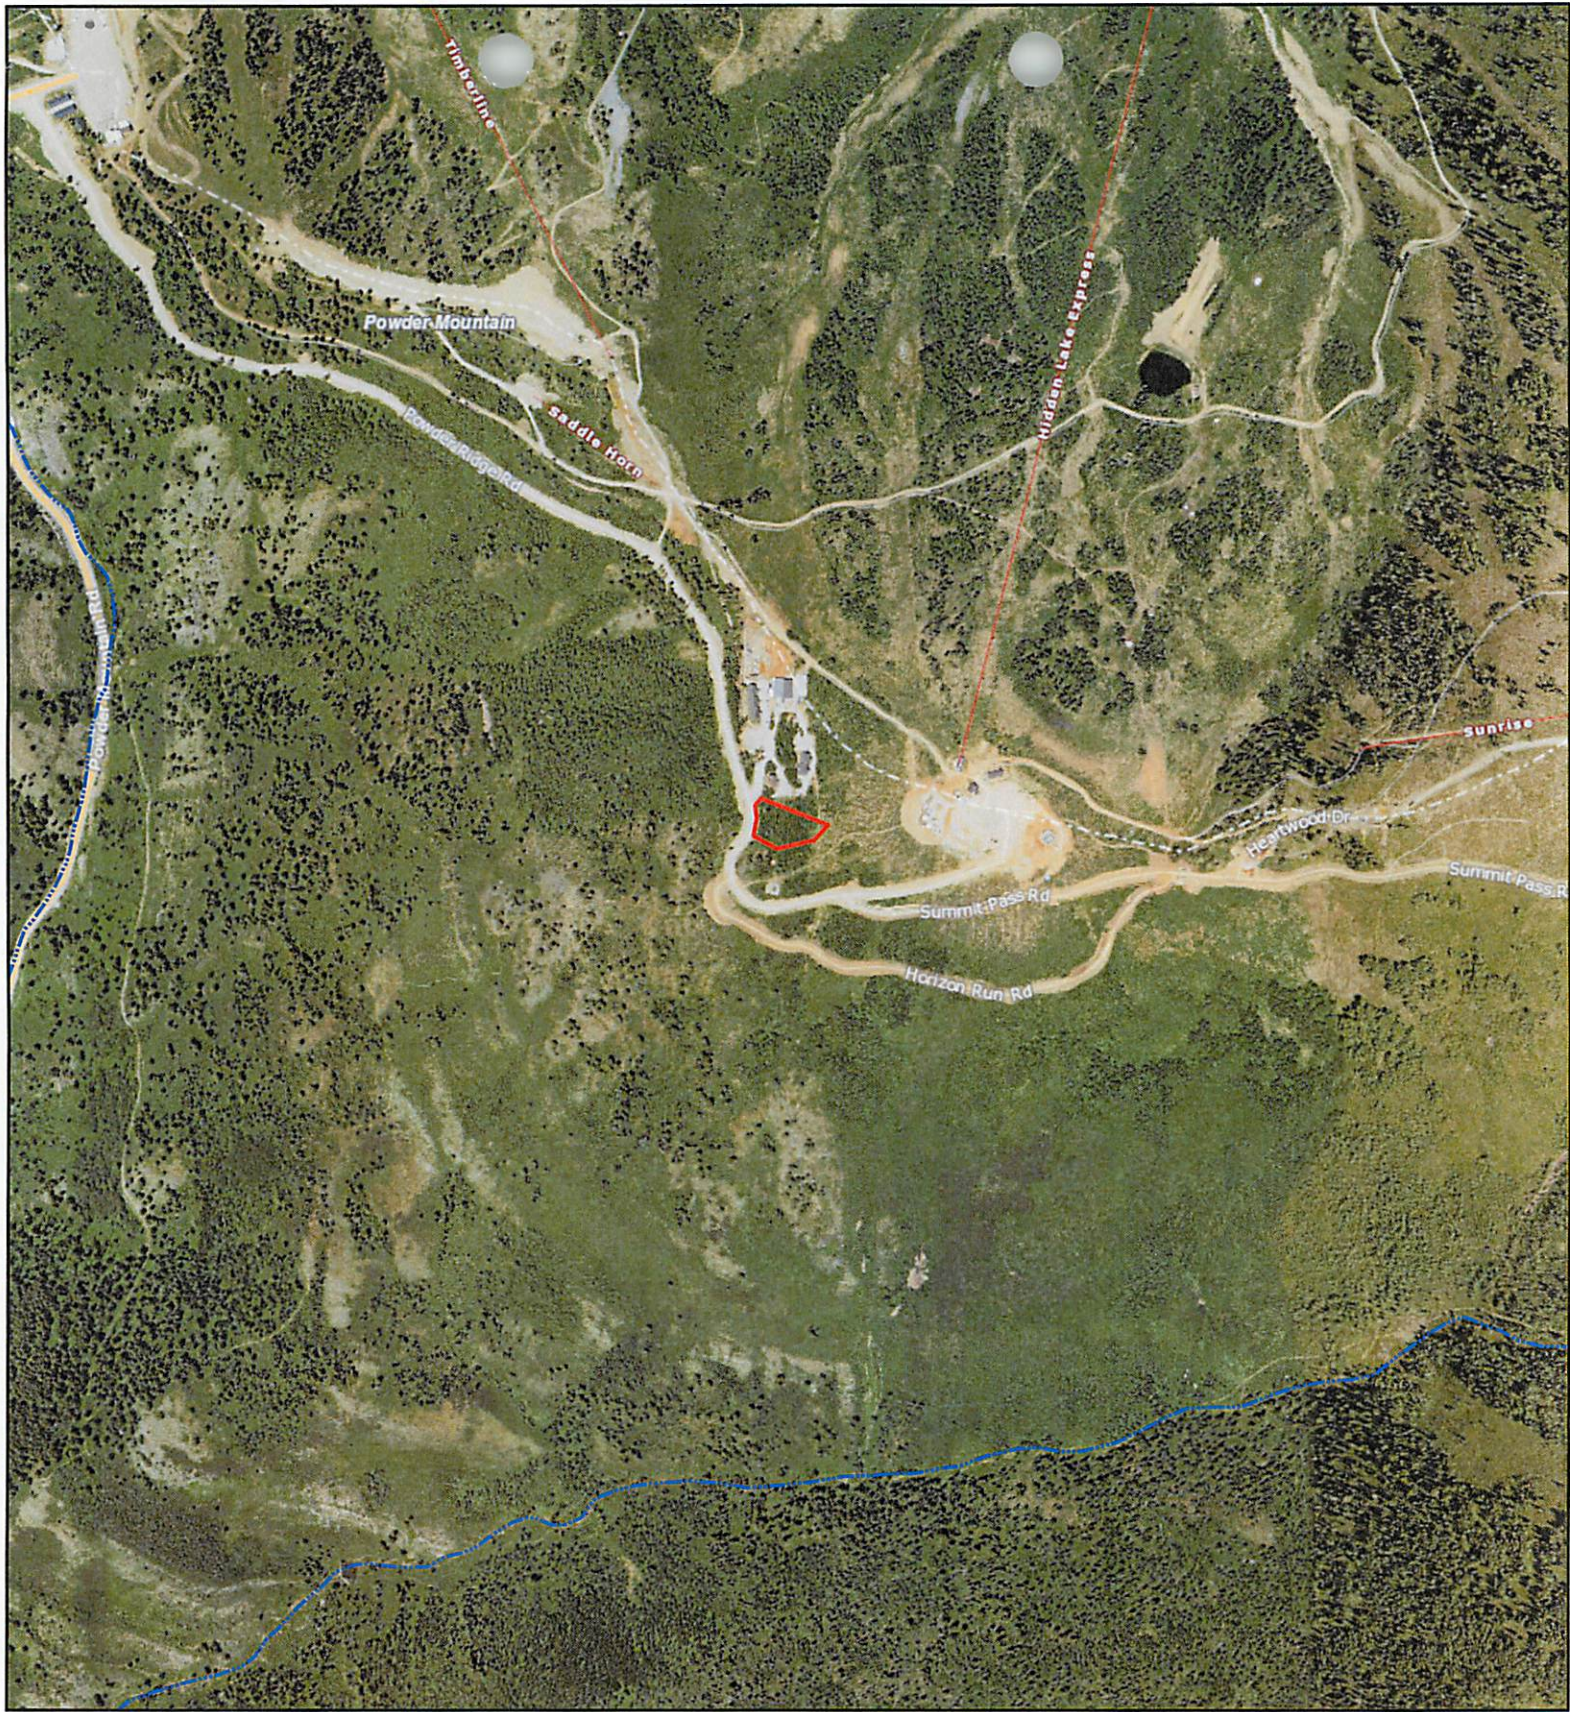
Geologic Hazards Assessment
 Parcel No. 23-012-0082
 Powder Ridge Road
 Eden, Utah
 Project Number: 1236-001
Drainage Map
