**GEOTECHNICAL AND GEOLOGIC HAZARD INVESTIGATION  
The Overlook – Phases II & III  
Summit Powder Mountain Resort  
Weber County, Utah**

IGES Project No. 01628-027

October 23, 2018

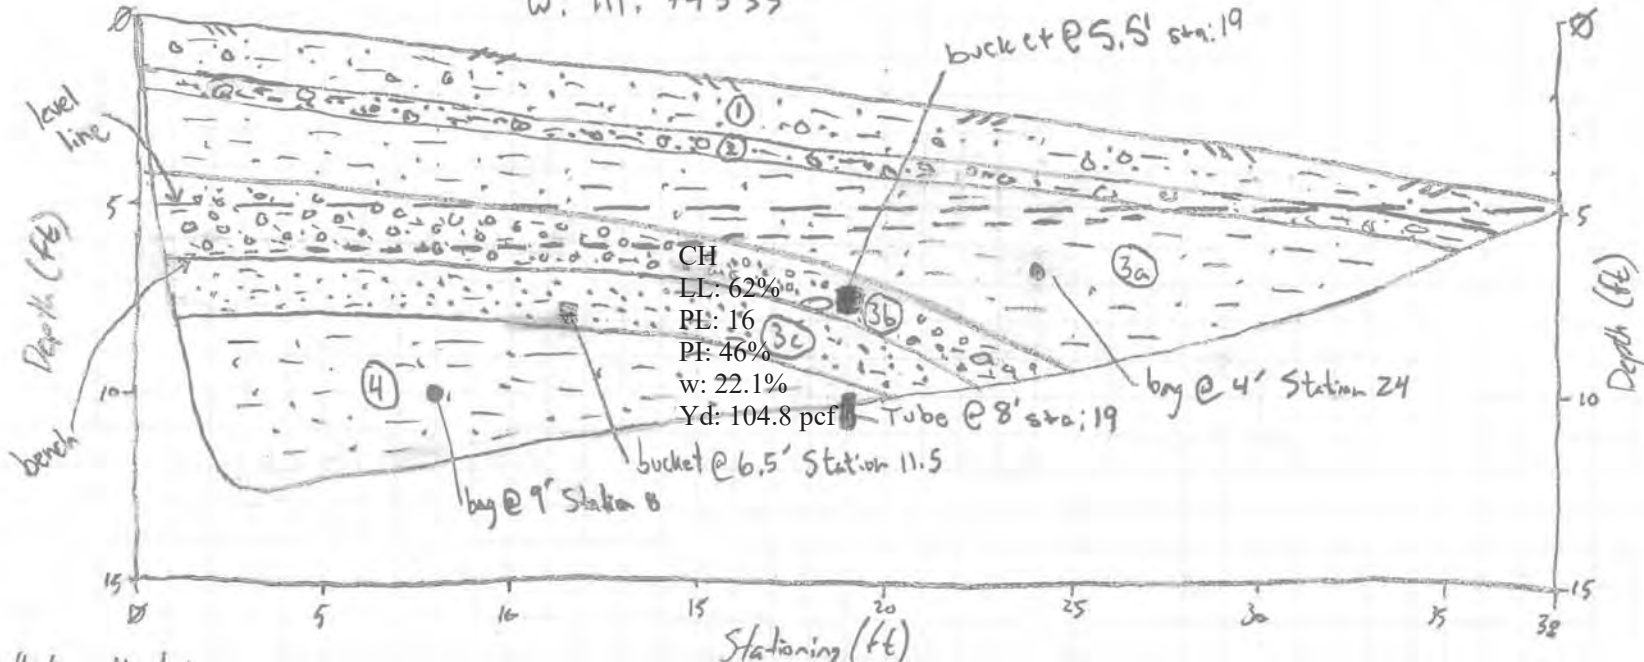
### LITHOLOGIC UNIT DESCRIPTIONS

**1. A/B Soil Horizon:** ~1-2' thick; light brown (5YR 4) sandy lean CLAY with gravel (CL), loose to medium stiff, dry, low plasticity, massive; gravel and larger sized clasts comprise ~10-15% of the unit; clasts are subrounded to subangular light gray (N7) to moderate reddish brown (10R 6) quartzite up to ~7' in diameter at the surface, though mode clast size ~0.5-1"; common plant roots; gradational, irregular basal contact.
