GEOTECHNICAL AND GEOLOGIC HAZARD INVESTIGATION
Lot 71R of Summit Eden Phase 1C
8488 E. Spring Park Road
Summit Powder Mountain Resort
Weber County, Utah

IGES Project No. 02565-001

August 30, 2017

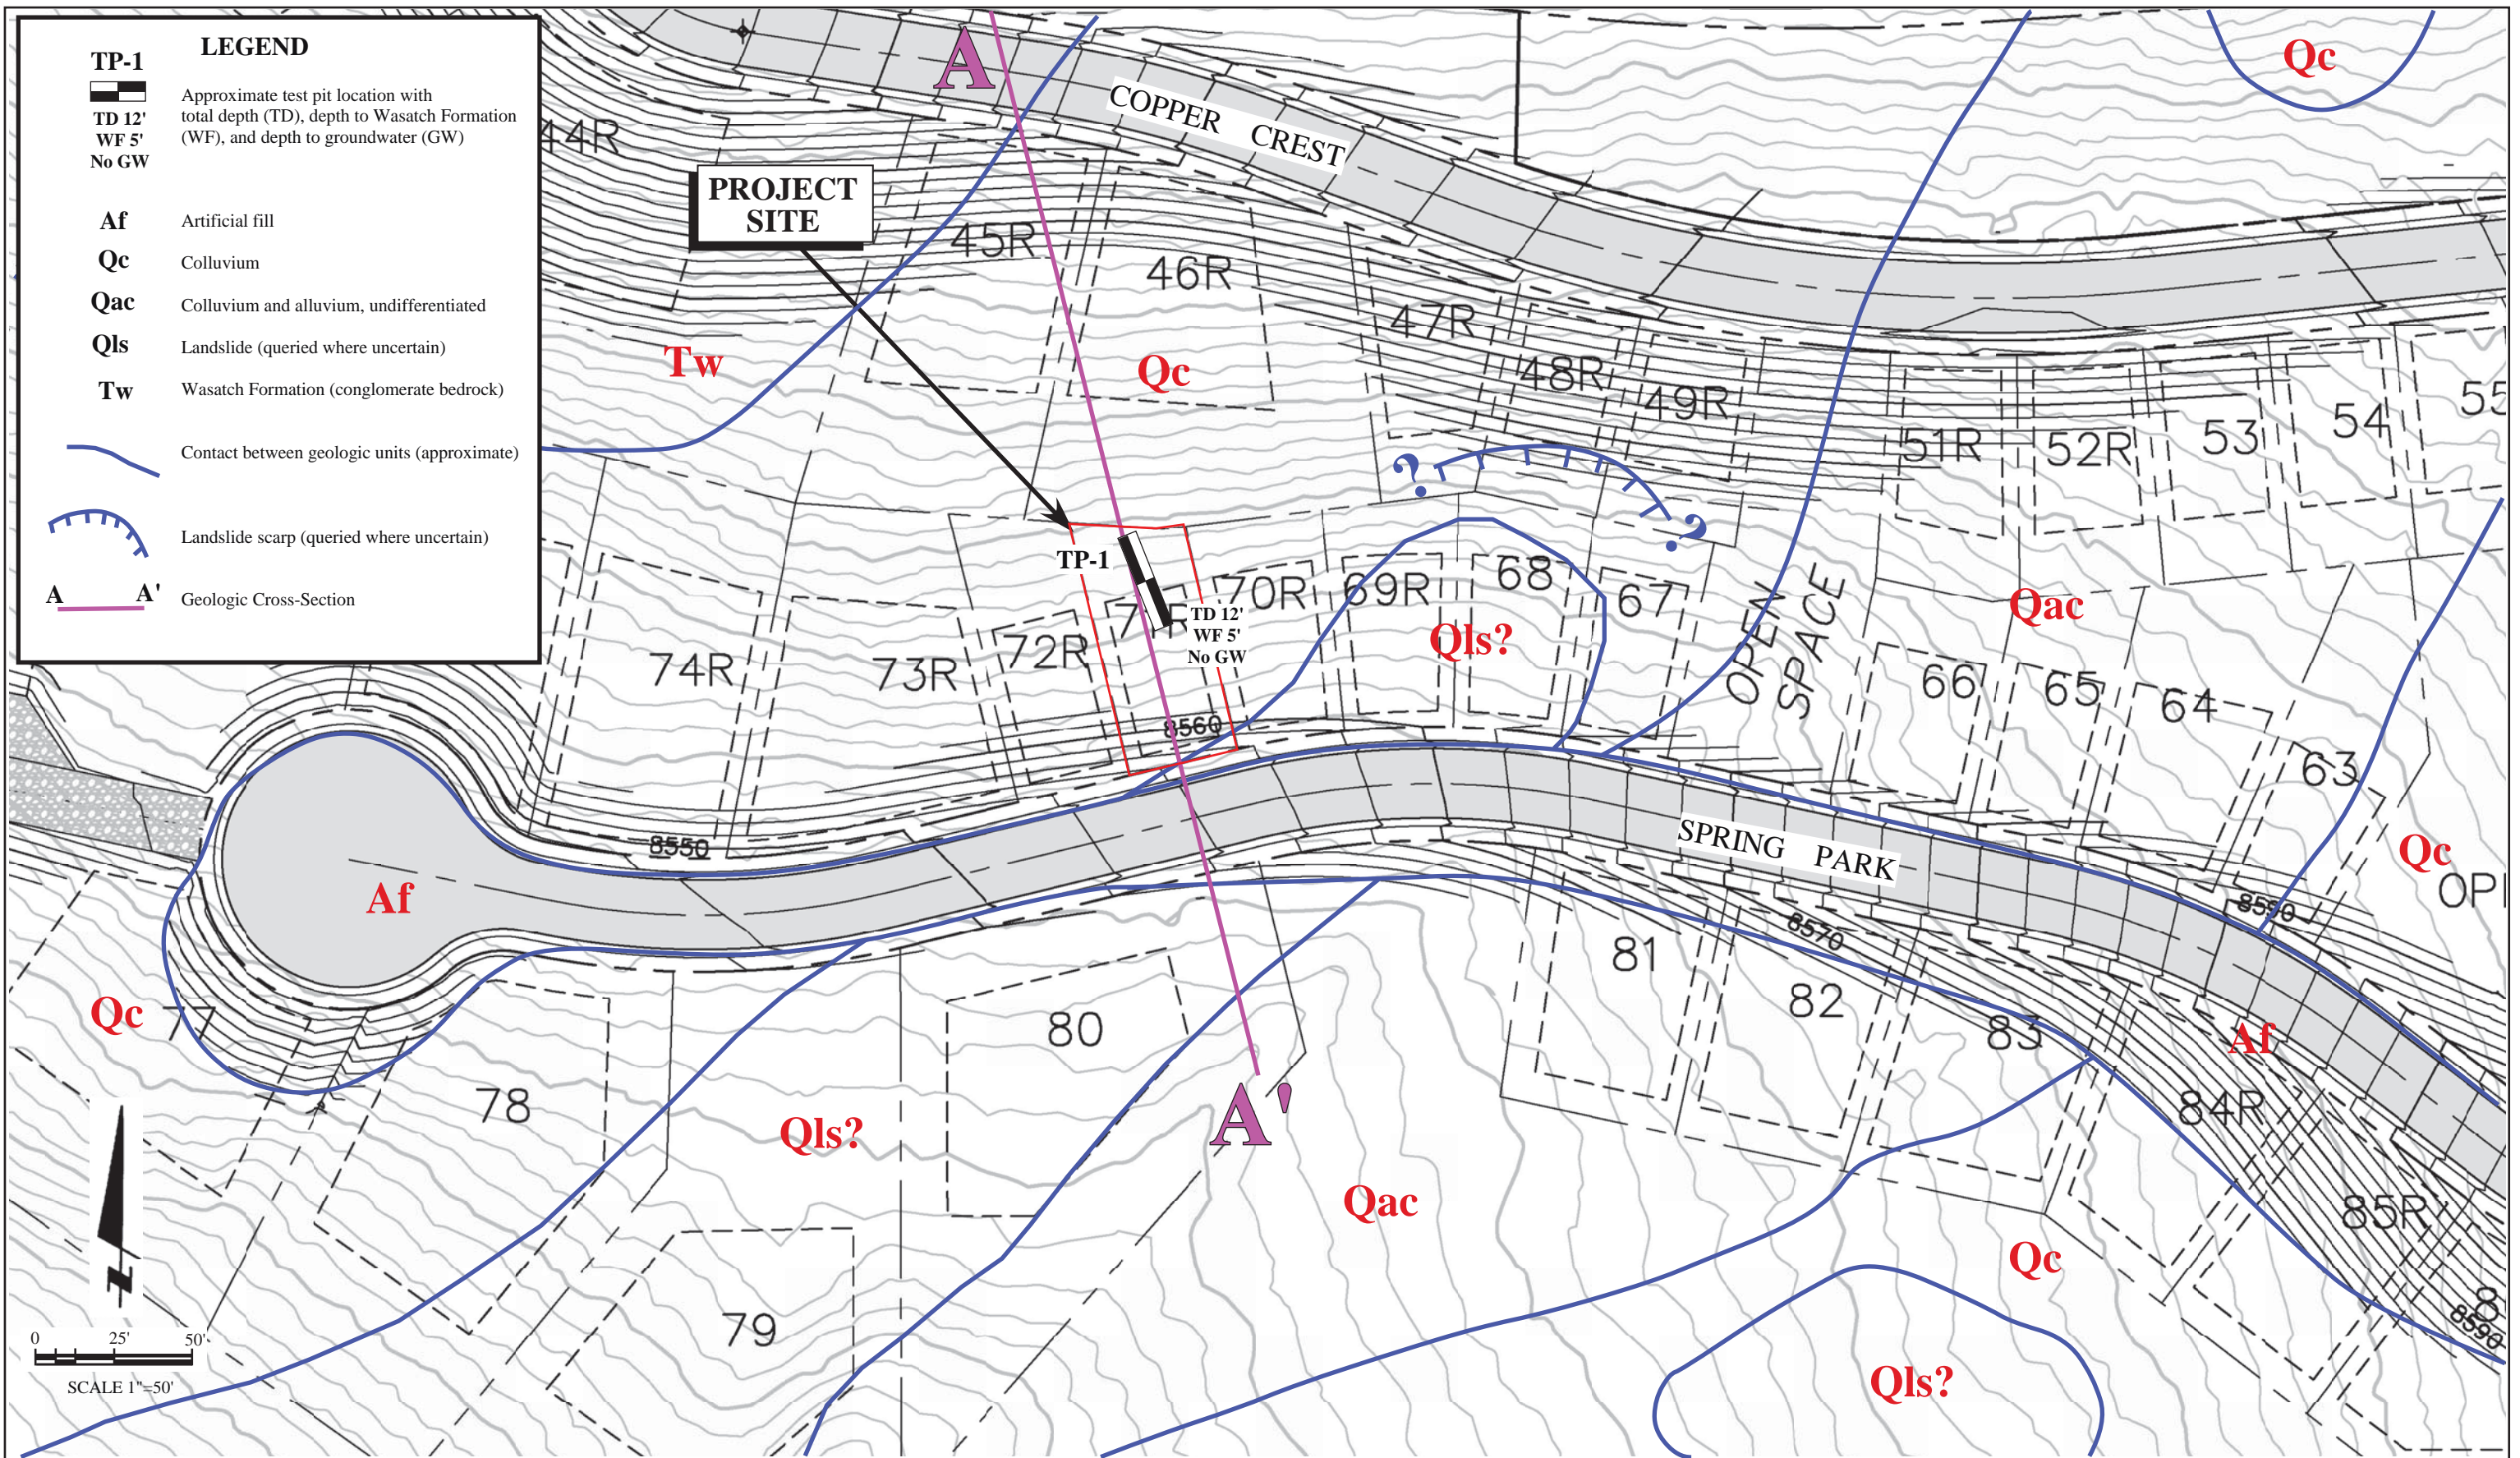
Mr. Peter E. Doumit, P.G., C.P.G., of IGES conducted reconnaissance of the site and the immediate adjacent properties on June 16, 2017. The site reconnaissance was conducted with the intent to assess the general geologic conditions present across the property, with specific interest in those areas identified in the geologic literature and aerial imagery reviews as potential geologic hazard areas. Additionally, the site reconnaissance provided the opportunity to geologically map the surficial geology of the area. Figure A-2 is a site-specific geologic map of the Lot 71R property and adjacent areas.

On June 19, 2017, a single exploration test pit was excavated in the north-central portion of the lot (see Figure A-2). The test pit was excavated to a depth of 12 feet below existing grade with the aid of a Caterpillar 315C tracked excavator. Upon completion of logging, the test pit was backfilled without compactive effort. A detailed log of the test pit is displayed in Figure A-3. Three distinct geologic units were encountered in the subsurface. The soil and moisture conditions encountered during our investigation are discussed in the following paragraphs.

Geotechnical & Geologic Hazard Investigation
 Lot 71R of Summit Eden Phase 1C
 Summit Powder Mountain Resort
 Weber County, Utah **GEOTECH & GEOLOGY MAP**

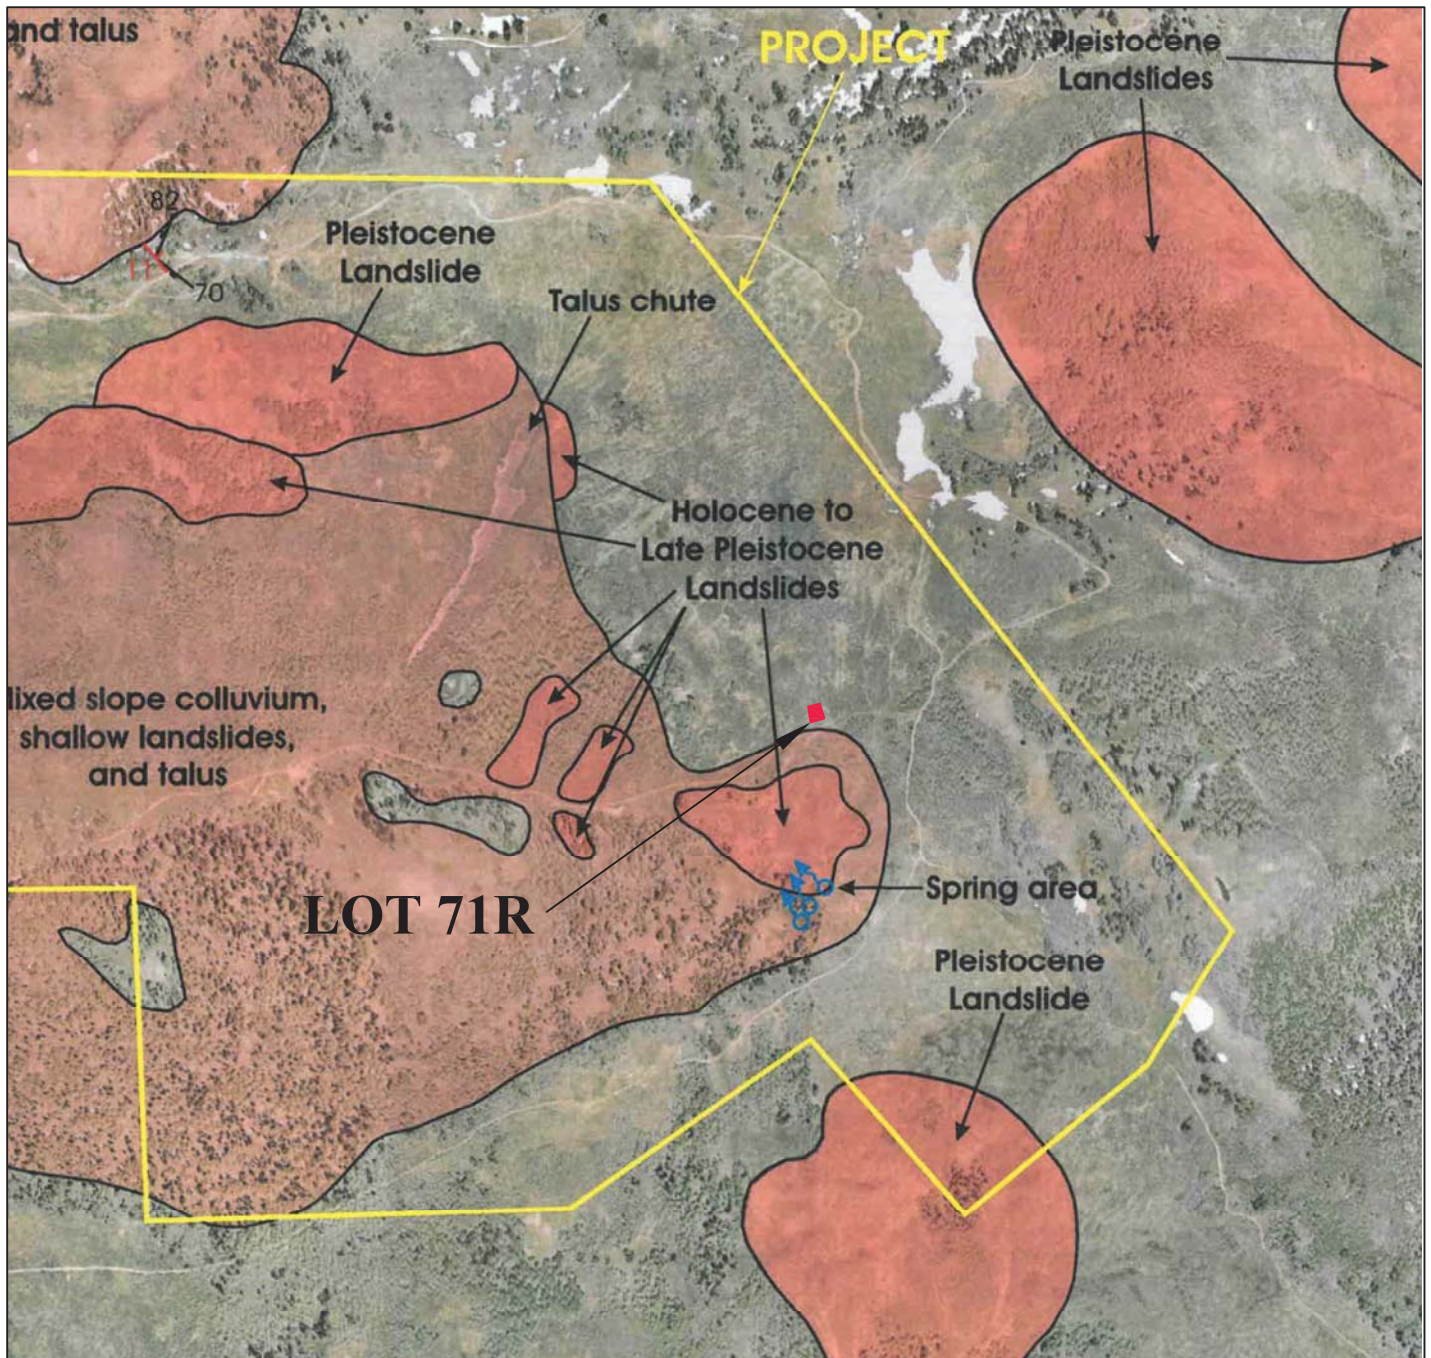
A-7

(2010) map as a base map, which reinterprets the southern half deposits to be definitive landslide deposits (see Figure A-7). As noted above, most recently Coogan and King (2016) on a regional scale show the southern margin of the property to be at the contact between the Wasatch Formation (to the north) and landslide deposits (to the south; see Figure A-8).

-Western Geologic (2012)
 Geologic Hazards
 Reconnaissance Report, Figure 3

Geotechnical & Geologic Hazard Investigation
 Lot 71R of Summit Eden Phase 1C
 Summit Powder Mountain Resort
 Weber County, Utah REGIONAL GEOLOGY MAP 2

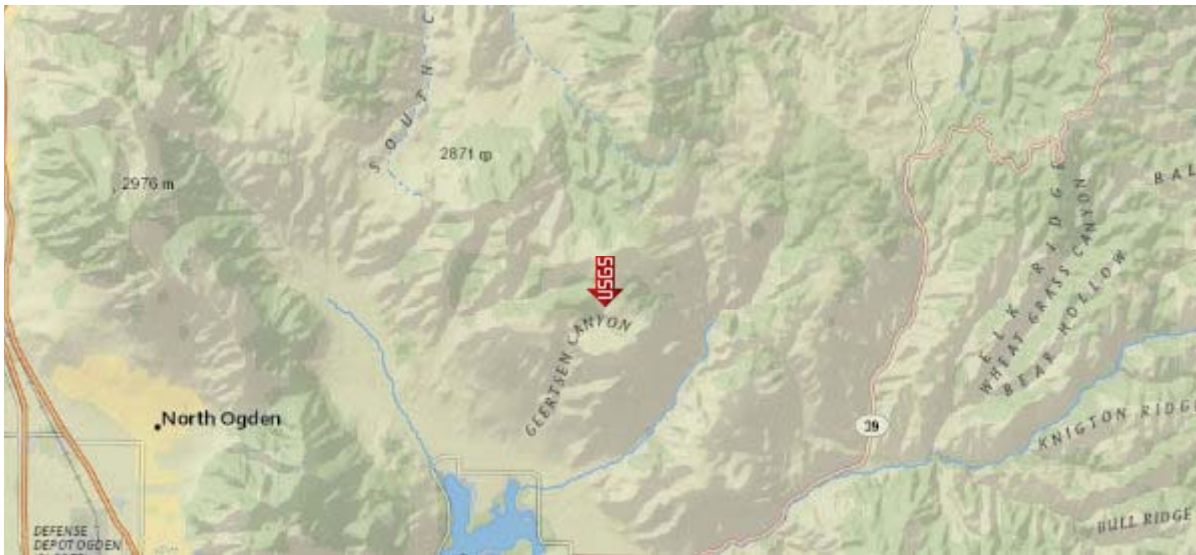
Following the criteria outlined in the 2015 International Building Code (IBC, 2015), spectral response at the site was evaluated for the *Maximum Considered Earthquake* (MCE) which equates to a probabilistic seismic event having a two percent probability of exceedance in 50 years (2PE50). Spectral accelerations were determined based on the location of the site using the *U.S. Seismic “DesignMaps” Web Application* (USGS, 2012/15); this software incorporates seismic hazard maps depicting probabilistic ground motions and spectral response data developed for the United States by the U. S. Geological Survey as part of NEHRP/NSHMP (Frankel et al., 1996). These maps have been incorporated into both *NEHRP Recommended Provisions for Seismic Regulations for New Buildings and Other Structures* (FEMA, 1997) and the *International Building Code* (IBC) (International Code Council, 2015).

$S_S = 0.811 \text{ g}$	$S_{MS} = 0.872 \text{ g}$	$S_{DS} = 0.582 \text{ g}$
$S_1 = 0.269 \text{ g}$	$S_{M1} = 0.412 \text{ g}$	$S_{D1} = 0.274 \text{ g}$

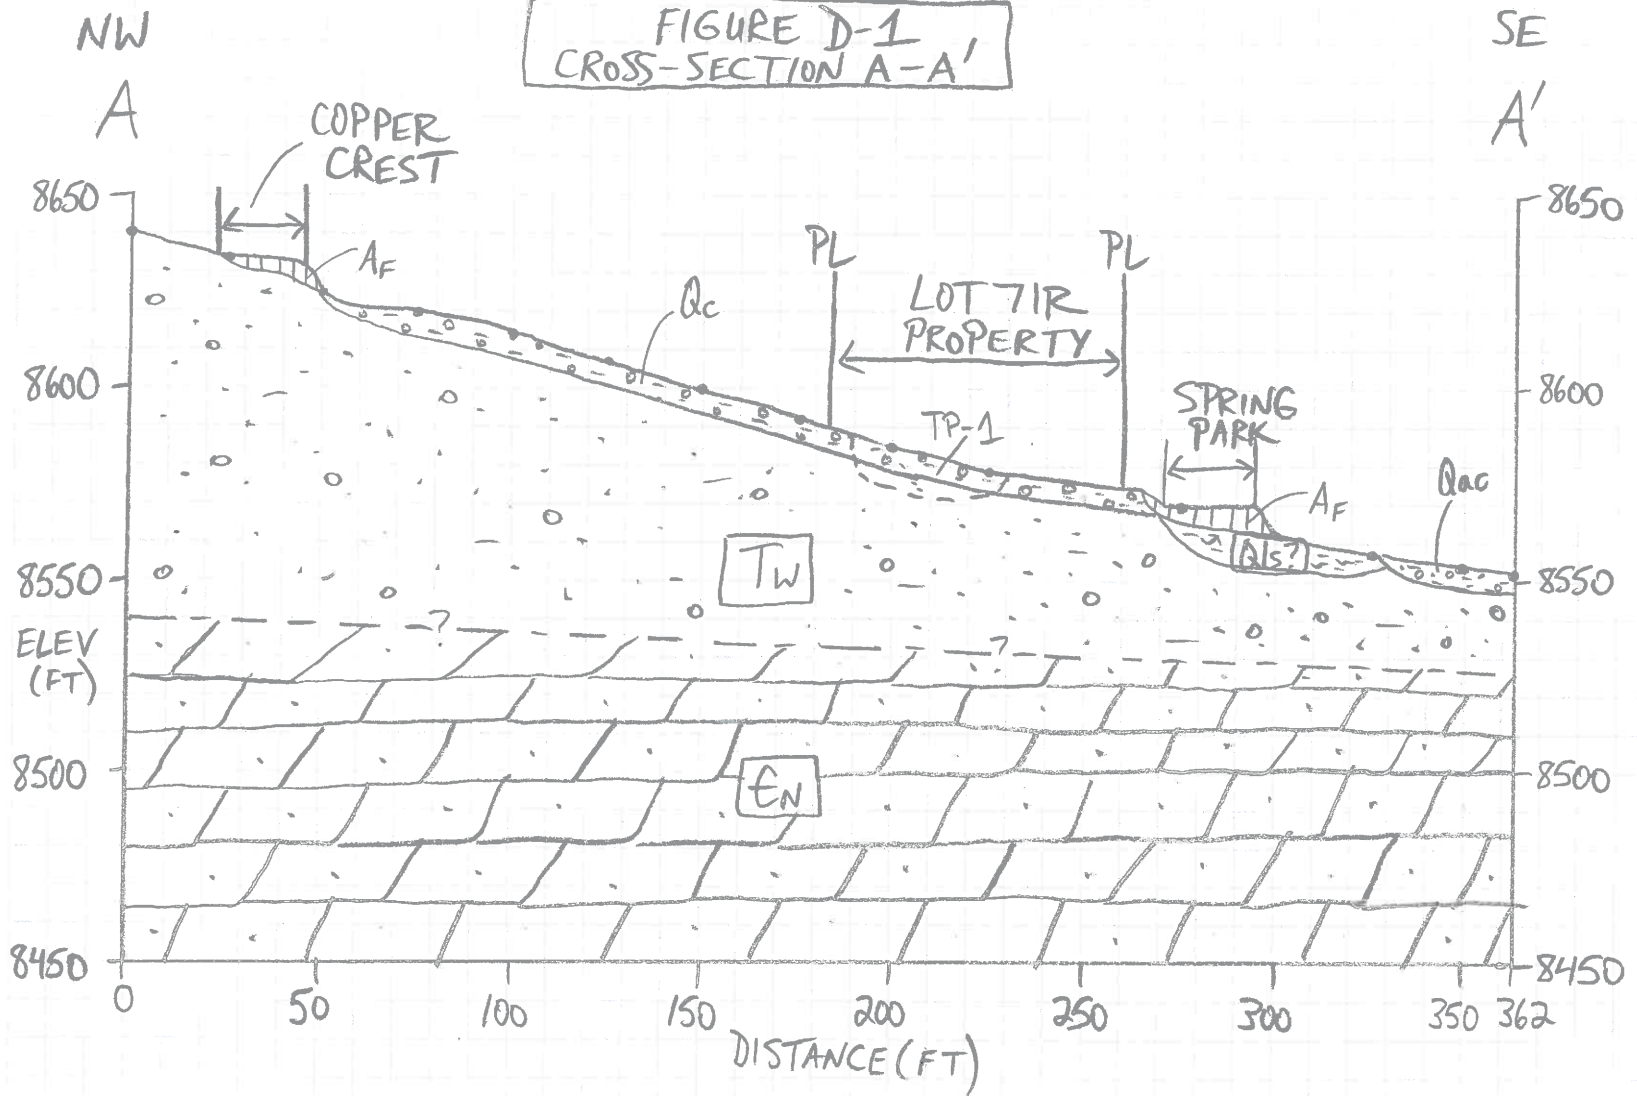
FIGURE D-1
CROSS-SECTION A-A'

The stability of the existing natural slope has been assessed in accordance with methodologies set forth in Blake et al. 2002 and AASHTO LRFD for Bridge Design Specifications with respect to a representative cross-section, illustrated on Figure D-1 in Appendix D (the section is identified in plan-view on Figure A-2). The stability of the slope was modeled using SLIDE, a computer application incorporating (among others) Spencer's Method of analysis. Calculations for stability were developed by searching for the minimum factor of safety for a translational-type failure occurring through surficial soils (colluvium and Qlos), just above the underlying conglomerate bedrock. A translational-type failure has been assumed, occurring within the surficial soils overlying bedrock. Analysis was performed for both static and seismic (pseudo-static) cases.

AF = ARTIFICIAL FILL

*NO VERTICAL EXAGGERATION

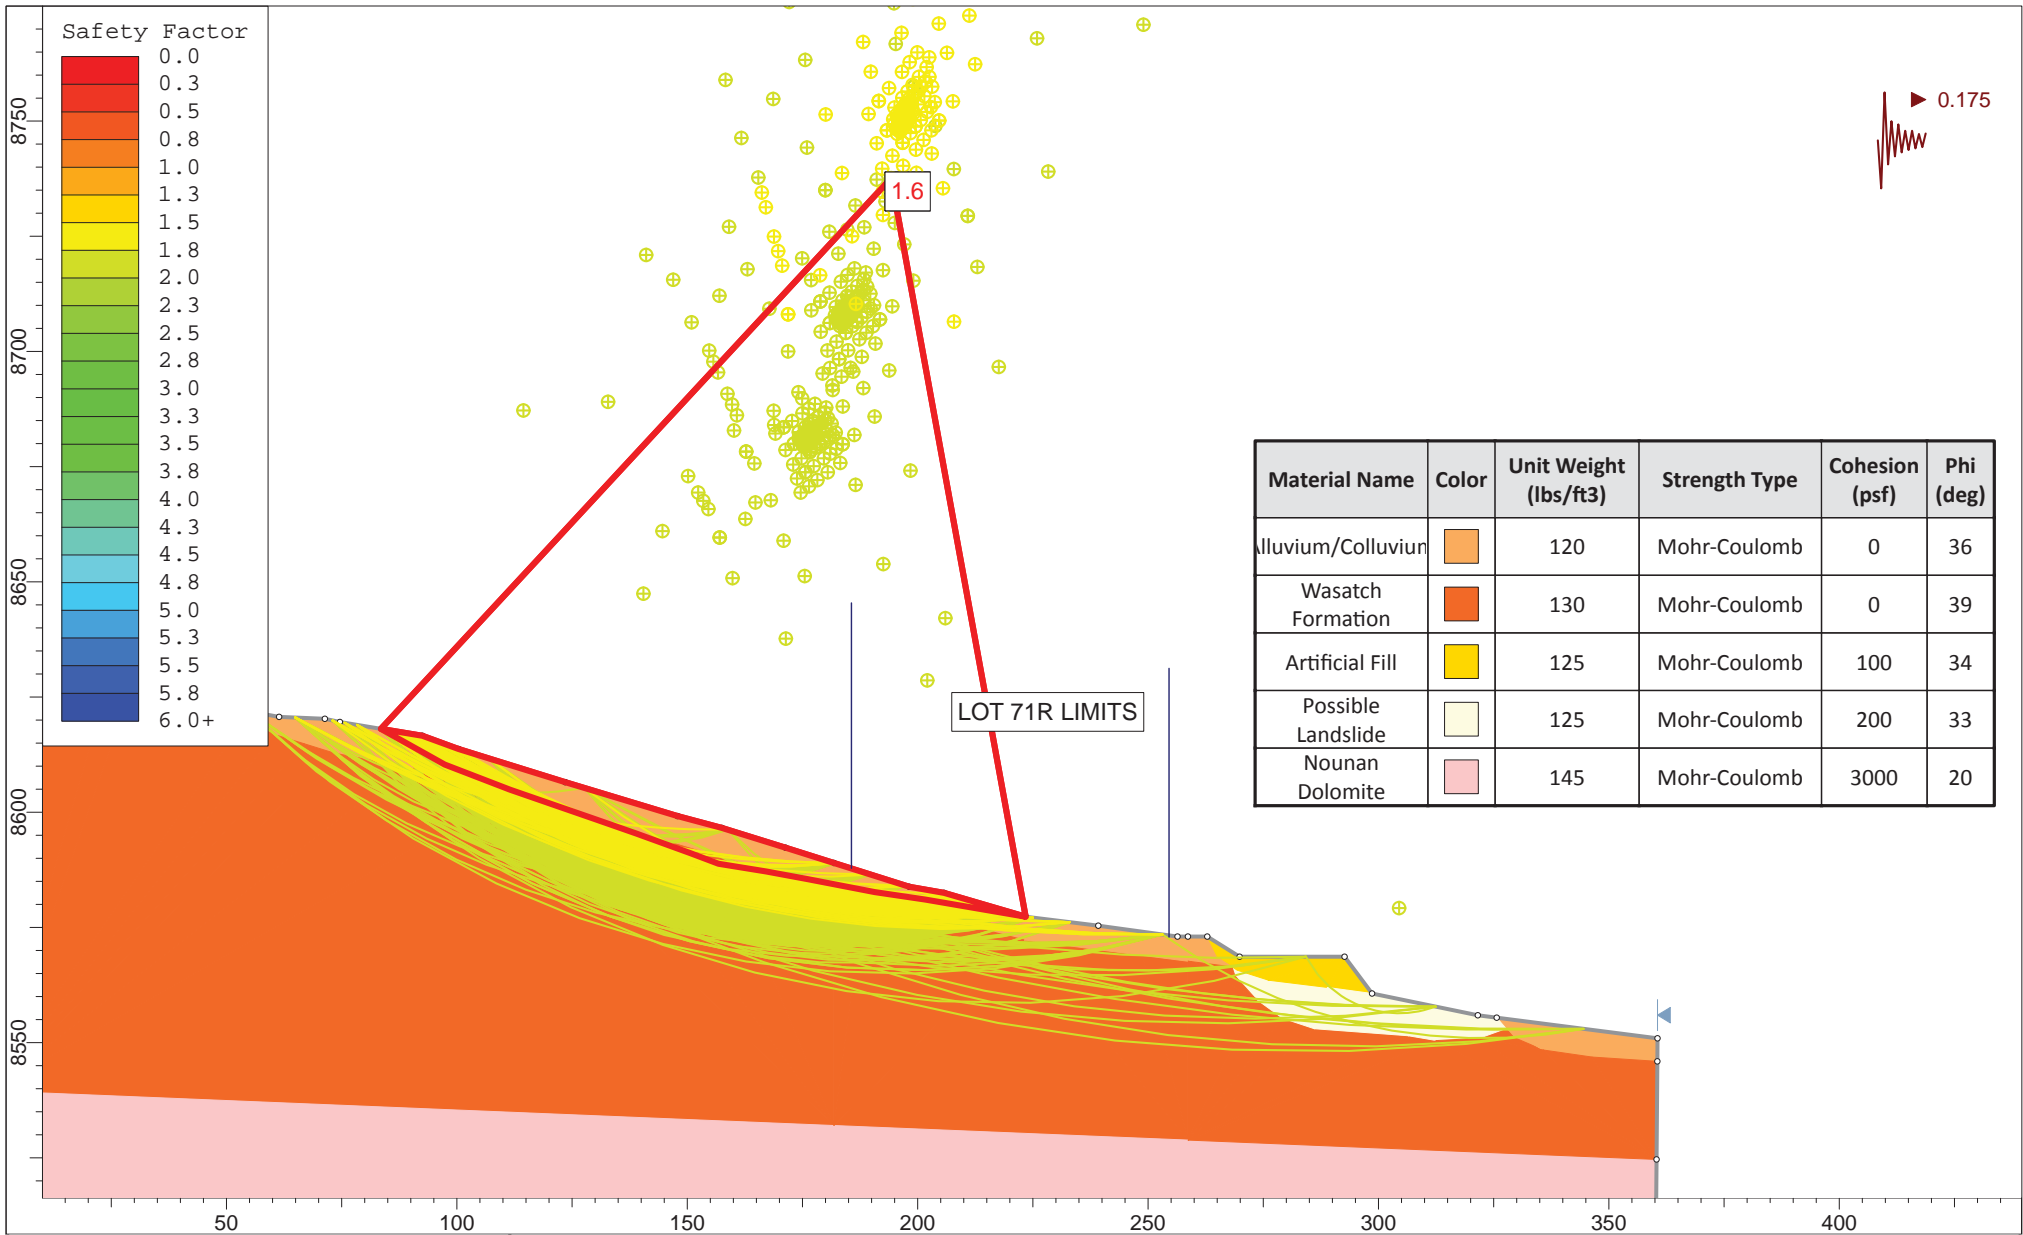
Section	Static Factor of Safety	Pseudo-Static Factor of Safety
Existing Condition	2.6	1.6

The results of the analysis indicated the existing conditions meet the minimum required factors-of-safety of 1.5 and 1.0 for both the static and seismic (pseudo-static) case, respectively. The planned improvements will include a basement level, which would tend to unload the slope and further improve the stability of the slope; significant fill placement on the slope, which would tend to load the slope and decrease stability, is not anticipated. A summary of the slope stability analysis is presented in Appendix D.

Project				Powder Mountain Lot 71R	
	Analysis Description				Seismic	
	Drawn By	TQH	Scale	1:500	Company	IGES Inc.
	Date	8/29/2017		File Name	Lot 71.slim

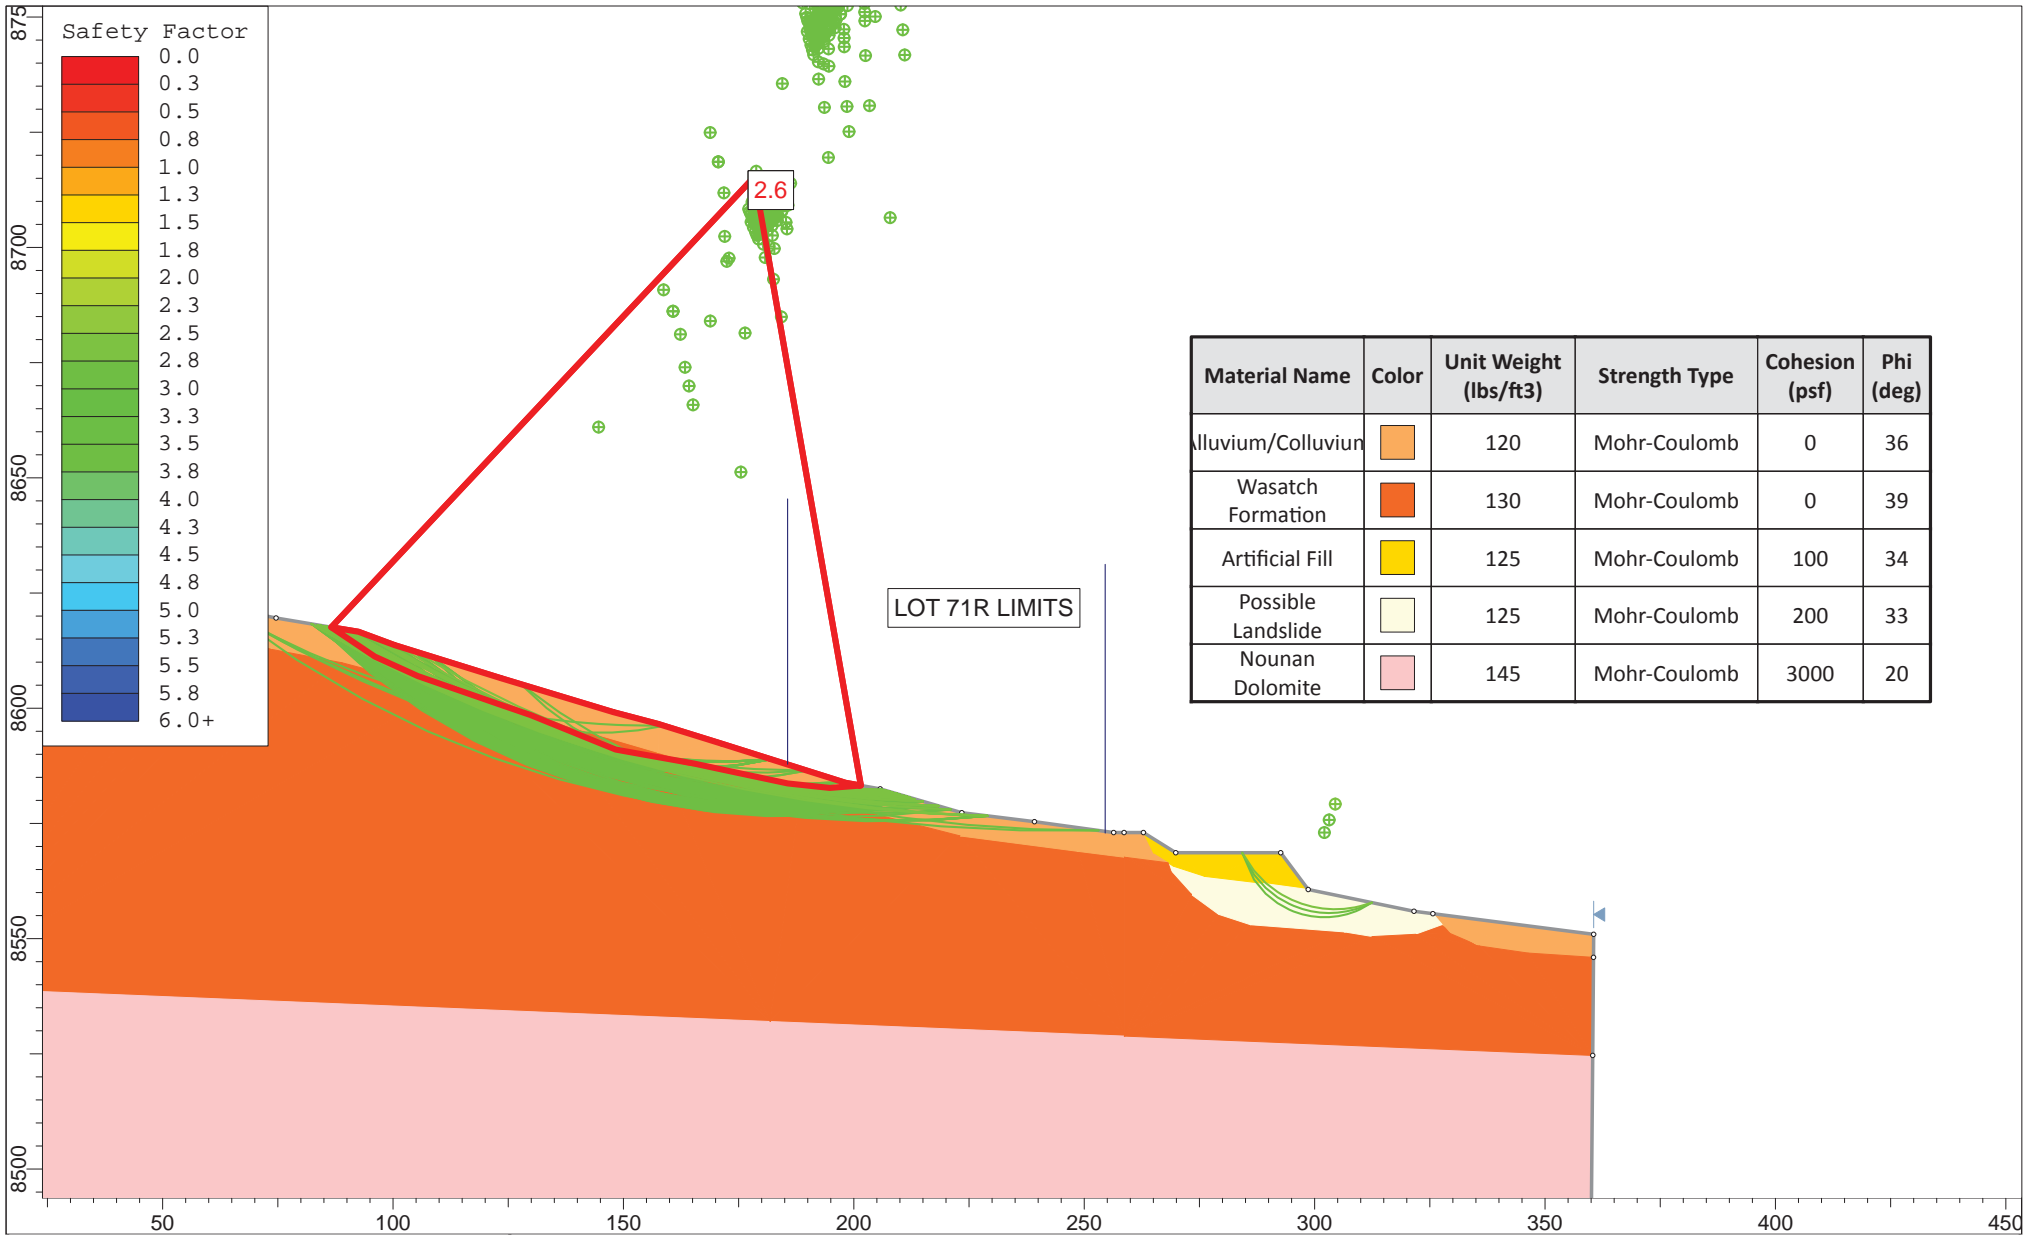
Project		Powder Mountain Lot 71R			
Analysis Description		Static			
Drawn By	TQH	Scale	1:500	Company	IGES Inc.
Date	8/29/2017	File Name	Lot 71.slim

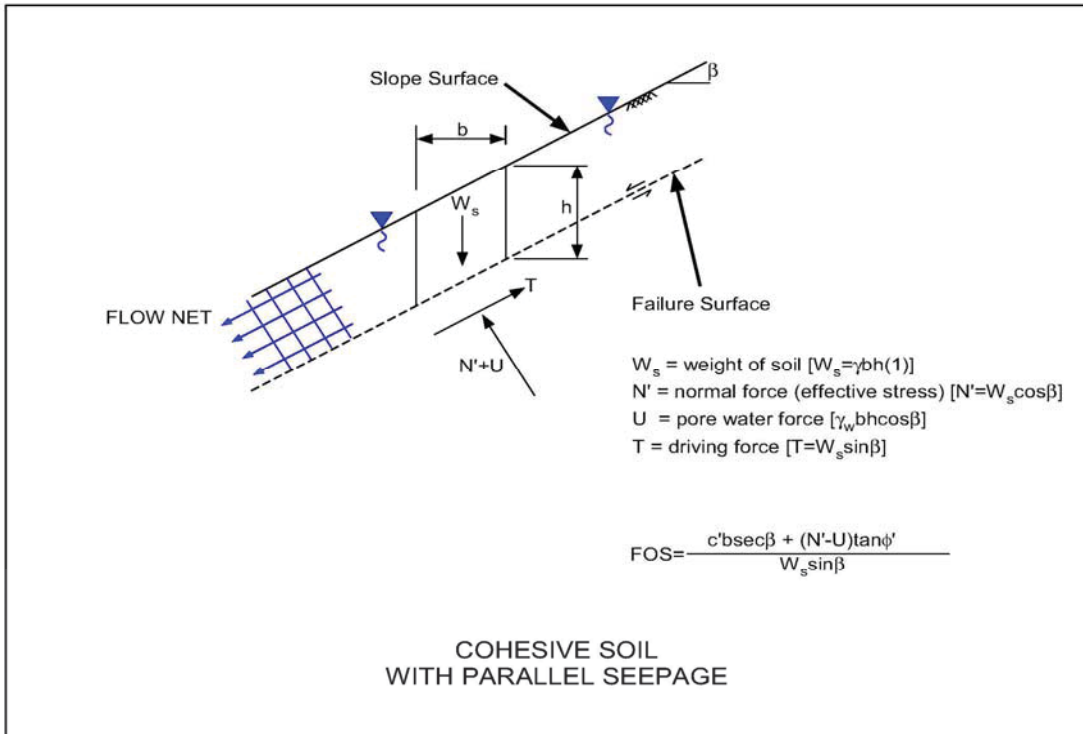
IGES assessed the potential for the upper three feet to become mobilized under saturated parallel seepage conditions. Our assessment assumes three feet of clayey colluvium or topsoil, fully saturated, and a 3.5H:1V slope (this would be a transient condition that could occur during primary spring run-off and snowmelt). Our model assumes an estimated effective friction angle of 28 degrees and a cohesion of 100 psf, and a saturated unit weight of 136 pcf. Based on this model, a factor-of-safety of 1.93 results. Sample calculations are presented in Appendix D.

This model assumes $c > 0$ and the face of the slope is saturated to depth h
