**GEOTECHNICAL AND GEOLOGIC HAZARD INVESTIGATION**  
**Lot 71R of Summit Eden Phase 1C**  
**8488 E. Spring Park Road**  
**Summit Powder Mountain Resort**  
**Weber County, Utah**

IGES Project No. 02565-001

August 30, 2017

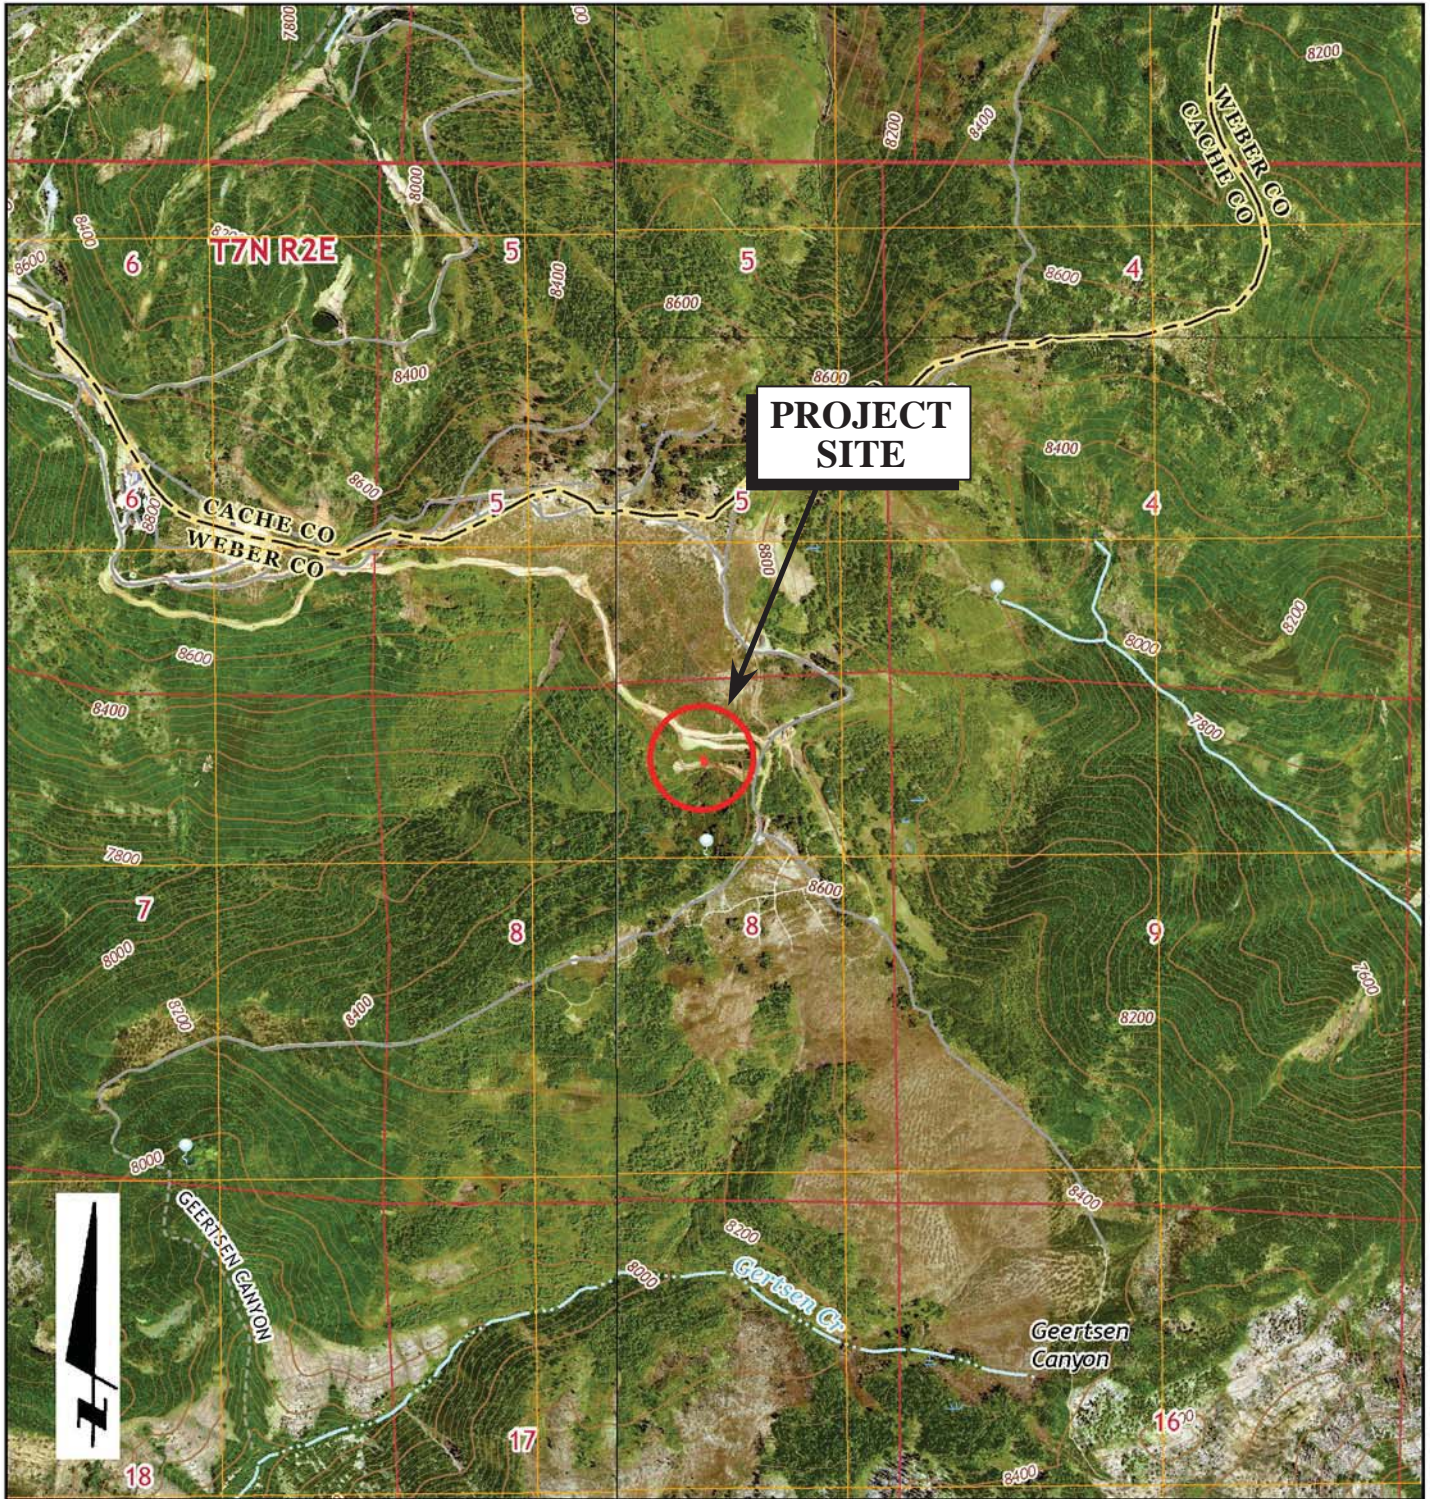
Figure  
**A-1**

SITE VICINITY MAP

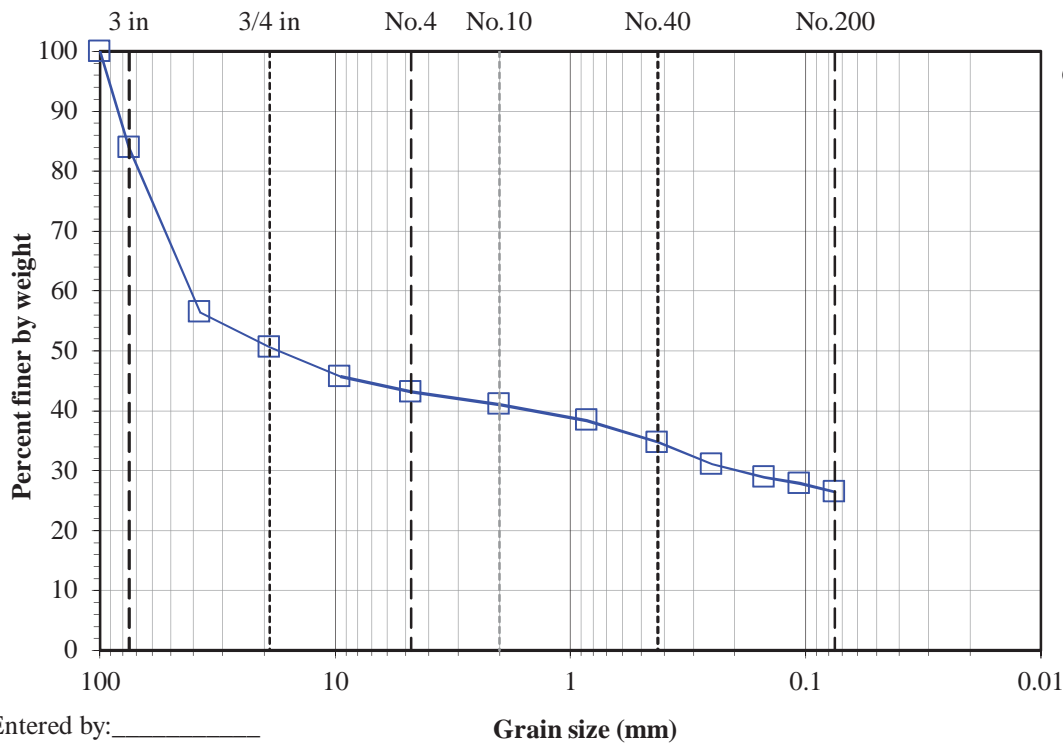
Sieve	Accum. Wt. Ret. (g)	Grain Size (mm)	Percent Finer
8"	-	200	-
6"	-	150	-
4"	-	100	100.0
3"	684.05	75	84.0
1.5"	1859.65	37.5	56.4
3/4"	2108.29	19	50.6
3/8"	2317.93	9.5	45.7
No.4	24.34	4.75	43.2
No.10	44.74	2	41.1
No.20	70.65	0.85	38.4
No.40	106.36	0.425	34.7
No.60	141.28	0.25	31.1
No.100	162.40	0.15	28.9
No.140	172.21	0.106	27.9
No.200	186.43	0.075	26.4

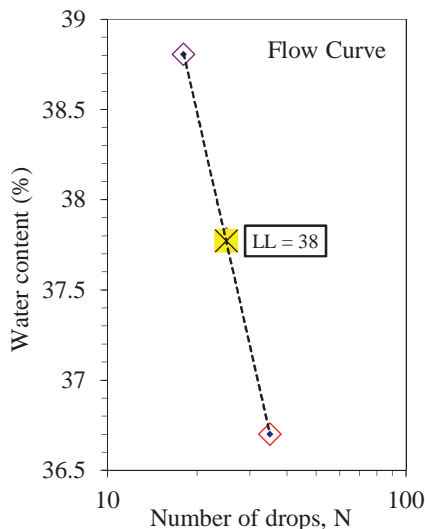
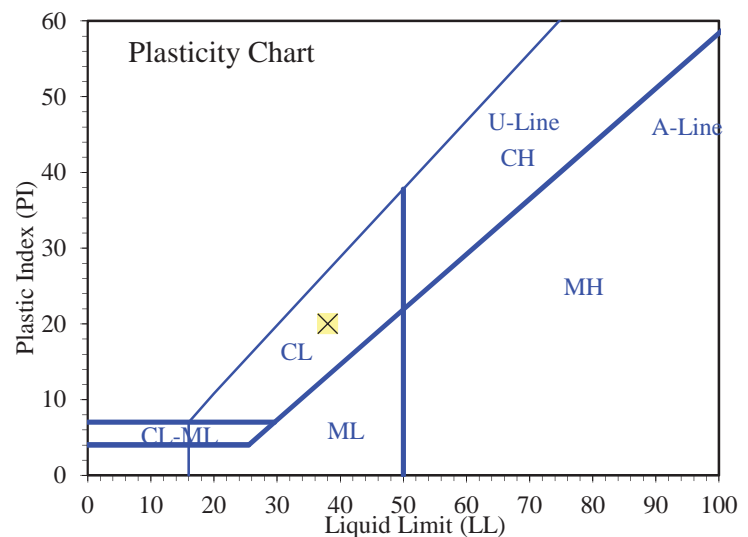
Determination No	1	2	3			
Number of Drops, N	35	25	18			
Wet Soil + Tare (g)	28.47	29.21	29.55			
Dry Soil + Tare (g)	26.58	27.20	27.47			
Water Loss (g)	1.89	2.01	2.08			
Tare (g)	21.43	21.88	22.11			
Dry Soil (g)	5.15	5.32	5.36			
Water Content, w (%)	36.70	37.78	38.81			
One-Point LL (%)		38

<b>Liquid Limit, LL (%)</b>	<b>38</b>
<b>Plastic Limit, PL (%)</b>	<b>18</b>
<b>Plasticity Index, PI (%)</b>	<b>20</b>
