## GEOLOGIC HAZARDS RECONNAISSANCE

GREEN HILLS COUNTRY ESTATES LOT 100R

1330 NORTH MAPLE DRIVE

HUNTSVILLE, WEBER COUNTY, UTAH

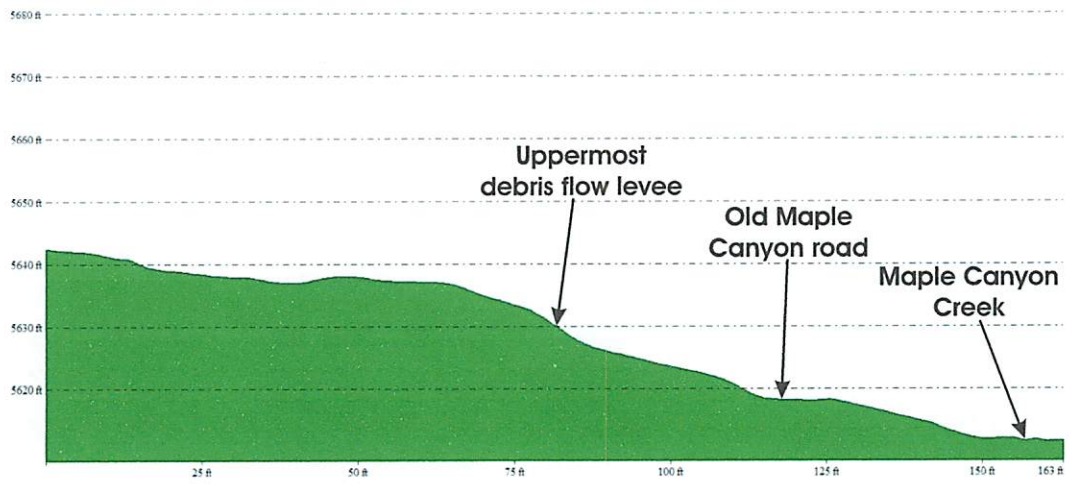
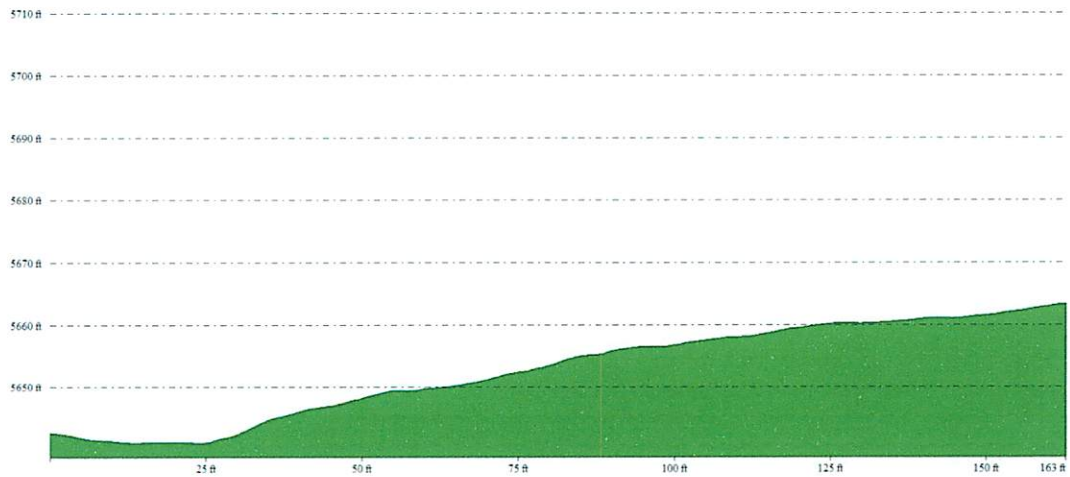
# WEST-EAST TOPOGRAPHIC PROFILE

in the Empirical Observations section above) is roughly 18 feet above the creek (Figure 3D). Given the above, the risk to the proposed building envelope appears to be low. The risk would increase if the home (or a subgrade entryway) is placed at or below 18 feet above the creek elevation. The unnamed drainage that flows toward the northwest site corner has a drainage basin that is small (less than 40 acres) and appears incapable of generating significant flows, and no evidence for debris flows from this drainage basin was observed during our reconnaissance or on air photos. However, we note that a high-intensity (cloudburst) rainstorm in this drainage basin could produce flooding that overwhelms the stormwater infrastructure. Recommendations to reduce this risk would be within the scope of the civil engineering design and grading plan for the Project, as discussed in the Stream Flooding section above. Typical stream setbacks under Weber County development guidelines will also reduce the risk from debris flows.

Profiles based on 2011 LIDAR data.

- ***Seismic Design*** – All habitable structures developed at the property should be constructed to current seismic hazards to reduce the risk of damage, injury, or loss of life from earthquake ground shaking.
- ***Site Grading and Drainage*** – No unplanned cuts should be made in the slopes at the site without prior geotechnical analyses, and proper site drainage should be maintained.
- ***Stream Flooding, Shallow Groundwater, and Debris Flows*** – The civil engineering design for the development should assess site hydrology and surface drainage, in accordance with all applicable local government guidelines. The preferred building envelope on higher slopes in the northwest part of the Project appears to have a low relative risk from all three hazards, but this risk will increase if the home is located closer to Maple Canyon Creek at a lower elevation relative to the creek.

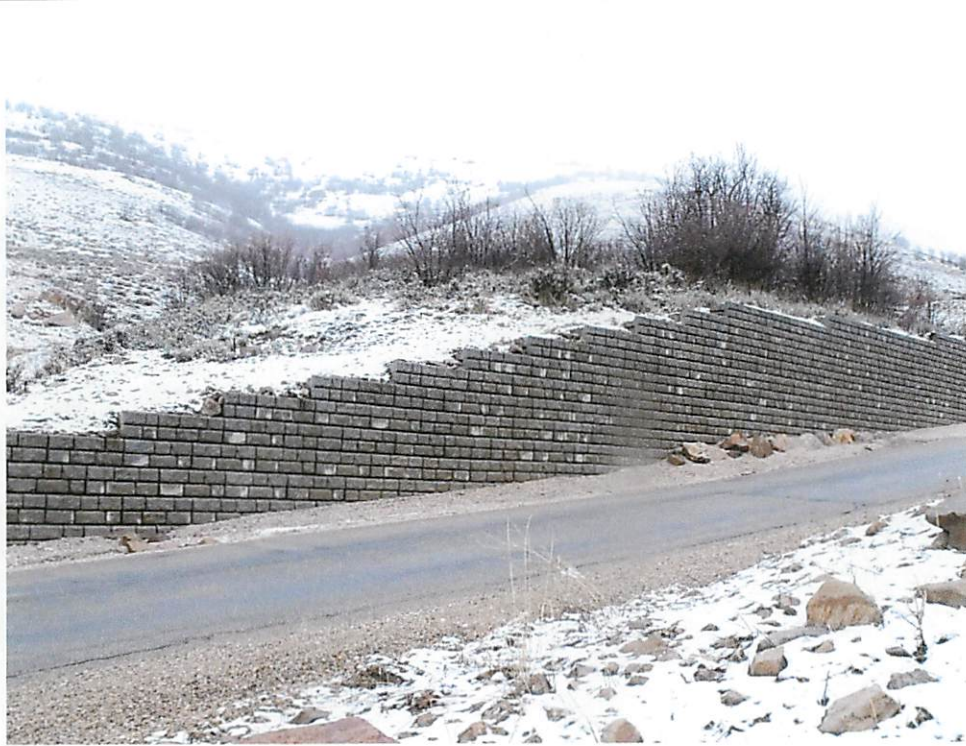
Photo 1. Retaining wall on Maple Drive

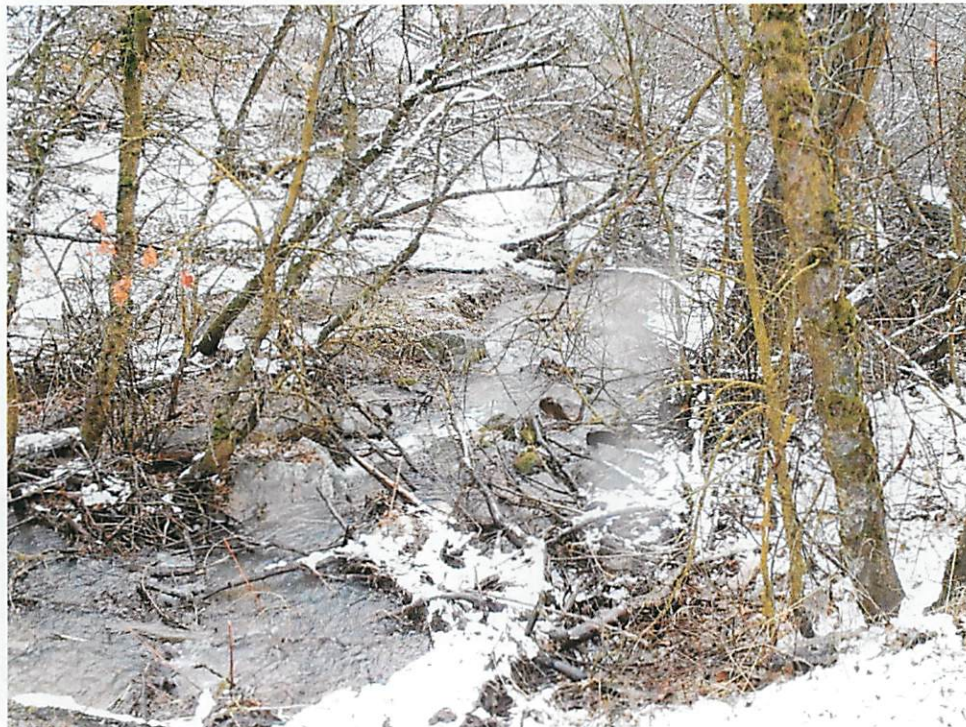
Photo 2. Maple Canyon Creek

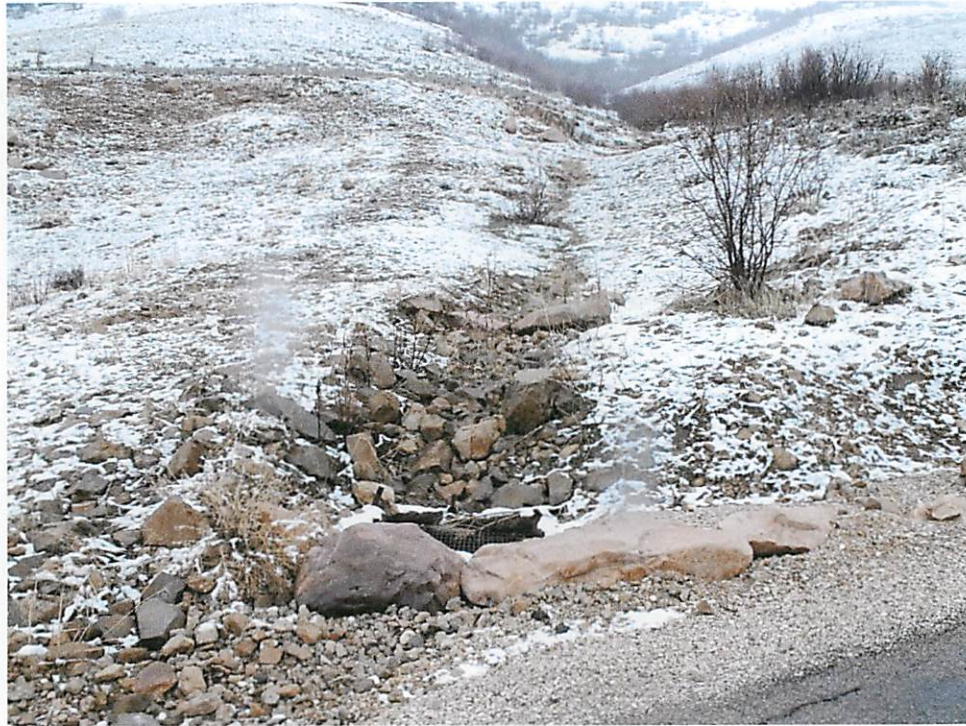
Photo 3. Unnamed drainage north of Project.

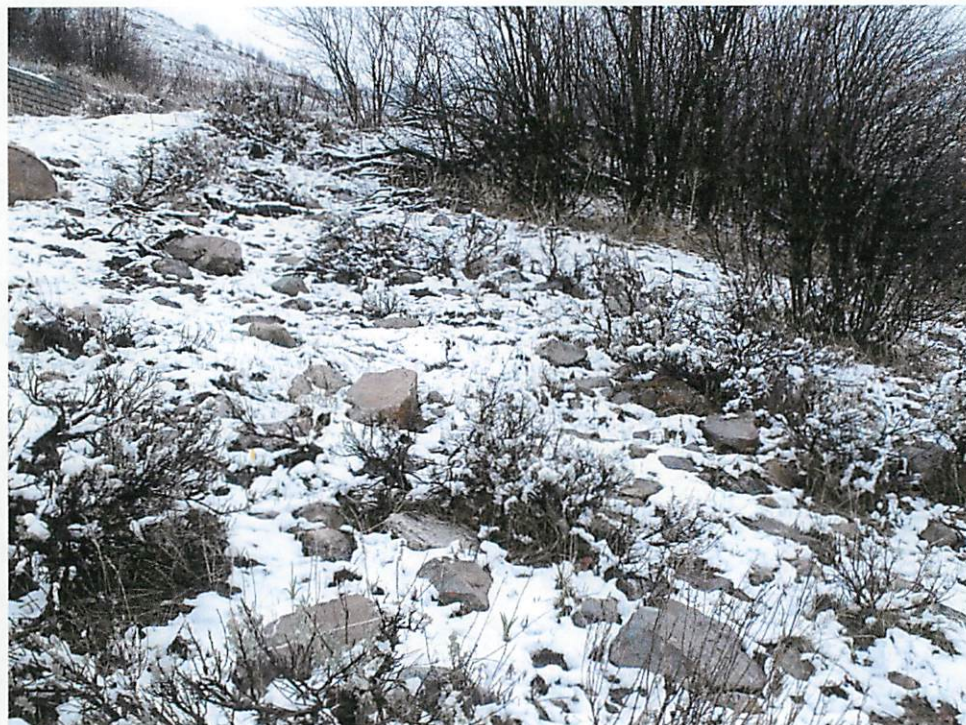
Photo 4. Typical surficial soils

Surficial soils that contain certain clays can swell or collapse when wet. A geotechnical engineering evaluation should be performed to address soil conditions and provide specific recommendations for site grading, subgrade preparation, and footing and foundation design.

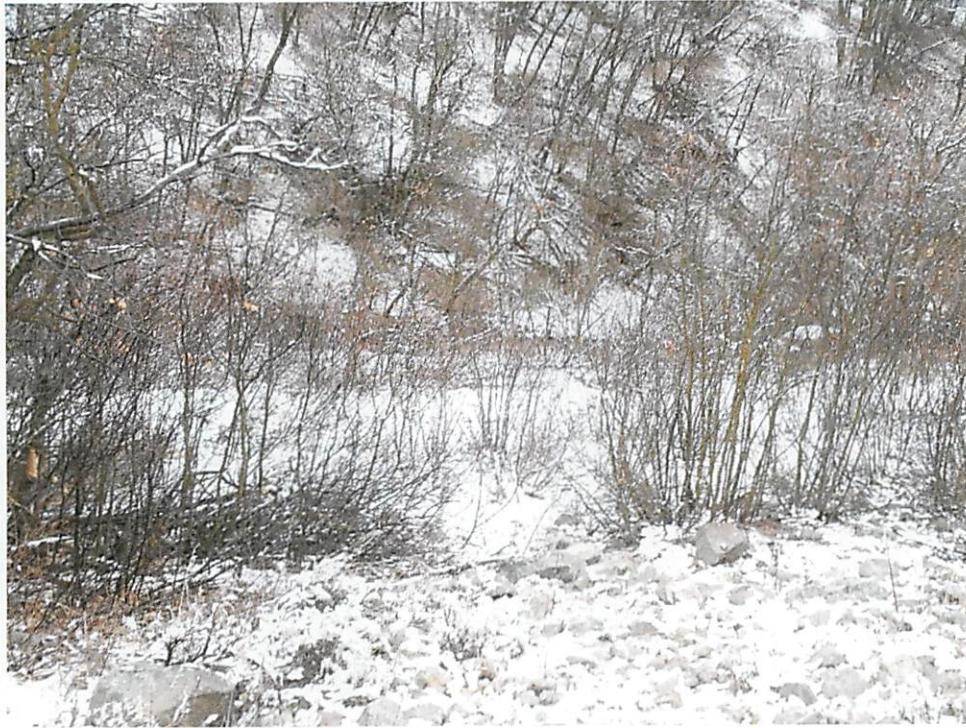
Photo 5. Sequences of boulder levees overlooking creek

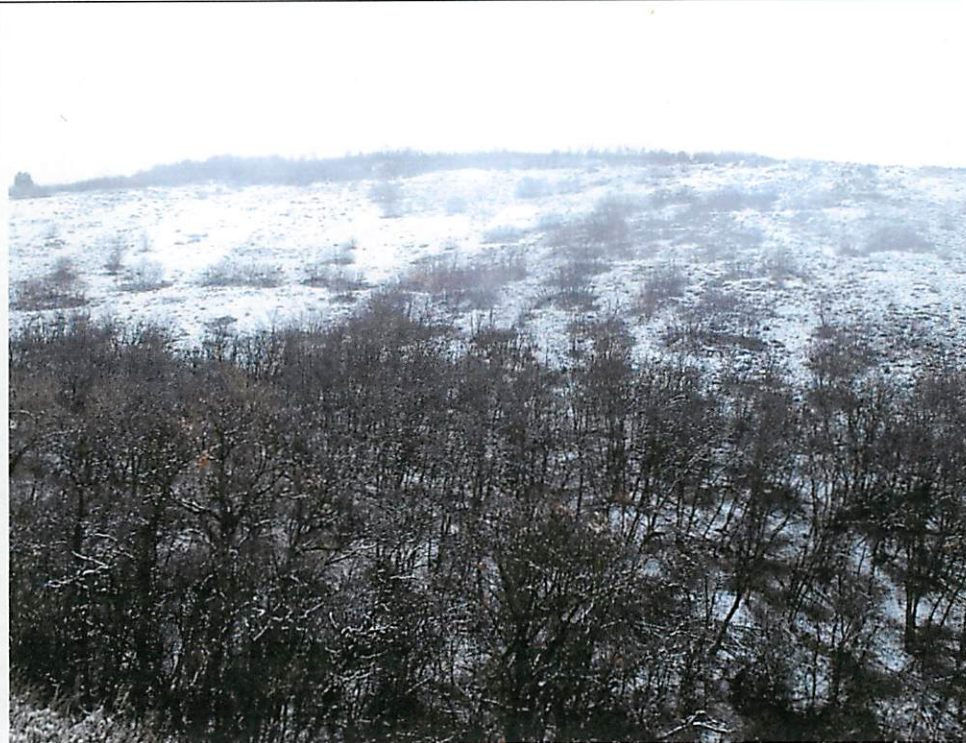
Slopes bounding Maple Canyon Creek on the northwest show a roughly 4:1 to 5:1 (horizontal:vertical) gradient toward the creek and to the southwest. Slopes southeast of the creek show an overall 1.5 to 2:1 gradient and dip toward the creek. The creek has an overall roughly 7:1 to 8:1 southwest gradient as it flows across the property. A concrete retaining wall was observed along the north side of the eastward continuation of Maple Drive north of the Project. The retaining wall showed no evidence for distress, and no evidence for prior or ongoing slope instability or landslides was observed at the site or on adjacent slopes. Several debris levees that we infer are from Holocene debris flows in Maple Canyon were observed along the north side of the creek below Maple Drive. The levees are marked by steps in the slope mantled by boulders on the upslope side. The old road up Maple Canyon is slightly above the creek on the north; the road (jeep trail) was abandoned when Maple Drive was installed. No other evidence for springs, seeps, bedrock outcrops, active faults, or other geologic hazards was observed.

Photo 6. North facing slopes overlooking Maple Canyon Creek
