**Geotechnical Investigation
WAJ Enterprises Property
Weber County, Utah**

**Geotechnical Investigation
WAJ Enterprises Property
Approximately 2050 North Big Sky Drive
Weber County, Utah
CG Project No.: 162-001**

October 12, 2018

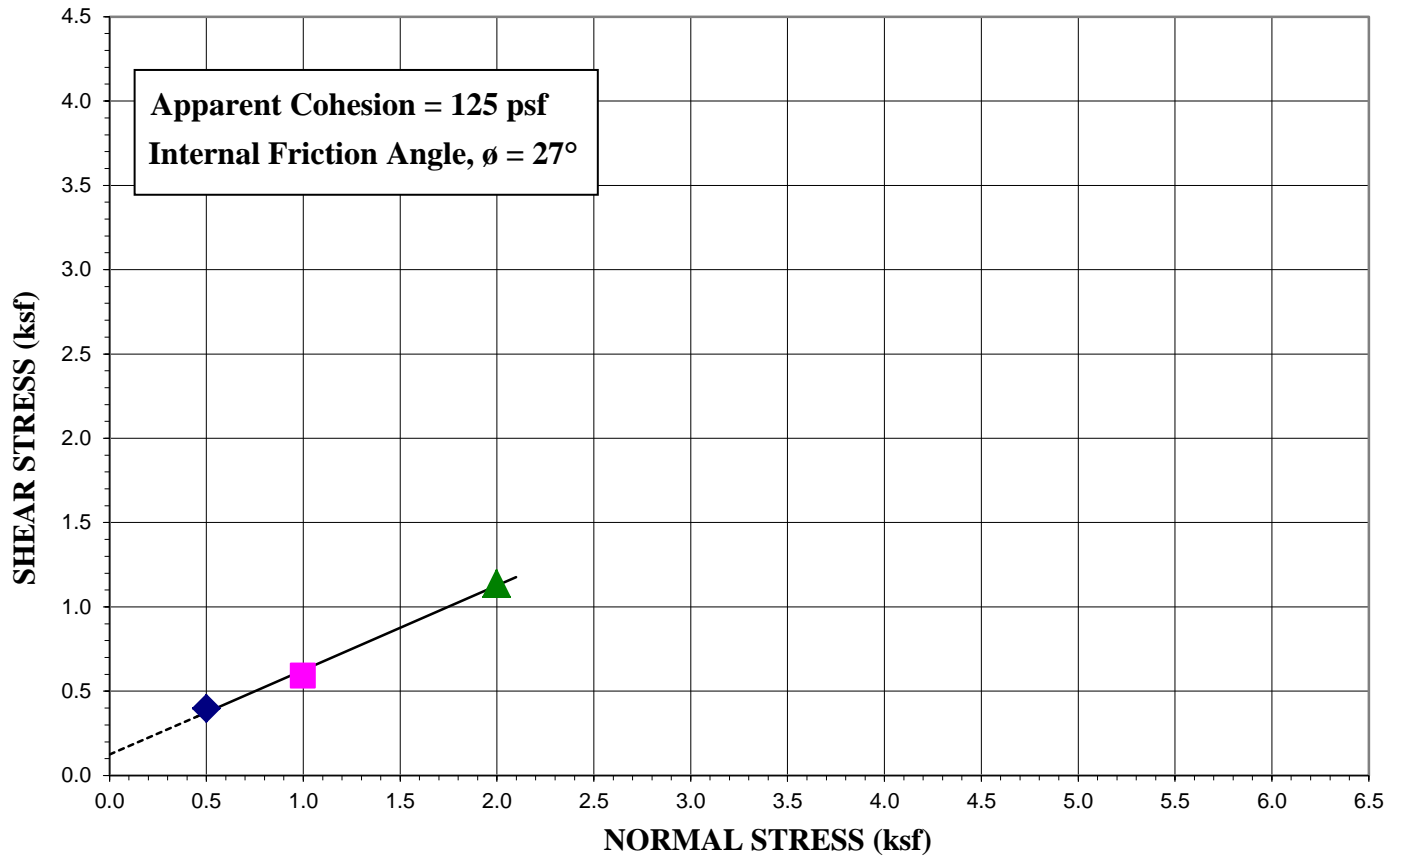
Plate
26

DIRECT SHEAR TEST

Location:	TP-5	Depth:	4.0 ft
Type of Test:	Consolidated Drained/Saturated		
Test No. (Symbol)	1 (◆)	2 (■)	3 (▲)
Sample Type:	Fully Softened Remolded		
Initial Height, in.	1	1	1
Diameter, in.	2.4	2.4	2.4
Dry Density Before, pcf	82.1	84.6	82.7
Moisture % Before	37.3	37.3	37.3
Normal Load, ksf	0.5	1.0	2.0
Shear Stress, ksf	0.40	0.59	1.14
Strain Rate	0.005 in/min

Sample Properties	
Cohesion, psf	125
Friction Angle, ϕ	27
Liquid Limit, %	49
Plasticity Index, %	30
Percent Gravel	---
Percent Sand	---
Percent Passing No. 200 sieve	97.1
Classification	Lean CLAY (CL)
