Geotechnical Investigation **Lot 3R Powder 11 at Powder Mountain**

**6599 North Powder Mountain Road
Eden, UT 84310**

July 1, 2020

GeoStrata Job No. 1174-006

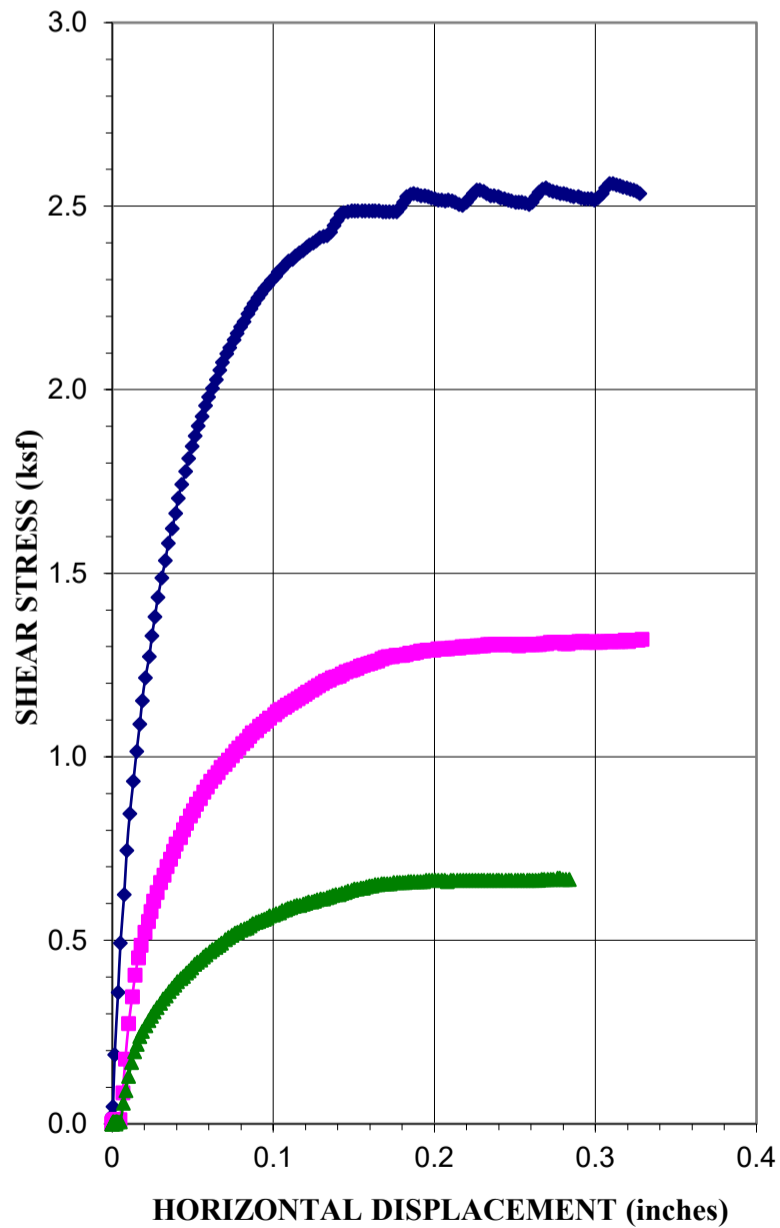
DIRECT SHEAR TEST

Source:	TP-1 at 12.5 feet
Type of Test:	Consolidated Drained/Saturated

Test No. (Symbol)	1 (◆)	2 (■)	3 (▲)
Sample Type	Remolded		
Initial Height, in.	0.844	0.895	0.887
Diameter, in.	2.5	2.5	2.5
Dry Density Before, pcf	109.7	104.3	105.4
Dry Density After, pcf	112.1	106.5	107.6
Moisture % Before	9.5	10.9	11.4
Moisture % After	18.6	20.2	20.4
Saturation, % Before	49.5	49.4	52.9
Saturation, % After	103.8	96.8	100.6
Normal Load, ksf	4.0	2.0	1.0
Shear Stress, ksf	2.53	1.29	0.65
Strain Rate	0.003333 IN/MIN

Direct shear tests were completed on remolded samples of the weathered bedrock soils observed within in the test pits. Due to the granular nature of the soil sampled, it was not feasible to obtain a relatively “undisturbed” sample of this deposit. The size of the aggregate exceeds the limits of our direct shear equipment, so the sample was screened, and the larger aggregate were removed
