## **GEOLOGIC HAZARDS EVALUATION PROPOSED CRIMSON RIDGE PHASE 2 SUBDIVISION ABOUT 1100 NORTH MORNINGSIDE LANE EDEN, UTAH**

**Letter of Transmittal:** REPORT  
Geologic Hazards Evaluation  
Proposed Crimson Ridge Phase 2 Subdivision  
About 1100 North Morningside Lane  
Eden, Utah

**WG&E Project No. 5378**

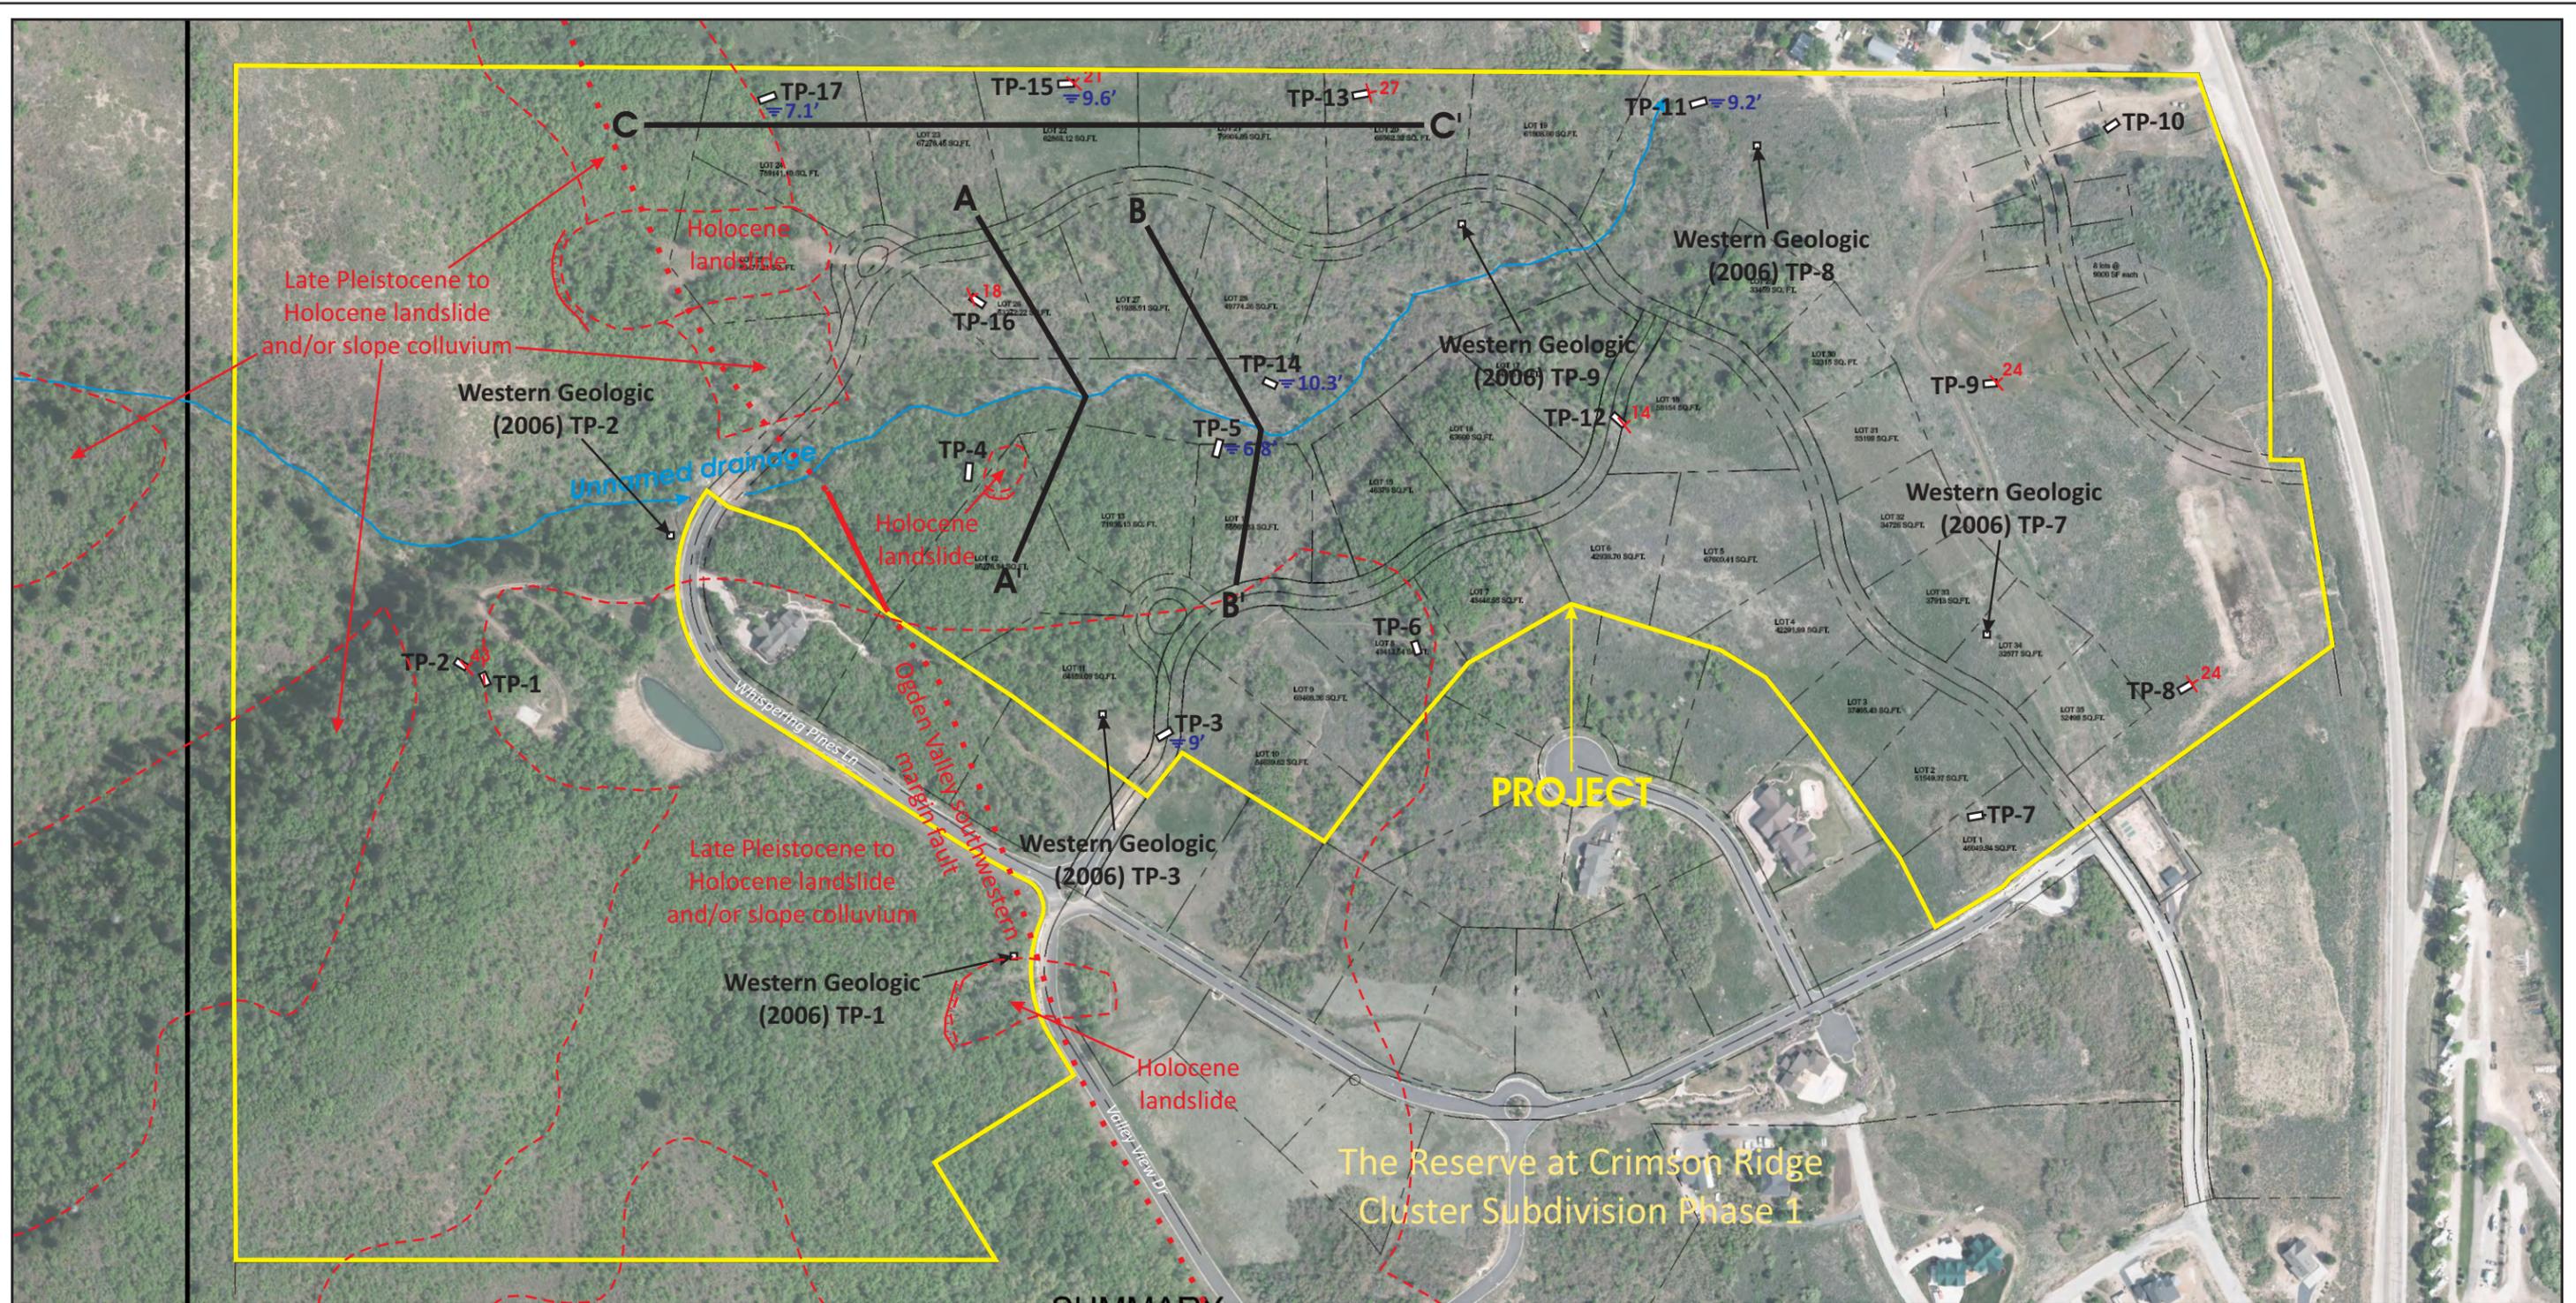
Source: Gardner Engineering Concept Map dated 9/20/19 and 2012 high-resolution orthophoto available from Utah AGRC.

<b>2012 AIR PHOTO</b>
<b>GEOLOGIC HAZARDS EVALUATION</b> Proposed Crimson Ridge Phase 2 Subdivision About 1100 North Morningside Lane Eden, Utah
<b>FIGURE 3A</b>

Fifteen onsite walk-in test pits and two offsite test pits (near the proposed water tank location further west) were also excavated at the Project on April 15-17 to assess subsurface conditions. The test pits were logged by Bill D. Black, P.G. of Western Geologic concurrently with the Project geotechnical investigation conducted by Christensen Geotechnical. Locations of the test pits are shown on Figures 3A-C. The test pit locations were measured using a hand-held GPS unit and by trend and distance methods. The test pits were logged at a scale of 1-inch equals five feet (1:60) following methodology in McAlpin (1996), and digitally photographed at 5-foot intervals to document the exposures. The photos are not provided herein, but are available on request. Logs of the test pits are provided on Figure 4A-I. Stratigraphic interpretations and descriptions are provided on the logs. Groundwater was observed at depths of from 6.8 feet to 10.3 feet bgs in TP-3, TP-5, TP-11, TP-14, TP-15, and TP-17, but was not observed in the remaining test pits to their explored depths (Figures 4B, 4C, and 4F-I). Groundwater depths encountered in the test pits are indicated on Figures 3A-C.

The Ogden Valley southwestern margin fault (Black and others, 2003) crosses the western part of the Project (Figures 3A-C). The U.S. Geological Survey Quaternary Fault and Fold Database of the United States indicates this structure is a class A, northeast-dipping normal fault with an overall length of 17 kilometers and average strike of N16°W. The most-recent movement on this fault is believed to be middle to late Quaternary. The fault is concealed beneath unfaulted Holocene-age sediments and Western Geologic (2006) found no evidence for active (Holocene-age) faulting in one trench excavated across the presumed fault location a few hundred feet south of the Project. The nearest active fault to the Project is the Weber section of the Wasatch fault zone 5.7 miles to the west (Black and others, 2003).

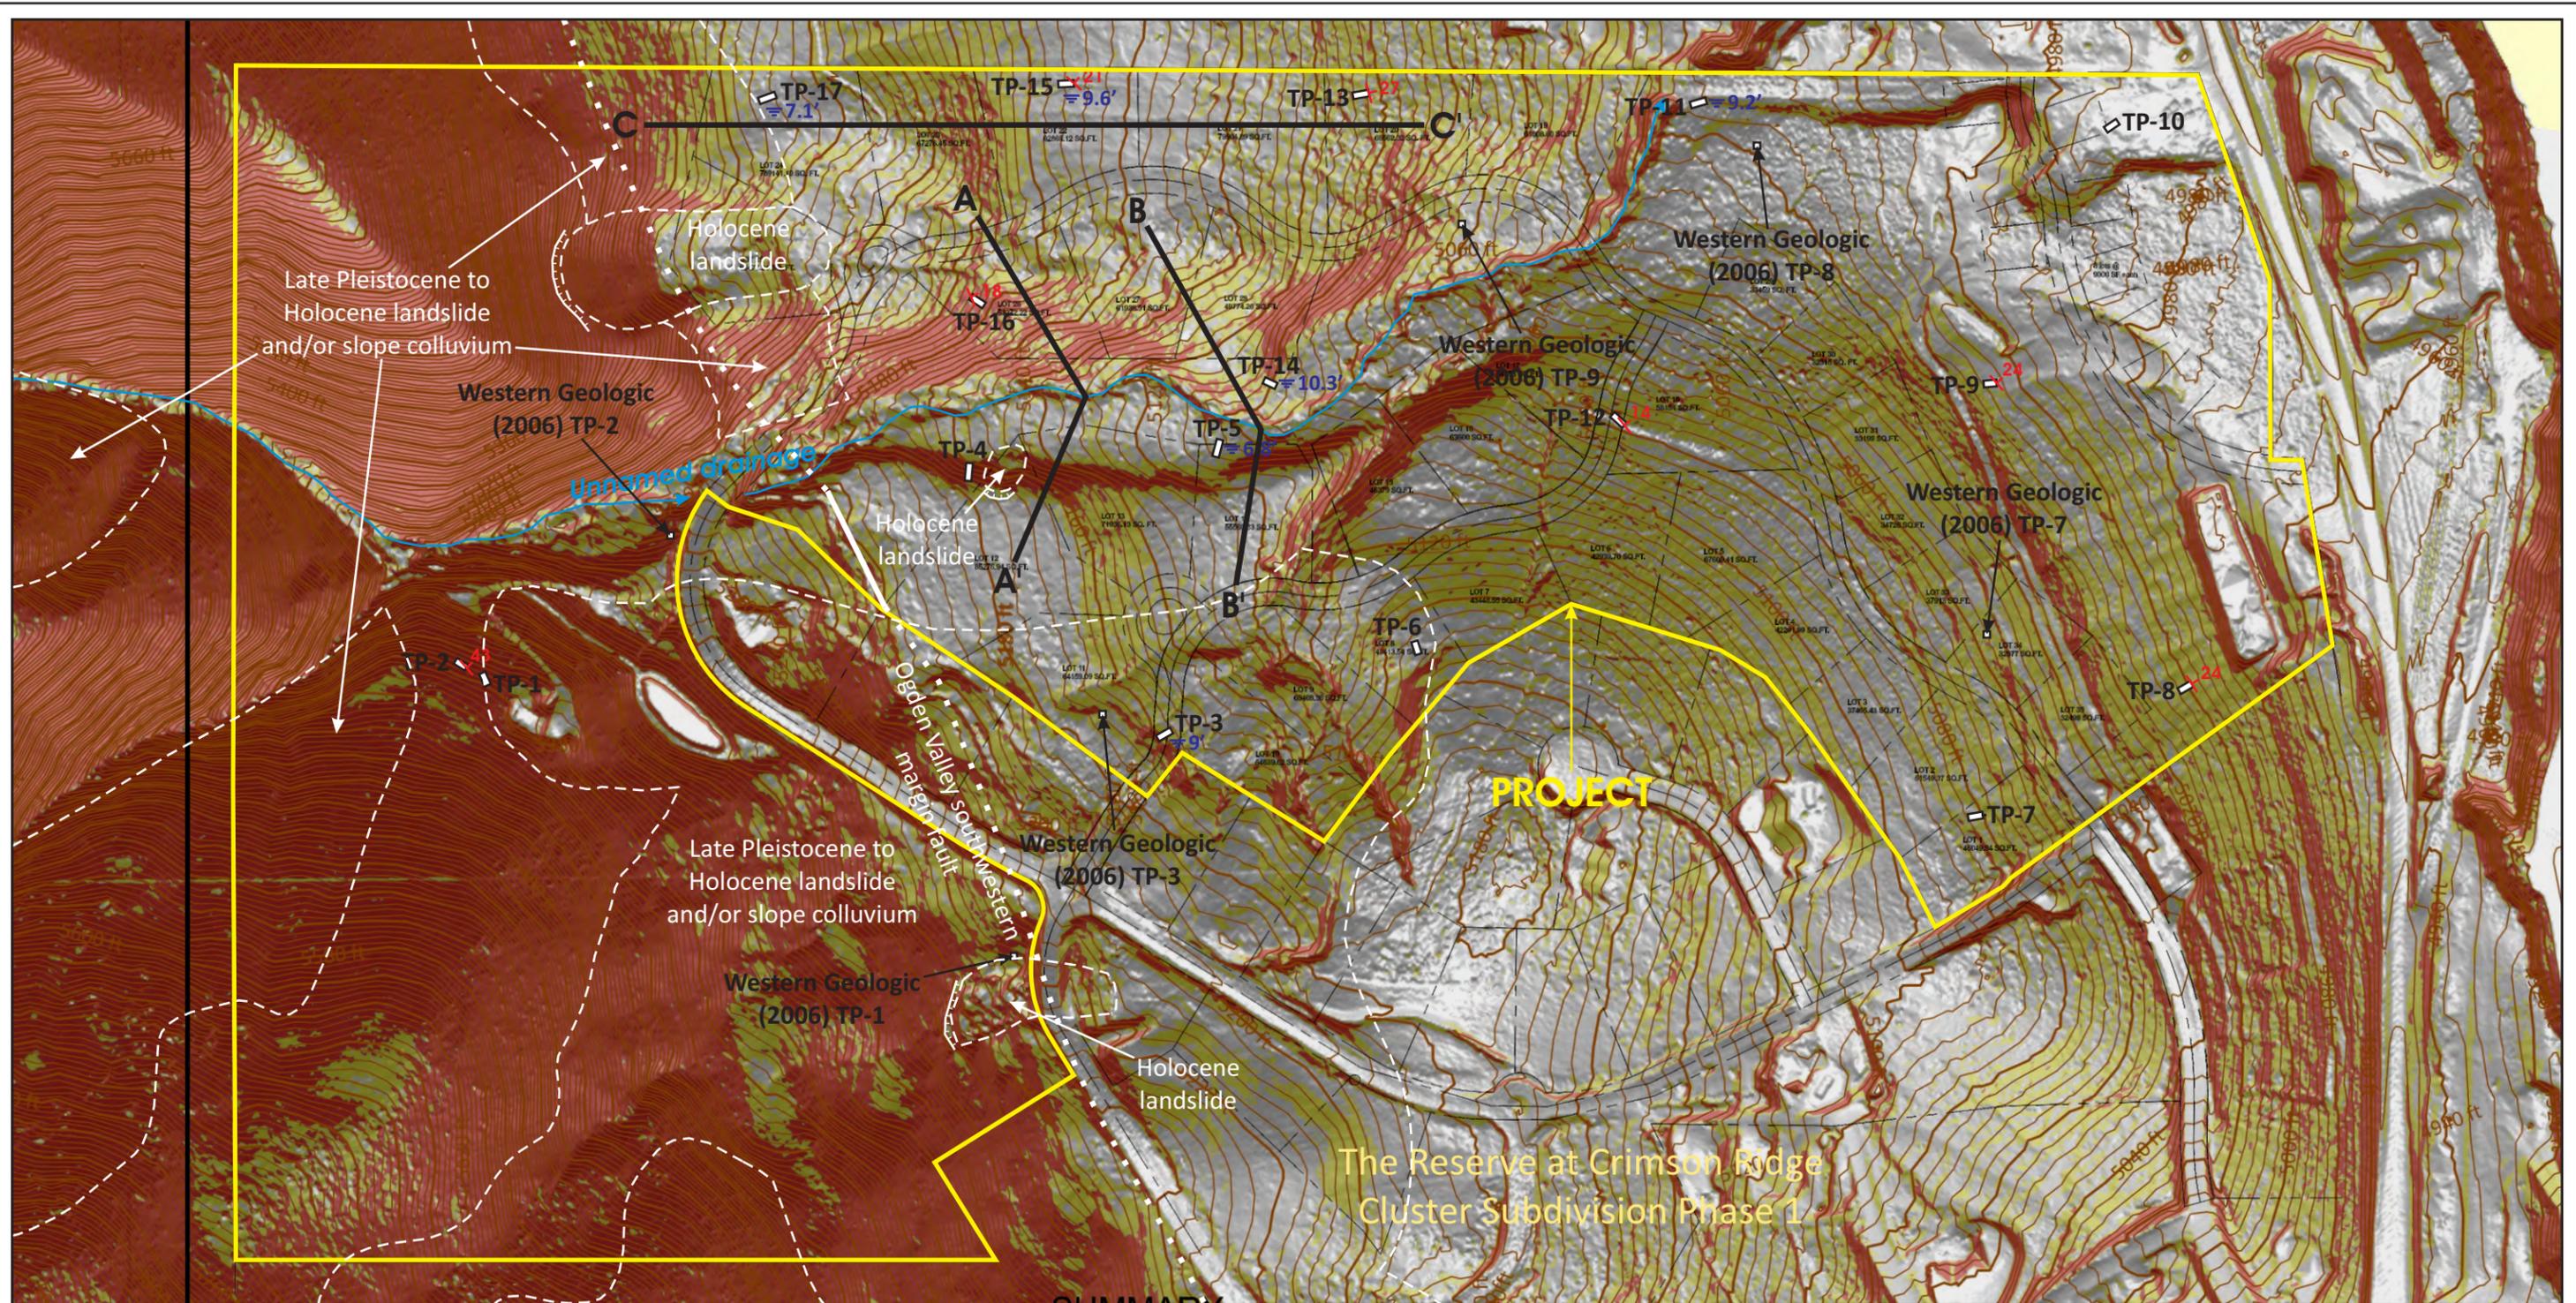
**FIGURE 3B**

Source: Gardner Engineering Concept Map dated 9/20/19 and 2011 geoprocessed LIDAR data available from Utah AGRC; contours generated by Global Mapper, 4-foot interval. Slope steepness <math>< 15\%</math> unshaded, 15-25% in yellow and >25% in red.

**2011 LIDAR IMAGE**

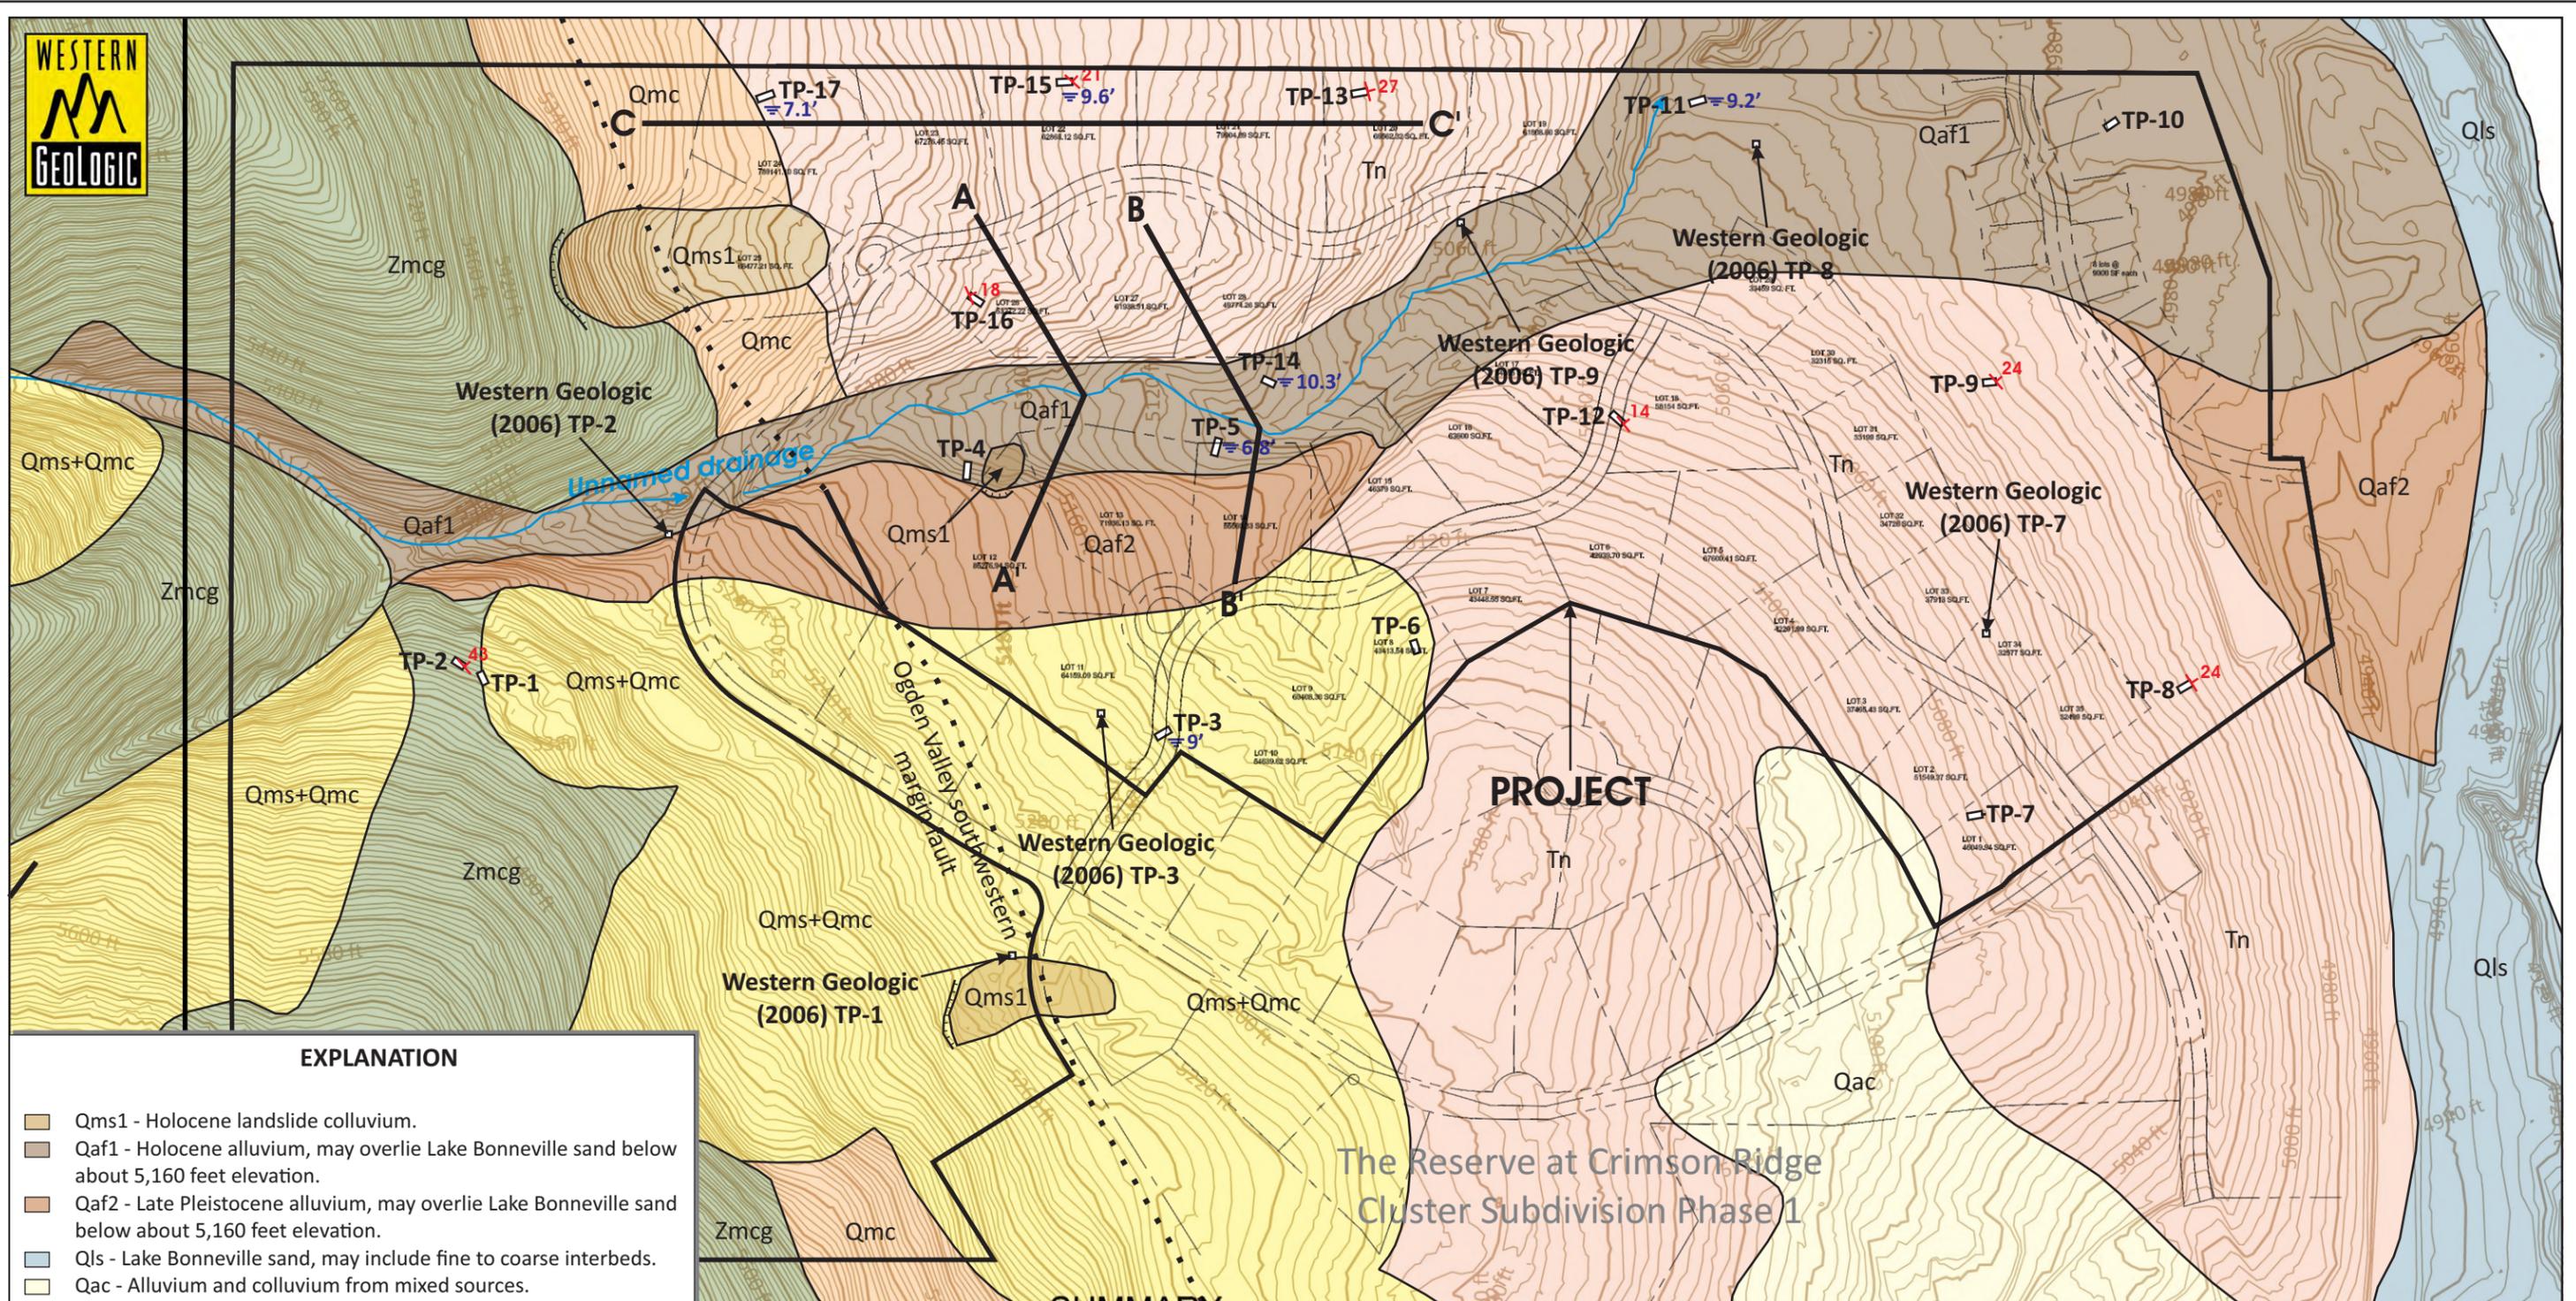
**FIGURE 3C**

**EXPLANATION**

- Qms1 - Holocene landslide colluvium.
- Qaf1 - Holocene alluvium, may overlie Lake Bonneville sand below about 5,160 feet elevation.
- Qaf2 - Late Pleistocene alluvium, may overlie Lake Bonneville sand below about 5,160 feet elevation.
- Qls - Lake Bonneville sand, may include fine to coarse interbeds.
- Qac - Alluvium and colluvium from mixed sources.
- Qmc - Slope colluvium from mixed mass wasting sources.
- Qms+Qmc - Undifferentiated landslides and slope colluvium.
- Tn - Tertiary Norwood Formation and surficial alluvium/colluvium.
- Zmcg - Precambrian Maple Canyon Formation.
- Quaternary (pre-Holocene age) fault, dotted where concealed.
- Landslide scarp.
- 9' Groundwater and depth below the ground surface.
- 18 Strike/dip.

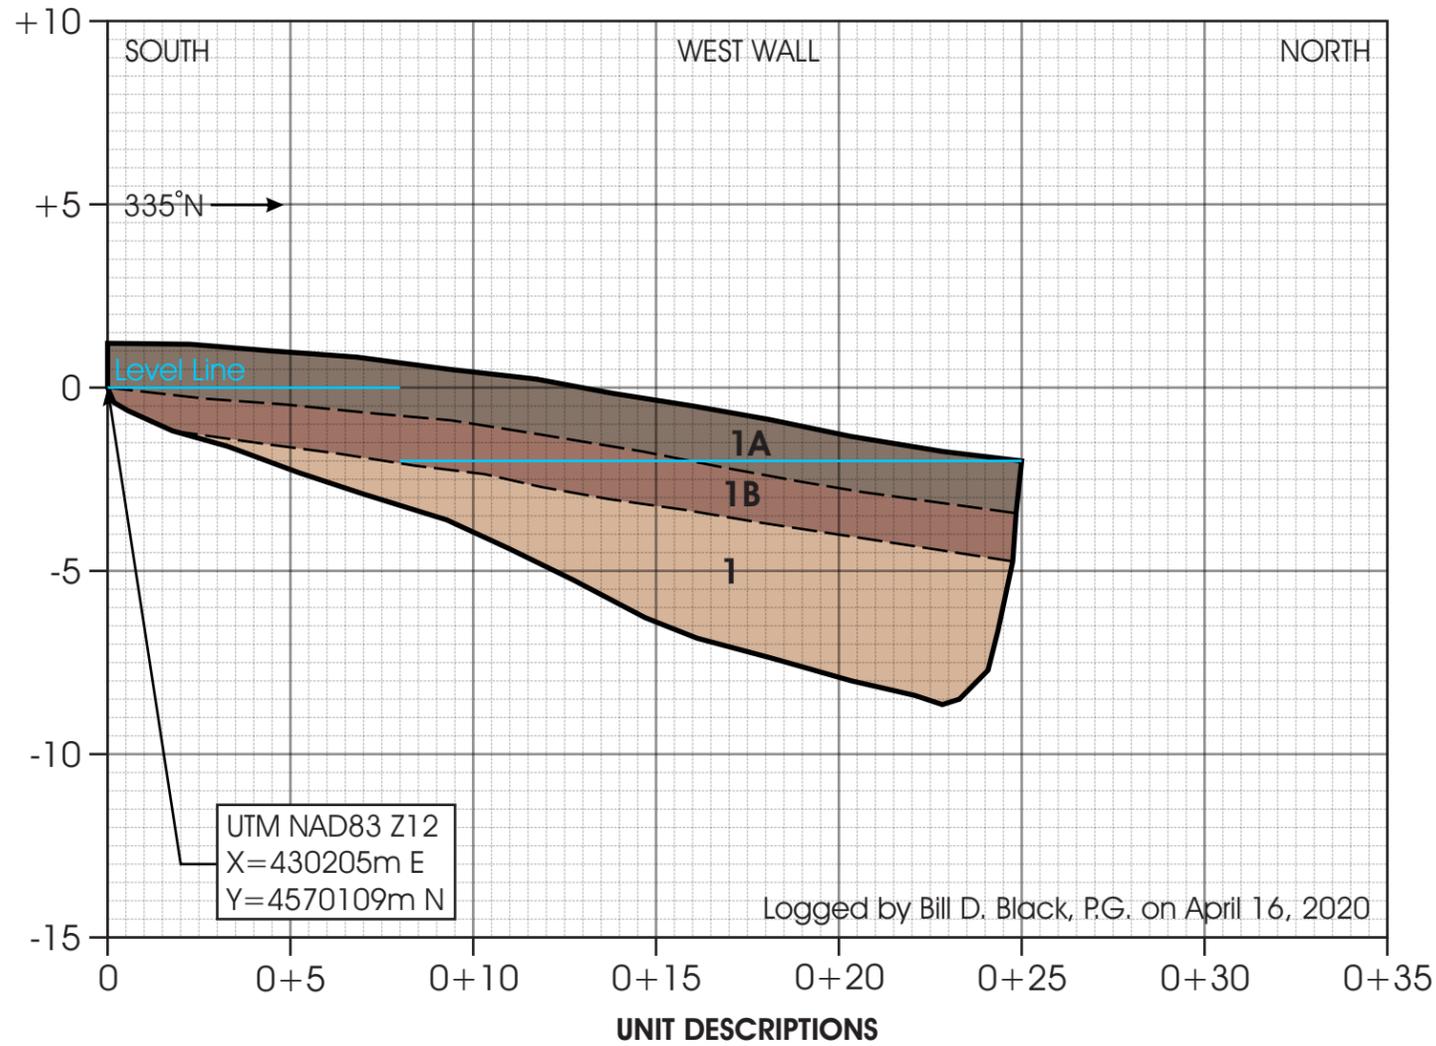
### TEST PIT 1

**Unit 1.** *Tertiary Norwood Formation (?)* - Brown, weathered claystone, dense, massive, with flecks of white gravel; modern A horizon (1A) and Bt horizon (1B) formed in unit.

- TP-1: Suspected landslide colluvium comprised of clayey sand (SC), overlying a block of Norwood Formation claystone;
- TP-2: Holocene alluvium/colluvium comprised of gravelly sand (SW), overlying late Pleistocene alluvium/colluvium comprised of sandy gravel to gravelly sand (GW/SW) with rounded to angular cobbles and boulders;
- TP-3: Holocene alluvium/colluvium comprised of clayey sand with gravel (SC), overlying late Pleistocene alluvium comprised of iron-oxide stained clayey sand to sandy clay (SC/CL);
- TP-7: Late Pleistocene to Holocene alluvium comprised of lean clay (CL) with trace silt, gravel and sand, overlying tuffaceous siltstone and sandstone of the Norwood Formation;
- TP-8: Holocene alluvium comprised of gravelly sand (SW) with cobbles; and

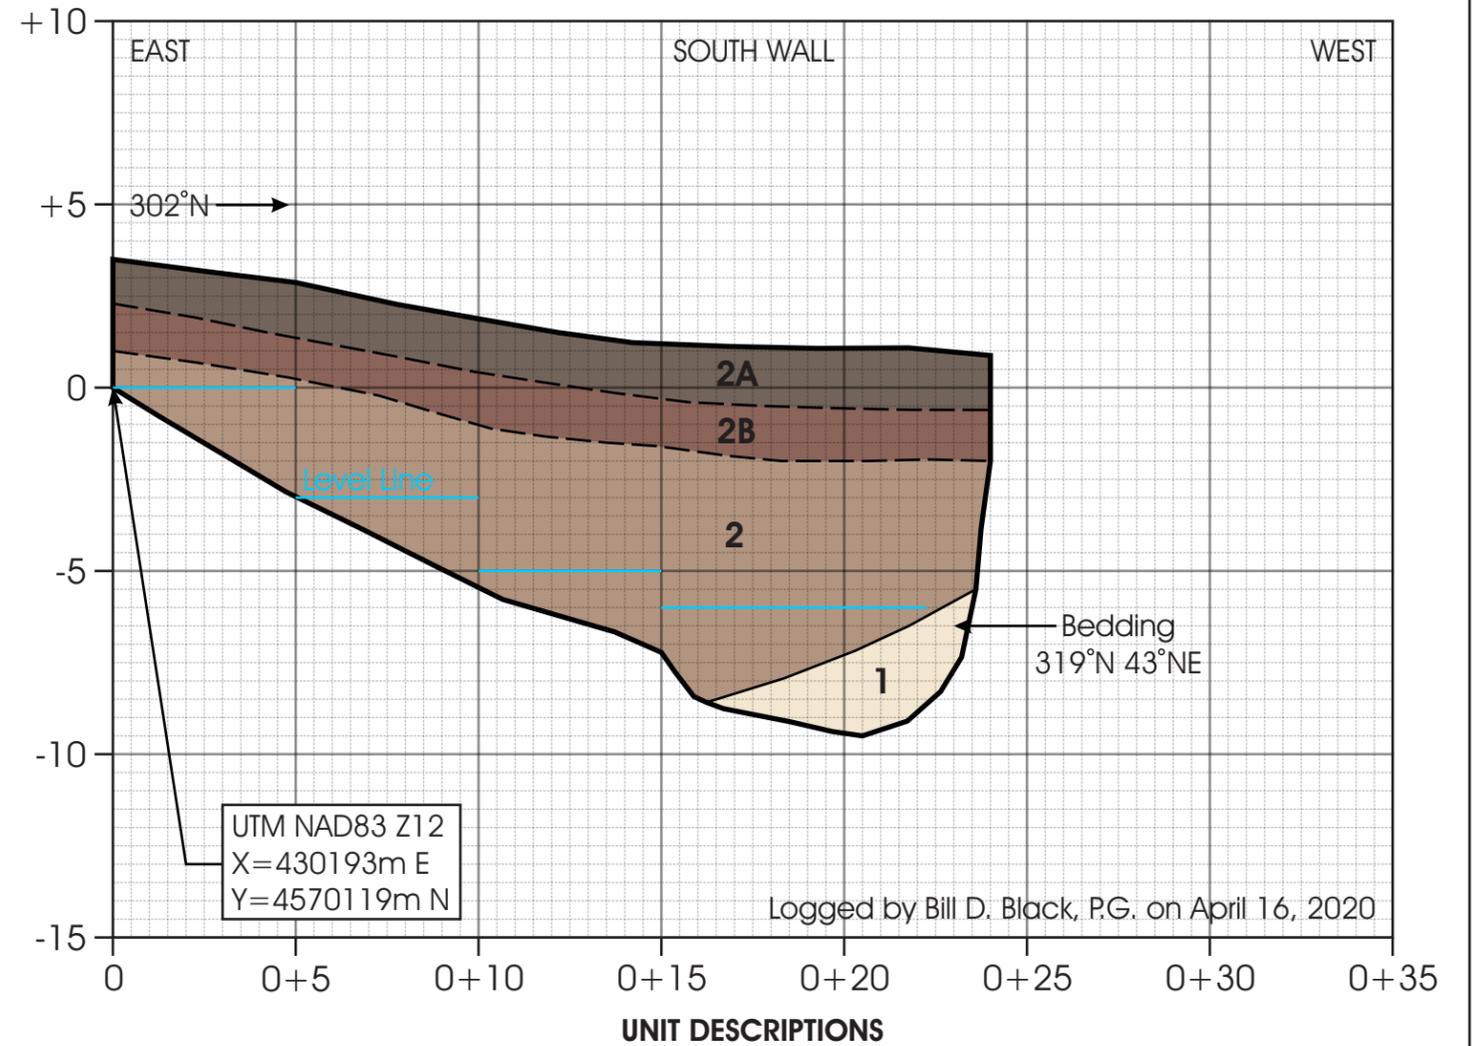
### TEST PIT 2

**Unit 1.** *Precambrian Maple Canyon Formation* - Fractured, pale gray, thinly bedded, dense, fine-grained sandstone (?) with carbonate infill.

**Unit 2.** *Pleistocene colluvium* - Brown to dark-brown, massive, moderate to high density, lean clay (CL) with sand, gravel and blocks of unit 1; modern A horizon (2A) and Bt horizon (2B) formed in unit.

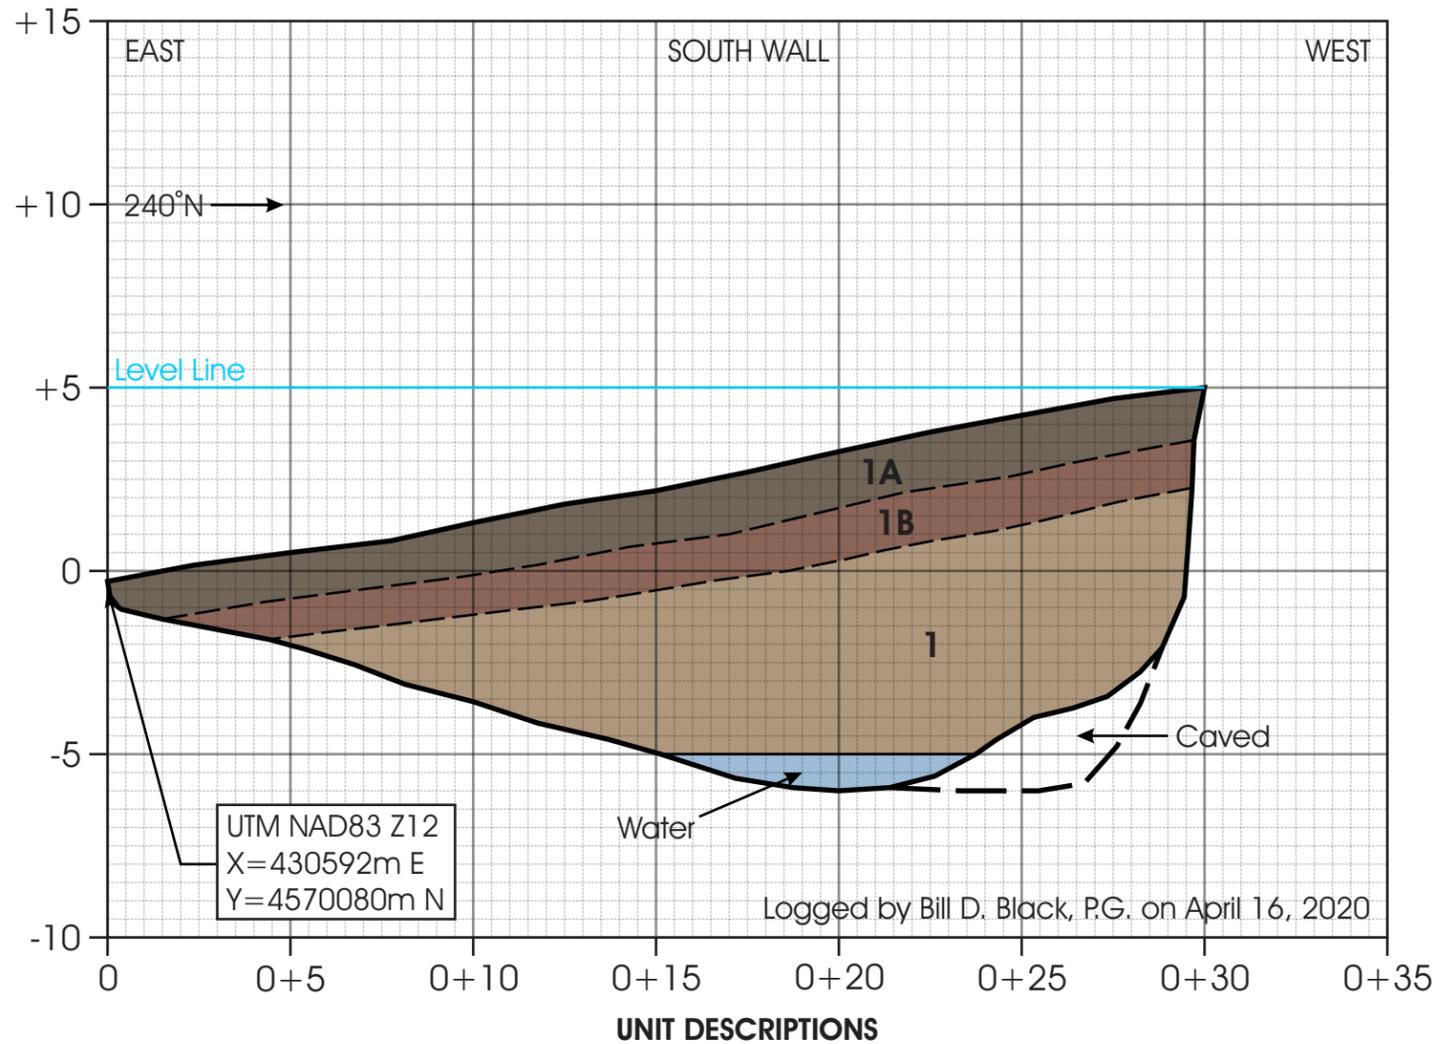
### TEST PIT 3

**Unit 1.** Late Pleistocene to Holocene colluvium - Reddish-brown, orange-brown and brown, moderate density, generally massive, sandy lean to fat clay (CL/CH) with gravel and cobbles in upper part; clasts subround with stage II carbonate; modern A horizon (1A) and Bt horizon (1B) formed in unit, test pit caving beneath soil horizons.

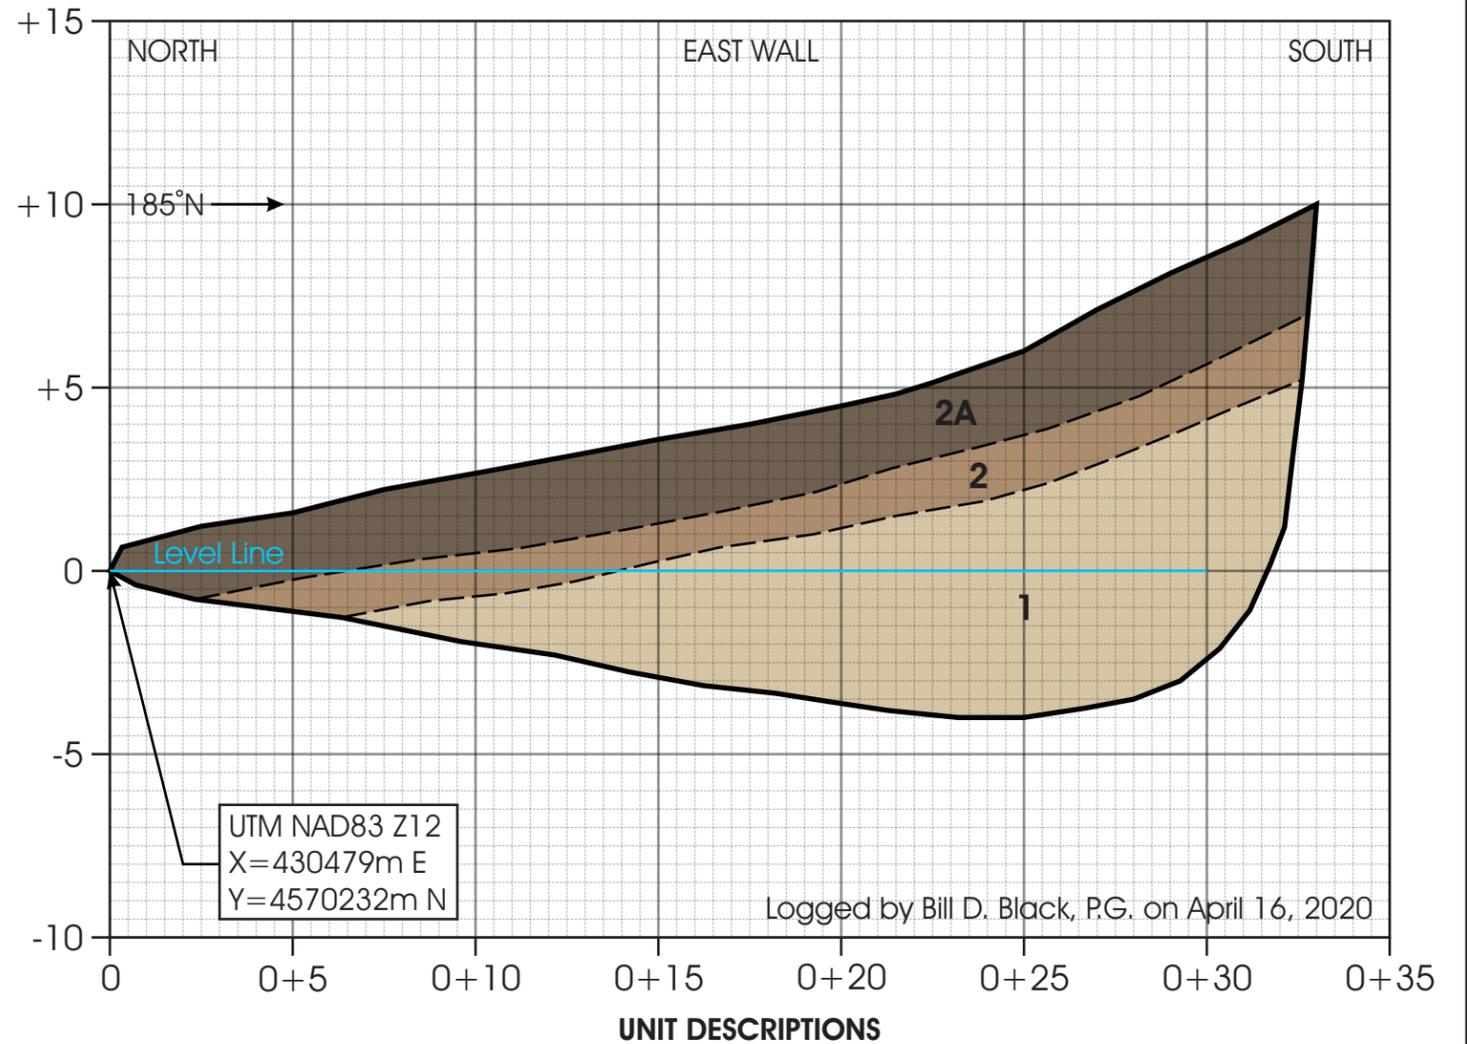
### TEST PIT 4

**Unit 1.** Late Pleistocene alluvium - Light brown, moderate density, poorly bedded, sandy gravel (GW) with clay, cobbles and boulders up to 2 feet across; clasts subangular to subround with stage II carbonate.

**Unit 2.** Early to mid-Holocene alluvium - Brown to dark brown, moderate density, generally massive, clayey sand (SC) with gravel and trace round to subround cobbles with stage II carbonate; modern A horizon (2A) formed in unit.

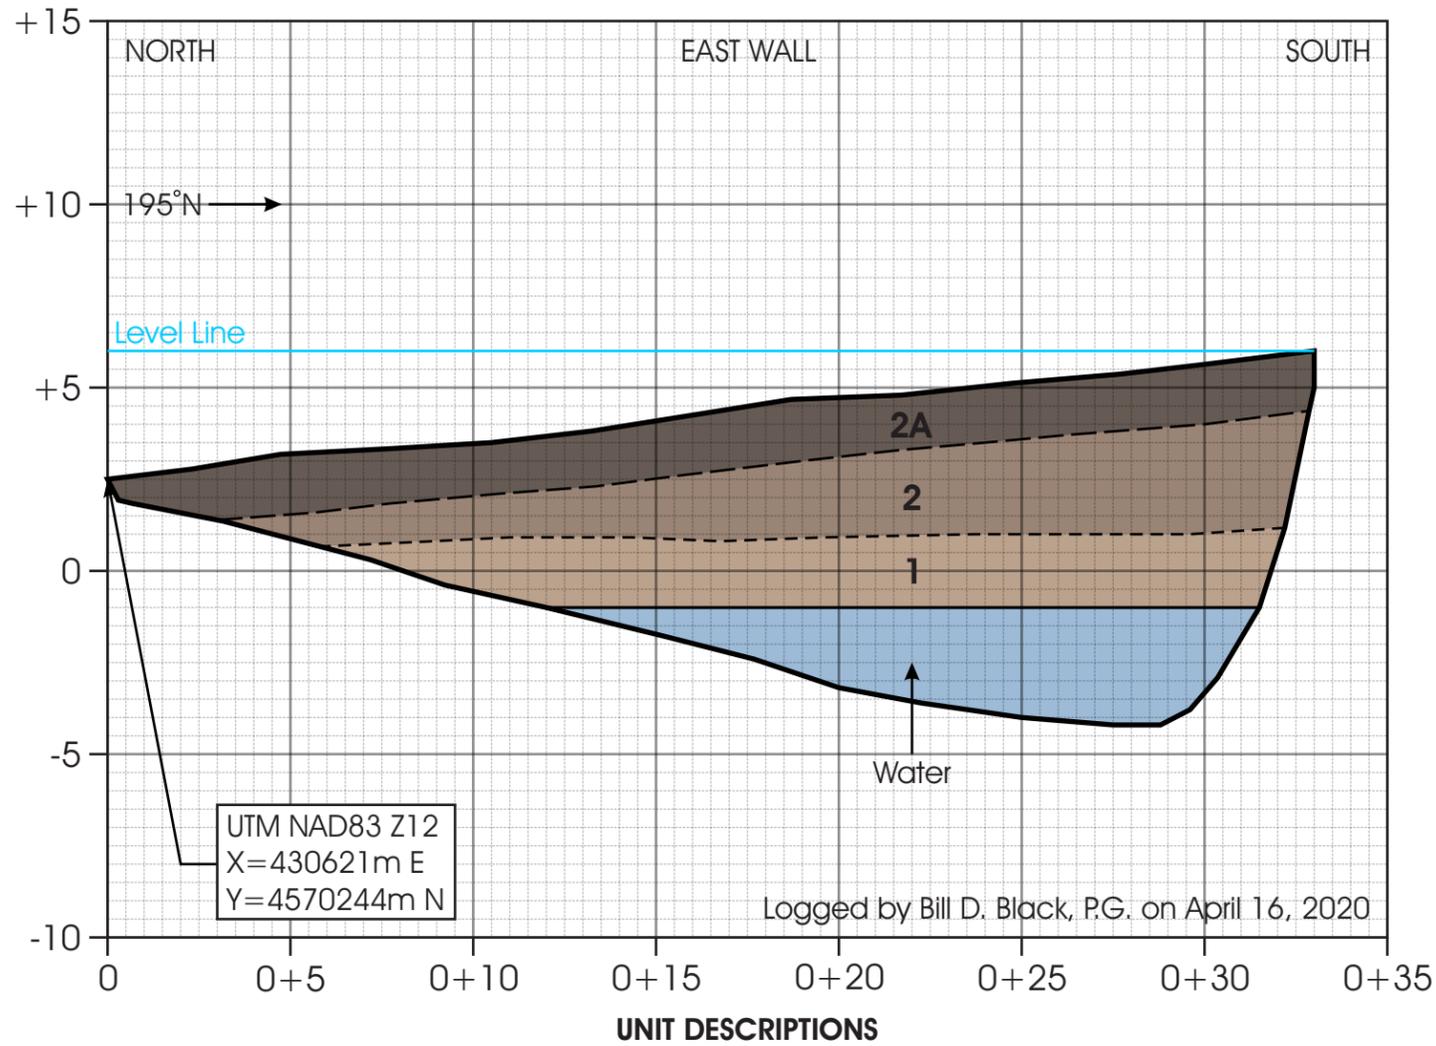
### TEST PIT 5

**Unit 1.** Late Pleistocene alluvium - Light brown, moderate to low density, poorly bedded, sandy gravel (GW) with clay, cobbles and trace boulders; clasts subangular to round with stage II carbonate.

**Unit 2.** Early to mid-Holocene alluvium - Brown to dark brown, low density, generally massive, clayey sand (SC) with silt and gravel; root penetrated and organic enriched; modern A horizon (2A) formed in unit.

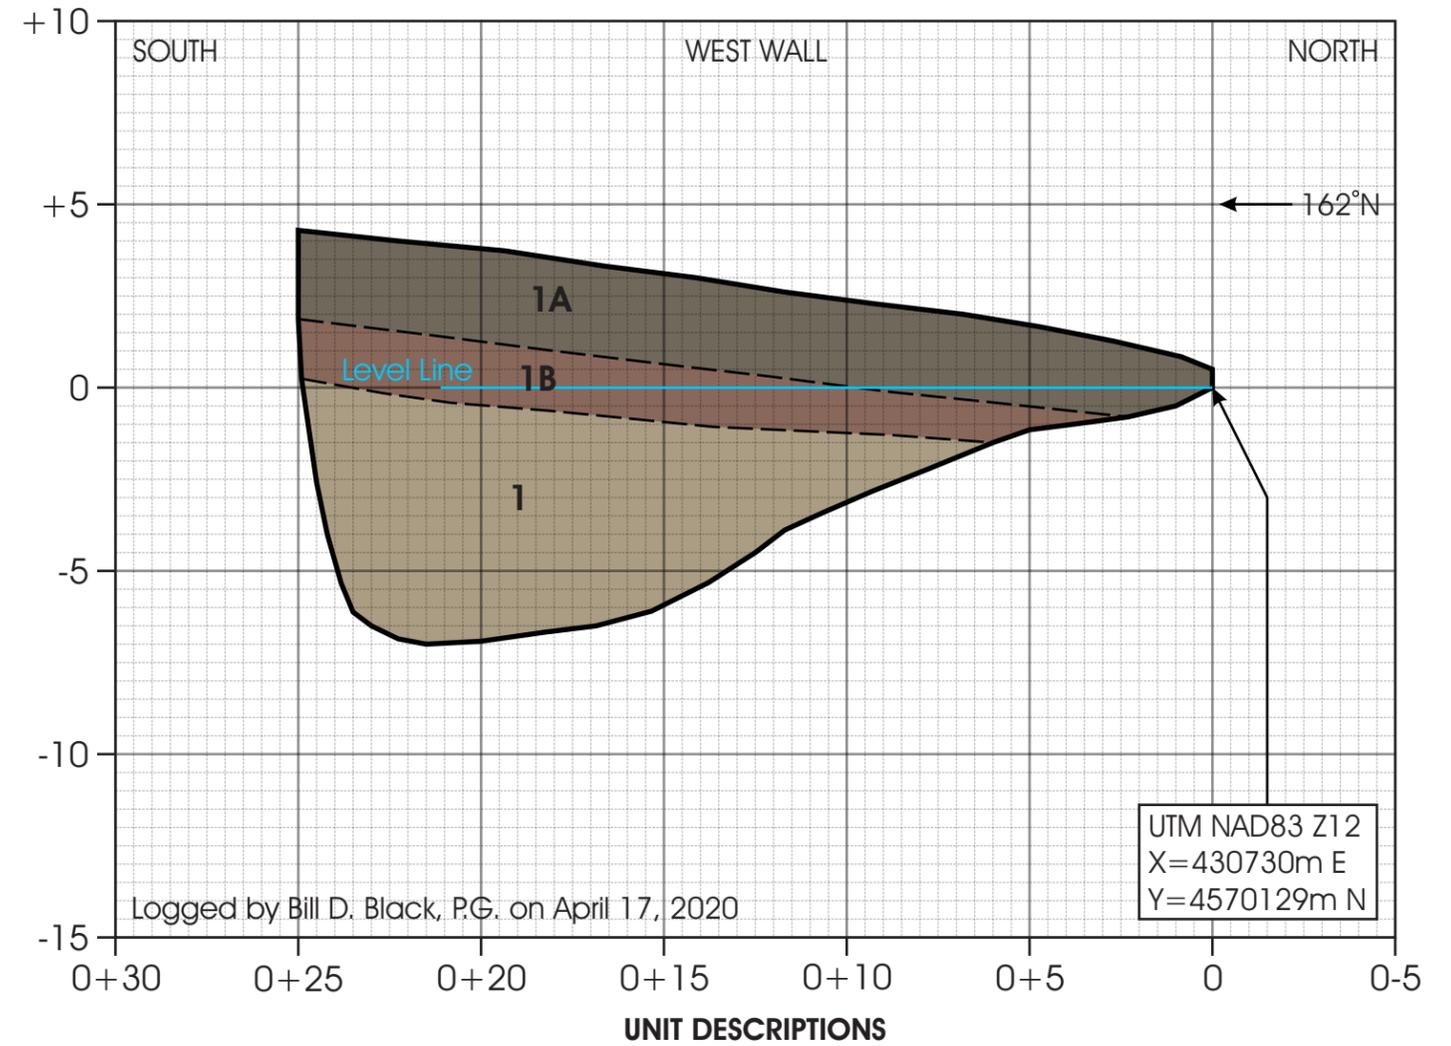
### TEST PIT 6

**Unit 1.** Late Pleistocene to Holocene colluvium - Olive-brown, reddish-brown and dark-grayish-brown, moderate density, generally massive, lean clay (CL) with trace sand and gravel; tuffaceous sandstone clasts in lower part; modern A horizon (1A) and Bt horizon (1B) formed in unit.

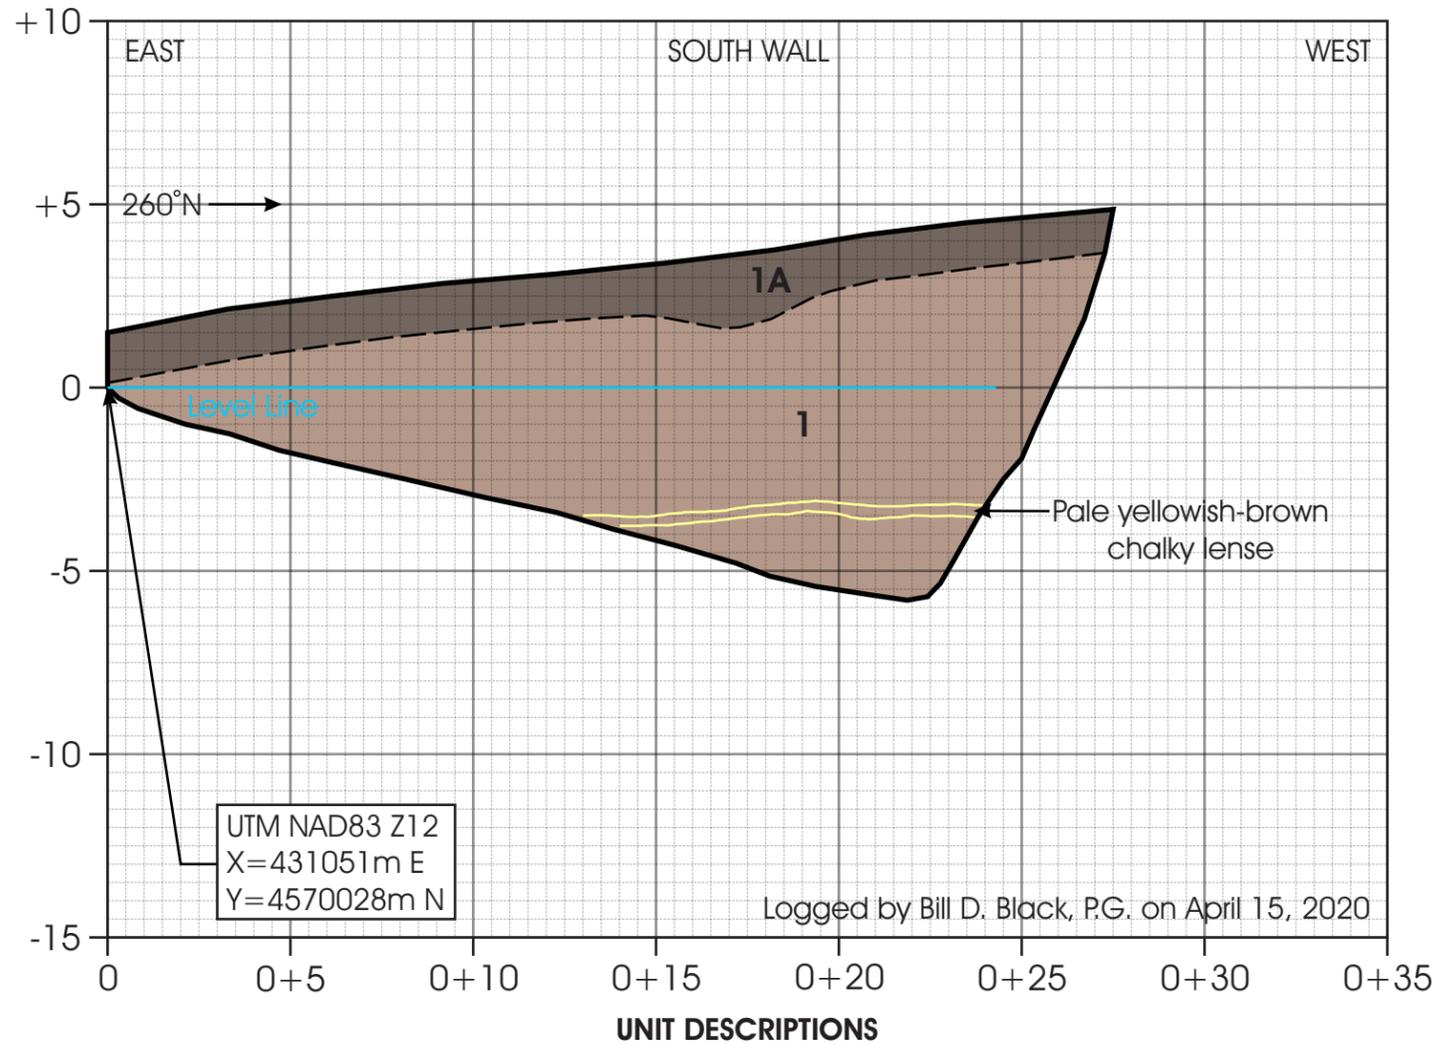
### TEST PIT 7

**Unit 1.** Early Holocene alluvium and colluvium - Pale-brown, grayish-brown and brown to dark-brown, moderate density, poorly bedded to massive, sandy lean to fat clay (CL/CH) with gravel and subangular to subround cobbles with strong stage II carbonate, density increases downward; modern A horizon (1A) formed in unit; may be weathered Tertiary Norwood Formation below chalky lense.
