## **GEOLOGIC HAZARDS EVALUATION PROPOSED CRIMSON RIDGE PHASE 2 SUBDIVISION ABOUT 1100 NORTH MORNINGSIDE LANE EDEN, UTAH**

**Letter of Transmittal:** REPORT  
Geologic Hazards Evaluation  
Proposed Crimson Ridge Phase 2 Subdivision  
About 1100 North Morningside Lane  
Eden, Utah

**WG&E Project No. 5378**

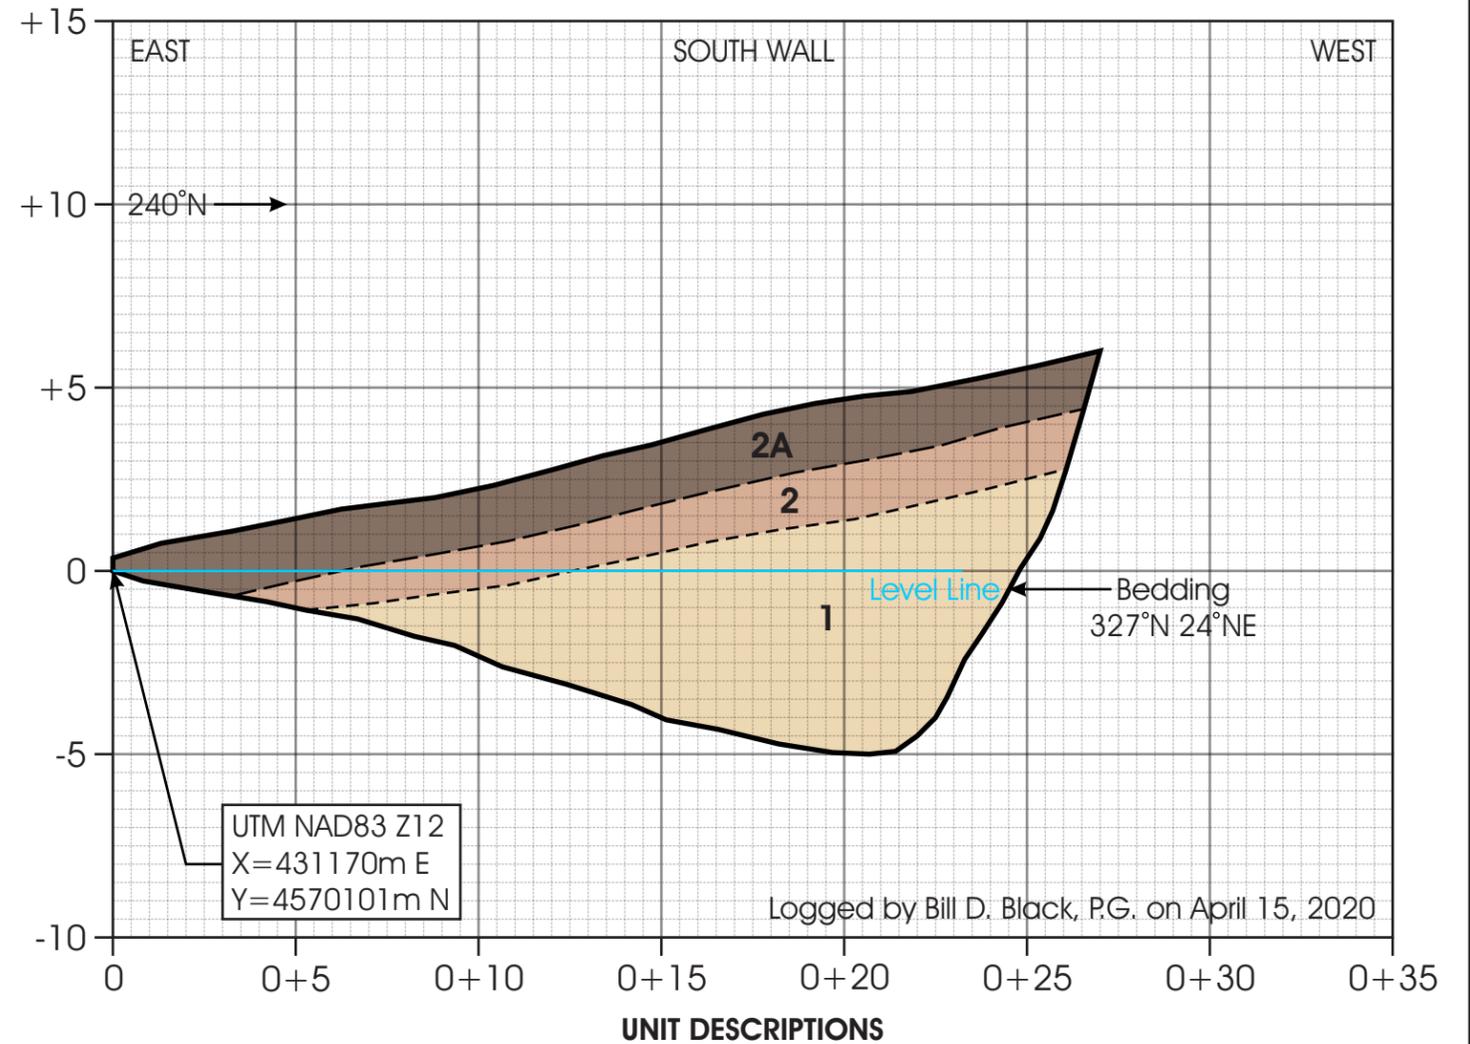
### TEST PIT 8

**Unit 1.** Tertiary Norwood Formation - Pale-brown to orange-brown weathered tuffaceous sandstone, dense, poorly to well bedded.

**Unit 2.** Early Holocene alluvium and colluvium - brown to dark brown, low density, generally massive, clayey sand (SC) with silt and gravel; root penetrated and organic enriched; modern A horizon (2A) formed in unit.

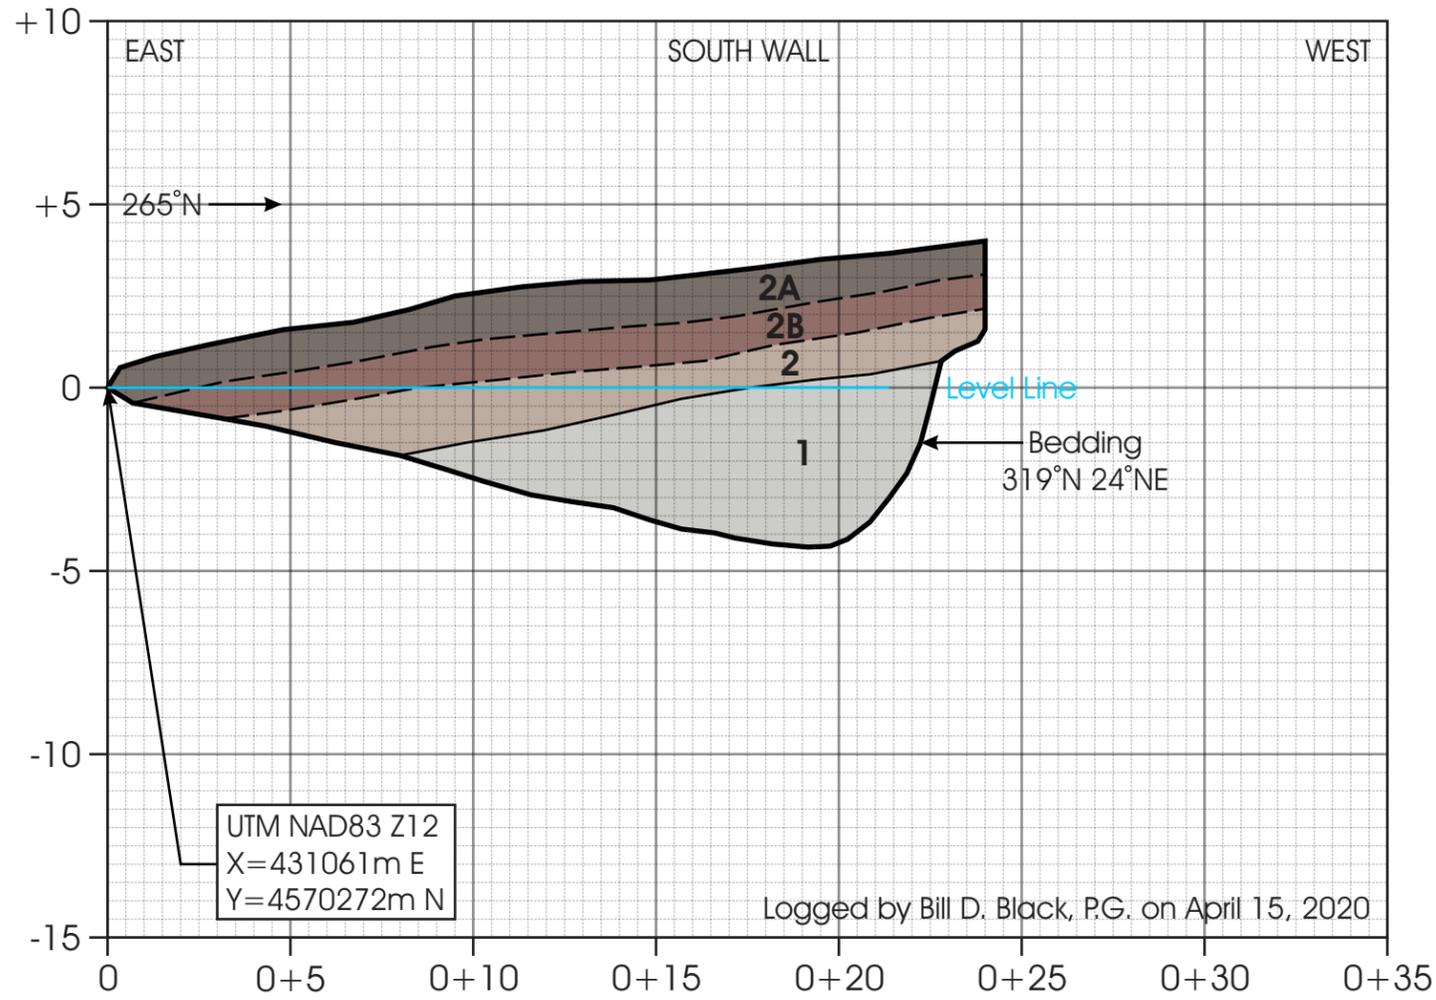
### TEST PIT 9

**Unit 1.** Tertiary Norwood Formation - Greenish-gray, dense, well-bedded, weathered tuffaceous sandstone.

**Unit 2.** Early to mid-Holocene alluvium and colluvium - Brown, reddish-brown, and dark-brown, low to moderate density, poorly bedded to massive, clayey sand to sandy clay (SC/CL) with gravel, cobbles and boulders; clasts subround to subangular with stage II carbonate, include tuffaceous sandstone; modern A horizon (2A) and Bw/Bt horizon (2B) formed in unit.

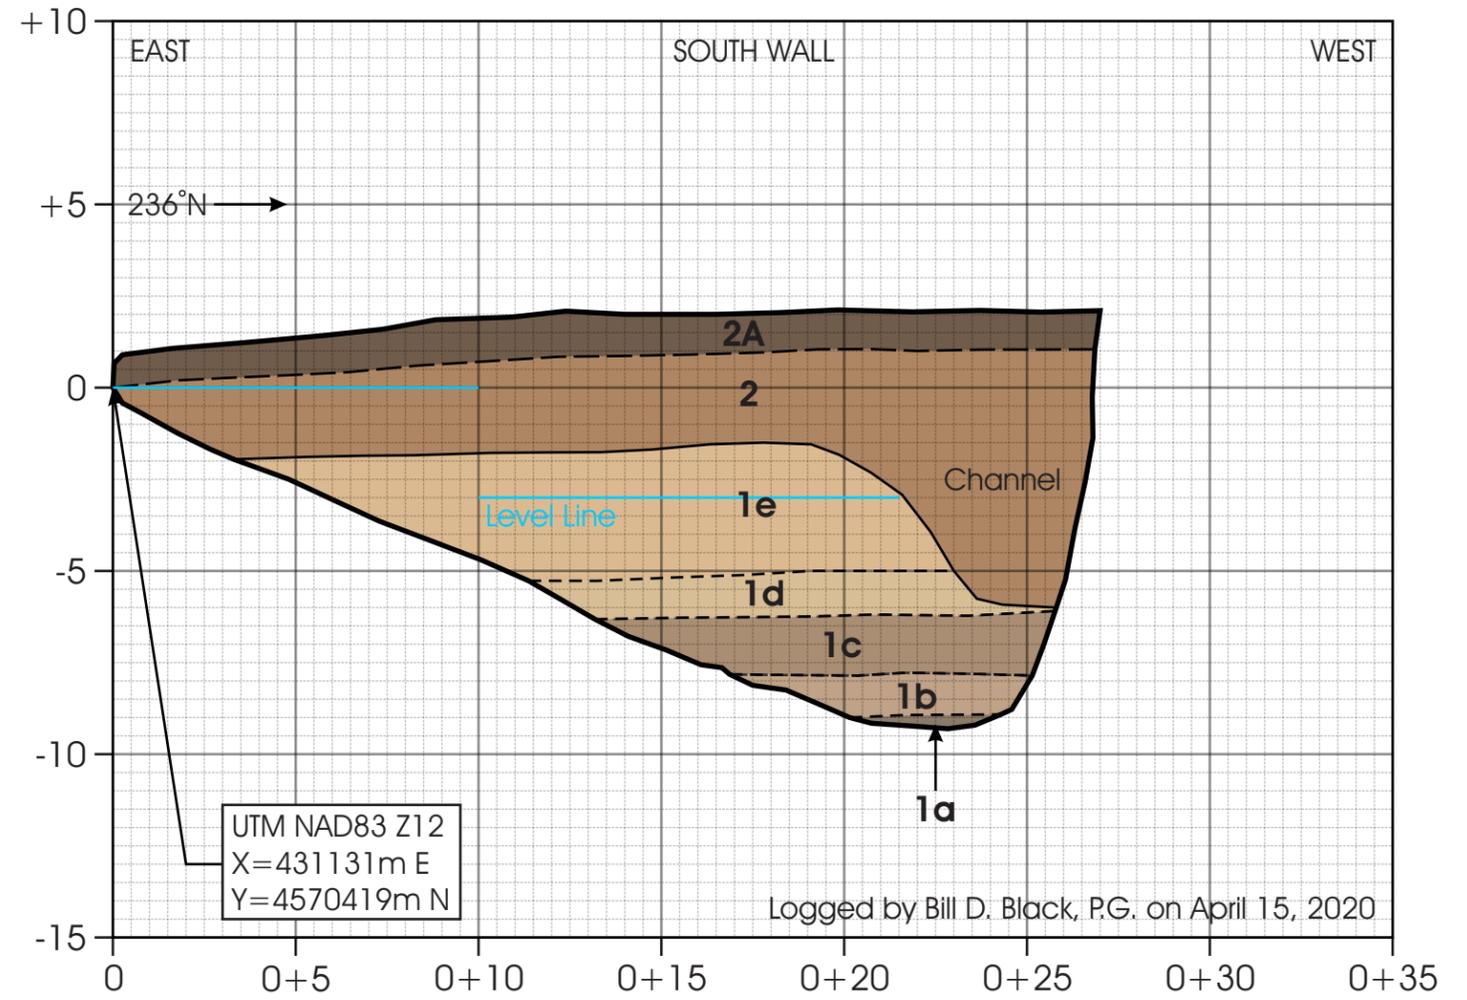
### TEST PIT 10

**Unit 1.** Late Pleistocene Lake Bonneville sediments - Sequence of well-bedded, moderate density, brown to reddish-brown, clay to gravel comprised of: 1a, lean clay (CL); 1b, gravelly sand to sandy gravel (SW/GW); 1c, lean clay (CL); 1d, coarse sand (SW) with gravel and cobbles; and 1e, silty sand (SM) with gravel.

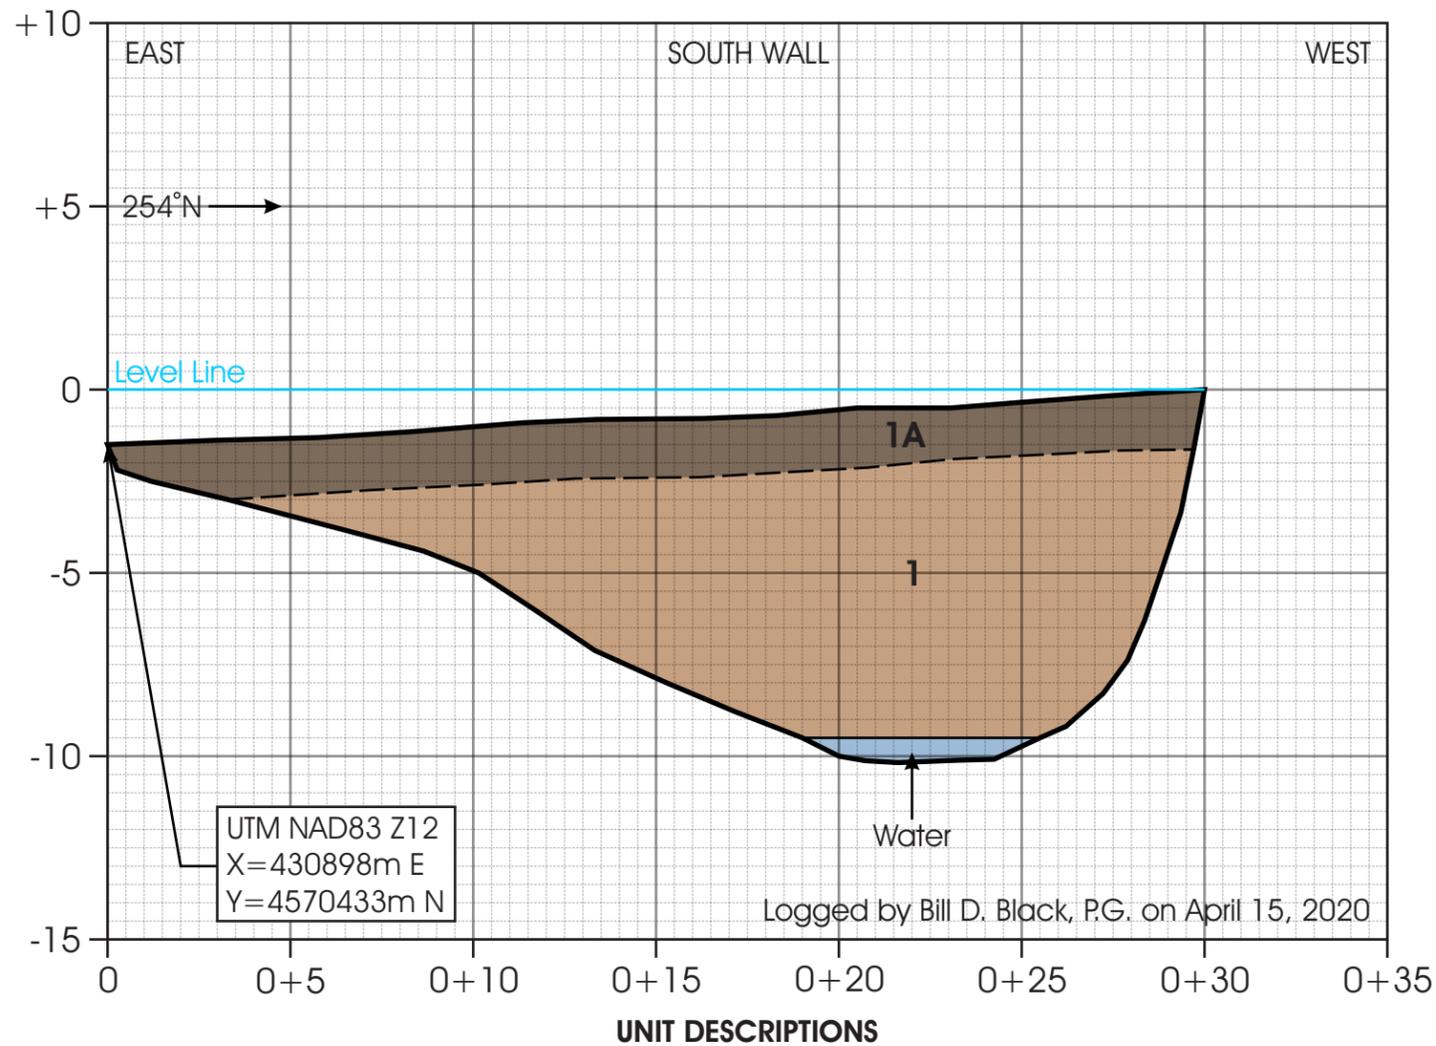
### TEST PIT 11

**Unit 1.** Early to mid-Holocene alluvium - Brown to dark-grayish-brown, moderate density, poorly bedded to massive, sandy gravel to gravelly sand (GW/SW) with trace cobbles and boulders; clasts subangular to subround with stage II carbonate; modern A horizon (2A) formed in unit.

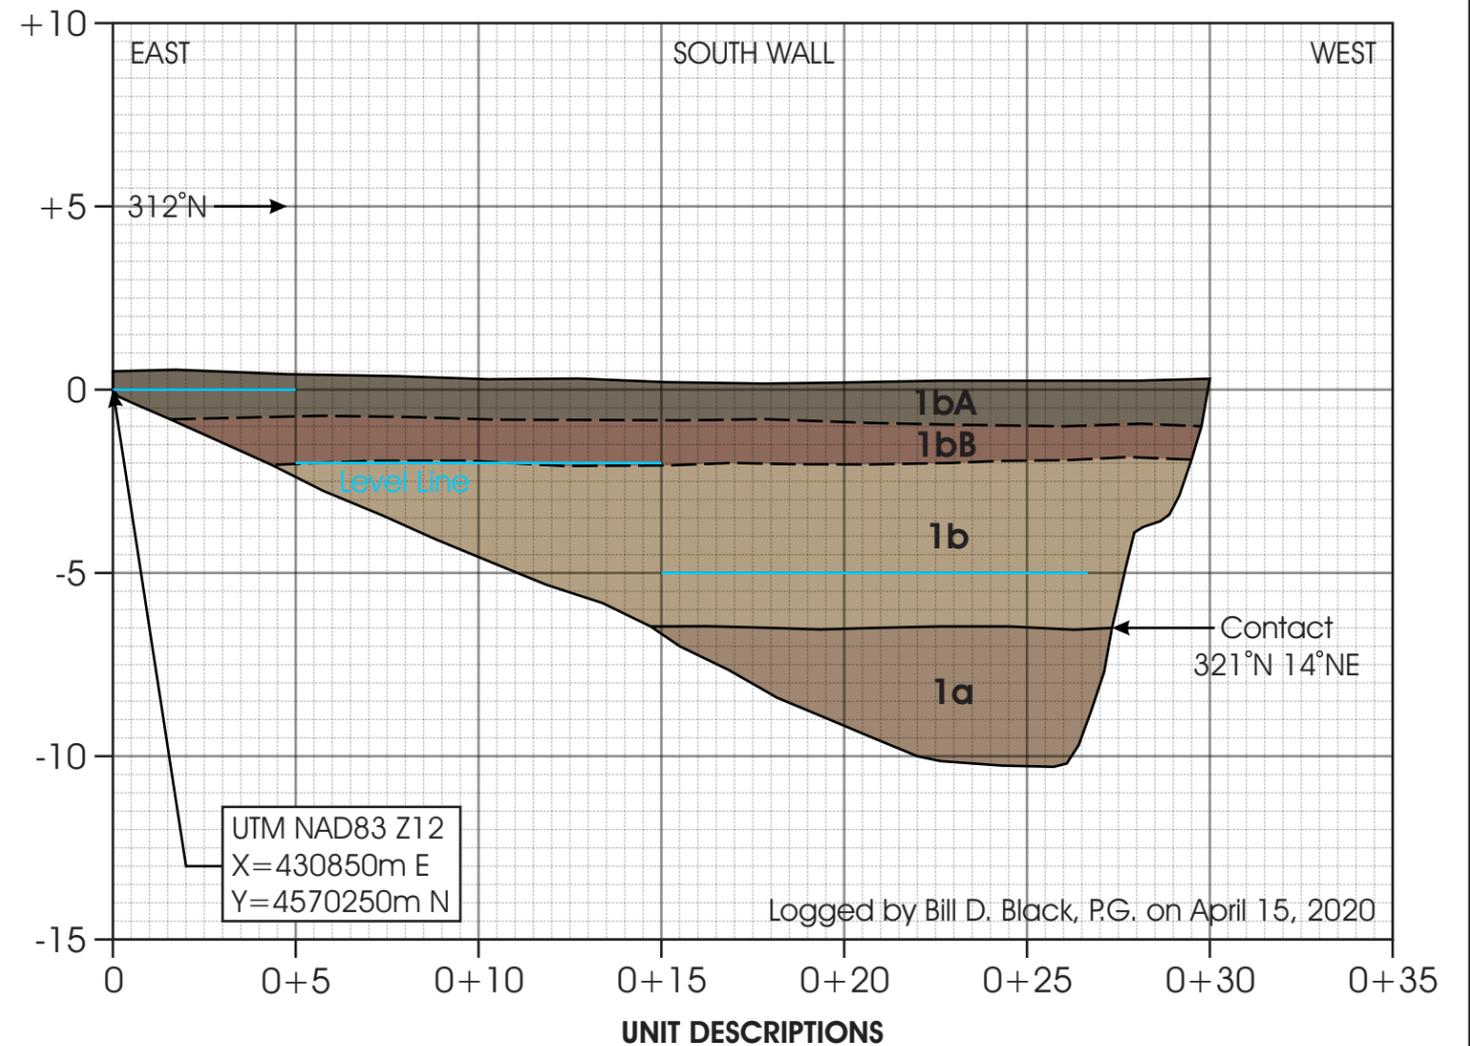
### TEST PIT 12

**Unit 1.** Tertiary Norwood Formation - Sequence of poorly to well bedded, moderate to high density, weathered tuffaceous bedrock comprised of a lower (1a) brownish-orange fractured siltstone, and an upper (1b) pale-brown to dark-brown, clayey sandstone to sandy claystone; modern A horizon (1bA) and Bw/Bt horizon (1bB) formed at surface.

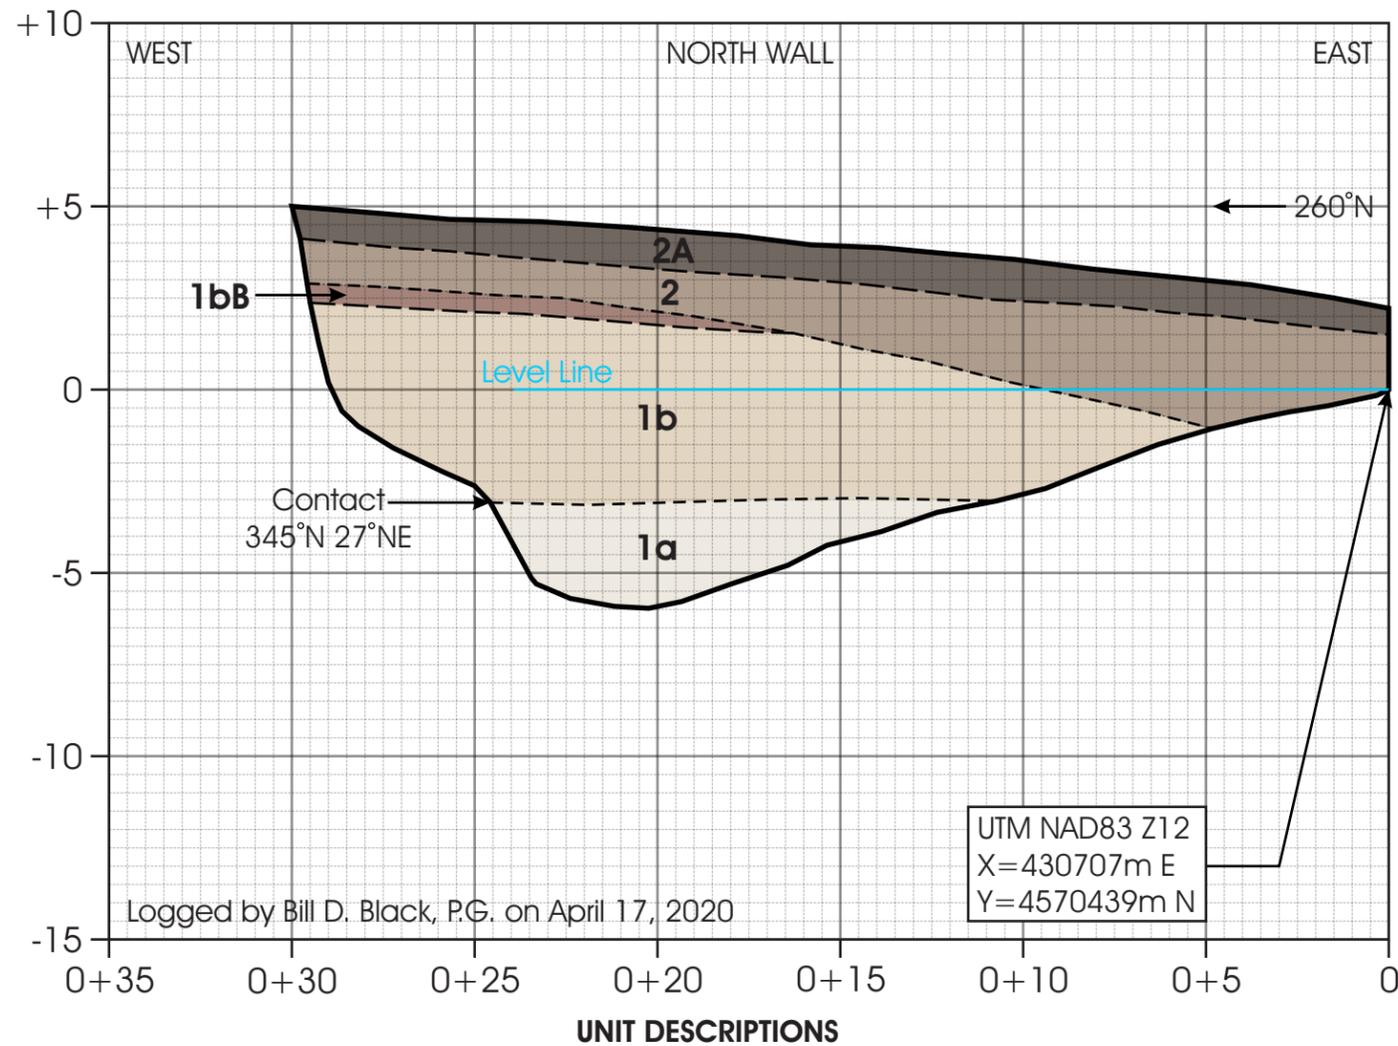
### TEST PIT 13

**Unit 1.** *Tertiary Norwood Formation* - Sequence of weathered, moderate to high density, poorly to well bedded, tuffaceous bedrock comprised of (1a) very-pale, green to reddish-brown claystone, and (1b) pale-orange-brown to pale-grayish-brown, conglomerate; Bt horizon formed in unit (1b).

**Unit 2.** *Early Holocene alluvium* - Brown to dark-brown, moderate density, poorly bedded to massive, sandy clay (CL) with gravel, cobbles and small boulders; clasts subround to subangular with strong stage II carbonate; modern A horizon (2A) formed in unit.

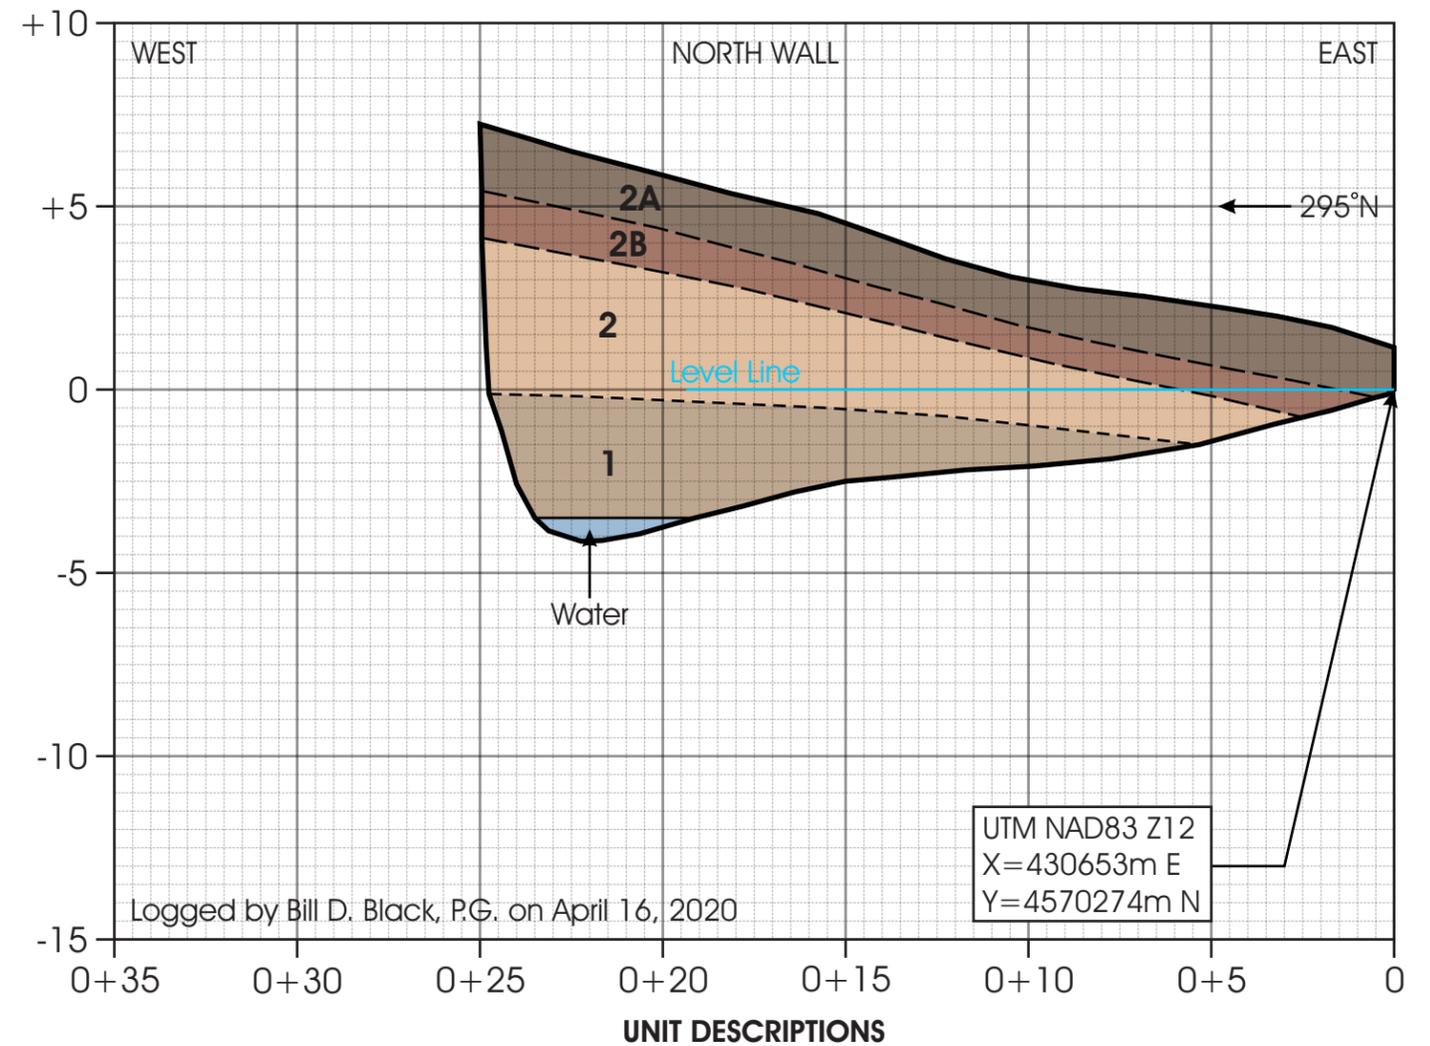
### TEST PIT 14

**Unit 1.** *Older Pleistocene alluvium* - Reddish-brown, dense, generally massive, clayey sand (SC) with pea gravel.

**Unit 2.** *Late Pleistocene alluvium* - Orange-brown, brown, and dark-brown, moderate density, generally massive, sandy clay to clayey sand (CL/SC) with gravel and trace cobbles; clasts subangular with stage II carbonate; modern A horizon (2A) and Bt horizon (2B) formed in unit.

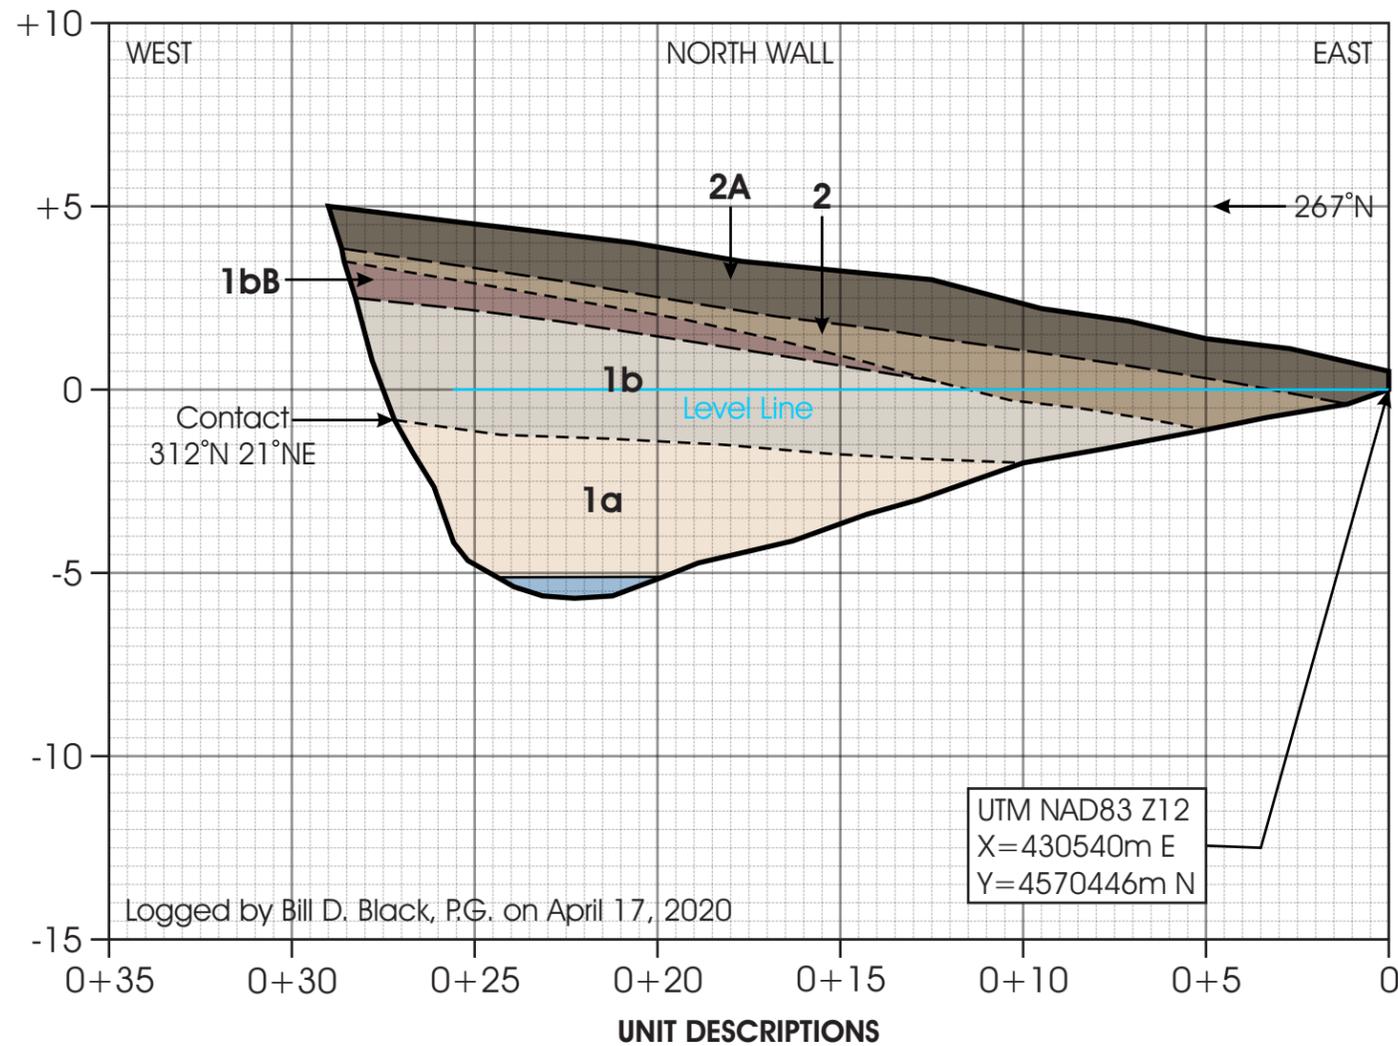
### TEST PIT 15

**Unit 1.** *Tertiary Norwood Formation* - Sequence of weathered, moderate to high density, poorly to well bedded, tuffaceous bedrock comprised of: 1a, pale-brown conglomerate, and 1b, pale-greenish-gray claystone; Bt horizon formed in unit (1bB).

**Unit 2.** *Early Holocene alluvium* - Brown to dark-brown, moderate density, poorly bedded to massive, sandy clay (CL) with gravel, cobbles and small boulders; clasts subround to subangular with strong stage II carbonate; modern A horizon

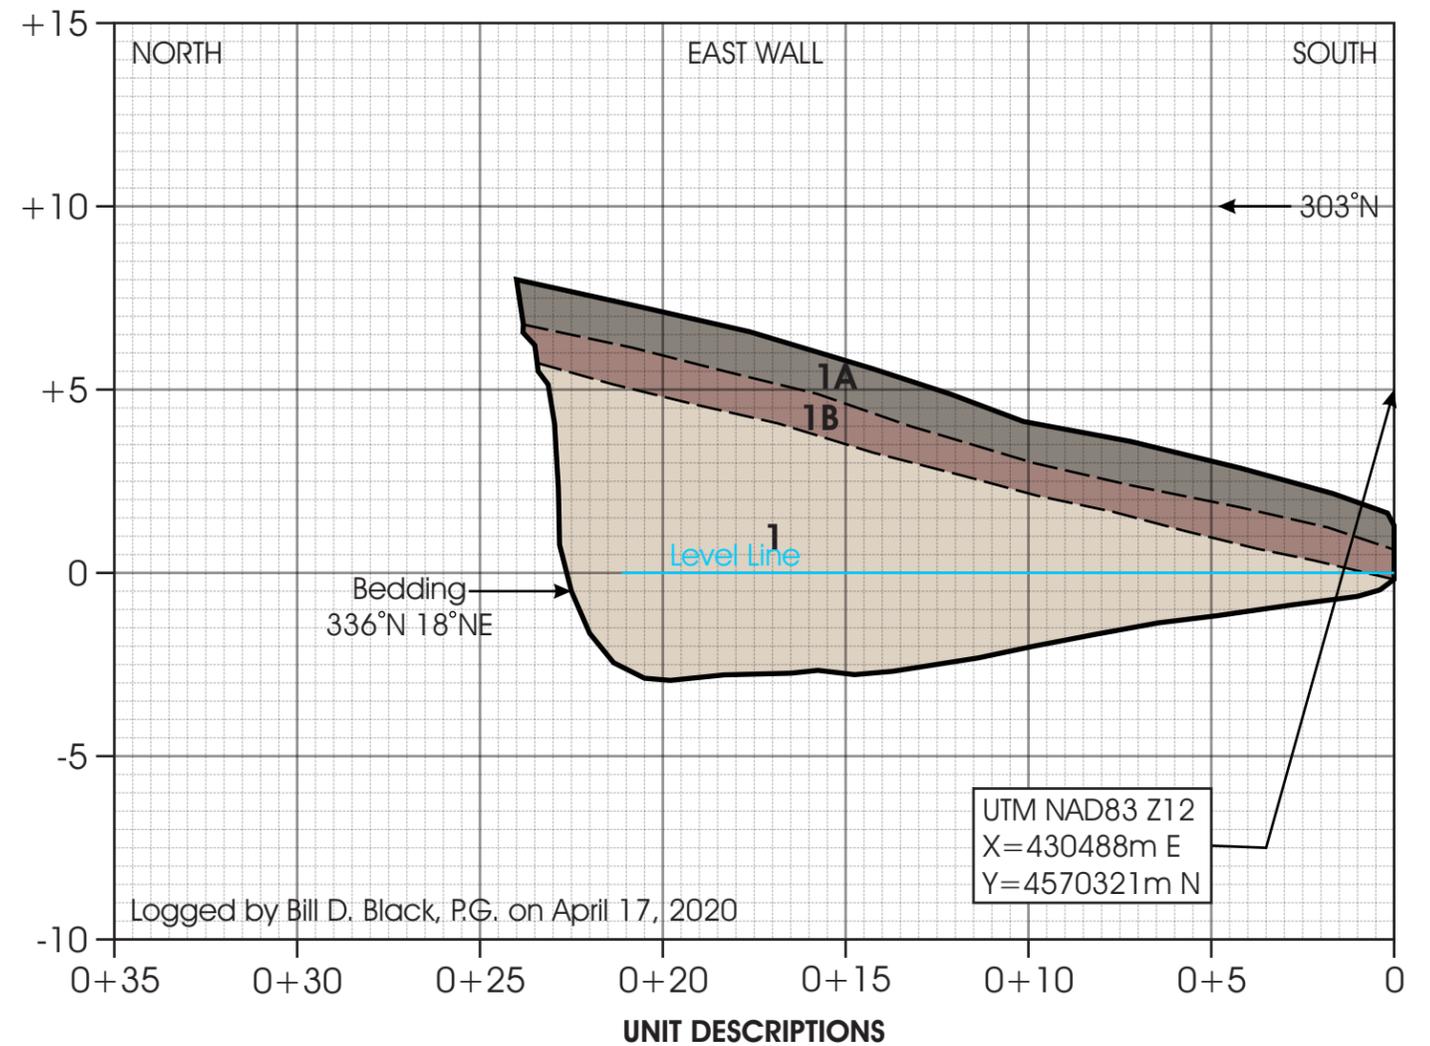
### TEST PIT 16

**Unit 1.** *Tertiary Norwood Formation* - Olive, white, pale-brown, and orange- to dark-brown, weathered tuffaceous conglomerate with stage III carbonate; modern A horizon (1A) and Bk horizon (1B) formed in unit.

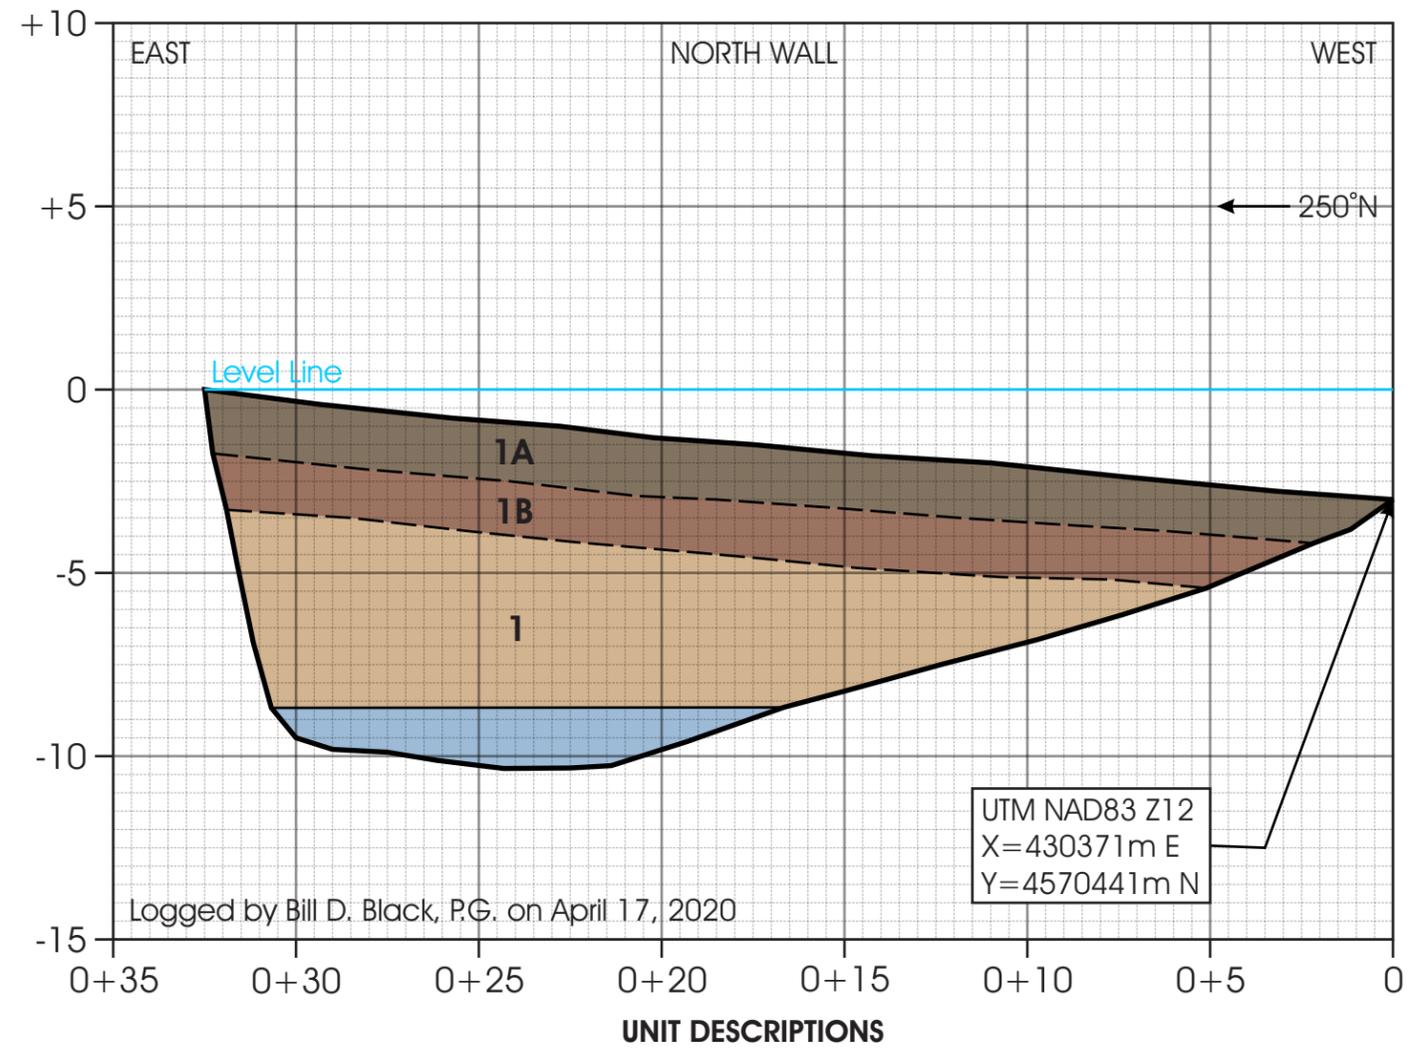
# TEST PIT 17

**Unit 1.** Tertiary Norwood Formation - Orange-brown, poorly bedded to massive, moderate to high density, weathered claystone; modern A horizon (1A) and Bw/Bt horizon (1B) formed in unit.

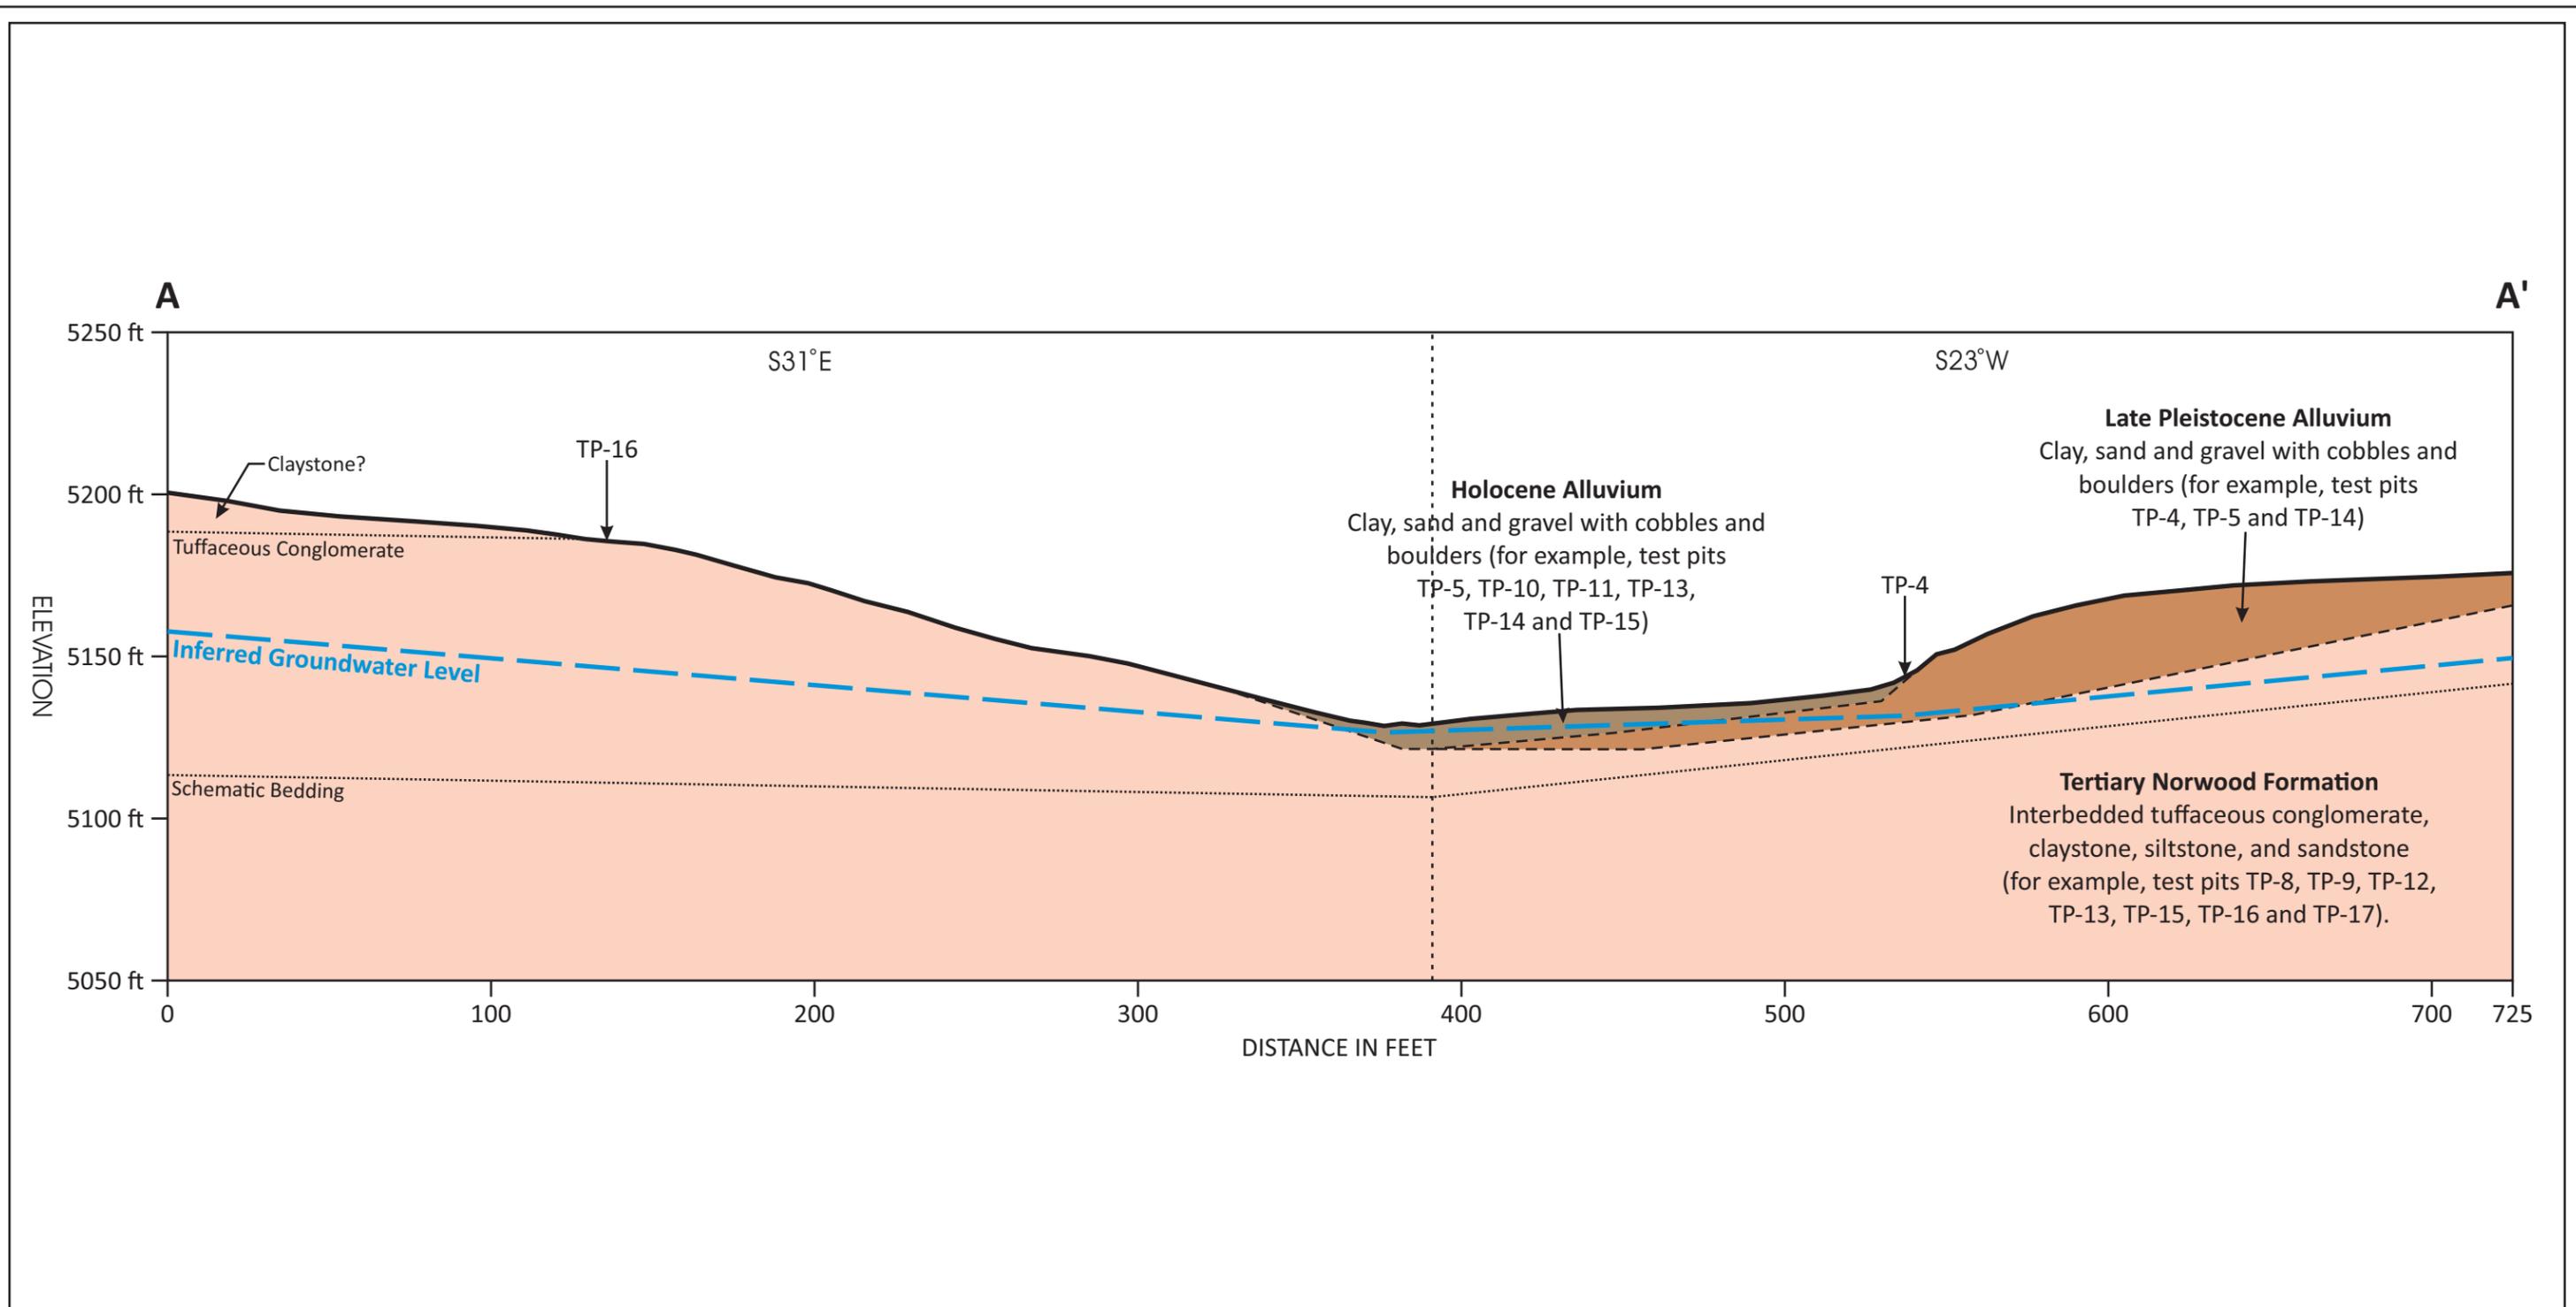
**FIGURE 5**

SCALE: 1 inch = 50 feet  
(no vertical exaggeration)  
Unit and textural contacts  
are approximate and inferred

**CROSS SECTION A-A'**

Figures 5 through 7 show three cross sections (A-A', B-B', and C-C') across the site as located on Figures 3A-C. Figures 5 and 6 are at a scale of 1 inch equals 50 feet and Figure 7 is at a scale of 1 inch equals 100 feet, with no vertical exaggeration. Units and contacts are based on subsurface data from the test pits (Figures 4A-I) and/or inferred from the geologic mapping on Figure 3C. The topographic profiles are based on geoprocessed 2011 LIDAR data. The LIDAR data provides a snapshot of topographic conditions at the time it was acquired; past, present and future surficial topography may vary. Units and contacts should be considered approximate and inferred, and variations should be expected at depth and laterally. We caution that some portions of the cross sections have limited or no subsurface data. Inferred groundwater levels are shown on the cross sections based on depths encountered in the test pits. Based on our test pit exposures, groundwater at the Project is generally from 10 to 30 feet deep, but appears to be locally less than 10 feet bgs along the unnamed creek and to the north along the range front base.
