## **GEOLOGIC HAZARDS EVALUATION PROPOSED CRIMSON RIDGE PHASE 2 SUBDIVISION ABOUT 1100 NORTH MORNINGSIDE LANE EDEN, UTAH**

**Letter of Transmittal:** REPORT  
Geologic Hazards Evaluation  
Proposed Crimson Ridge Phase 2 Subdivision  
About 1100 North Morningside Lane  
Eden, Utah

**WG&E Project No. 5378**

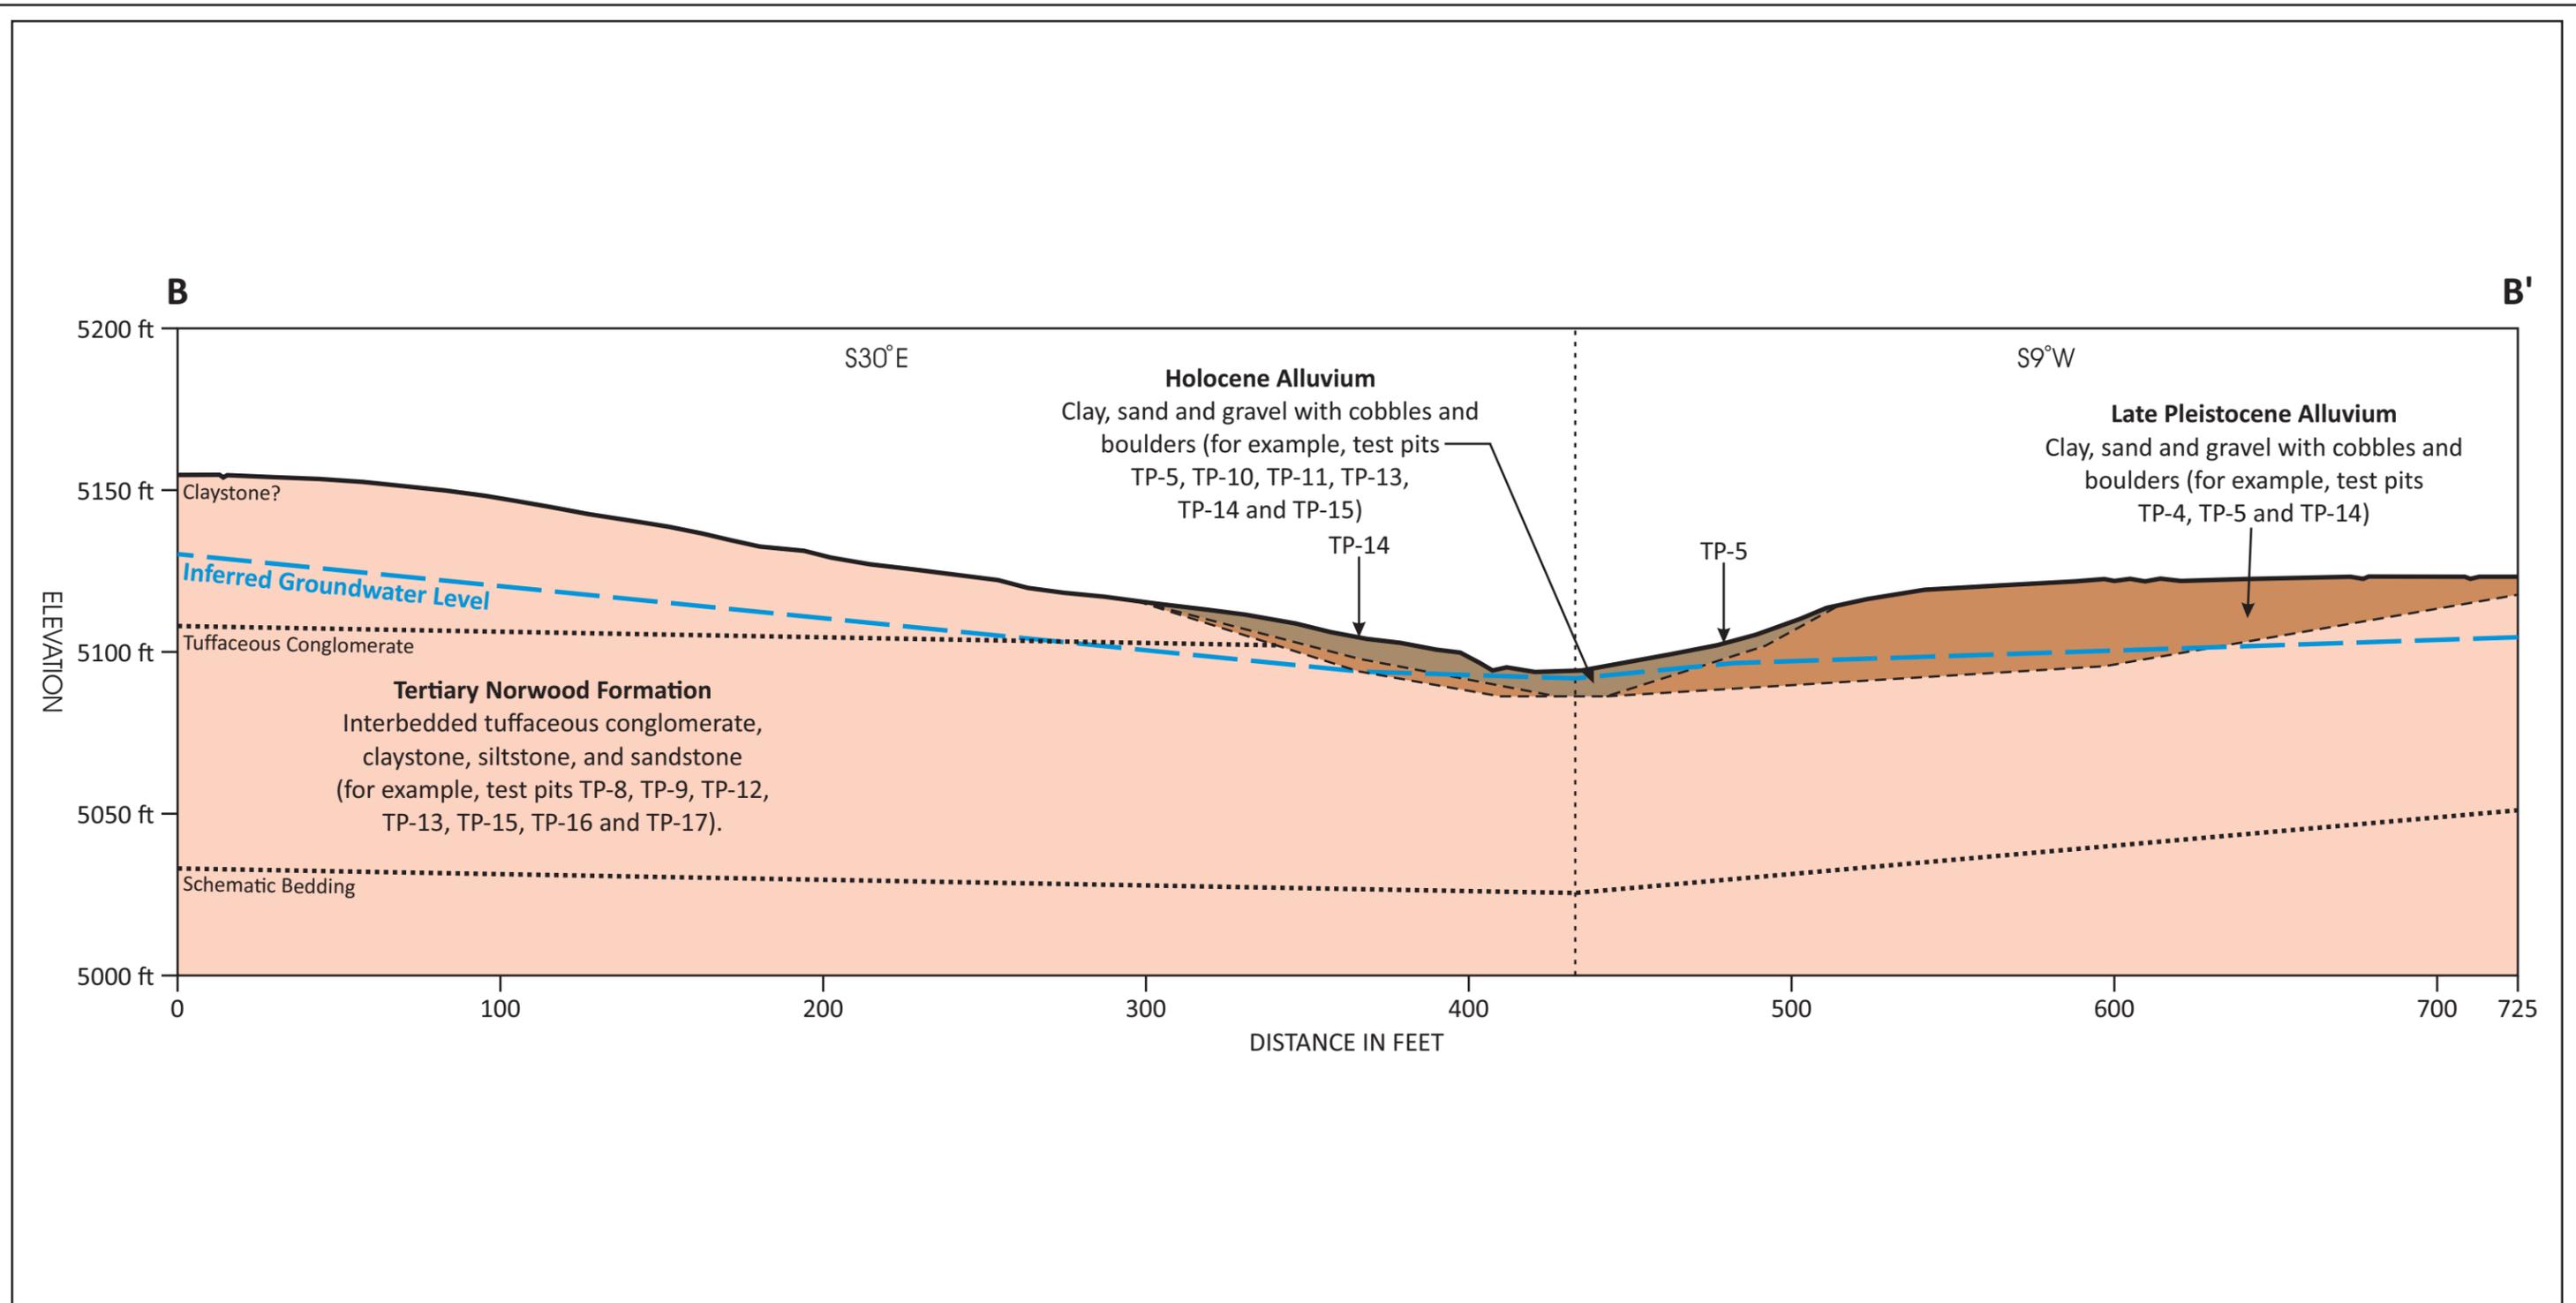
**FIGURE 6**

SCALE: 1 inch = 50 feet  
(no vertical exaggeration)  
Unit and textural contacts  
are approximate and inferred

**CROSS SECTION B-B'**

Figures 5 through 7 show three cross sections (A-A', B-B', and C-C') across the site as located on Figures 3A-C. Figures 5 and 6 are at a scale of 1 inch equals 50 feet and Figure 7 is at a scale of 1 inch equals 100 feet, with no vertical exaggeration. Units and contacts are based on subsurface data from the test pits (Figures 4A-I) and/or inferred from the geologic mapping on Figure 3C. The topographic profiles are based on geoprocessed 2011 LIDAR data. The LIDAR data provides a snapshot of topographic conditions at the time it was acquired; past, present and future surficial topography may vary. Units and contacts should be considered approximate and inferred, and variations should be expected at depth and laterally. We caution that some portions of the cross sections have limited or no subsurface data. Inferred groundwater levels are shown on the cross sections based on depths encountered in the test pits. Based on our test pit exposures, groundwater at the Project is generally from 10 to 30 feet deep, but appears to be locally less than 10 feet bgs along the unnamed creek and to the north along the range front base.

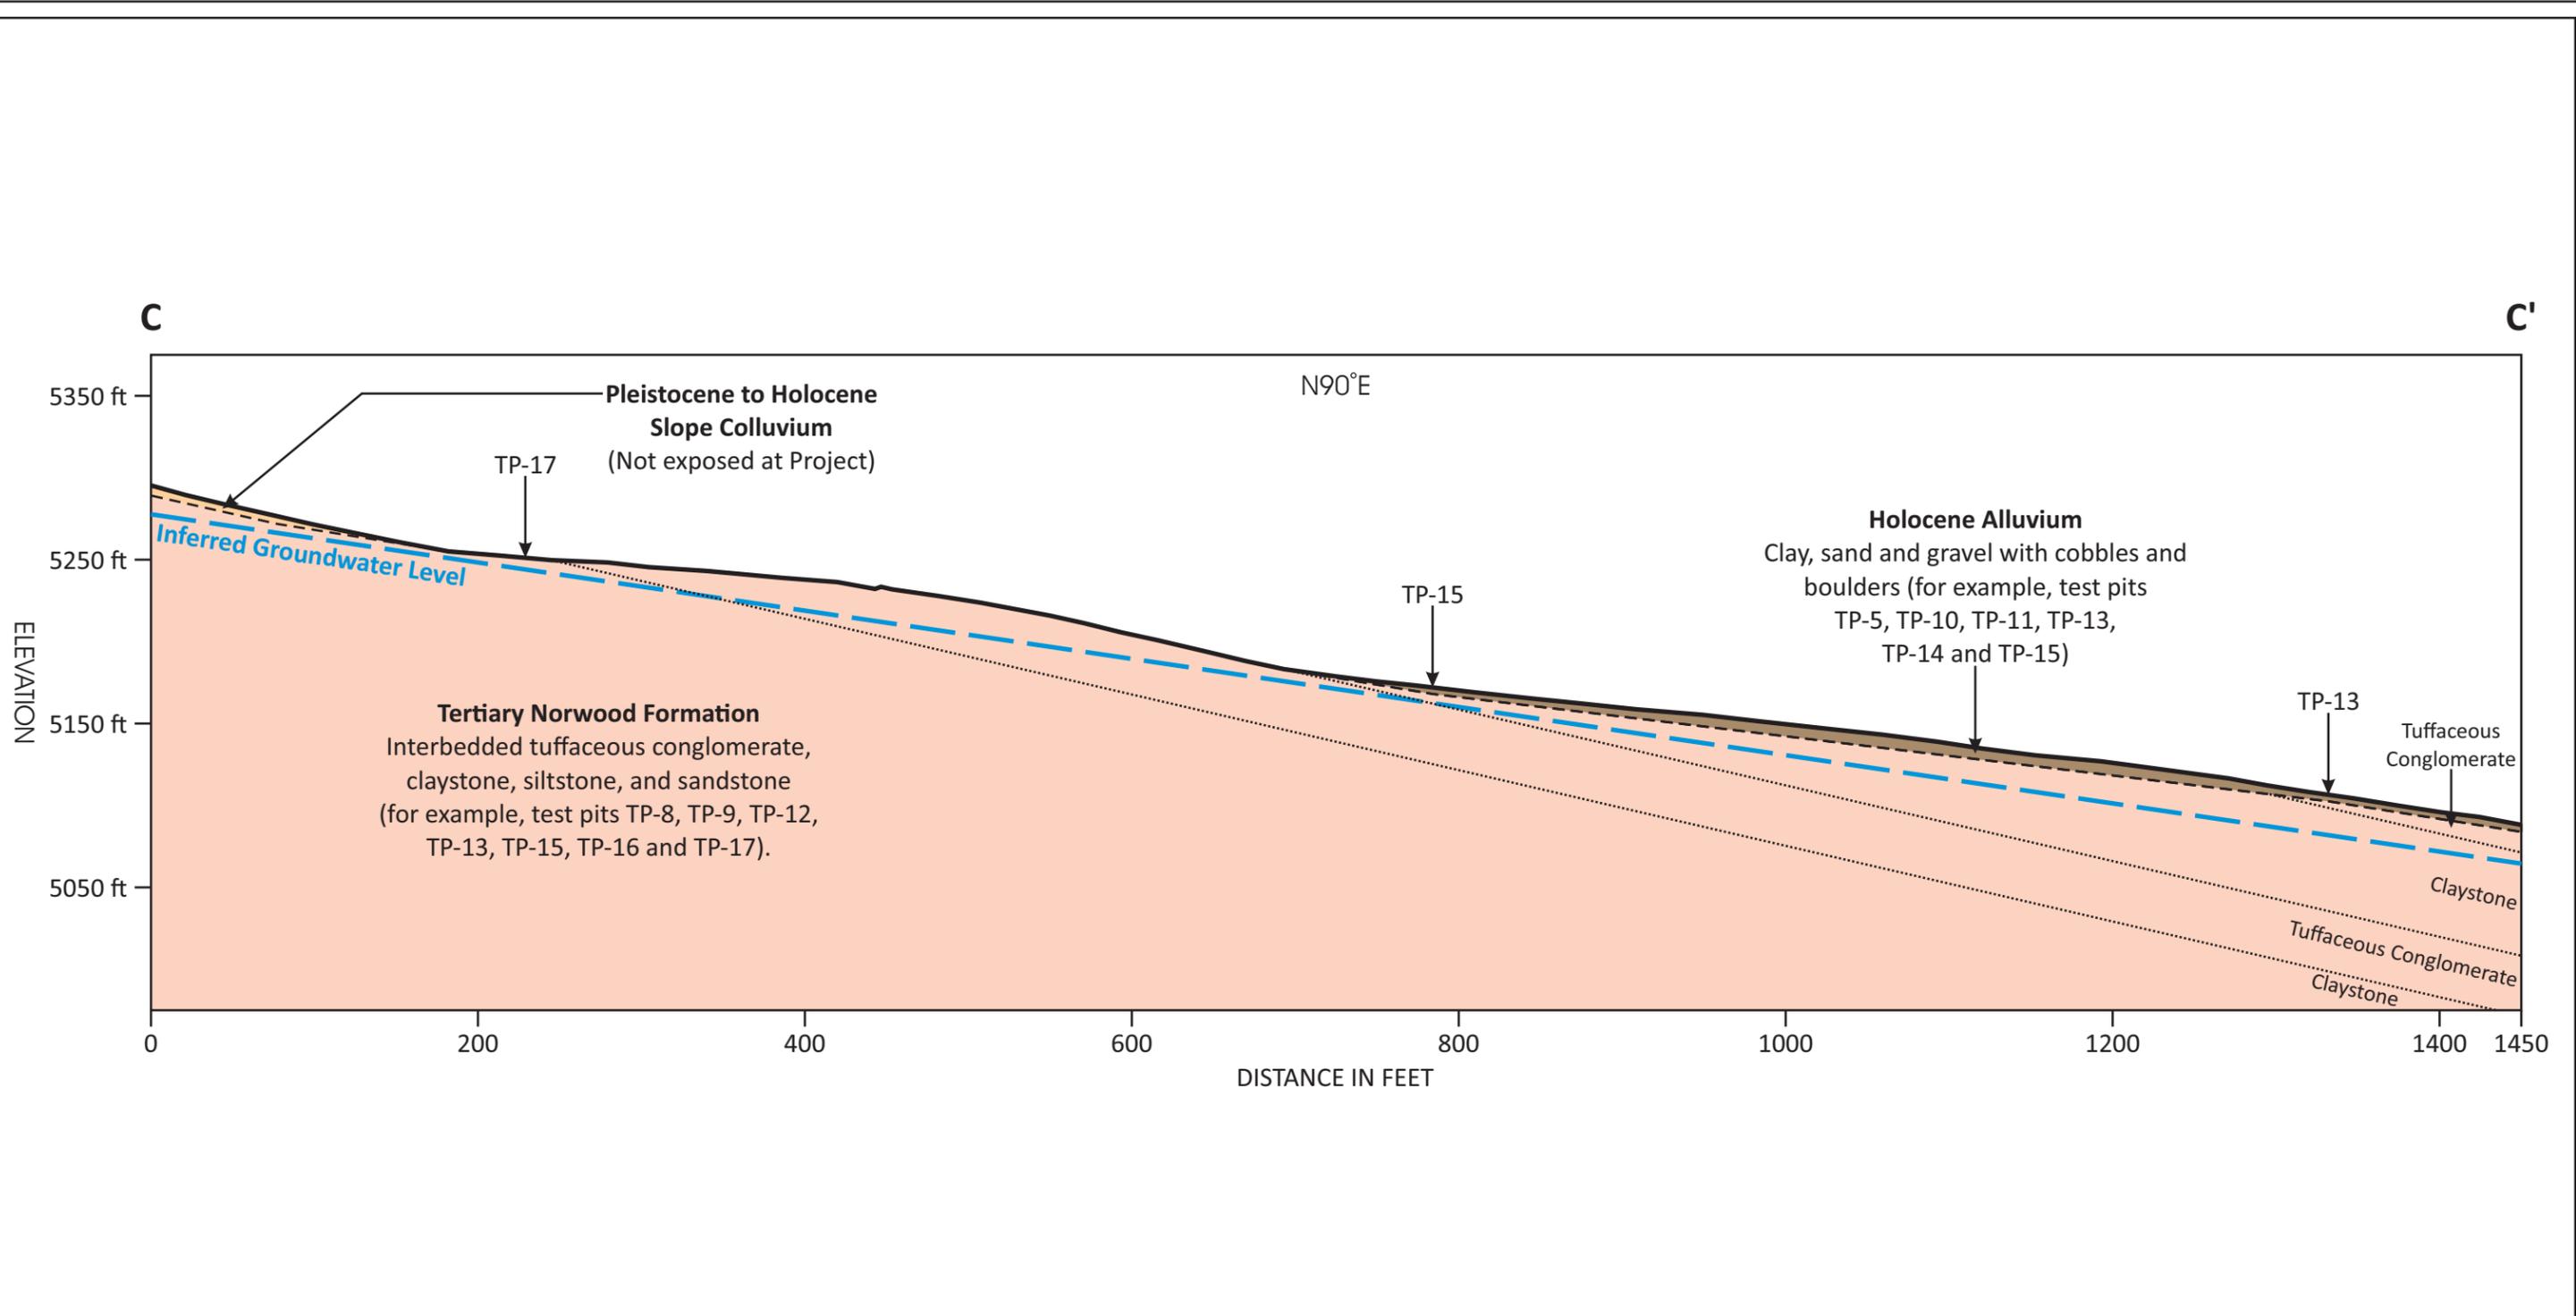
SCALE: 1 inch = 100 feet  
(no vertical exaggeration)  
Unit and textural contacts  
are approximate and inferred

**CROSS SECTION C-C'**
