# Staff Report for Administrative Hillside Review Approval

<b>Application Request:</b>	Consideration and action on a Hillside Review Application for 6682 Chaparral Road, Huntsville.
<b>Type of Decision:</b>	Administrative
<b>Applicant:</b>	George Haley
<b>File Number:</b>	HSR 2021-01

## **GEOLOGIC HAZARDS EVALUATION LEGENDS AT HAWKINS CREEK LOT 2 6682 EAST CHAPARRAL ROAD HUNTSVILLE, WEBER COUNTY, UTAH**

**Geotechnical Investigation  
Legends at Hawkins Creek Lot 2  
Weber County, Utah**

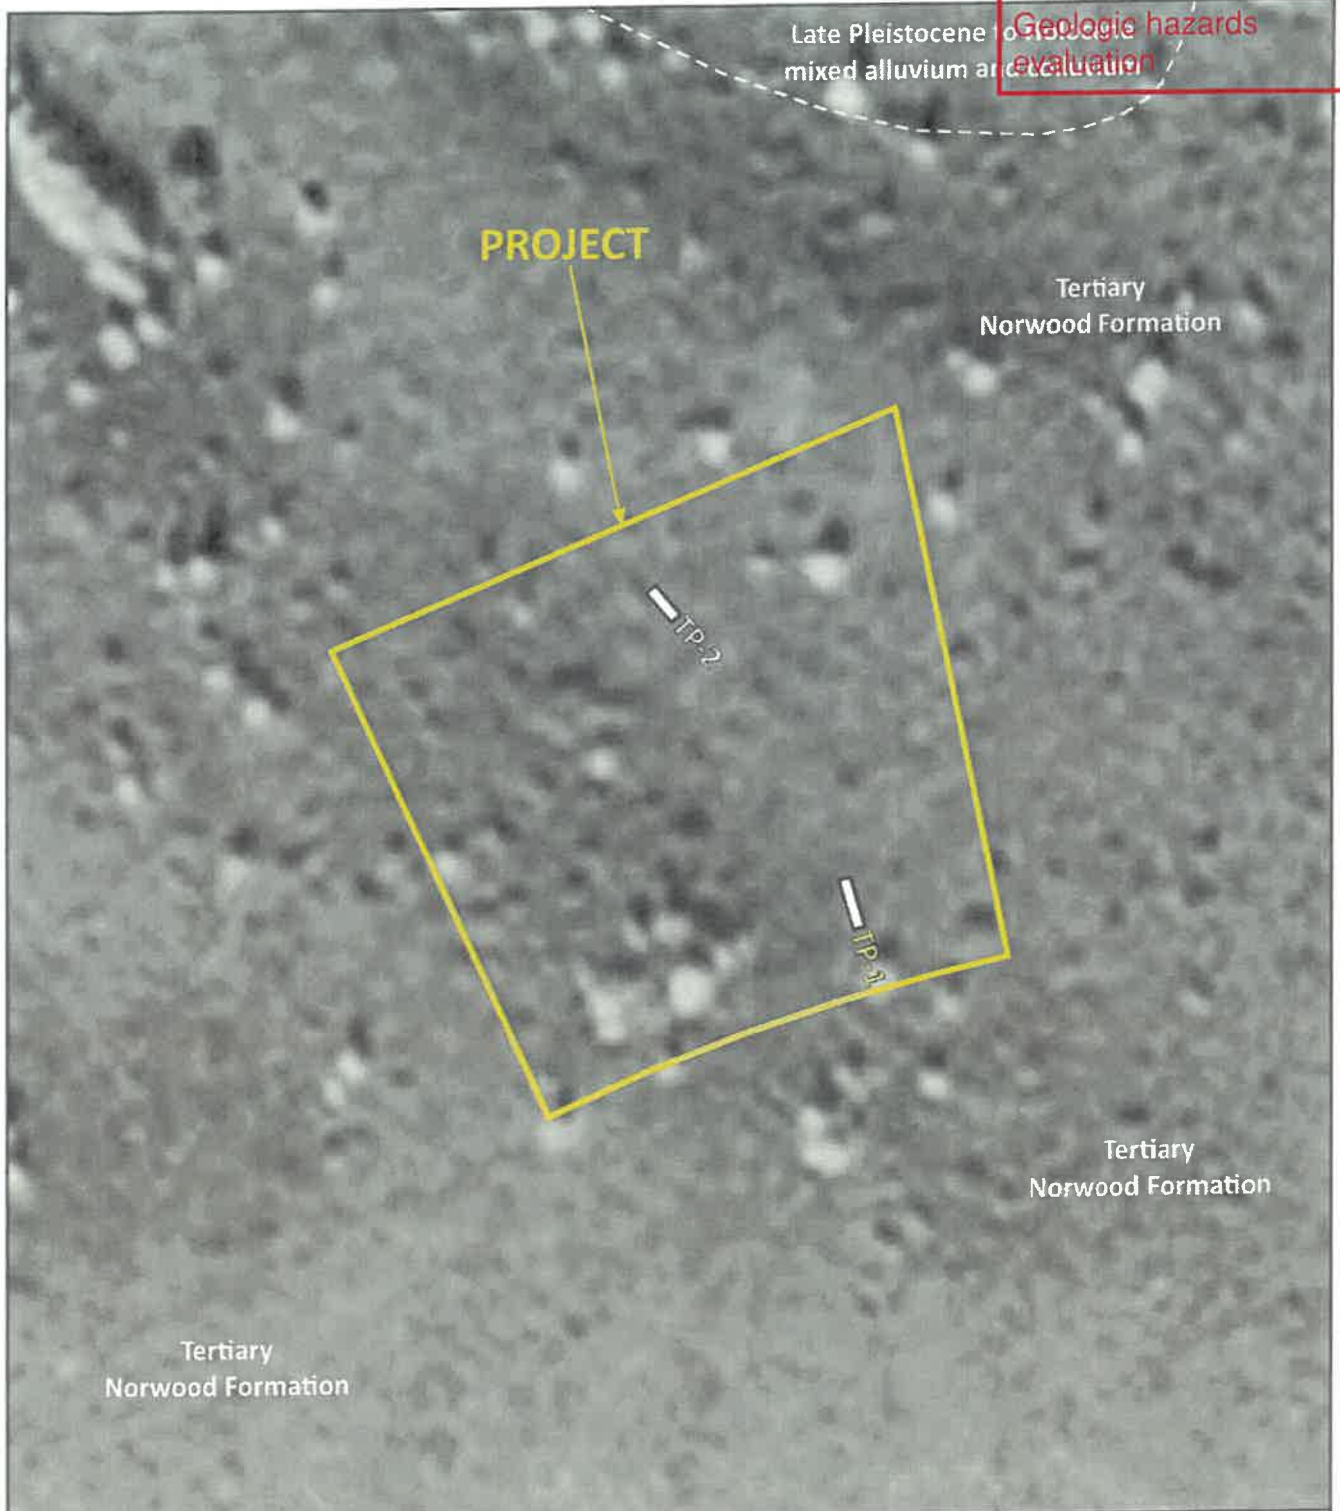
<b>1997 AERIAL PHOTO</b>
<b>GEOLOGIC HAZARDS EVALUATION</b> Legends at Hawkins Creek Lot 2 6682 East Chaparral Road Huntsville, Weber County, Utah
<b>FIGURE 3A</b>

Source: Utah AGRC 1997 Digital Orthophoto, 1 m resolution.

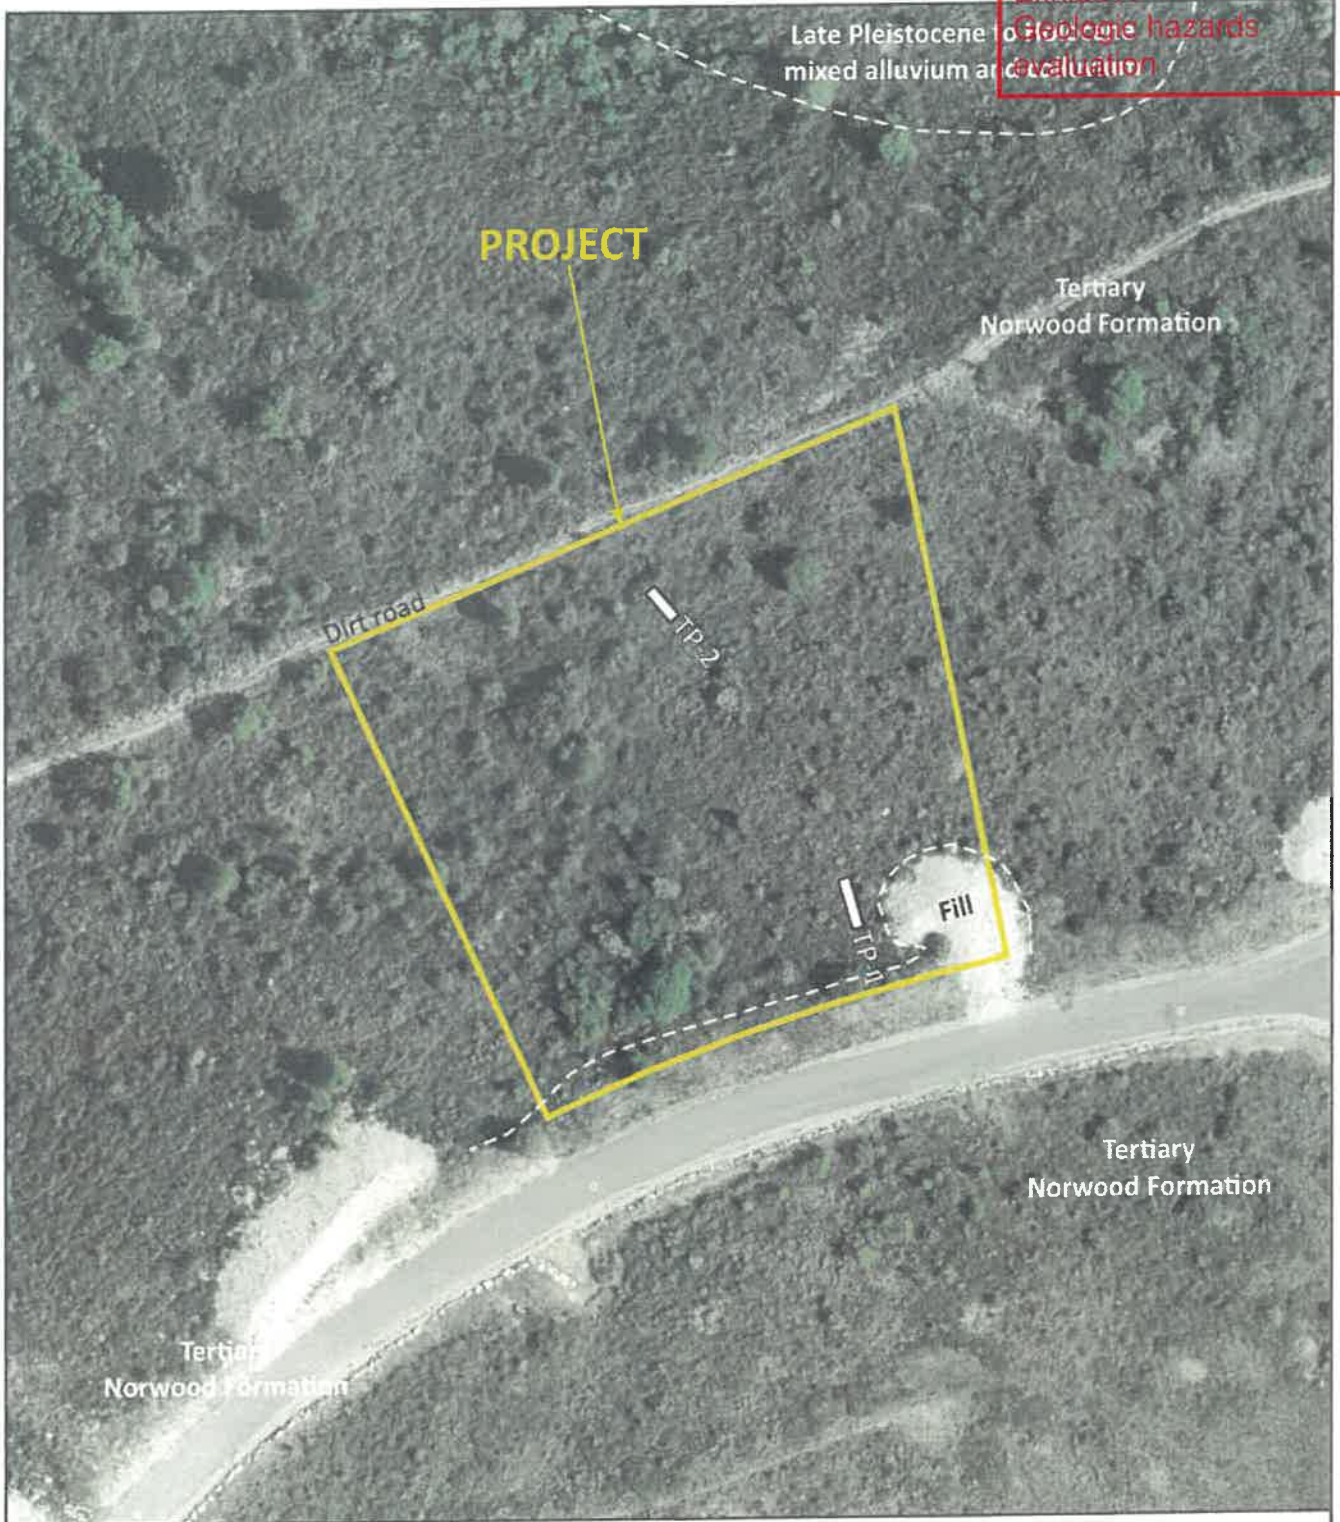
**FIGURE 3B**

Source: Utah AGRC, 2012 High Resolution Orthophoto, 12.5 cm resolution.

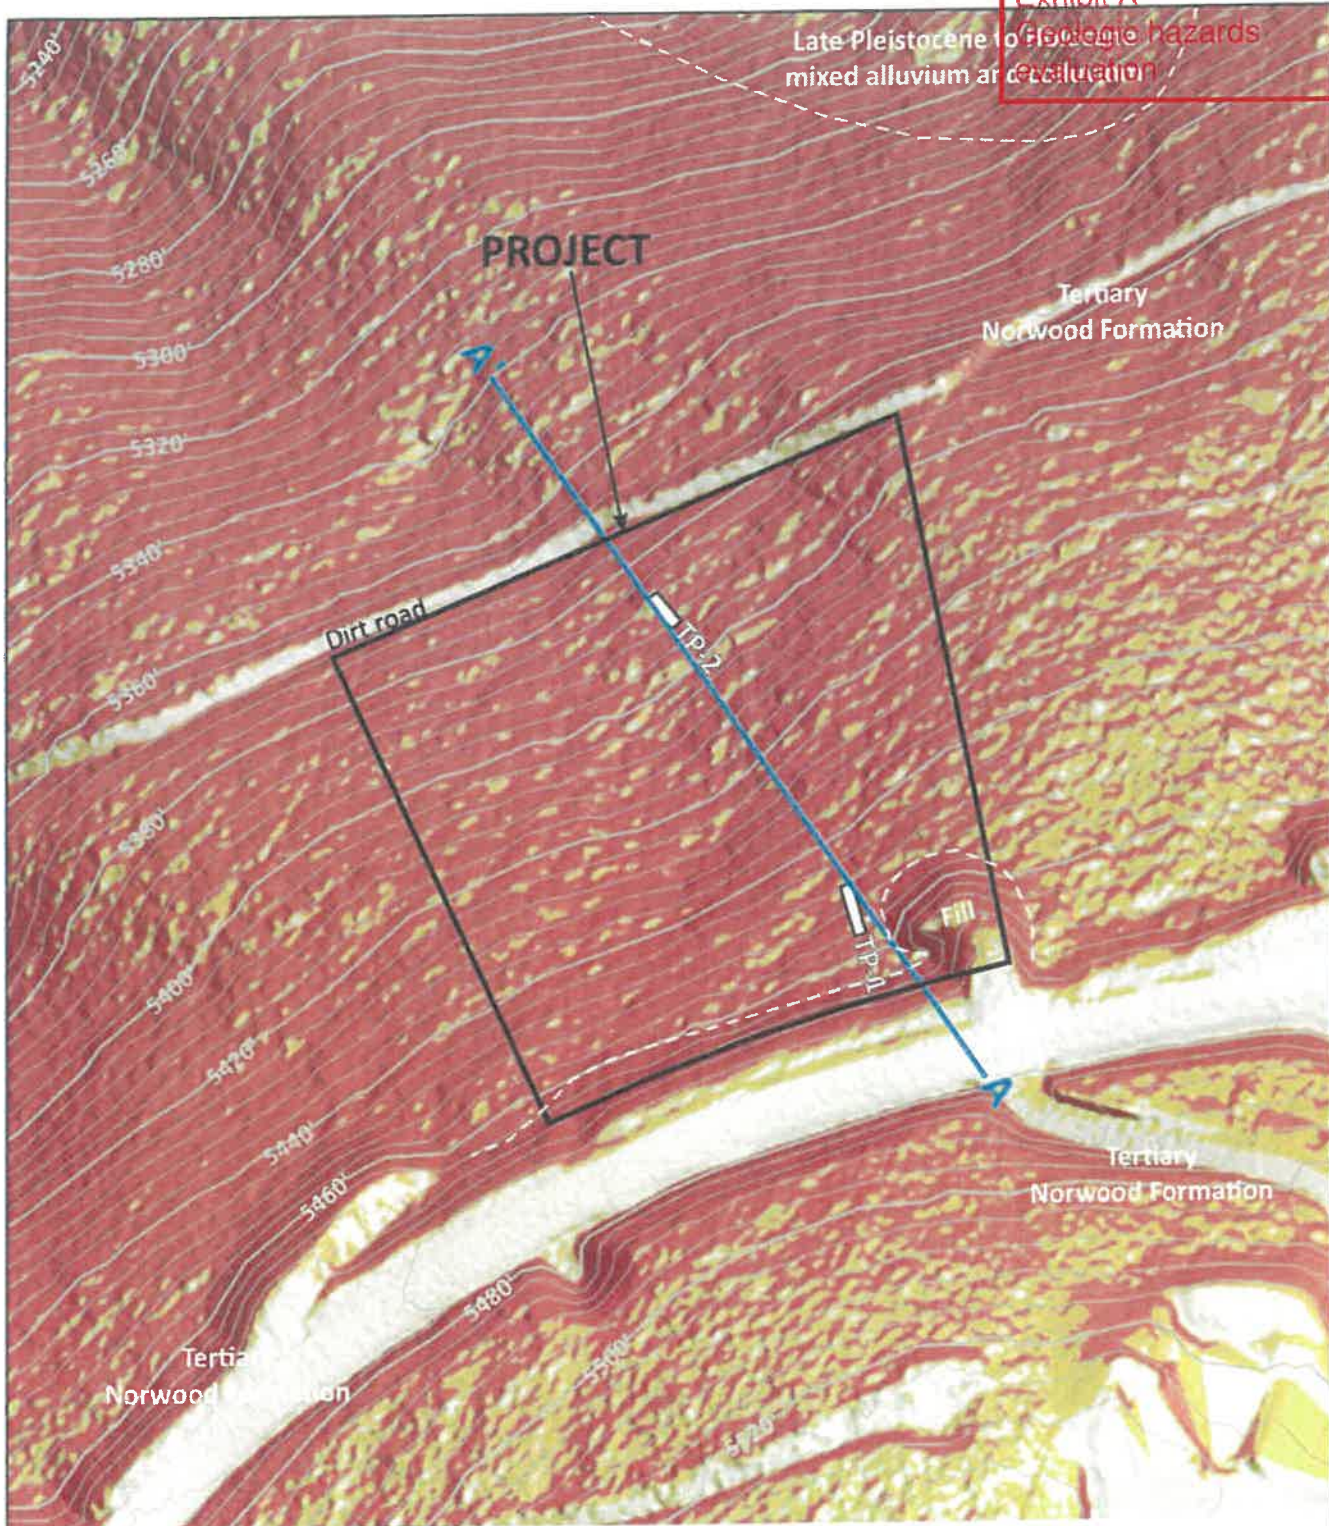
### LIDAR ANALYSIS

Source: Utah AGRC, 2016 LIDAR Bare Earth DEM. 50 cm resolution; 4-foot contour interval; slope gradients <15% unshaded, 15-25% in yellow, and >25% in red.

Figure 5 shows one cross section (A-A’) across the site at a scale of 1 inch equals 30 feet with no vertical exaggeration. Location of the cross section is shown on Figure 3C. Units and contacts are based on subsurface data from the test pits (Figure 4) and/or inferred from the geologic mapping on Figures 3A-C. The topographic profile is based on geoprocessed 2016 LIDAR data. The LIDAR data provides a snapshot of topographic conditions at the time it was acquired; past, present and future surficial topography may vary. Units and contacts should be considered approximate and inferred, and variations should be expected at depth and laterally. We caution that some portions of the cross section have limited or no subsurface data, particularly at depth. Schematic bedding dip was calculated using <http://app.visiblegeology.com/apparentDip.html> based on the profile trend (325° N) and the mean strike and dip (311° N 17° NE) from our measurements.

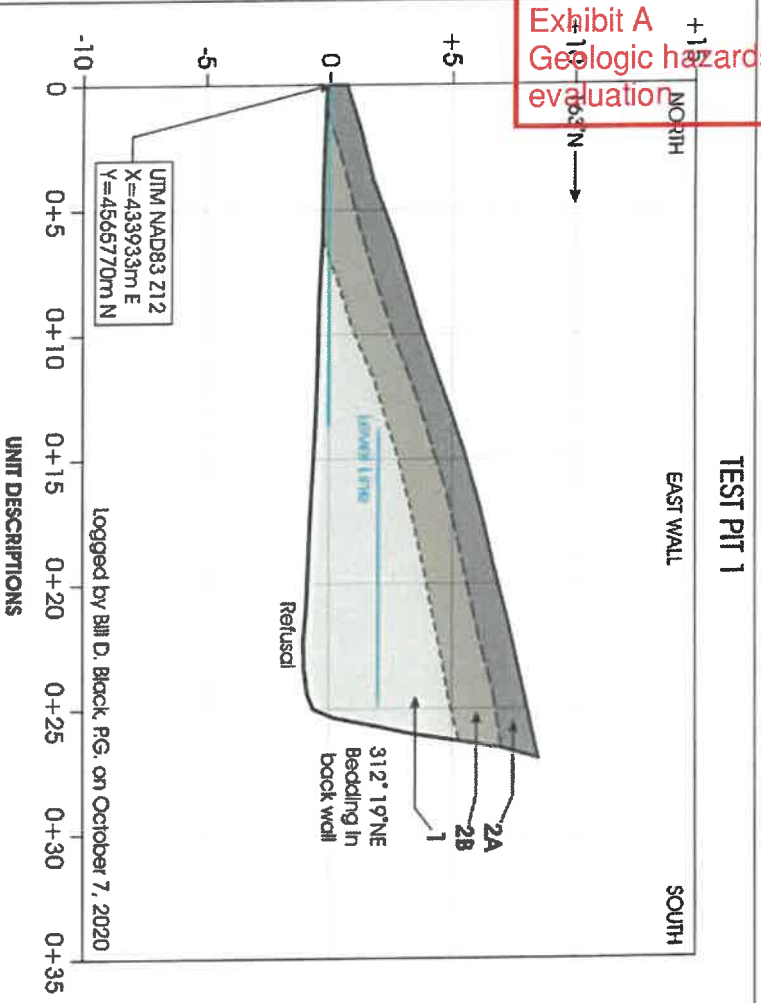
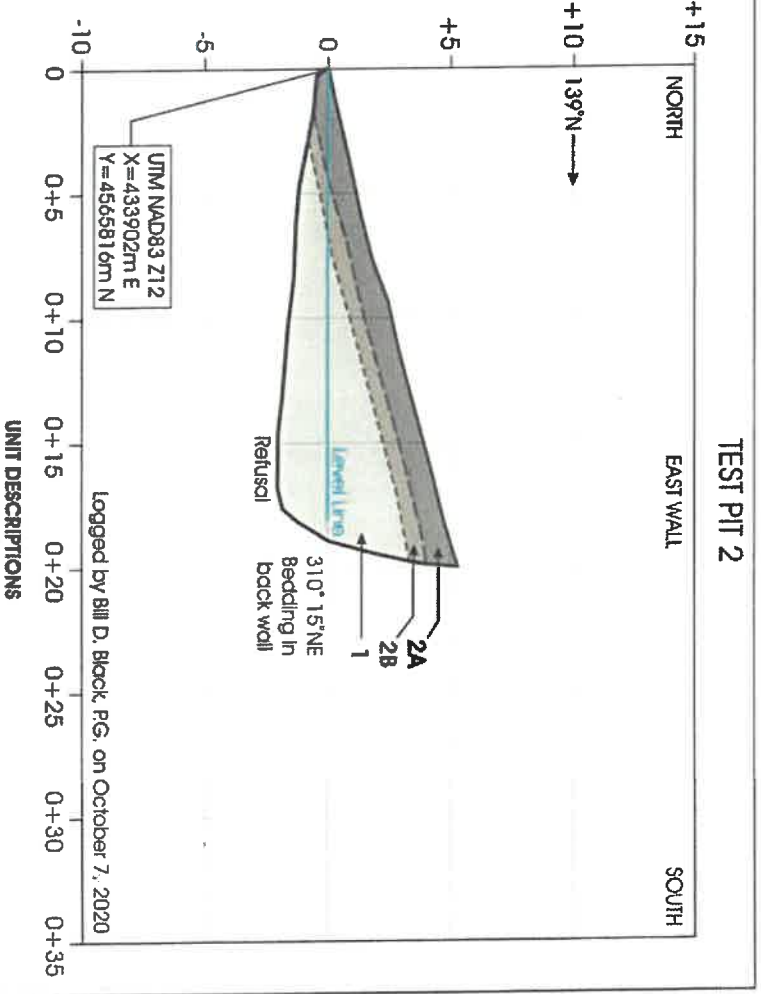
**TEST PIT LOGS**

Scale 1 inch equals 5 feet with no vertical exaggeration

Two test pits were excavated at the Project on October 7, 2020 to assess subsurface conditions. The test pits were logged by Bill D. Black, P.G. of Western Geologic concurrently with the Project geotechnical investigation conducted by Christensen Geotechnical. Locations of the test pits are shown on Figures 3A-C. The test pit locations were measured using a hand-held GPS unit and by trend and distance methods. The test pits were logged at a scale of 1-inch equals five feet (1:60) following methodology in McCalpin (1996), and digitally photographed at 5-foot intervals to document the exposures. The photos are not provided herein, but are available on request. Logs of the test pits are provided on Figure 4. Stratigraphic interpretations and descriptions are provided on the logs. Bedrock strike and dips were measured in both test pits. Bedrock in TP-1 showed a strike and dip of 312° N 19° NE, whereas bedrock in TP-2 showed a strike and dip of 310° N 15° NE. The measured strike and dips appear similar to those reported nearby on Figure 2. Mean strike and dip of the test pit measurements is 311° N 17° NE.

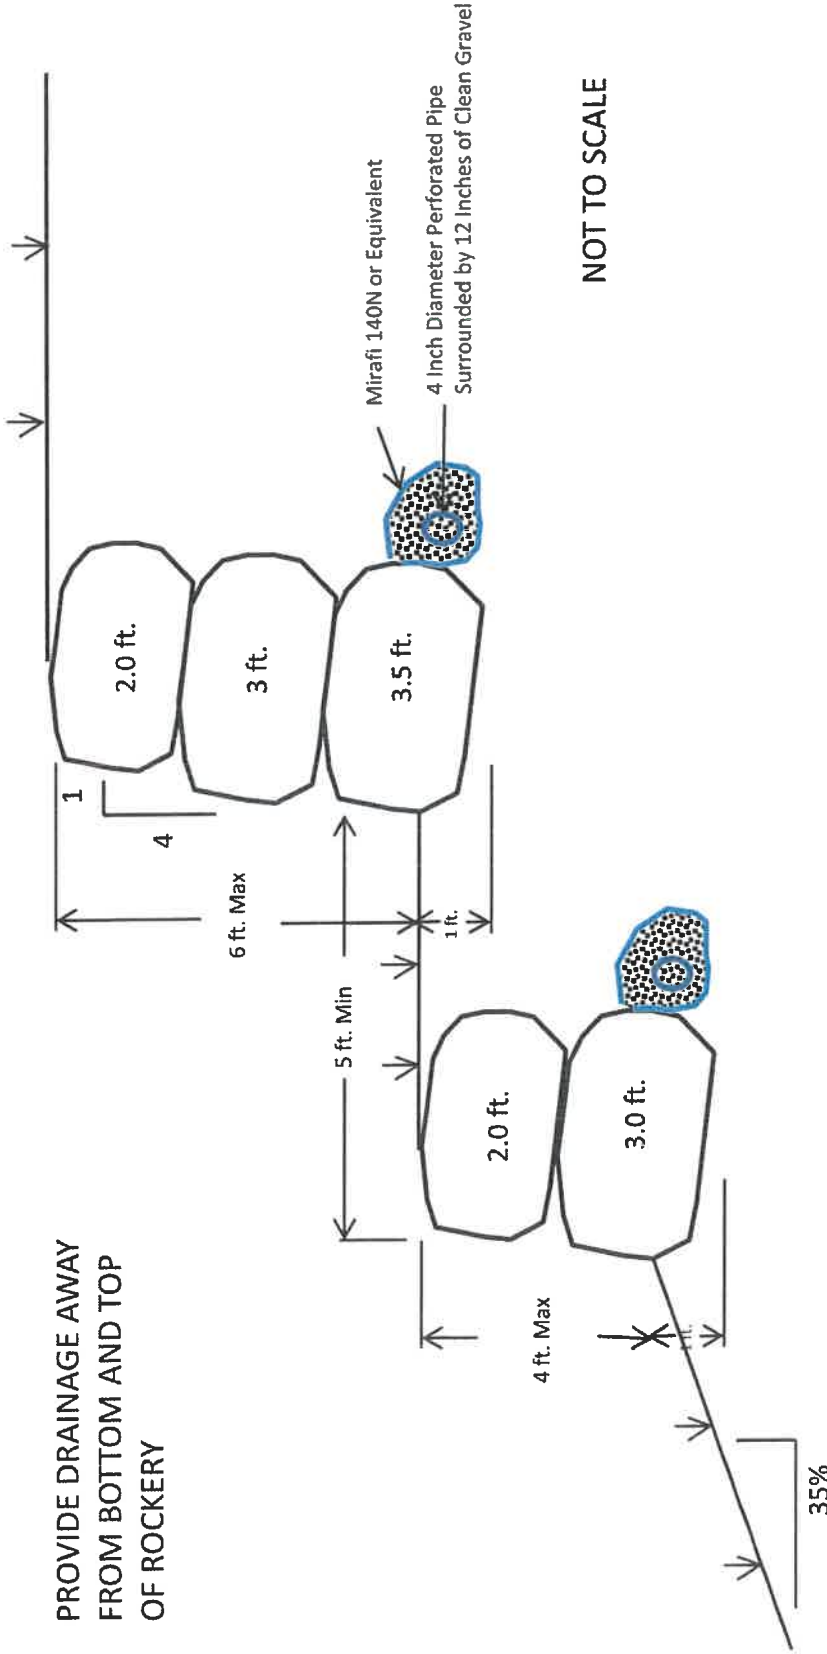
### ROCKERY 1 DETAIL

PROVIDE DRAINAGE AWAY  
FROM BOTTOM AND TOP  
OF ROCKERY

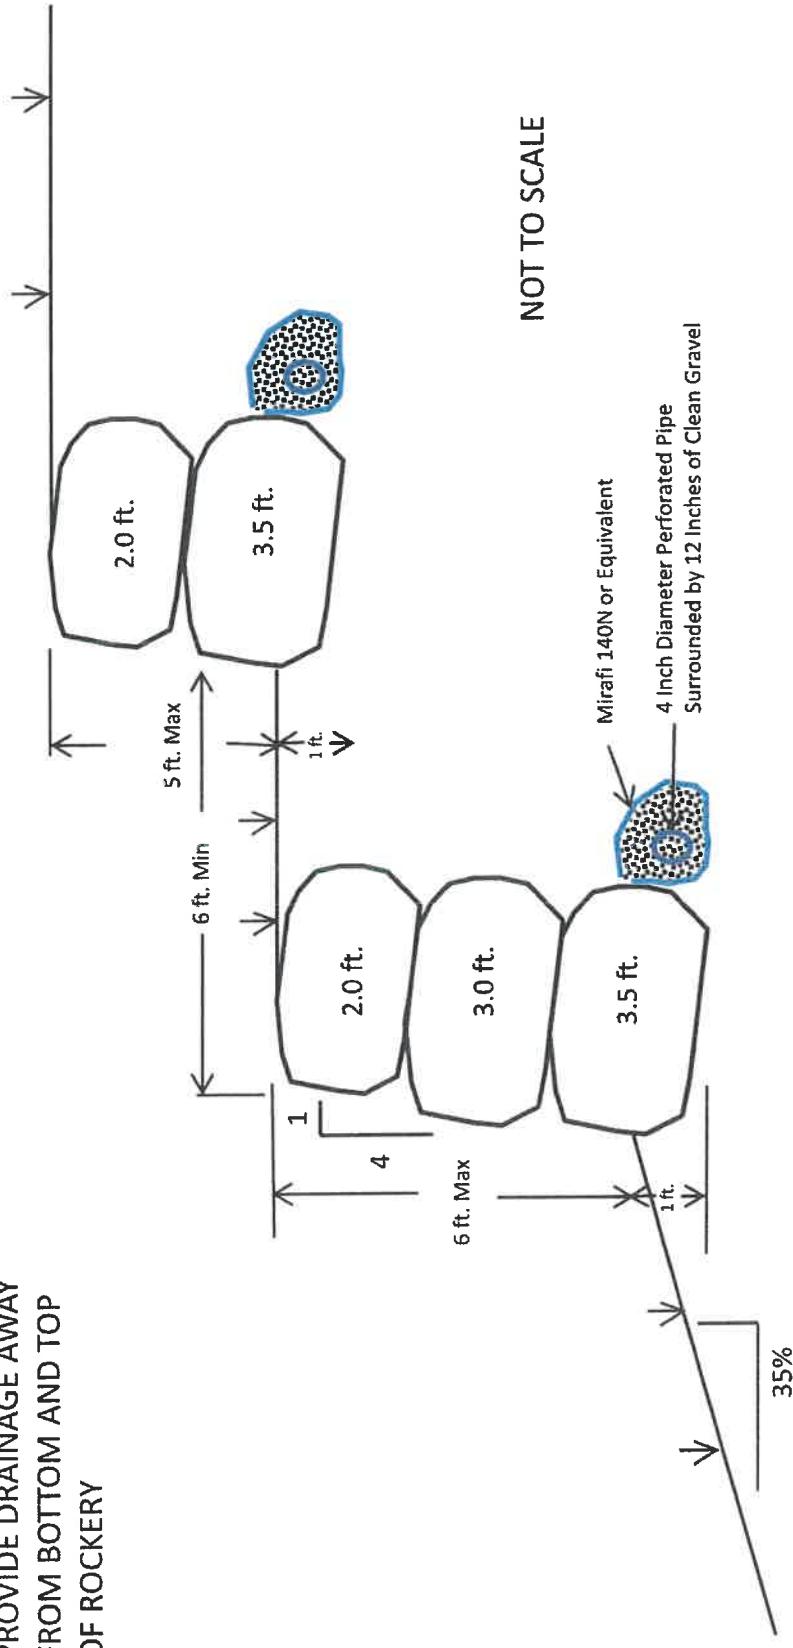
### ROCKERY 3 DETAIL

PROVIDE DRAINAGE AWAY  
FROM BOTTOM AND TOP  
OF ROCKERY

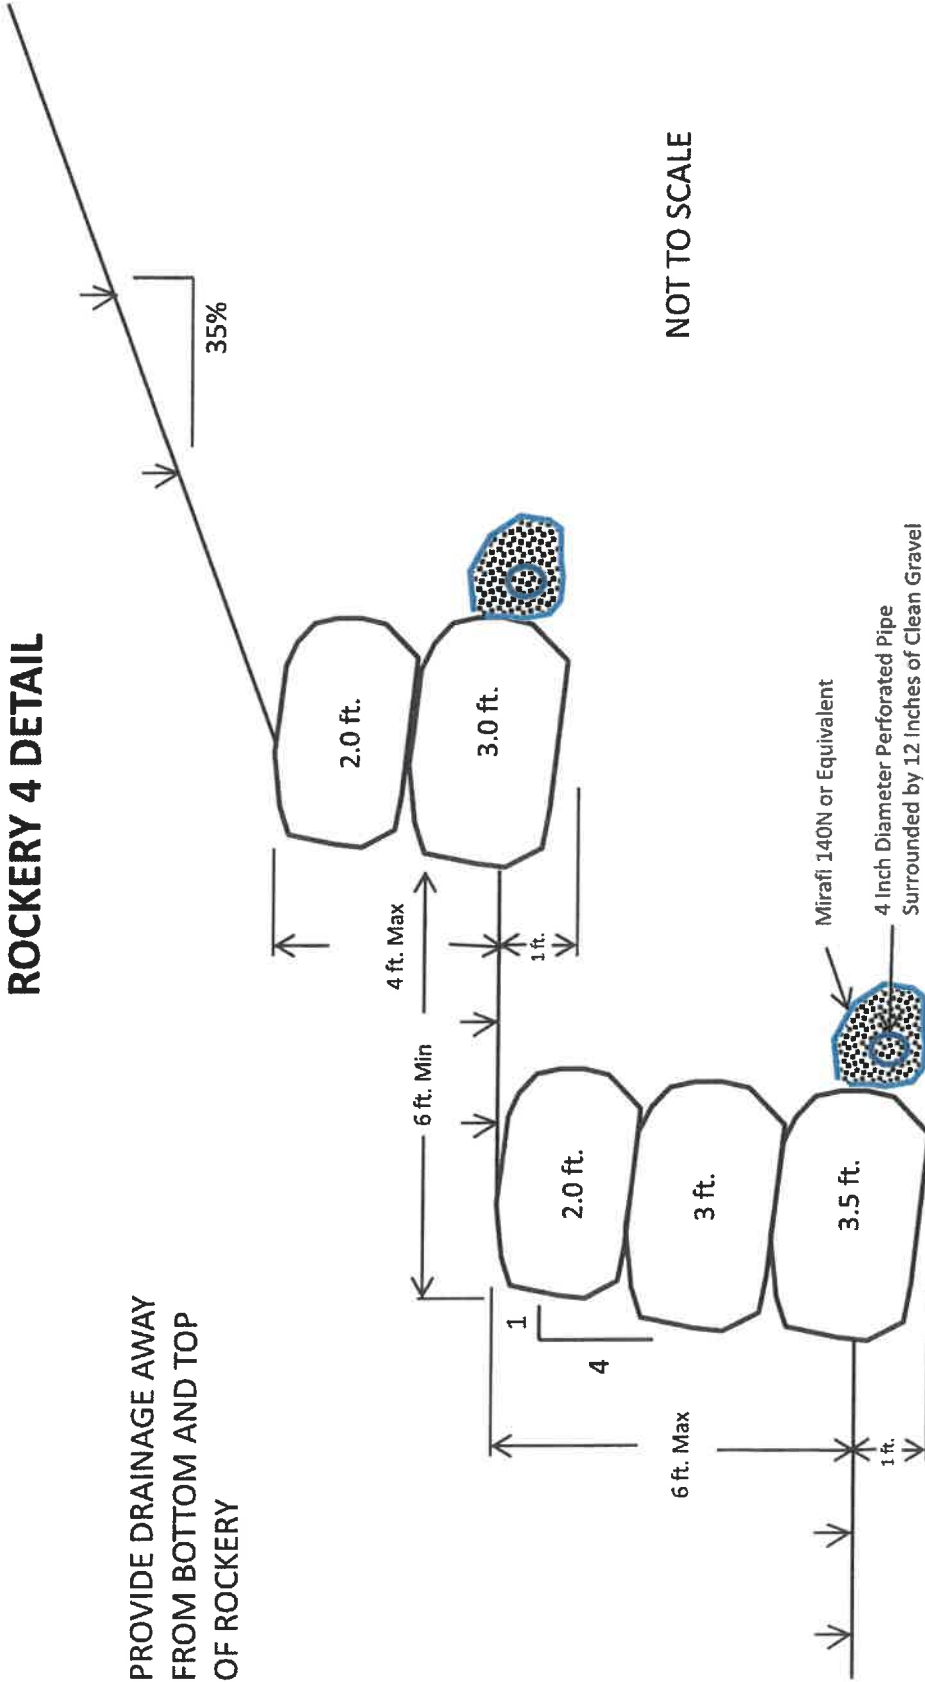
# ROCKERY 4 DETAIL

PROVIDE DRAINAGE AWAY  
FROM BOTTOM AND TOP  
OF ROCKERY

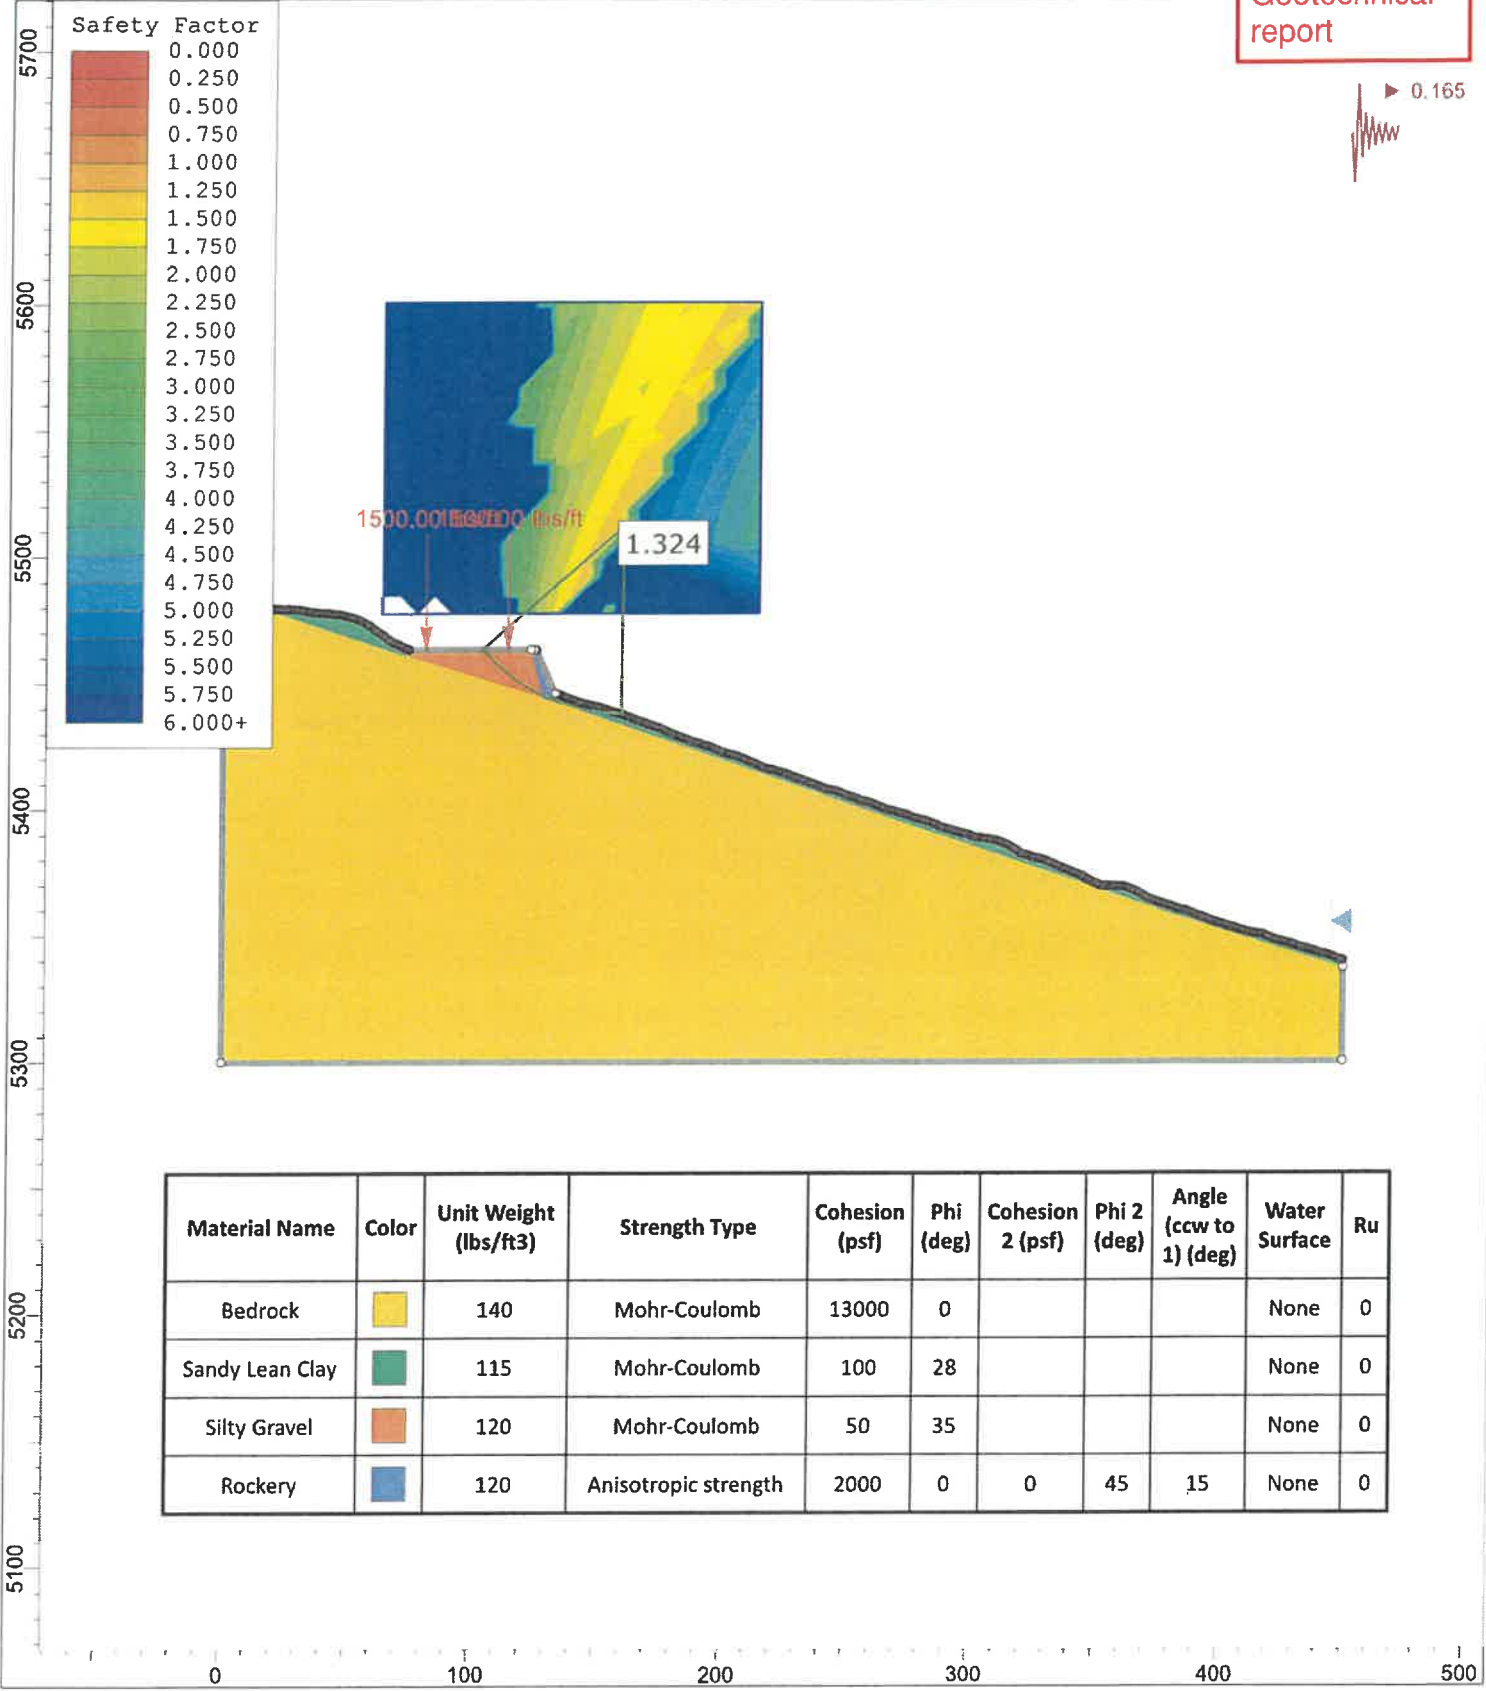
Material Name	Color	Unit Weight (lbs/ft <sup>3</sup> )	Strength Type	Cohesion (psf)	Phi (deg)	Cohesion 2 (psf)	Phi 2 (deg)	Angle (ccw to 1) (deg)	Water Surface	Ru
Bedrock	Yellow	140	Mohr-Coulomb	13000	0				None	0
Sandy Lean Clay	Green	115	Mohr-Coulomb	100	28				None	0
Silty Gravel	Orange	120	Mohr-Coulomb	50	35				None	0
Rockery	Blue	120	Anisotropic strength	2000	0	0	45	15	None	0

Global Stability - Pseudo Static
