**Geotechnical Investigation
Legacy Mountain Development
Huntsville, Weber County, Utah**

March 30, 2021

**Geotechnical Investigation
Legacy Mountain Development
Approximately 6000 East Nighthawk Lane
Huntsville, Weber County, Utah
CG Project No.: 133-009**

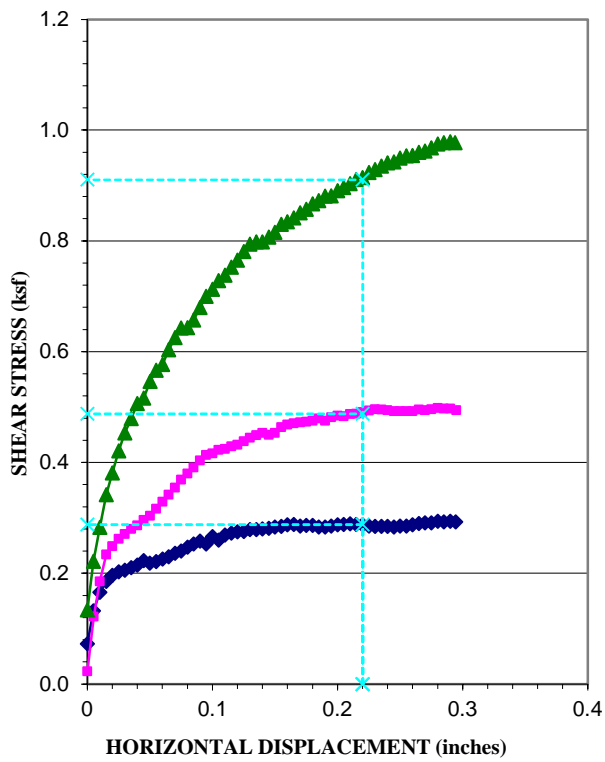
Plate
50

Location:	TP-21	Depth:	3.0 ft
Type of Test:	Consolidated Drained/Saturated		
Test No. (Symbol)	1 (◆)	2 (■)	3 (▲)
Sample Type:	Fully Softened		
Initial Height, in.	1	1	1
Diameter, in.	2.4	2.4	2.4
Dry Density Before, pcf	75.7	74.9	74.5
Moisture % Before	45.1	45.1	45.1
Normal Load, ksf	0.5	1.0	2.0
Shear Stress, ksf	0.29	0.49	0.91
Strain Rate	0.0006 in/min

Sample Properties	
Cohesion, psf	75
Friction Angle, ϕ	23
Liquid Limit, %	59
Plasticity Index, %	39
Percent Gravel	---
Percent Sand	---
Percent Passing No. 200 sieve	80.2
Classification	Fat CLAY with sand

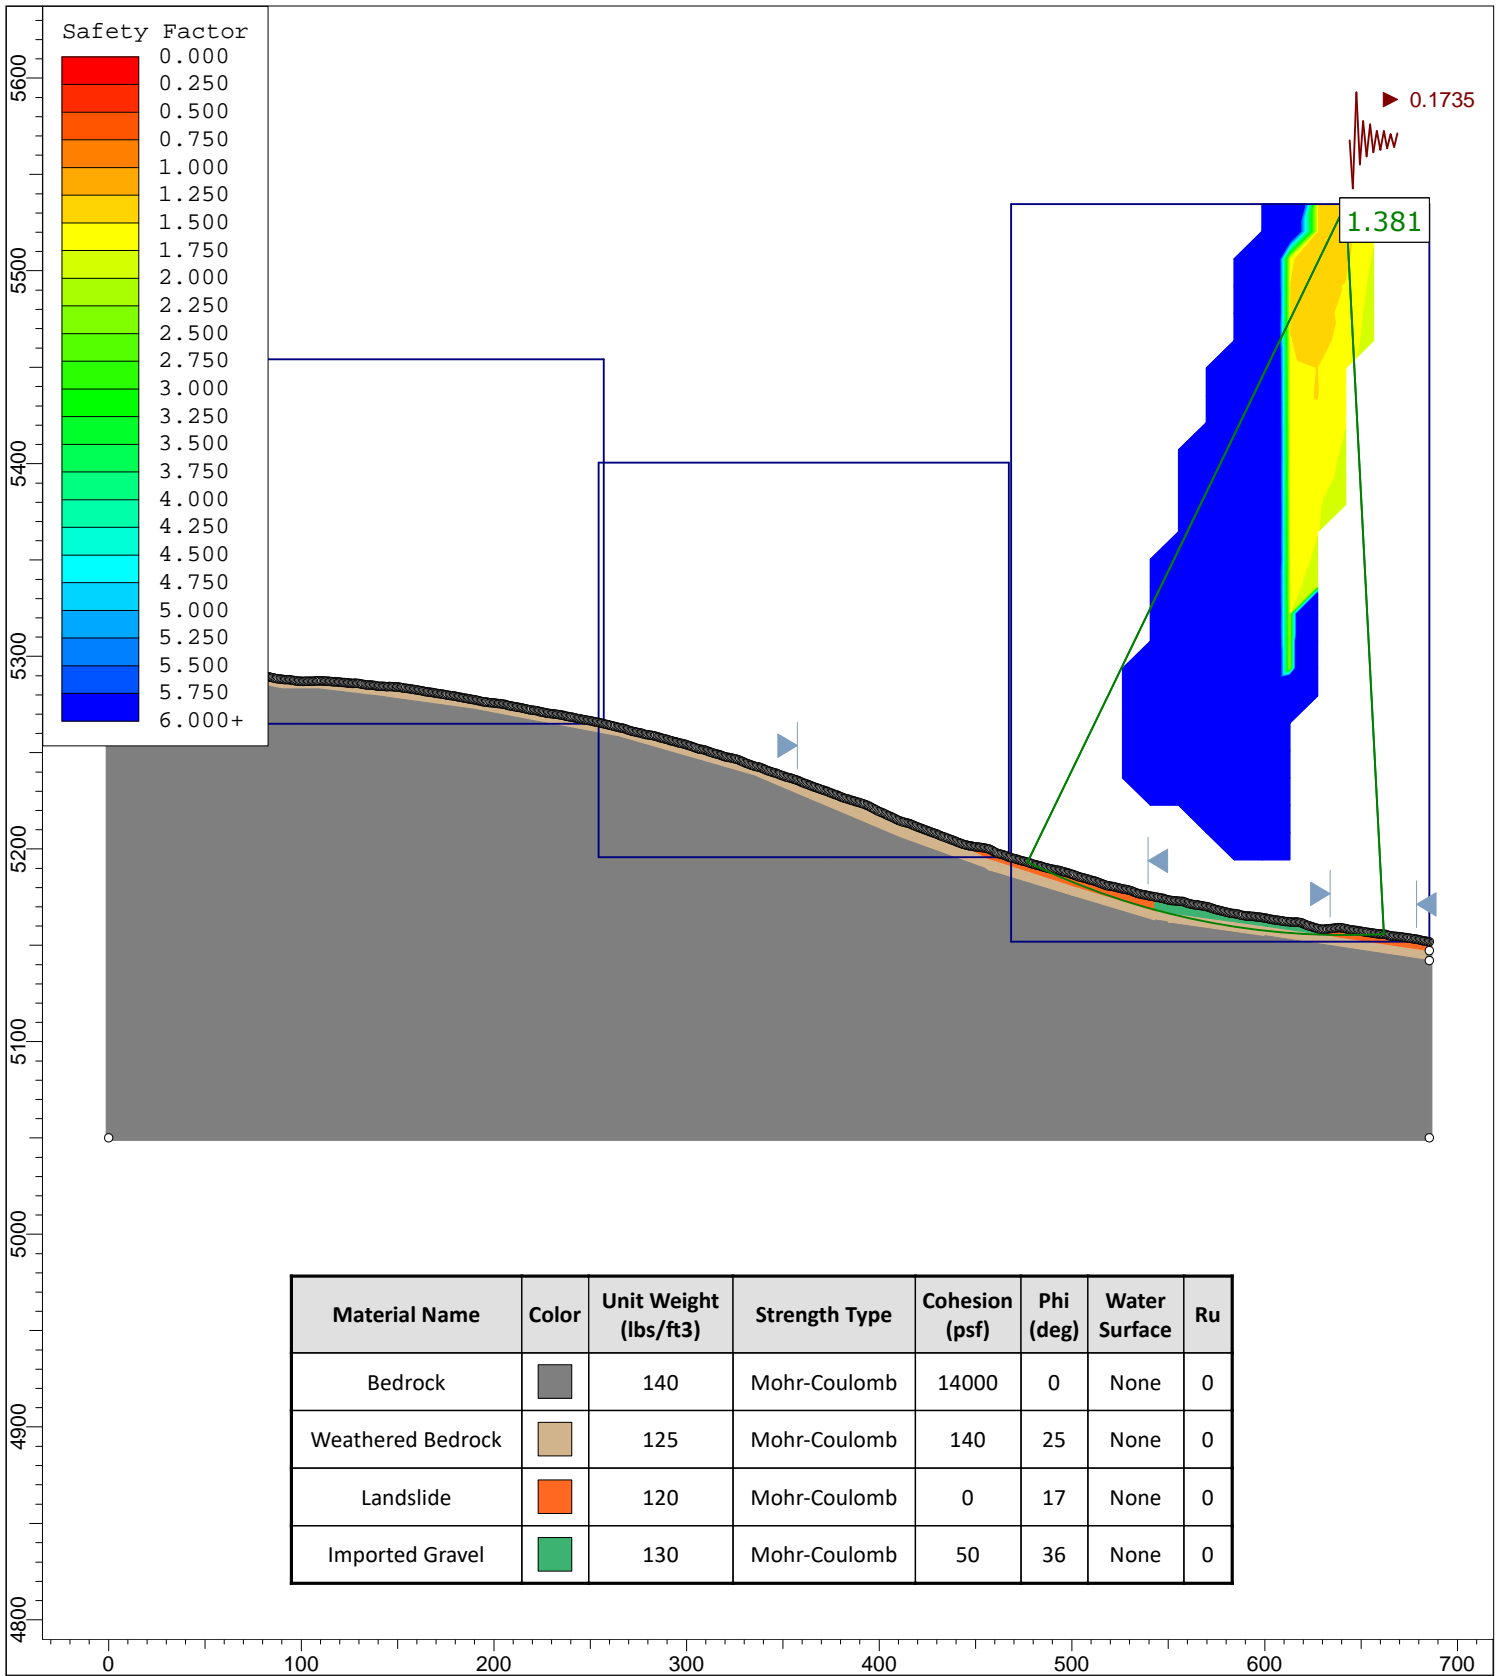
Plate
53

Profile A with Gravel Fill - Pseudo Static

and D indicate that the slopes at these locations have safety factors greater than 1.5 and 1.0 when outside the landslide deposits and outside the areas with steep slopes (steep meaning slopes steeper than 25 percent). Our analyses of Profiles A, F, G, and H indicate that adequate factors of safety for a home site is achieved when the landslide soils in the vicinity of the proposed home is removed and replaced with a gravel structural fill.
