## GEOLOGIC HAZARDS EVALUATION THE RESERVE AT CRIMSON RIDGE, LOT 2-R 1013 NORTH VALLEY VIEW DRIVE LIBERTY, WEBER COUNTY, UTAH

**SUBJECT:** Geologic Hazards Evaluation  
The Reserve at Crimson Ridge, Lot 2-R  
1013 North Valley View Drive  
Liberty, Weber County, Utah

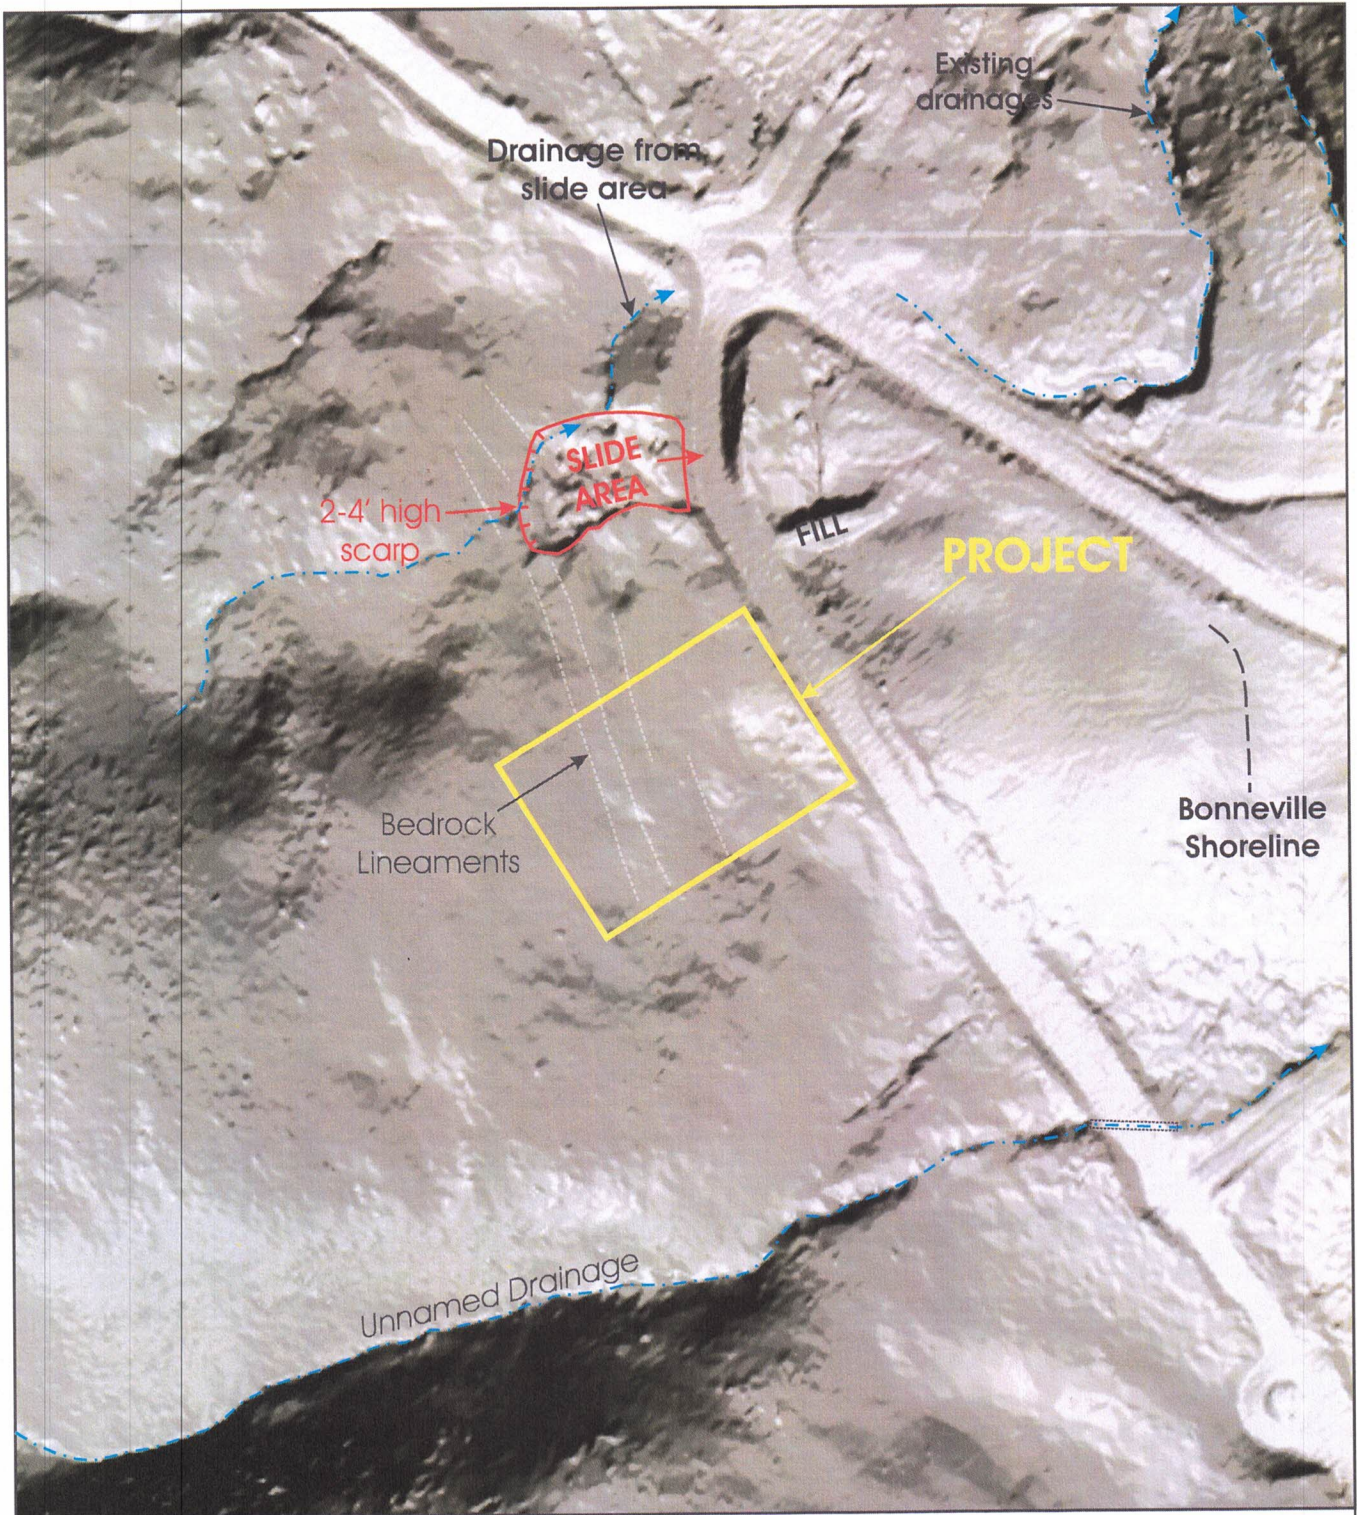
FIGURE 3A

Source: Utah AGRC, 1-meter LIDAR Bare Earth DEM, 2011.

High-resolution orthophotography from 2012 (Figure 3B) and 1-meter bare earth DEM LIDAR from 2011 available from the Utah AGRC (Figure 3A) were reviewed to obtain information about the geomorphology of the Project area. The site is at the western margin of Ogden Valley on east- to northeast-facing slopes overlooking Pineview Reservoir. One slope failure is evident on the air photos about 400 feet northwest of the site. This failure reportedly occurred around April-May 2006. The existing paved street was reportedly installed in 2009, although it is possible that this slide was caused by grading activity. The failure toe has been removed and buttressed with a retained rock

wall. An unnamed ephemeral drainage appears to have crossed the slide area, which now follows the scarp base to the northeast, cuts across the left-lateral margin of the slide, and then crosses the road (Figures 3A-B). Below the road, the drainage re-enters its former course and proceeds downslope to the east. No other geologic hazards were evident at the site or in the area on the photos.

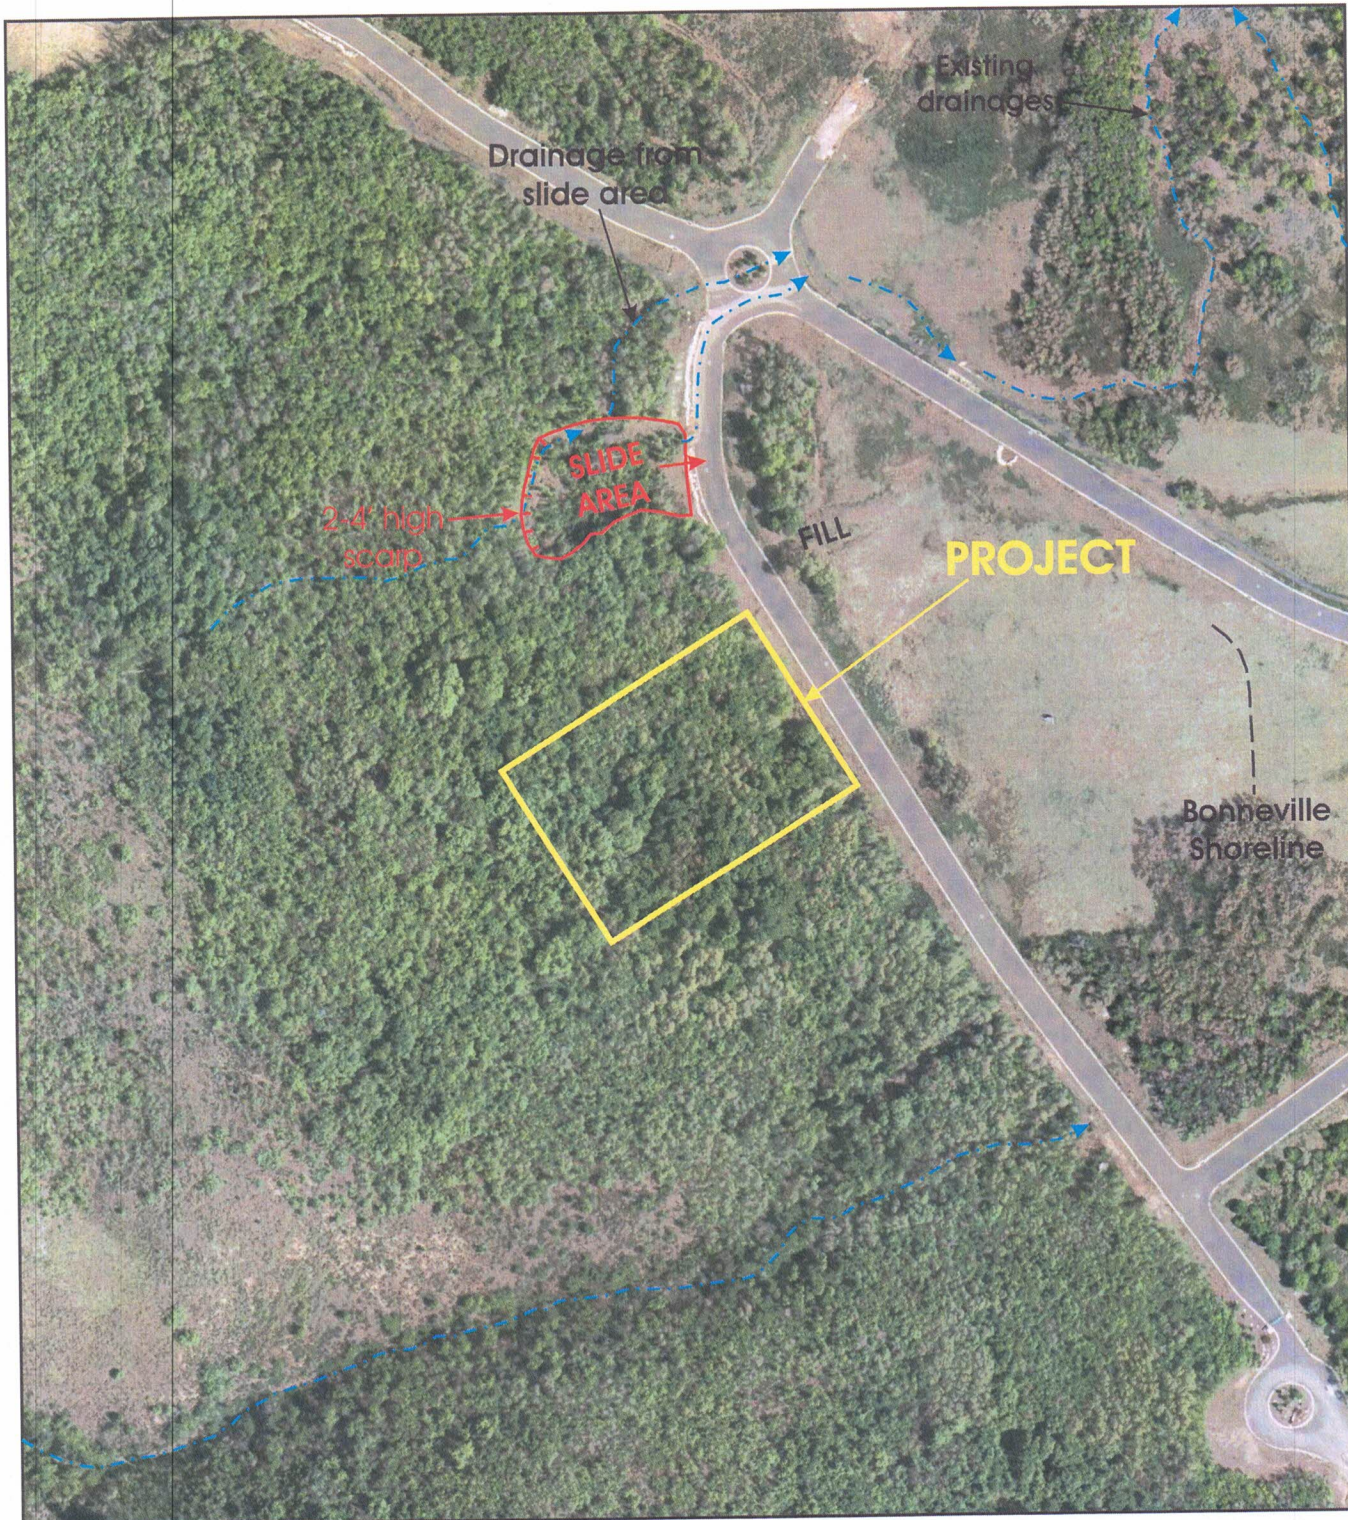
FIGURE 3B

Source: Utah AGRC, High Resolution Orthophoto, 6-inch resolution, 2012.

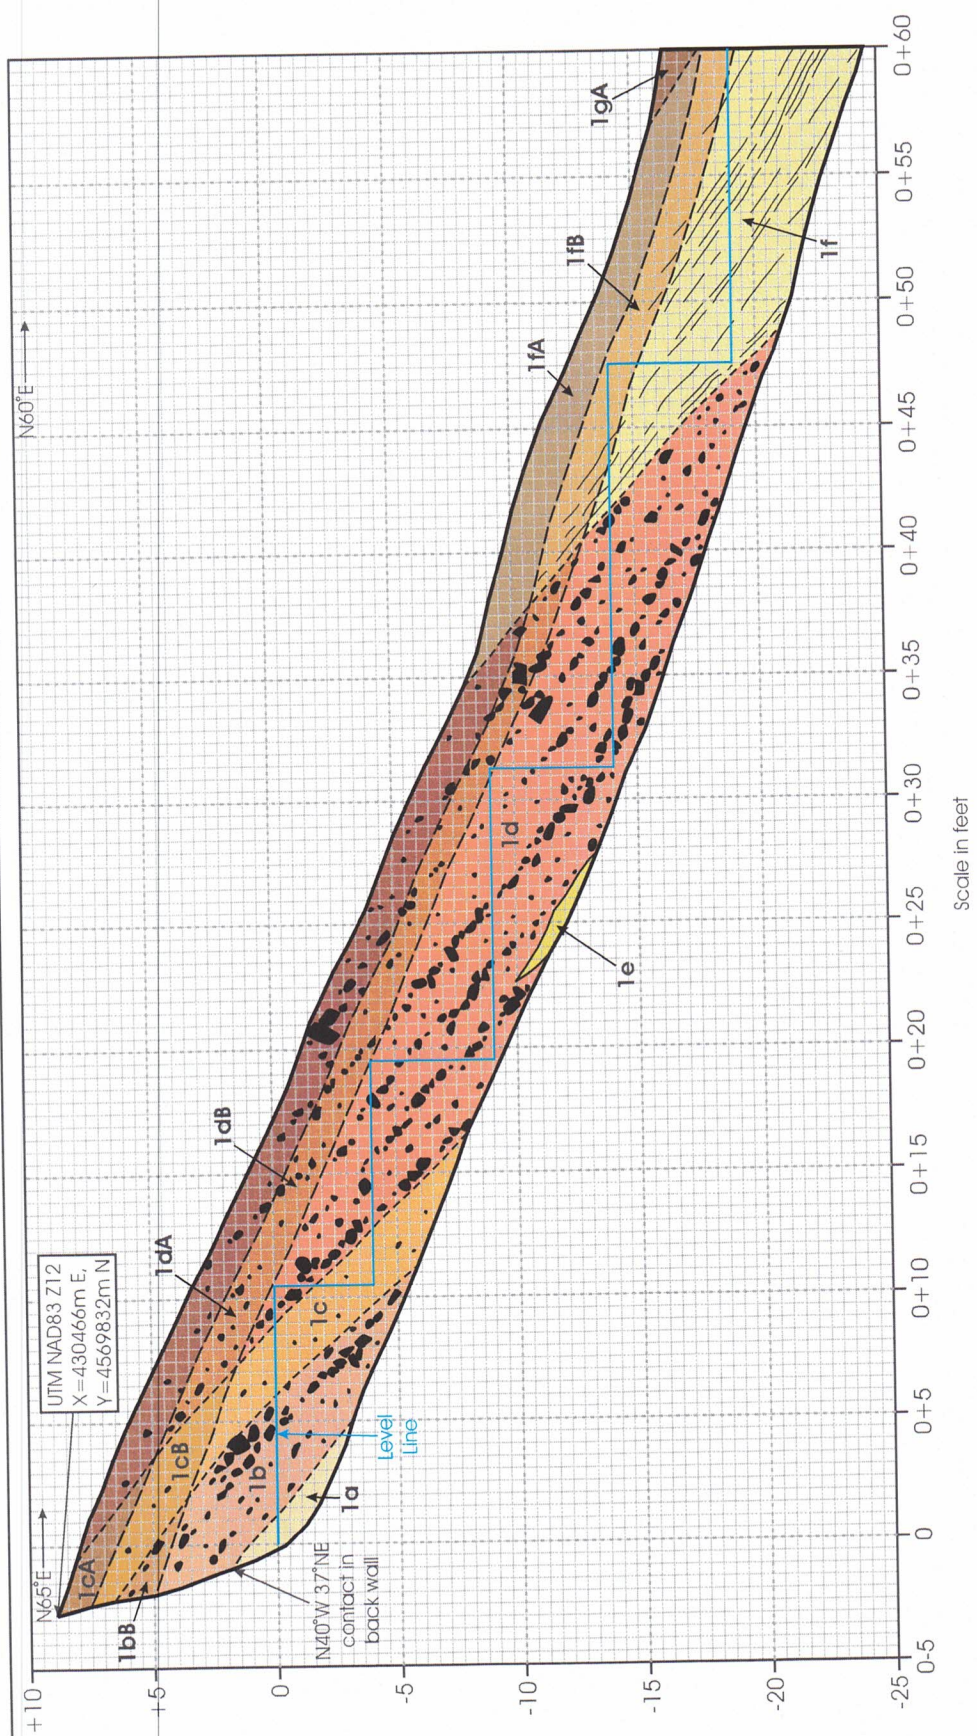
**TRENCH LOG, SHEET 1**

See Figure 5d for unit descriptions

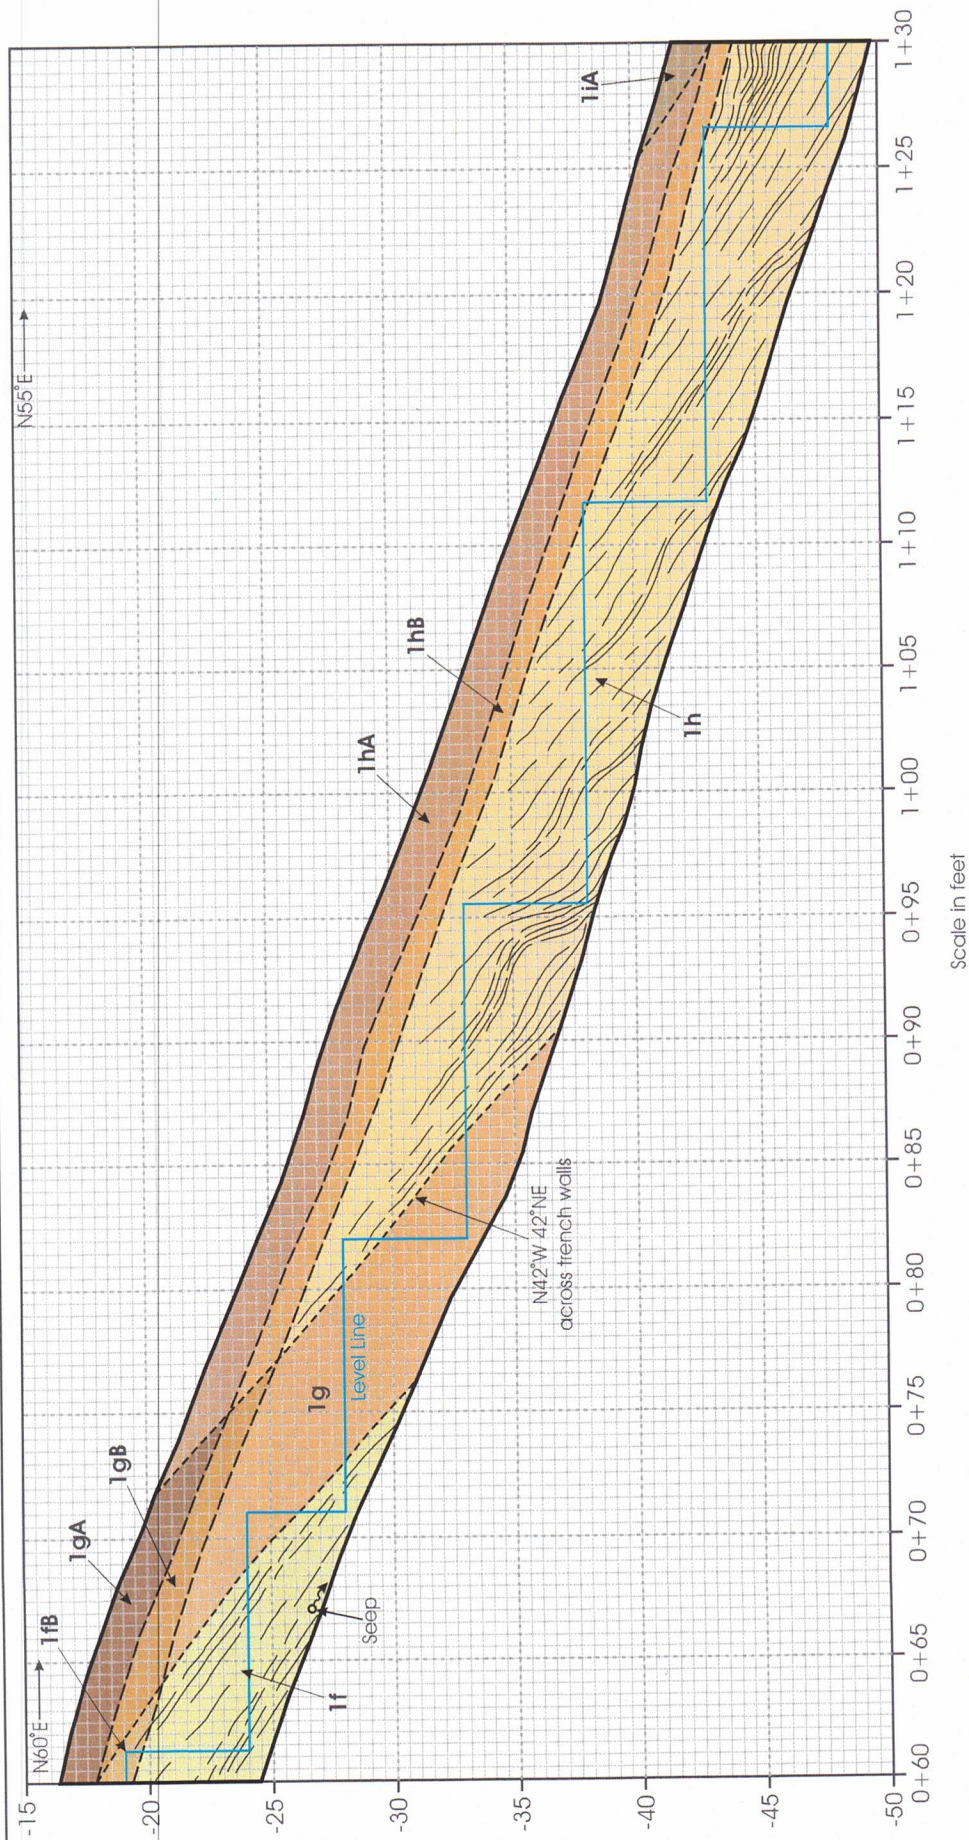
**FIGURE 5B**

**TRENCH LOG, SHEET 2**

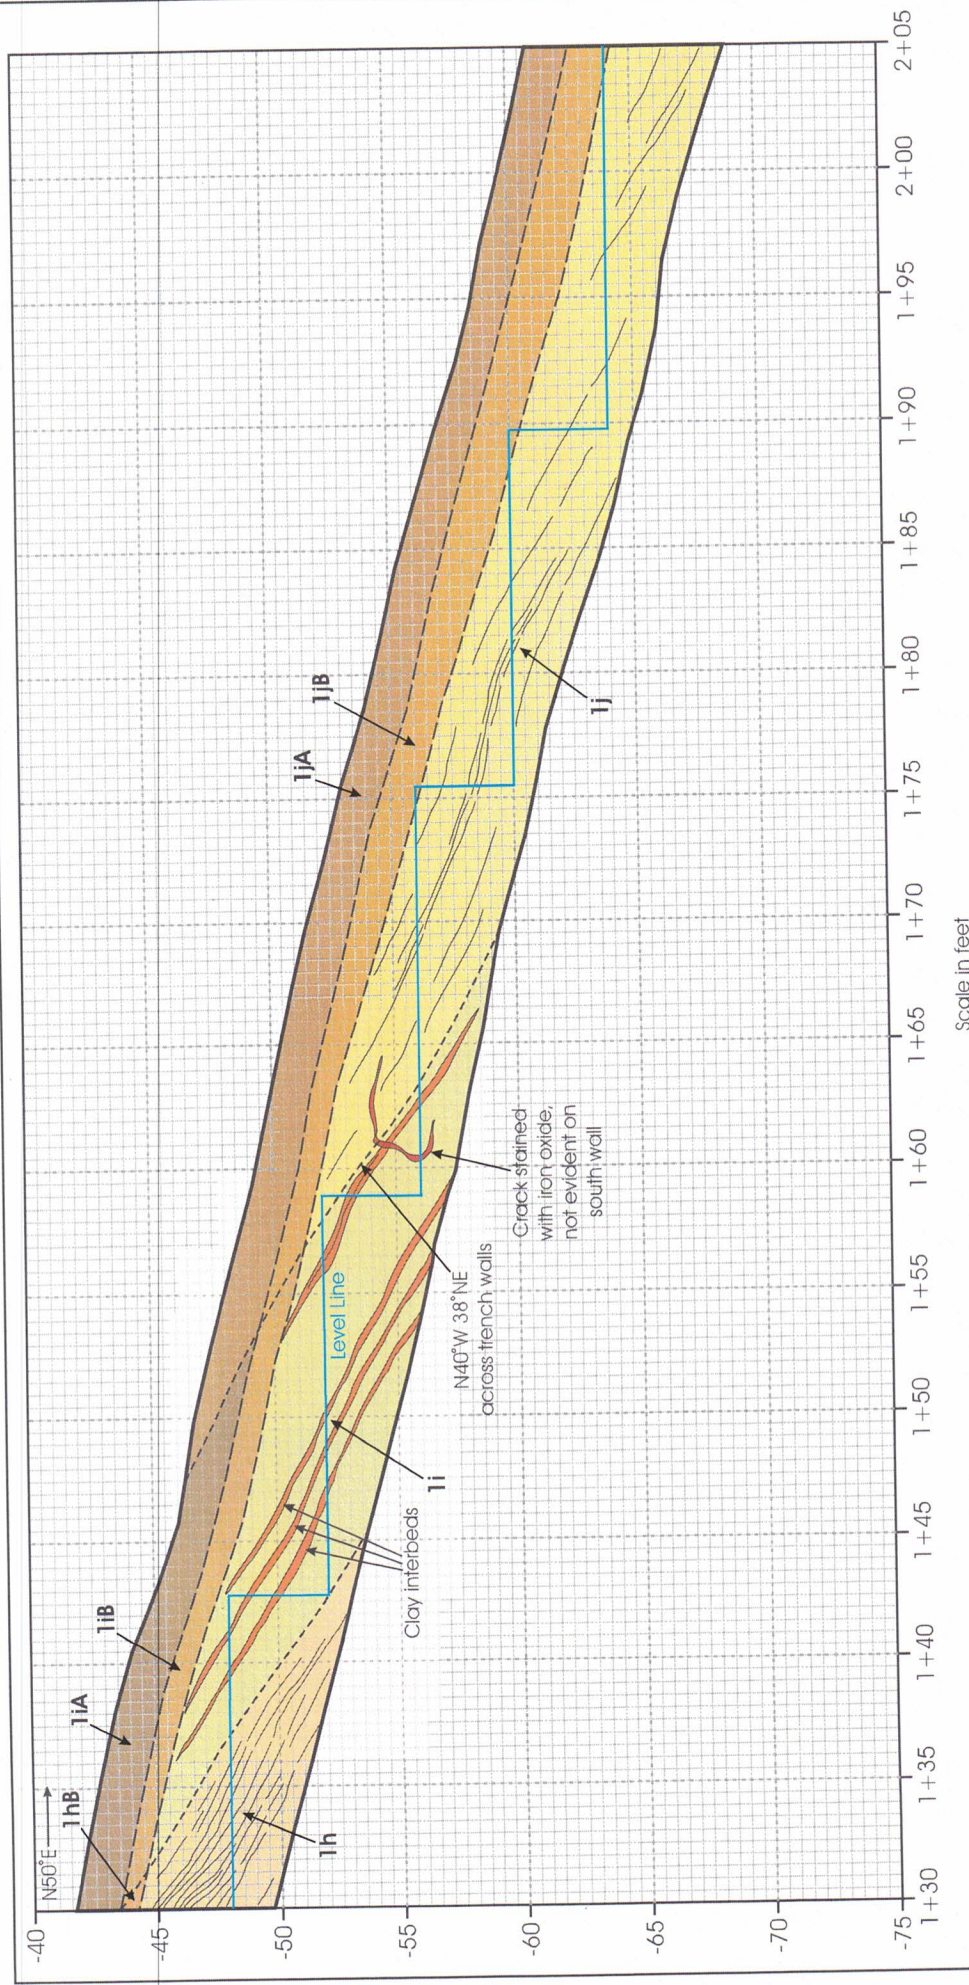
**TRENCH LOG, SHEET 3**

**1i.** Olive clayey sand (SC) with interbeds of reddish-brown lean to fat clay (CL/CH); likely weathered tuffaceous sandstone; fractured in places and with zones of iron-oxide staining.

**1jA.** Organic-enriched, root-penetrated, A-horizon soil formed in unit.

**1jB.** Vertisol B horizon formed in unit.

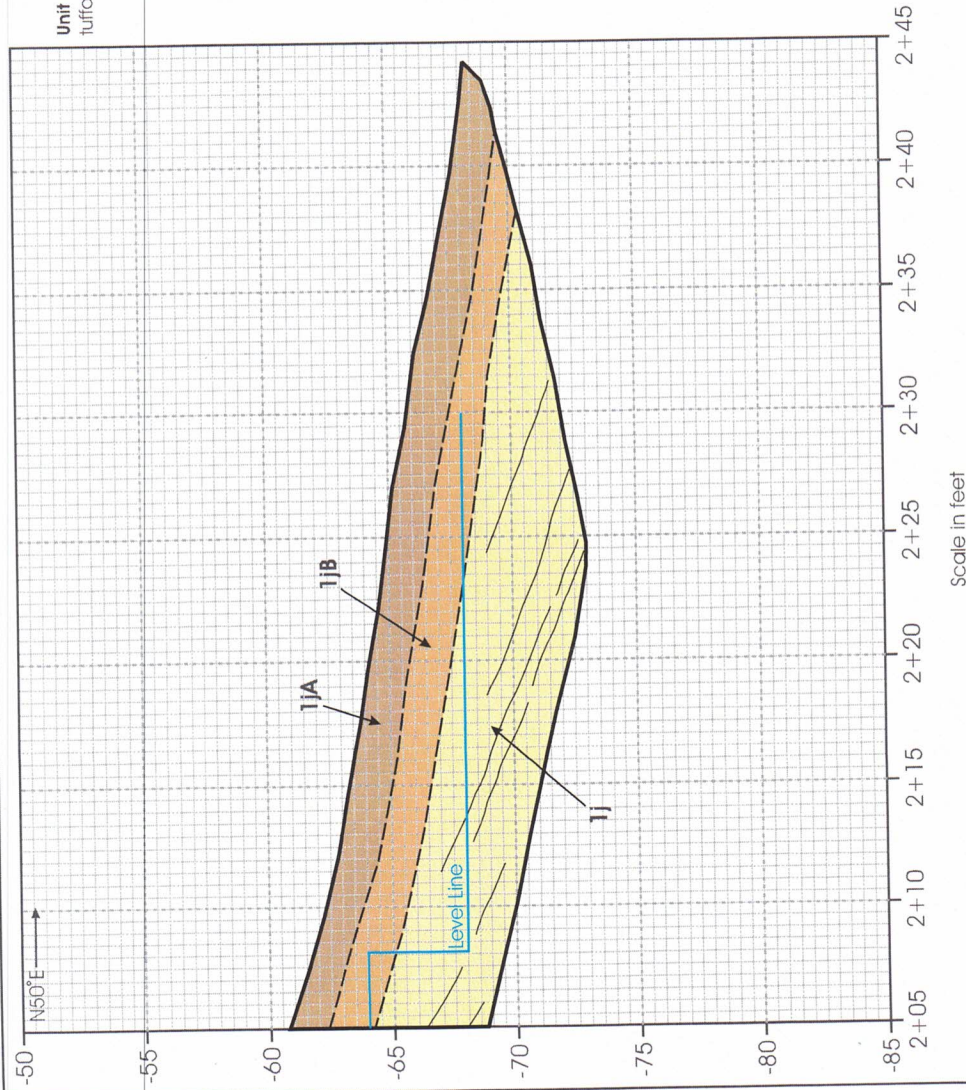
**FIGURE 5D**

SCALE: 1 inch = 5 feet  
(no vertical exaggeration)  
North Wall Logged, West to East  
Trench logged by Bill D Black, PG,  
on June 1-2, 2016

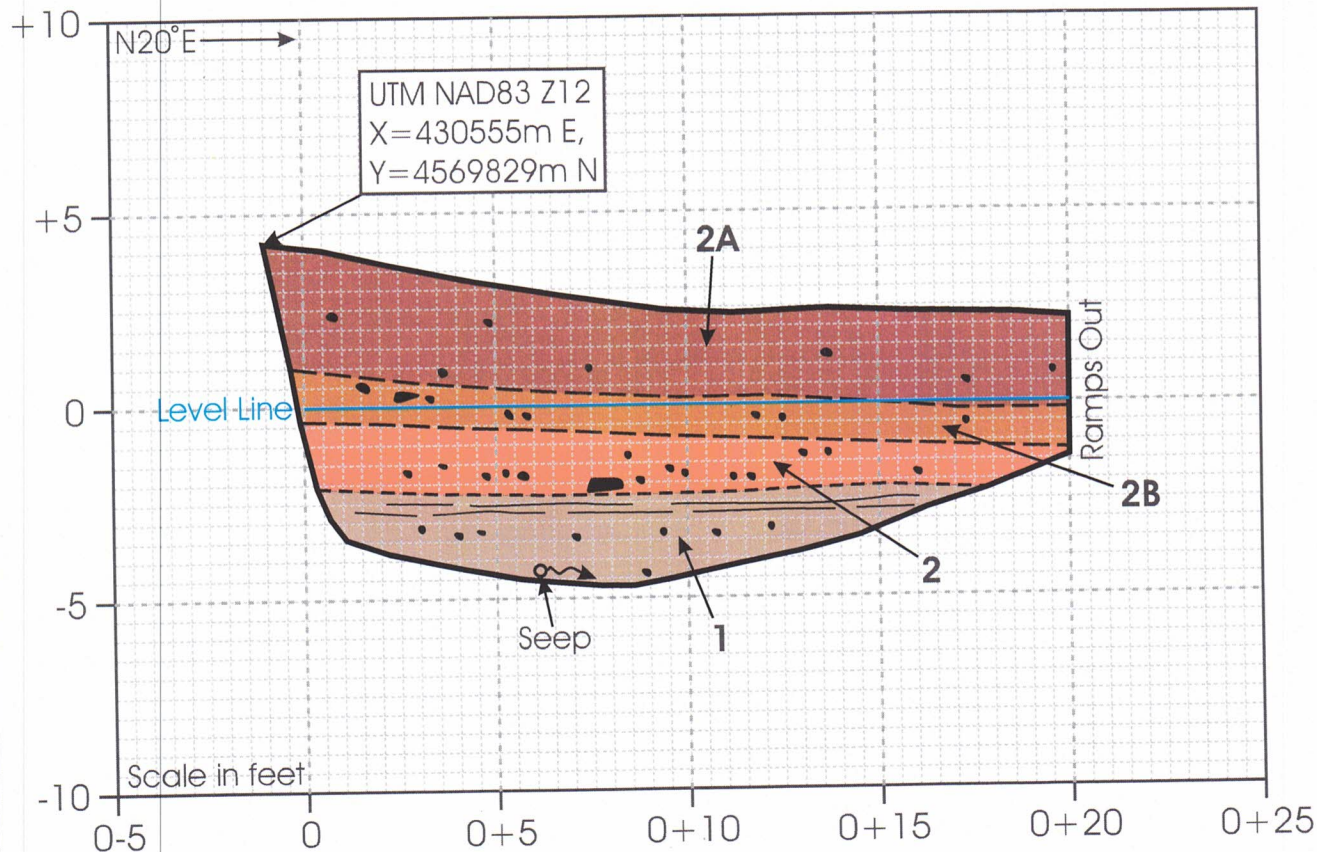
FIGURE 6A

**Unit 1.** *Latest Pleistocene to Holocene Alluvium and Colluvium* - Reddish-brown to gray, moderate to high density, poorly bedded to massive, bedded, sandy clay (CL) with gravel; topset lean to fat clay lense; likely shallow slump deposits.

**Unit 2.** *Holocene Alluvium and Colluvium* - Reddish-brown to dark-brown, moderate density, massive, sandy clay with gravel and trace cobbles (CL); likely slope colluvium.

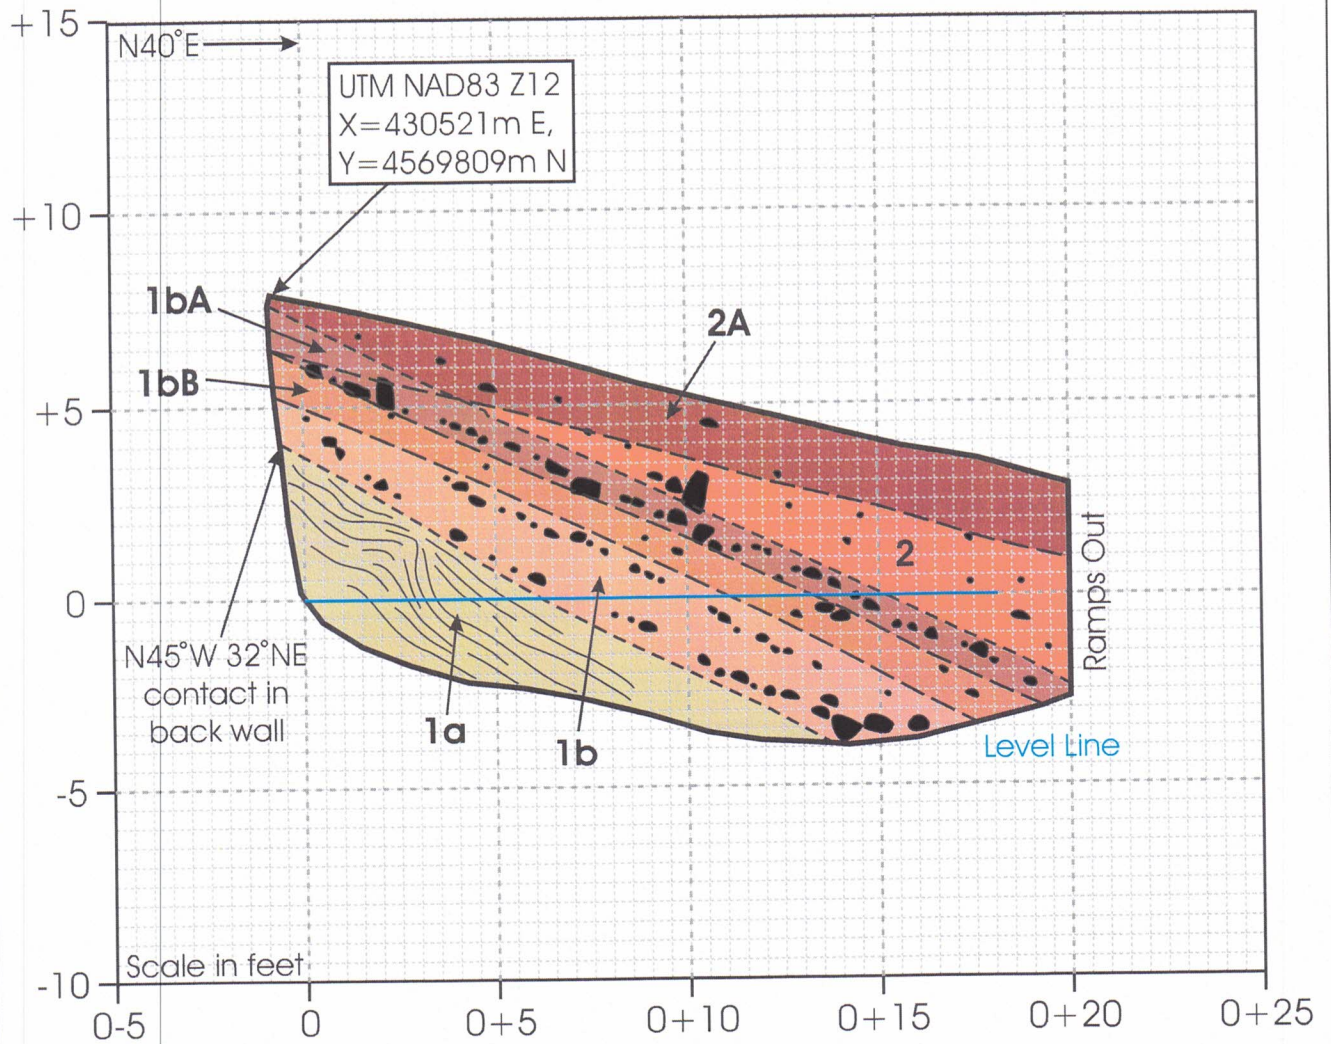
FIGURE 6B

**Unit 1. Tertiary Norwood Formation** - Sequence of weathered, poorly to well-bedded, moderate to high density, tuffaceous claystone, sandstone, and conglomerate.

- 1a. Claystone to sandstone comprised of sandy clay to clayey sand (CL-CH/SC), iron-oxide staining along bedding; likely corresponds to unit 1h in trench (Figure 5).
- 1b. Conglomerate comprised of reddish-brown clayey sand with gravel, cobbles, and trace boulders (SC).
  - 1bA. Paleosol A horizon formed in unit.
  - 1bB. B-horizon soil formed in unit.

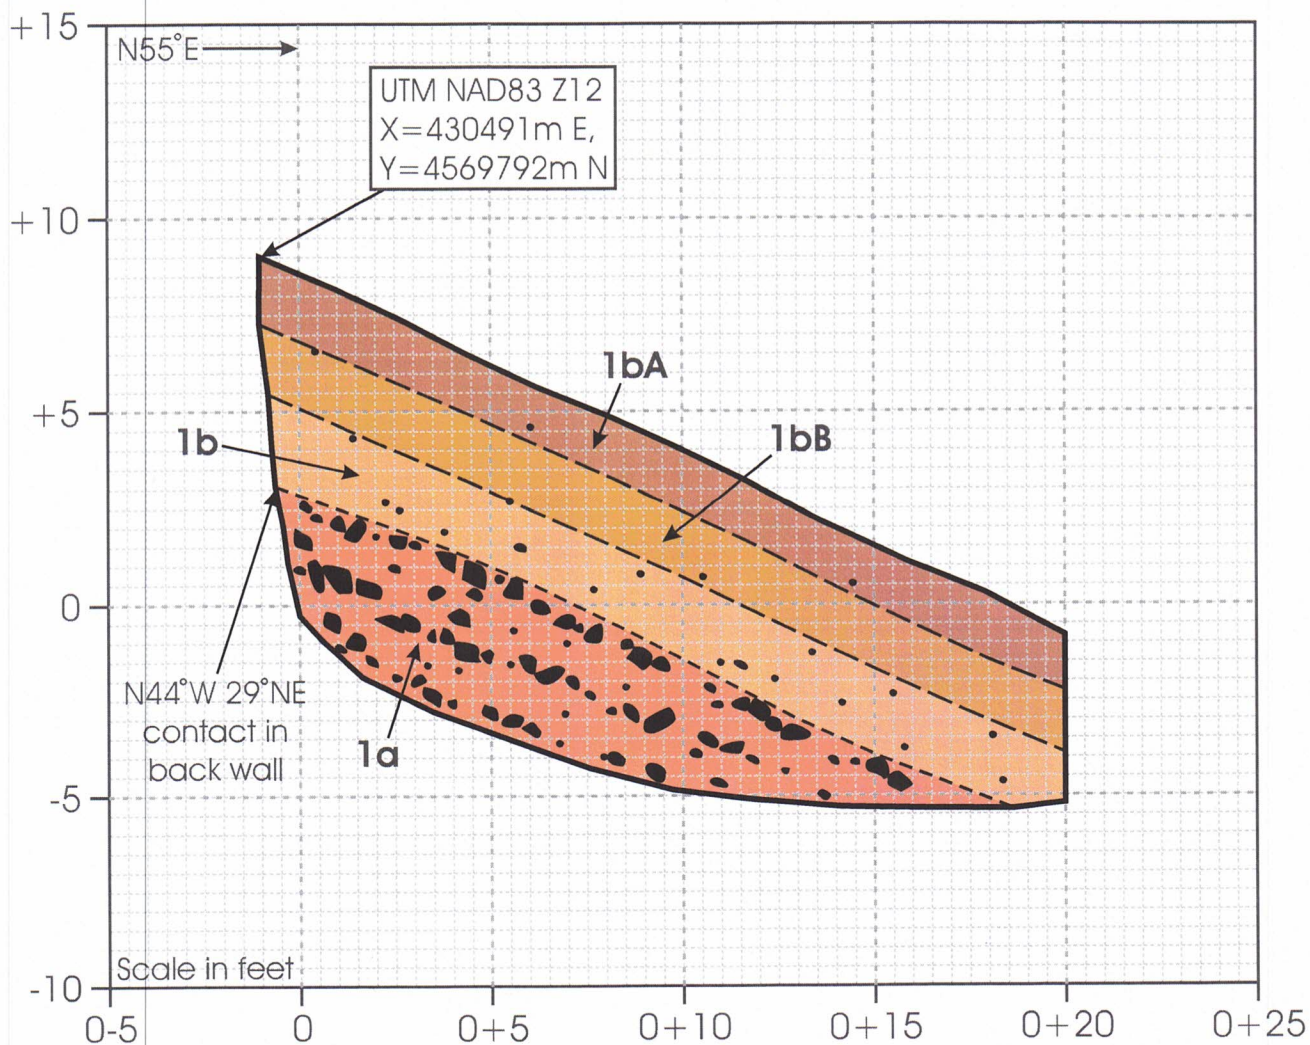
**FIGURE 6C**

**Unit 1.** *Tertiary Norwood Formation* - Sequence of weathered, moderate density, poorly bedded, tuffaceous conglomerate and sandstone.
