**Geotechnical Investigation
Mountainside PRUD Phase 2
Eden, Utah**

October 24, 2022

**Geotechnical Investigation
Mountainside PRUD Phase 2
Approximately 4560 North Seven Bridges Road
Eden, Utah
CG Project No.: 133-017**

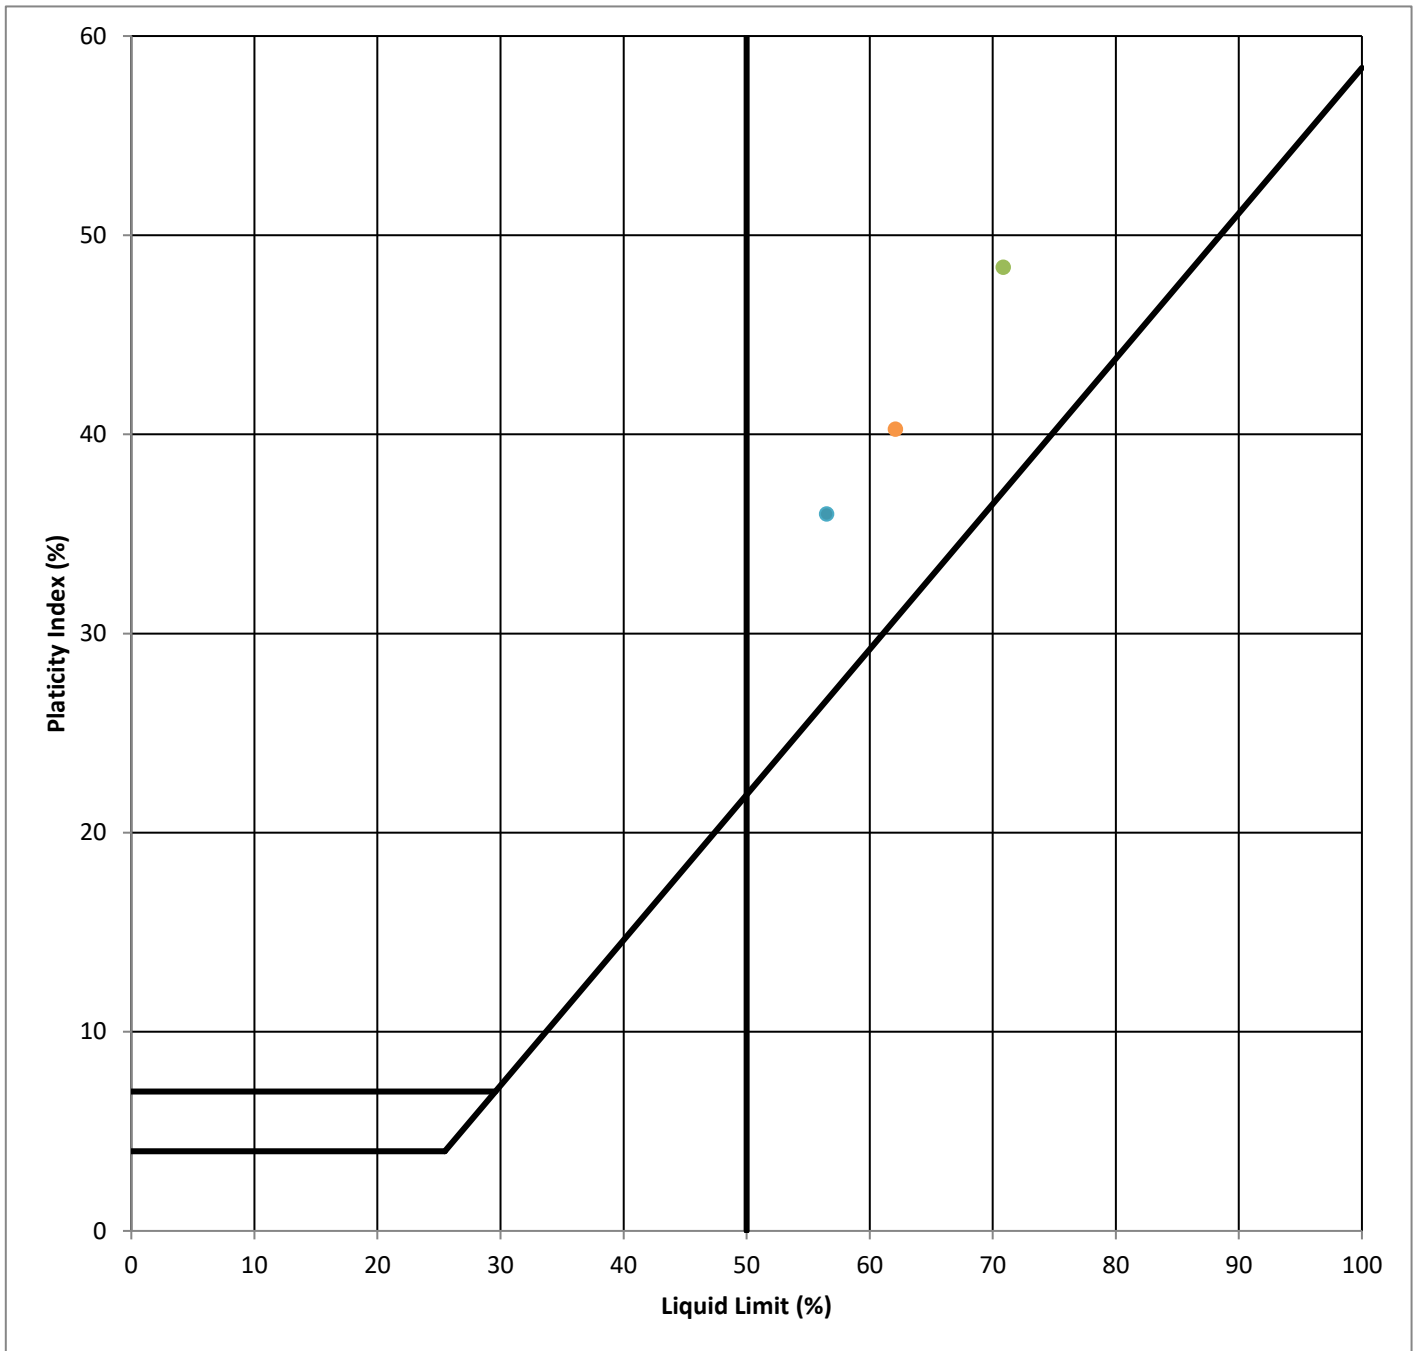
| | <p>Lewis Homes Mountainside PRUD Phase 2 Eden, Utah Project No.: 133-017</p> | <p>Plate 11</p> |

Atterberg Limits

| Location | Depth (ft) | | Classification | Liquid Limit | PI |
| TP-3 | 4 | ● | Fat CLAY with sand | 56 | 36 |

The results of our laboratory tests are also presented on the Test Pit Logs, Plates 3 through 9, and more detailed laboratory results are presented on the laboratory testing plates, Plates 11 through 13.

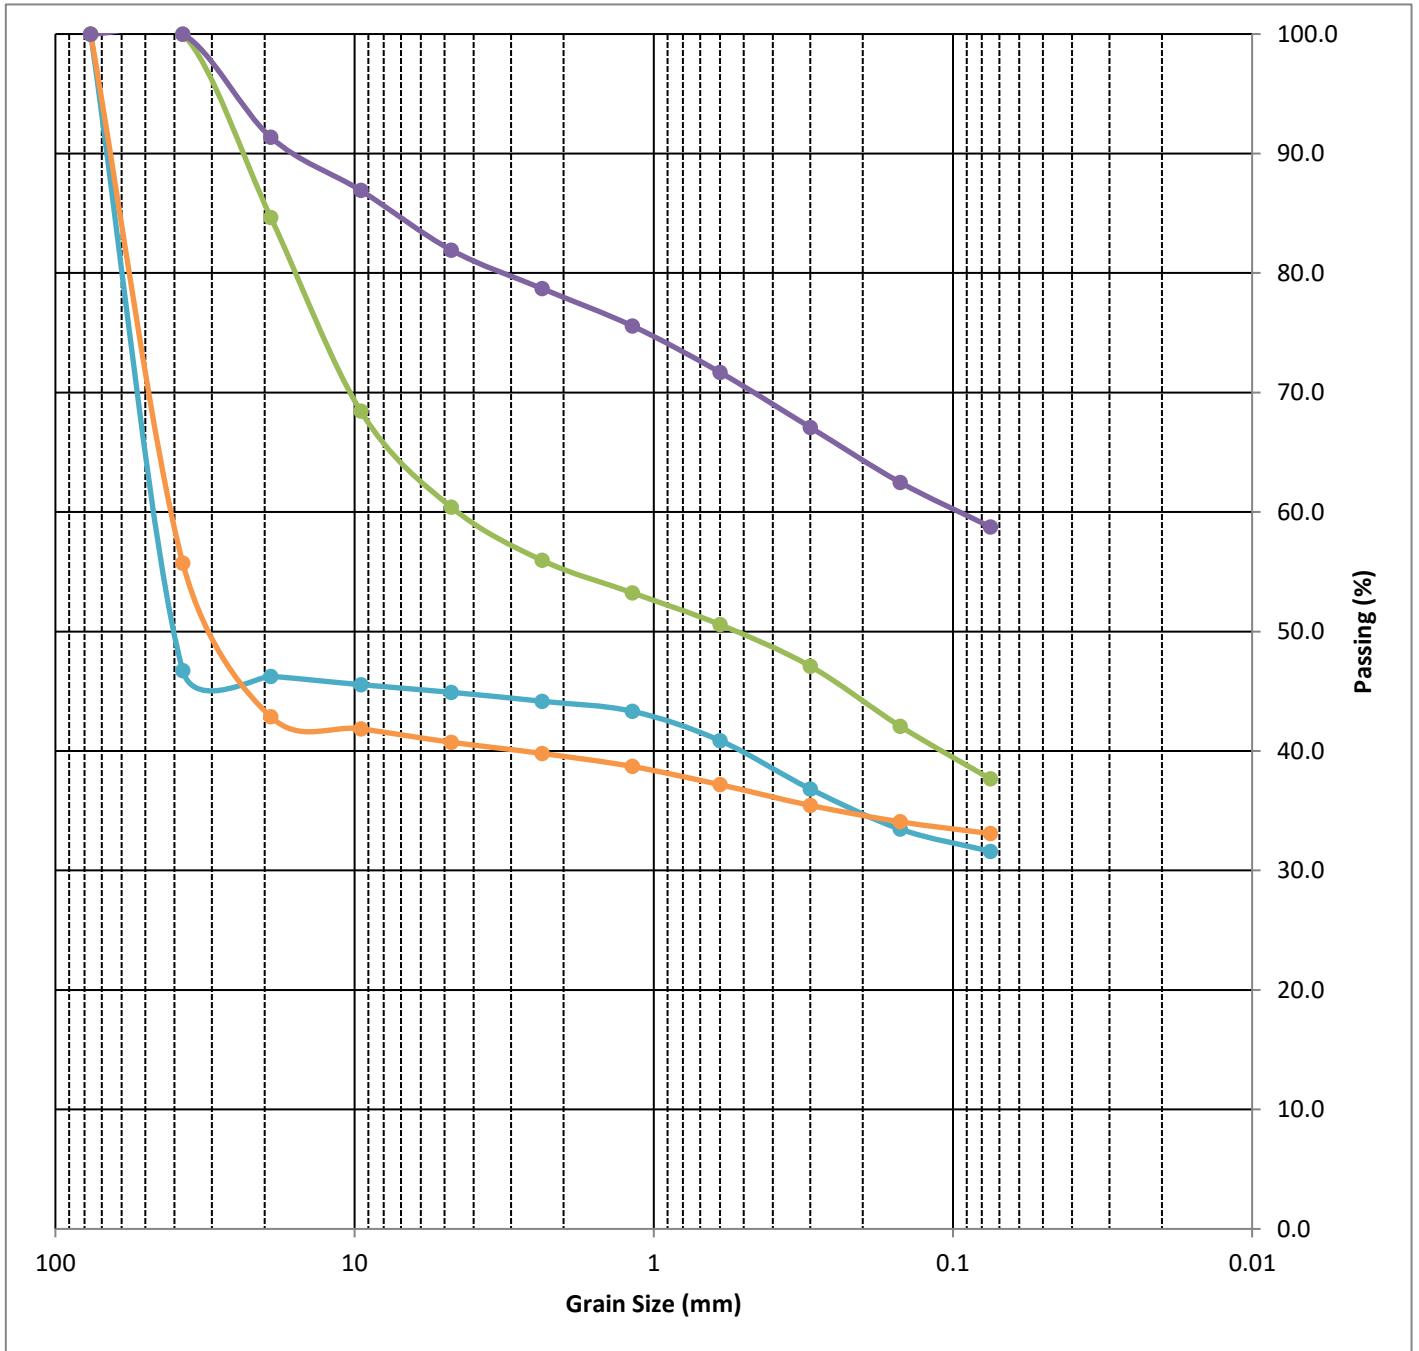
| | <p>Lewis Homes Mountainside PRUD Phase 2 Eden, Utah Project No.: 133-017</p> | <p>Plate 12</p> |

Grain Size Distribution

| Location | Depth | | Classification | % Gravel | % Sand | % Silt and Clay |
| TP-1 | 4 | ● | Clayey GRAVEL with sand | 55.1 | 13.3 | 31.6 |

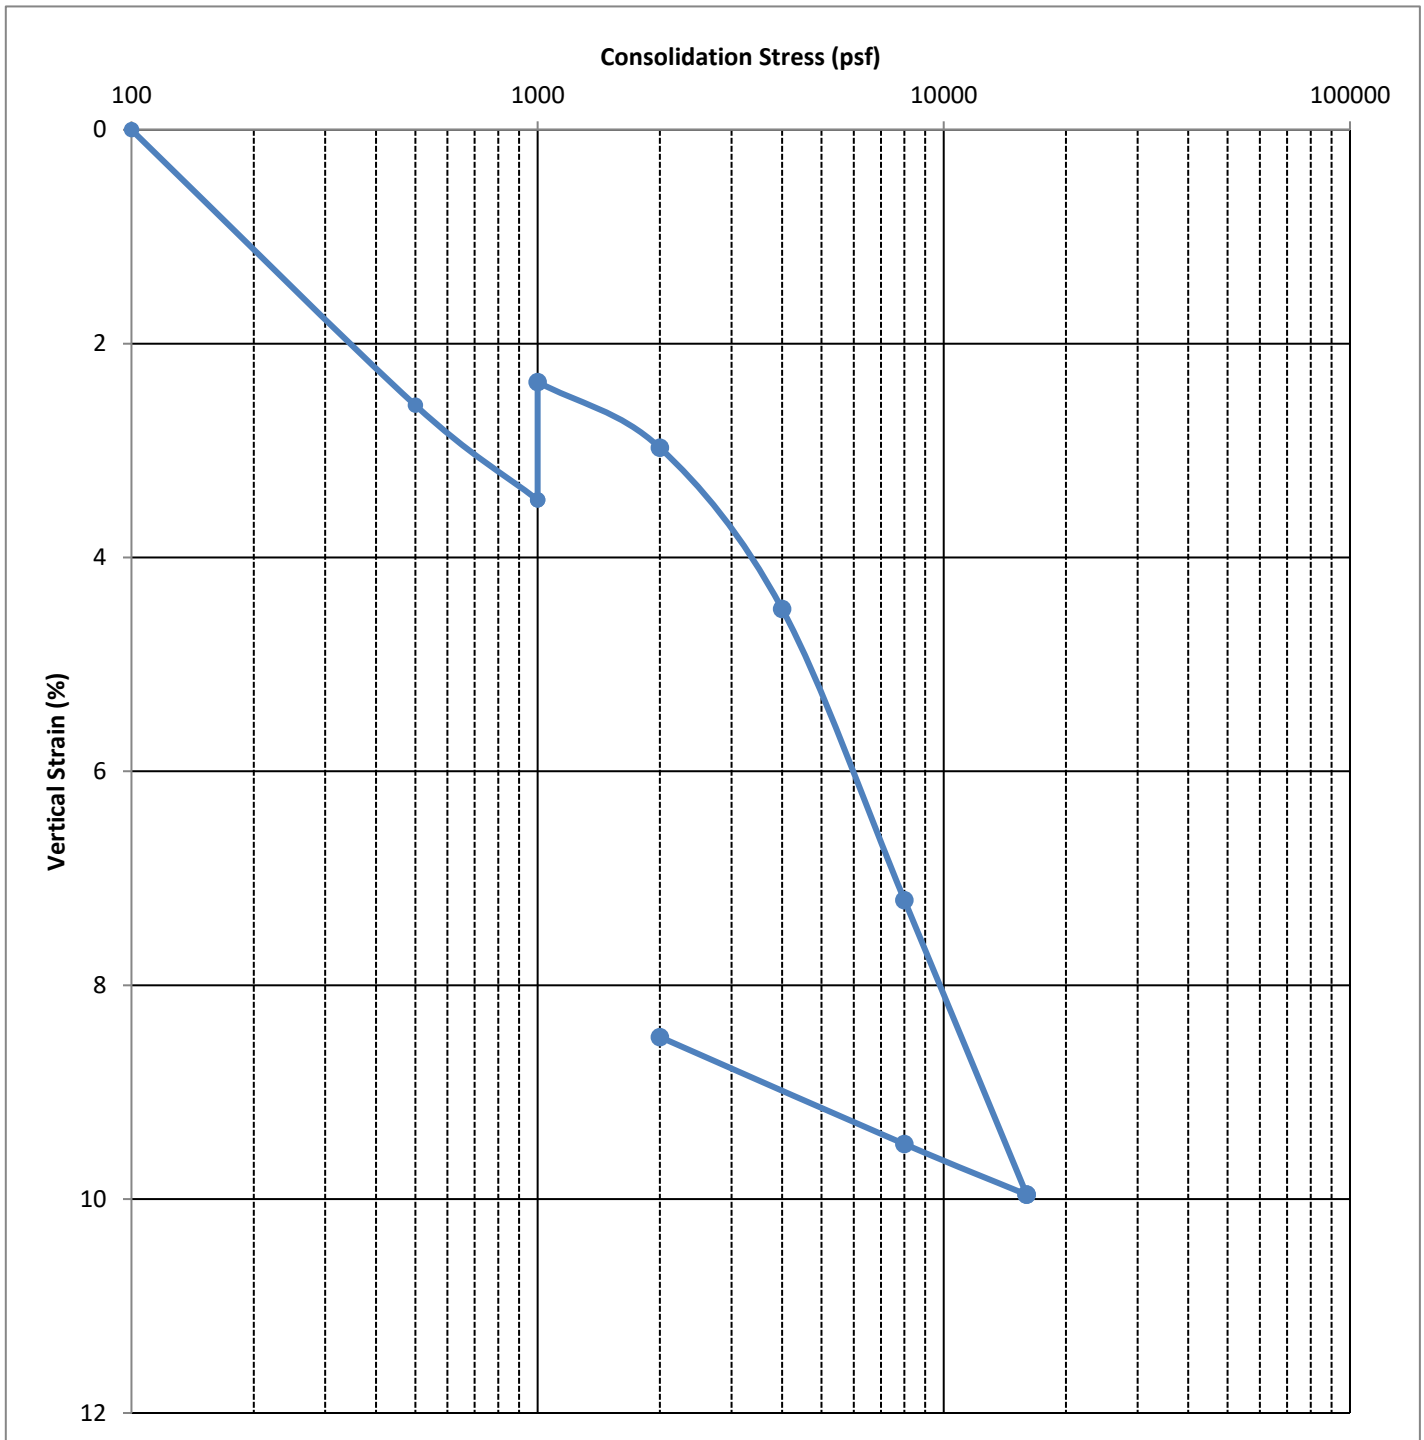
| | Lewis Homes Mountainside PRUD Phase 2 Eden, Utah Project No.: 133-017 | Plate 13 |

1-D Consolidation

| Location | Depth (ft) | Dry Density (pcf) | Moisture Content (%) | σ_o (psf) | σ_p (psf) | C_c | C_r | OCR |
| TP-3 | 4 | 100.7 | 24.0 | 500 | 3,000 | 0.091 | 0.016 | 6.0 |

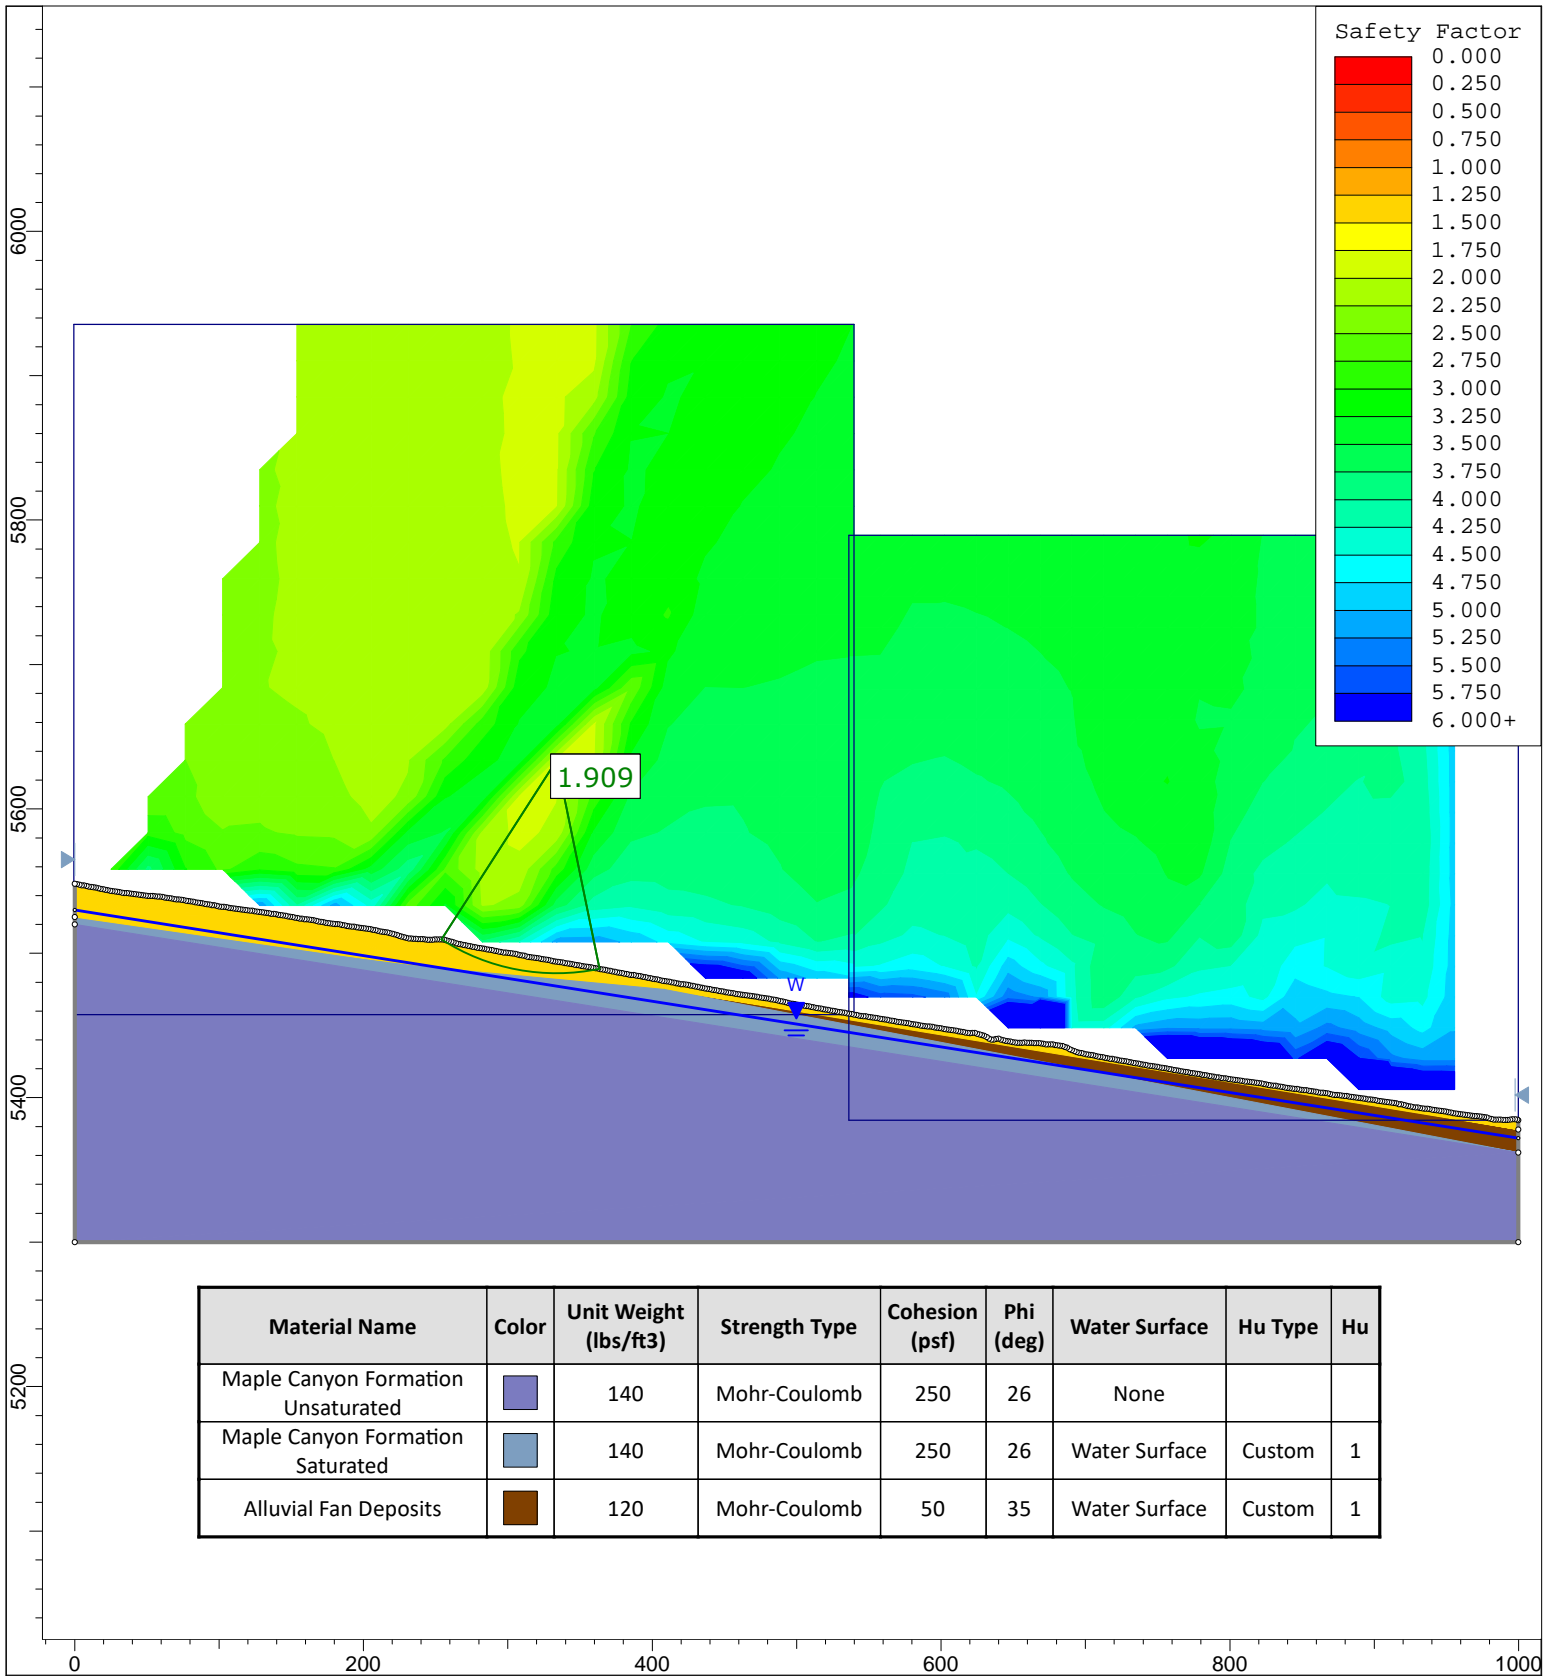
Plate
14

Global Stability - Static

As recommended in the Geologic Hazards Evaluation by Western Geologic, a slope stability assessment was performed using the Slide computer program and the modified Bishop's method of slices. The location of the profile assessed is shown on Plate 2 and is based on the cross section presented in The Western Geologic report for the development. The alluvial fan deposits were assumed to have a strength consisting of an angle of internal friction of 35 degrees and a cohesion of 50 psf. The landslide deposits and the Maple Canyon Formation bedrock strength values were based on the 2018 GeoStrata report and consisted of a friction angle of 18 degrees and no cohesion for the landslide deposits and an angle of internal friction of 26 degrees and 250 psf cohesion for the bedrock. For the imported gravel, we assumed a strength value consisting of an angle of internal friction of 36 degrees and 20 psf cohesion.

seismic conditions, respectively, were considered acceptable. Our analyses indicate that the profile has a safety factor greater than 1.5 for the static condition; however, a safety factor less than 1.0 was assessed for the pseudo static. Further assessment indicates a pseudo static factor of safety greater than 1.0 for Lots 25 to 50. For Lots 72 to 83, a safety factor greater than 1.0 was achieved when the landslide deposits in the vicinity of the proposed homes are removed and replaced with a gravel structural fill.

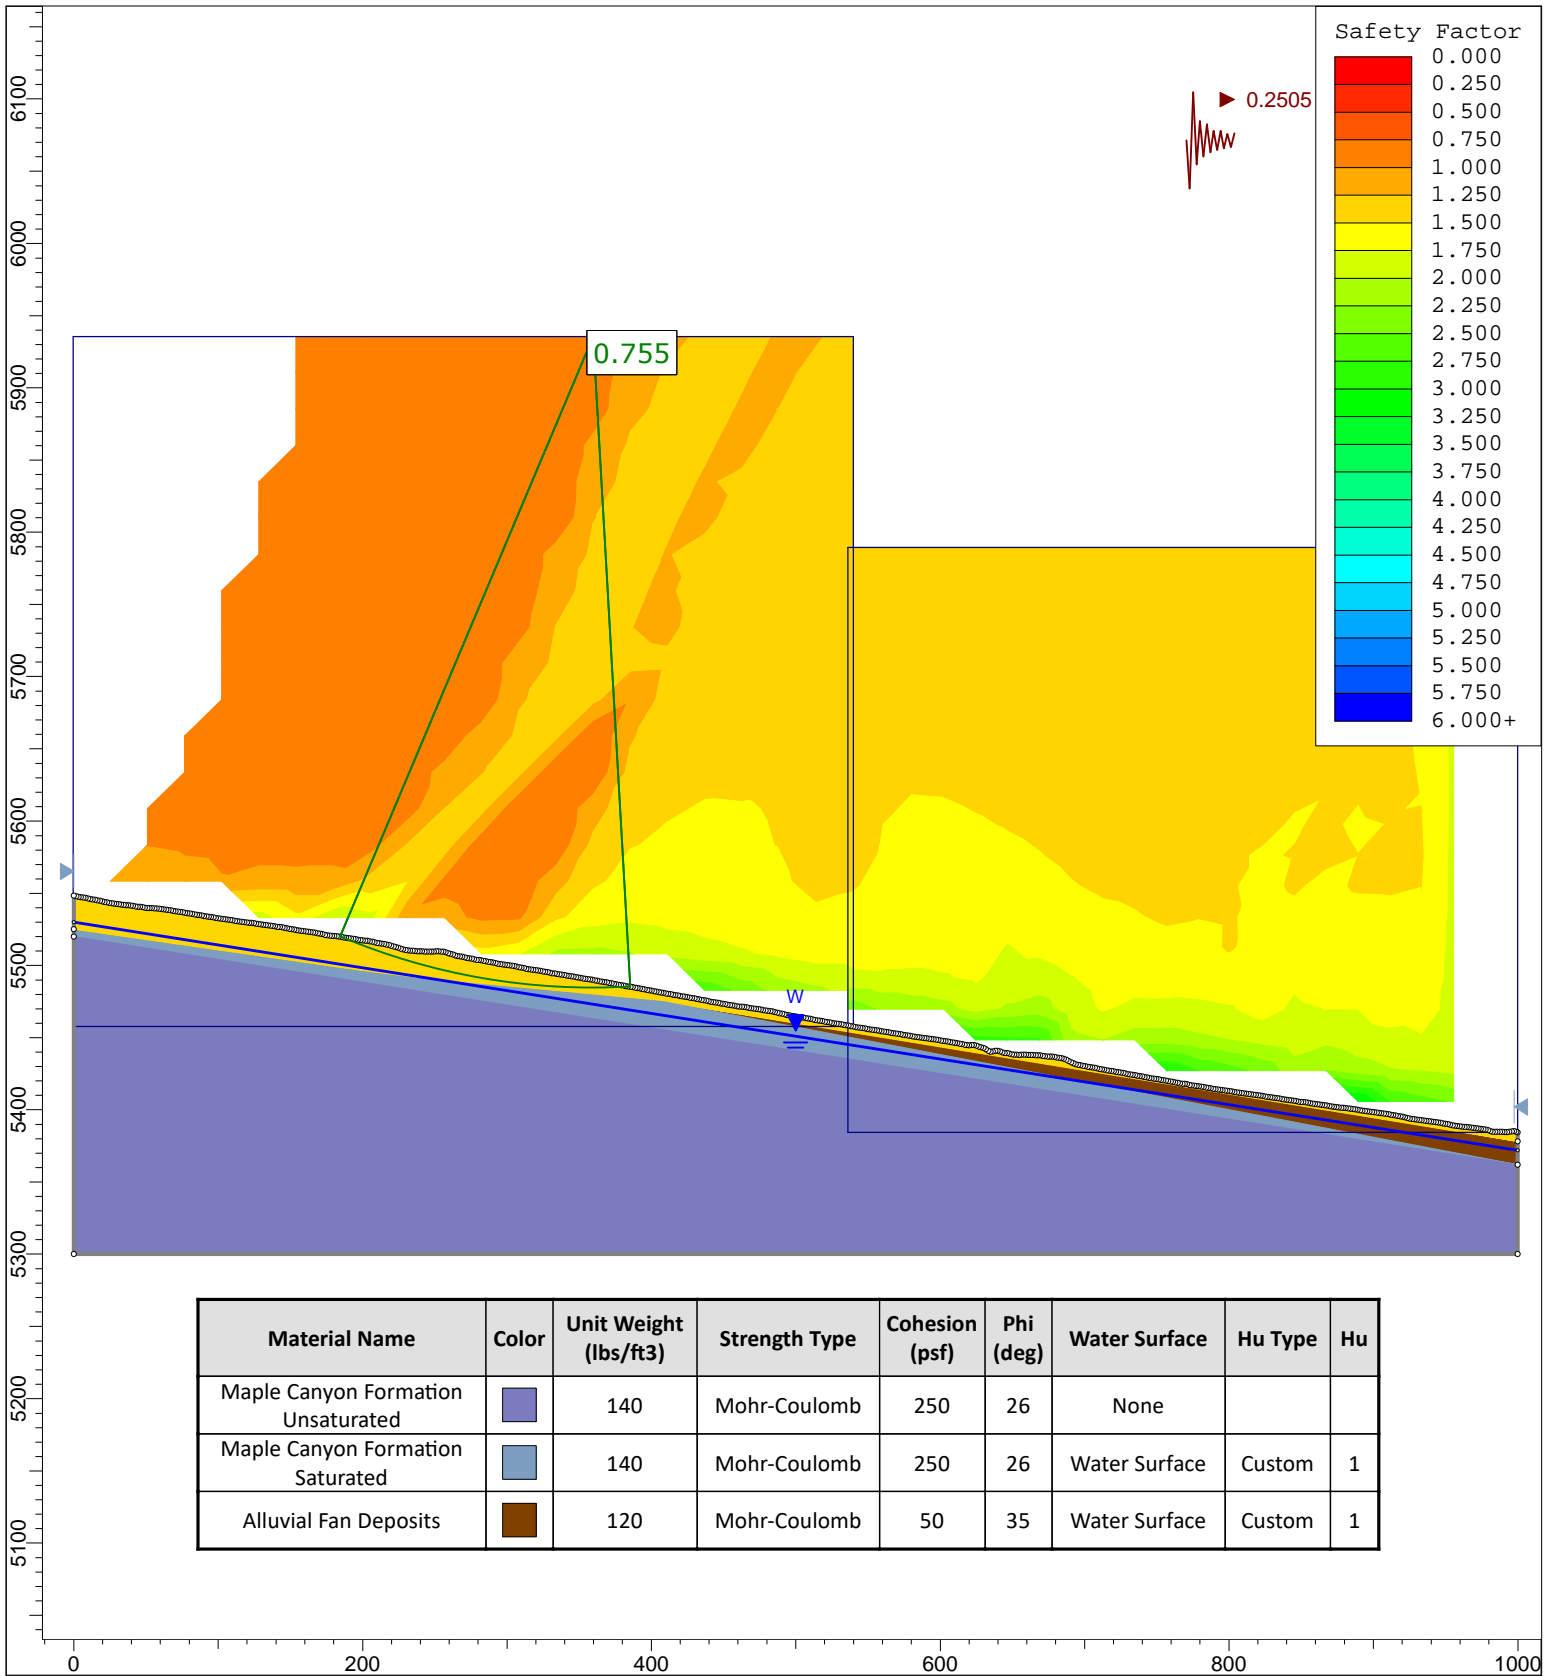
Plate
15

Global Stability - Pseudo Static

The profile was assessed under static and pseudo static conditions. The pseudo static condition is used to assess the slope during a seismic event. As indicated in Section 4.1, the peak ground acceleration at this site is estimated to be 0.501g. As is common practice, half of this value was used in our pseudo static assessments. Minimum factors of safety of 1.5 and 1.0 for static and

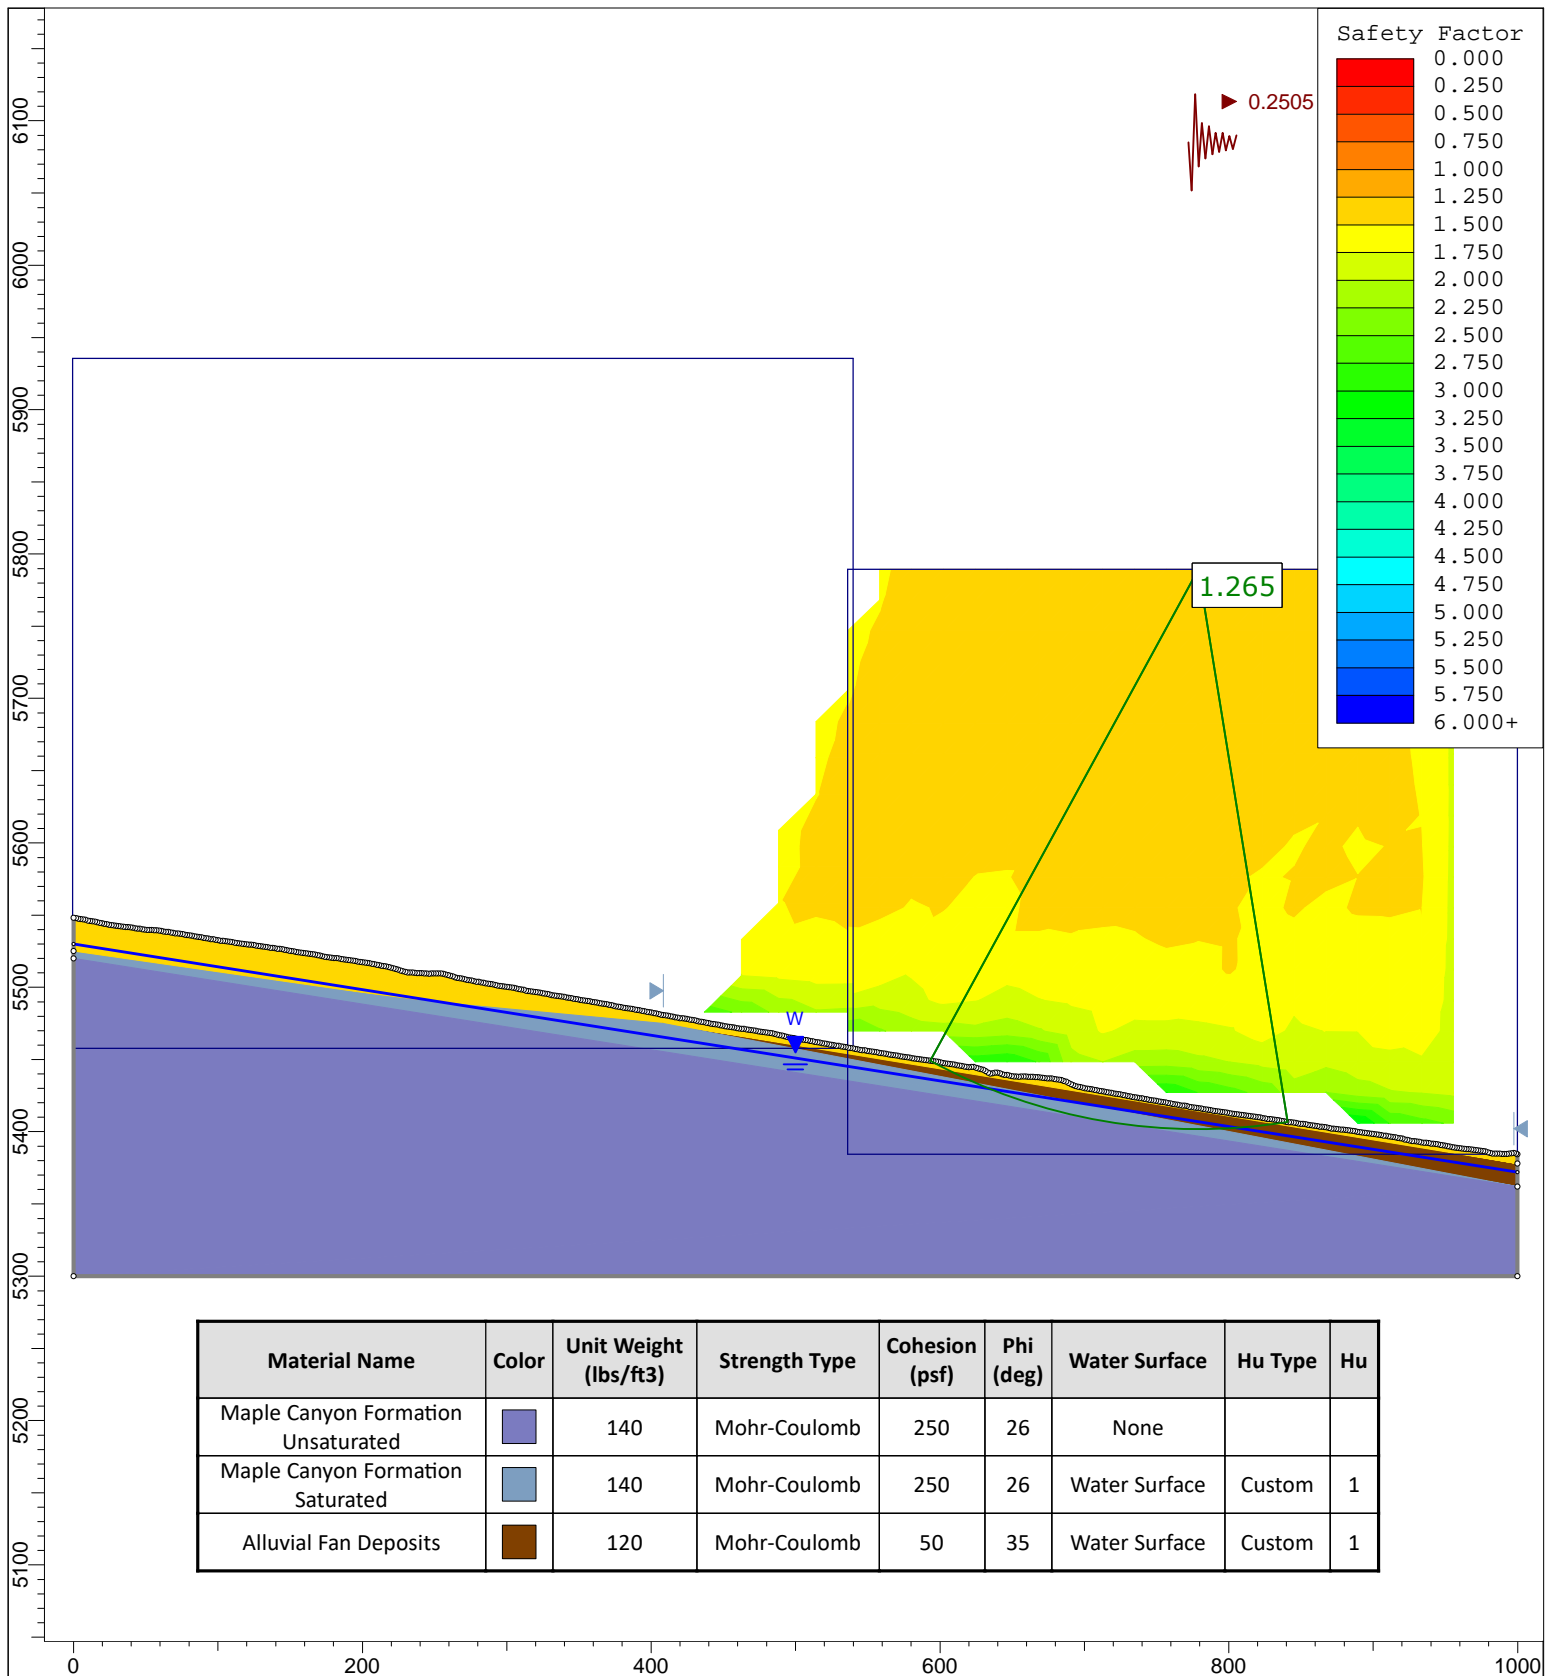
Plate
16

Global Stability - Pseudo Static Lots 25 to 50

Based on these results, it is our opinion that the factors of safety with regard to slope stability are adequate for residential construction at Lots 25 to 50 in the sites current condition. At lots 72 to 83, adequate factors of safety are achieved when all landslide deposits are removed from below the structures and replaced with gravel structural fill. We recommend that the gravel fill extend down to non-deformed, weathered bedrock and extend at least 15 feet beyond the edge of the structures. We estimate that the landslide deposits on these lots are 5 to 25 feet thick. Once the landslide deposits are removed and replaced with gravel structural fill in the vicinity of structures, Lots 72 to 83 will be suitable for residential construction.

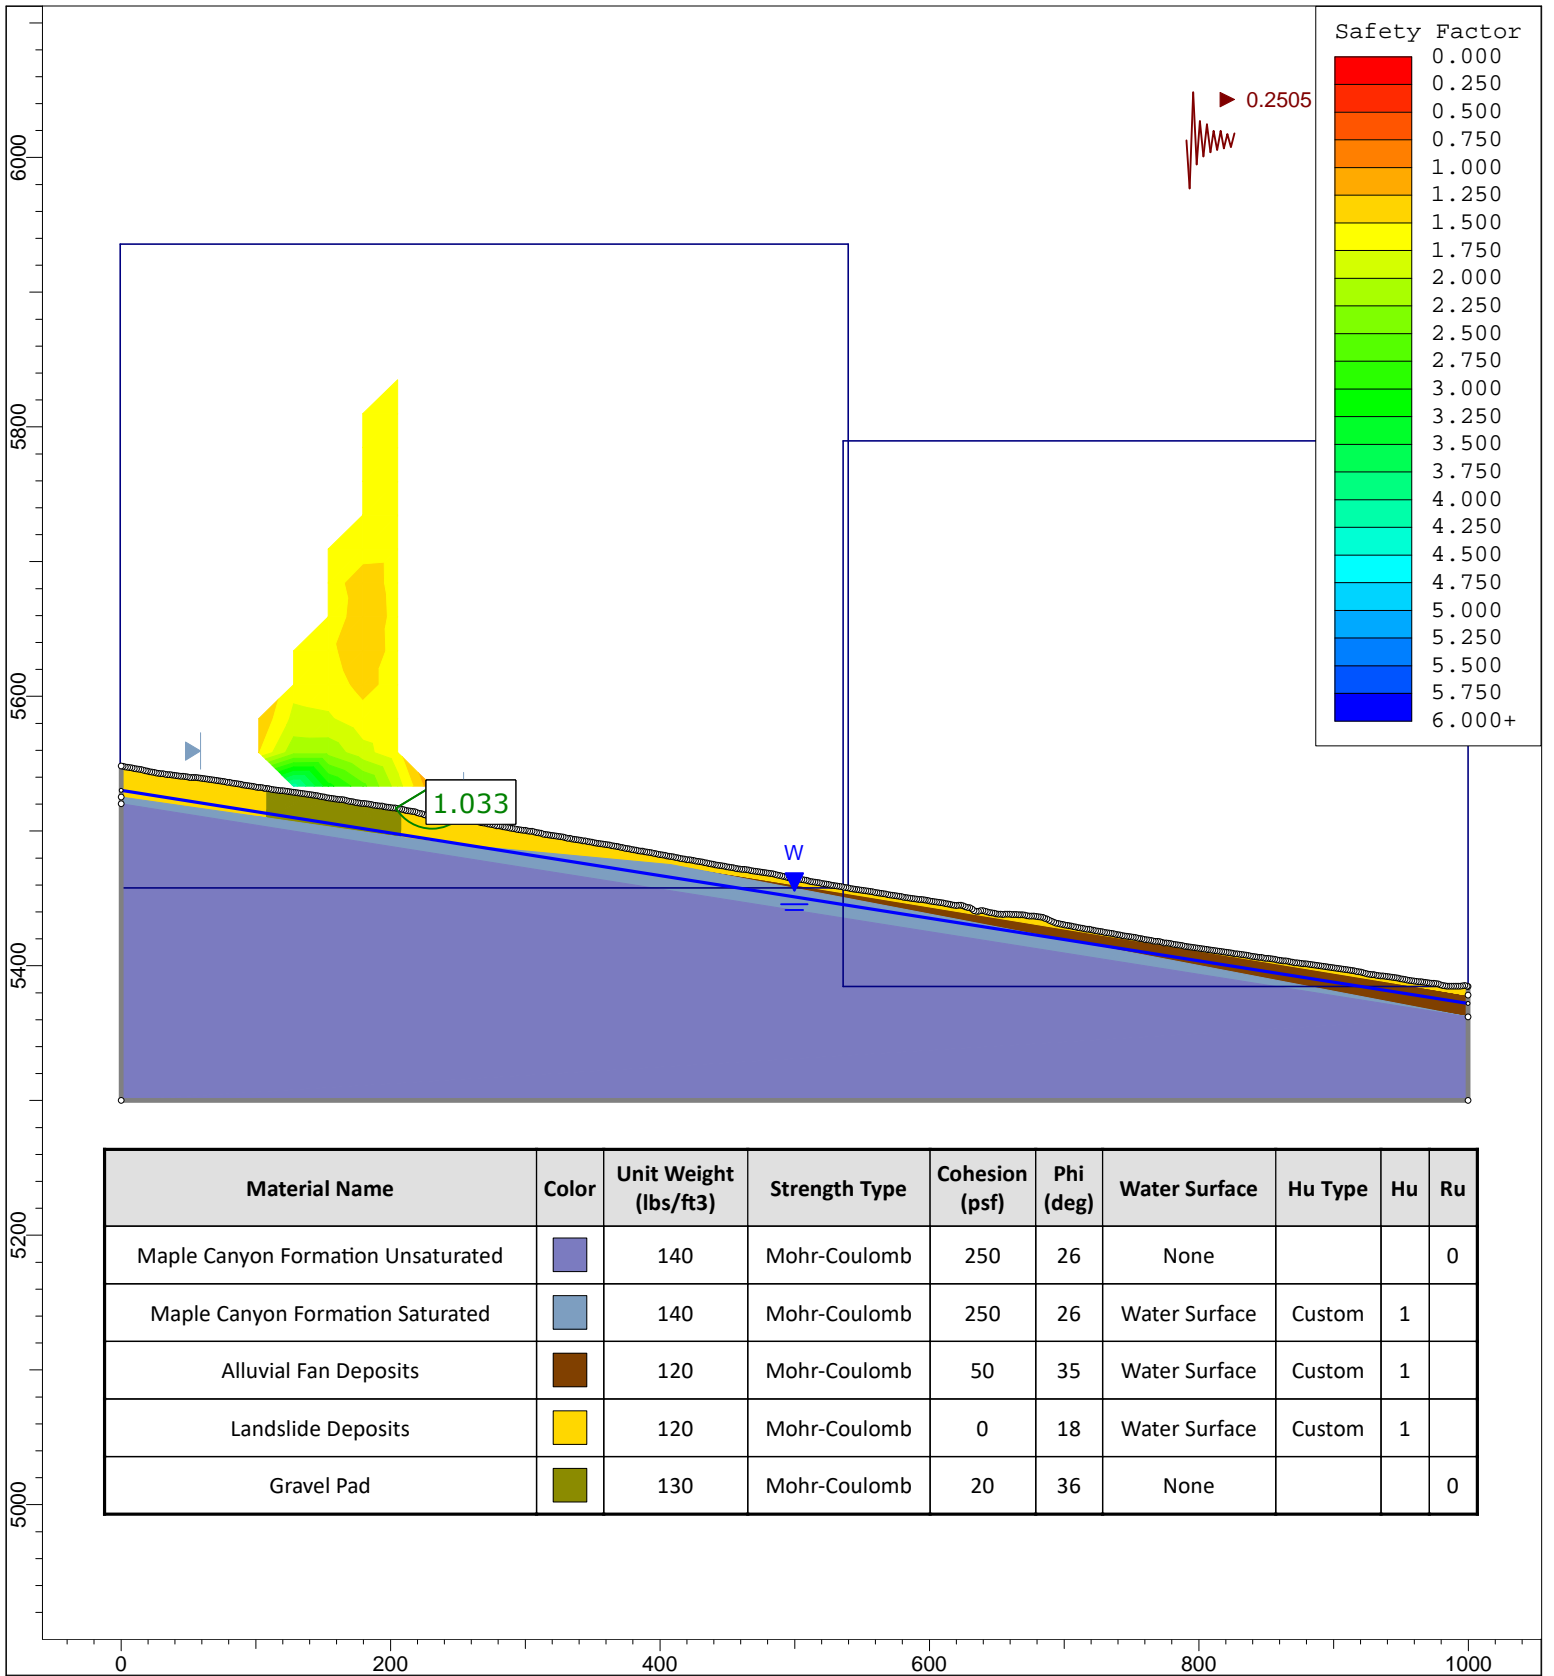
Global Stability - Pseudo Static Lots 72 to 83 with Gravel Pad
