**AQUATIC RESOURCES ASSESSMENT REPORT
LYNC CONSTRUCTION STAGECOACH SITE
SEPTEMBER 3, 2021**

This report describes vegetative, edaphic, and hydrologic parameters pursuant to current federal wetlands regulations associated with an approximately 40-acre study area, referred to as the Stagecoach Site (SS). The focus of this report is the identification and delineation of waters of the U.S., including wetlands that are *potentially* located within the site as indicated by National Wetland Inventory (NWI) mapping.

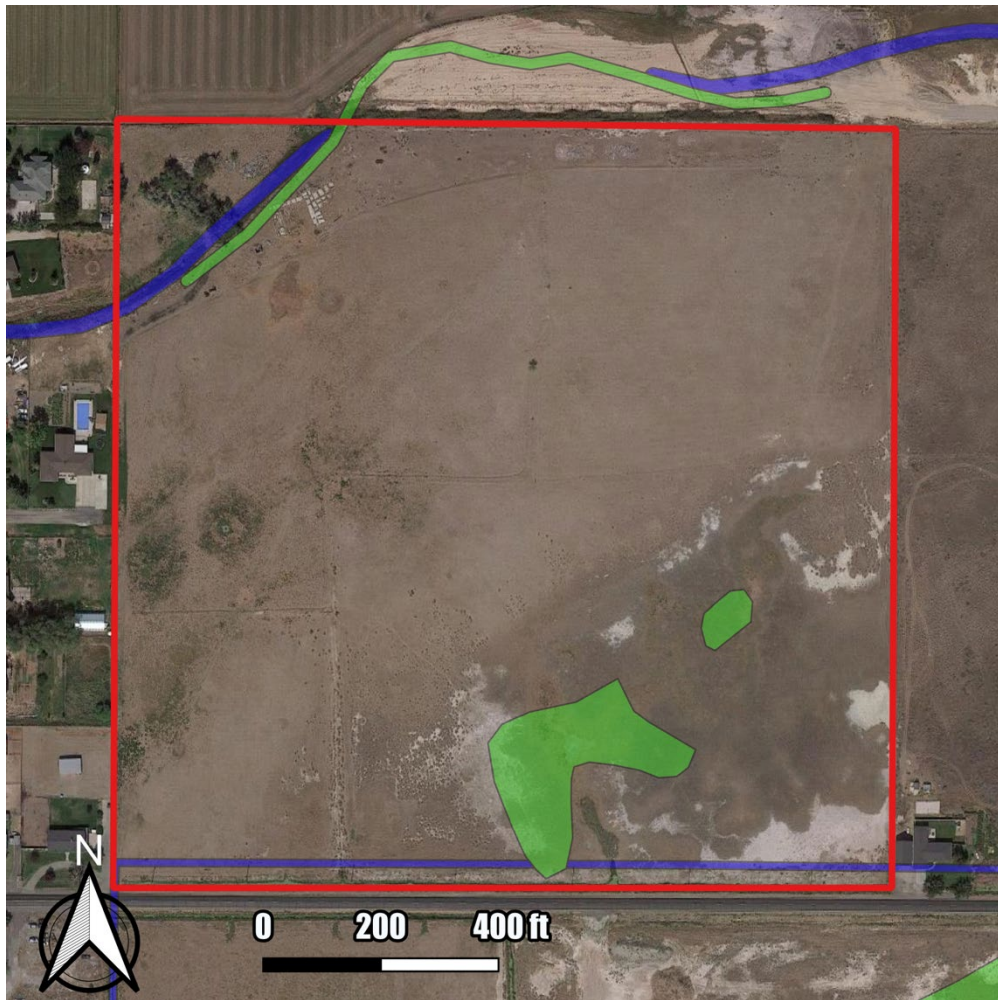
FIGURE 1. POTENTIAL WETLANDS MAPPED BY THE NWI ON THE SS.

Potential wetlands on the SS as mapped by the National Wetland Inventory are shown above. The potential wetlands mapped in green are mapped as PEM1C, or Palustrine Emergent Persistent Seasonally Flooded. The Walker Slough (northwest corner) and irrigation ditches are mapped in blue.

The wetland investigative field survey for this report was requested by Mr. Joshua Wiscombe on behalf of Lync Construction. Mr. Wiscombe was KE's main point-of-contact during the study. The purpose of the wetland assessment study was to provide the landowner with reliable information regarding the approximate location(s) and size(s) of any areas that might contain regulated waters of the U.S., including wetlands, so that such areas would be avoided where practicable, and for determining whether a full wetland delineation was warranted for determining land usability. KE was asked to identify potential federally regulated waters and wetlands throughout the formerly irrigated livestock pasture/grazing land that has been historically in agricultural use. Since the site includes a few areas previously mapped as *potential* wetlands, i.e., the National Wetland Inventory (NWI), KE made specific effort to focus our wetland assessment on those areas (Figure 1).

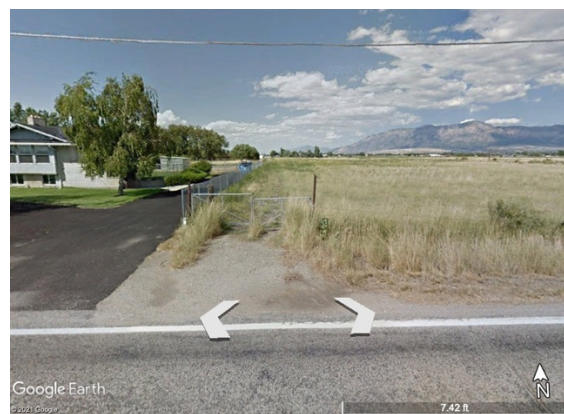
FIGURE 2. LOCATION OF THE STAGECOACH SITE (SS).

The SS is located northwest of Ogden, Weber County, Utah within Section 21, Township 6 North, Range 2 West, Salt Lake Meridian. More precisely, the approximate center of the project is located at 41.23644310° , -112.07109757° in decimal degrees. To reach the site, from I-15, take Exit 344 for Highway 145, State Highway 39. Turn west on Highway 39 and drive approximately 2.5 miles, and turn south (left) on S 3500 W. Go approximately 2/3 mile to W 1800 S and turn right on W 1800 S. The entrance will be 0.5 mile on the right (north). A photograph of the entrance is shown on the right.

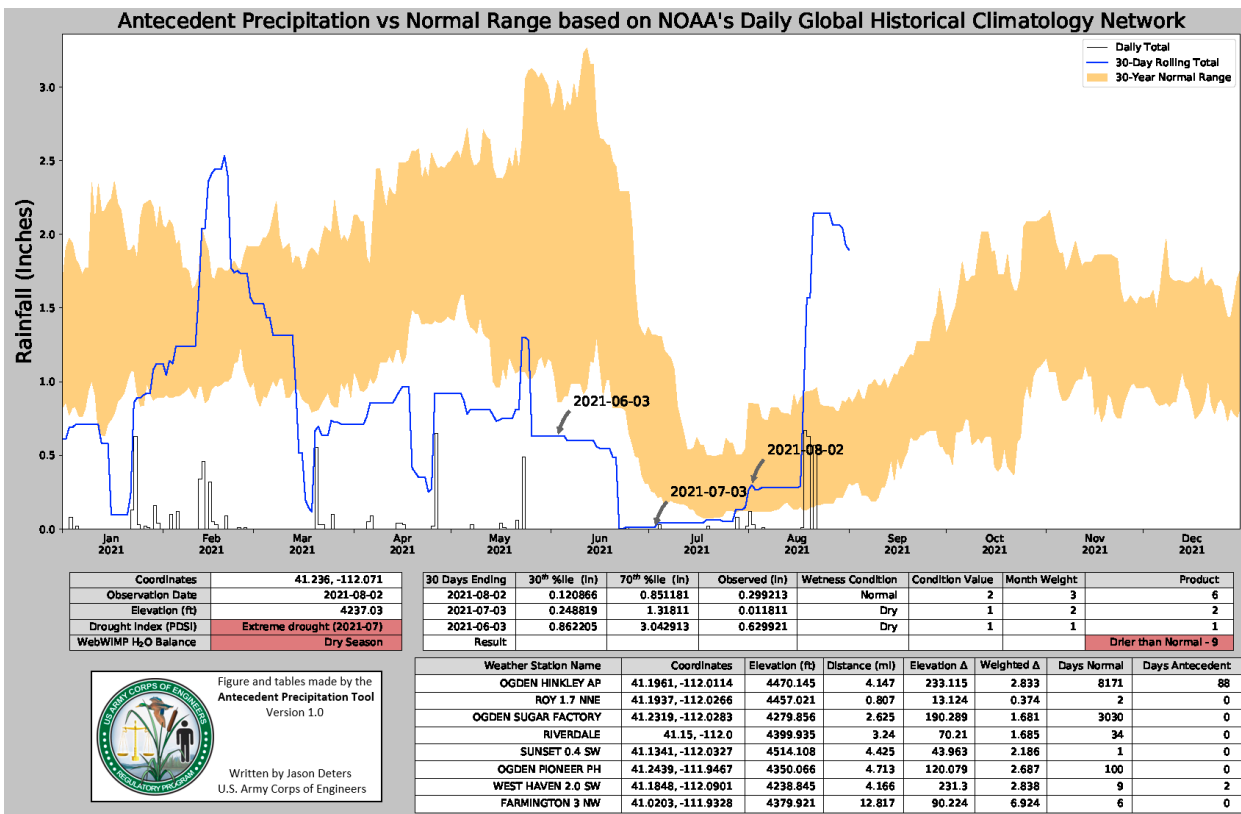
FIGURE 4. ANTECEDENT PRECIPITATION FOR THE SS AT THE TIME OF KE'S SITE VISIT.

Conditions on the day of KE's field study were dry, sunny, and hot, ideal for accurately matching and identifying moist soil colors with the appropriate color chip in the Munsell Color Book. However, as stated on the attached Wetland Determination Data Forms – Arid West Region (Summary of Findings), the antecedent precipitation was less, i.e., *drier*, than normal (Figure 4).

The figure is derived using the Antecedent Precipitation Tool developed by Jason Deters of the Corps.

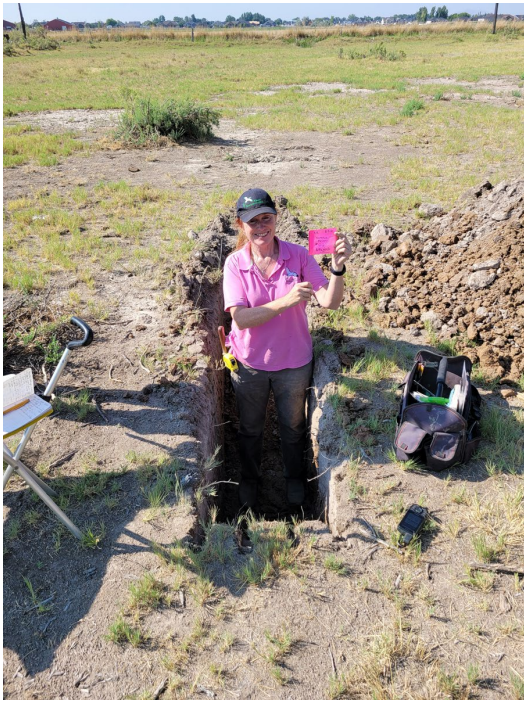
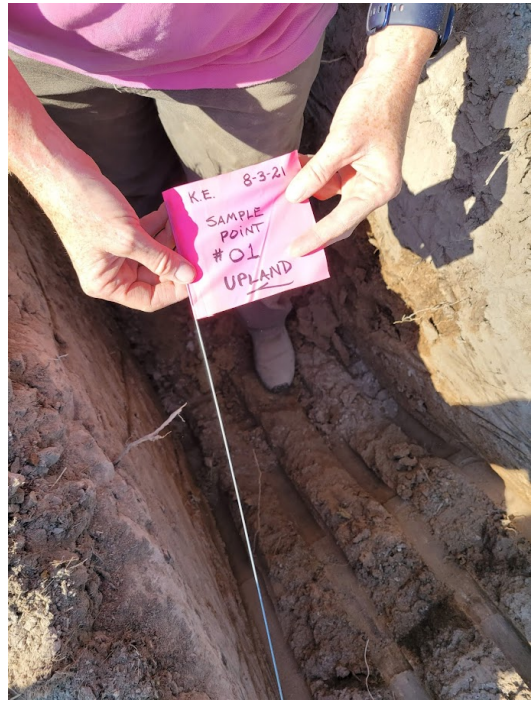
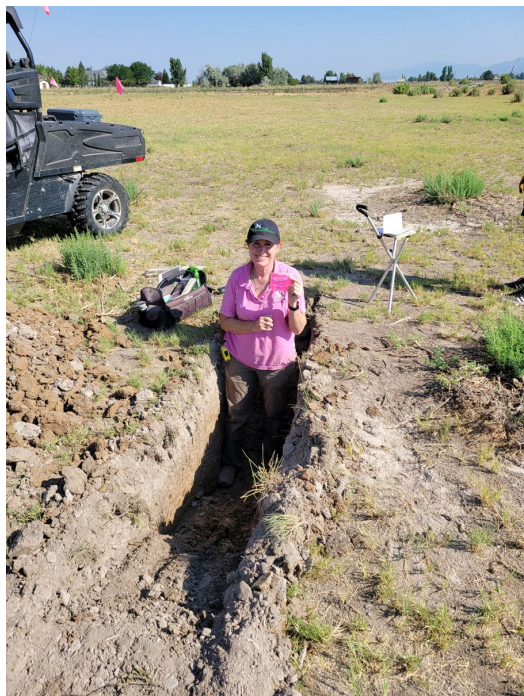
PHOTOGRAPHS OF SAMPLE SITE #01.

Depth (inches)	Matrix		Redox Features				Texture	Remarks
	Color (moist)	%	Color (moist)	%	Type ¹	Loc ²		
0-9	10YR4/2	100	NA				Silt Loam	
9-17	10YR2/2	99	7.5YR4/3	1	C	M	Silt Loam	
17-27	7.5YR 4/3	99	10YR6/8	1	C	M	Silt Clay Loam	
27-39	7.5YR4/3	92	7.5YR6/1	8	D	M	Silt Clay Loam

39" Excavated pit.

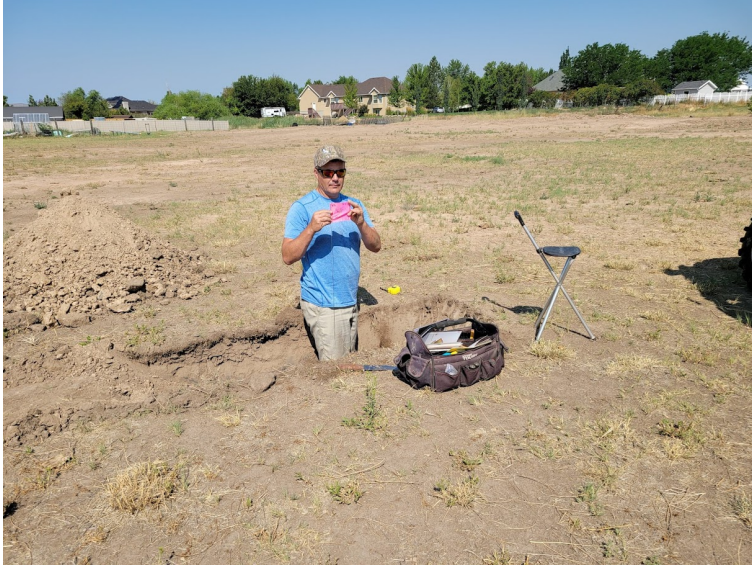
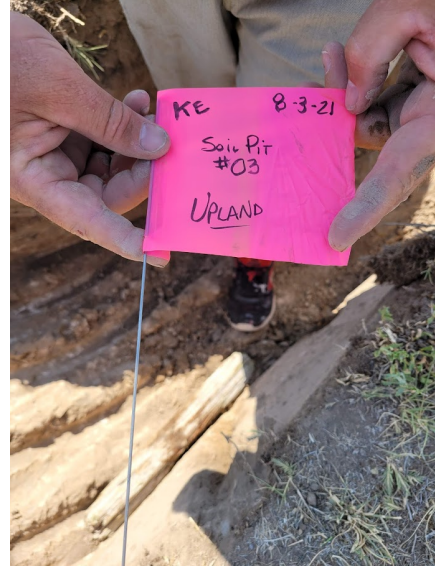
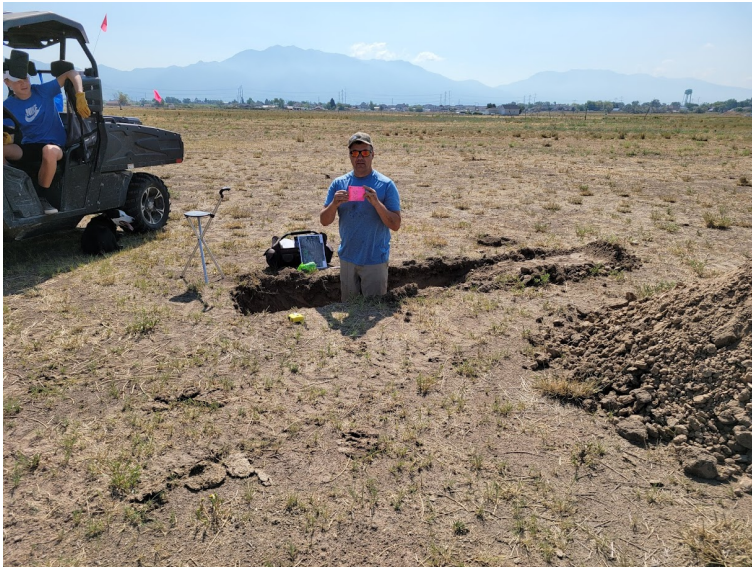
PHOTOGRAPHS OF SAMPLE SITE #03.

Field Observations: Surface Water Present? Yes <input type="checkbox"/> No <input checked="" type="checkbox"/> Depth (inches): _____ Water Table Present? Yes <input type="checkbox"/> No <input checked="" type="checkbox"/> Depth (inches): _____ Saturation Present? (includes capillary fringe) Yes <input type="checkbox"/> No <input checked="" type="checkbox"/> Depth (inches): _____		
Wetland Hydrology Present? Yes _____ No <input checked="" type="checkbox"/>		
Describe Recorded Data (stream gauge, monitoring well, aerial photos, previous inspections), if available: 30" Excavated pit. Remarks: _____ _____ _____

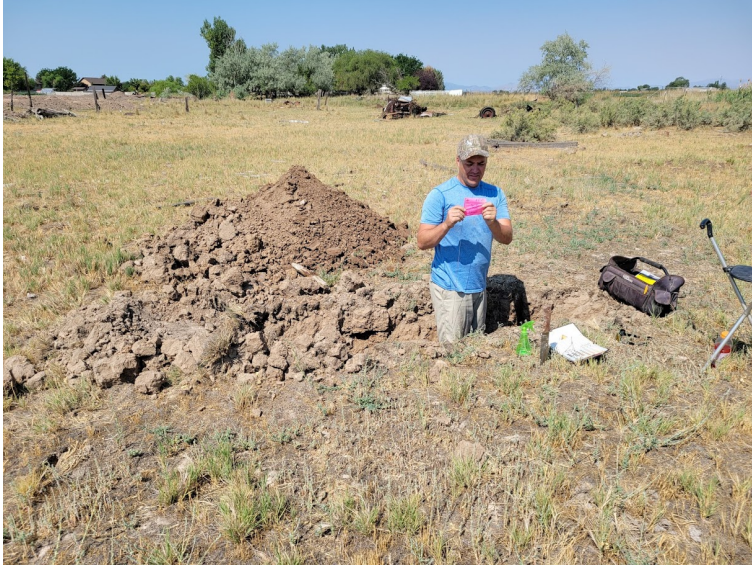
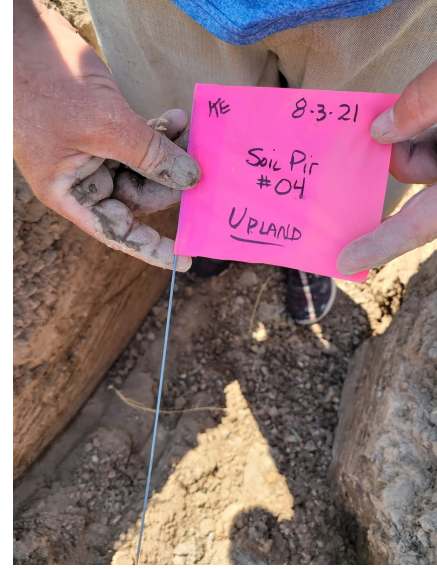
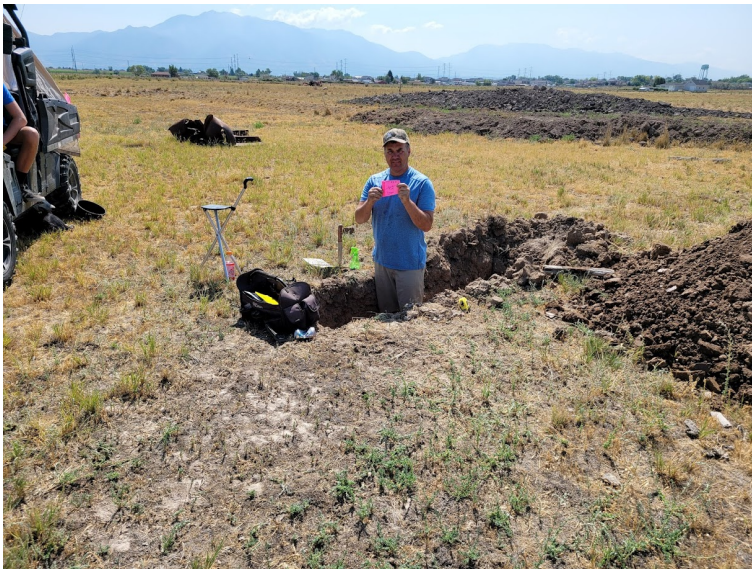
PHOTOGRAPHS OF SAMPLE SITE #04.

Depth (inches)	Matrix		Redox Features				Texture	Remarks
	Color (moist)	%	Color (moist)	%	Type ¹	Loc ²		
0-32	7.5YR4/3	100	NA				Silt Clay

32" Excavated pit.

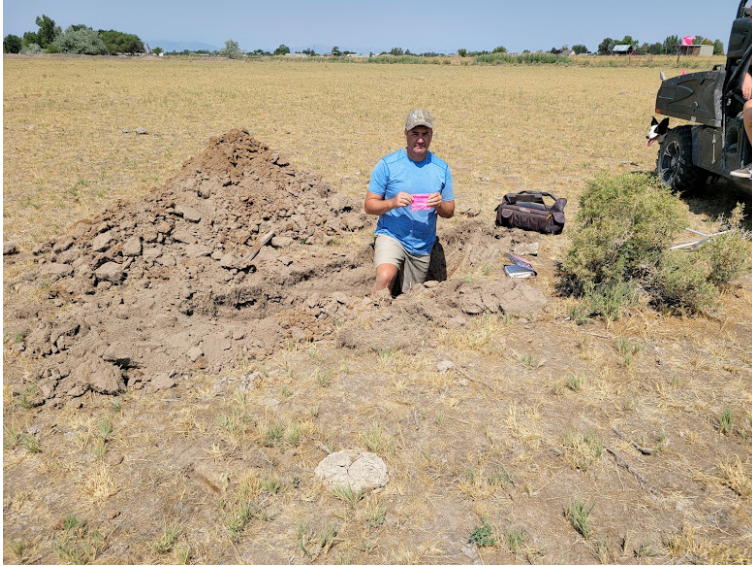
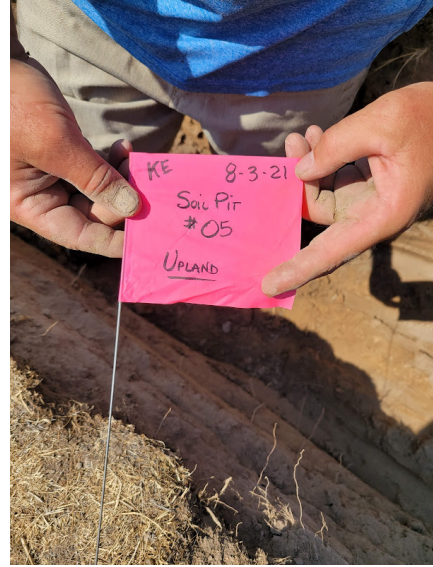
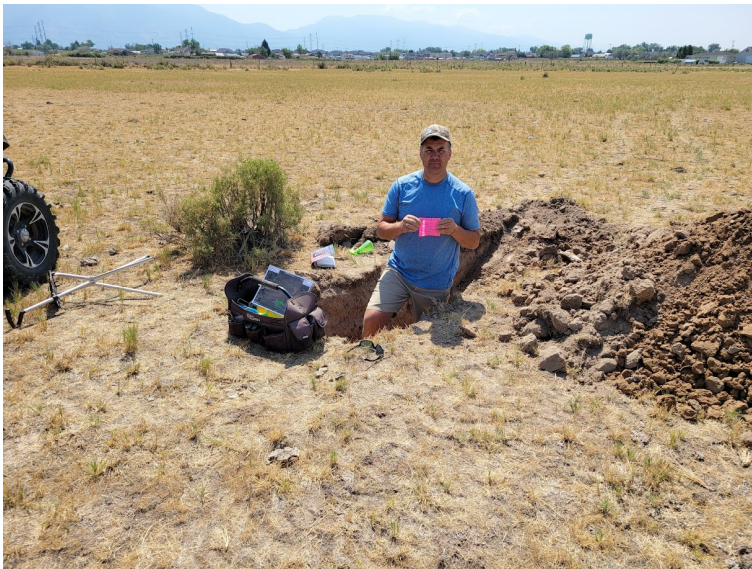
PHOTOGRAPHS OF SAMPLE SITE #05.

Profile Description: (Describe to the depth needed to document the indicator or confirm the absence of indicators.)								
Depth (inches)	Matrix		Redox Features				Texture	Remarks
	Color (moist)	%	Color (moist)	%	Type ¹	Loc ²		
0-11	7.5YR3/2	100	NA				Silt Loam	
11-15	10YR3/2	50	NA				Matrix, clay/silt loam	
	10YR4/2	50						
15-36	7.5YR4/3	100	NA				Silt Loam

36" Excavated pit.

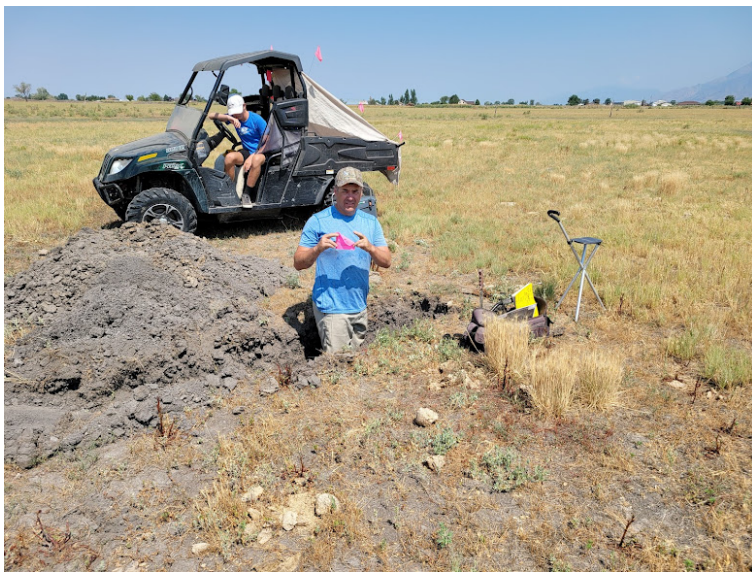
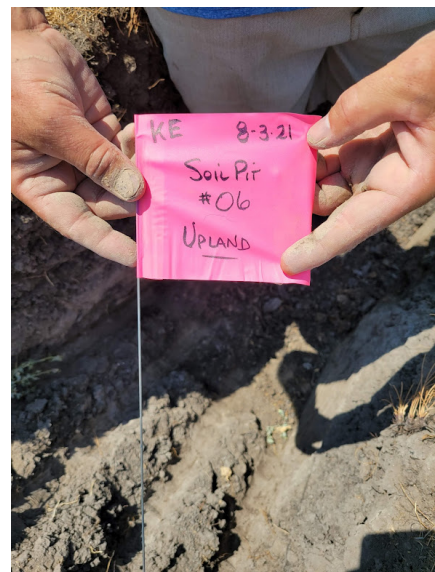
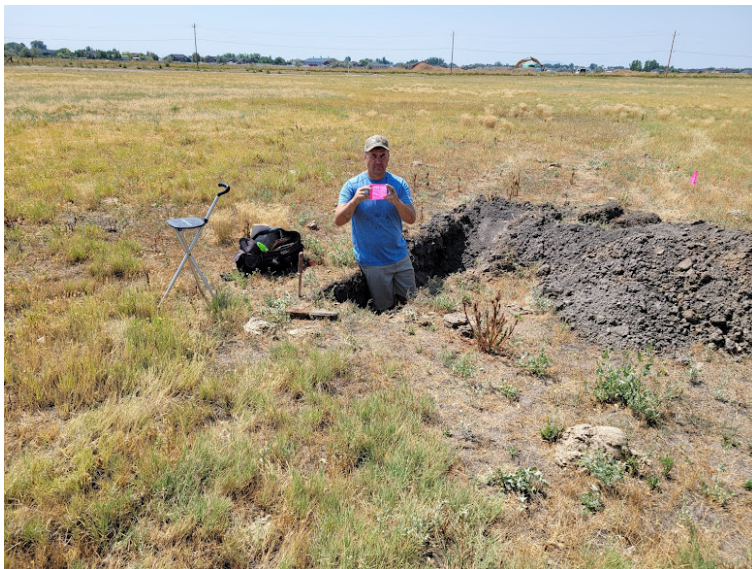
PHOTOGRAPHS OF SAMPLE SITE #06.

Depth (inches)	Matrix		Redox Features				Texture	Remarks
	Color (moist)	%	Color (moist)	%	Type ¹	Loc ²		
0-15	10YR2/1	100	NA				Silt Clay Loam	
15-30	10YR2/1	100	NA				Silt Loam	
30-34	10YR4/2	100	NA				Silt Loam

34" Excavated pit.

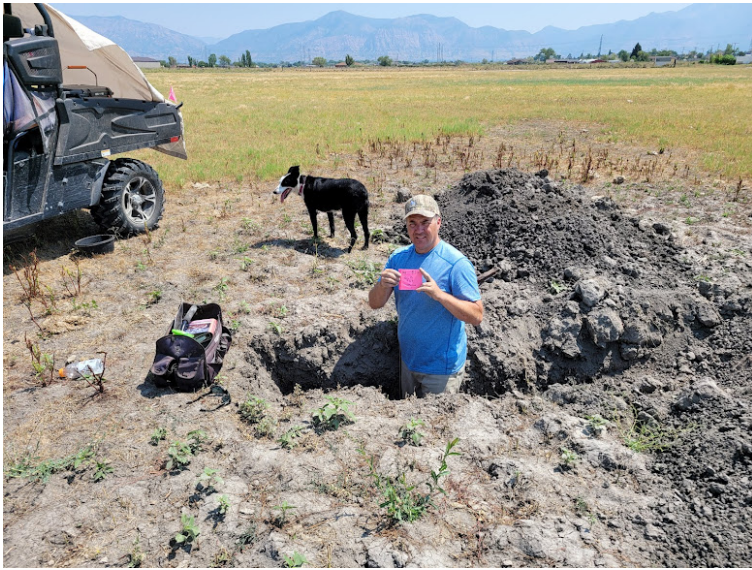
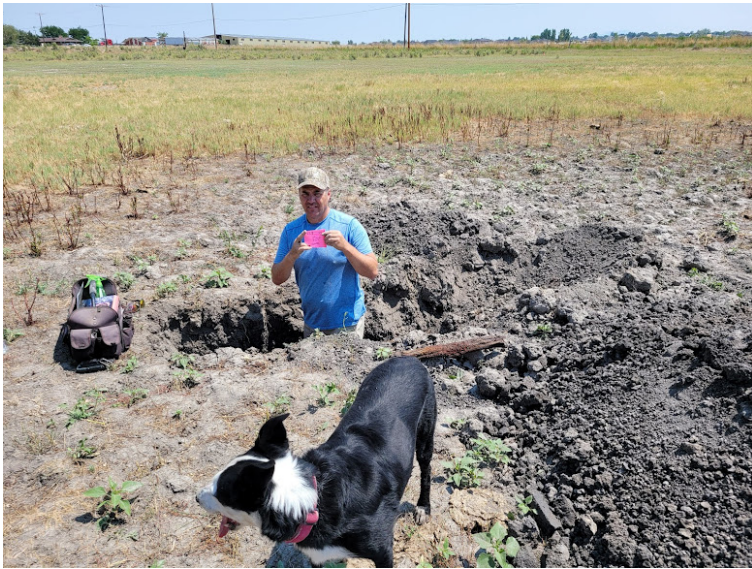
PHOTOGRAPHS OF SAMPLE SITE #07.

Profile Description: (Describe to the depth needed to document the indicator or confirm the absence of indicators.)								
Depth (inches)	Matrix		Redox Features				Texture	Remarks
	Color (moist)	%	Color (moist)	%	Type ¹	Loc ²		
0-17	10YR2/1	100	NA				Silt Clay Loam	
17-44	10YR2/1	100	NA				Silty Clay

44" Excavated pit.

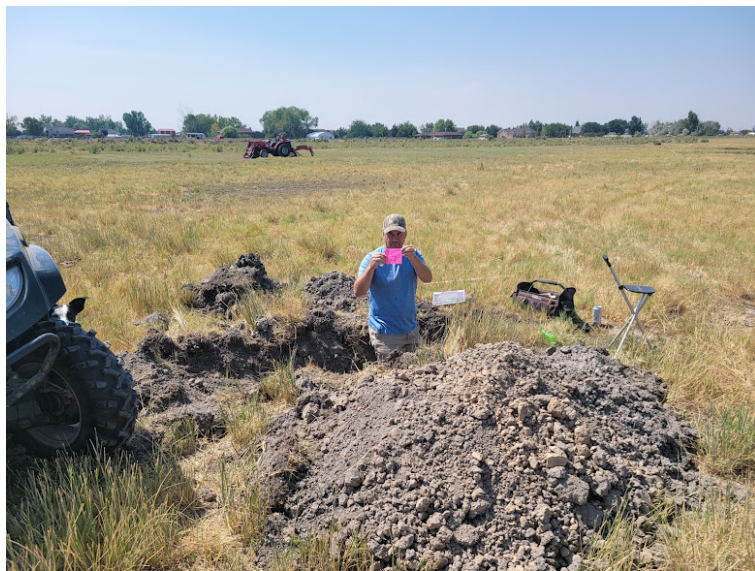
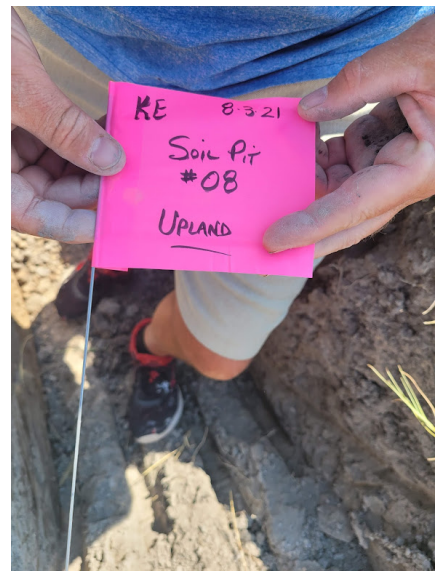
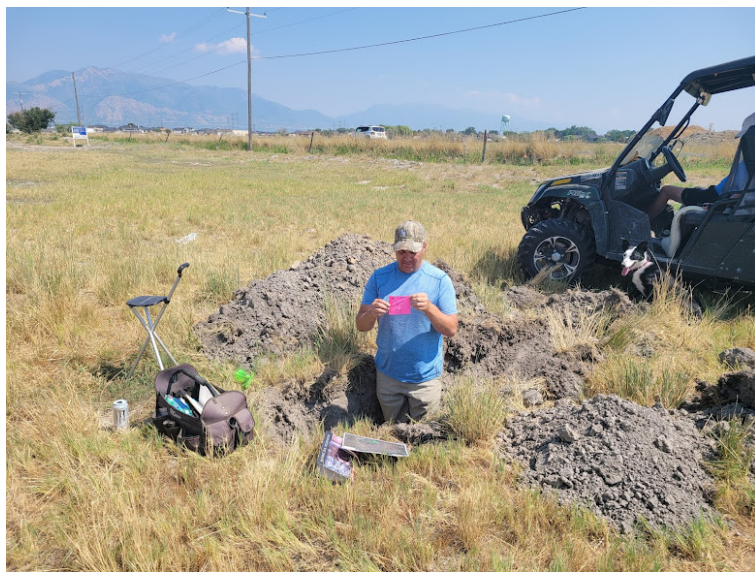
PHOTOGRAPHS OF SAMPLE SITE #08.

Depth (inches)	Matrix		Redox Features				Texture	Remarks
	Color (moist)	%	Color (moist)	%	Type ¹	Loc ²		
0-36	7.5YR3/1	100	NA				Silt Clay

36" Excavated pit.

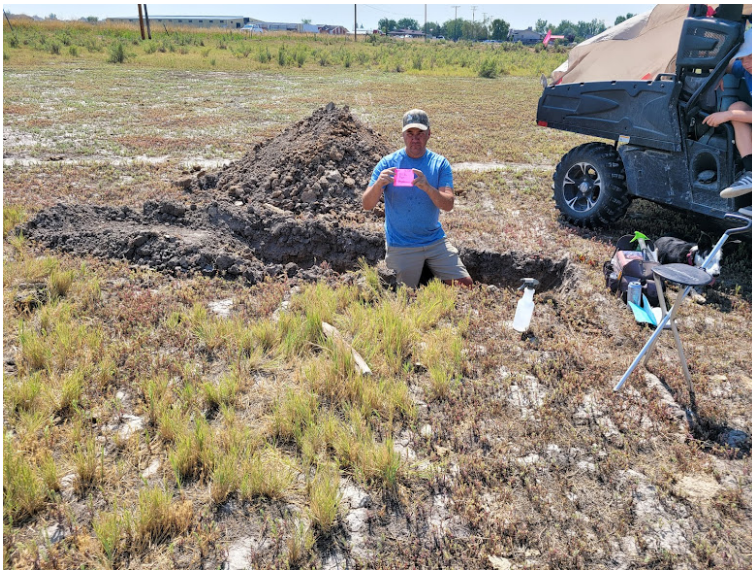
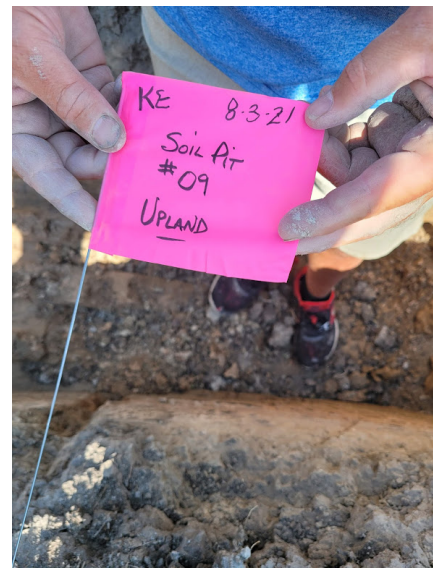
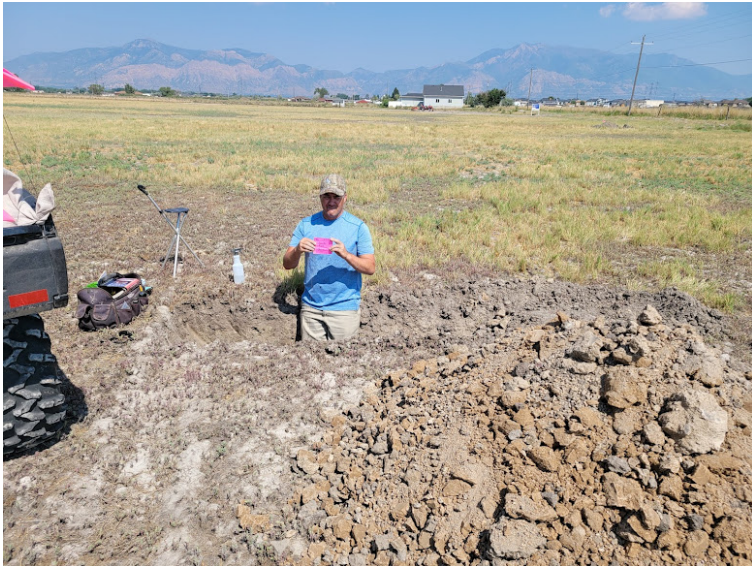
PHOTOGRAPHS OF SAMPLE SITE #09.

Profile Description: (Describe to the depth needed to document the indicator or confirm the absence of indicators.)								
Depth (inches)	Matrix		Redox Features				Texture	Remarks
	Color (moist)	%	Color (moist)	%	Type ¹	Loc ²		
0-11	10YR3/1	100	NA				Silty Clay Loam	
11-20	2.5YR5/2	50	NA				Matrix, clay/silt loam	
	10YR2/1	50						
20-36	10YR5/3	100	NA				Silt Clay Loam	
¹ Type: C=Concentration, D=Depletion, RM=Reduced Matrix, CS=Covered or Coated Sand Grains. ² Location: PL=Pore Lining, M=Matrix.								
Hydric Soil Indicators: (Applicable to all LRRs, unless otherwise noted.)						Indicators for Problematic Hydric Soils³:		
<input type="checkbox"/> Histosol (A1) <input type="checkbox"/> Histic Epipedon (A2) <input type="checkbox"/> Black Histic (A3) <input type="checkbox"/> Hydrogen Sulfide (A4) <input type="checkbox"/> Stratified Layers (A5) (LRR C) <input type="checkbox"/> 1 cm Muck (A9) (LRR D) <input type="checkbox"/> Depleted Below Dark Surface (A11) <input type="checkbox"/> Thick Dark Surface (A12) <input type="checkbox"/> Sandy Mucky Mineral (S1) <input type="checkbox"/> Sandy Gleyed Matrix (S4)			<input type="checkbox"/> Sandy Redox (S5) <input type="checkbox"/> Stripped Matrix (S6) <input type="checkbox"/> Loamy Mucky Mineral (F1) <input type="checkbox"/> Loamy Gleyed Matrix (F2) <input type="checkbox"/> Depleted Matrix (F3) <input type="checkbox"/> Redox Dark Surface (F6) <input type="checkbox"/> Depleted Dark Surface (F7) <input type="checkbox"/> Redox Depressions (F8) <input type="checkbox"/> Vernal Pools (F9)			<input type="checkbox"/> 1 cm Muck (A9) (LRR C) <input type="checkbox"/> 2 cm Muck (A10) (LRR B) <input type="checkbox"/> Reduced Vertic (F18) <input type="checkbox"/> Red Parent Material (TF2) <input type="checkbox"/> Other (Explain in Remarks)

Describe Recorded Data (stream gauge, monitoring well, aerial photos, previous inspections), if available:					
36" Excavated pit.					
Remarks: _____ _____

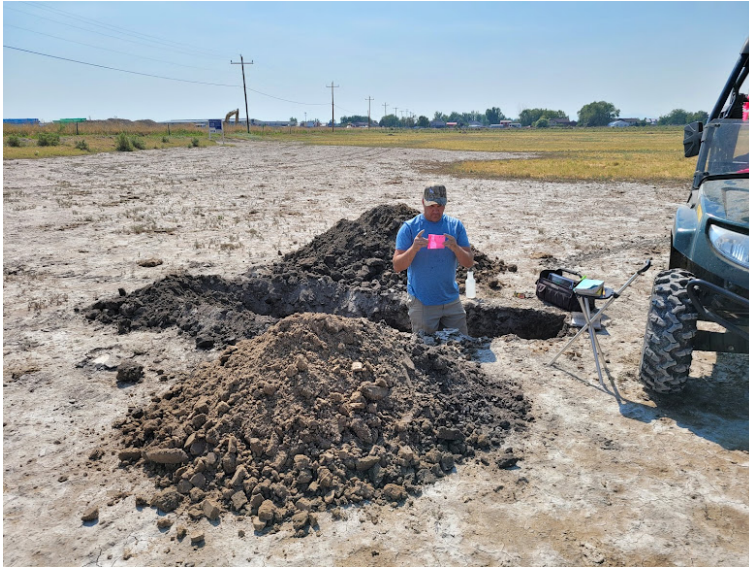
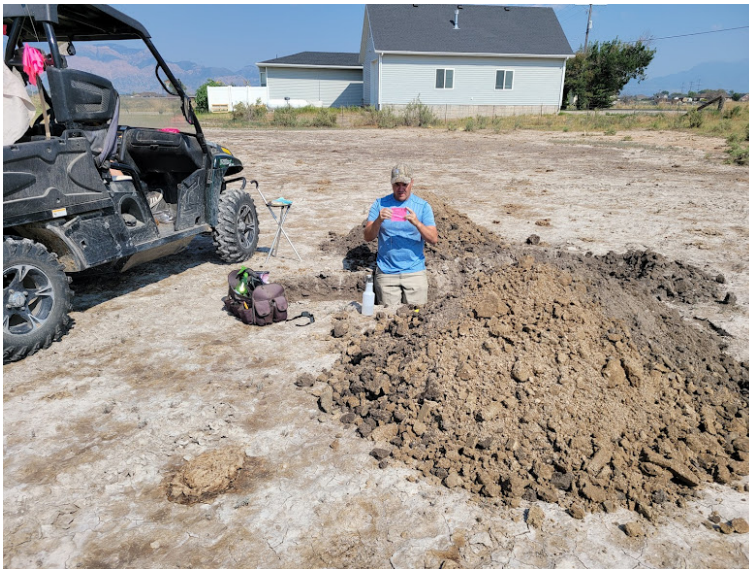
PHOTOGRAPHS OF SAMPLE SITE #10

Profile Description: (Describe to the depth needed to document the indicator or confirm the absence of indicators.)								
Depth (inches)	Matrix		Redox Features				Texture	Remarks
	Color (moist)	%	Color (moist)	%	Type ¹	Loc ²		
0-16	10YR2/1	100	NA				Silt Loam	
16-25	10YR5/2	90	NA				Sandy Loam	
	10YR2/1	10					Sandy Loam	
25-35	2.5YR5/2	100	10YR5/8	<1	C	M	Sandy Loam

Remarks:
Soil Cracks, Playa

35" Excavated pit.

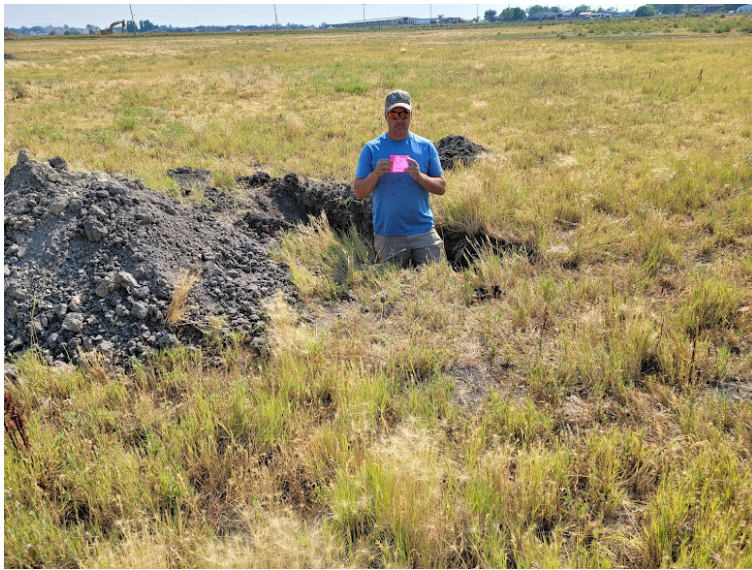
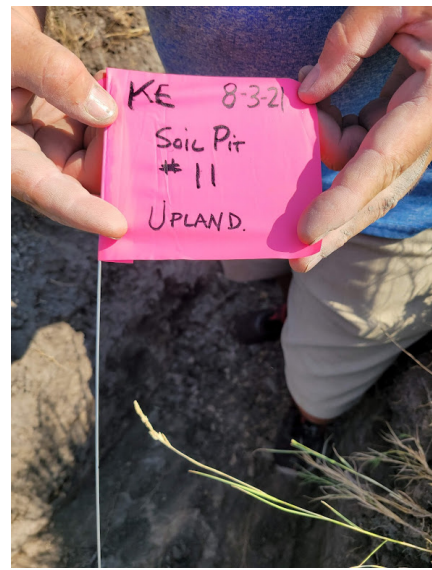
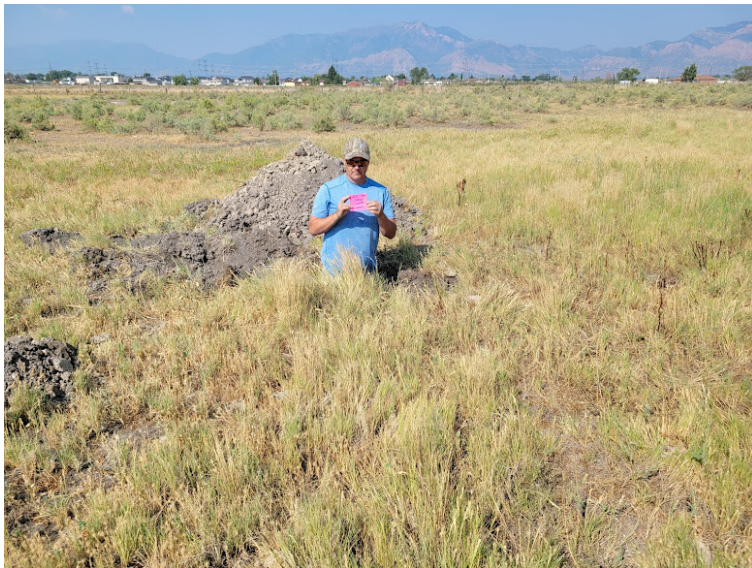
PHOTOGRAPHS OF SAMPLE SITE #11

Depth (inches)	Matrix		Redox Features				Texture	Remarks
	Color (moist)	%	Color (moist)	%	Type ¹	Loc ²		
0-23	10YR2/1	100	NA				Silt Clay Loam	
23-36	10YR4/1*	100	NA				Silt Clay Loam (calcic horizon)	
36-39	10YR4/1	98	7.5YR5/2	2			Silt Clay Loam

39" Excavated pit.

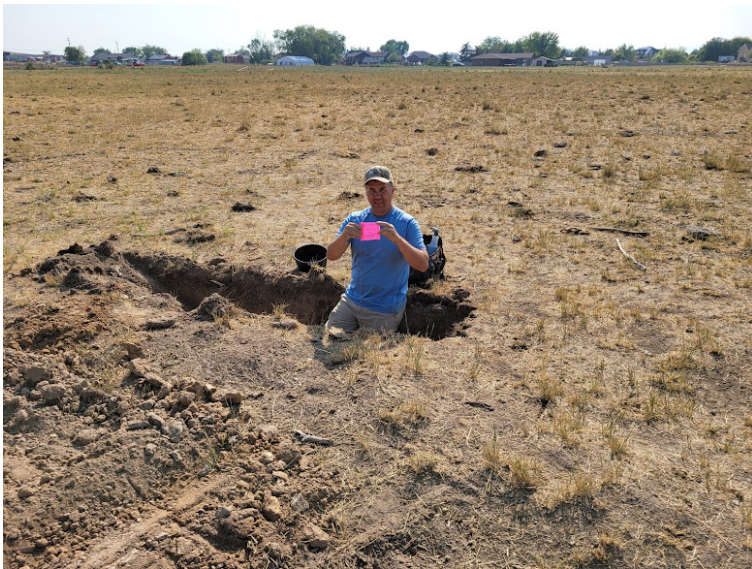
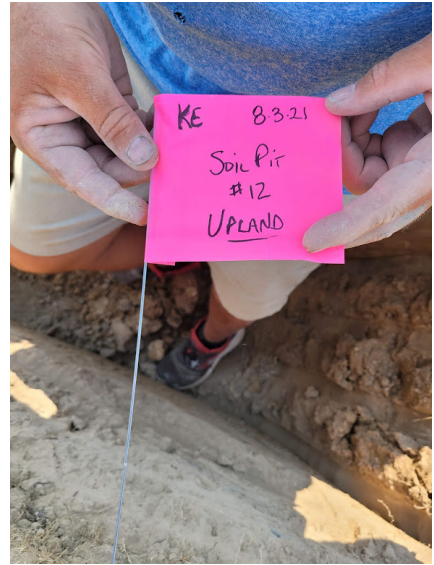
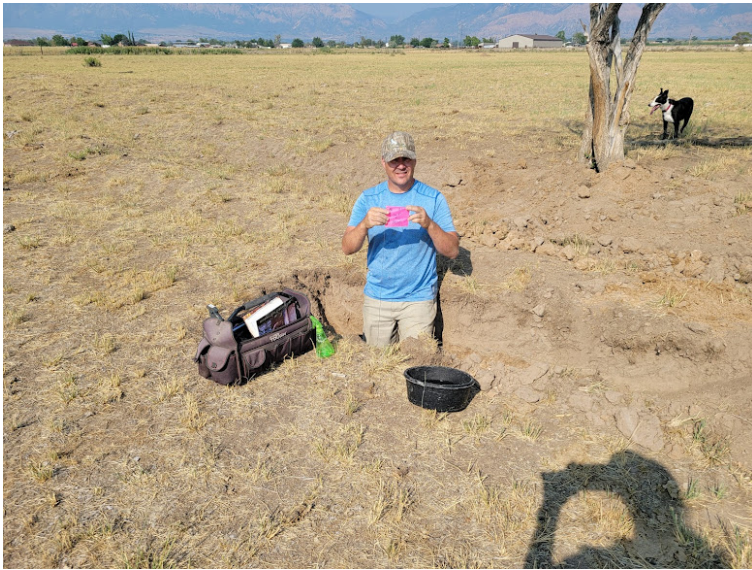
PHOTOGRAPHS OF SAMPLE SITE #12

Depth (inches)	Matrix		Redox Features				Texture	Remarks
	Color (moist)	%	Color (moist)	%	Type ¹	Loc ²		
0-12	7.5YR4/3	100	NA				Silt Loam	
12-37	7.5YR5/4	100	NA				Silt Loam

37" Excavated pit.

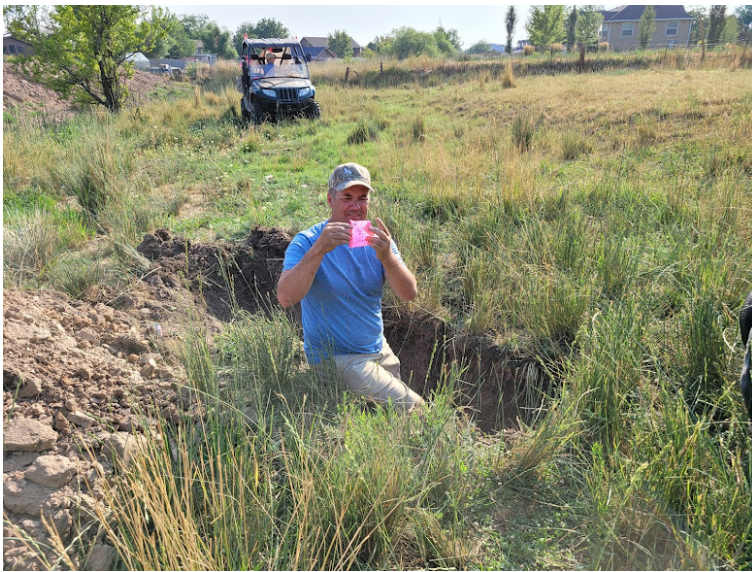
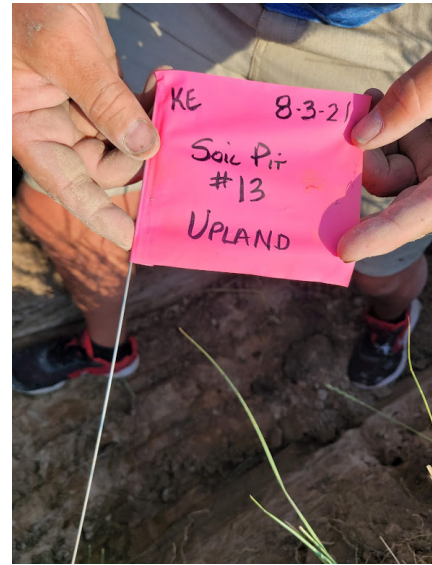
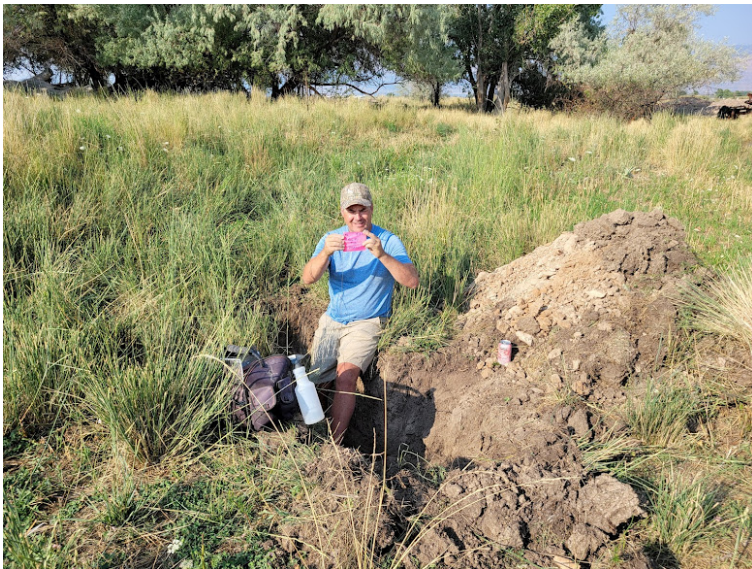
PHOTOGRAPHS OF SAMPLE SITE #13

Profile Description: (Describe to the depth needed to document the indicator or confirm the absence of indicators.)								
Depth (inches)	Matrix		Redox Features				Texture	Remarks
	Color (moist)	%	Color (moist)	%	Type ¹	Loc ²		
0-15	10YR3/2	97	10YR6/8	3			Silt Loam	
15-26	10YR5/2	100	NA				Silt Clay	
26-36	7.5YR5/4	80	NA				Loam

Saturation Present? (includes capillary fringe)	Yes <input type="checkbox"/> No <input checked="" type="checkbox"/>	Depth (inches): _____	
Describe Recorded Data (stream gauge, monitoring well, aerial photos, previous inspections), if available:			
36" Excavated pit.			
Remarks:
