GEOLOGIC AND GEOTECHNICAL ENGINEERING STUDY

Proposed Monument at Powder Mountain Development

East of Intersection of Summit Pass Road and Heartwood Drive
Eden, Utah

CMT PROJECT NO. 20435

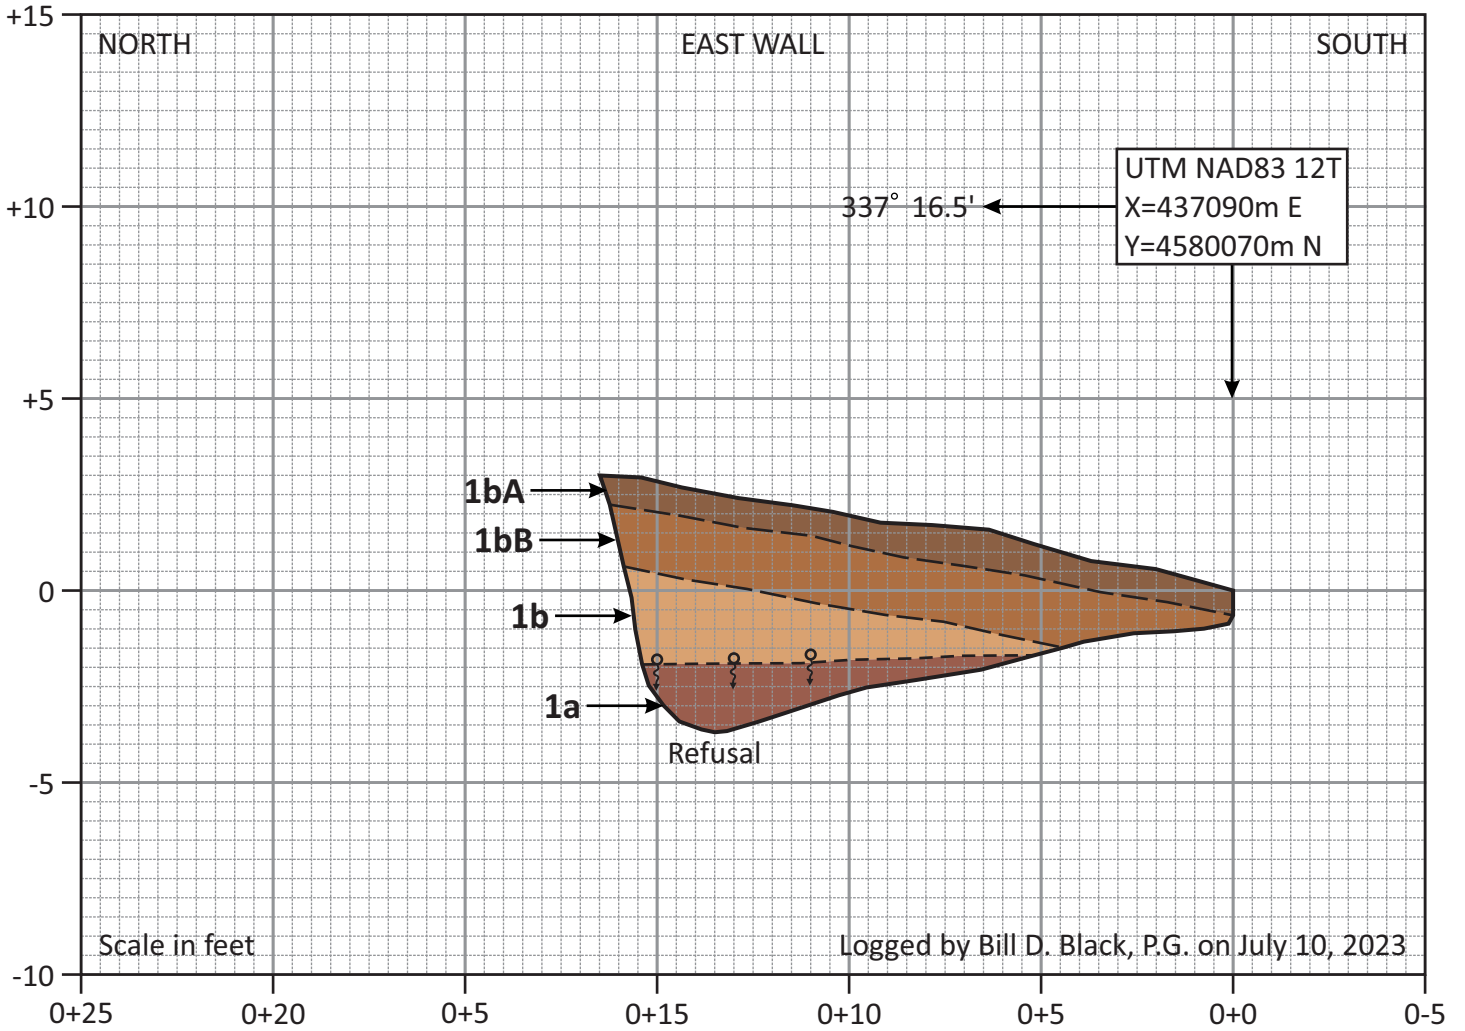
TEST PIT 4

Unit 1. Tertiary Wasatch Formation - weathered conglomerate comprised of a lower (1a) brownish-red, dense, massive, sandy clay with gravel (CL); and an upper (1b) orange-brown, brown and grayish-brown; massive; medium dense; clayey sand with gravel (SC) and round to subangular cobbles and boulders with strong stage II carbonate; A and Bt soil horizons formed in unit 1b (1bA and 1bB); roughly 1-foot thick saturated zone at base of unit 1b seeping into test pit, likely perched groundwater from snowmelt infiltration.

Moist soils and seepage were observed in test pits TP-4, TP-5, TP-11 and TP-13 in the northeast part of the site. The seepage appeared to be residual moisture from recent snowmelt infiltration. No seepage or groundwater was observed in the remaining test pits or boreholes to their explored depths. No site-specific groundwater information was available for the Project, but the Utah Division of Water Rights Well Drillers' database indicates two water wells owned by Summit Mountain Holding Group (SMHG) are to the southeast and west, as located on **Figure 2**. The SMHG well southeast of the Project was drilled in May 2013 to a depth of 2,800 feet. Static groundwater in this well was reportedly at a depth of 1,147 feet bgs. The SMHG well west of the Project was drilled in December 2017 to a depth of 2,500 feet. Static groundwater in this well was reportedly at a depth of 1,225.49 feet bgs.

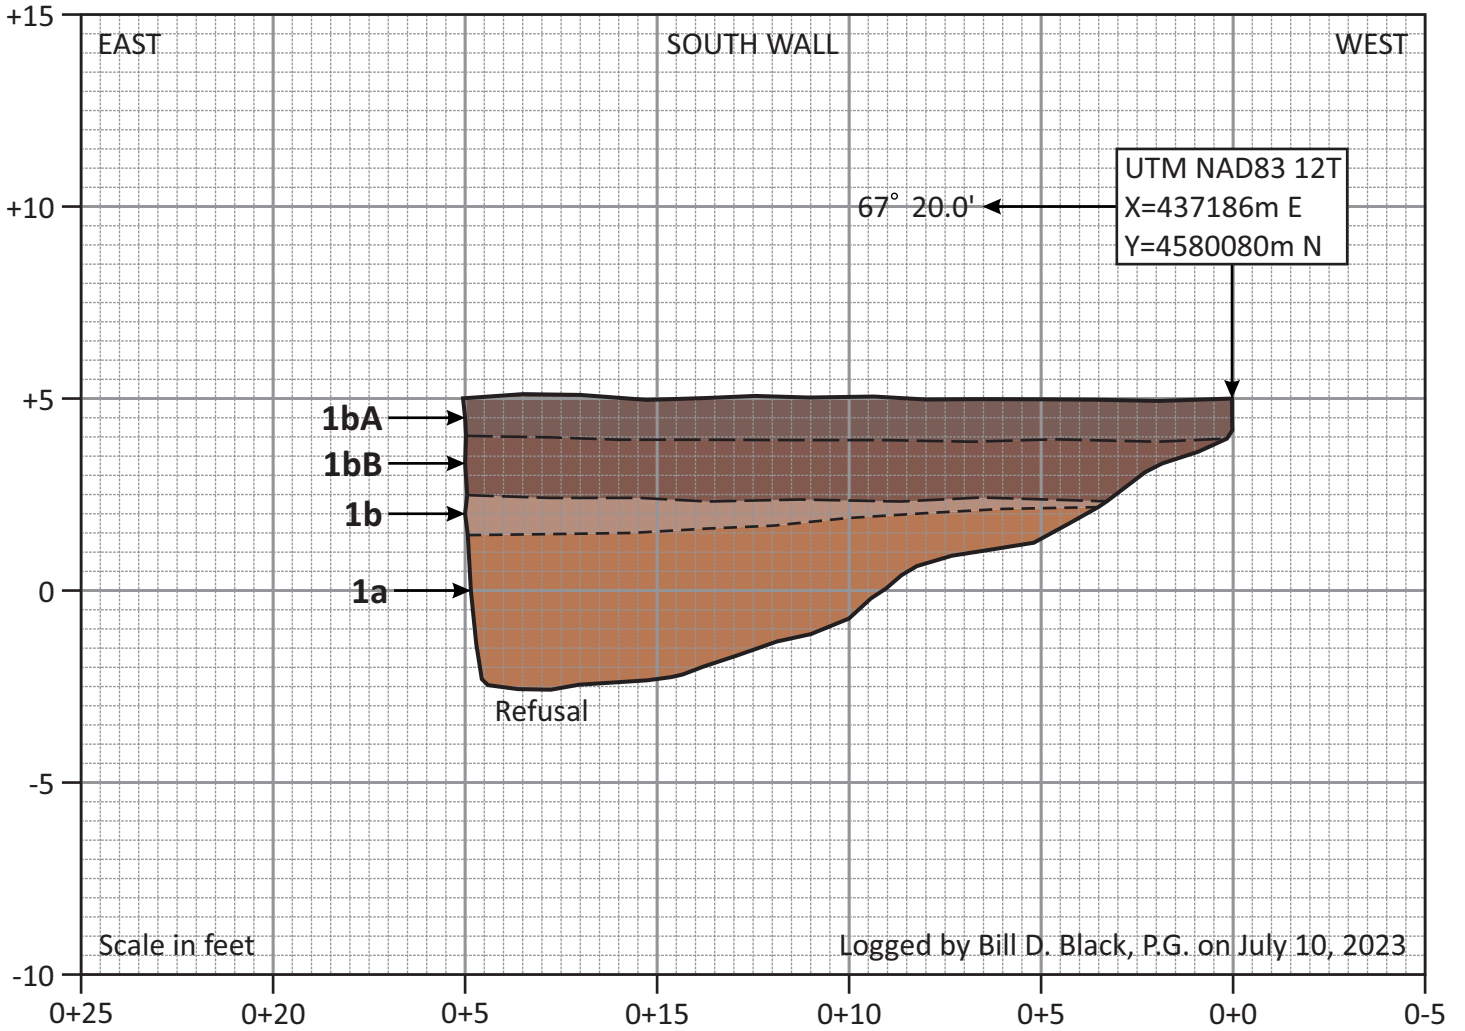
TEST PIT 5

Unit 1. Tertiary Wasatch Formation - weathered conglomerate comprised of a lower (1a) reddish-brown, dense, massive, clayey sand to clayey gravel (SC/GC) with round to subangular cobbles, slightly moist with remnant saturated pockets; and an upper (1b) reddish-brown, brown and grayish-brown; massive; medium dense; clayey gravel with sand (GC) and round to subround cobbles and boulders with strong stage II carbonate; A and Bt/Bk soil horizons formed in unit 1b (1bA and 1bB).

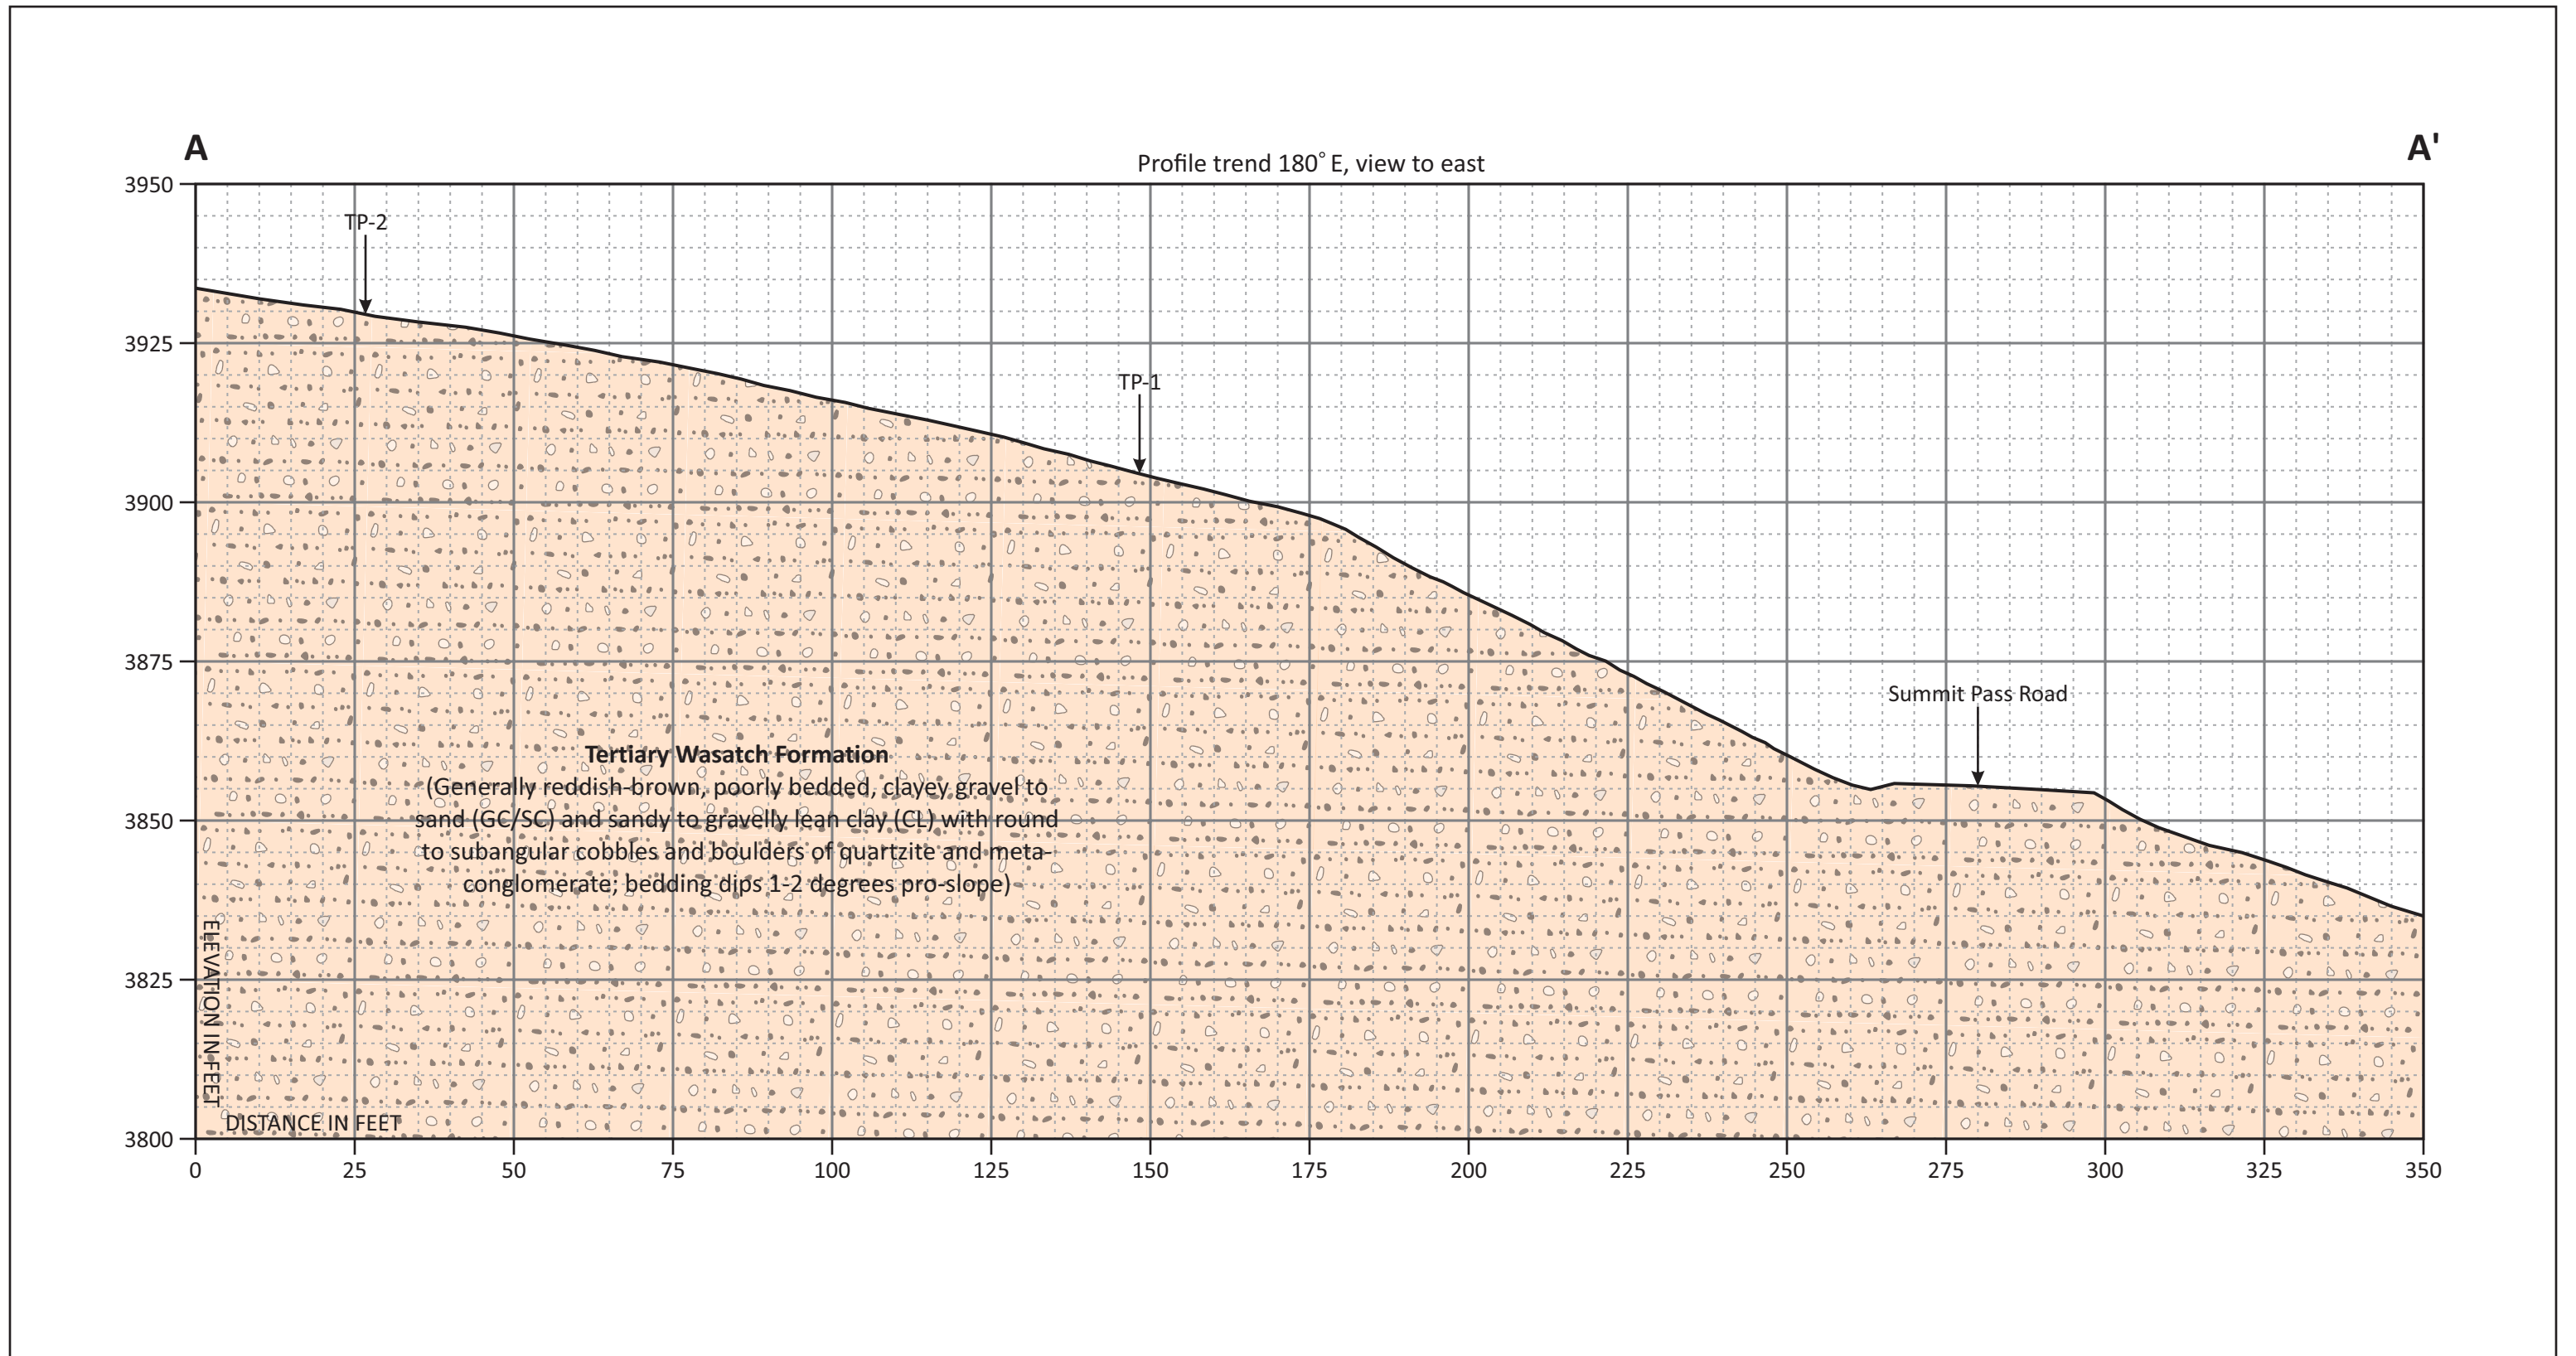
Scale 1 inch equals 25 feet (1:300) with no vertical exaggeration. Profile based on geoprocessed LIDAR data from 2016. Contacts and units are inferred and approximate.

Figure 8, Cross Section A-A', shows one geologic cross section across the steepest slopes in the south part of the site, as located on **Figures 5 and 6**. The cross section is at a scale of 1 inch equals 25 feet with no vertical exaggeration. The geology is based on subsurface data from test pits TP-1 and TP-2 (**Figures 7A-B**), and the regional and site-specific geologic mapping on **Figures 2 and 6**. The topographic profile is based on geoprocessed LIDAR data from 2016. The LIDAR data provide a snapshot of topographic conditions at the time of acquisition; past, present and future surficial topography may vary. Units and contacts should be considered approximate and inferred, and variations should be expected at depth and laterally.

- Cross-section A-A' consists of a 350-foot long horizontal cross section with an overall elevation change of about 145 feet to the northeast. The geologic cross section (**Figure 8**) shows the entire profile to consist of Tertiary Wasatch Formation generally composed of Clayey Gravel to Clayey Sand. Based on the slope stability analysis, the current slope has factors of safety for both static and pseudo-static (earthquake) conditions greater than those typically considered acceptable (See **Figures 31 and 32 Stability Results**). The ten failure surfaces with the lowest factors of safety are shown on the stability analysis plots, with the lowest calculated factor of safety highlighted.
