ENGINEERING ADDENDUM

The following letter is provided by Solid Structural Engineering for the Huntsville B&B at

1188 South Old Trappers Loop Road
Huntsville, UT 84317

JOB SUMMARY REPORT

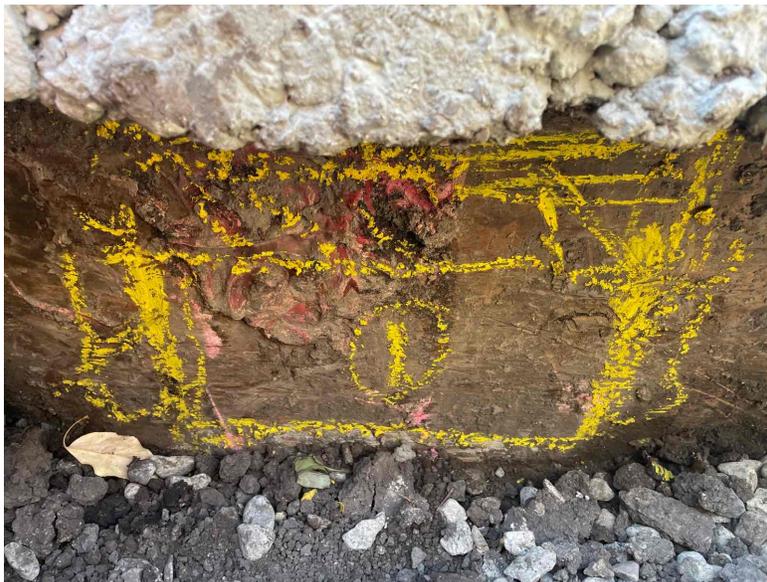
Jobsite Photo #1

Client Provided Drawings	Yes
Scope of Work	Locate rebar within concrete piers
Quantity of Column Areas	5
Slab Type	- Cast Place Rebar
Limitations Encountered	- Unable to see through slab (too thick)
Marking Medium	- Crayon
Results Notes	Used GPR to scan for any reinforcement in the piers. All findings are marked on surface with yellow crayon. Limited data was found in these areas due to the amount of space scanning was restricted and gaining more data was not possible. Each of the piers were found to have reinforcement.

- The reinforcement in the (5) concrete piers is adequate based on the scans and report provided by GPRS.
