DANCING MOOSE FARM ART & ECOLOGY CENTER

13485 EAST HWY 39
HUNTSVILLE, UT

SITE PLAN

Project #	14-1180	A102
Date	02-04-15

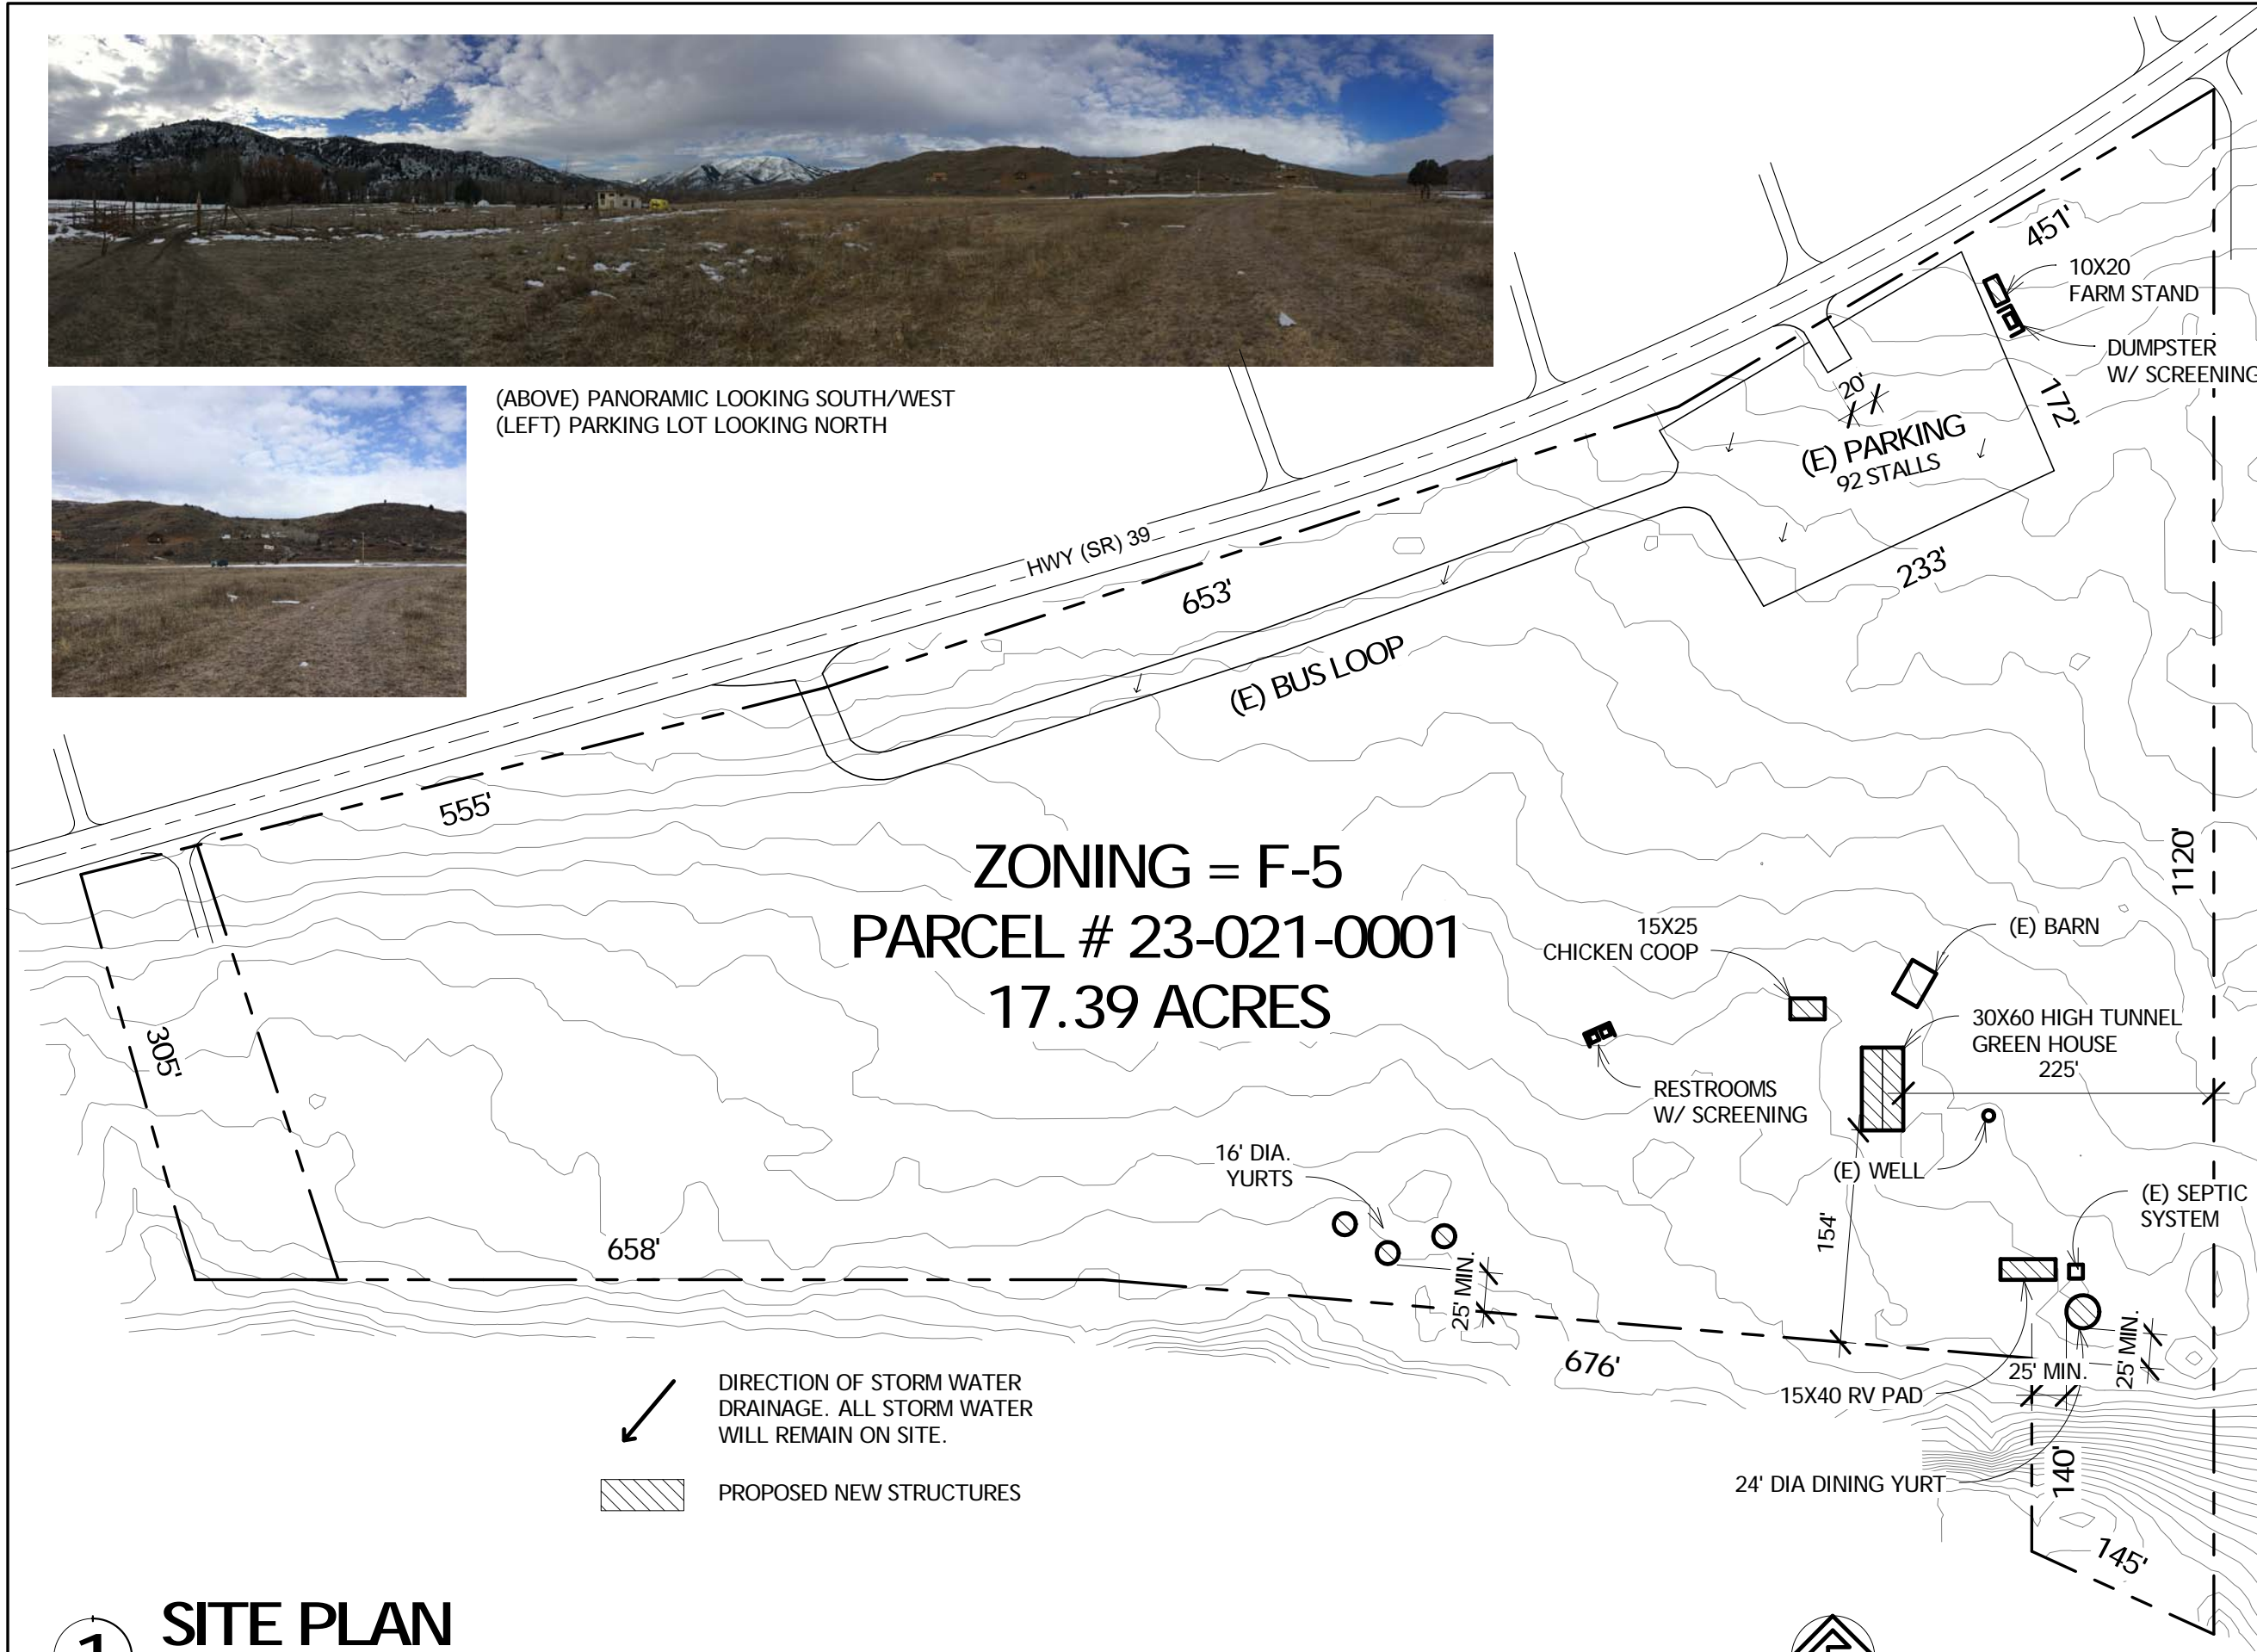
1 SITE PLAN

DIRECTION OF STORM WATER DRAINAGE. ALL STORM WATER WILL REMAIN ON SITE.

PROPOSED NEW STRUCTURES
