GEOTECHNICAL ENGINEERING AND GEOLOGIC STUDY

Sundown Condominiums Phase 3

About 6550 North Powder Mountain Road
Eden, Utah

CMT PROJECT NO. 24298

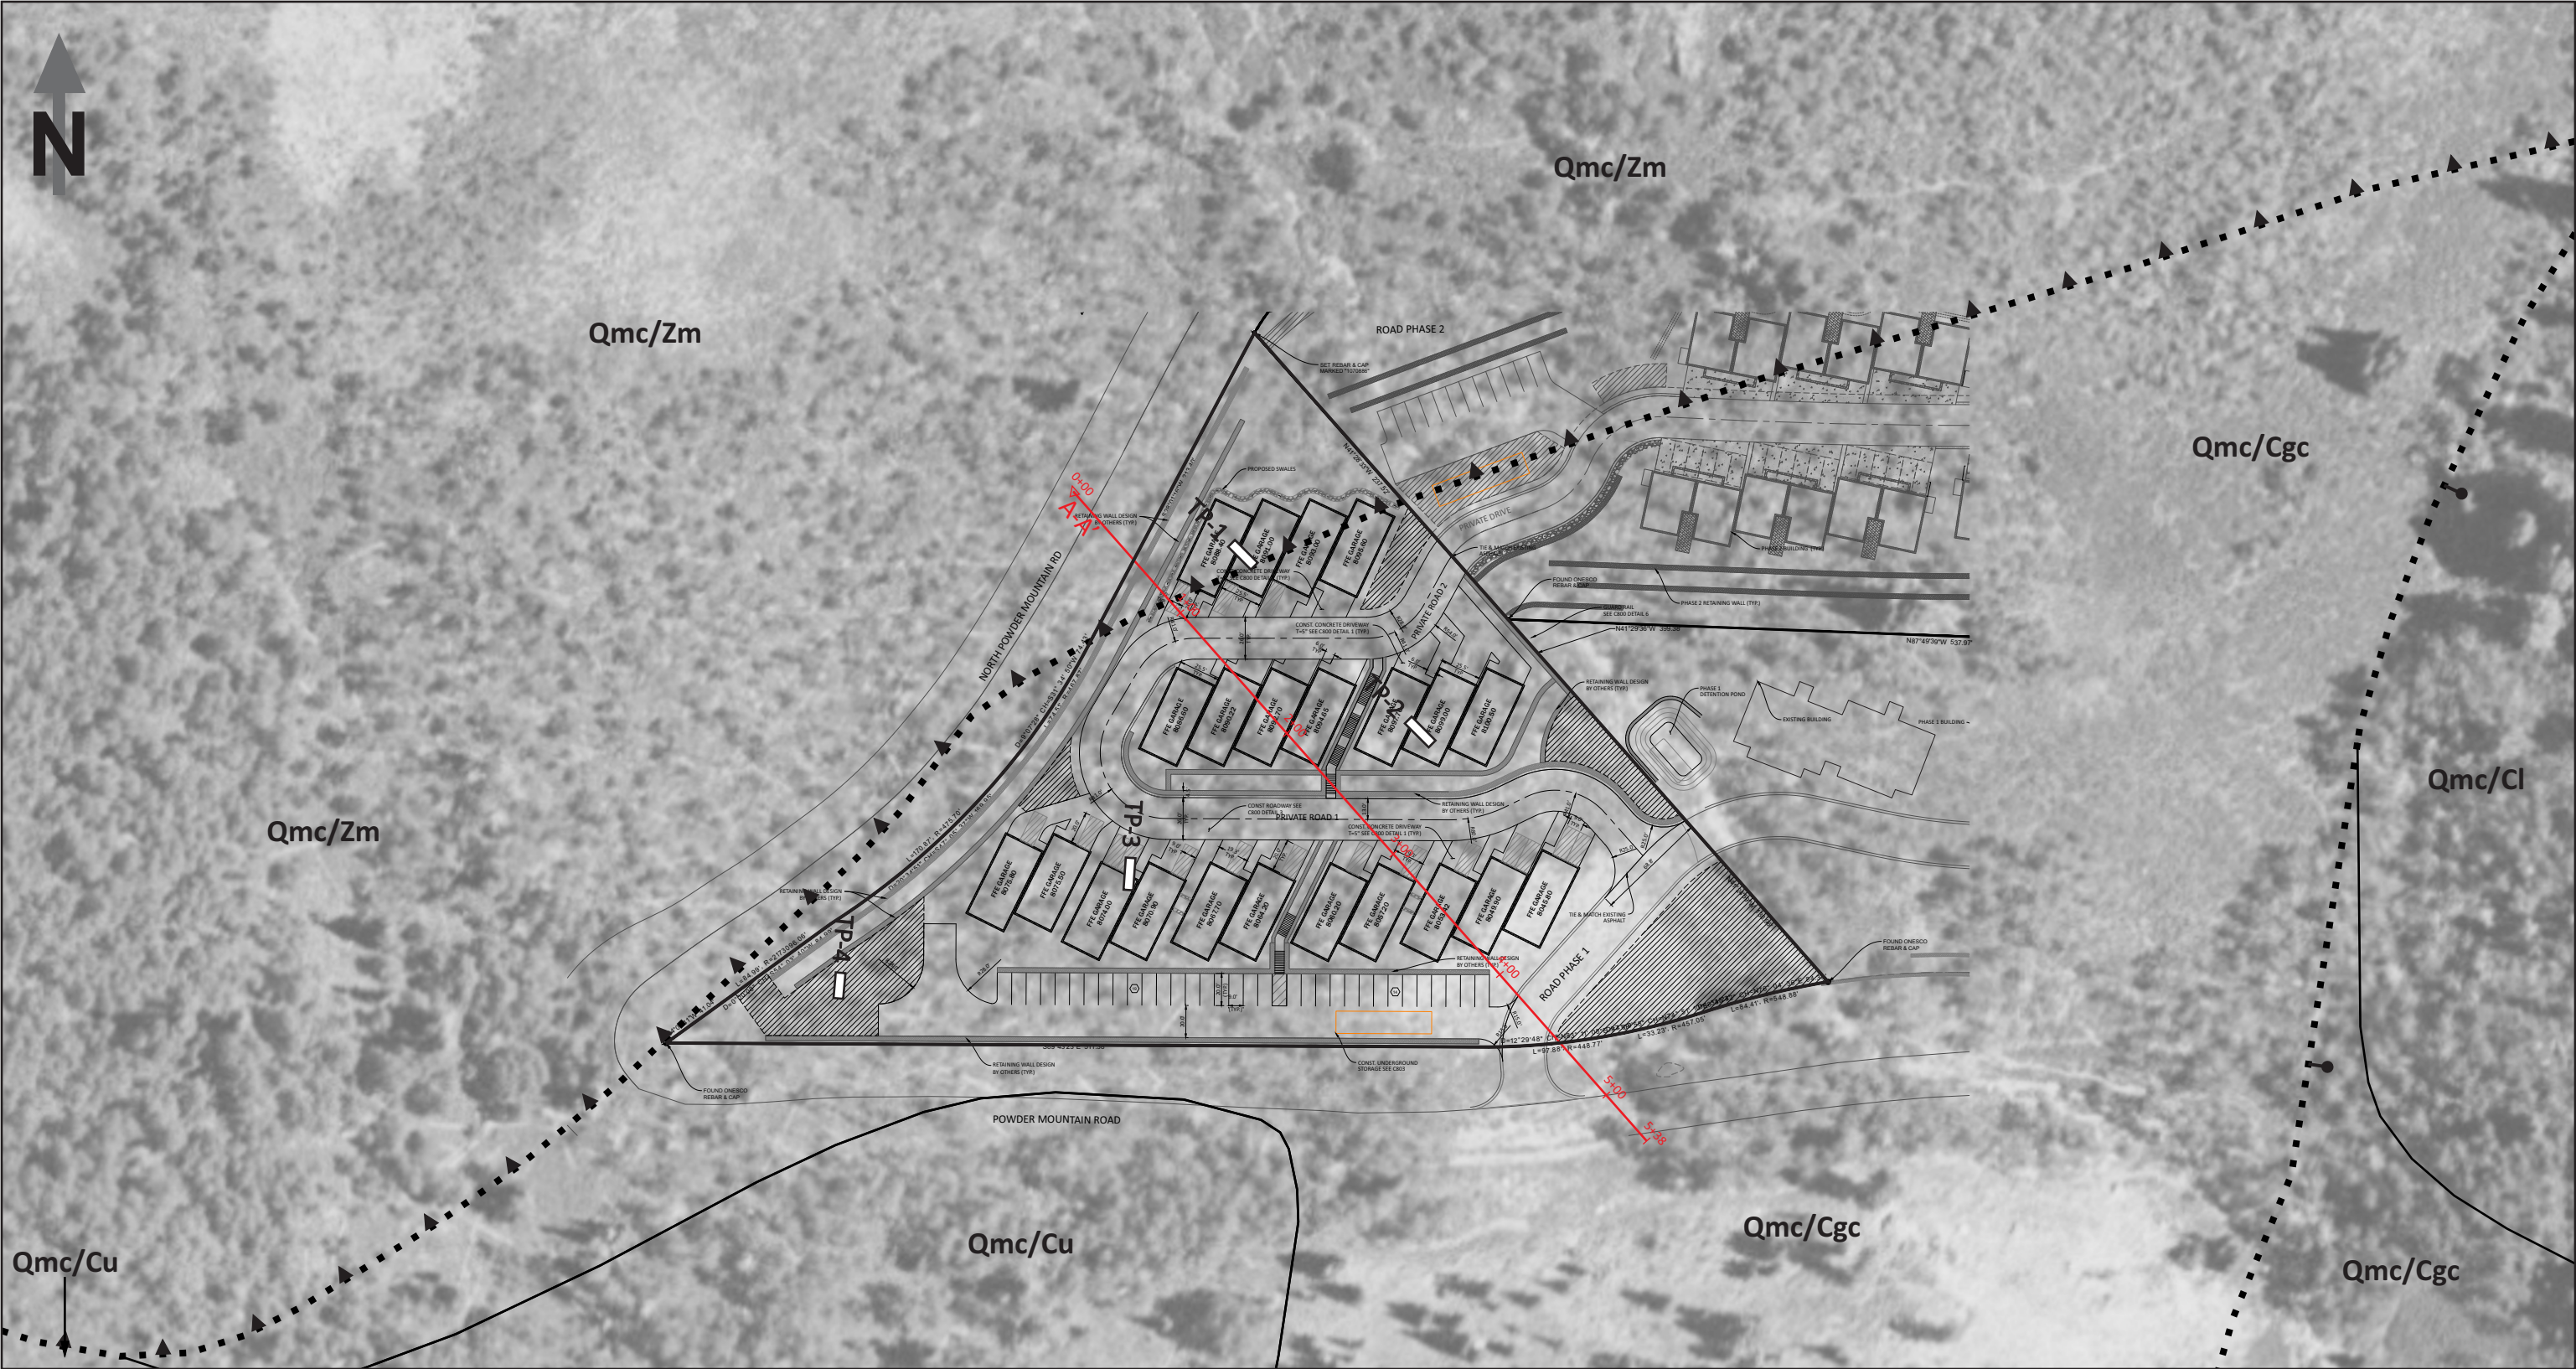
Sundown Condominiums Phase 3 About 6550 North Powder Mountain Road, Eden, Utah	1958 Air Photo	Date:	17-Jun-2025	Figure 4
			CMT No.:	24298

Base:
U.S. Department of Agriculture, frames AAJ 26V-74 and AAJ 26V-75, dated June 17, 1958, original
scale 1:20,000.

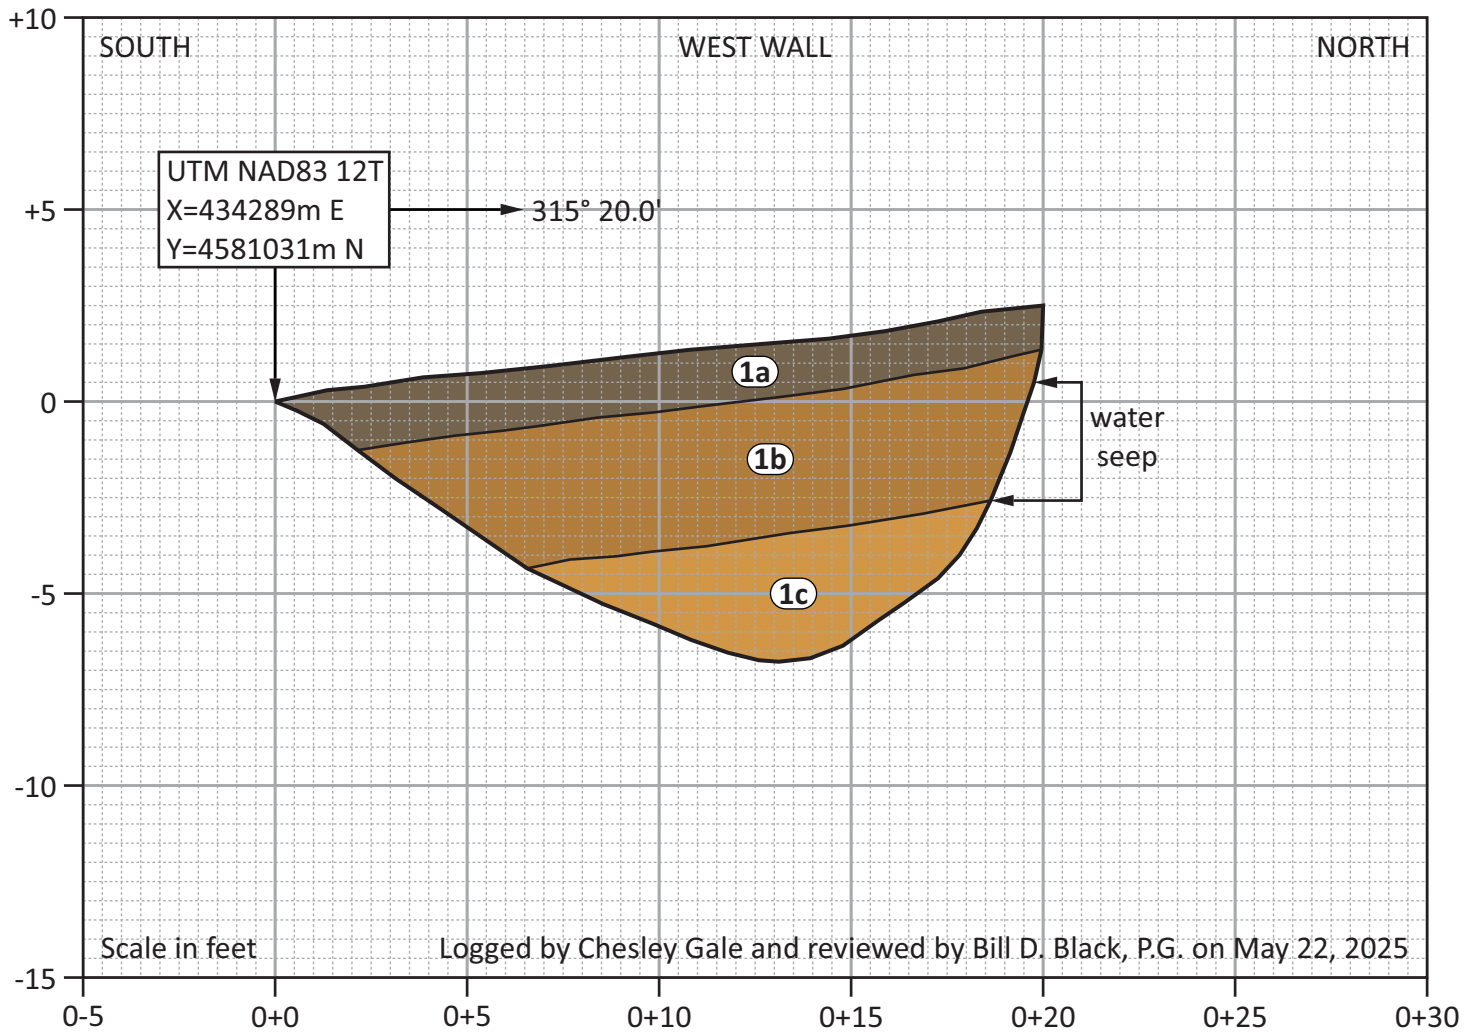
TEST PIT 1

Unit 1. *Upper Pleistocene to Holocene mass wasting colluvium* - sequence comprised of an upper (**1a**) dark brown, moist, medium stiff, silt (ML) with gravel, subangular to angular cobbles and roots; a middle (**1b**) red brown, very moist to wet, medium dense, massive, silty sand and gravel (SM-GM) with subround to subangular cobbles; and a lower (**1c**) light red tan, slightly moist, very dense, massive, silty sand and gravel (SM-GM) with subangular to subround cobbles.

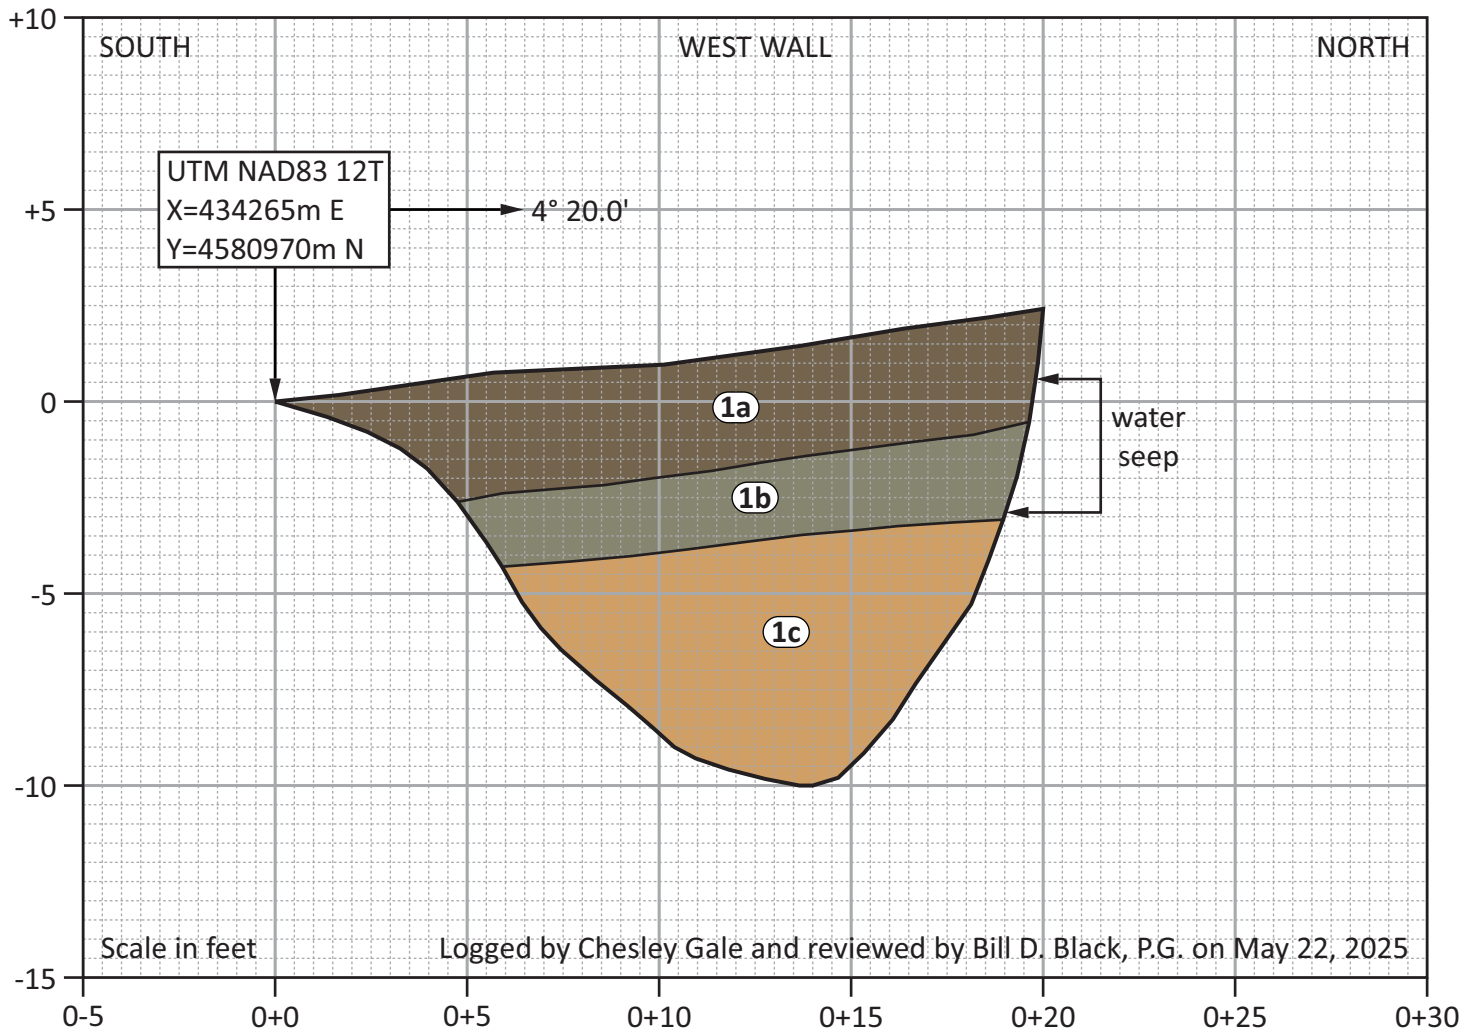
TEST PIT 3

Unit 1. *Upper Pleistocene to Holocene mass wasting colluvium* - sequence comprised of an upper (**1a**) dark brown, moist, soft to medium stiff, massive, sandy silt (ML) with some gravel and trace boulders; a middle (**1b**) dark gray, very moist to wet, loose to medium dense, massive, silty clayey gravel (GM-GC) with cobbles and sand; and a lower (**1c**) moist, very stiff, poorly bedded, sandy silt (ML) with fine layers of gravel, cobbles and oxidation.

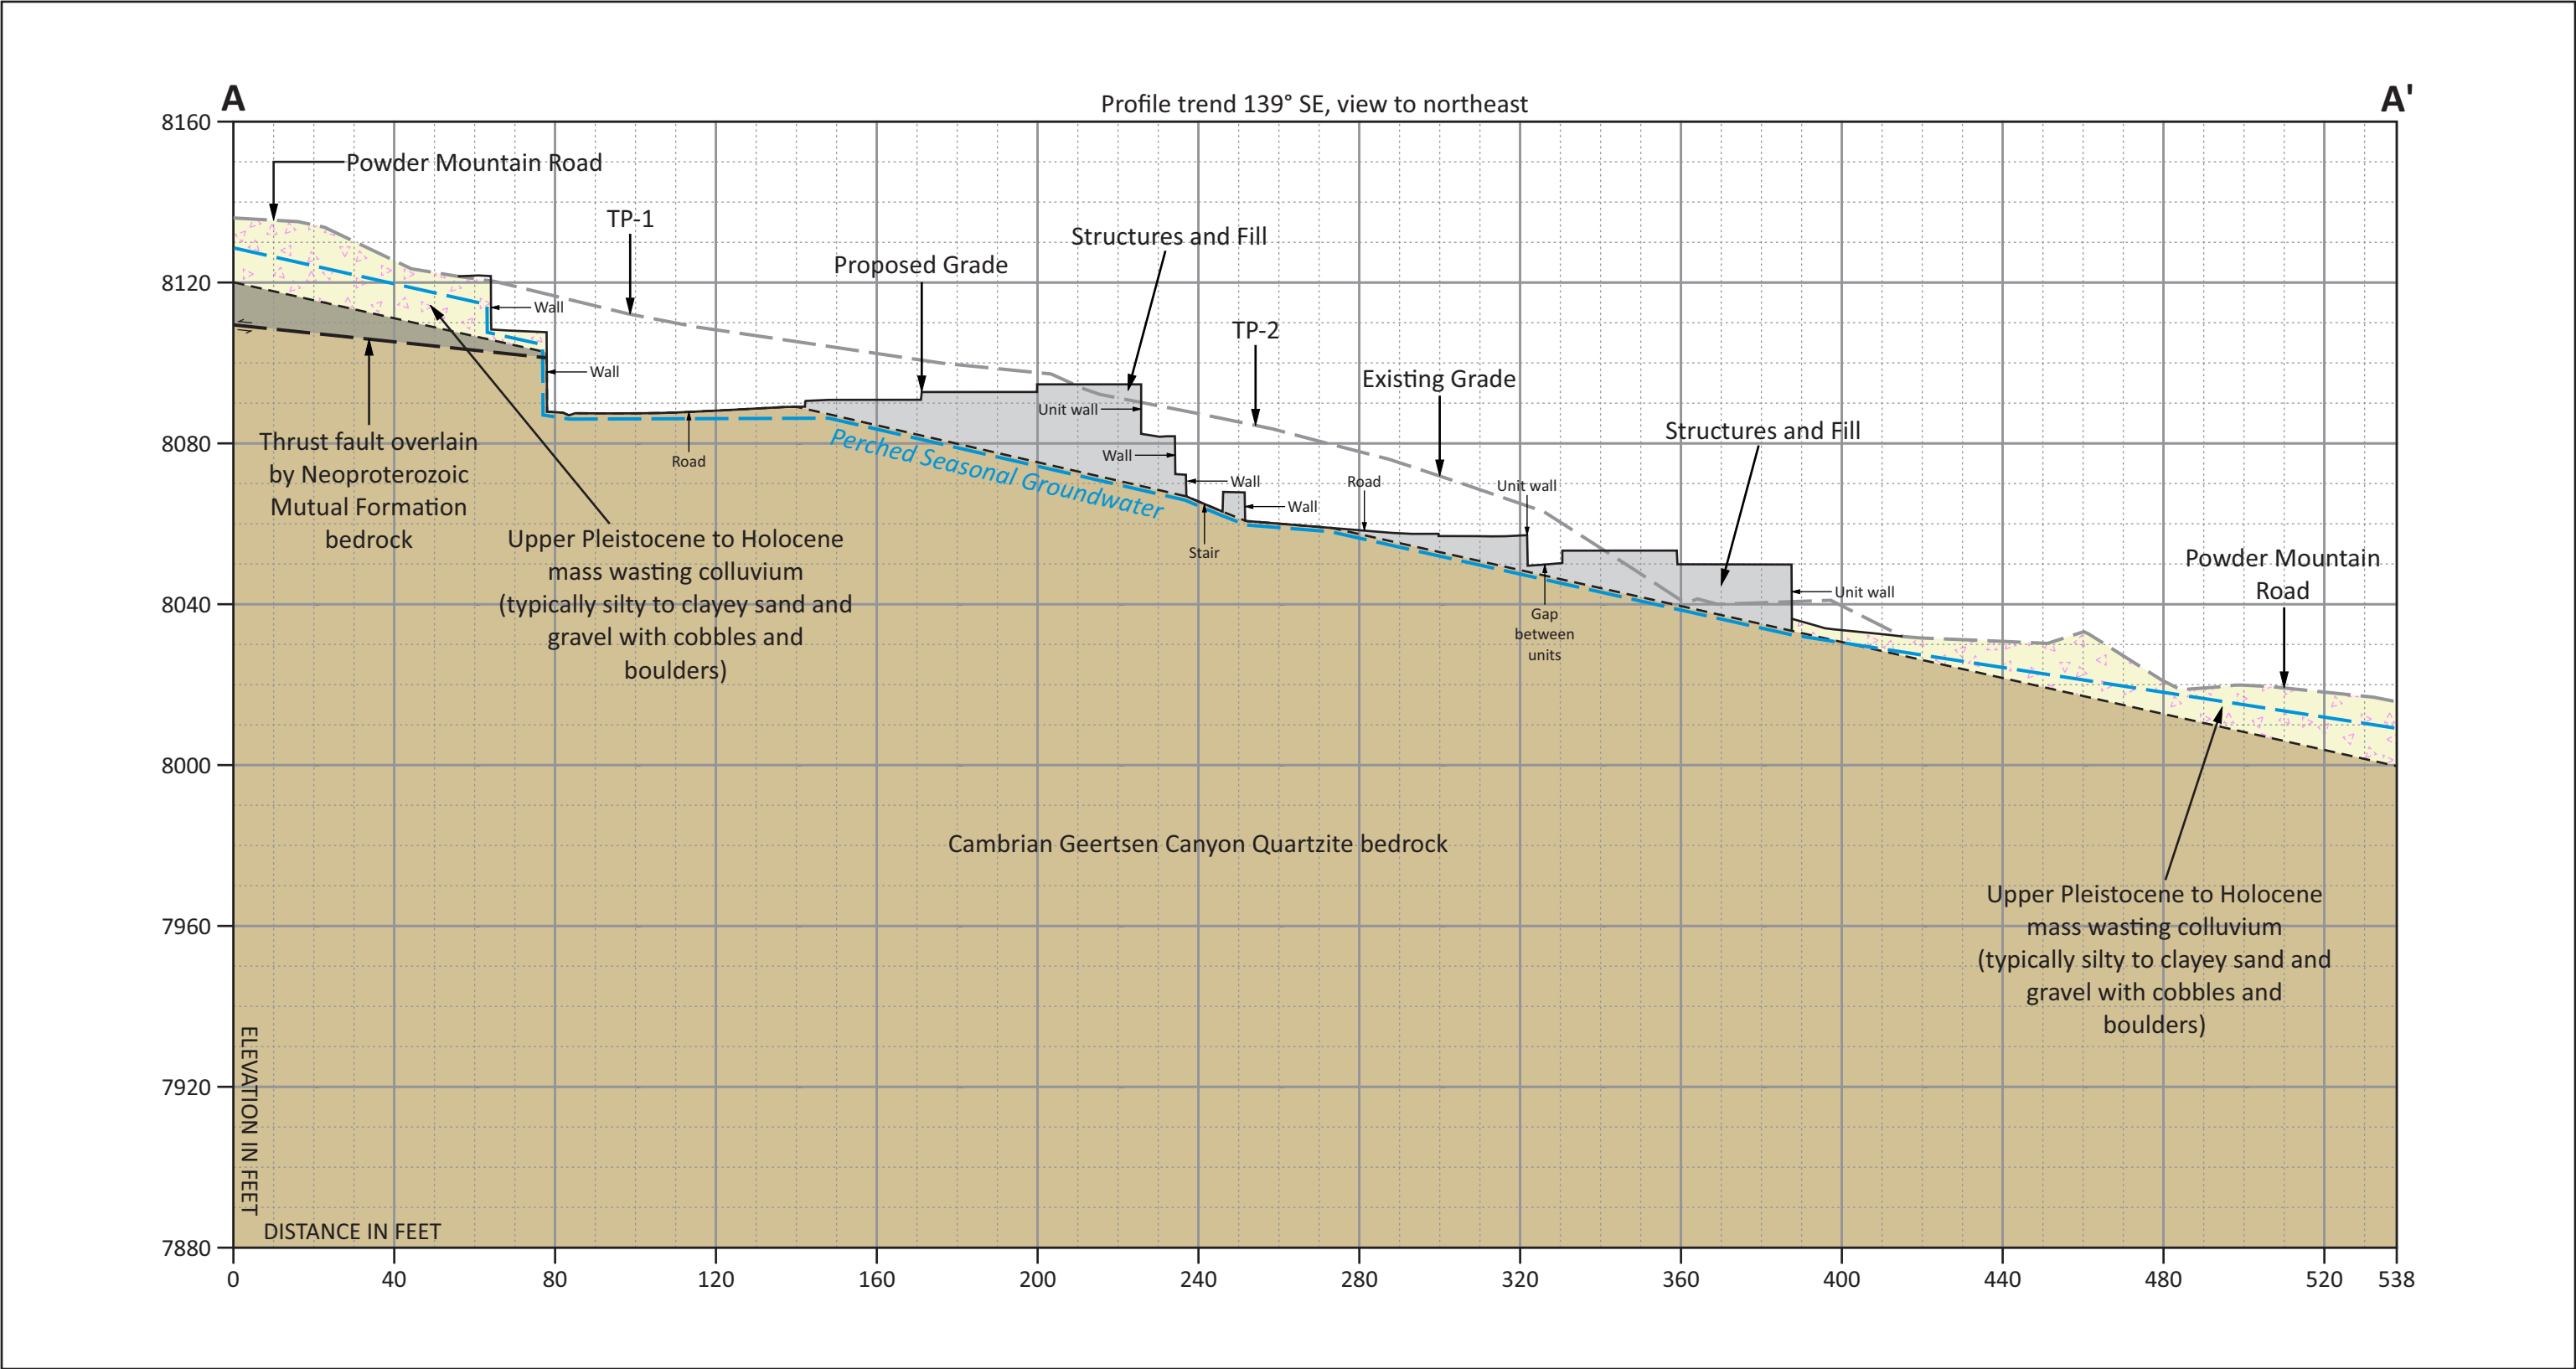
Scale 1 inch equals 40 feet (1:480) with no vertical exaggeration. Existing and proposed grades based on Fawkes Consultants Inc. exhibit dated 6/10/2025.

The stability analyses provided are based on **Figure 6A, Cross Section A-A'** and represent projected final grading as provided by Fawkes Consultants Inc (project Civil Engineer). If/where grade changes are made, CMT must review final grading plans. Further, bedrock was not encountered within the upper about 11 feet explored but is assumed to be shallow based on adjacent explorations completed for Phase 2 and was assumed in the slope modeling. CMT must be allowed to review the construction excavations to confirm the conditions assumed. Where bedrock is anticipated within the deeper cuts, heavy equipment and possible blasting could become necessary to complete the excavations.

- Cross-section A-A' (**Figure 6**) consists of a roughly 538-foot-long horizontal cross section with an overall elevation change of about 120 feet with a moderate to steep slope and dip to the southeast at an overall roughly 4.5:1 (horizontal:vertical; or 22.2%, 12.5 degrees) excluding building construction cuts which will require retaining structures. Based on the slope stability analysis, the overall slope generally has factors of safety for both static and pseudo-static (earthquake) conditions in excess of those typically considered acceptable with the exception of the cut sections downslope of the proposed structures (See

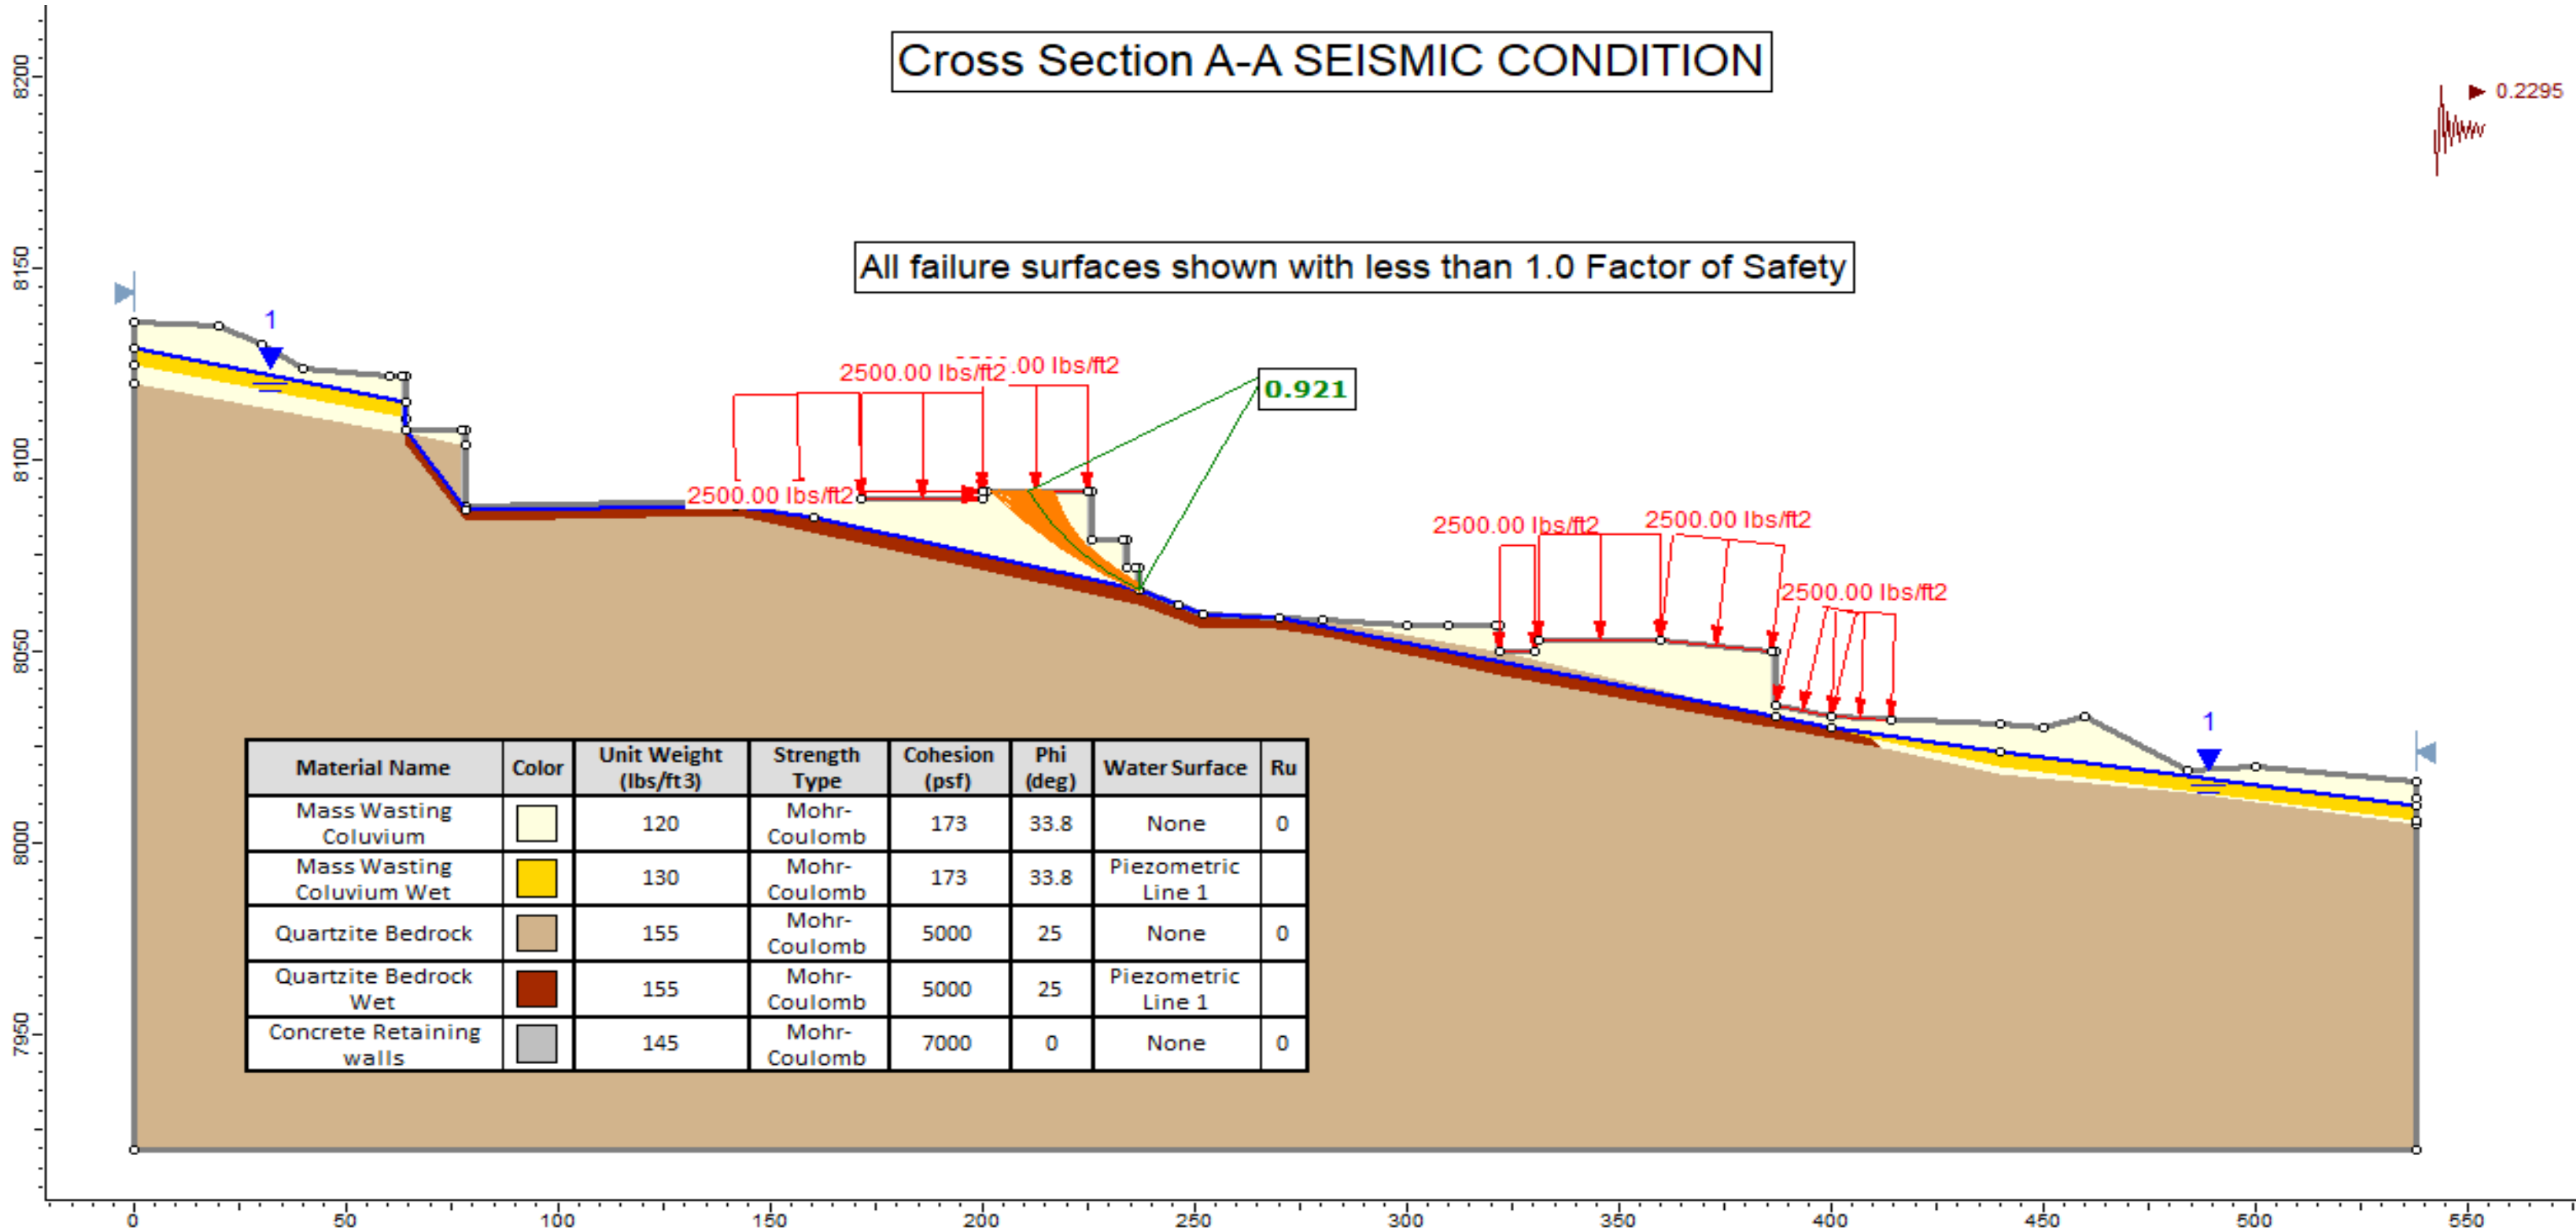
Cross Section A-A SEISMIC CONDITION

All failure surfaces shown with less than 1.0 Factor of Safety

Figures 9A and 9B Stability Results). Planned retaining walls and foundation walls will require further design to resist these lateral loads. The failure surfaces with the lowest factors of safety are shown on the stability analysis plot, with the lowest calculated factor of safety displayed (1.057-Static: .921-Seismic).
