**Geotechnical Investigation
Proposed Cobabe Ranch Water Reservoir
Approximately 2720 North 5100 East
Eden, Weber County, Utah**

July 2, 2025

**Geotechnical Investigation
Proposed Cobabe Ranch Water Reservoir
Approximately 2720 North 5100 East
Eden, Weber County, Utah
CG Project No.: 133-024**

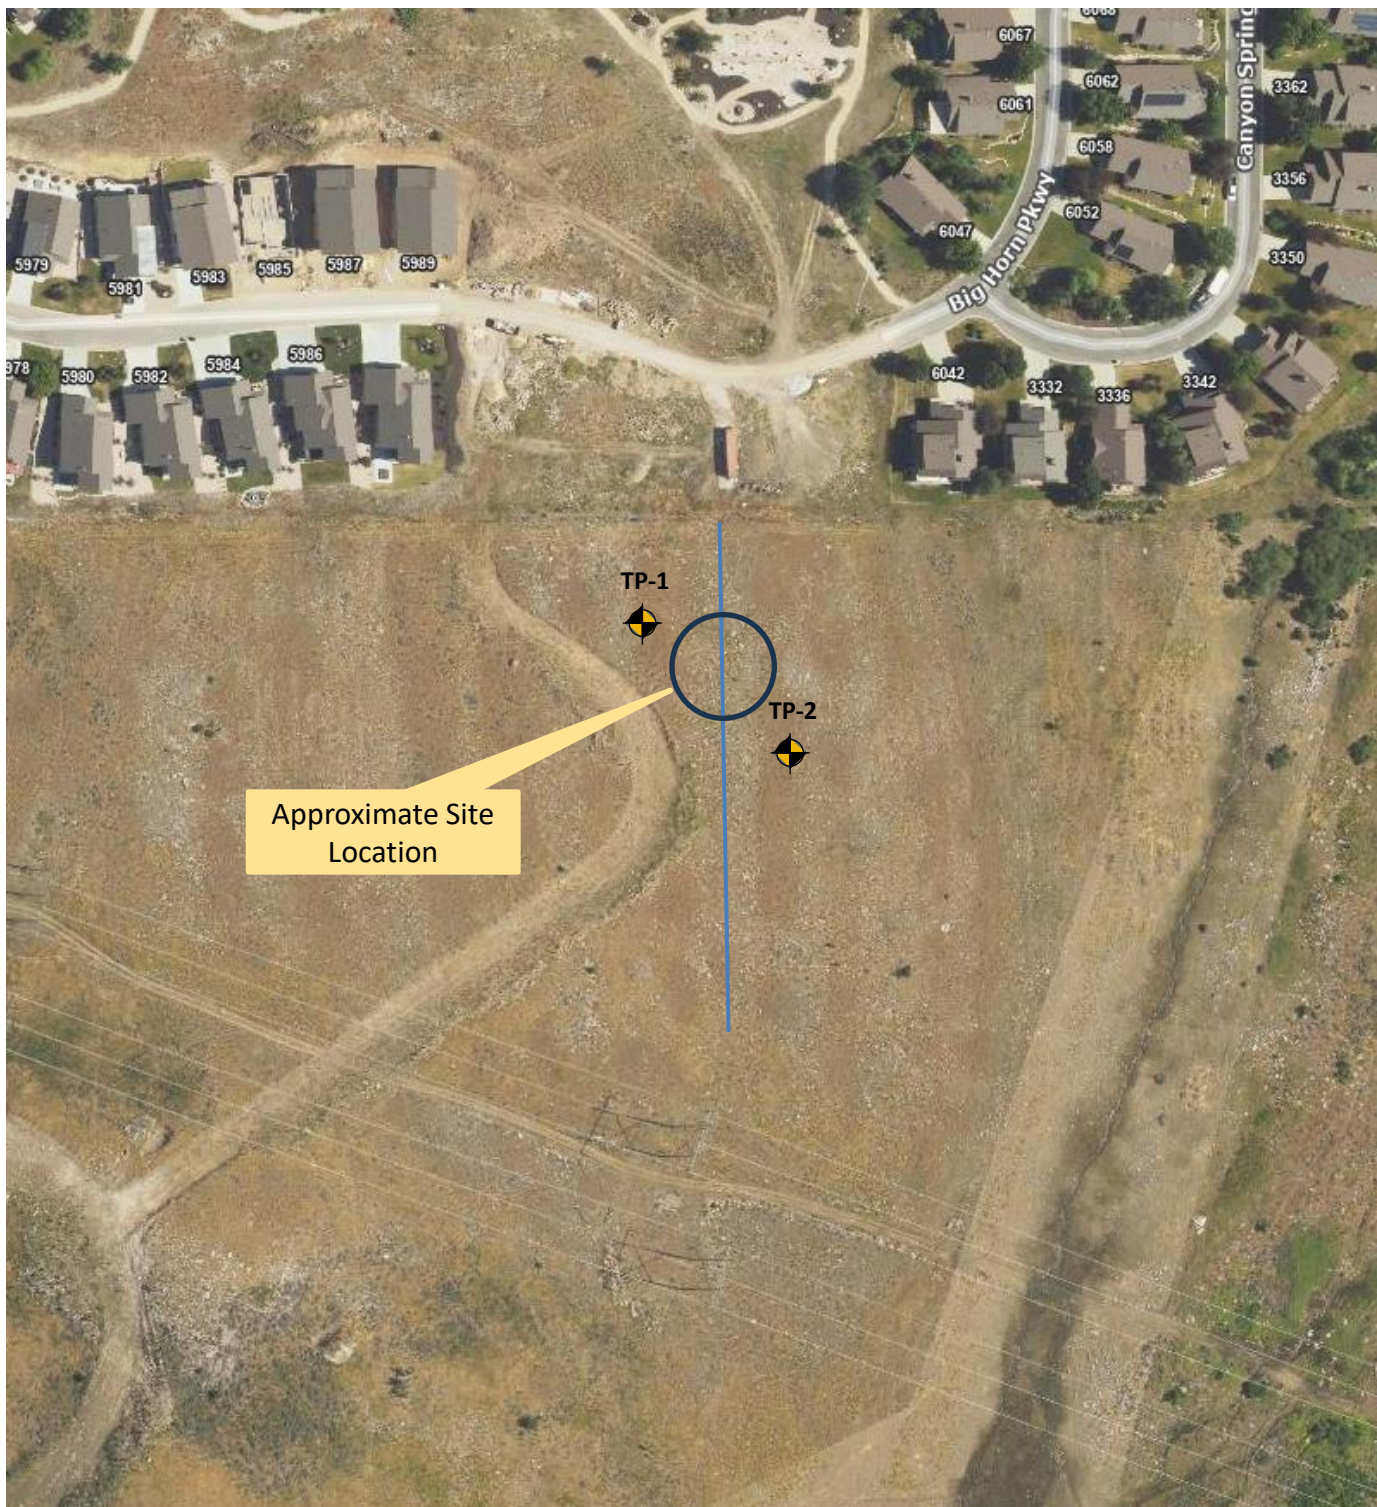
Approximate Test Pit Location

Slope Stability Profile

Exploration Location Map

The subsurface conditions at the site were explored by excavating two test pits at the site of the water reservoir. The test pits were excavated to depths of 27 and 29 feet below the existing site grade. The approximate test pit locations are shown on the Exploration Location Map, Plate 2. The subsurface conditions as encountered in the test pits were recorded at the time of excavation and are presented on the attached Test Pit Logs, Plates 3 and 4. A key to the symbols and terms used on the Test Pit Logs may be found on Plate 5.

As recommended in the Geologic Hazards Evaluation by Western Geologic, the stability of the slope at the site was assessed using the Slide computer program and the modified Bishop's method of slices. The location of the profile is shown on Plate 2 and is based on the cross section presented in the Western Geologic report. A direct shear test of the bedrock produced a strength for this material consist of an angle of internal friction of 31 degrees and a cohesion of 120 psf. This soil strength was conservatively used in our analyses for both the bedrock and the overlying soil.

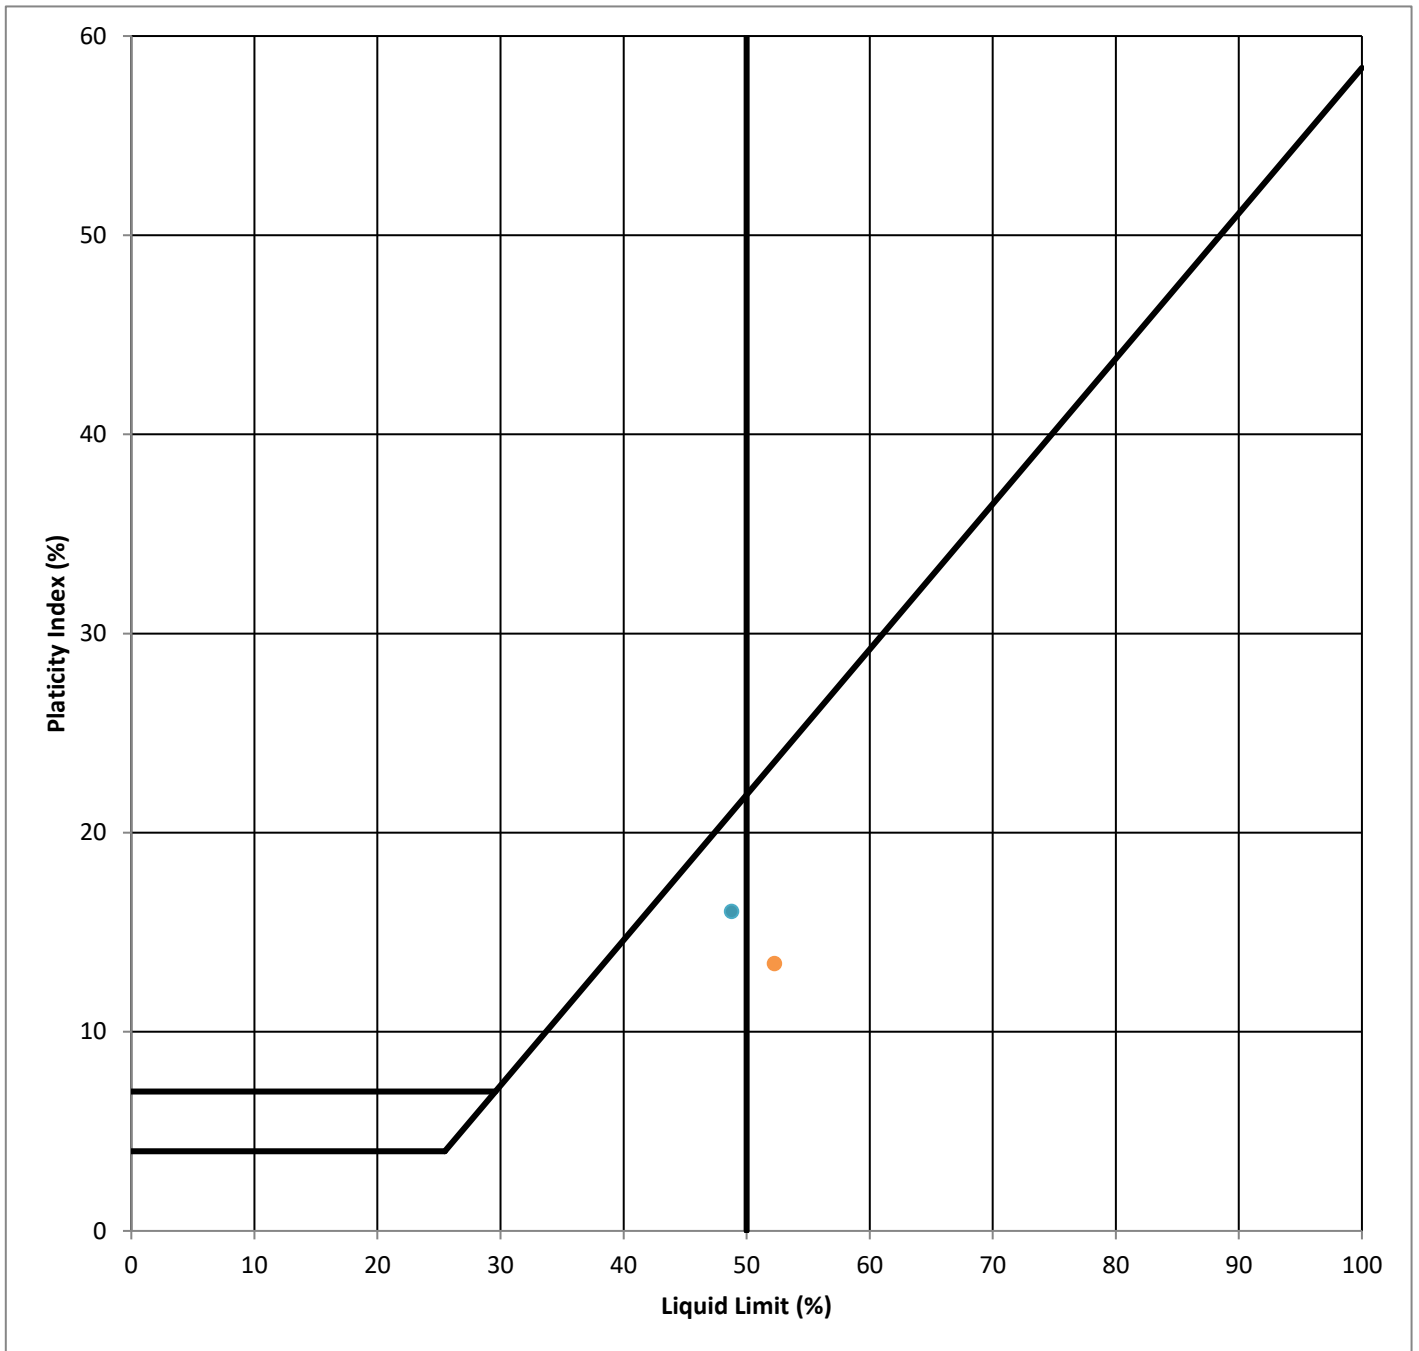
Eden Valley Opportunity LLC Cobabe Ranch Water Reservoir Eden, Weber County, Utah Project No.: 133-024	Plate 6
---	---	------------------------------

Atterberg Limits

Location	Depth (ft)		Classification	Liquid Limit	PI
TP-1	15	●	SILT	49	16
TP-1	25	●	Elastic SILT	52	13

The results of our laboratory tests are also presented on the Test Pit Logs, Plates 3 and 4, and more detailed laboratory results are presented on the laboratory testing plates, Plates 6 through 10.

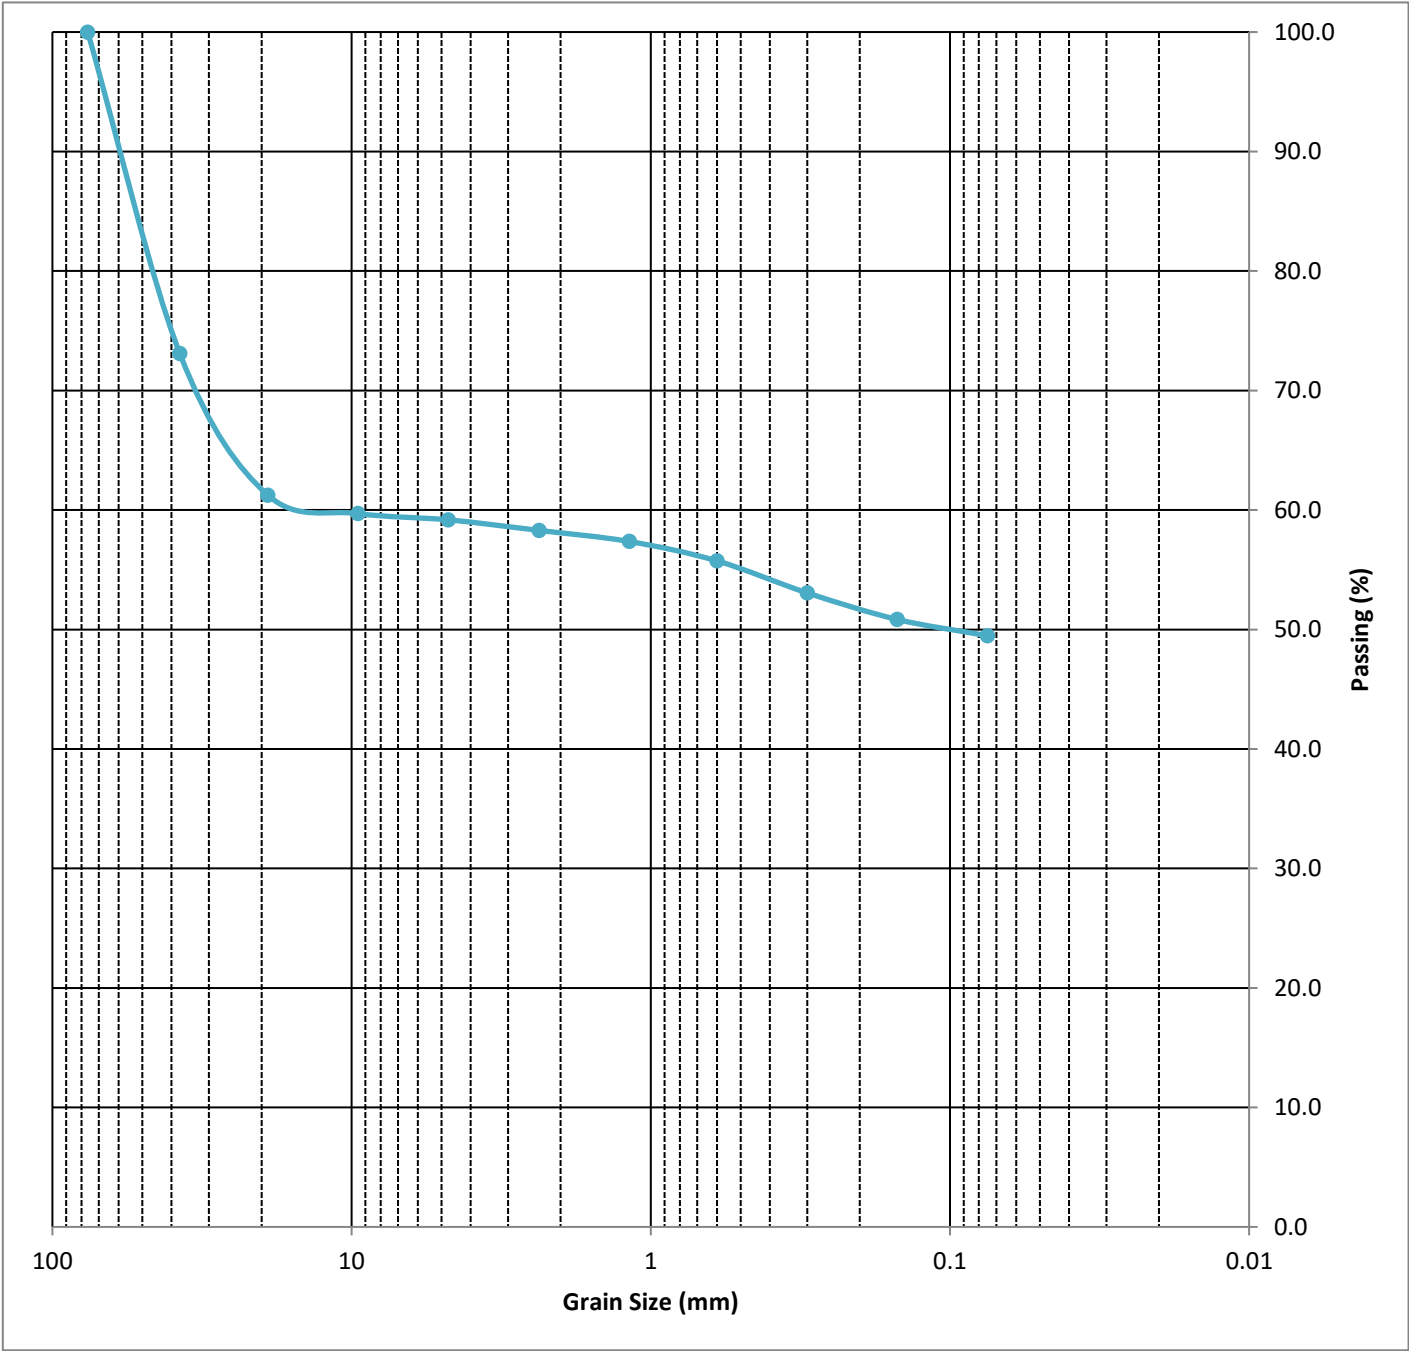
Grain Size Distribution

Location	Depth		Classification	% Gravel	% Sand	% Silt and Clay
TP-1	5	●	Clayey GRAVEL with sand	40.8	9.7	49.5

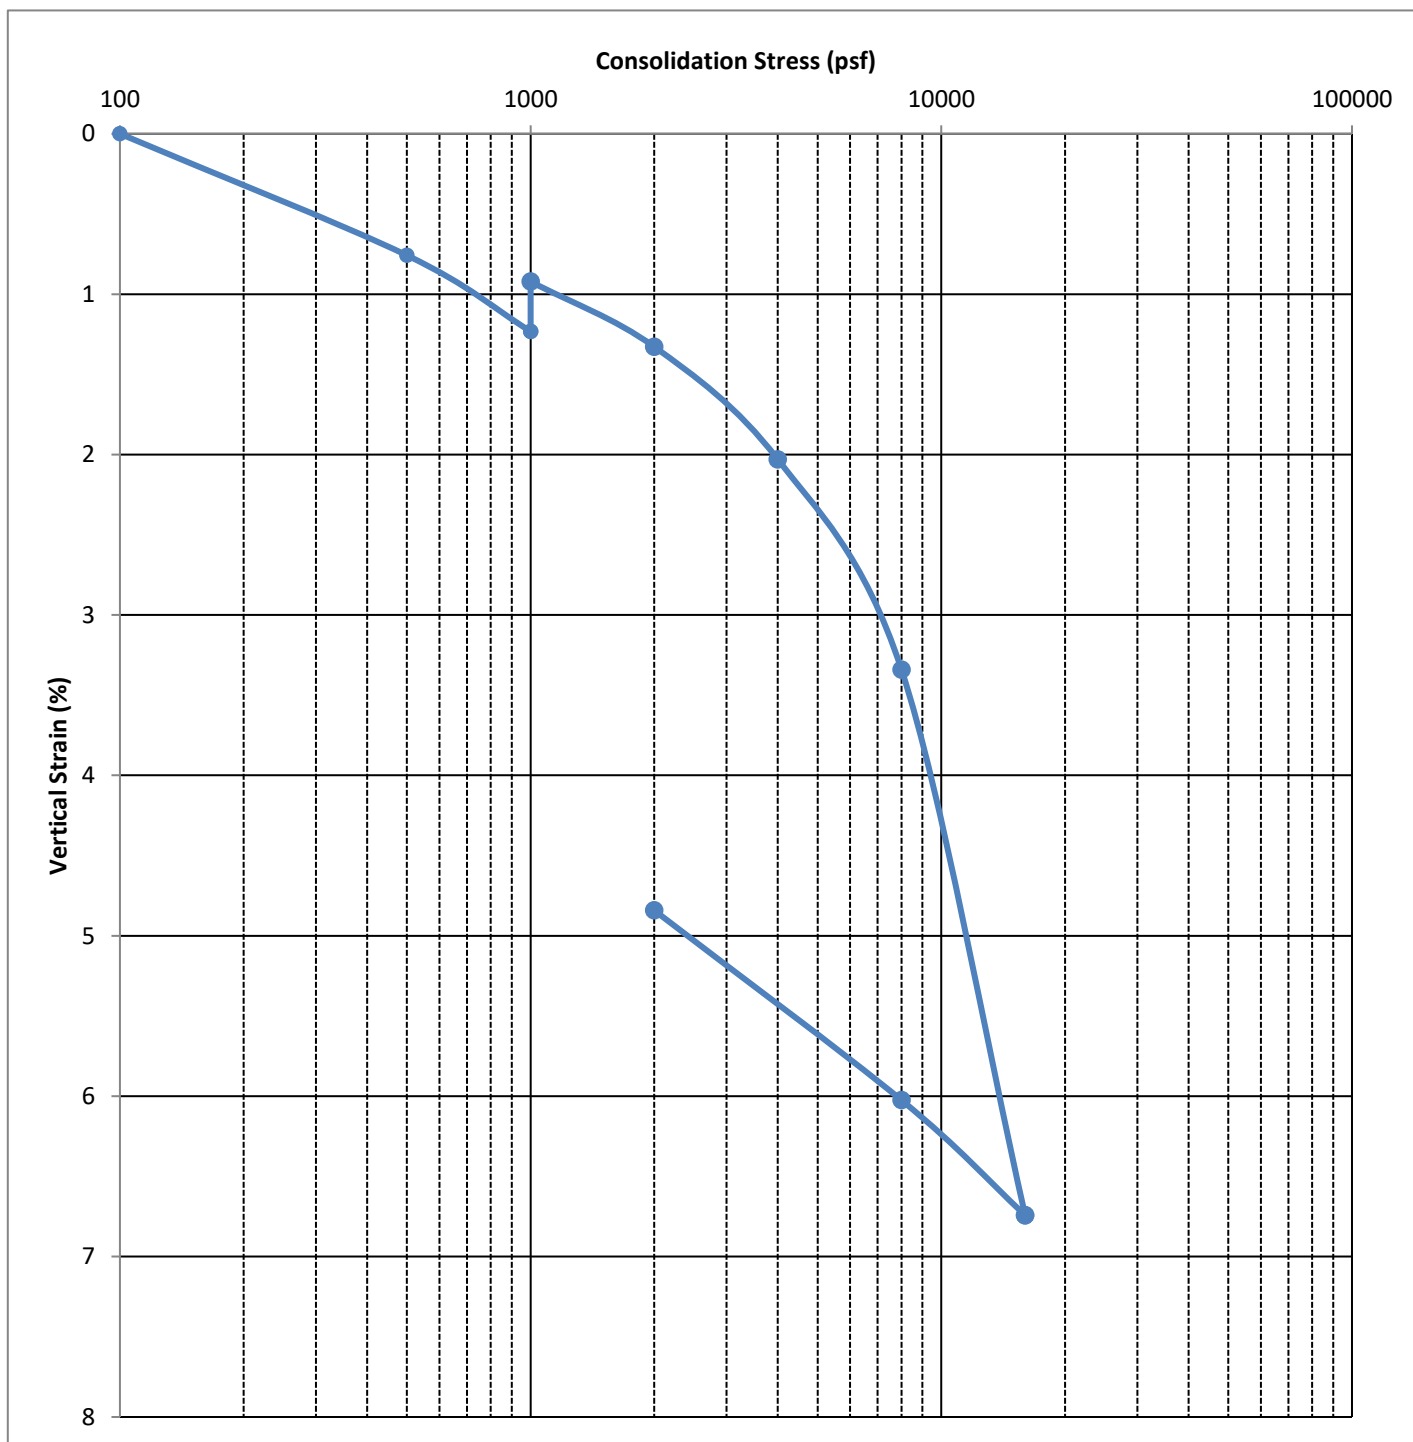
Eden Valley Opportunity LLC Cobabe Ranch Water Reservoir Eden, Weber County, Utah Project No.: 133-024	Plate 8
---	---	------------------------------

1-D Consolidation

Location	Depth (ft)	Dry Density (pcf)	Moisture Content (%)	σ_o (psf)	σ_p (psf)	C_c	C_r	OCR
TP-1	15	78.7	33.2	1,600	5,800	0.078	0.021	3.6

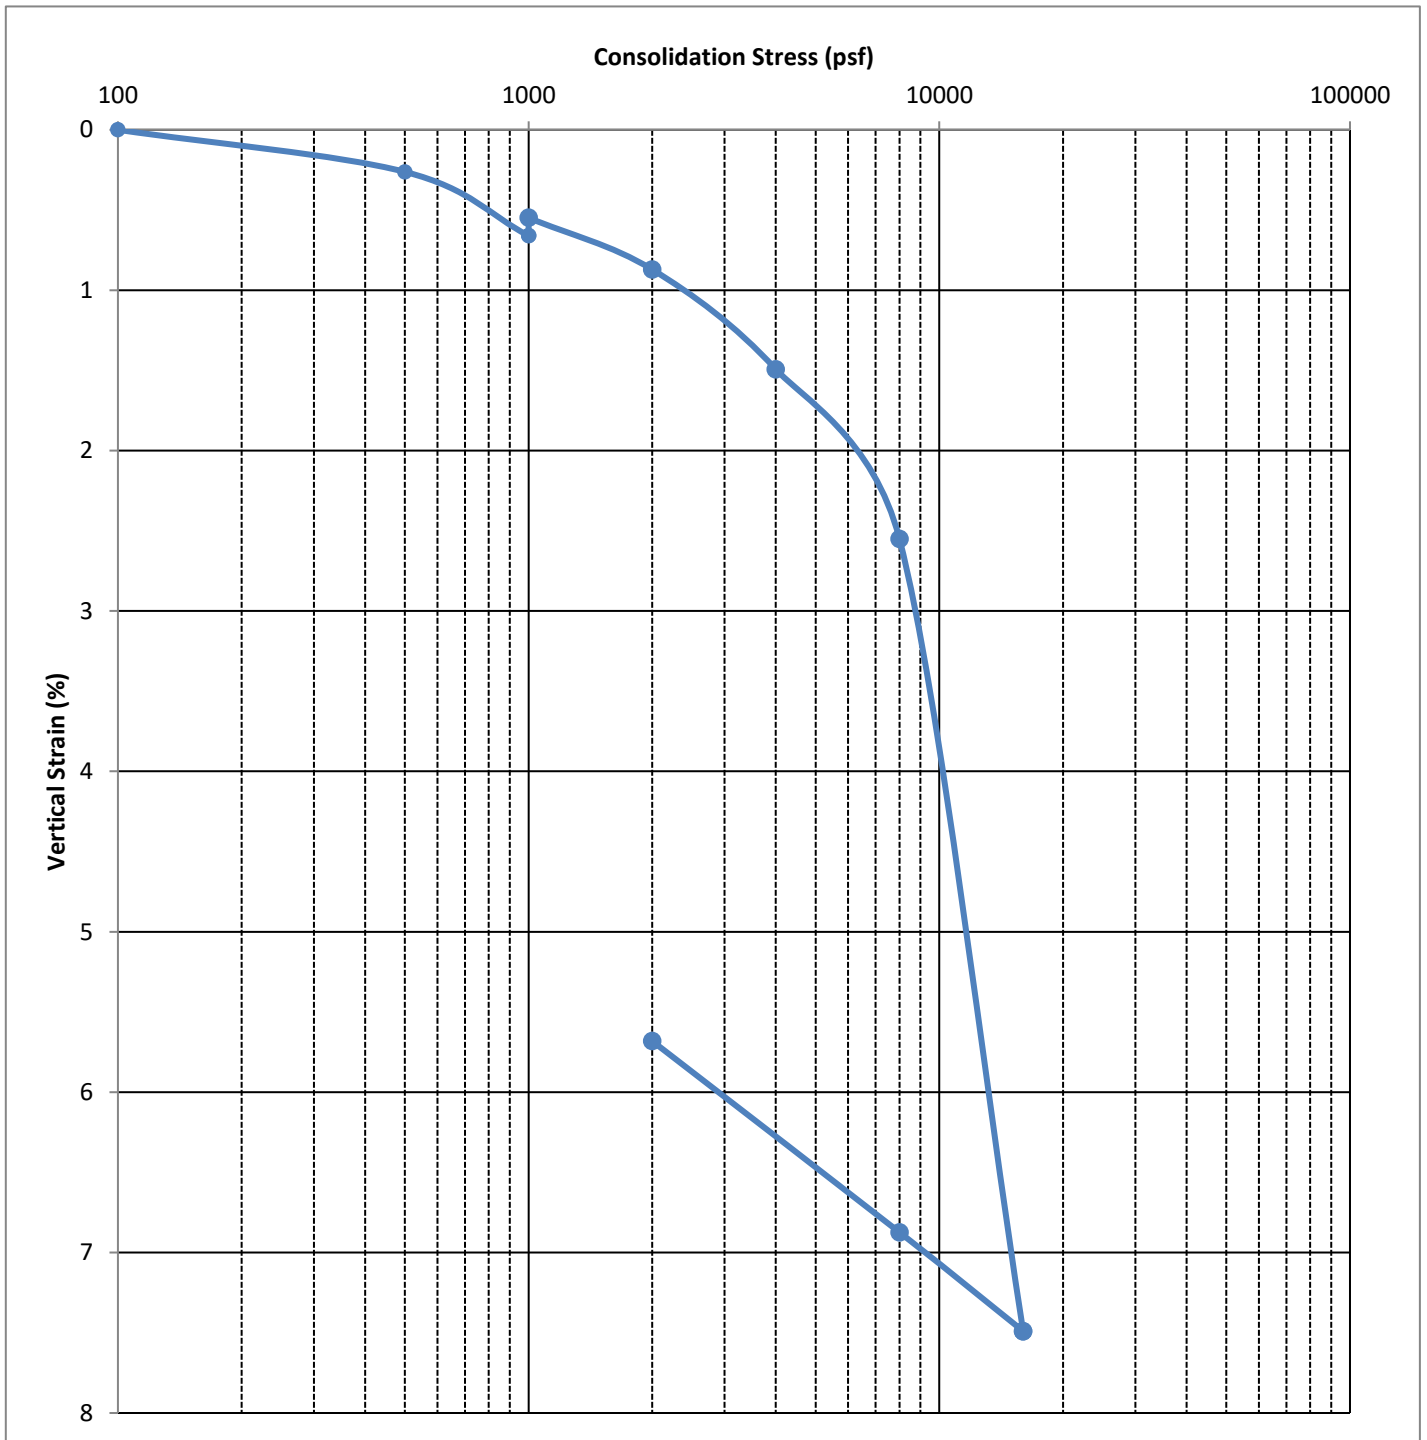
Eden Valley Opportunity LLC Cobabe Ranch Water Reservoir Eden, Weber County, Utah Project No.: 133-024	Plate 9
---	---	------------------------------

1-D Consolidation

Location	Depth (ft)	Dry Density (pcf)	Moisture Content (%)	σ_o (psf)	σ_p (psf)	C_c	C_r	OCR
TP-1	25	73.3	24.8	2,300	4,000	0.100	0.020	1.7

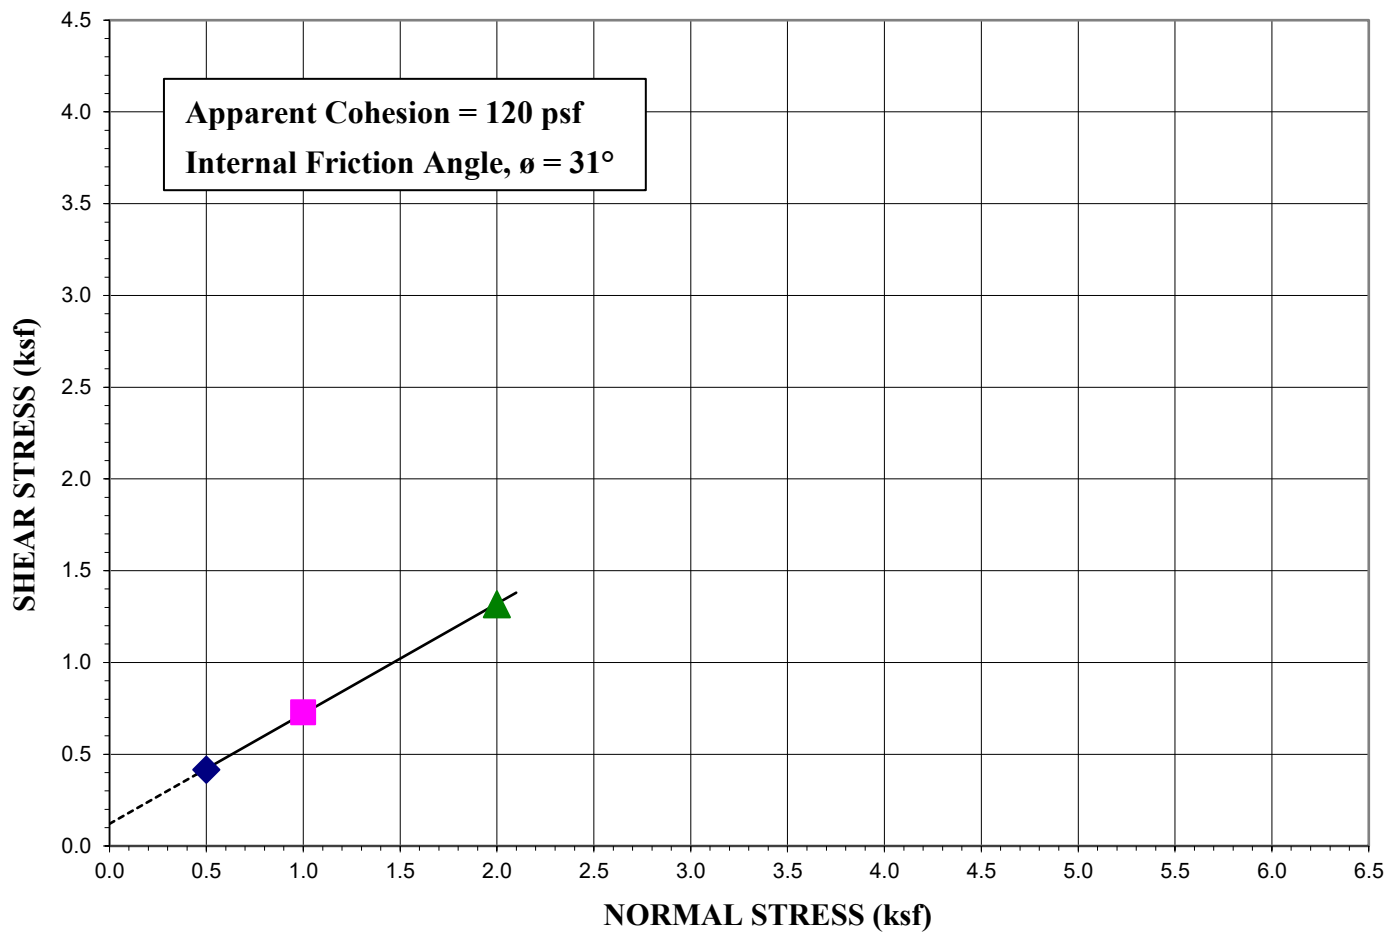
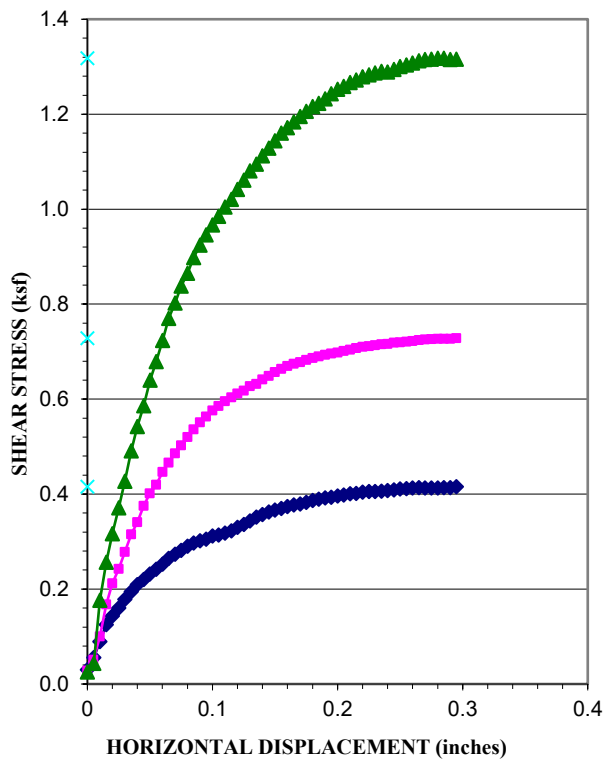
10

Location:	TP-1		
Depth:	15.0 ft		
Type of Test:	Consolidated Drained/Saturated		
Test No. (Symbol)	1 (◆)	2 (■)	3 (▲)
Sample Type:	Fully Softened		
Initial Height, in.	1	1	1
Diameter, in.	2.4	2.4	2.4
Dry Density Before, pcf	99.8	100.5	100.4
Moisture % Before	24.2	24.2	24.2
Normal Load, ksf	0.5	1.0	2.0
Shear Stress, ksf	0.42	0.73	1.32
Strain Rate	0.0009 in/min

Sample Properties	
Cohesion, psf	120
Friction Angle, ϕ	31
Liquid Limit, %	49
Plasticity Index, %	16
Percent Gravel	---
Percent Sand	---
Percent Passing No. 200 sieve	96.4
Classification	SILT (ML)

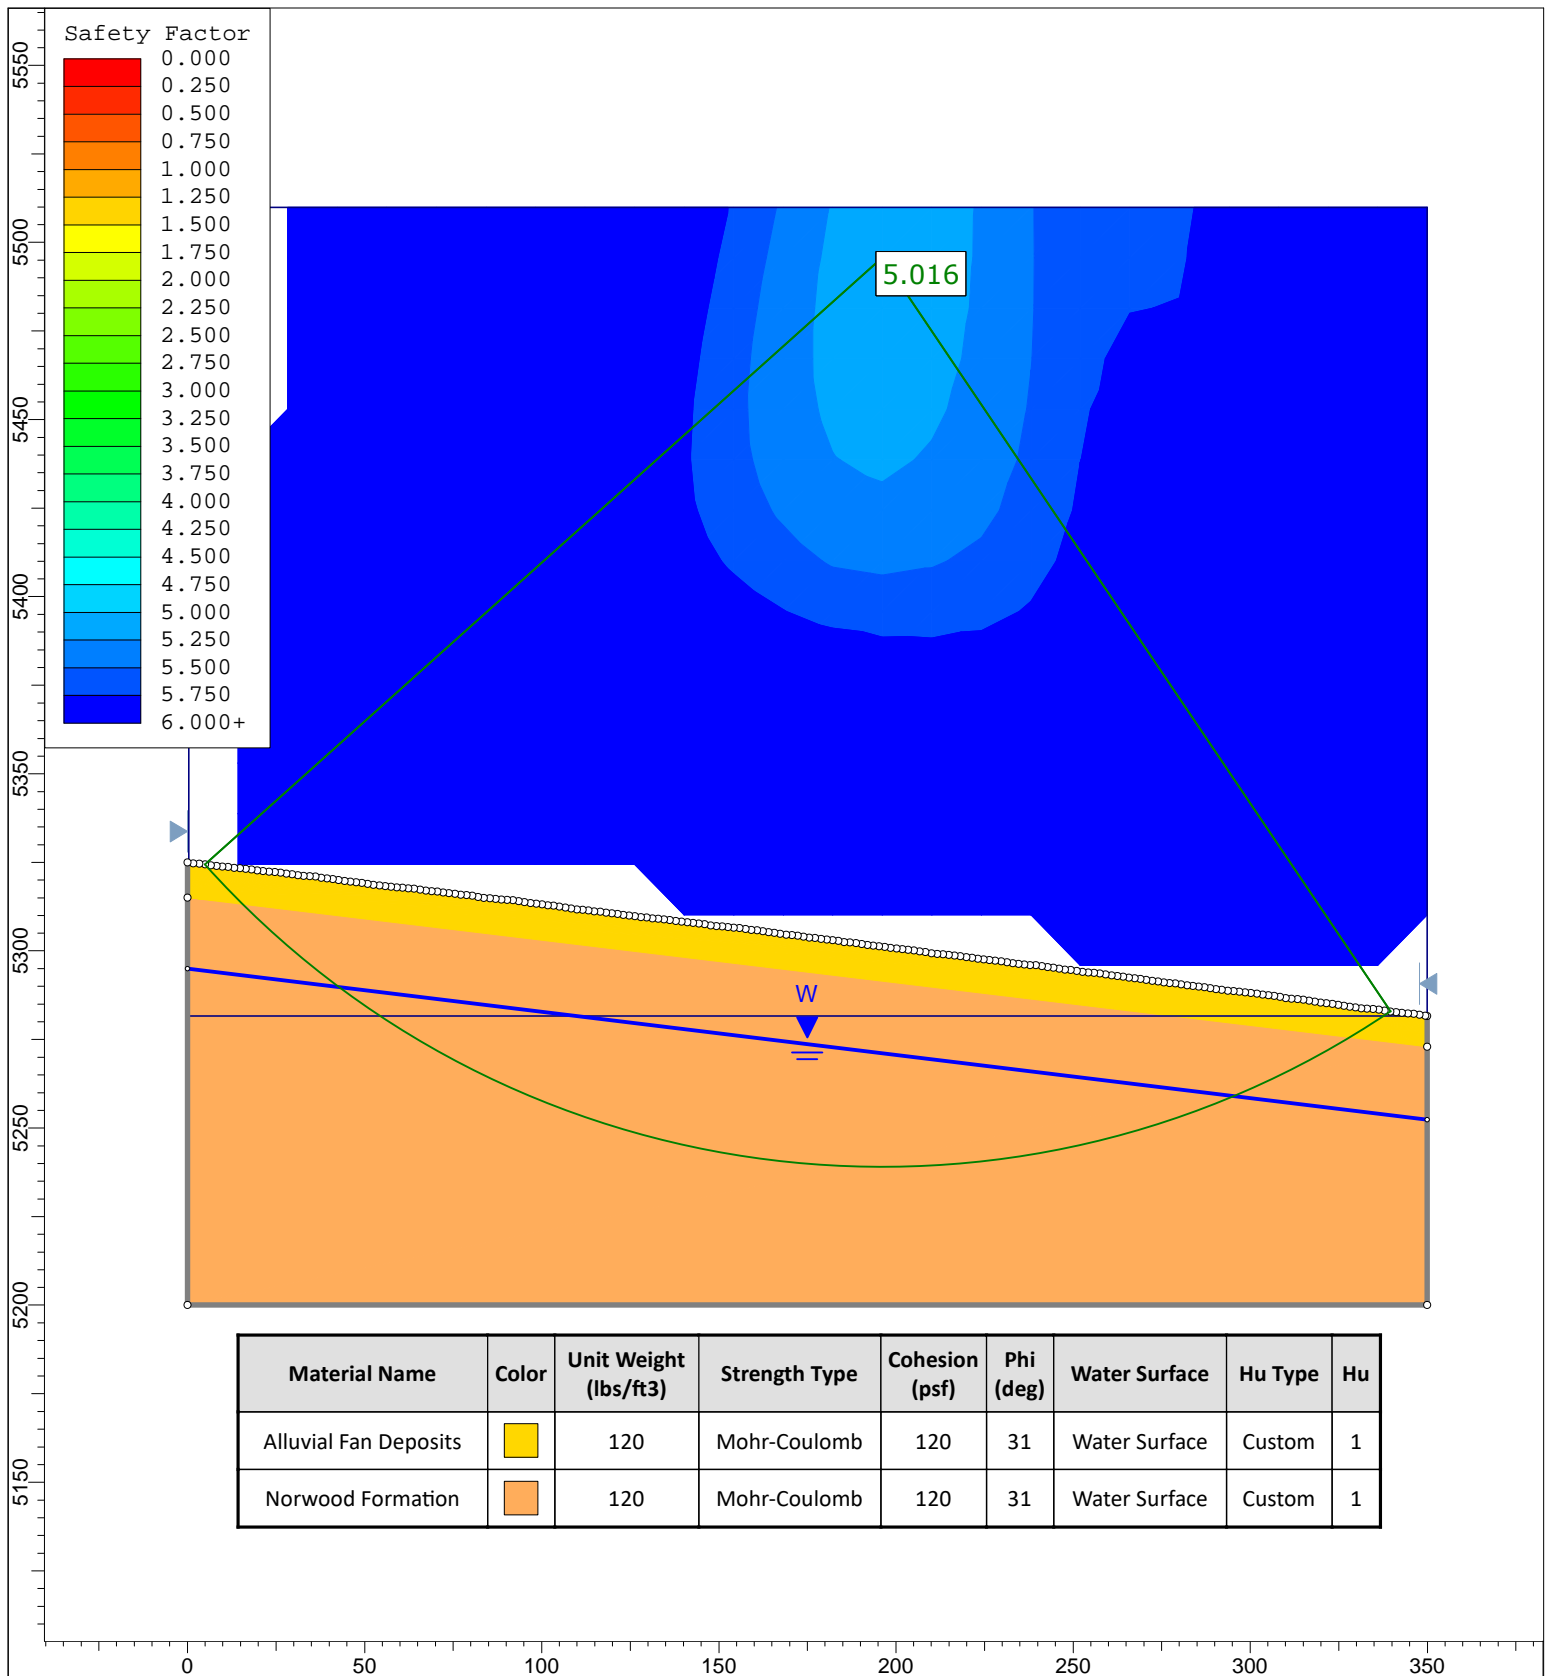
Global Stability - Static

The profile was assessed under static and pseudo static conditions. The pseudo static condition is used to assess the slope during a seismic event. As indicated in Section 4.1, the peak ground acceleration at this site is estimated to be 0.476g. As is common practice, half of this value was used in our pseudo static assessments. Minimum factors of safety of 1.5 and 1.1 for static and seismic conditions, respectively, were considered acceptable. Our analyses indicate that the slope in the area of the proposed water reservoir has safety factors greater than 1.5 and 1.1 for the static and pseudo static conditions. It is therefore our opinion that the proposed site is suitable for

construction of the reservoir. The results of our slope stability assessments may be found on Plates 11 and 12.

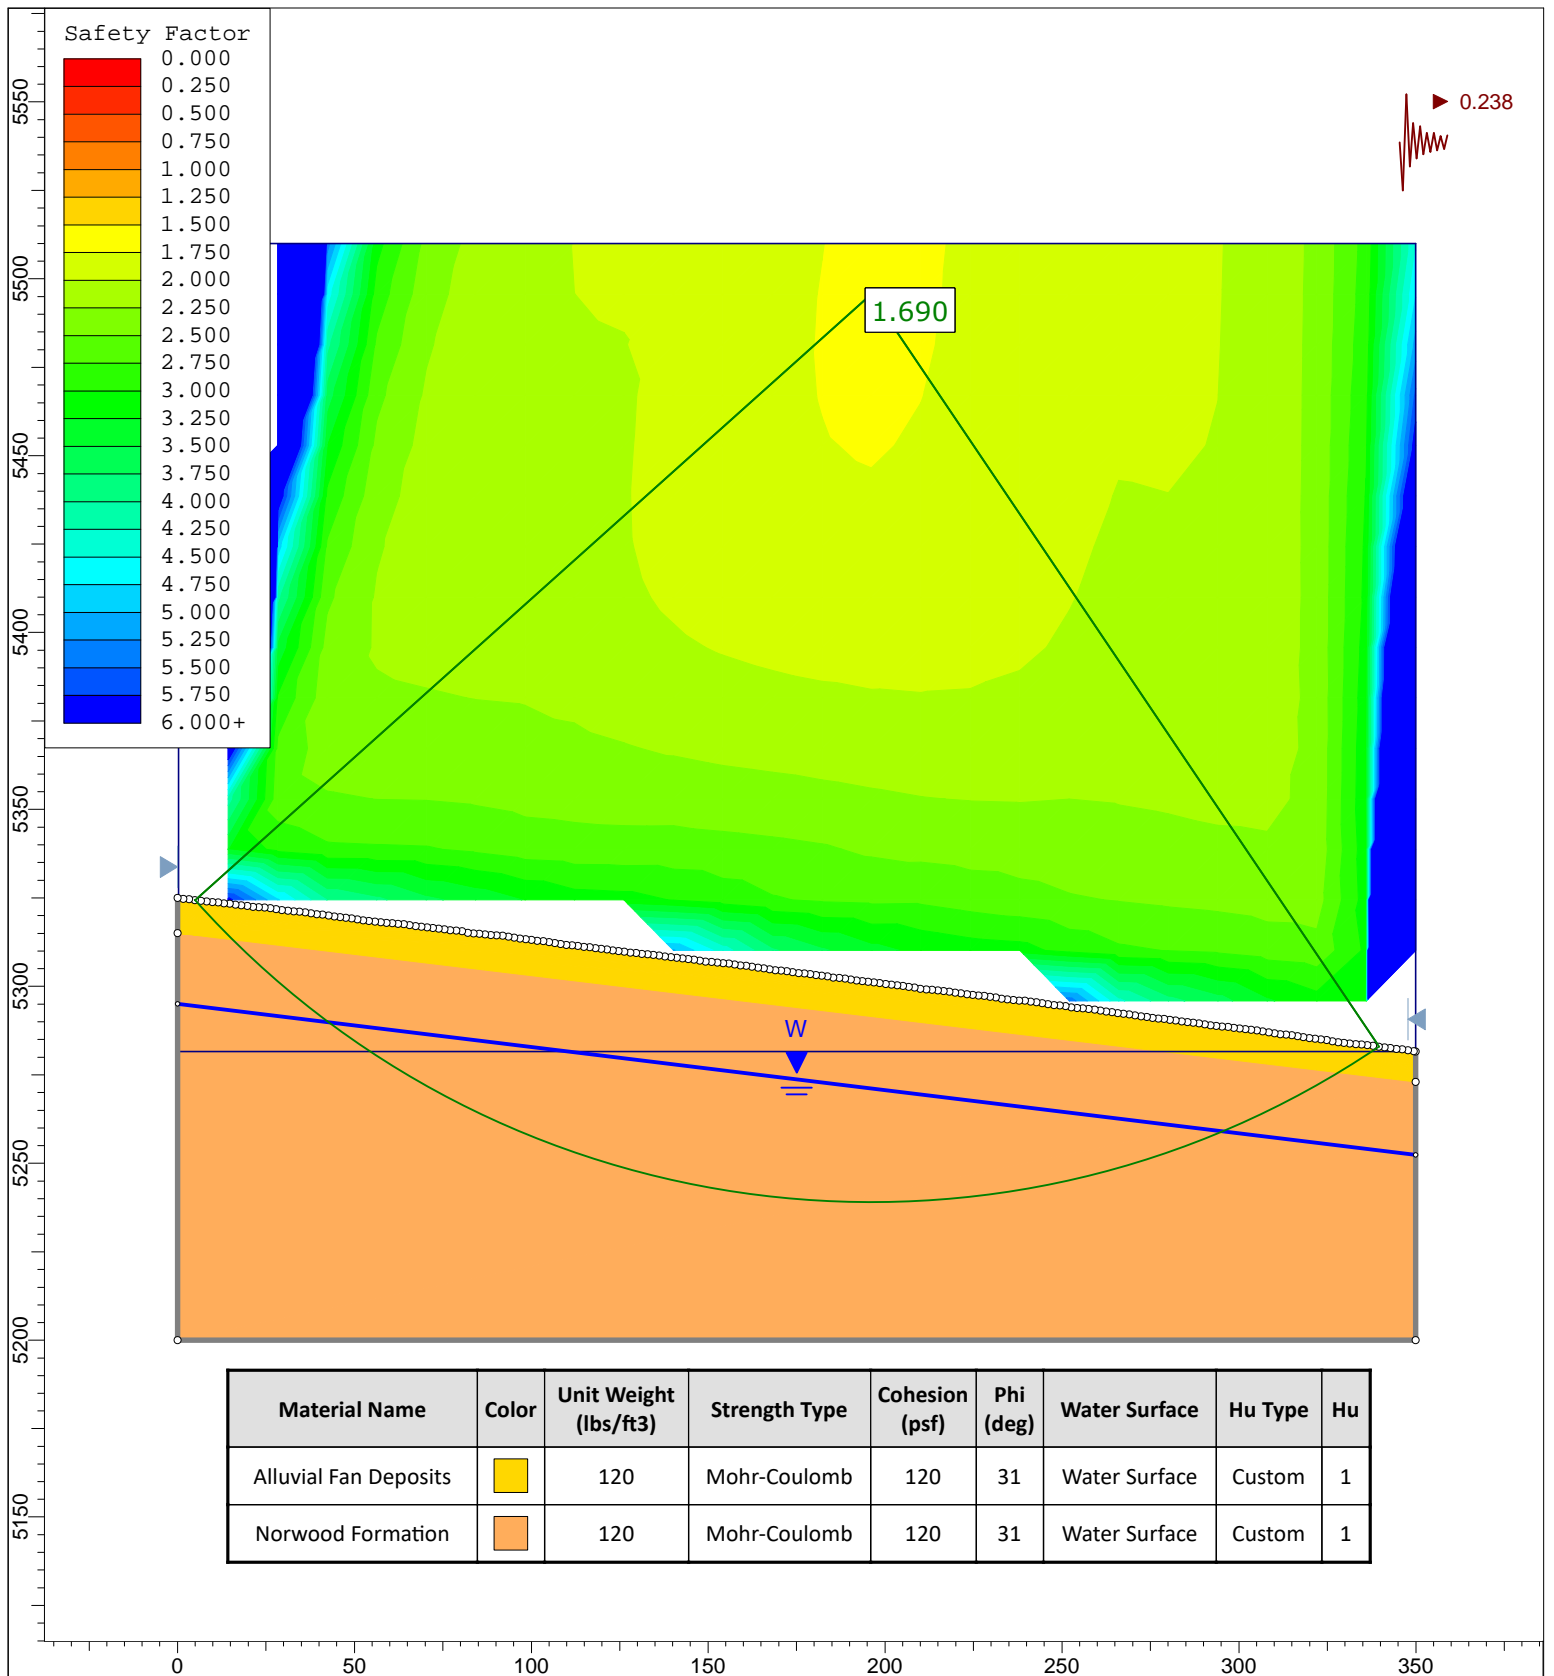
Plate
12

Global Stability - Pseudo Static
