**Re: Engineering Geology Assessment-Addendum I
Lot 15, Ski Lake Estates No. 3
6640 East 1100 South
Huntsville, Utah
Job No. 145150**

This letter is an addendum to the engineering geology assessment letter for the subject lot located in Huntsville, Weber County, Utah. Earthtec Engineering previously completed a geotechnical engineering study¹ and an addendum letter² to the geotechnical report for the subject lot. An engineering geology assessment letter³ was also prepared by Earthtec Engineering.

The purpose of this letter is to respond to the geology review comments⁴ provided by Simon Associates, LLC, third-party consultant, hired by Weber County to review the referenced geology assessment letter.

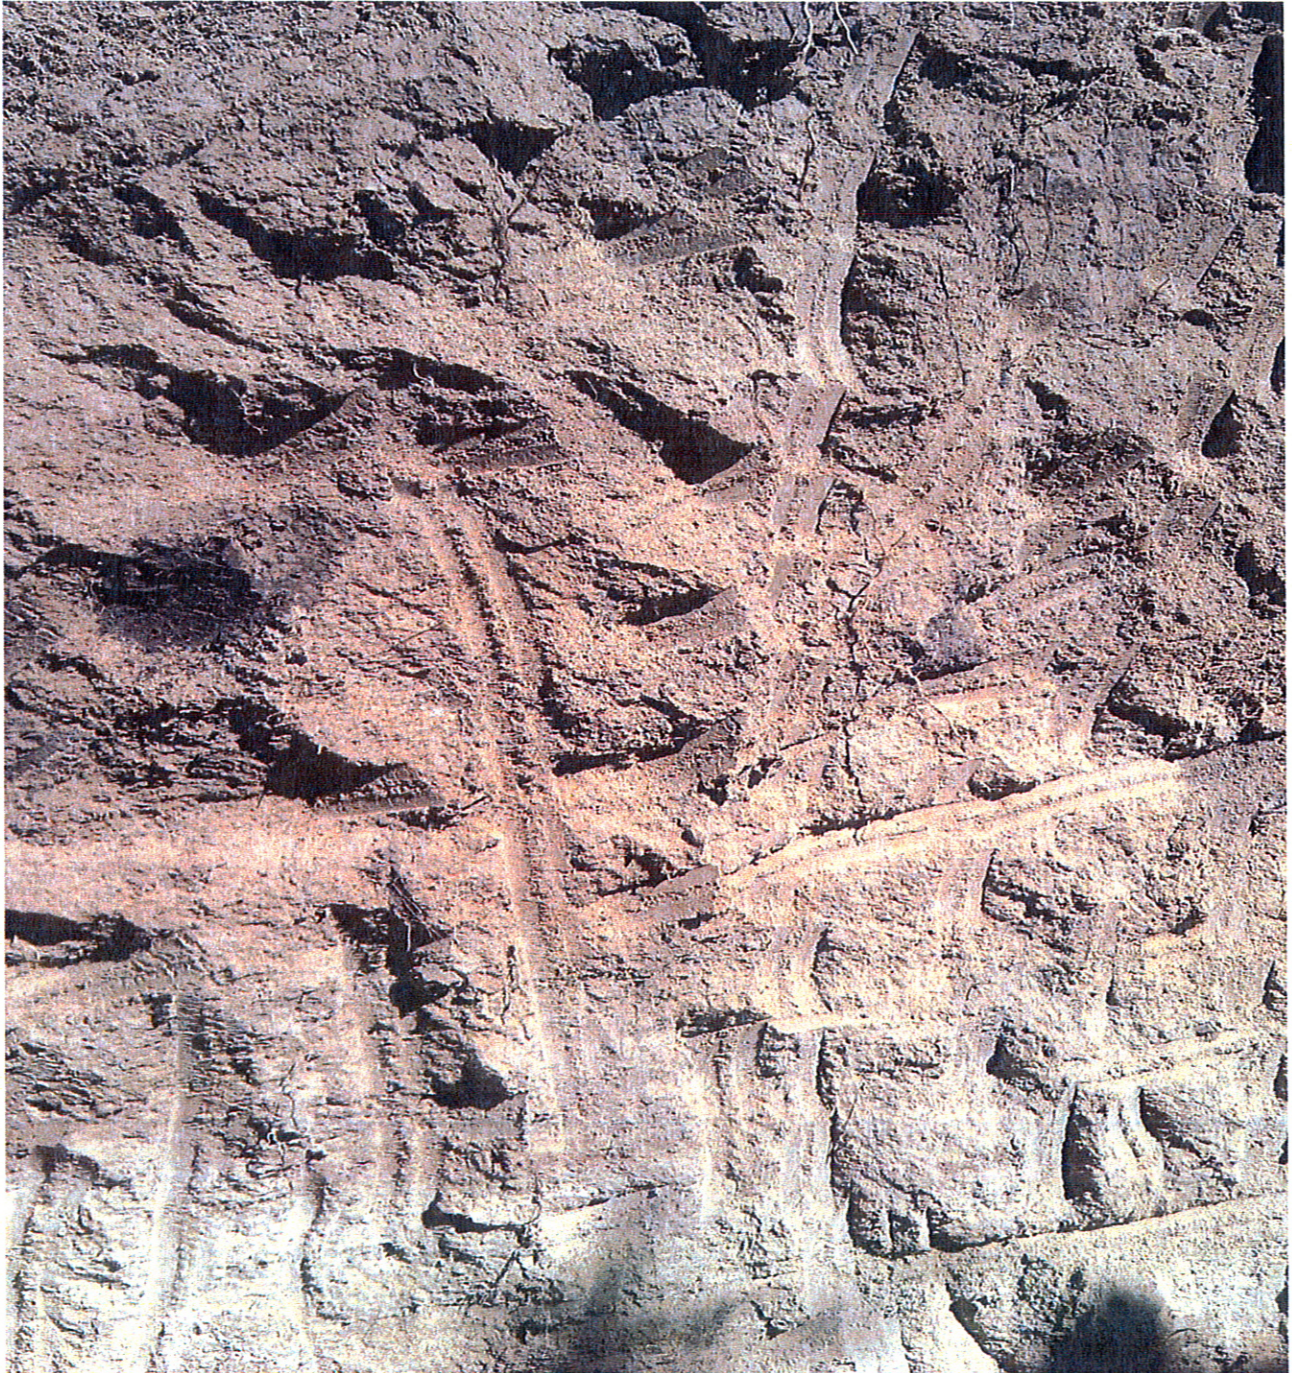
Test Pit 3- West side, middle of the trench.

TP-3 was photographed as shown in Exhibit 1 through 3, Appendix A. No photographs of TP-5 were taken, and this test pit was backfilled.

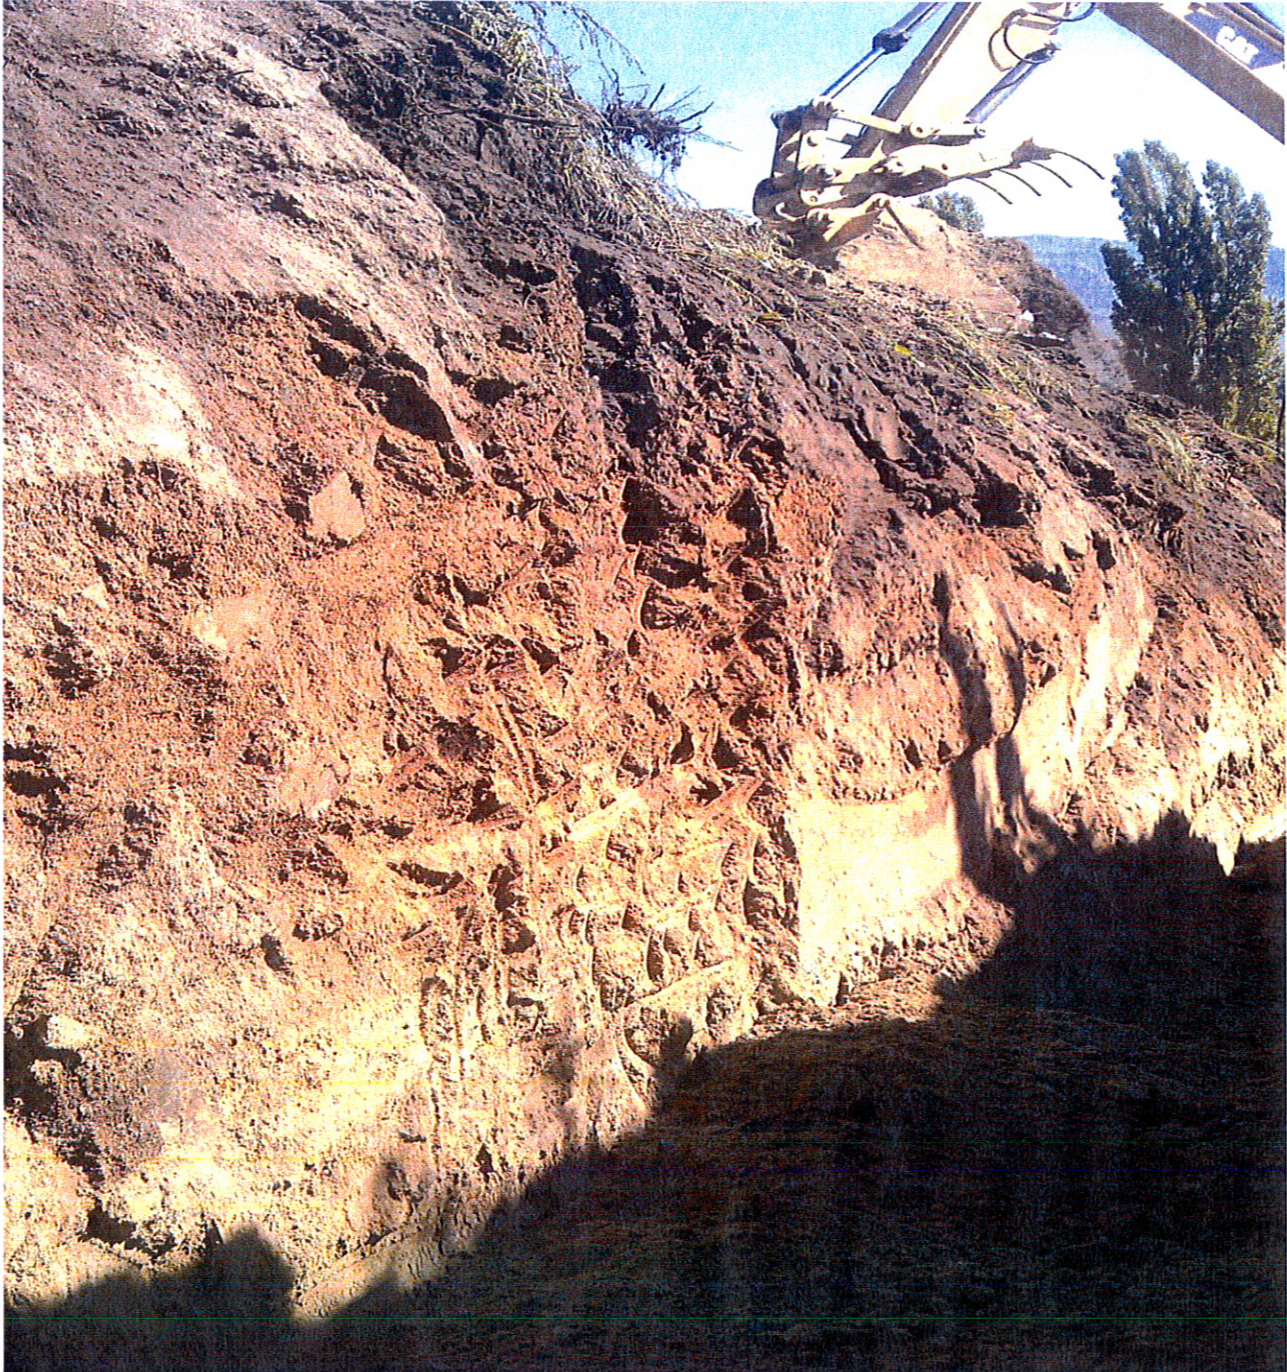
PHOTO EXHIBIT 2

Test Pit 3- West side of sidewall.

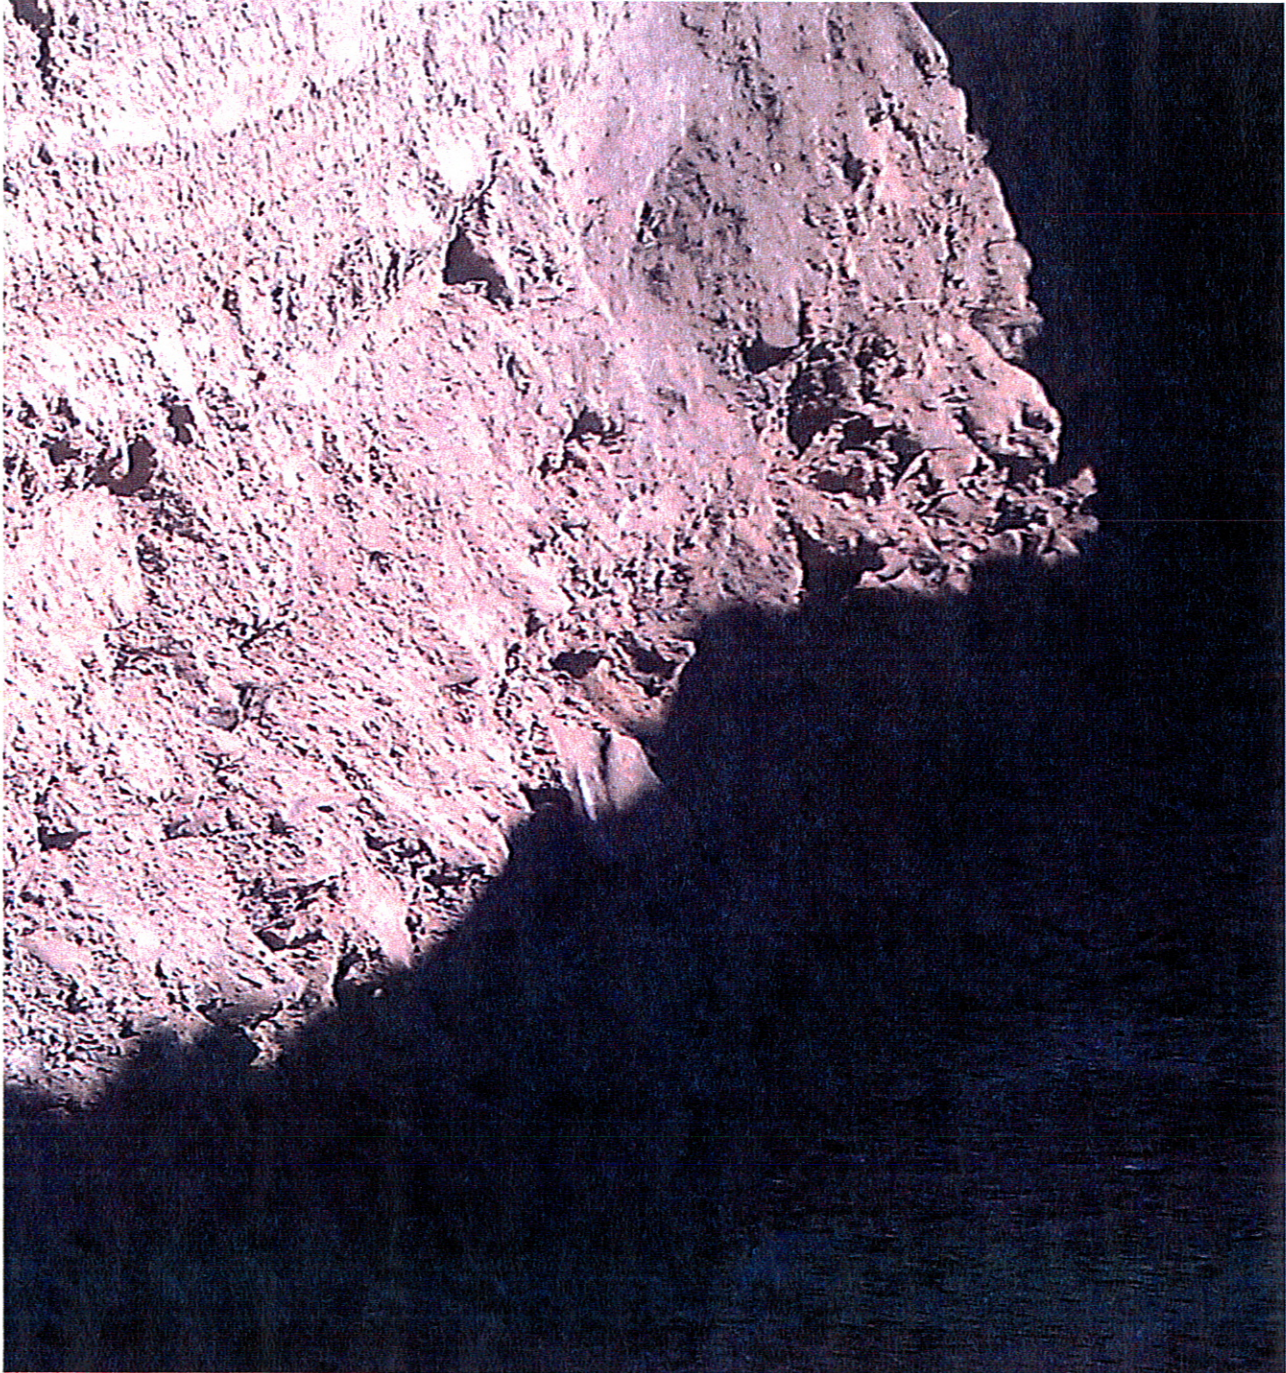
PHOTO EXHIBIT 3

Test Pit 3- West side of sidewall at the north end of the trench. Showing the gravel in the sidewall.

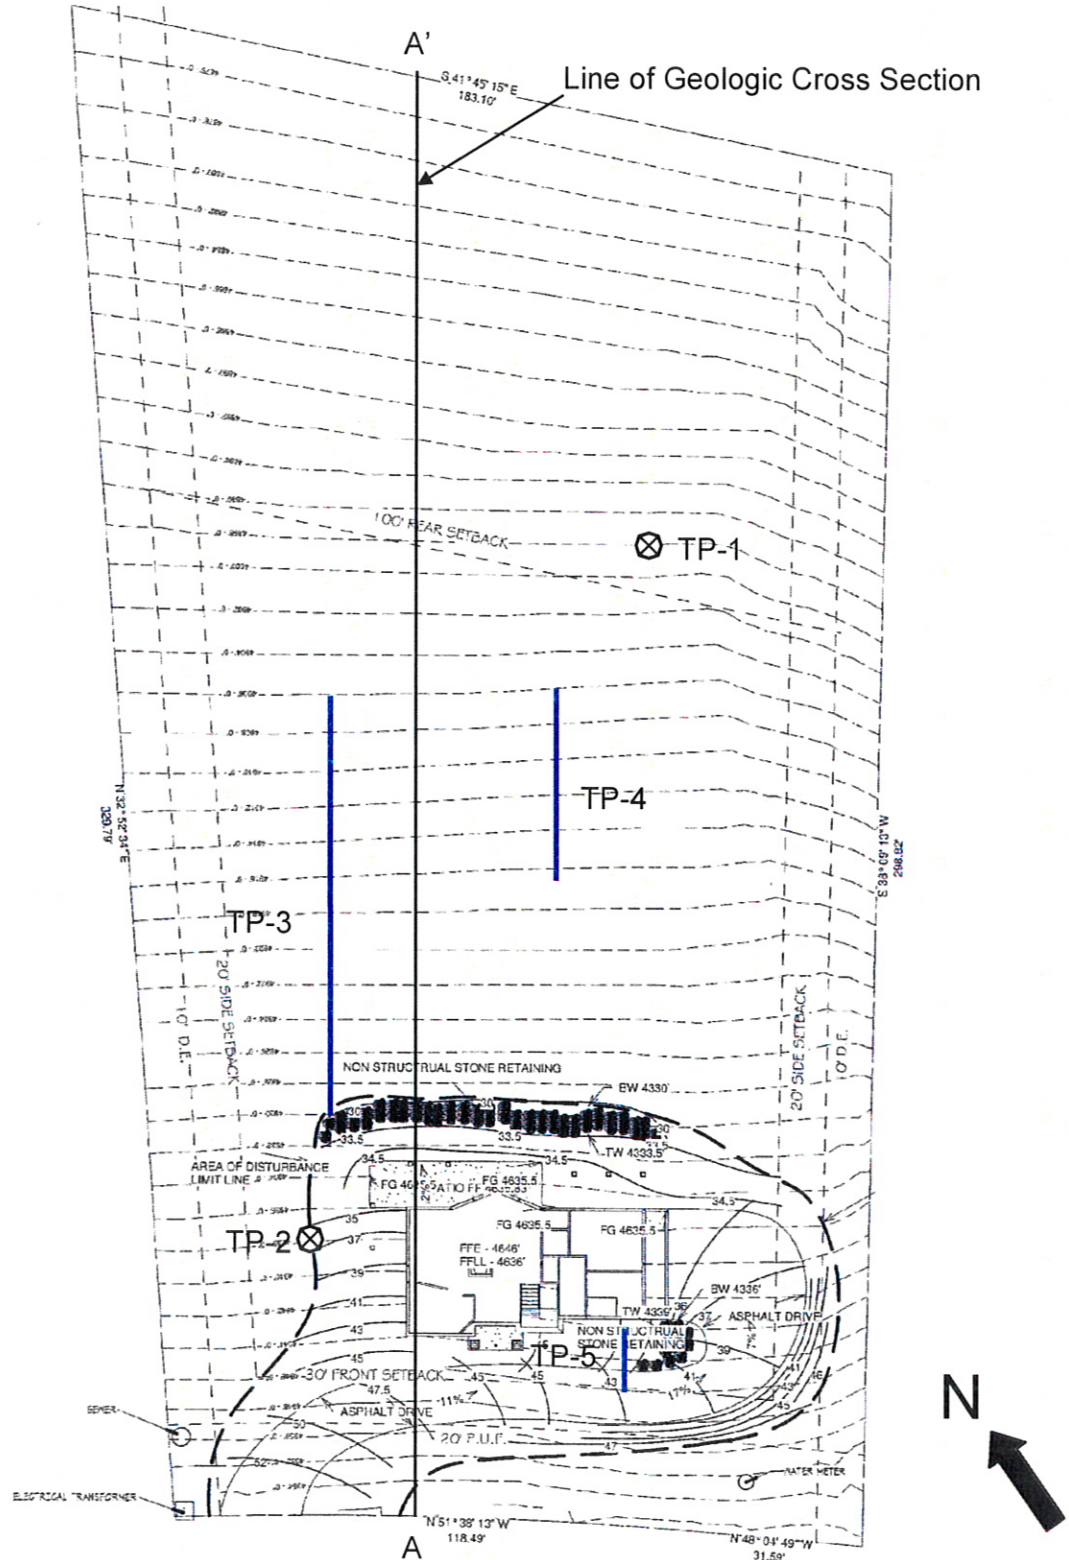
FIGURE 3

See the revised Figure 3, Appendix B. Test Pit 5 was approximately 4-5 feet long.

SITE PLAN AND LOCATIONS OF TEST PITS-REVISED

Review Comment 4 states: "SA recommends Weber County request EEI provide an updated site plan (Figure 3) depicting the approximate length of the test pits, particularly the extension of TP-3.
