Re: **Engineering Geology Assessment-Addendum I**  
**Lot 15, Ski Lake Estates No. 3**  
**6640 East 1100 South**  
**Huntsville, Utah**  
**Job No. 145150**

This letter is an addendum to the engineering geology assessment letter for the subject lot located in Huntsville, Weber County, Utah. Earthtec Engineering previously completed a geotechnical engineering study<sup>1</sup> and an addendum letter<sup>2</sup> to the geotechnical report for the subject lot. An engineering geology assessment letter<sup>3</sup> was also prepared by Earthtec Engineering.

**APPENDIX A**  
**PHOTO EXHIBITS**

# SITE PLAN AND LOCATIONS OF TEST PITS-REVISED

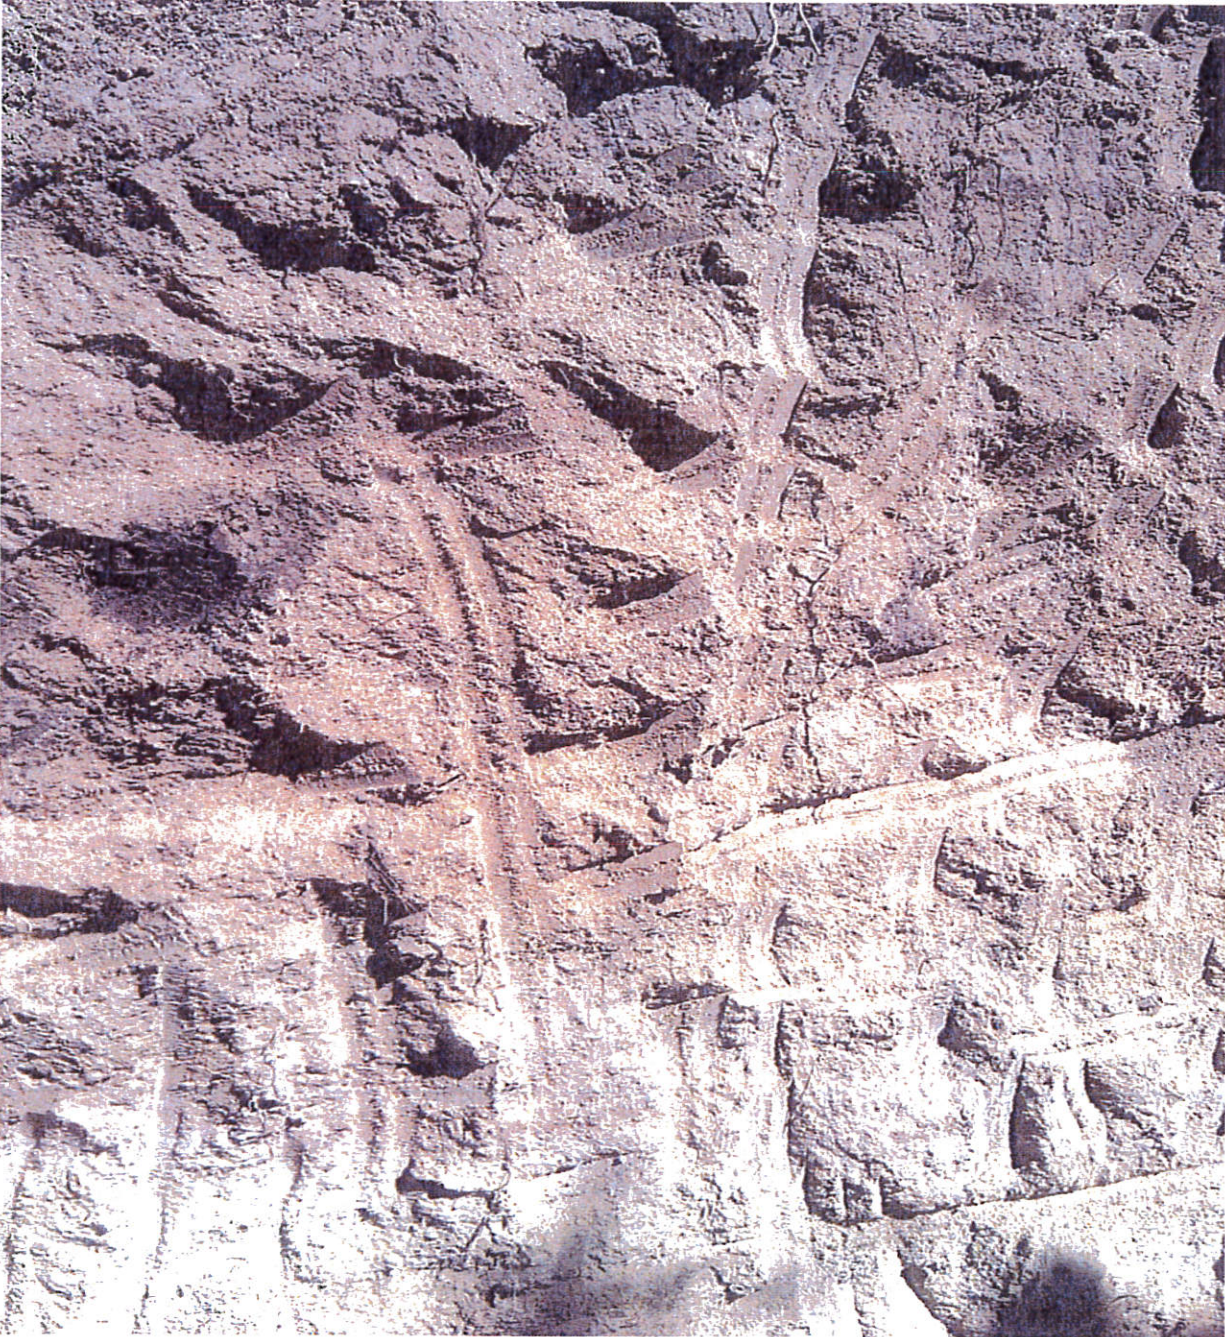
PHOTO EXHIBIT 1

Test Pit 3- West side, middle of the trench.

TP-3 was photographed as shown in Exhibit 1 through 3, Appendix A. No photographs of TP-5 were taken, and this test pit was backfilled.

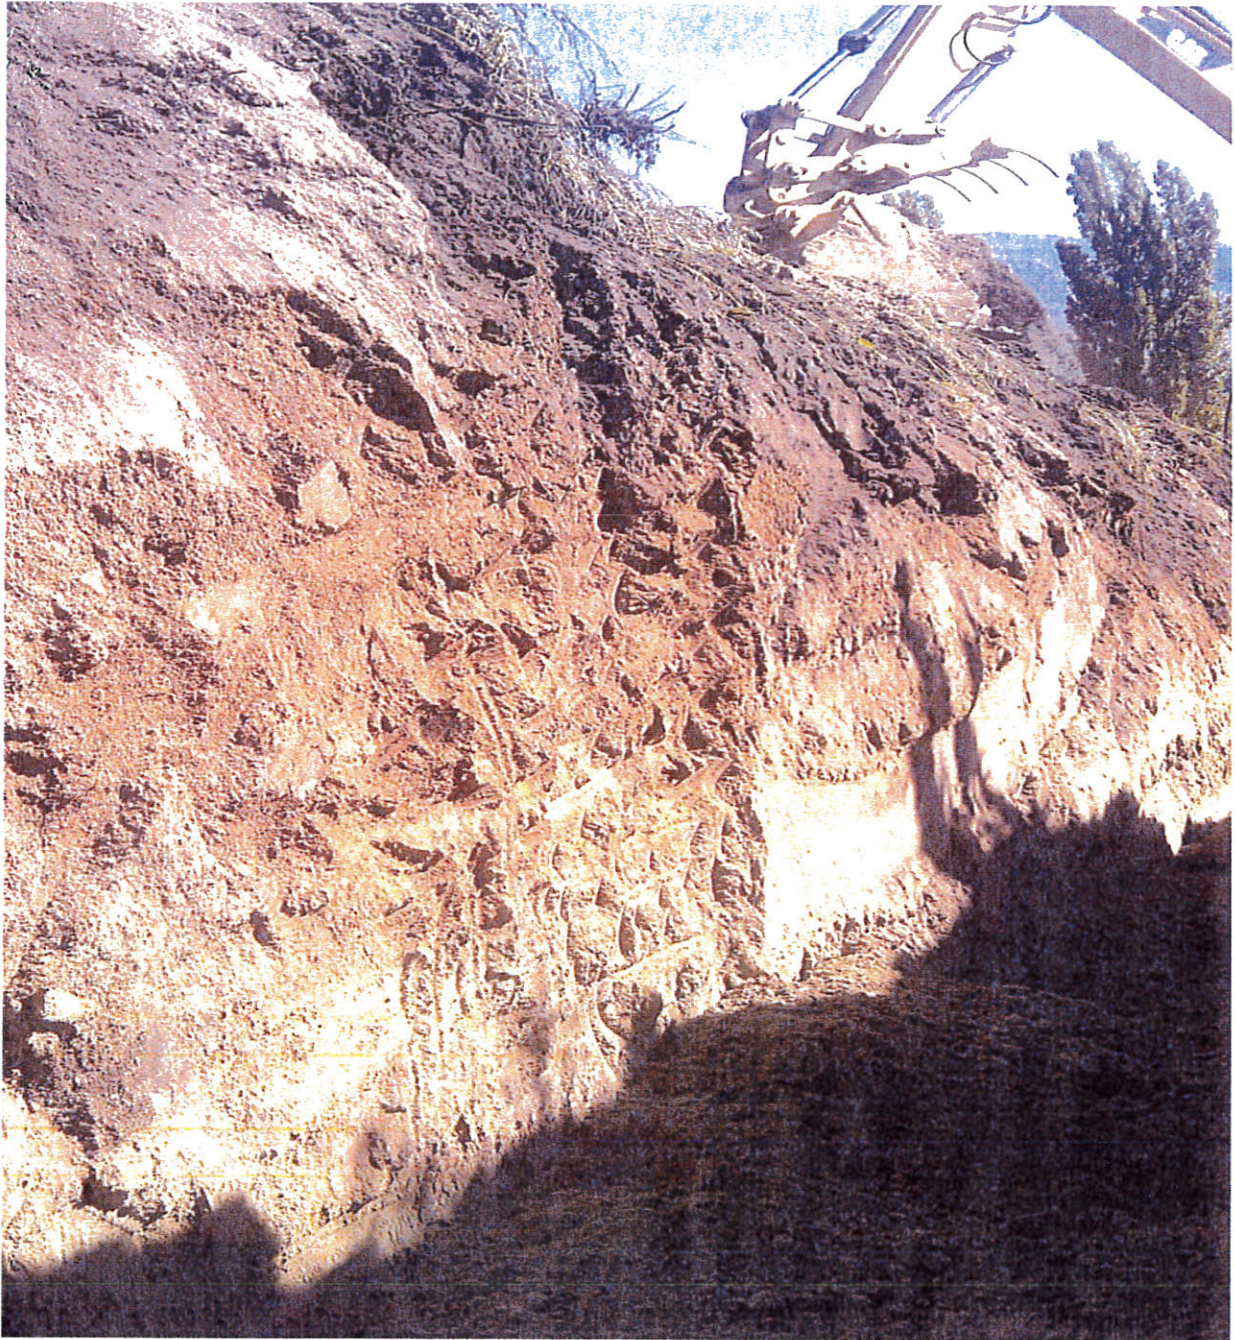
PHOTO EXHIBIT 2

Test Pit 3- West side of sidewall.

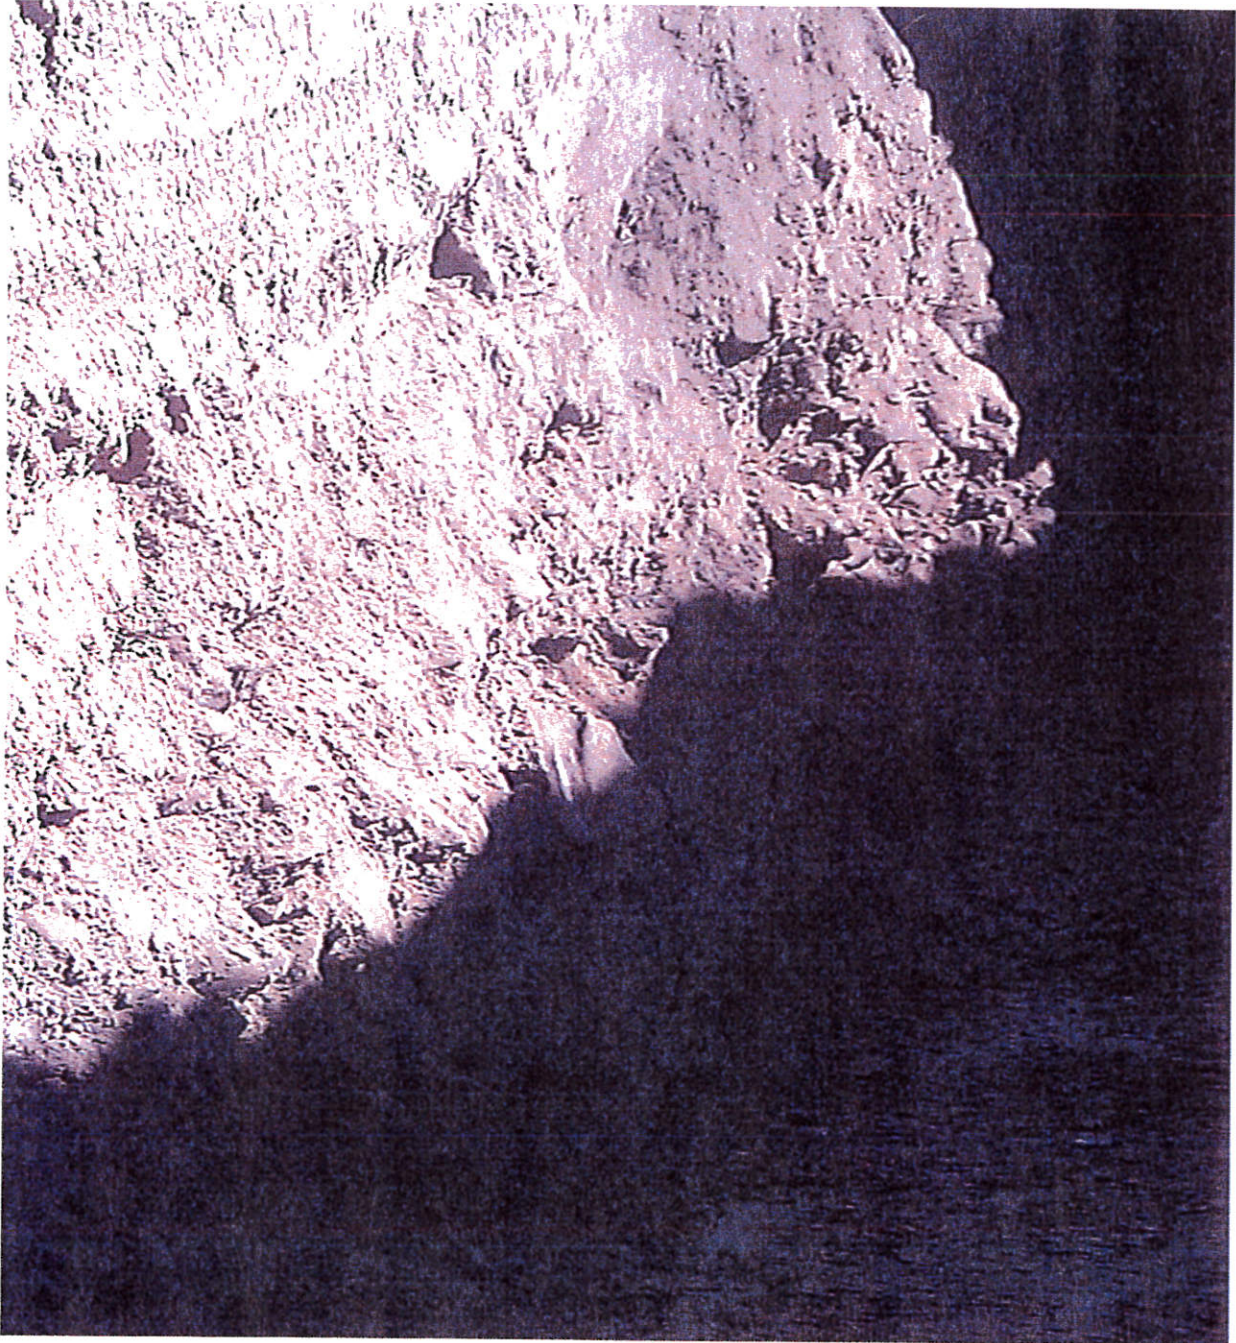
PHOTO EXHIBIT 3

Test Pit 3- West side of sidewall at the north end of the trench. Showing the gravel in the sidewall.
