GEOLOGIC HAZARDS EVALUATION

LOT 5 BIG SKY ESTATES NO. 1

2337 NORTH PANORAMA CIRCLE

LIBERTY, WEBER COUNTY, UTAH

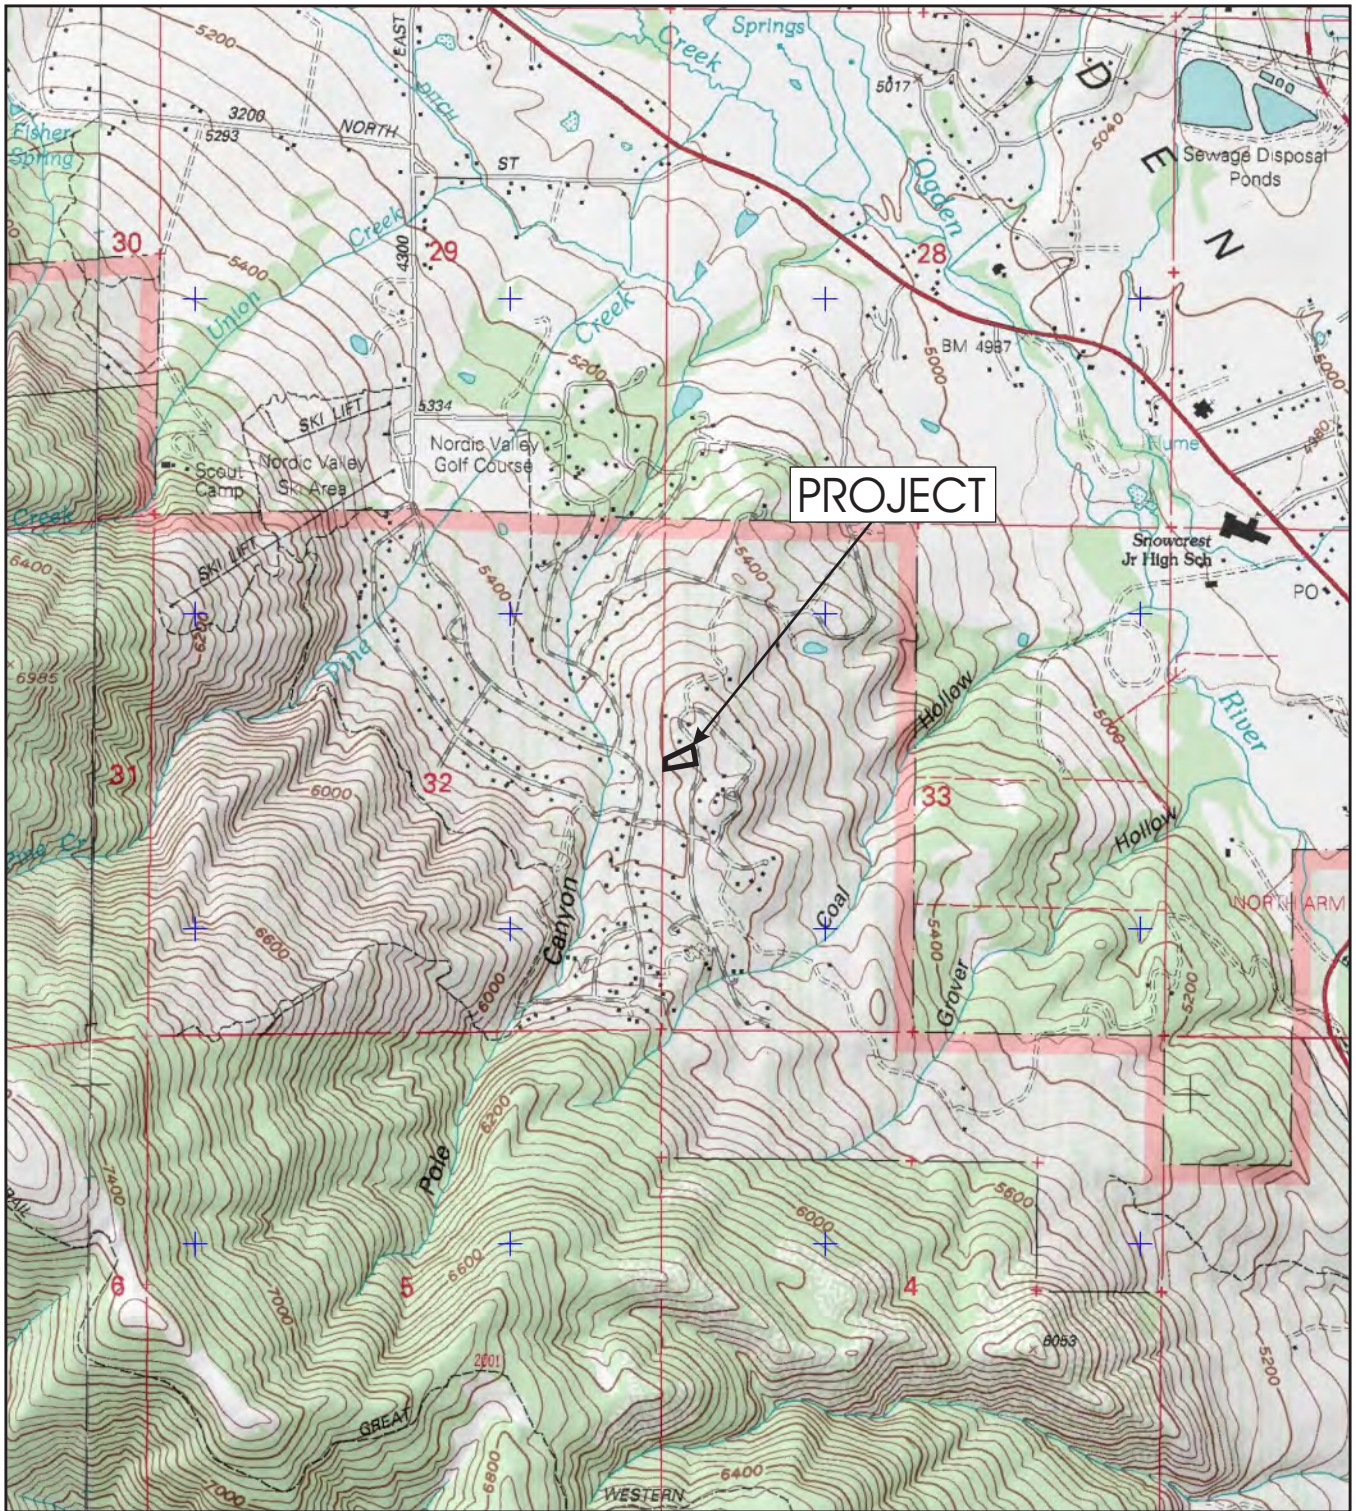
FIGURE 1

Source: U.S. Geological Survey 7.5 Minute Series Topographic Maps, Utah - Huntsville, 1998;
 Project location SW1/4, Section 33, T7N, R1E (SLBM); about 5,525 to 5,615 feet elevation (ASL).

The U.S. Geological Survey (USGS) topographic map of the Huntsville Quadrangle shows the site is at the western margin of Ogden Valley between Pole Canyon and Coal Hollow Creeks, and is on southwest- to east-facing slopes slightly below a hilltop overlooking the southern end of Nordic Valley to the west (Figure 1). Pole Canyon Creek flows to the north about 560 feet west of the property. Nordic Valley Ski Area is about 0.8 miles to the northwest. No active drainages are shown crossing the site on Figure 1, and no springs or seeps were observed at the site or are shown in the site area on Figure 1.

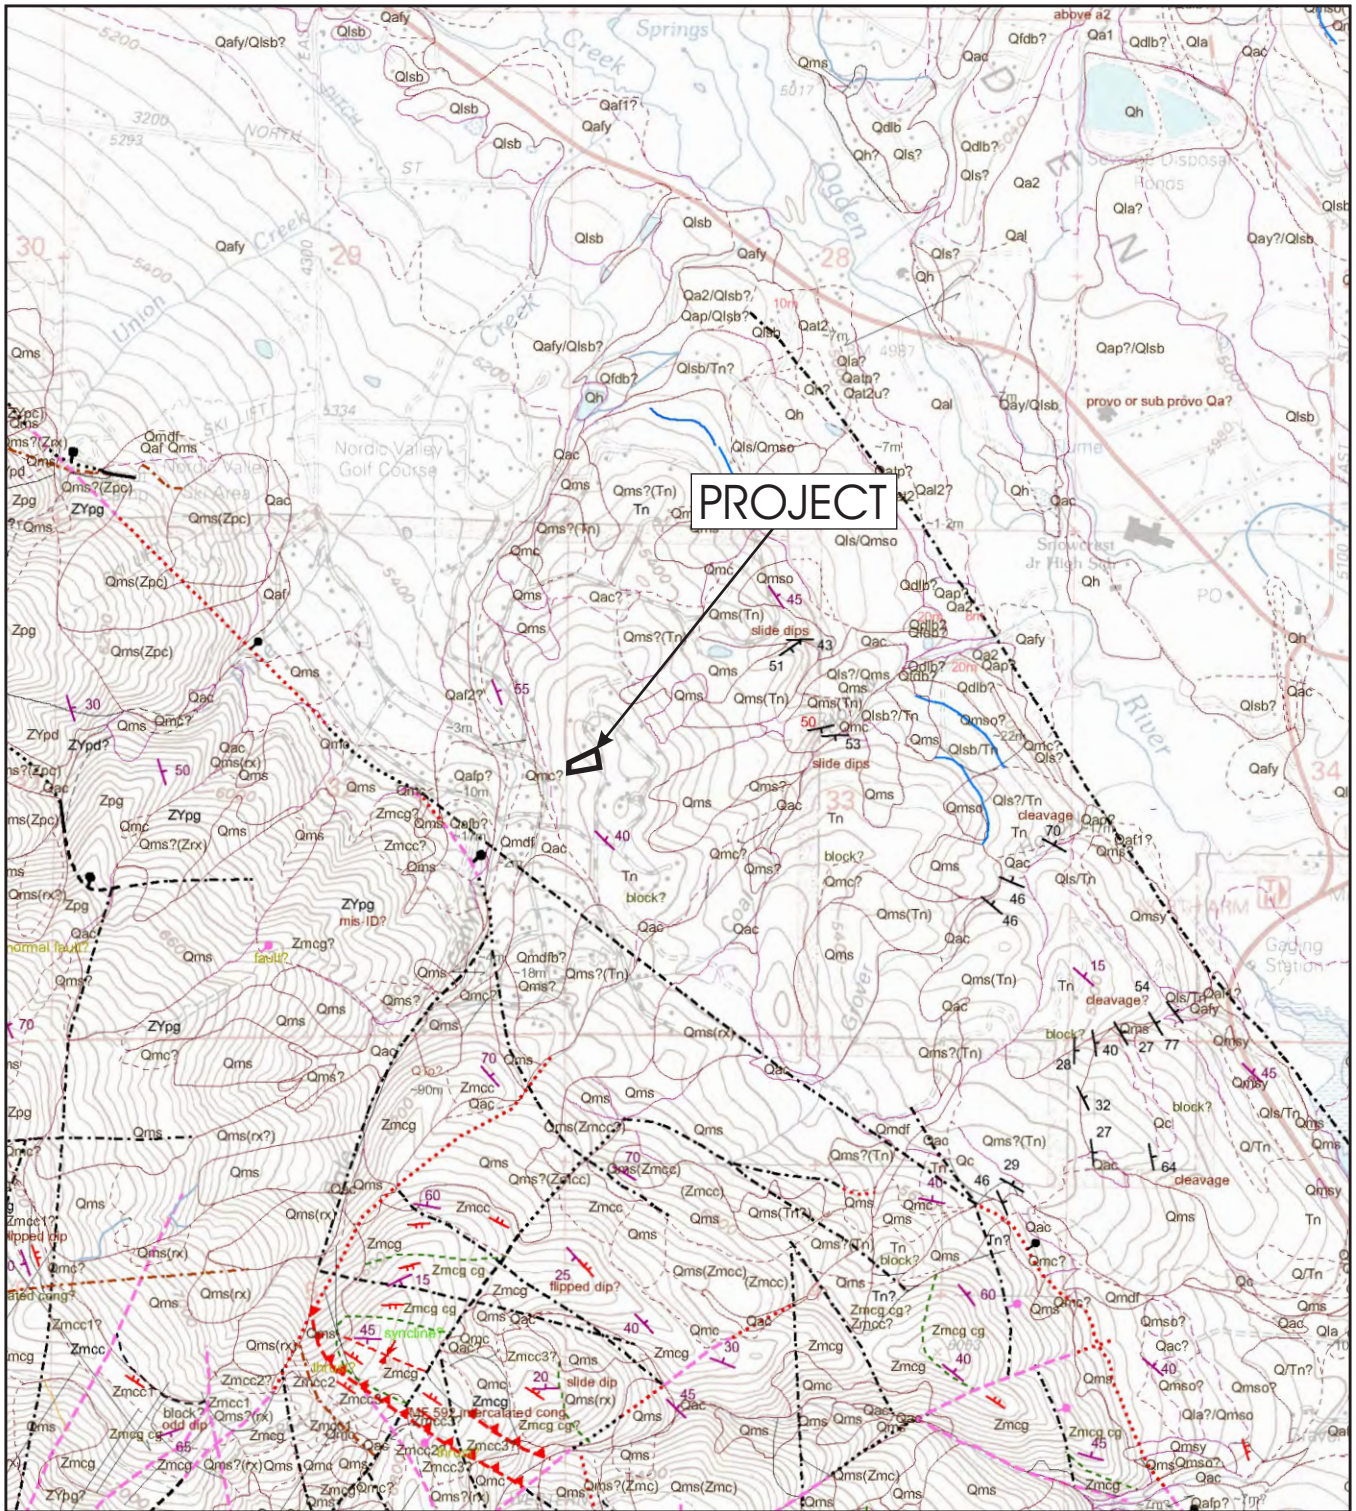
FIGURE 2

Figure 2 shows the site in bedrock of the Norwood Formation (unit Tn, Figure 2). Descriptions of geologic units within 0.5 miles of the site from the adjoining Snow Basin Quadrangle (King and others, 2008) are as follows:

Figure 2 shows several strike and dip measurements in Norwood Formation in the site area. Those shown in black were measured by the UGS, whereas those in purple are from U.S. Geological Survey (USGS) data (Jon King, Utah Geological Survey, verbal communication, February 29, 2016). The nearest measurement is about 750 feet south of the property and shows a strike/dip of N46°W 40° NE. Several additional measurements are to the east and southeast that show generally northwest-trending strikes and dips generally between about 27 to 46 degrees to the northeast. Norwood Formation bedrock in the area has average dips of about 30 to 45 degrees, although this unit has local depositional variations that may produce lower and higher dips within a relatively short distance (Jon King, Utah Geological Survey, verbal communication, February 29, 2016).

Source: 2014 unpublished Utah Geological Survey mapping; see text for description of nearby surficial geologic units.

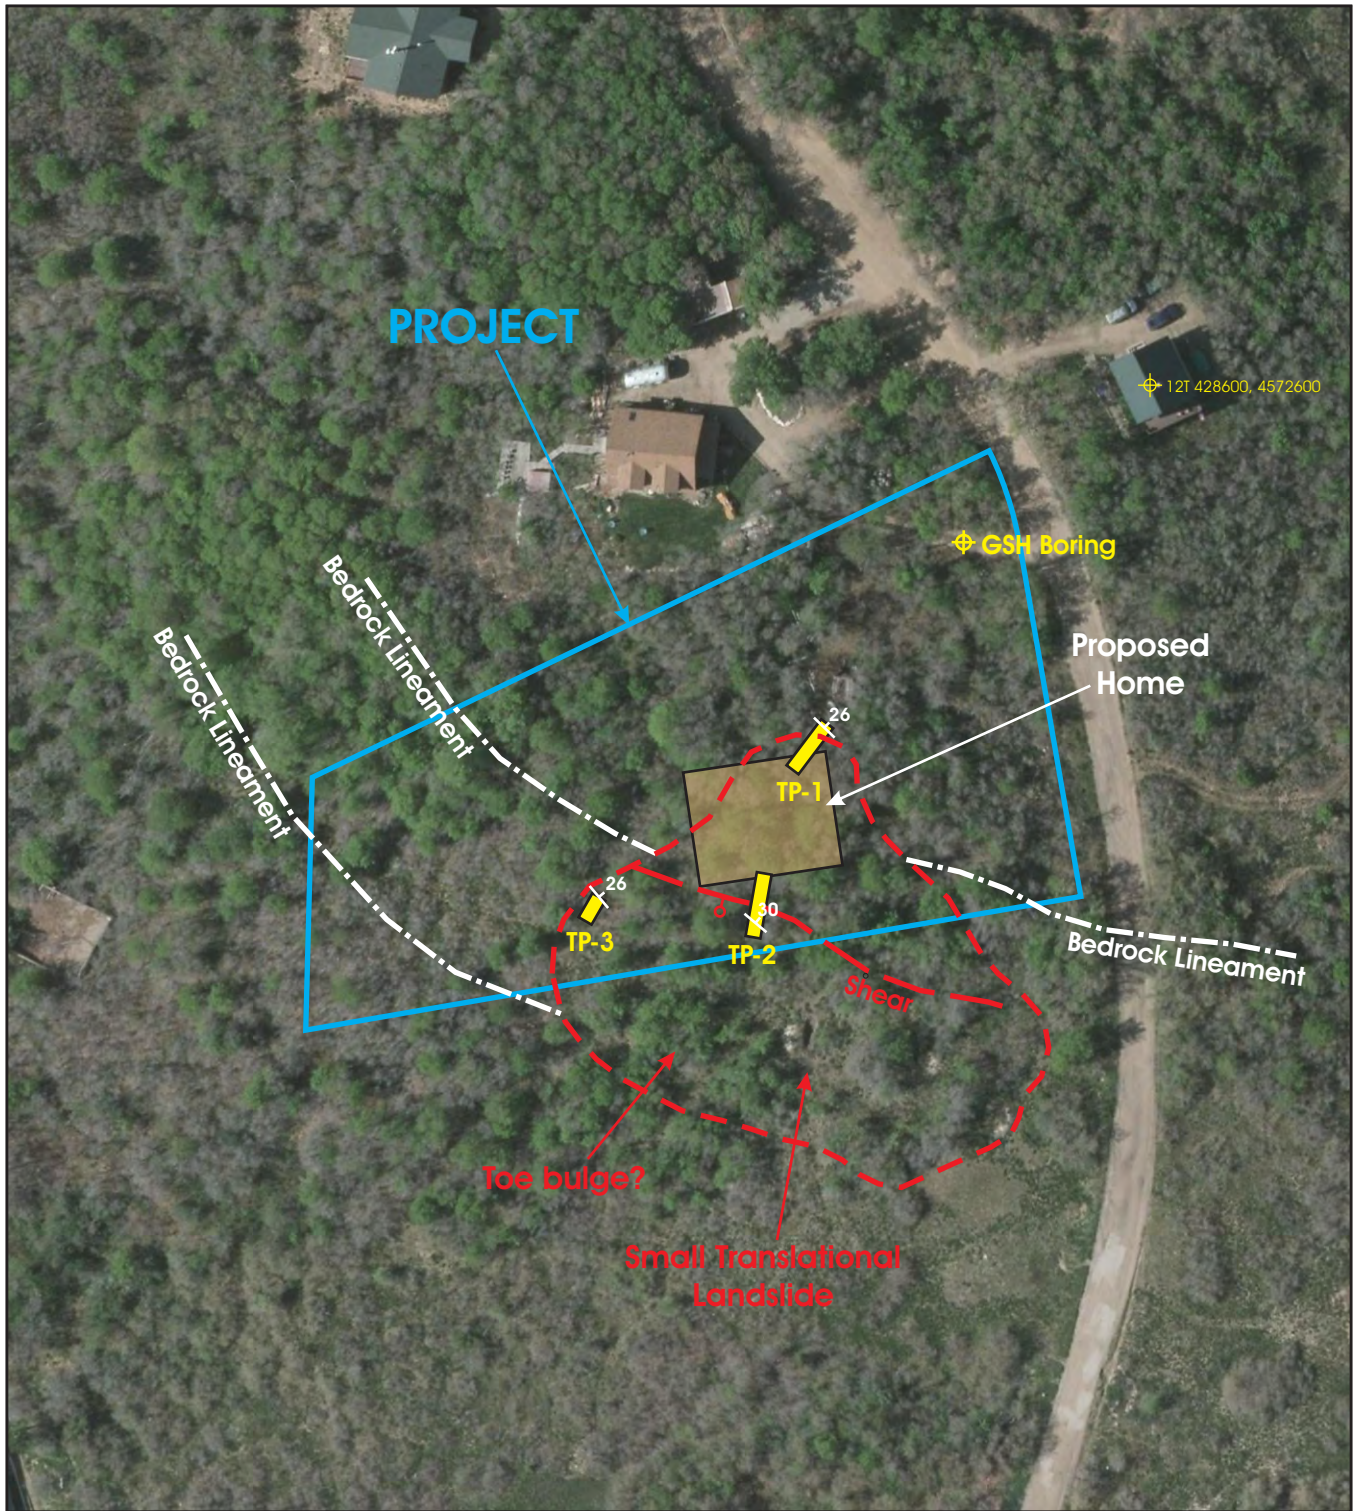
FIGURE 3A

High-resolution orthophotography from 2012 and 1-meter bare earth DEM LIDAR from 2011 available from the Utah AGRC (Figures 3A and 3B) were reviewed to obtain information about the geomorphology of the site area. Several bedrock lineaments (presumably contacts between subunits in the Norwood Formation) are evident of Figures 3A and 3B that are obscured across the Project by what appears to be a small landslide. The landslide head is slightly north of the proposed home; the failure then widens and descends downslope to the southwest to about 85-90 feet southwest of the home. A slight bulge is evident on both the 2012 aerial photo and 2011 LIDAR image in the toe area (Figures 3A and 3B). We note that this bulge is not evident on the surveyed topography on Figure 3C, which may be just an anomaly of the surveying methodology. Morphology of the landslide appears subdued or obscured, suggesting it may be an older feature (possibly latest Pleistocene to early Holocene in age). No evidence of other geologic hazards were observed on the air photos in the site area.

Source: Utah AGRC, 2012 High-Resolution Orthophoto, 6-inch resolution.

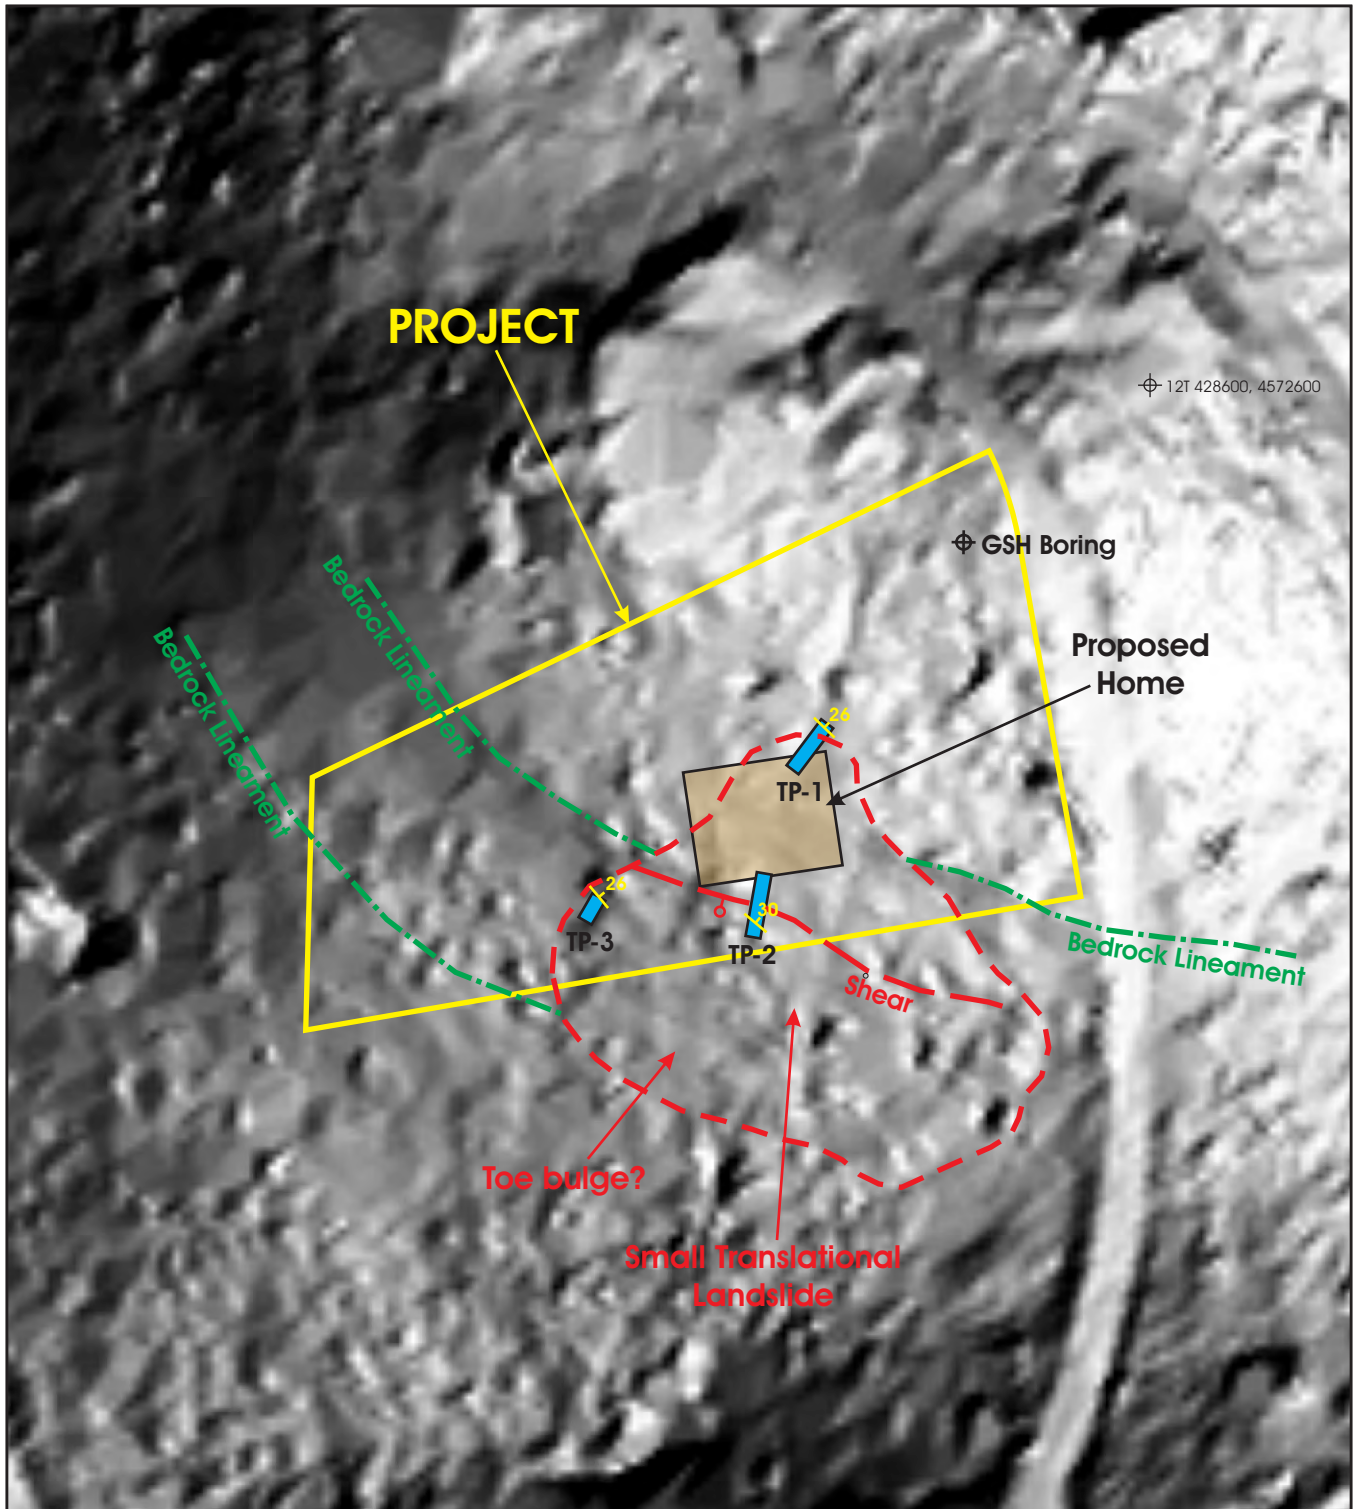
Source: Utah AGRC, 2011 LIDAR Bare Earth DEM.

2011 LIDAR IMAGE
GEOLOGIC HAZARDS EVALUATION Lot 5 Big Sky Estates No. 1 2337 North Panorama Circle Liberty, Weber County, Utah
FIGURE 3B

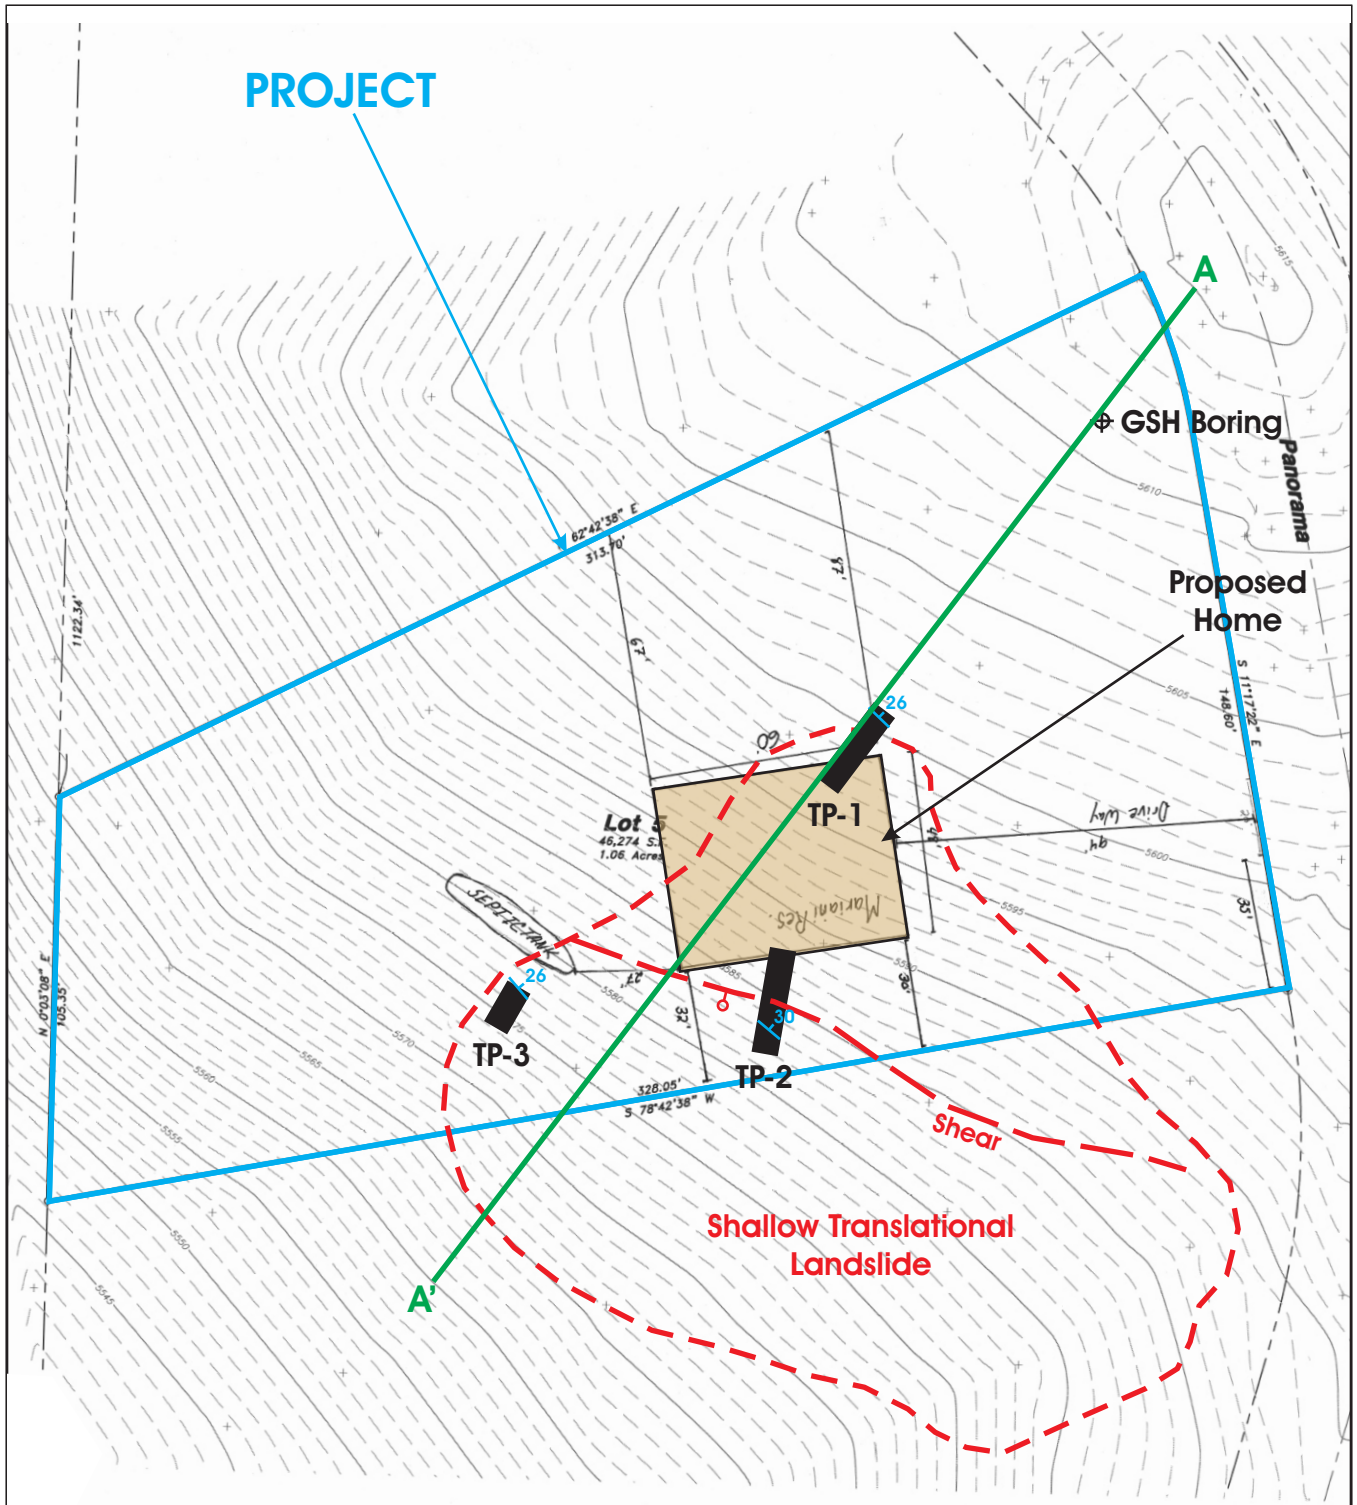
SITE PLAN

Three test pits were excavated at the property in April 2016 to evaluate subsurface conditions. Test pit locations are shown on Figures 3A-3C, and were measured using a

Scale 1:600
(1 inch = 50 feet)

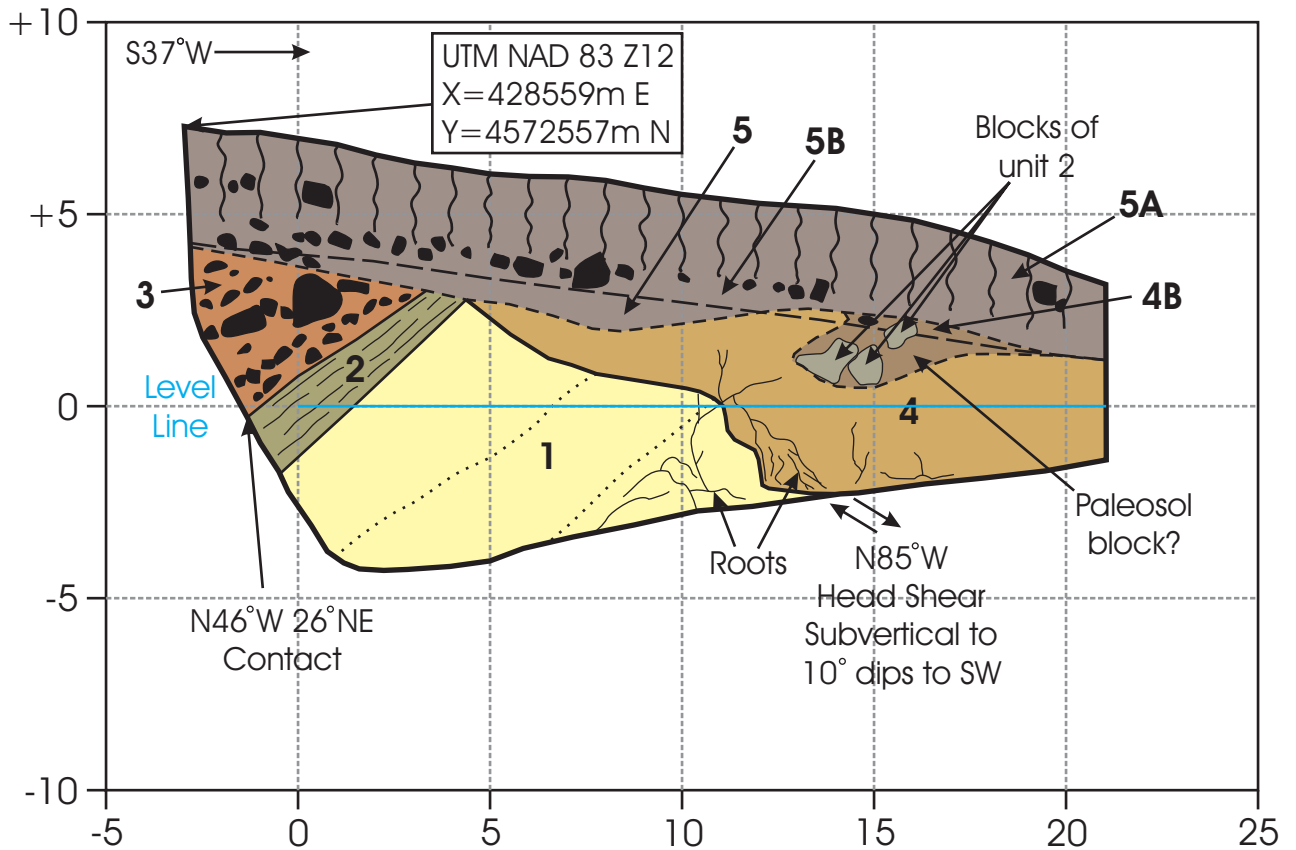
Test pit 1 (Figure 4A) exposed a sequence of weathered Norwood Formation consisting of tuffaceous sandstone overlain by claystone and conglomerate (units 1-3, respectively). The contact between units 2 and 3 showed a strike/dip of N46°W 26° NE, which is similar to regional strike and dips. Units 1-3 in test pit 1 are in turn overlain by a shallow landslide and surficial alluvium and colluvium. The soil profile (A horizon and a well-developed Bt vertisol) suggests the landslide is likely early Holocene in age or older.

UNIT DESCRIPTIONS

Unit 1. *Tertiary Norwood Formation* - Carbonate-enriched tuffaceous sandstone; slightly fractured, pale-brown, high density, well to poorly bedded, with zones of pale-olive brown clay and iron oxide along cleavage fractures.

Unit 2. *Tertiary Norwood Formation* - Olive, reddish-olive, well bedded, moist, moderate density, fat clay (CH).

SCALE: 1 inch = 5 feet
(no vertical exaggeration)
East Wall Logged, North to South

- ***Excavation Inspection*** – To reduce the risk from landsliding, we recommend that the home be founded on underlying undeformed bedrock and that the foundation excavation be inspected by a licensed engineering geologist to confirm that no deformation is present, as well as to recognize any differing conditions that could affect the performance of the planned structure.

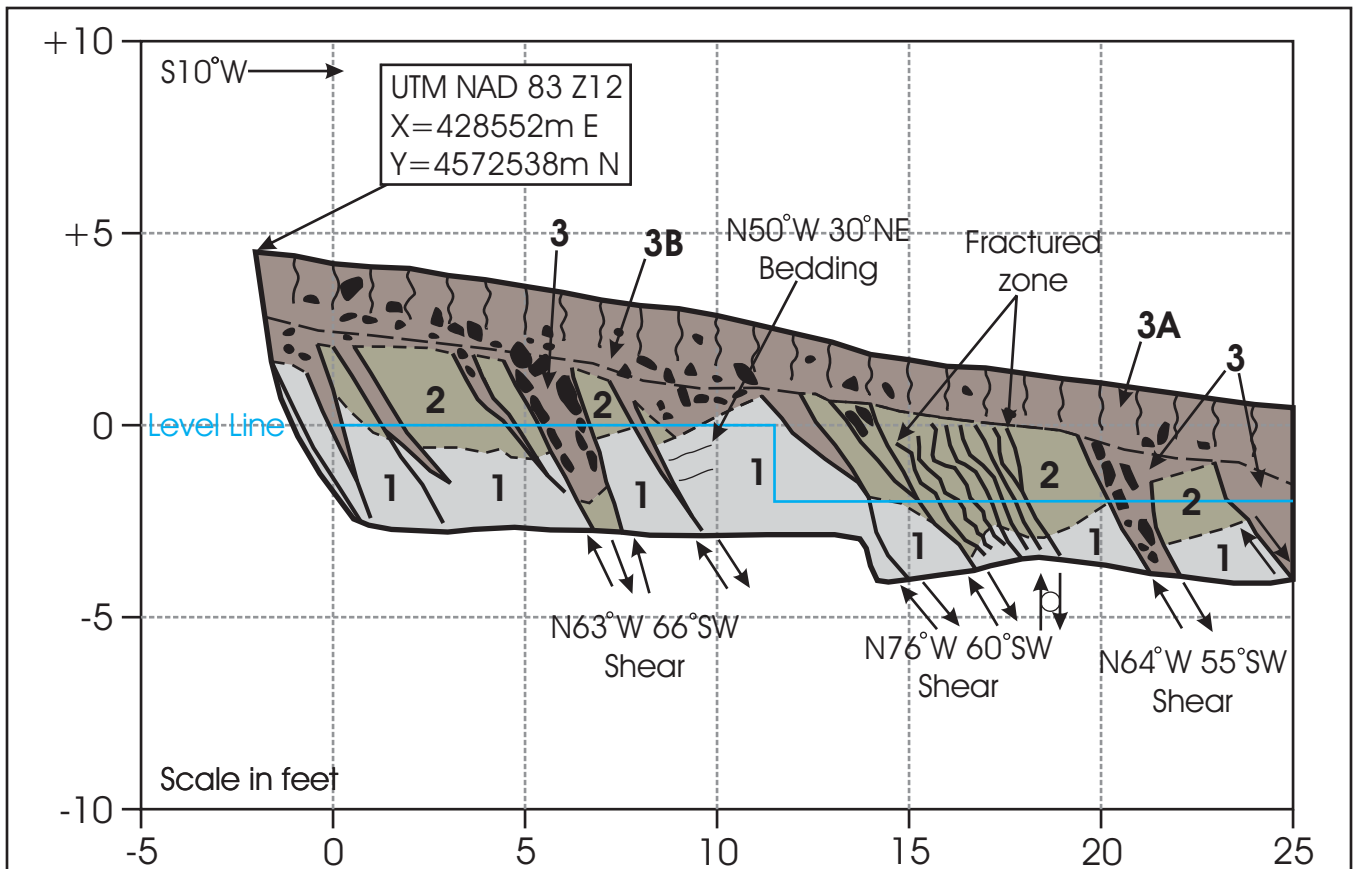
FIGURE 4B

Test pit 2 (Figure 4B) exposed fractured and sheared sandstone bedrock (units 1 and 2) overlain by landslide colluvium (unit 3). Bedding in unit 1 near 9 feet horizontal (Figure 3B) showed a strike/dip of N50°W 30° NE, which suggests only a few degrees of backtilting and horizontal rotation. Many of the shears appeared to die out slightly above the trench floor, although several showed down-to-the-southwest displacements of up to several feet and continued below the test pit bottom. Trend of the shears ranged between N63° W to N76° W, generally similar to topographic contour trends.

UNIT DESCRIPTIONS

Unit 1. Tertiary Norwood Formation - Fractured, very dense, pale-gray, carbonate-enriched, well-bedded tuffaceous sandstone.

Unit 2. Tertiary Norwood Formation - Fractured, very dense, olive-gray, well-bedded tuffaceous sandstone with iron-oxide staining along cleavage faces.

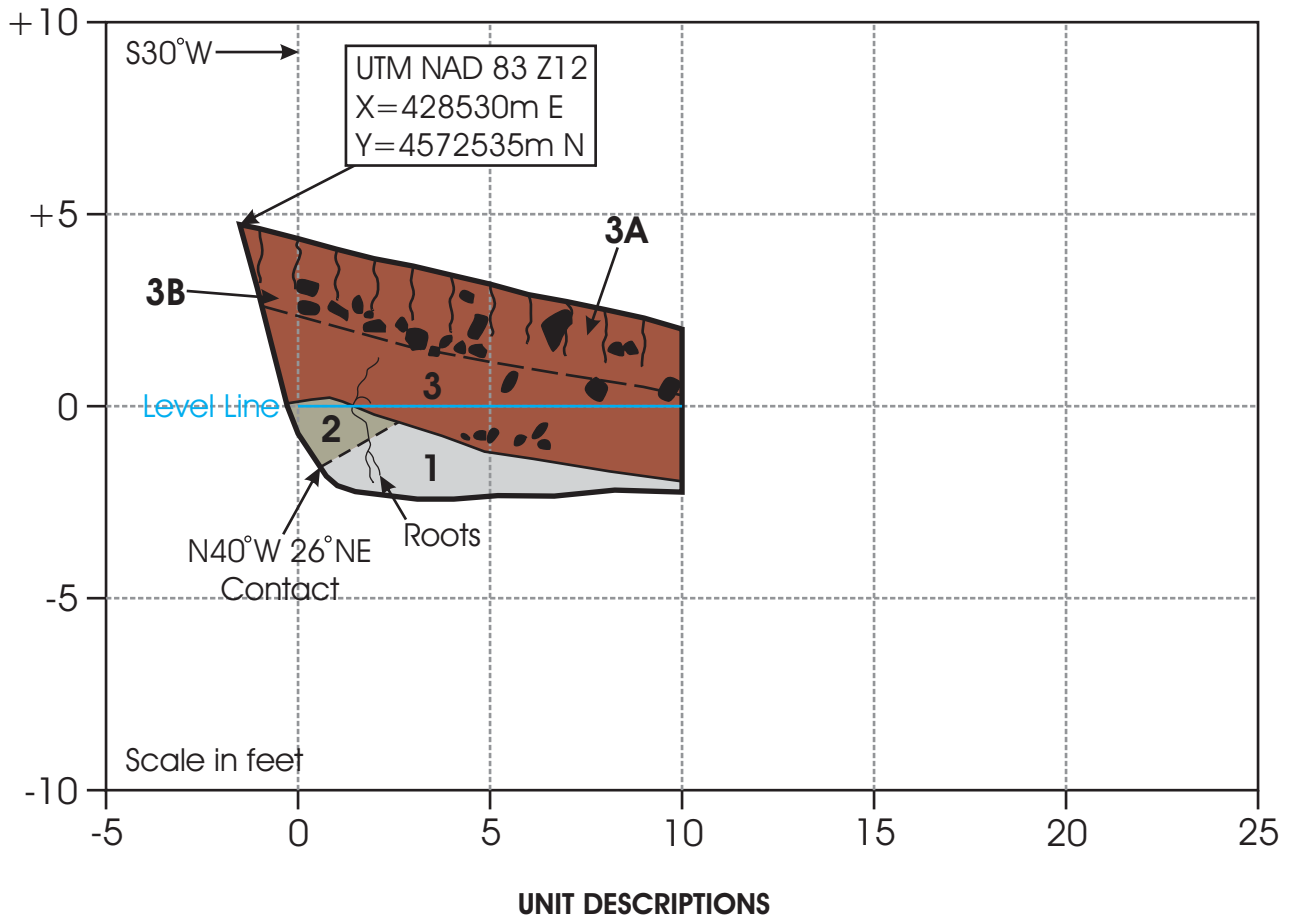
FIGURE 4C

Test pit 3 (Figure 4C) on the lateral margin of the slide (Figures 3A-C) exposed landslide colluvium overlying what we infer is in-place bedrock. The contact between units 1 and 2 (Figure 4C) showed a strike/dip of N40°W 26° NE, which is also similar to regional strike and dip measurements.

Unit 1. *Tertiary Norwood Formation* - Fractured, very dense, pale-gray, carbonate-enriched, well-bedded tuffaceous sandstone.

Unit 2. *Tertiary Norwood Formation* - Fractured, very dense, olive-gray, well-bedded tuffaceous sandstone with iron-oxide staining along cleavage faces.

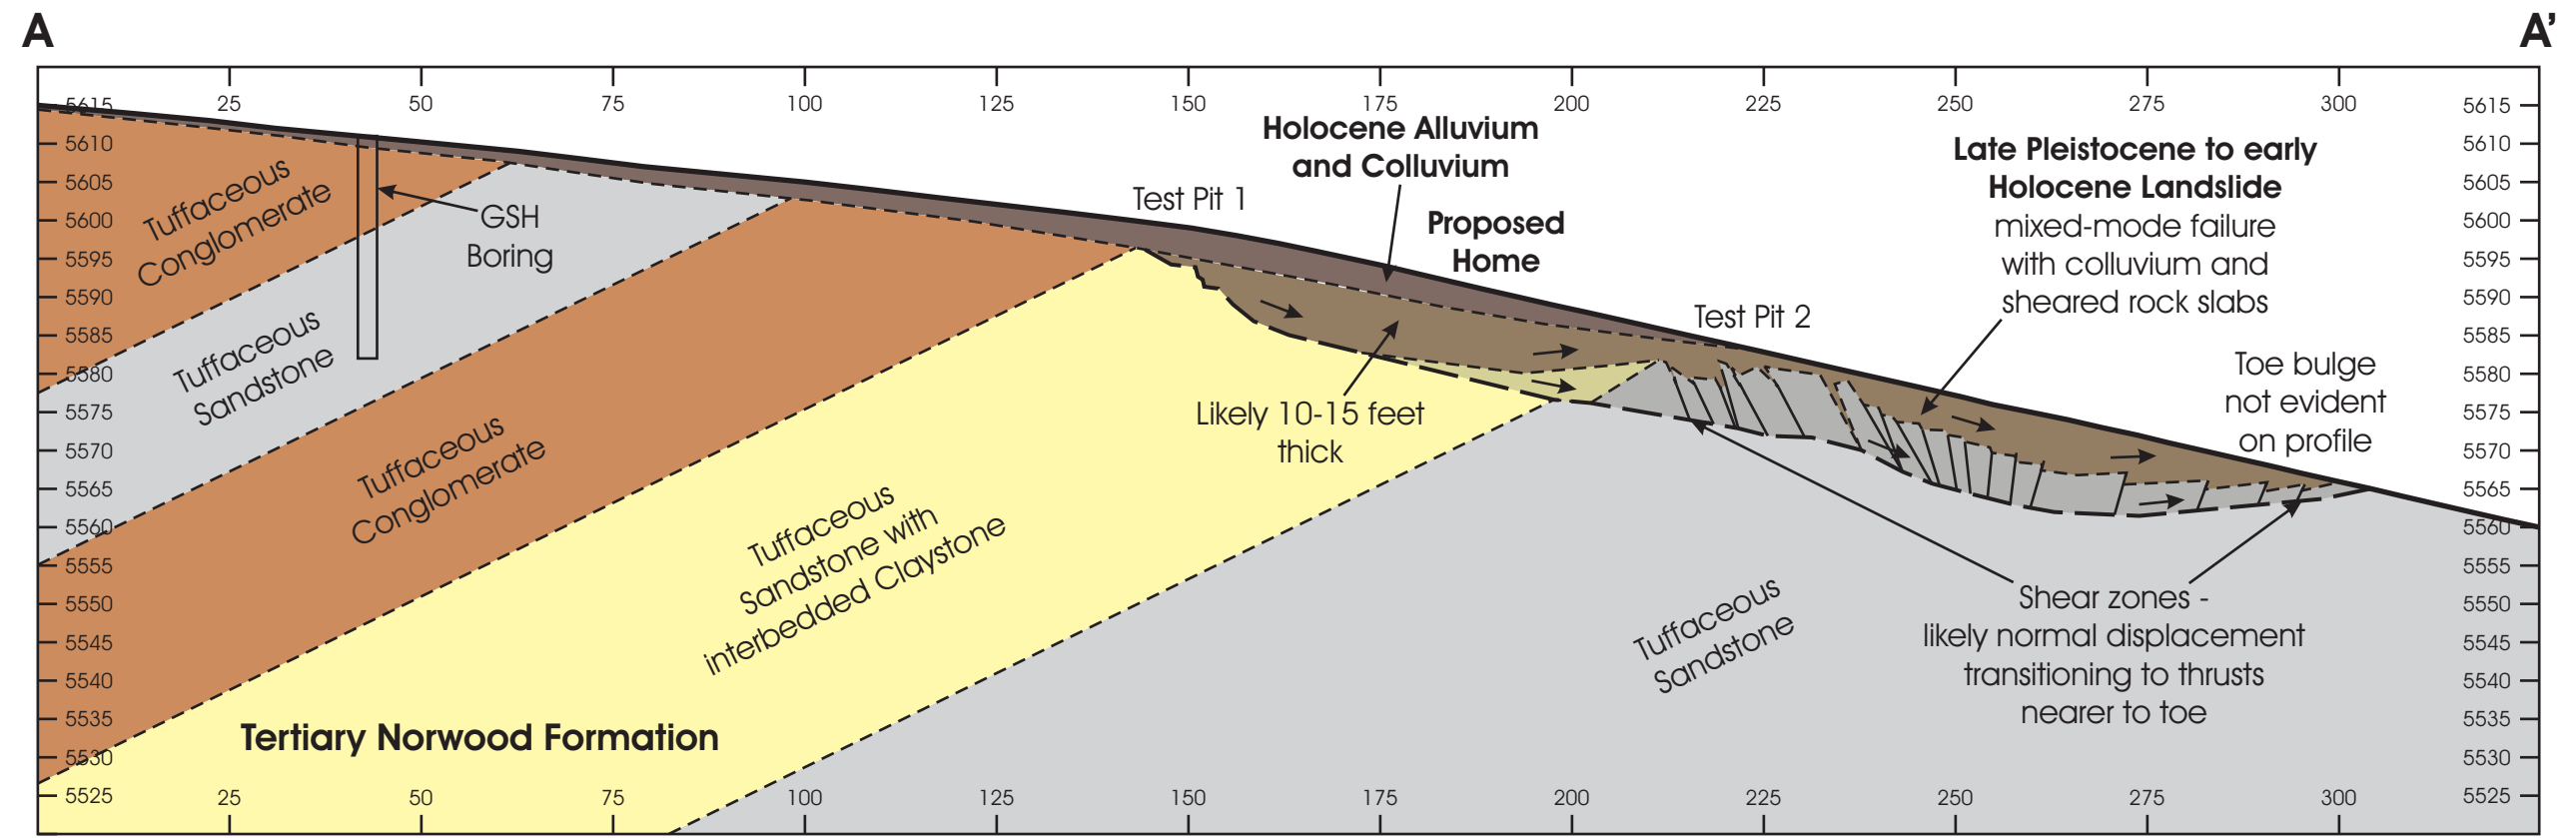
CROSS SECTION

Figure 5 shows a cross section across the slope through the proposed home location at a scale of 1 inch equals 25 feet with no vertical exaggeration. The profile location is shown on Figure 3C (A-A', in blue). Units and contacts are inferred based on the subsurface data discussed above and our review of the log for the GSH boring in the northeastern part of the site (which is not reproduced herein). We use an overall dip of 26 degrees for contacts within the Norwood Formation, similar to the measurements in test pits 1 and 3. The profile trend generally matches the bedrock dip direction. We anticipate that the landslide exposed in the test pits likely originated as a shallow rotational slump in near-surface weathered claystone and sandstone bedrock in the area of test pit 1, and then propagated downslope as a translational block/slab failure through the underlying sandstone (Figure 5). The landslide does not appear to have caused a substantial amount of deformation, suggesting that it may not have moved very far and likely has a shallow failure plane that is only about 10-15 feet deep in the area of the proposed home (Figure 5). Given its failure mechanism, we would anticipate a slight bulge at the toe from thrusting, which is confirmed by the aerial photo and LIDAR image (Figures 3A-B). However, the surveyed topography shows no slope inflection in the toe area, and the slope also shows very little overall variance (Figure 5). This may be just an anomaly of the surveying (such as a lack of frequent and closely spaced data points).

SCALE: 1 inch = 25 feet
 No vertical exaggeration
 Contacts based on subsurface data and are inferred in unexplored areas and at depth

A portion of the site, and particularly the area of the proposed home, is on what appears to be an older (late Pleistocene to early Holocene) landslide that is likely shallow and involved both shallow rotational and translational movement. Deformation from and colluvial deposits of the landslide are exposed in all the test pits at the site, although the low degree of deformation suggests it did not move very far. However, given the above we rate the risk from landsliding as high. We recommend stability of the slopes be evaluated in a geotechnical engineering evaluation prior to building based on site specific data and subsurface information included in this report. Recommendations for reducing the risk from landsliding should be provided if factors of safety are determined to be unsuitable. The stability evaluation should take into account possible perched groundwater and fluctuating seasonal levels. Care should also be taken that site grading does not destabilize slopes in this area without prior geotechnical analysis and grading plans, and that proper drainage is maintained.
