Staff Report for Administrative Approval Hillside Review – Notice of Conditional Approval

Application Request: Consideration and action on a request to approve a Hillside Review for Lots 9R, 10R, 11R, 12R, 14R and 15R in the Summit Eden Ridge Nests PRUD, Amendment 1 located in Cache County, Utah

**GEOTECHNICAL AND GEOLOGIC HAZARD INVESTIGATION
The Ridge Nests Development
Powder Mountain Resort
Weber and Cache Counties, Utah**

IGES Project No. 01628-008

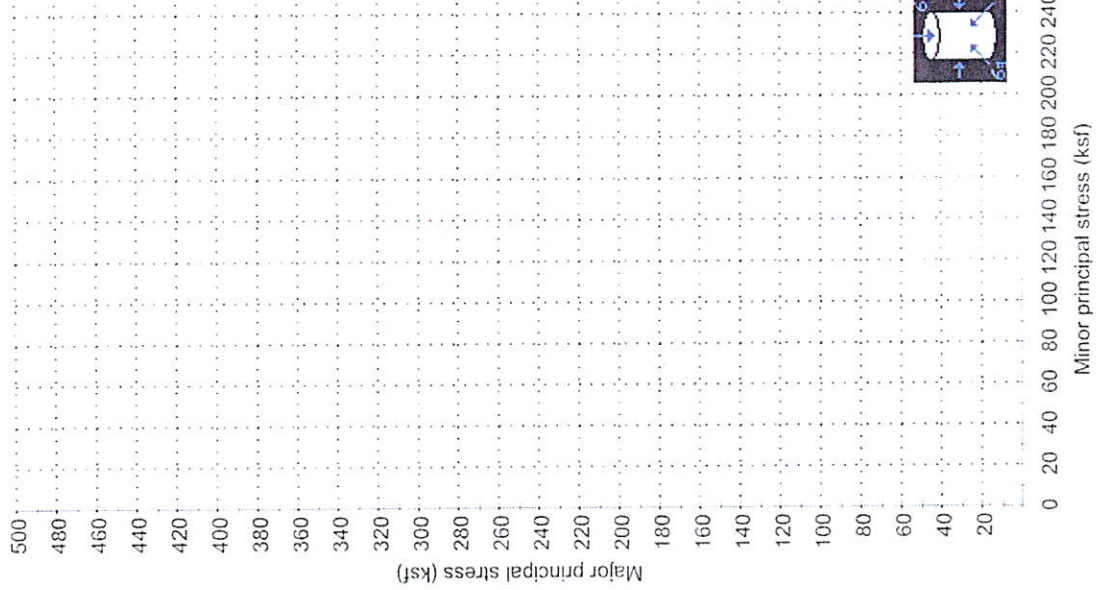
Rock Mass Parameters

tensile strength = -0.590 ksf
 uniaxial compressive strength = 9,491 ksf
 global strength = 53,814 ksf
 deformation modulus = 12165.97 ksf

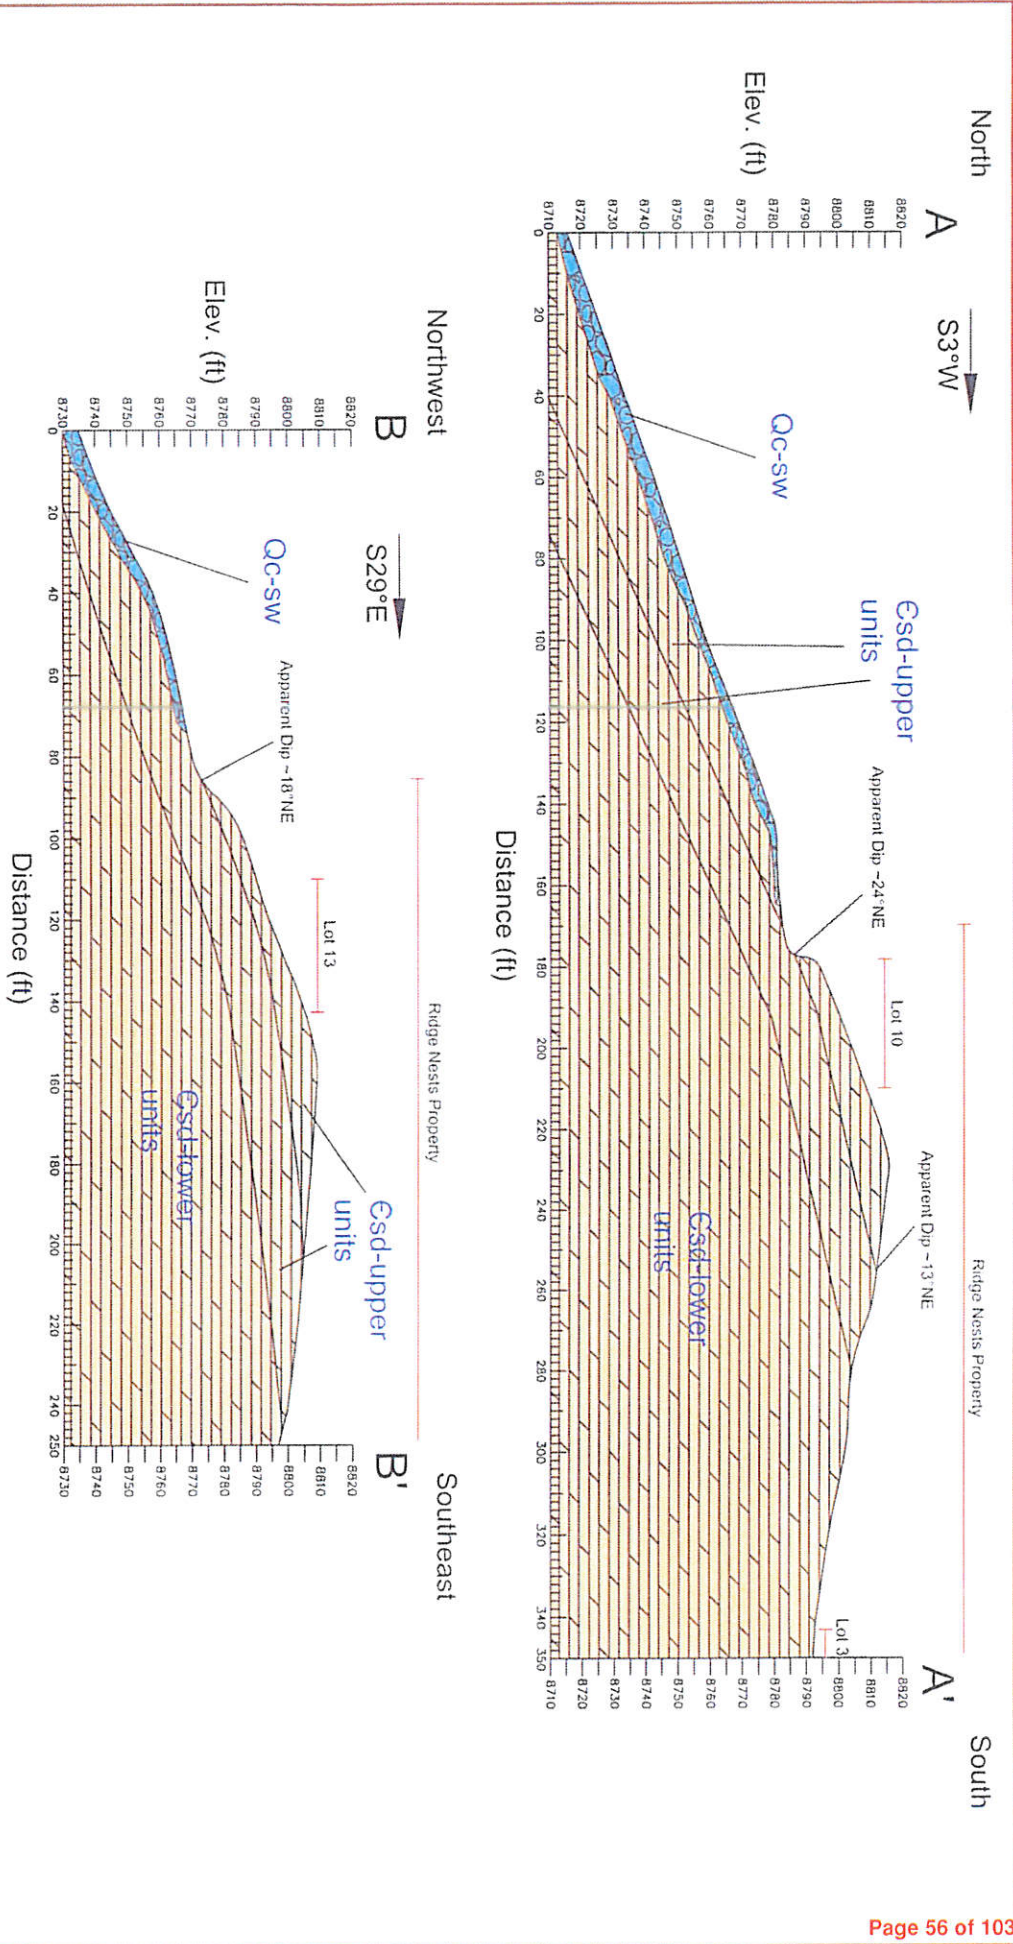
FIGURE 1

CROSS-SECTIONS

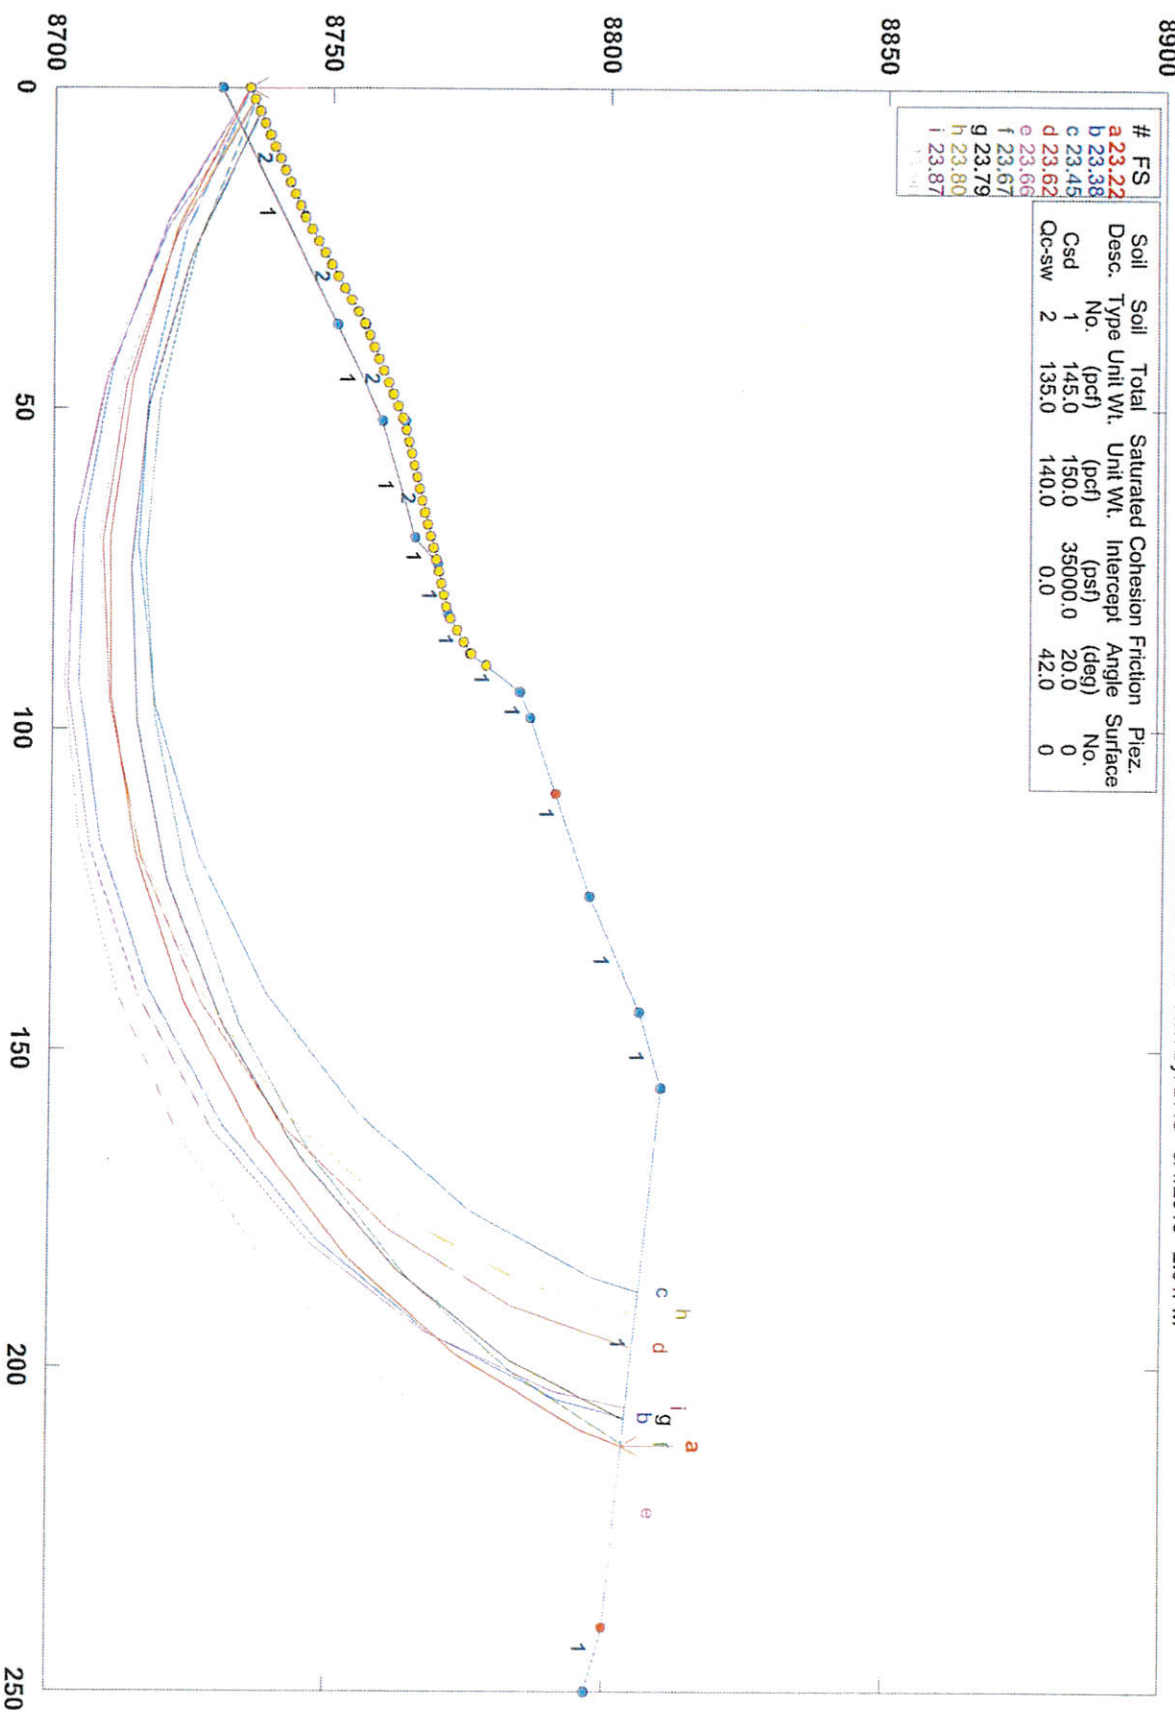
Summit/Ridge Nests; B-B'; Static

GSTABL7 v.2 F_{Smin}=23.22
 Safety Factors Are Calculated By The Modified Bishop Method

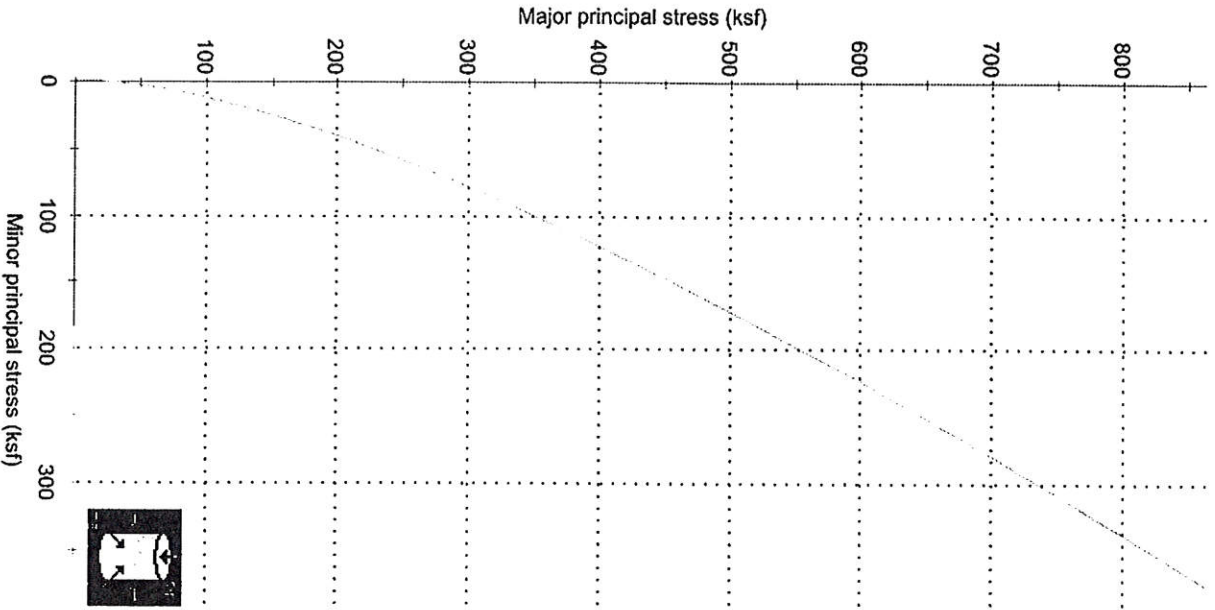
Analysis of Rock Strength using RocLab

Hoek-Brown Classification
 intact uniaxial comp. strength (sigci) = 1500 ksf
 GSI = 45 mi = 9 Disturbance factor (D) = 0.7
 intact modulus (EI) = 637500 ksf
 modulus ratio (MR) = 425

Hoek-Brown Criterion
 mb = 0.438 s = 0.0003 a = 0.508

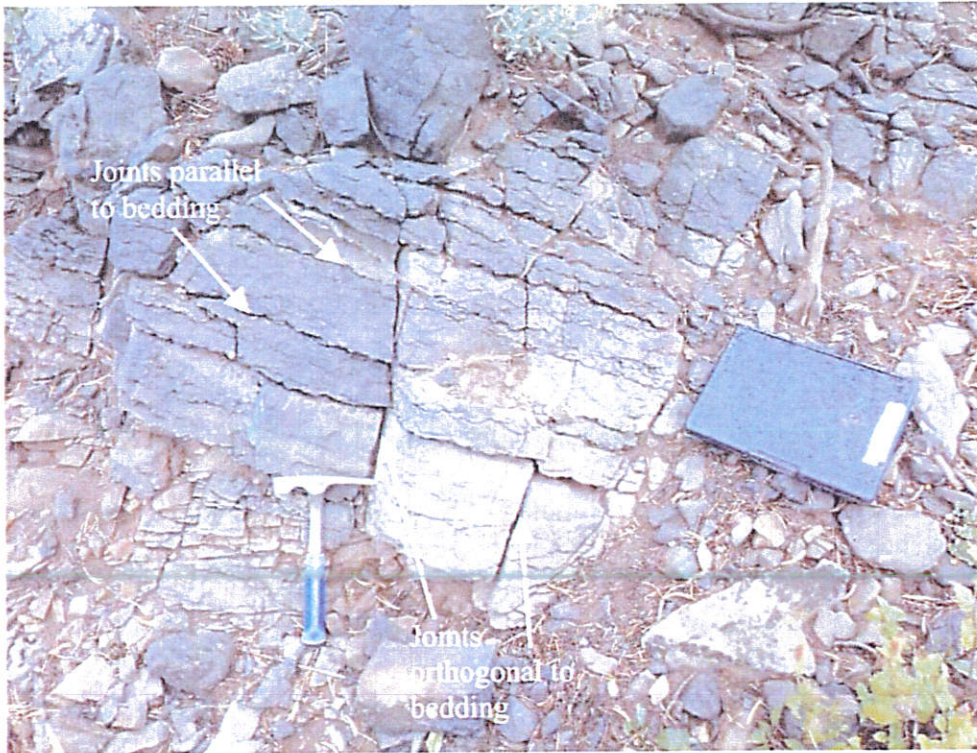
Photo 1. Finer-grained dolomite lithology, exhibiting thinner beds and blocky jointing.

Bedrock: Based on our review of geologic literature and field observations, the majority of the site is underlain by bedrock consisting of undifferentiated Cambrian-age dolomite (Cr). This rock unit is fairly hard – samples could only be obtained with a firm blow from a rock hammer. Where exposed, the bedrock was moderately weathered, closely fractured, and dark gray, and reacted weakly to dilute HCl. At the time of our field work Geneva was excavating a utility line just off-site to the northeast – the trench exposed dolomite from the surface to the bottom of the trench (about nine feet). Geneva personnel indicated that excavation of the dolomite was very difficult, requiring a ram-hoe (a large jack-hammer on the end of an excavator arm). In addition to the dolomite, in Test Pit 1 at a depth of about 3½ feet we encountered very hard stratum that is believed to be representative of the Tertiary-age Wasatch Formation (Tw), which generally consists of well-cemented conglomerate.

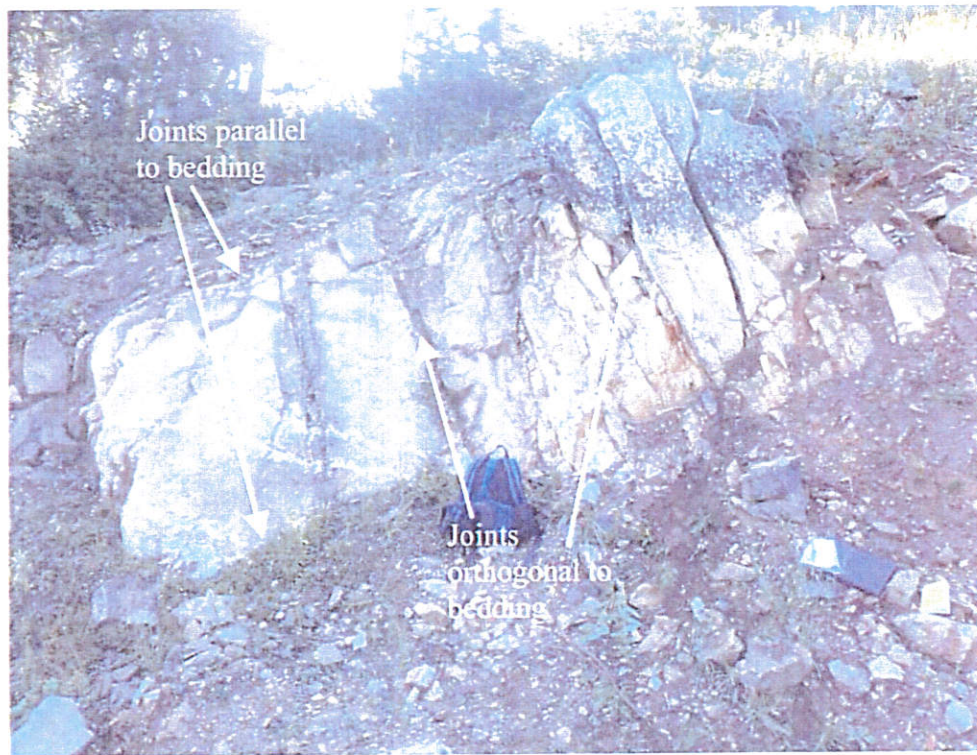
Photo 2. Coarser-grained dolomite lithology, exhibiting thicker beds and wider jointing.
