# Staff Report for Administrative Approval – Hillside Review – Notice of Approval

**Application Request:** Consideration and action on a request to approve a Hillside Review for Lots 22 and 23 in The Legends at Hawkins Creek, a Cluster Subdivision.

**REPORT  
GEOTECHNICAL STUDY  
LOTS 22 AND 23  
THE LEGENDS AT HAWKINS CREEK  
6564 AND 6585 EAST CHAPARRAL ROAD  
NEAR EDEN, WEBER COUNTY, UTAH**

**REPORT  
GEOLOGICAL HAZARDS STUDY  
LOTS 22 AND 23  
THE LEGENDS AT HAWKINS CREEK  
6564 AND 6585 EAST CHAPARRAL ROAD  
NEAR EDEN, WEBER COUNTY, UTAH**

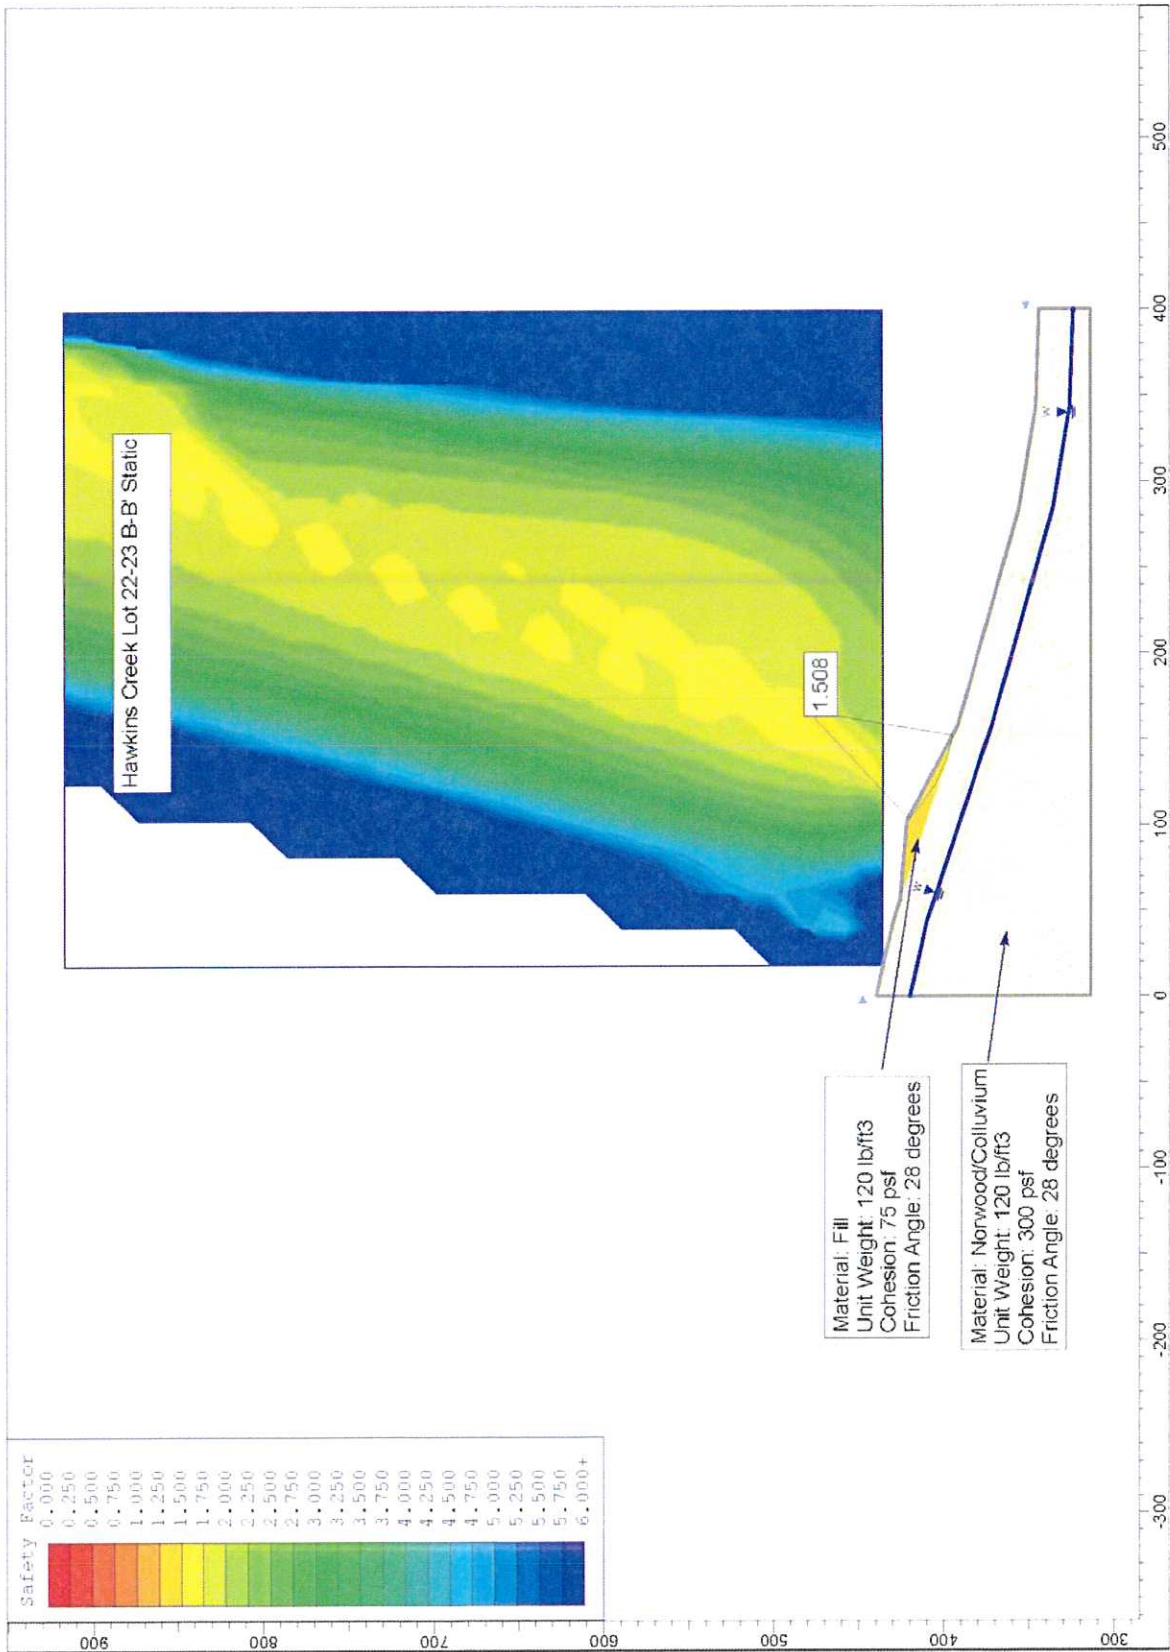
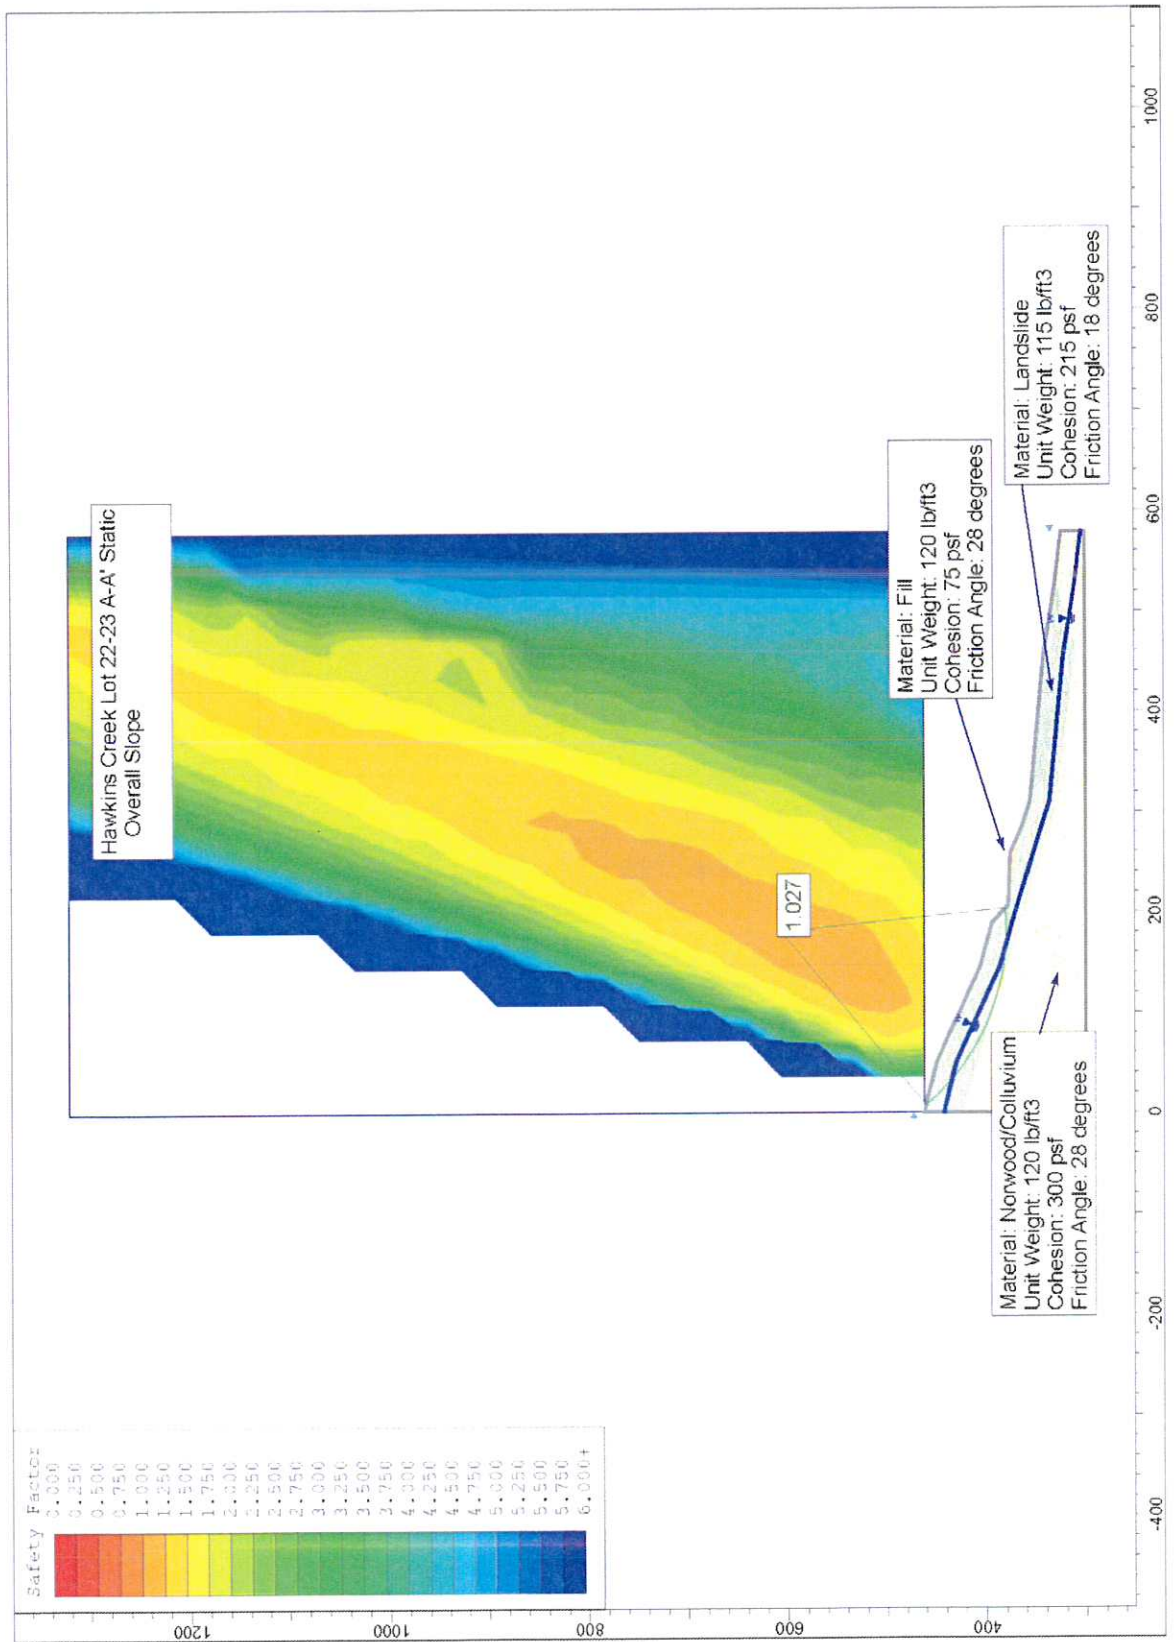
# STABILITY RESULTS

We evaluated the global stability of the existing slope using the computer program *SLIDE*. This program uses a limit equilibrium (Simplified Bishop) method for calculating factors of safety against sliding on an assumed failure surface and evaluates numerous potential failure surfaces, with the most critical failure surface identified as the one yielding the lowest factor of safety of those evaluated. We analyzed the following configurations based on cross-sections provided in the referenced geologic study (see geological study in appendix for cross-section information and location):

Typically, the required minimum factors of safety are 1.5 for static conditions and 1.0 for seismic (pseudostatic) conditions. The results of our analyses indicate that the existing onsite slope configurations analyzed will meet both these requirements provided our recommendations are followed (see Figures 7 through 10); however, the steeper offsite slopes within the mass movement deposits do not meet the required factor of safety, thus structures should not be constructed within the mass movement deposits ( see Figure 11).

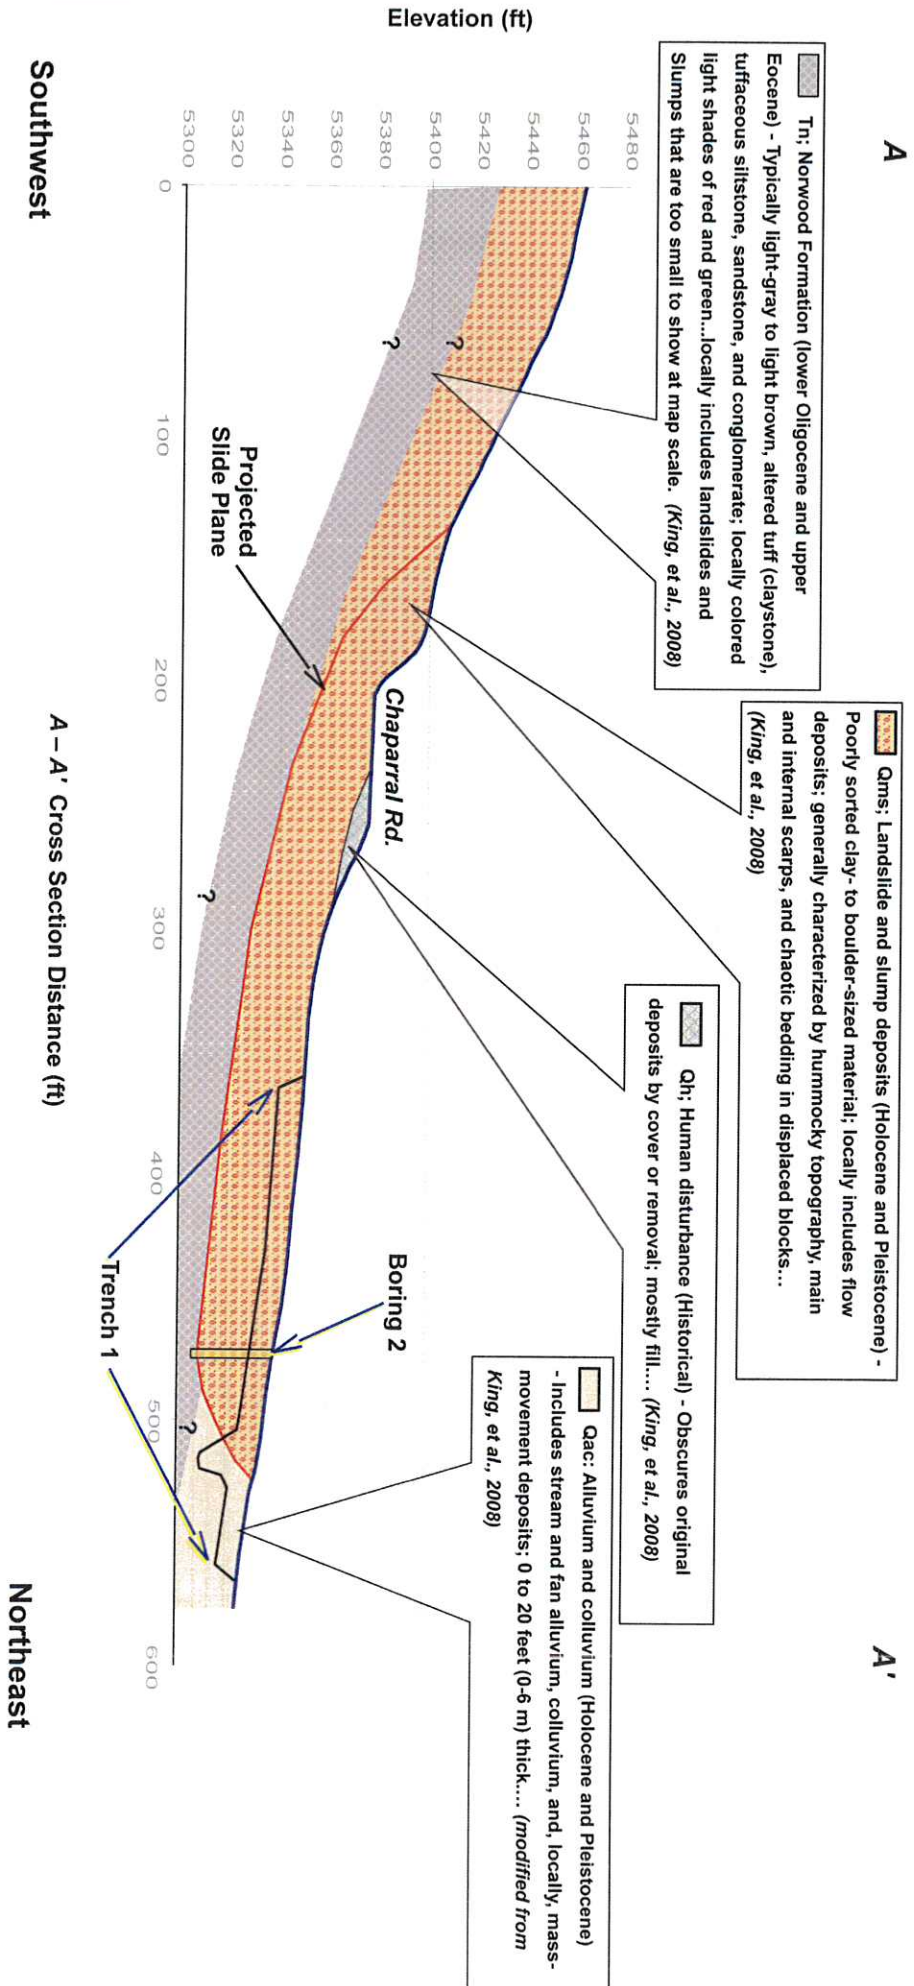
FIGURE 16  
 SLOPE CROSS  
 SECTION A-A'

\* From Section Shown on Figure 4 and 15
