**GEOTECHNICAL & GEOLOGIC
HAZARD INVESTIGATION
Horizon Neighbourhood Development
Summit Powder Mountain Resort
Weber County, Utah**

IGES Project No. 01628-013

August 3, 2016

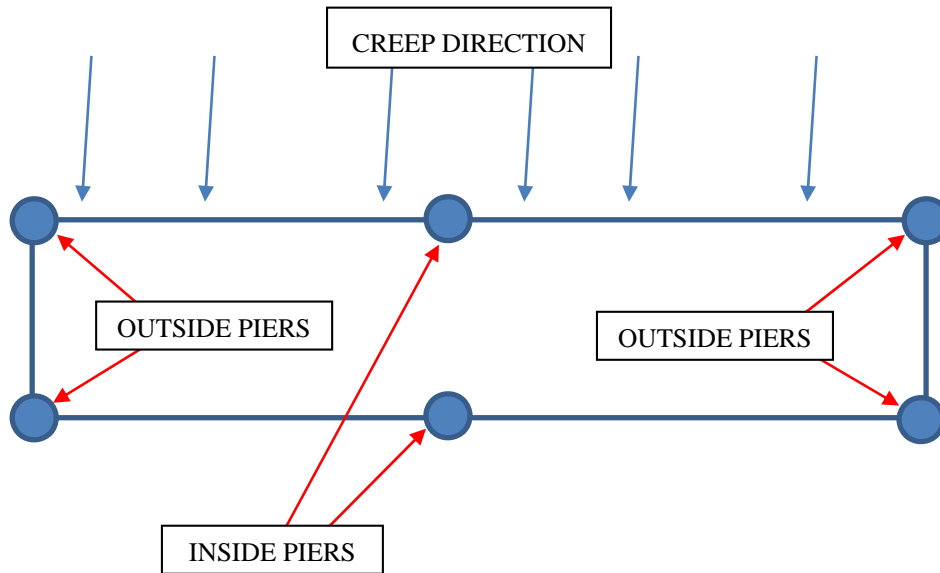
Table 6.3.2-1 is for outside piers, and Table 6.3.2-2 is for inside piers:

Sample design calculations are presented in Appendix E. Pier reinforcement should be designed by the structural engineer.

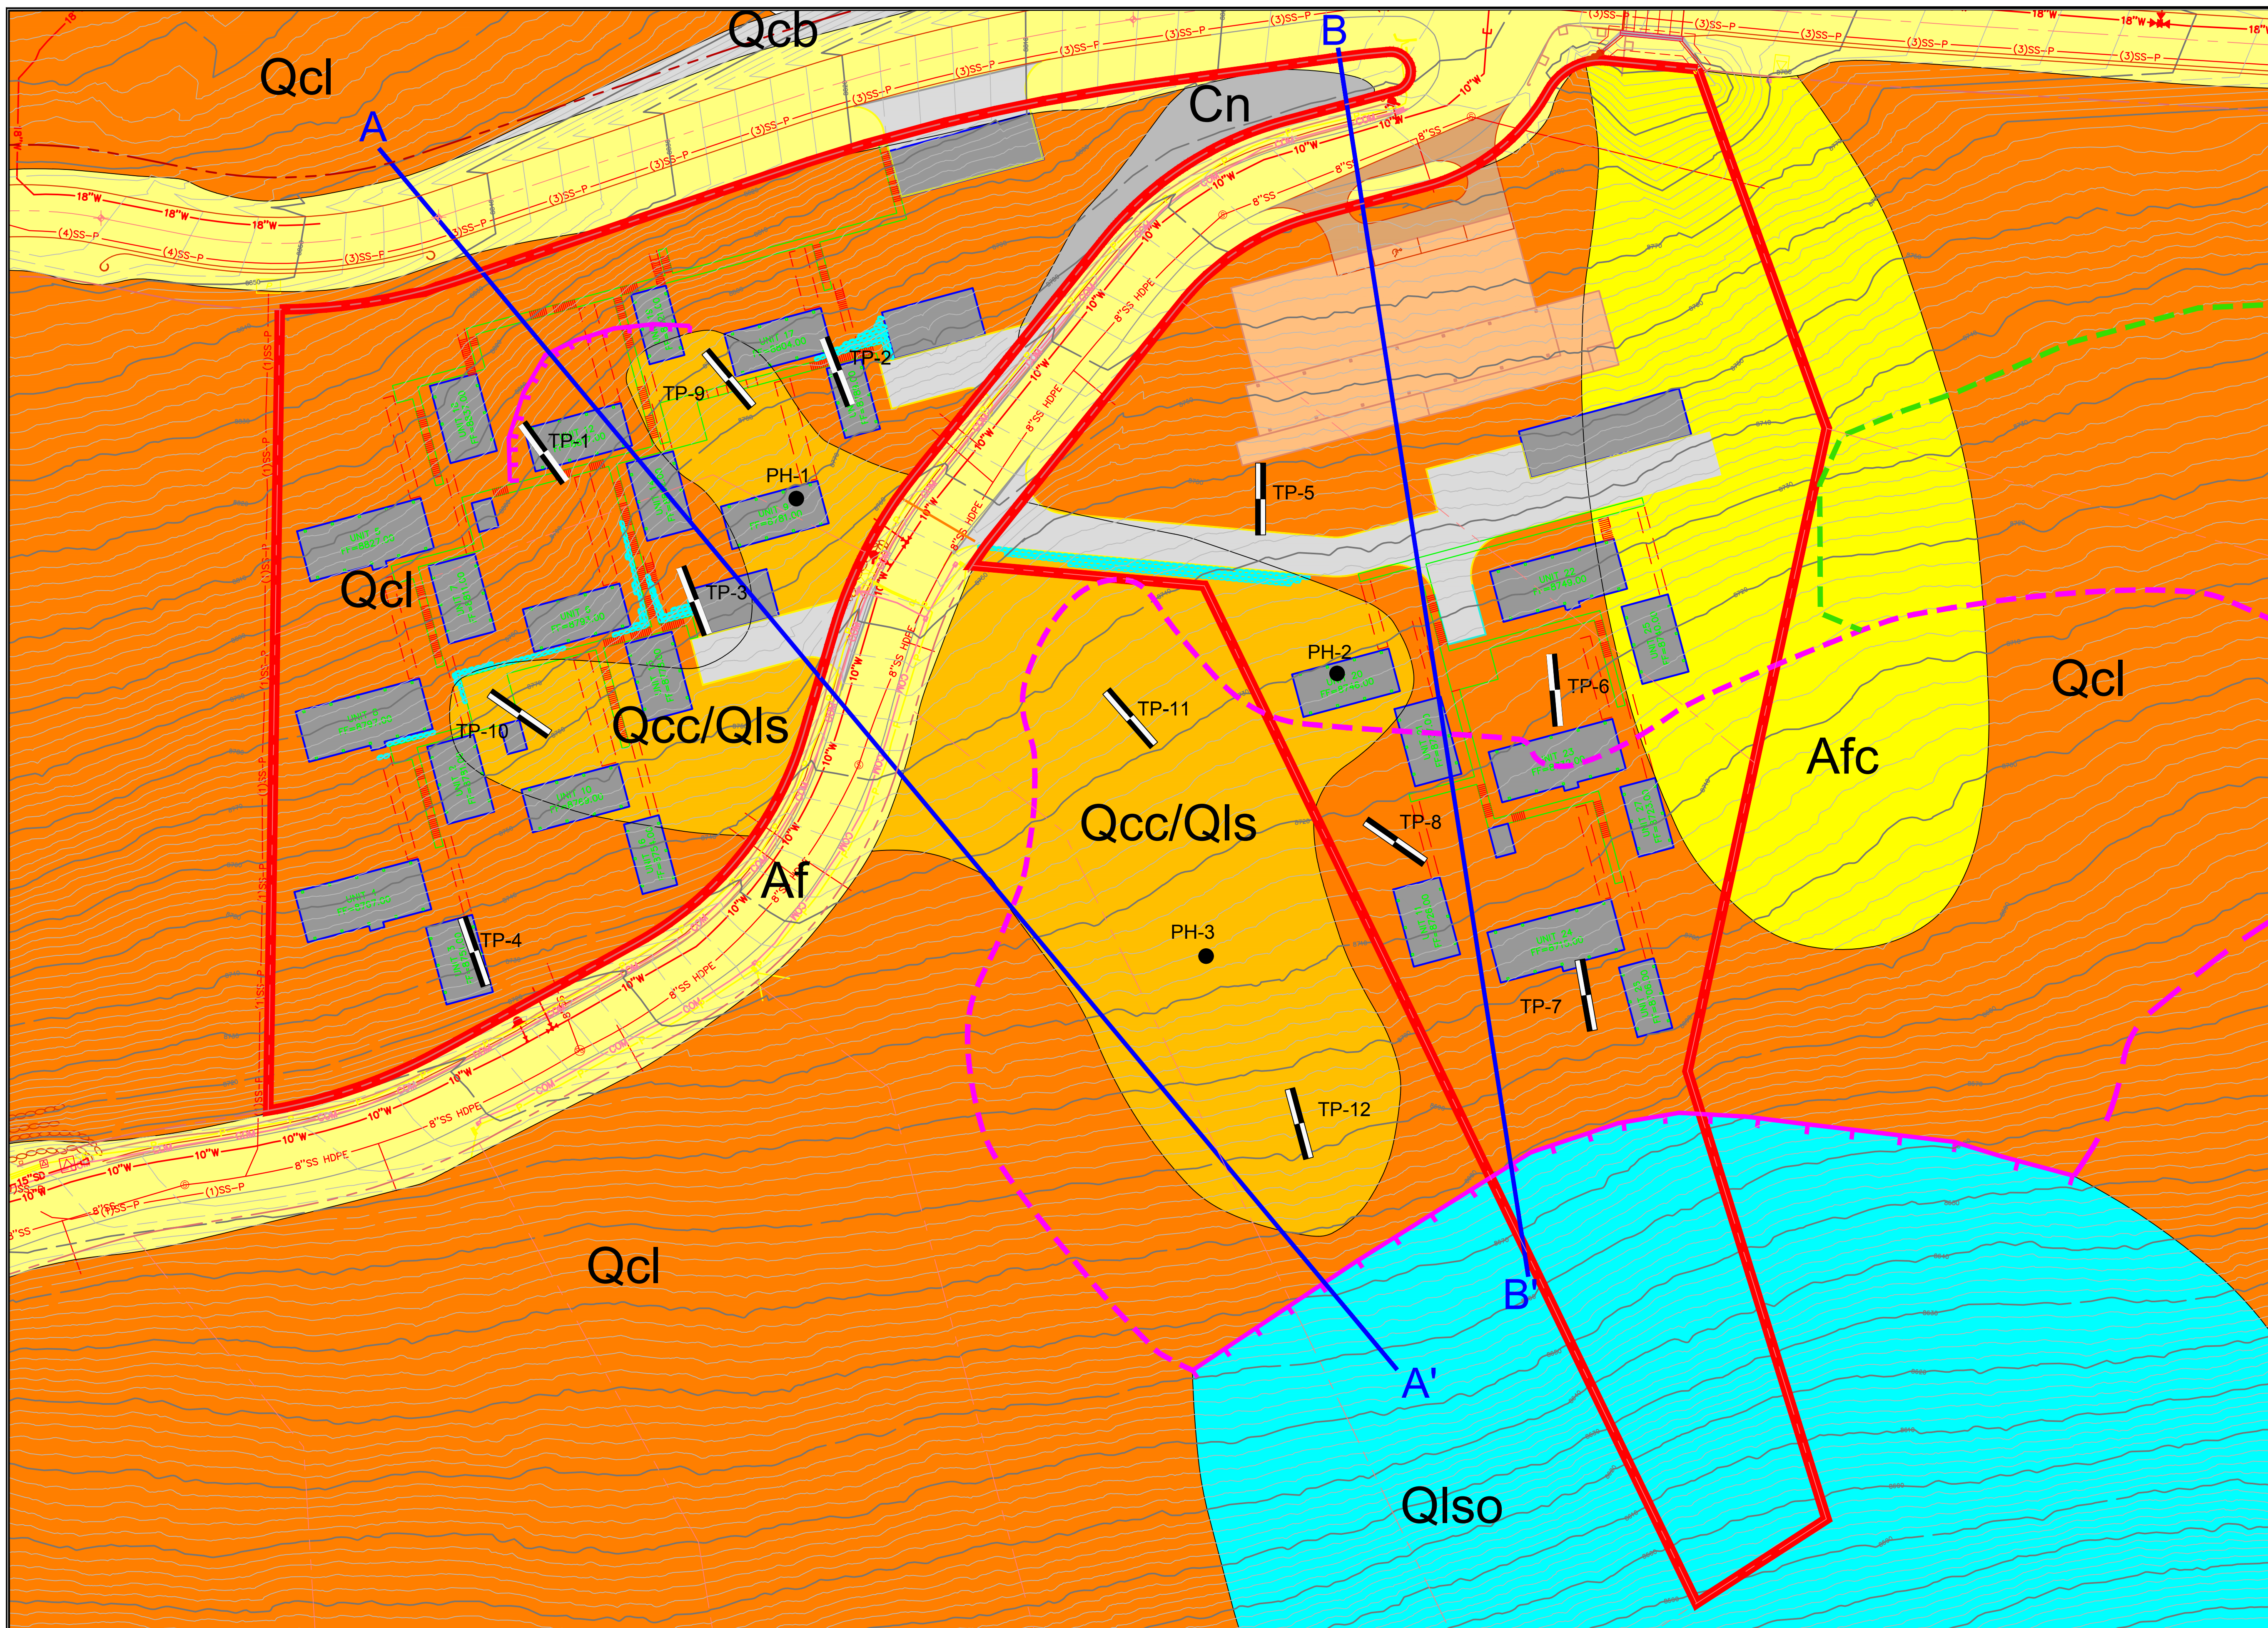
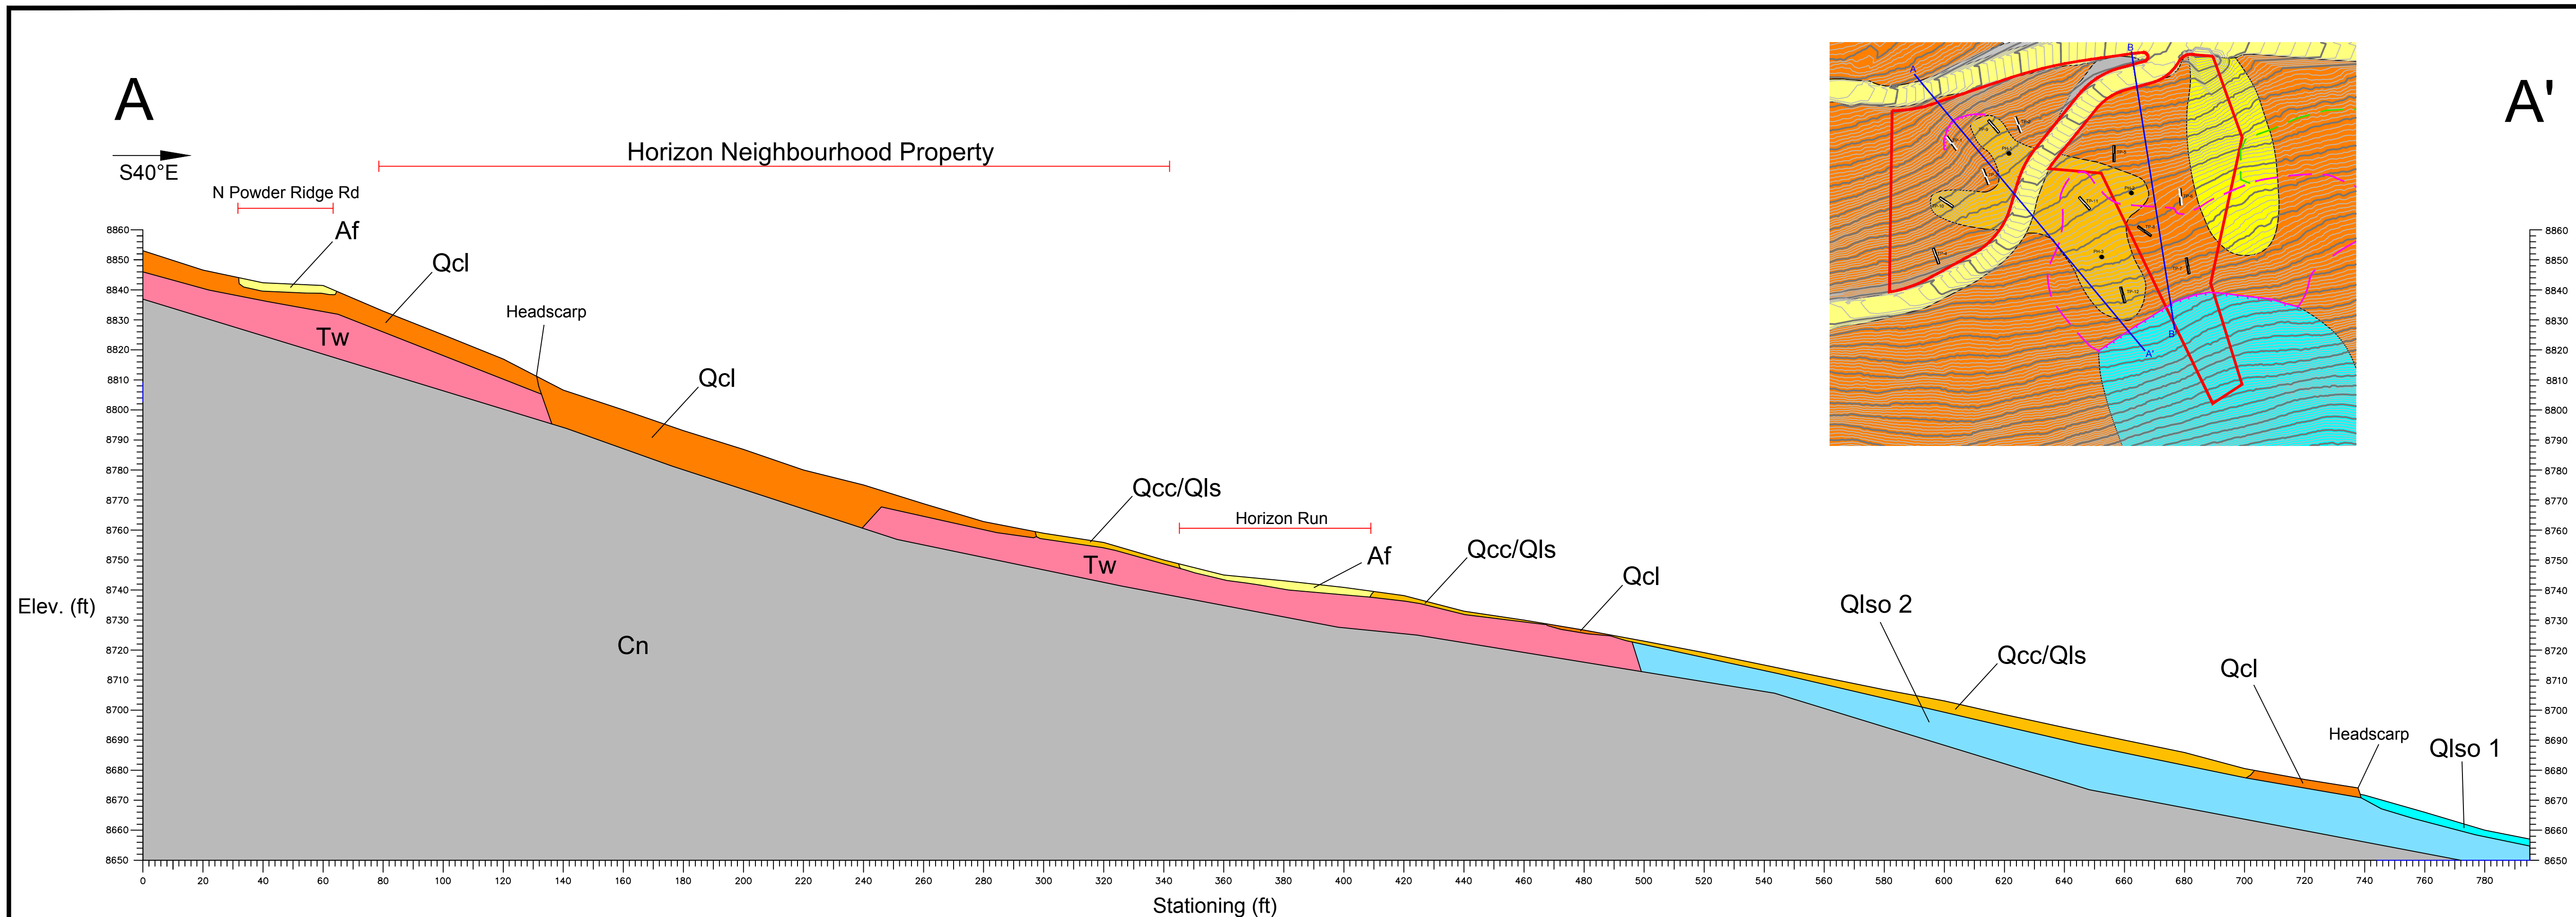
The *Geotechnical Map*, Plate A-1 in Appendix A, shows the approximate location of the exploration test pits and potholes and the surficial geologic materials as mapped from the site reconnaissance. The exploration test pits and potholes were specifically located to assess the presence or absence of adverse geologic features, assess the depth to bedrock, and to observe subsurface conditions. Subsurface conditions as encountered in the exploration test pits and potholes were logged at the time of our investigation by a licensed geologist. The test pit logs are presented in Figures A-2 through A-13 of Appendix A. A *Key to Soil Symbols and Terminology* is presented as Figure A-14 and a *Key to Physical Rock Properties* is presented as Figure A-15.

Artificial Fill: Artificial fill (denoted as either Af or Afc on Plate A-1) was observed throughout the site. Af represents asphalt and road embankment fill material found in association with and restricted to the existing roads that bound the property, including North Powder Ridge Road and

Colluvium: Two classes of colluvial units were observed to underlie the topsoil and be the source material for the topsoil (Qcl and Qcc/Qls on Plate A-1). The most prevalent form was a dark brown loosely consolidated unit (map symbol Qcl) that was gradational between lean clay with gravel (CL) and clayey gravel (GC). This form was often silty, poorly sorted, and contained subrounded to subangular quartzite rock fragments that comprised between 15 and 50% of the unit. Boulders were found to be as much as 2 feet in diameter. The second, less common form of colluvium was a light brown, well-cemented, silty clay with gravel (CL-ML) gradational to a silty, clayey gravel (GC, GM) (map symbol Qcc/Qls). This form contained abundant pinhole voids throughout, was poorly sorted, and contained subrounded to subangular quartzite rock fragments that comprised between 25 and 50% of the unit. Boulders were found to be as much as 1.5 feet in diameter, and were on average smaller than the loose colluvium unit. It is possible that this cemented unit is derived, at least in part, from the Qcl unit that was remobilized in a small landslide associated with the small headscarp found between TP-1 and TP-2.

Bedrock Colluvium: This material (denoted as Qcb on Plate A-1) consists of colluvium whose parent material largely consists of dolomite; this material was found to be present along the northeastern part of the Horizon Run roadcut and along the northern road cut of North Powder Ridge Road. It consisted of clasts of dolomite bedrock generally less than 6 inches in diameter that was not associated with any in-place bedrock outcrop.

Pleistocene Landslide: This material (denoted as Qlso on Plate A-1) was found as a lobe extending to the south (downslope) from a noted landslide headscarp in the southernmost part of the property. It was characterized by generally irregular, slightly hummocky topography and was largely devoid of trees within its trace. This unit is part of the previously-mapped landslide deposit that crosses the Horizon Neighbourhood property (Sorensen and Crittenden, Jr. (1979) and Western Geologic (2012); see Section 5.1.2).

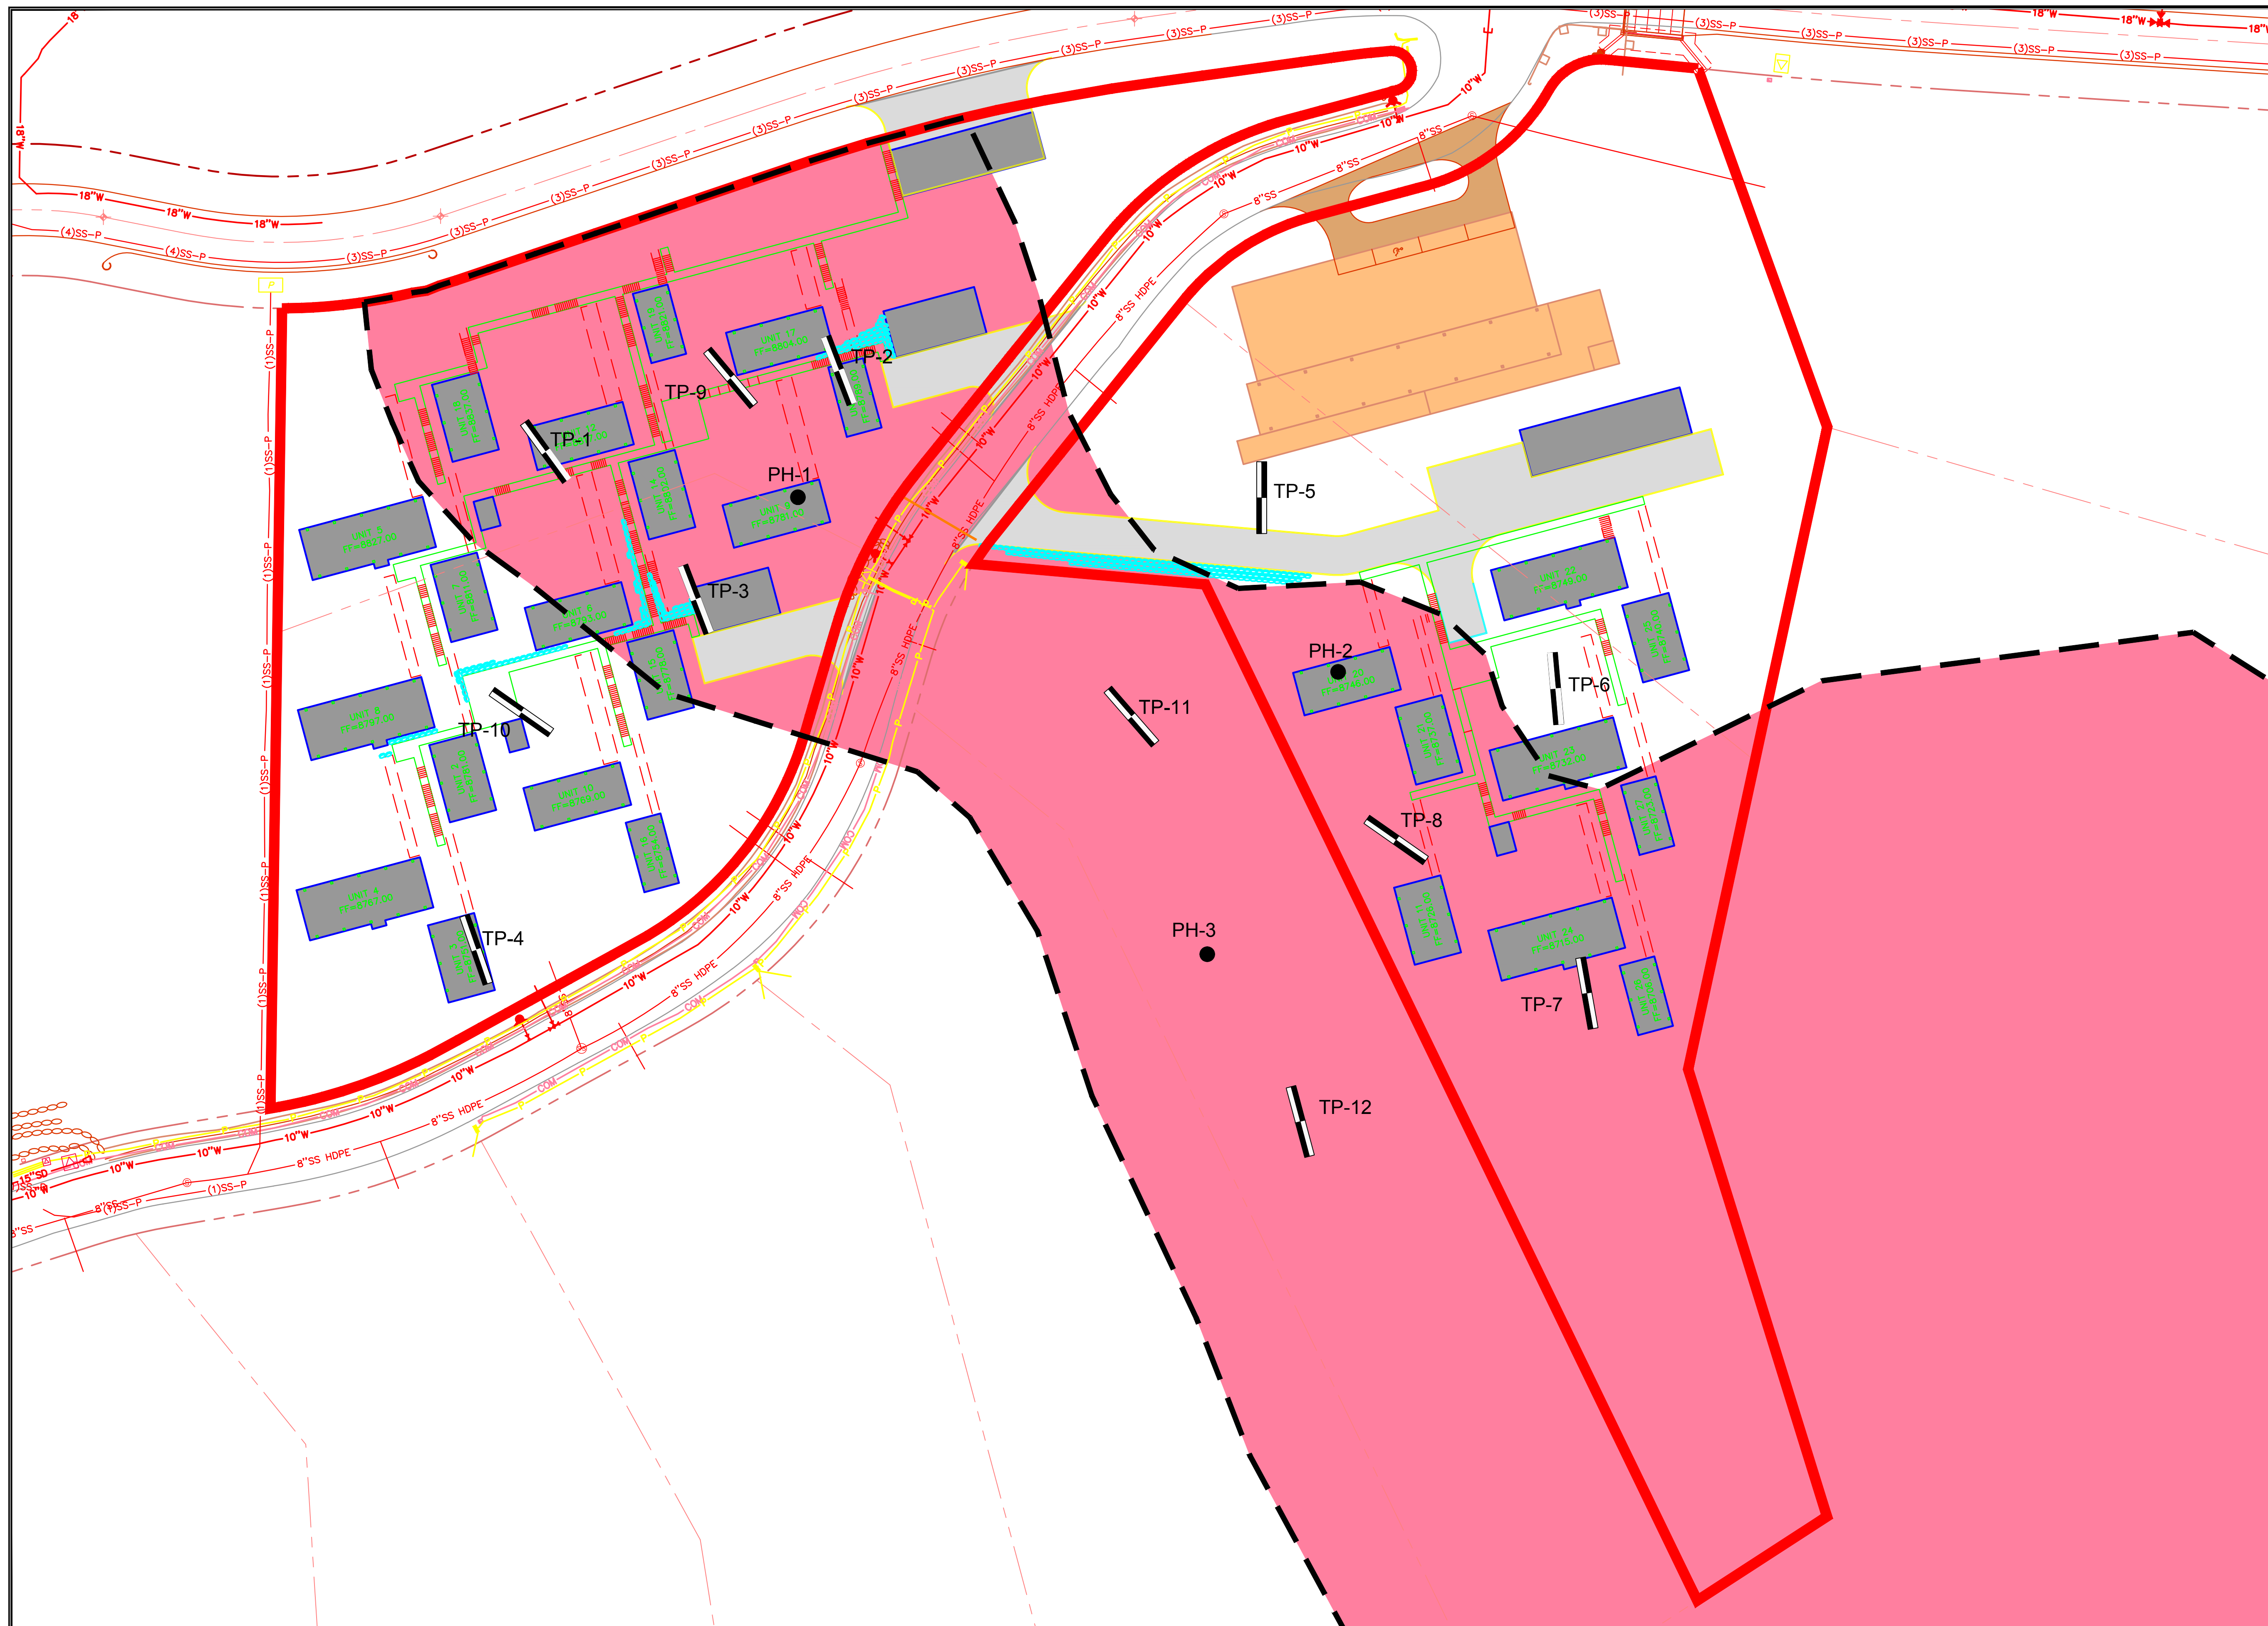
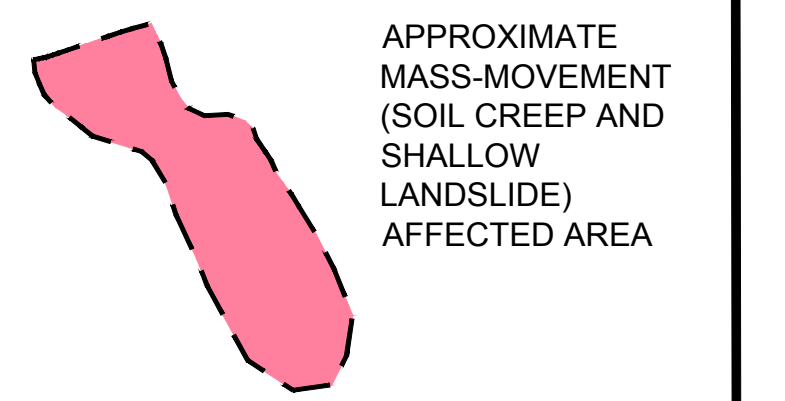
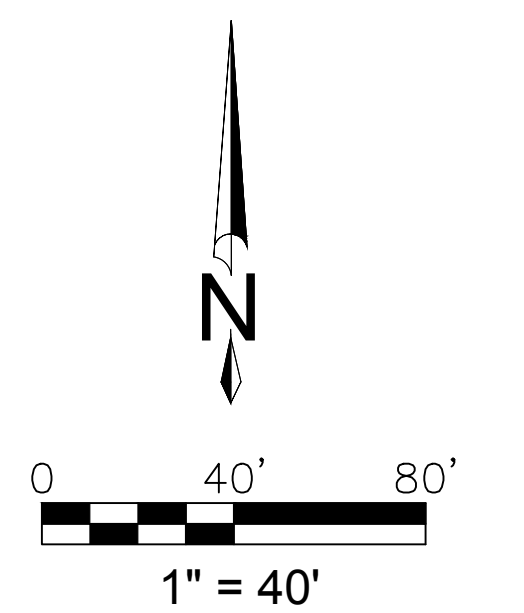
**PLATE A-3
FOOTINGS DELINEATION MAP**

APPROXIMATE MASS-MOVEMENT (SOIL CREEP AND SHALLOW LANDSLIDE) AFFECTED AREA

*STRUCTURES WITHIN OR STRADDLING SHADED AREA MUST BE SUPPORTED ON DRILLED PIER FOUNDATIONS ANCHORED 10 FEET INTO DOLOMITE BEDROCK.

STRUCTURES OUTSIDE OF THE BOUNDARY ARE EXPECTED TO BE SUPPORTED ON DRILLED PIER FOUNDATIONS ANCHORED 10 FEET INTO WASATCH FORMATION BEDROCK OR DOLOMITE BEDROCK, IF PRESENT LESS THAN 20 FEET BELOW EXISTING GRADE.

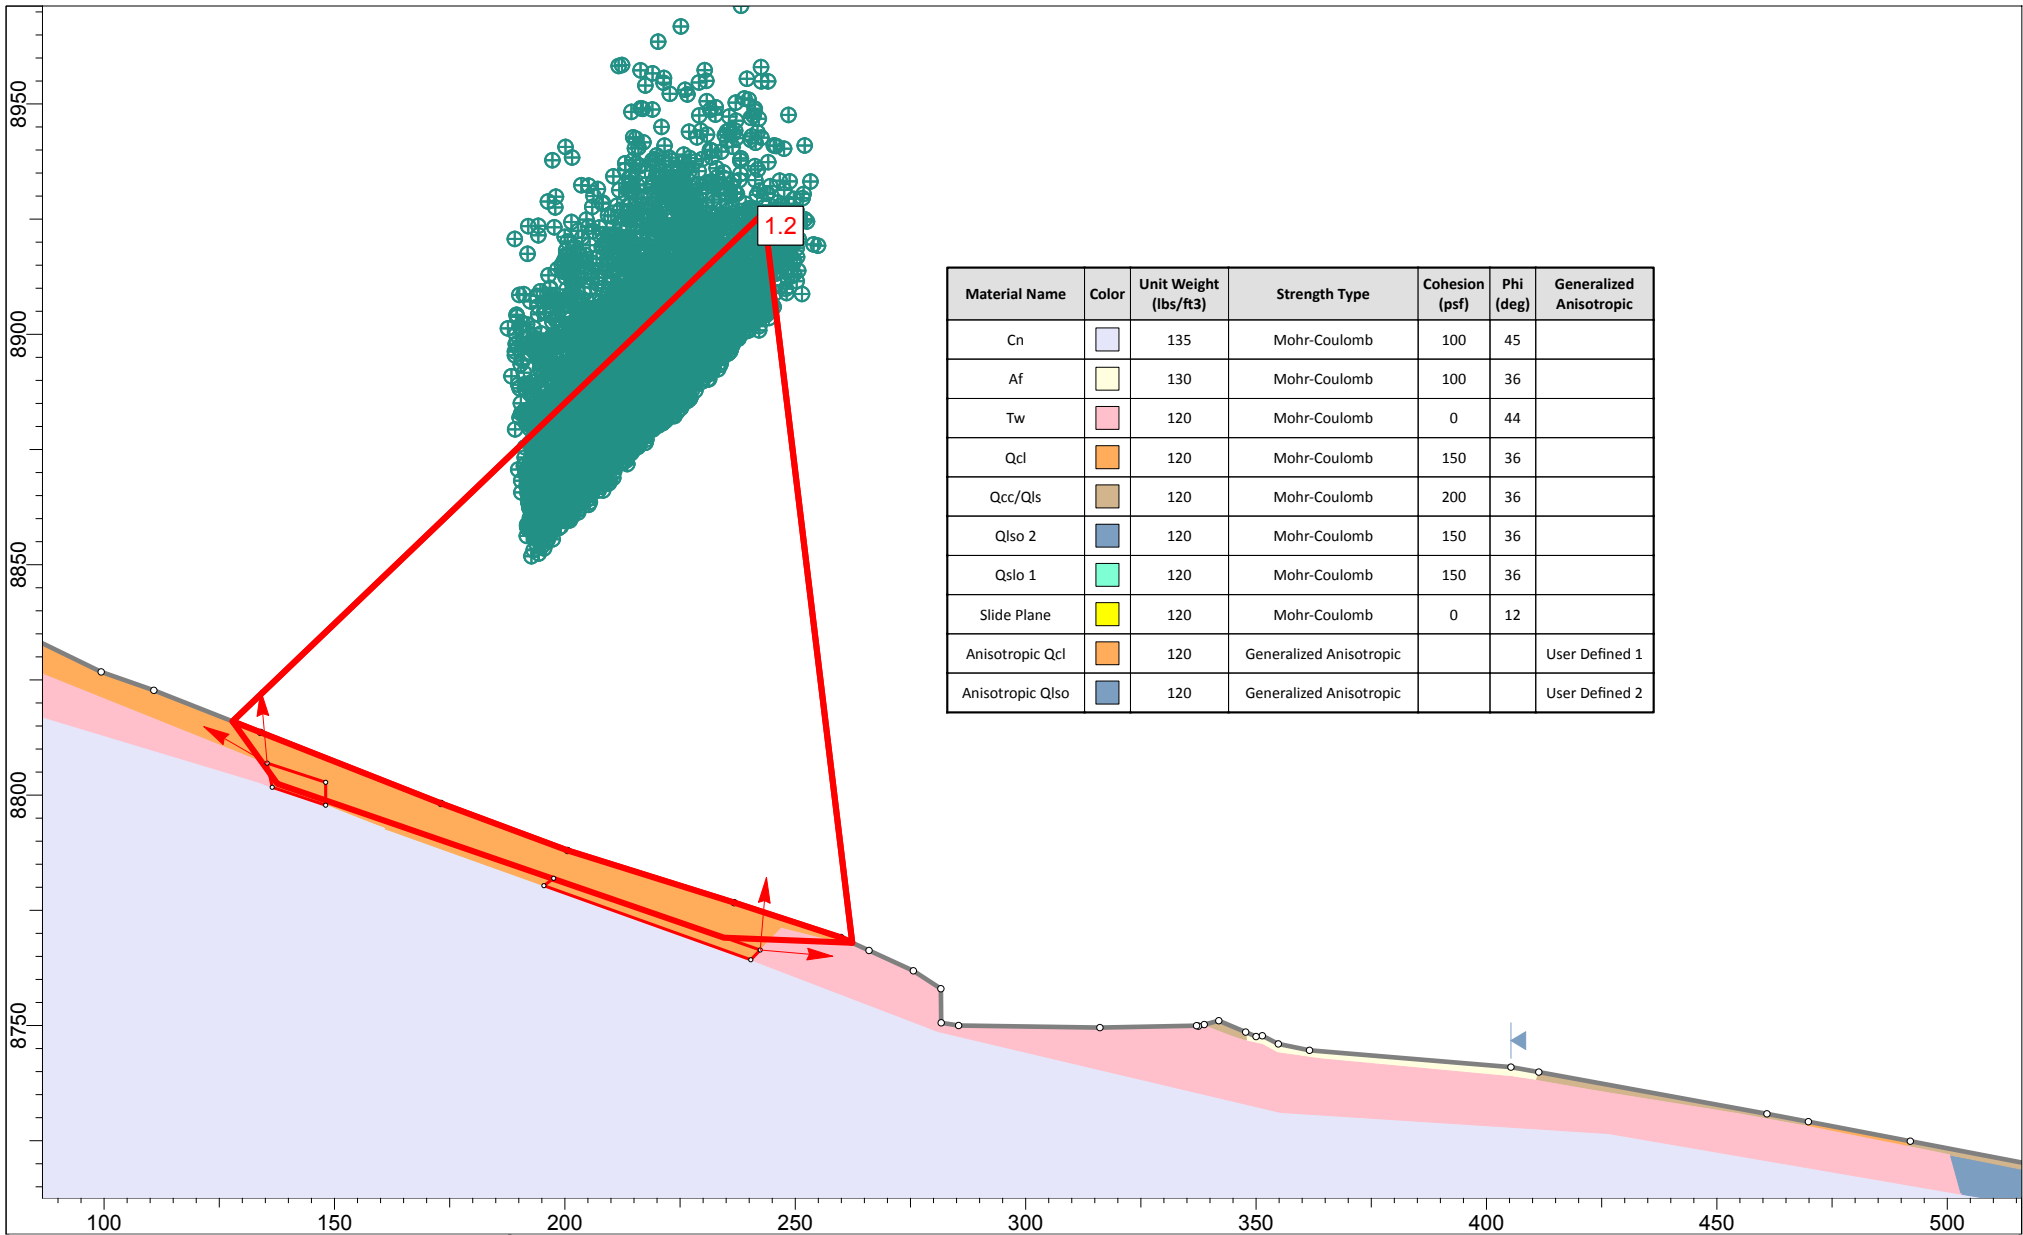
Material Name	Color	Unit Weight (lbs/ft ³)	Strength Type	Cohesion (psf)	Phi (deg)	Generalized Anisotropic
Cn		135	Mohr-Coulomb	100	45	
Af		130	Mohr-Coulomb	100	36	
Tw		120	Mohr-Coulomb	0	44	
Qcl		120	Mohr-Coulomb	150	36	
Qcc/Qls		120	Mohr-Coulomb	200	36	
Qlso 2		120	Mohr-Coulomb	150	36	
Qslo 1		120	Mohr-Coulomb	150	36	
Slide Plane		120	Mohr-Coulomb	0	12	
Anisotropic Qcl		120	Generalized Anisotropic			User Defined 1
Anisotropic Qlso		120	Generalized Anisotropic			User Defined 2

Project		Geotechnical and Geological Hazard Investigation - Summit Horizon Neighborhood, Utah	
Analysis Description		Section A-A' - Static Analysis	
Drawn By	TOH	Company	IGES
Date	7-27-2016	File Name	A-A' Static.slim

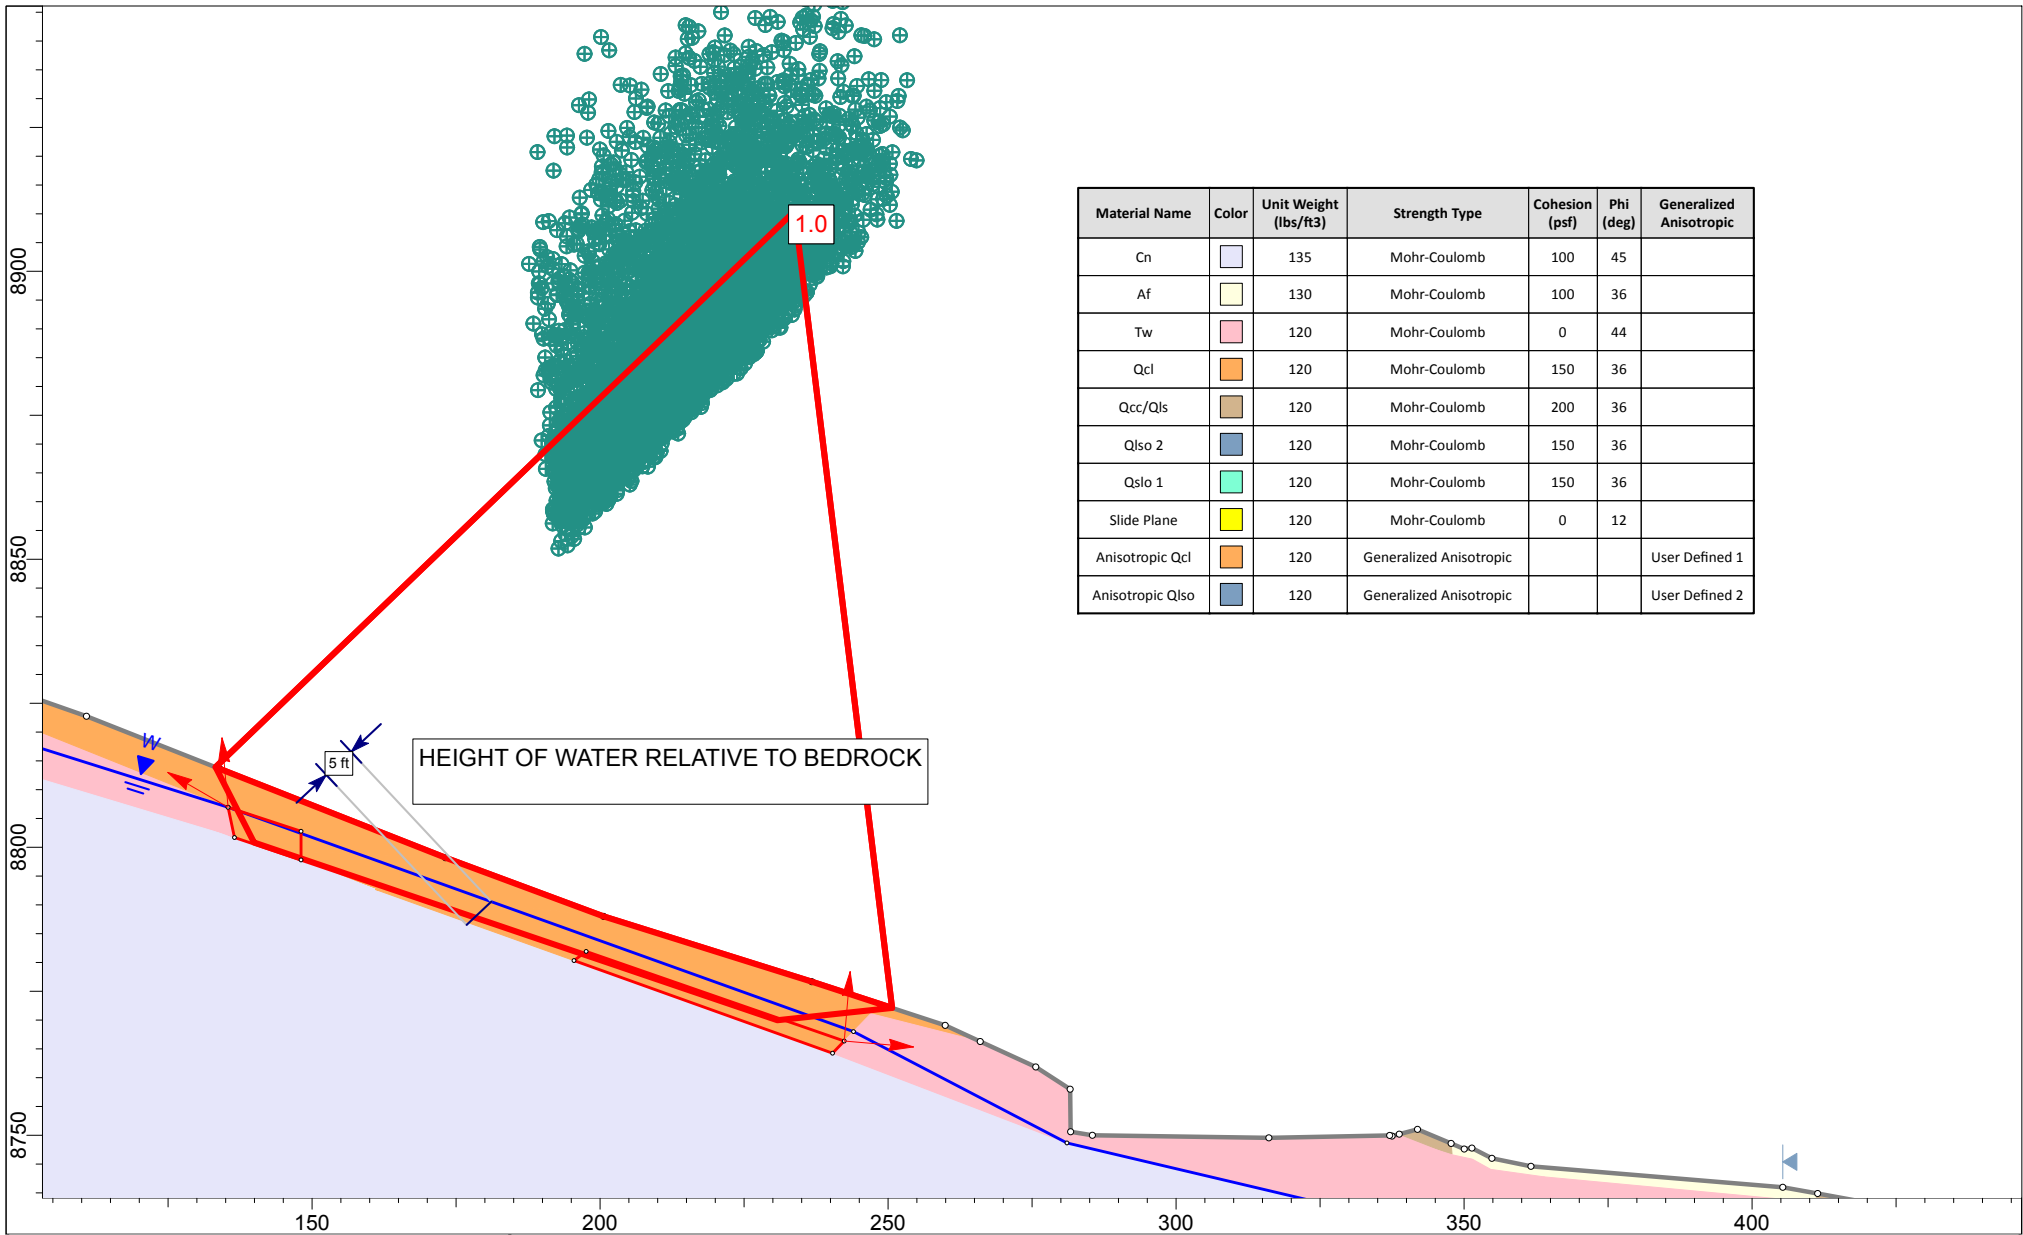
Project Geotechnical and Geological Hazard Investigation - Summit Horizon Neighborhood, Utah	
	Analysis Description Section A-A' - Water Table Fluctuations	
	Drawn By TOH	Company IGES
	Date 7-27-2016	File Name A-A' Static.slim

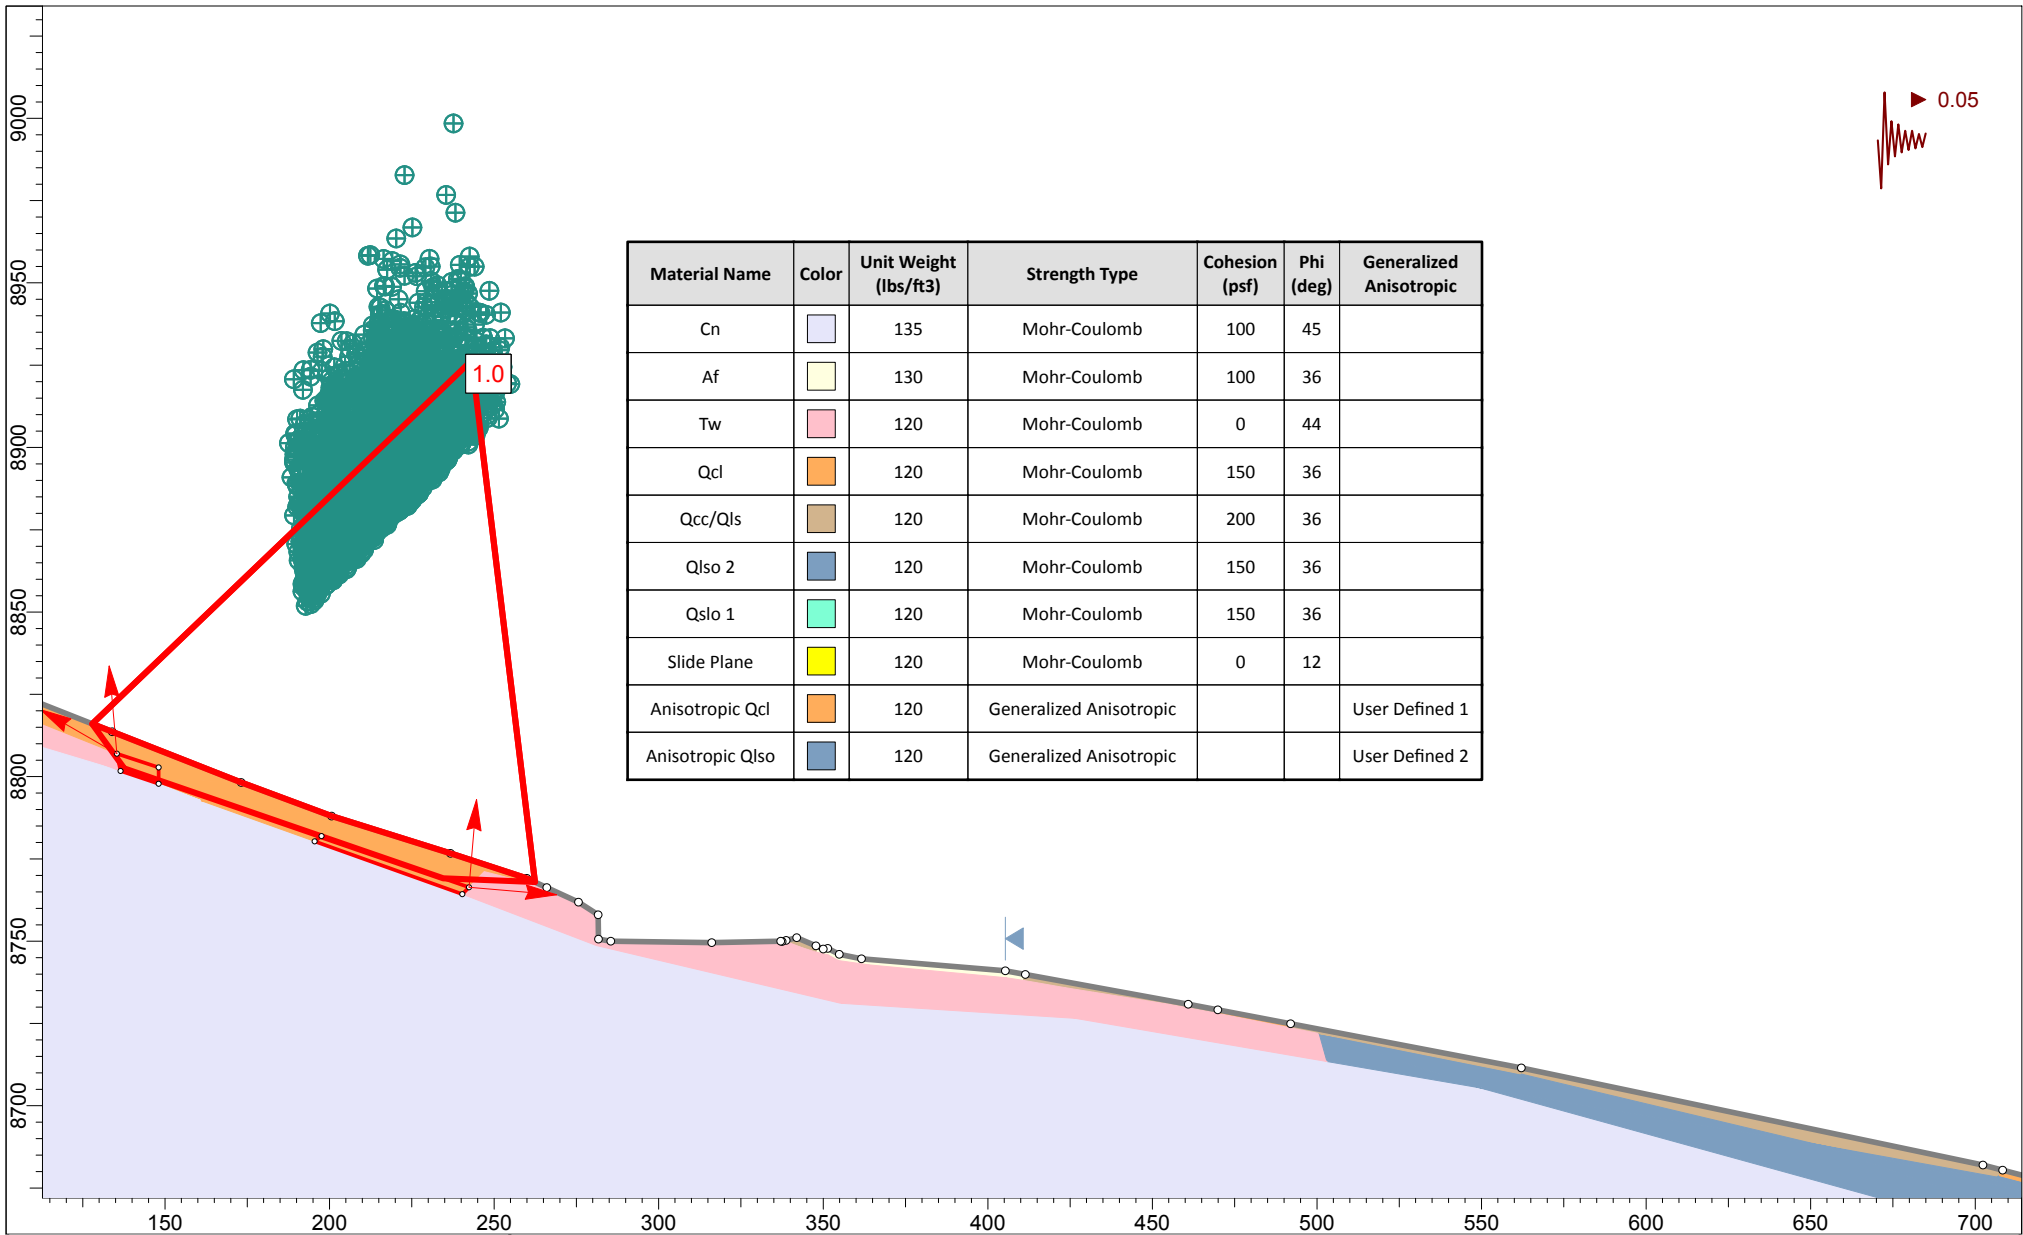
Project		Geotechnical and Geological Hazard Investigation - Summit Horizon Neighborhood, Utah	
Analysis Description		Section A-A' - Yield Acceleration	
Drawn By	TOH	Company	IGES
Date	7-27-2016	File Name	A-A' Seismic.slim

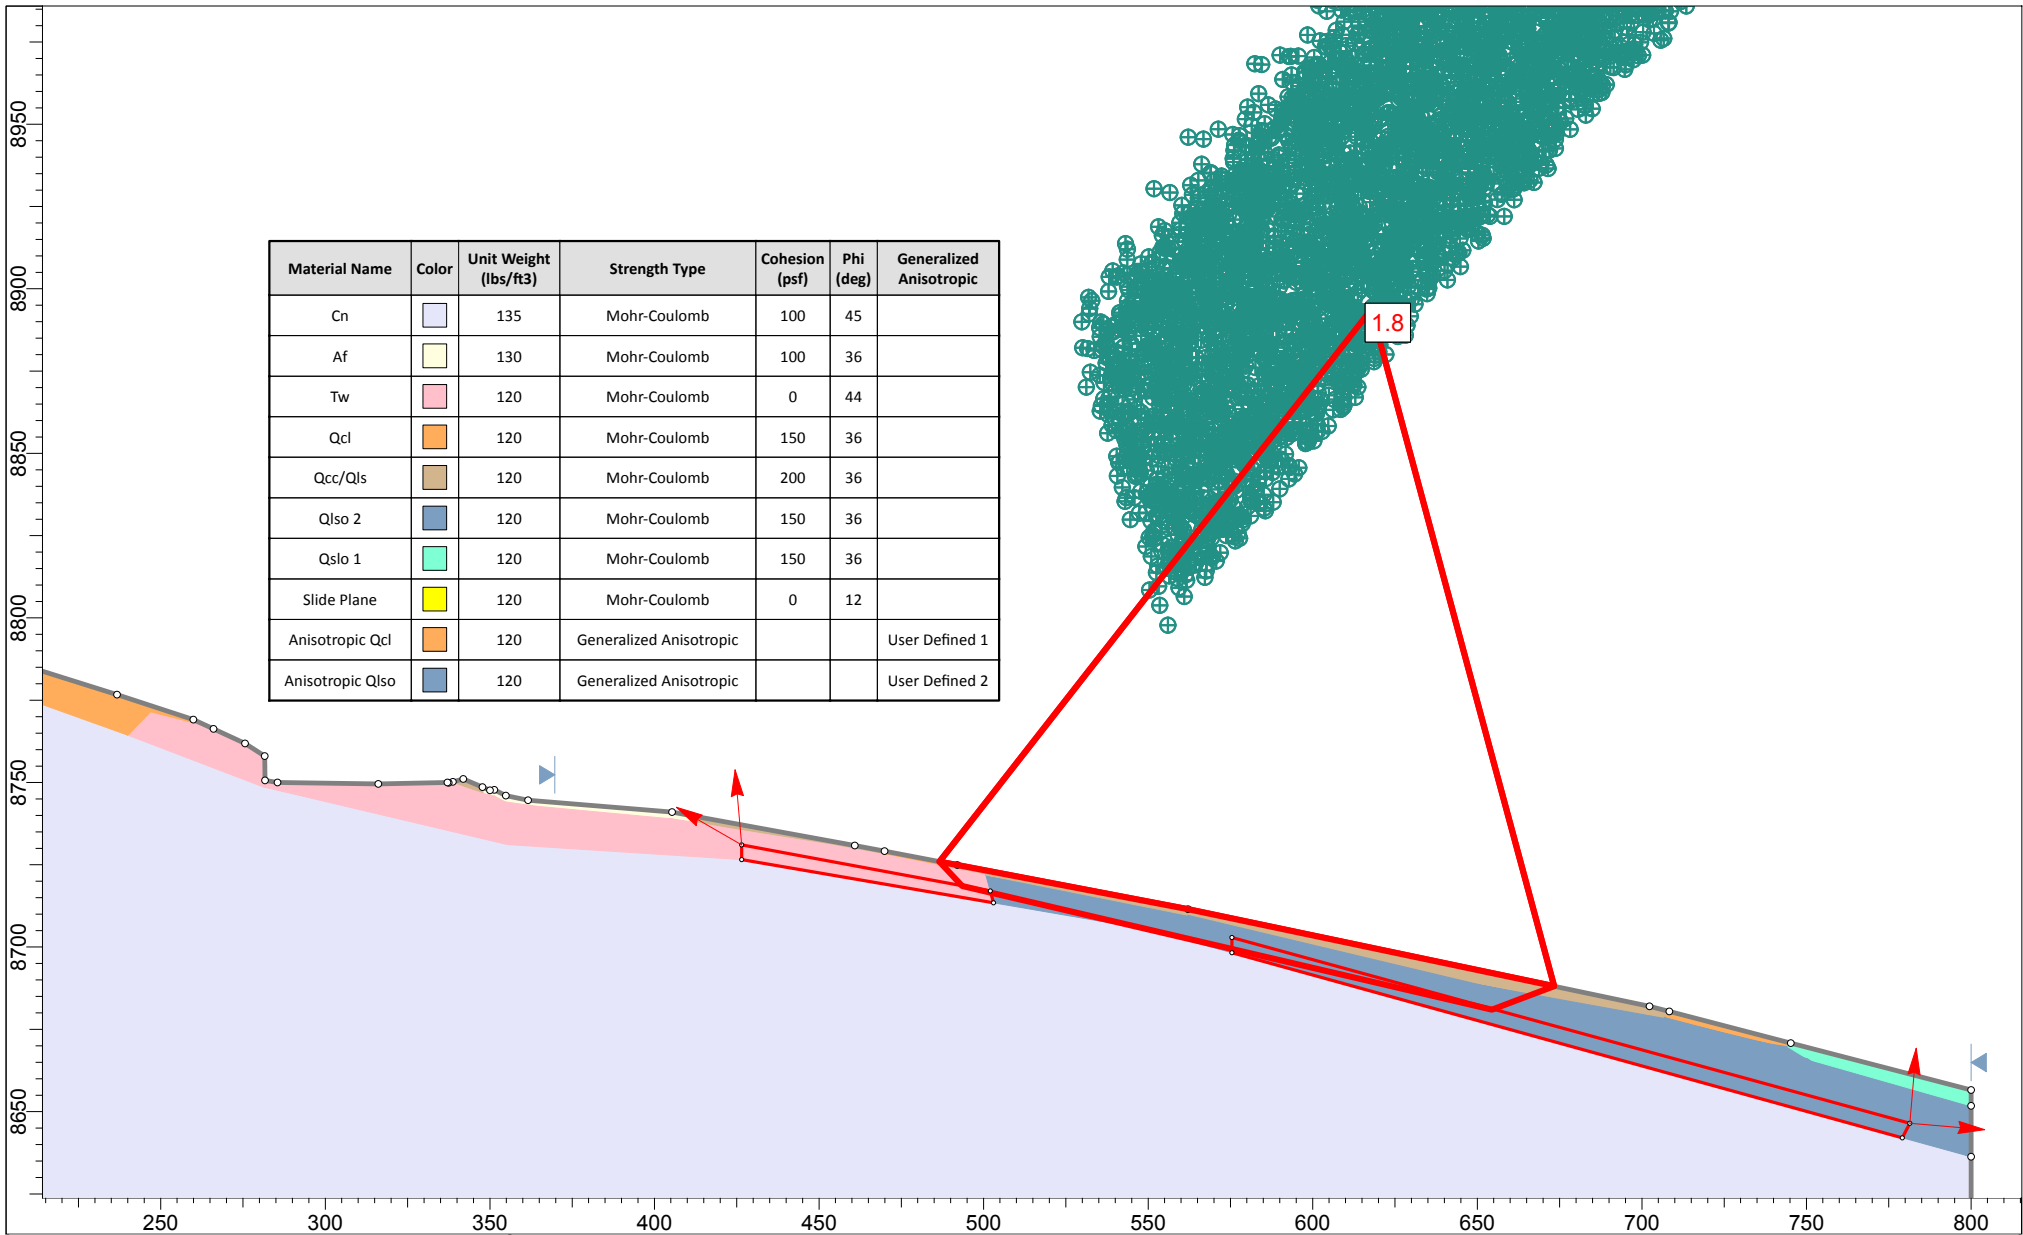
Project		Geotechnical and Geological Hazard Investigation - Summit Horizon Neighborhood, Utah	
Analysis Description		Section A-A' - Downslope Static	
Drawn By	TOH	Company	IGES
Date	7-27-2016	File Name	A-A' Static.slim
