**GEOTECHNICAL & GEOLOGIC
HAZARD INVESTIGATION
Horizon Neighbourhood Development
Summit Powder Mountain Resort
Weber County, Utah**

IGES Project No. 01628-013

August 3, 2016

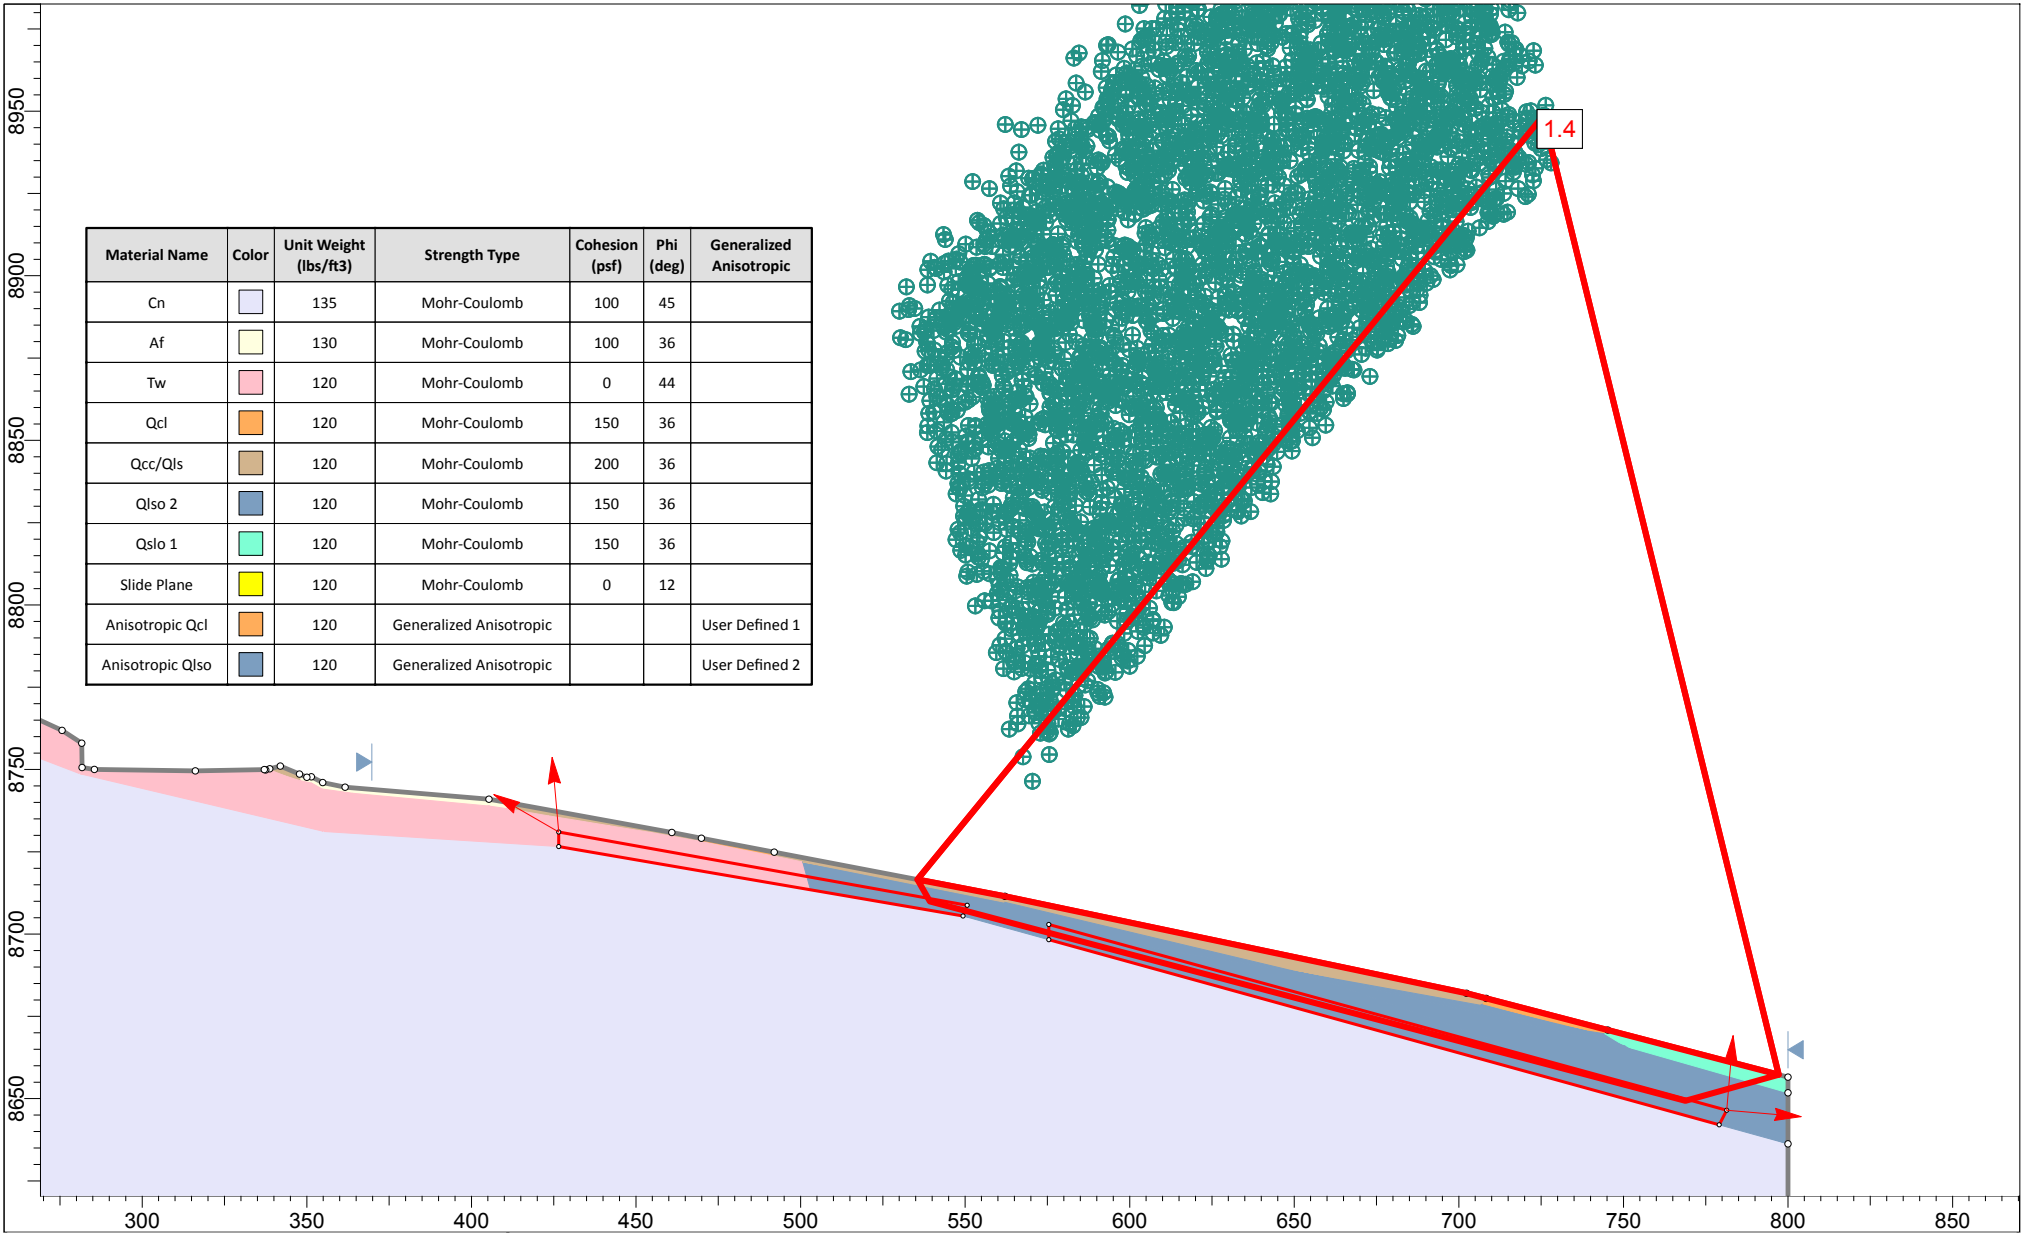
Project		Geotechnical and Geological Hazard Investigation - Summit Horizon Neighborhood, Utah	
Analysis Description		Section A-A' - Downslope Static	
Drawn By	TOH	Company	IGES
Date	7-27-2016	File Name	A-A' Static.slim

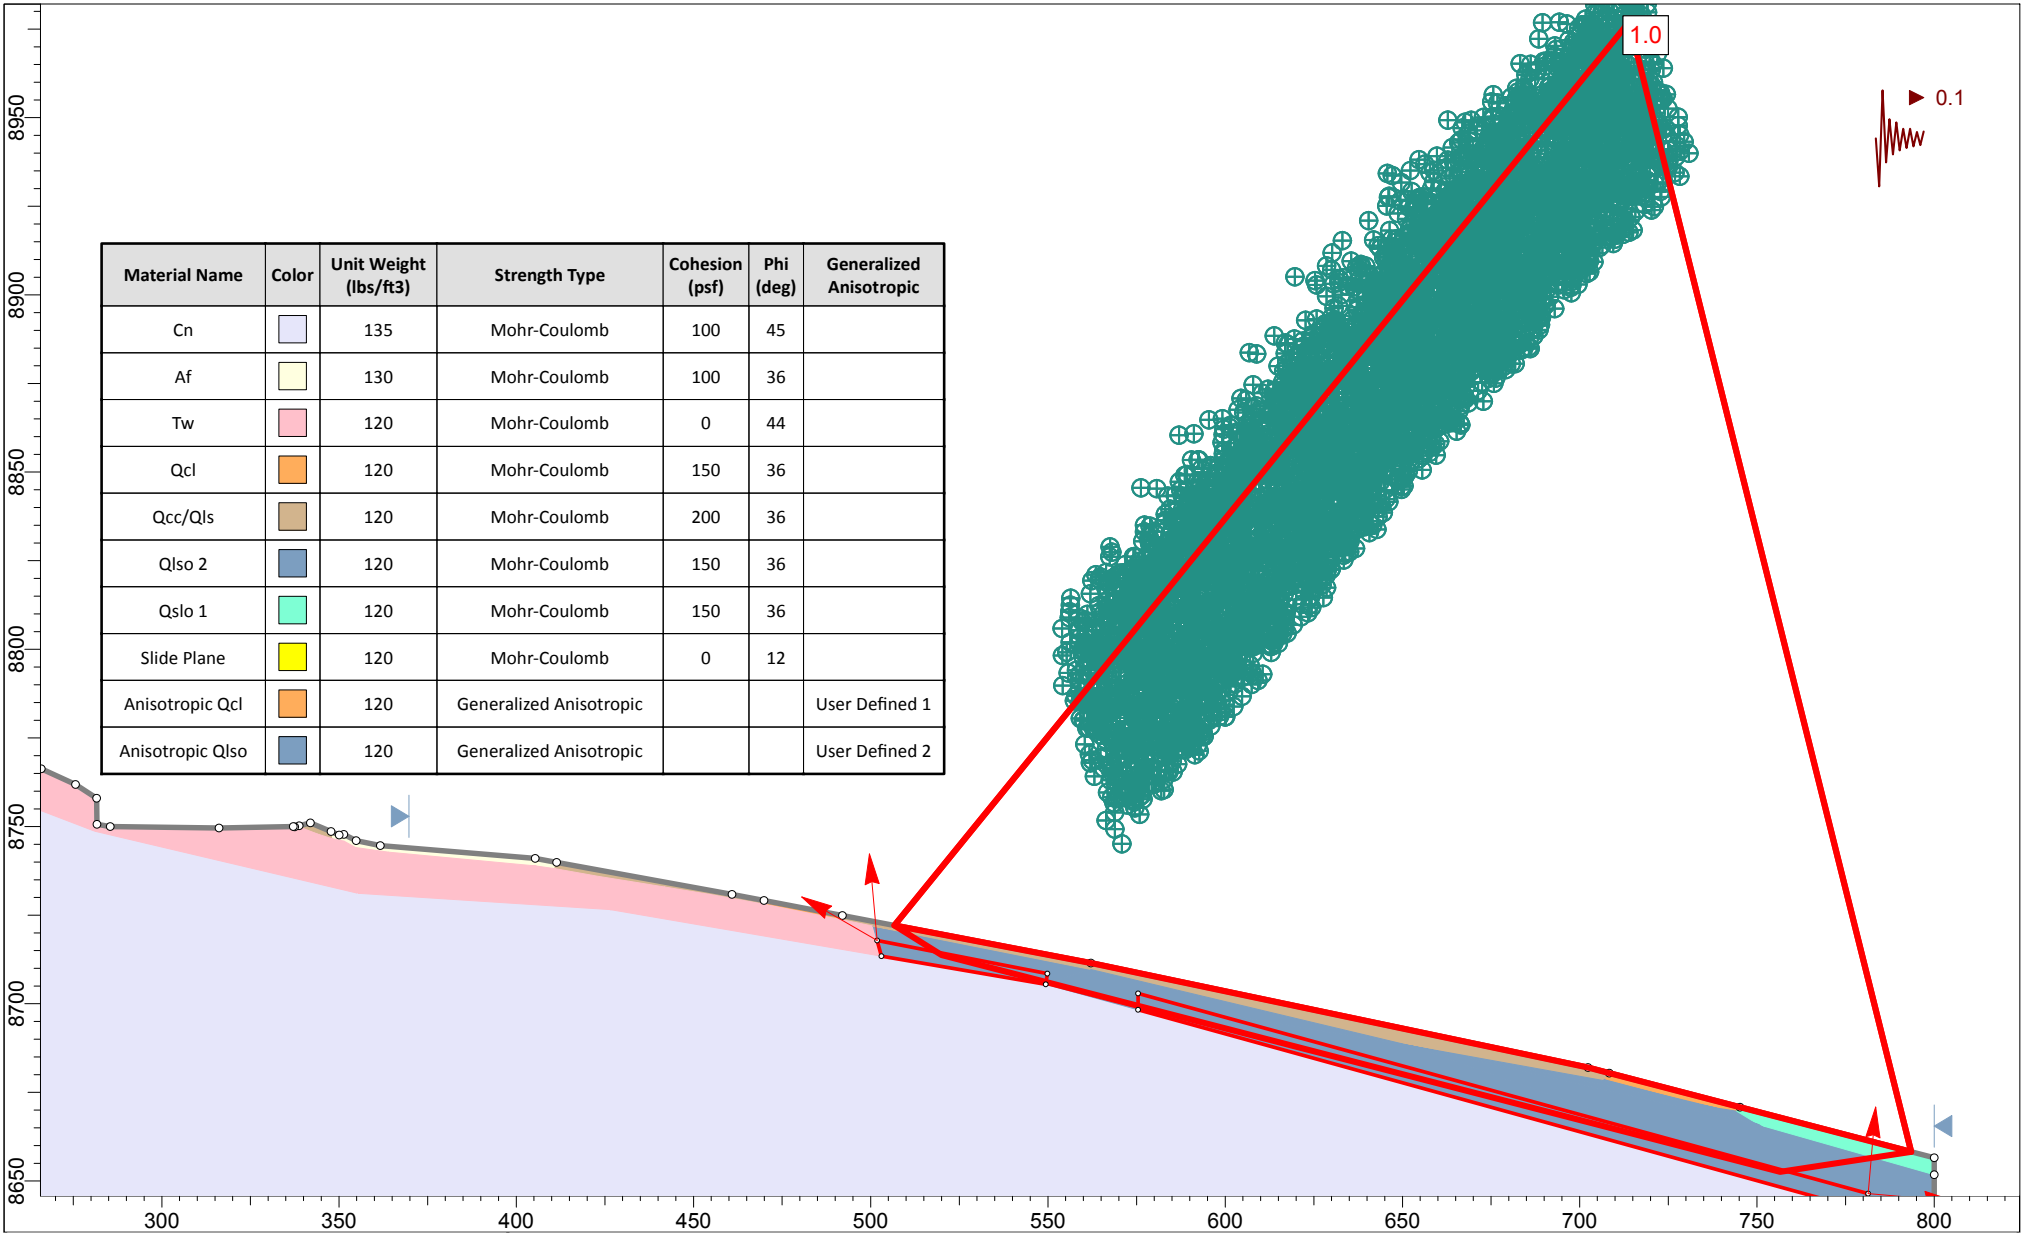
Project		Geotechnical and Geological Hazard Investigation - Summit Horizon Neighborhood, Utah	
Analysis Description		Section A-A' - Downslope Yield Acceleration	
Drawn By	TOH	Company	IGES
Date	7-27-2016	File Name	A-A' Static.slim

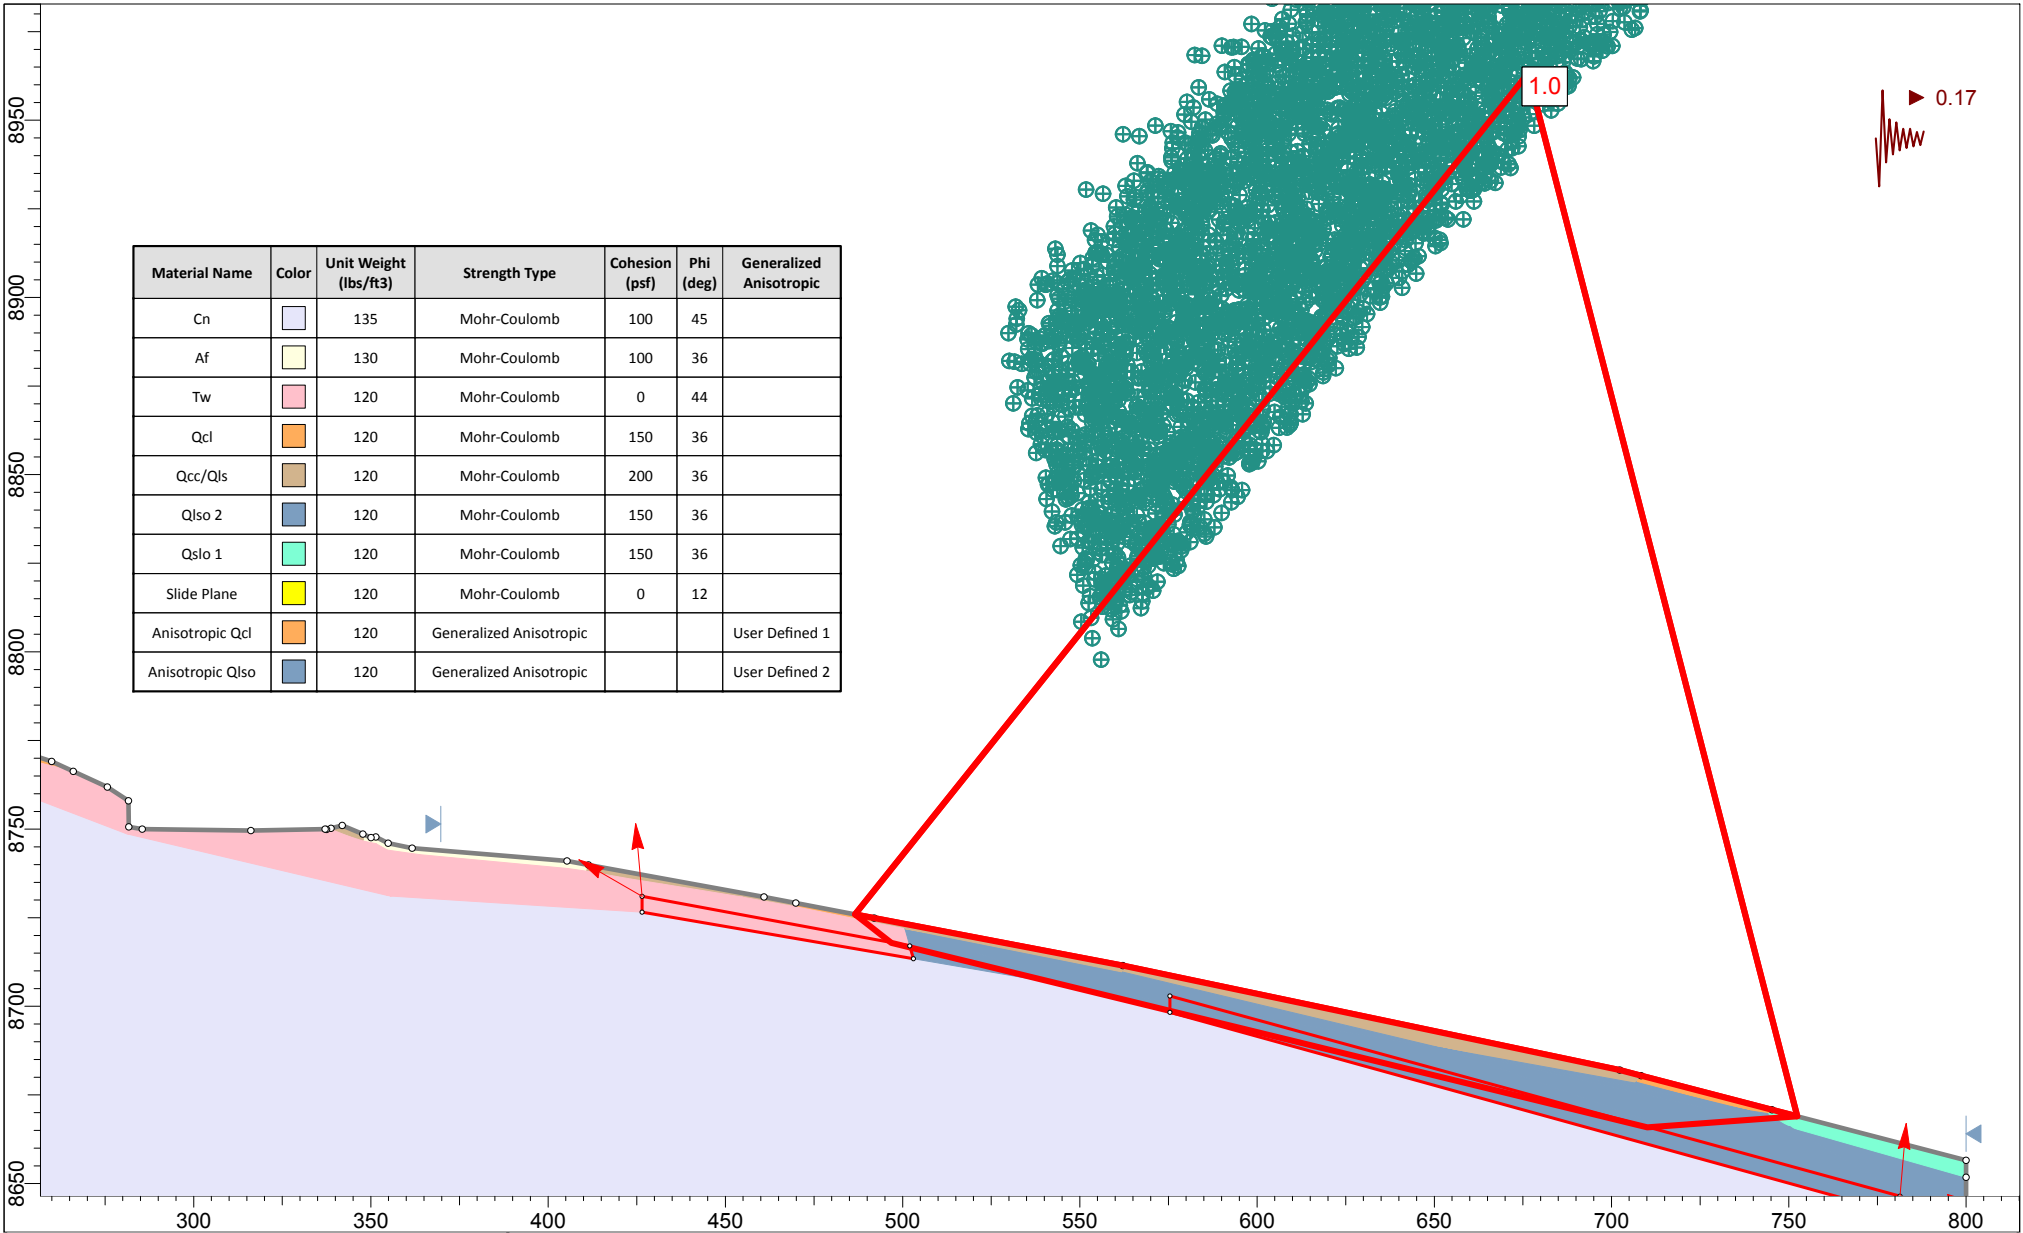
Project		Geotechnical and Geological Hazard Investigation - Summit Horizon Neighborhood, Utah	
Analysis Description		Section A-A' - Downslope Yield Acceleration	
Drawn By	TOH	Company	IGES
Date	7-27-2016	File Name	A-A' Static.slim

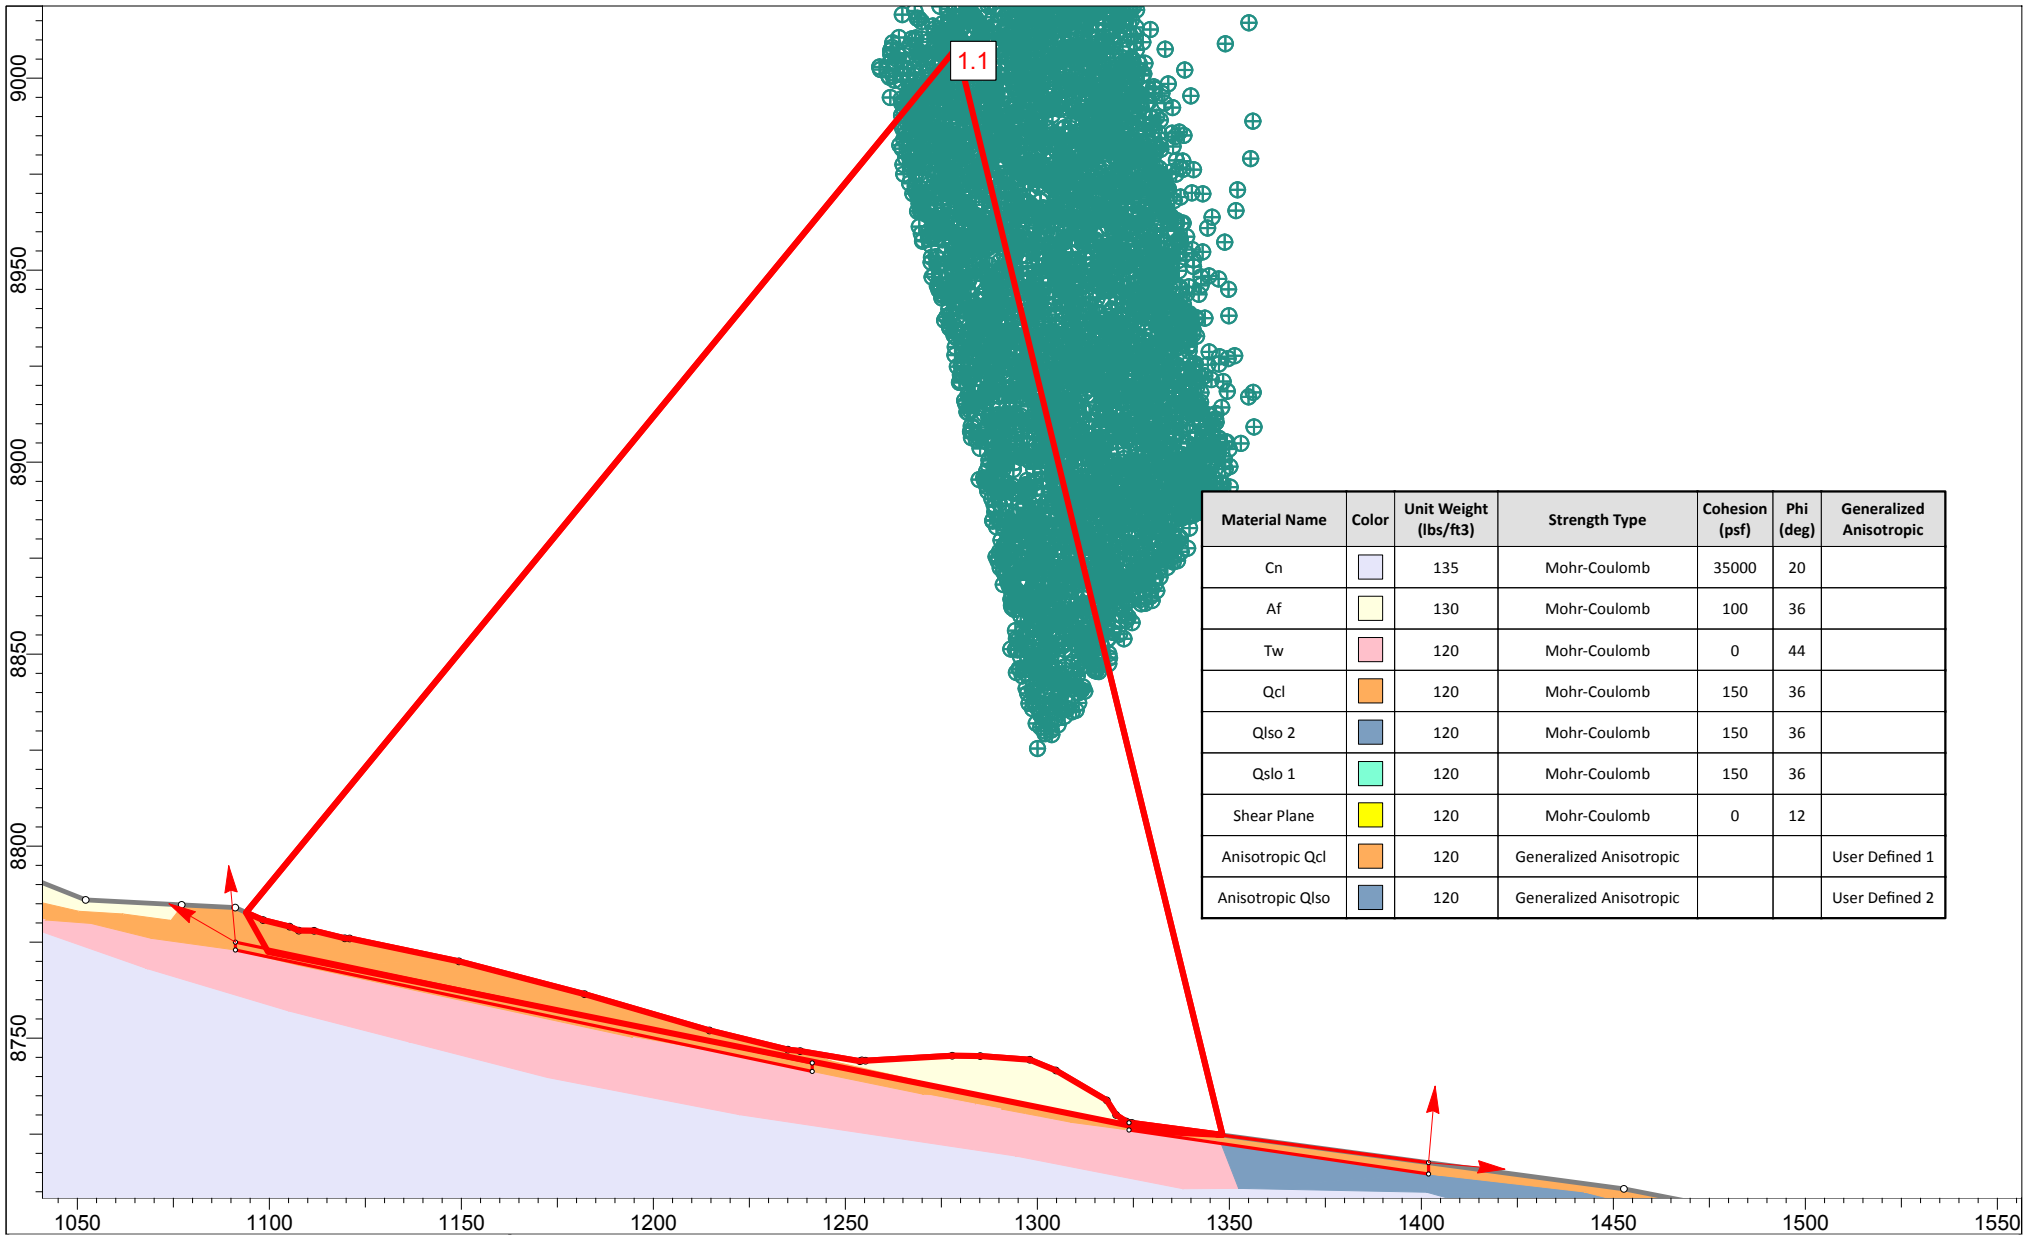
<i>Project</i>		Geotechnical and Geological Hazard Investigation - Summit Horizon Neighborhood, Utah	
<i>Analysis Description</i>		Section B-B' - Static	
<i>Drawn By</i>	TOH	<i>Company</i>	IGES
<i>Date</i>	7-27-2016	<i>File Name</i>	B-B' Static.slim

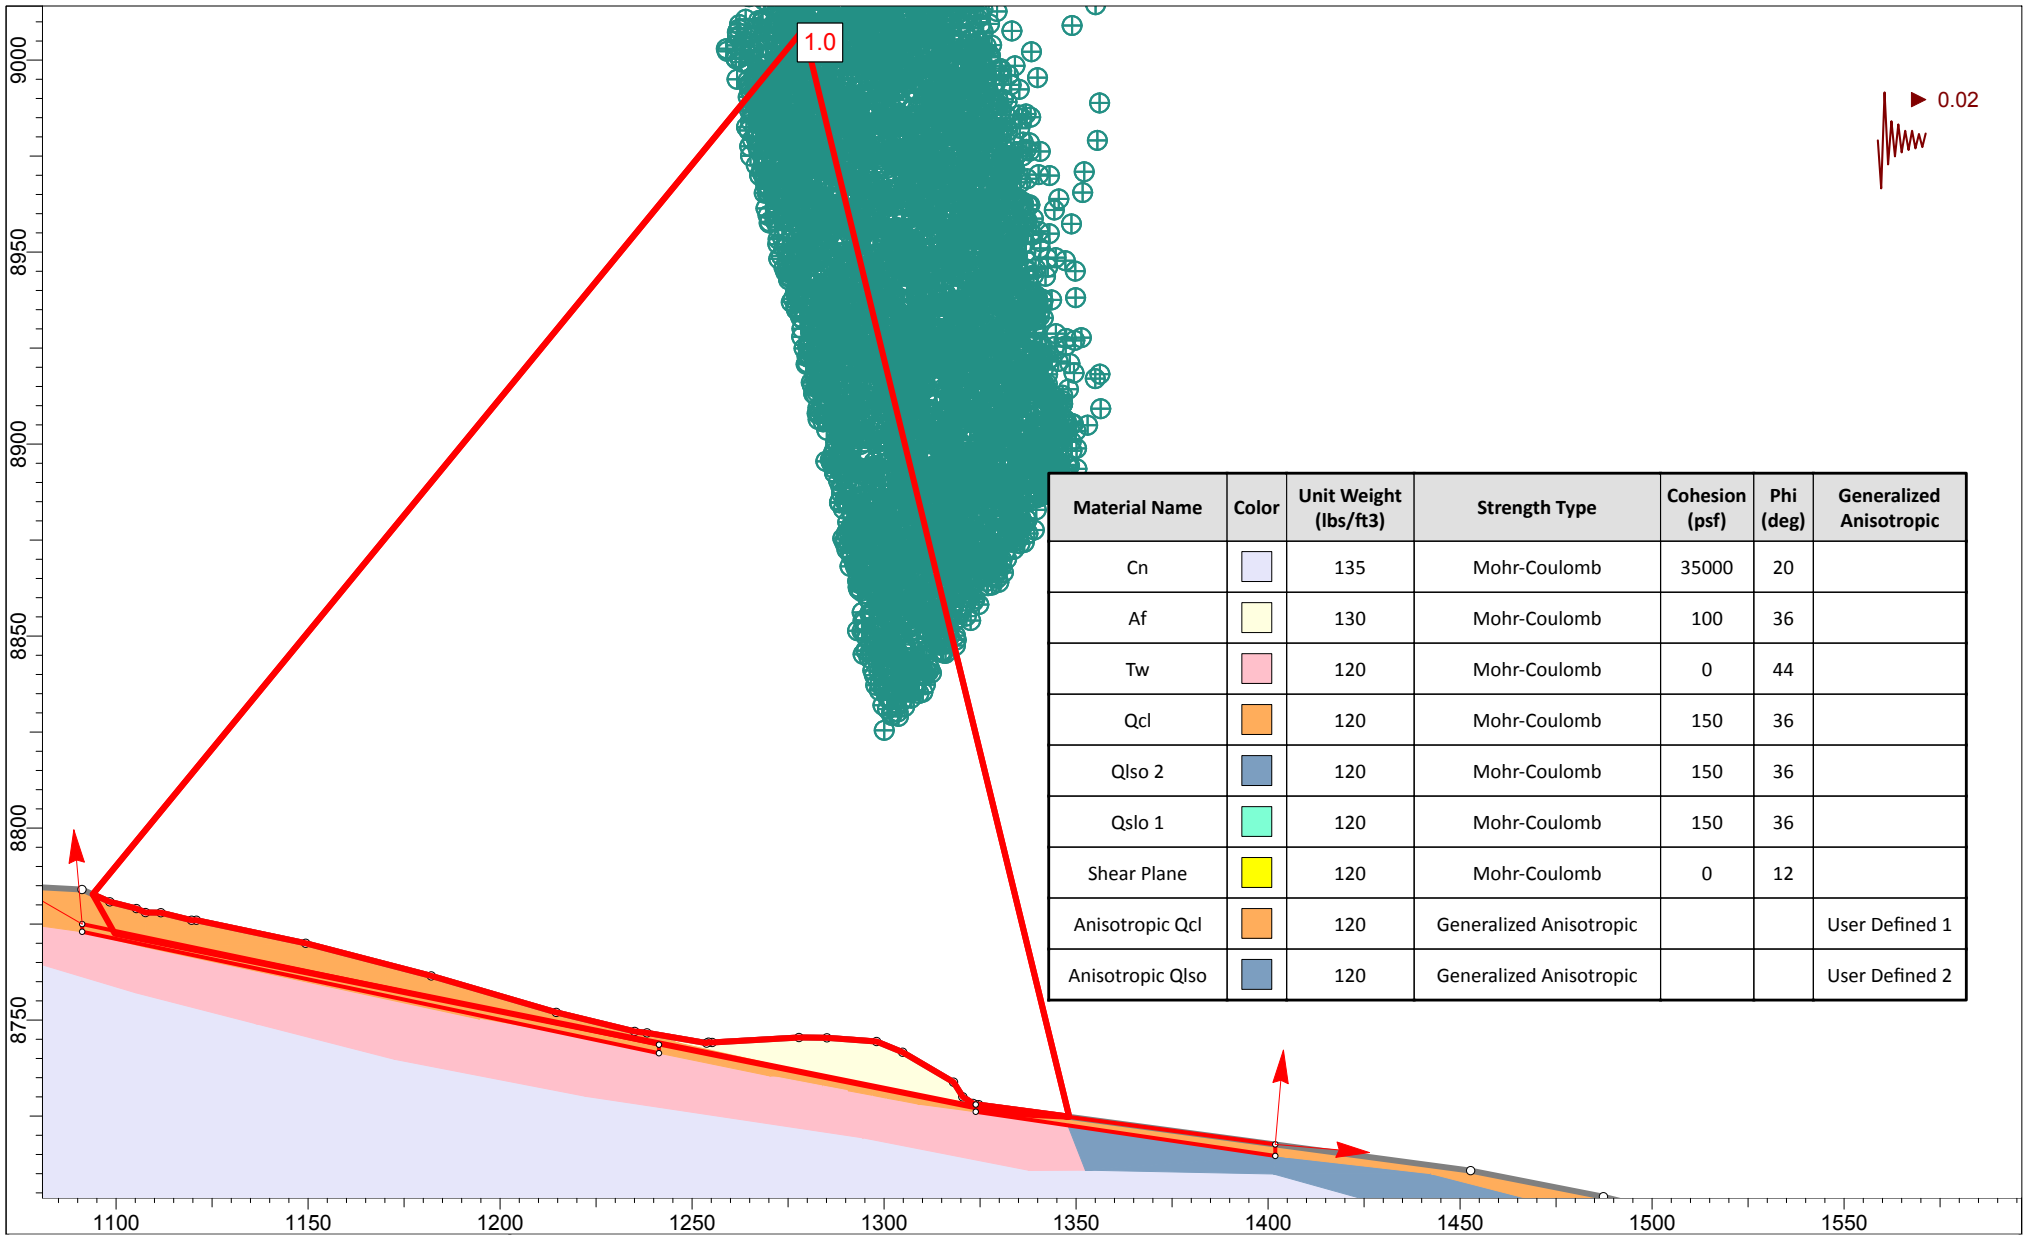
<i>Project</i>		Geotechnical and Geological Hazard Investigation - Summit Horizon Neighborhood, Utah	
<i>Analysis Description</i>		Section B-B' - Seismic	
<i>Drawn By</i>	TOH	<i>Company</i>	IGES
<i>Date</i>	7-27-2016	<i>File Name</i>	B-B' Static.slim

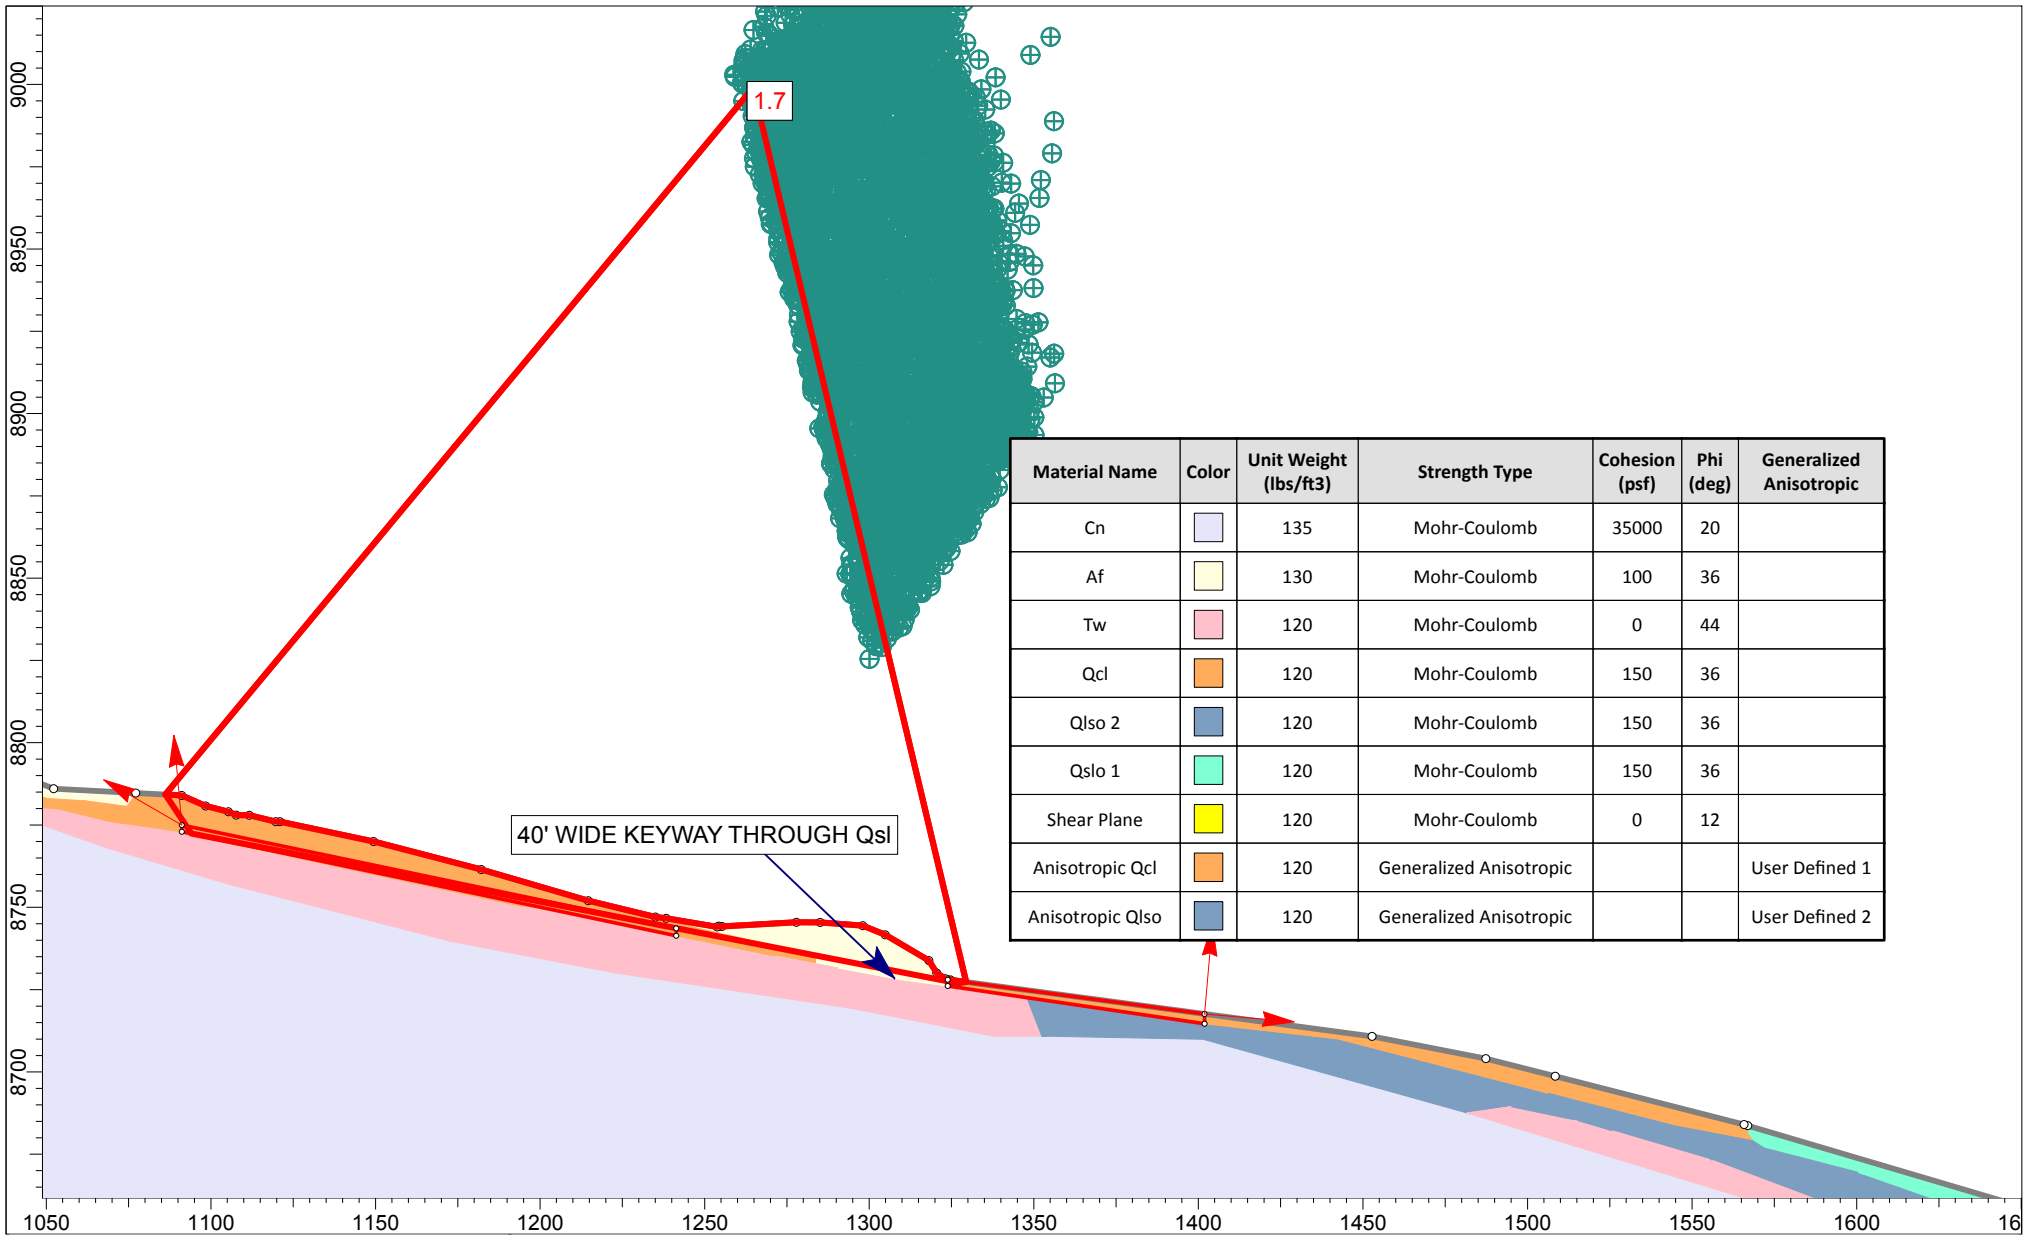
Project		Geotechnical and Geological Hazard Investigation - Summit Horizon Neighborhood, Utah	
Analysis Description		Section B-B' - Static with Keyway	
Drawn By	TOH	Company	IGES
Date	7-27-2016	File Name	B-B' Static.slim

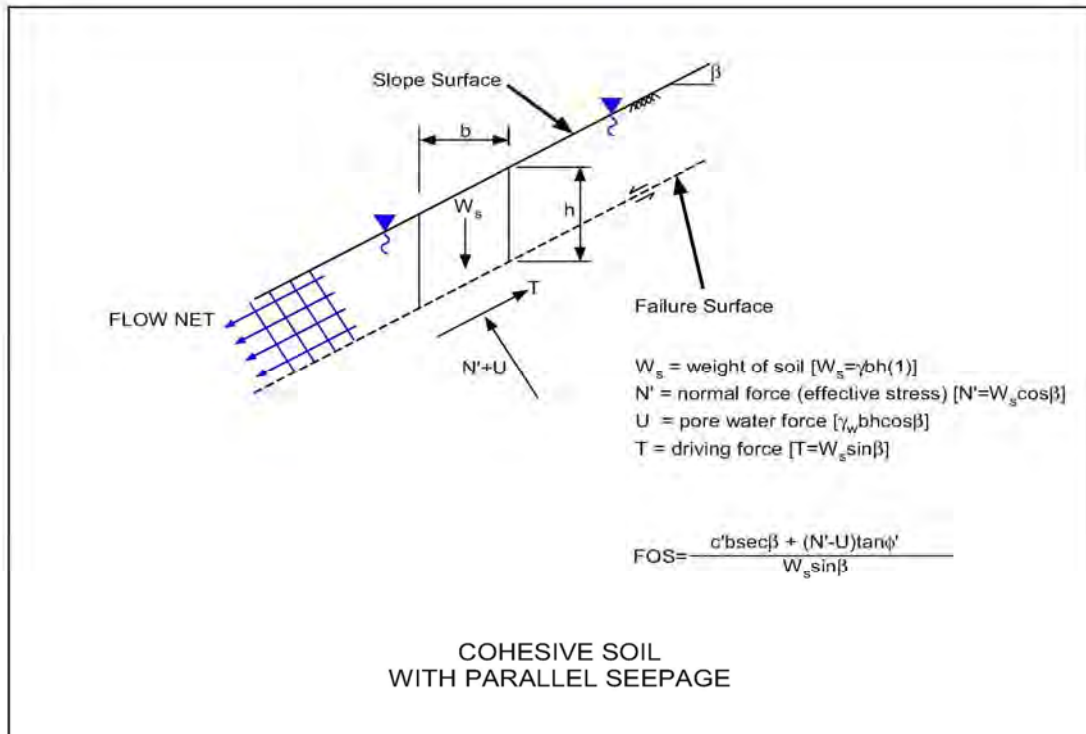
Figure C-2

This model assumes $c > 0$ and the face of the slope is saturated to depth h

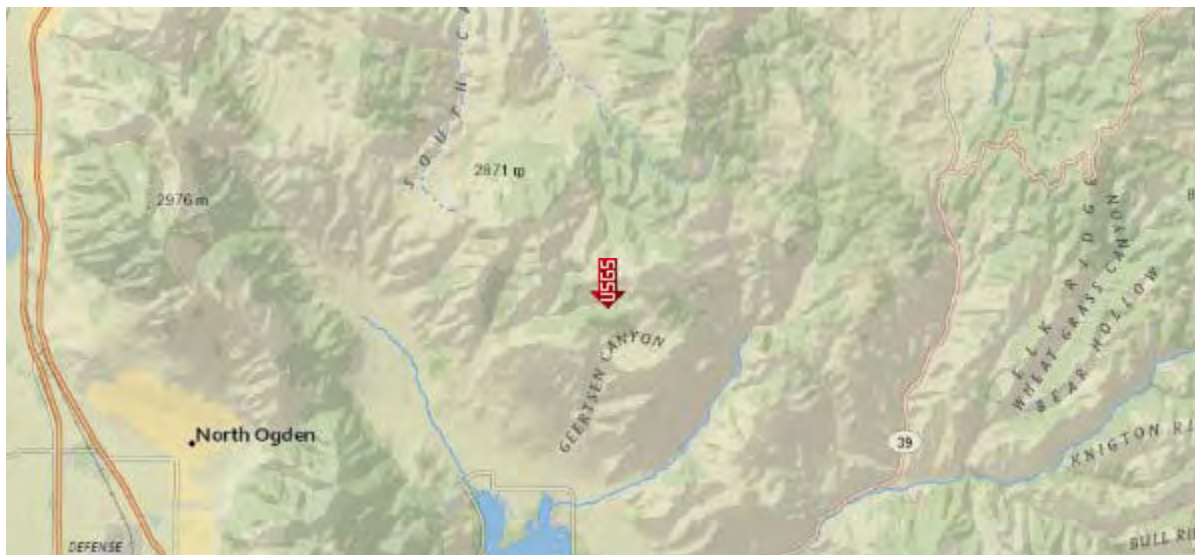
Site Soil Classification Site Class B – “Rock”

Risk Category I/II/III

USGS-Provided Output

$S_S = 0.829 \text{ g}$	$S_{MS} = 0.829 \text{ g}$	$S_{DS} = 0.553 \text{ g}$
$S_1 = 0.276 \text{ g}$	$S_{M1} = 0.276 \text{ g}$	$S_{D1} = 0.184 \text{ g}$

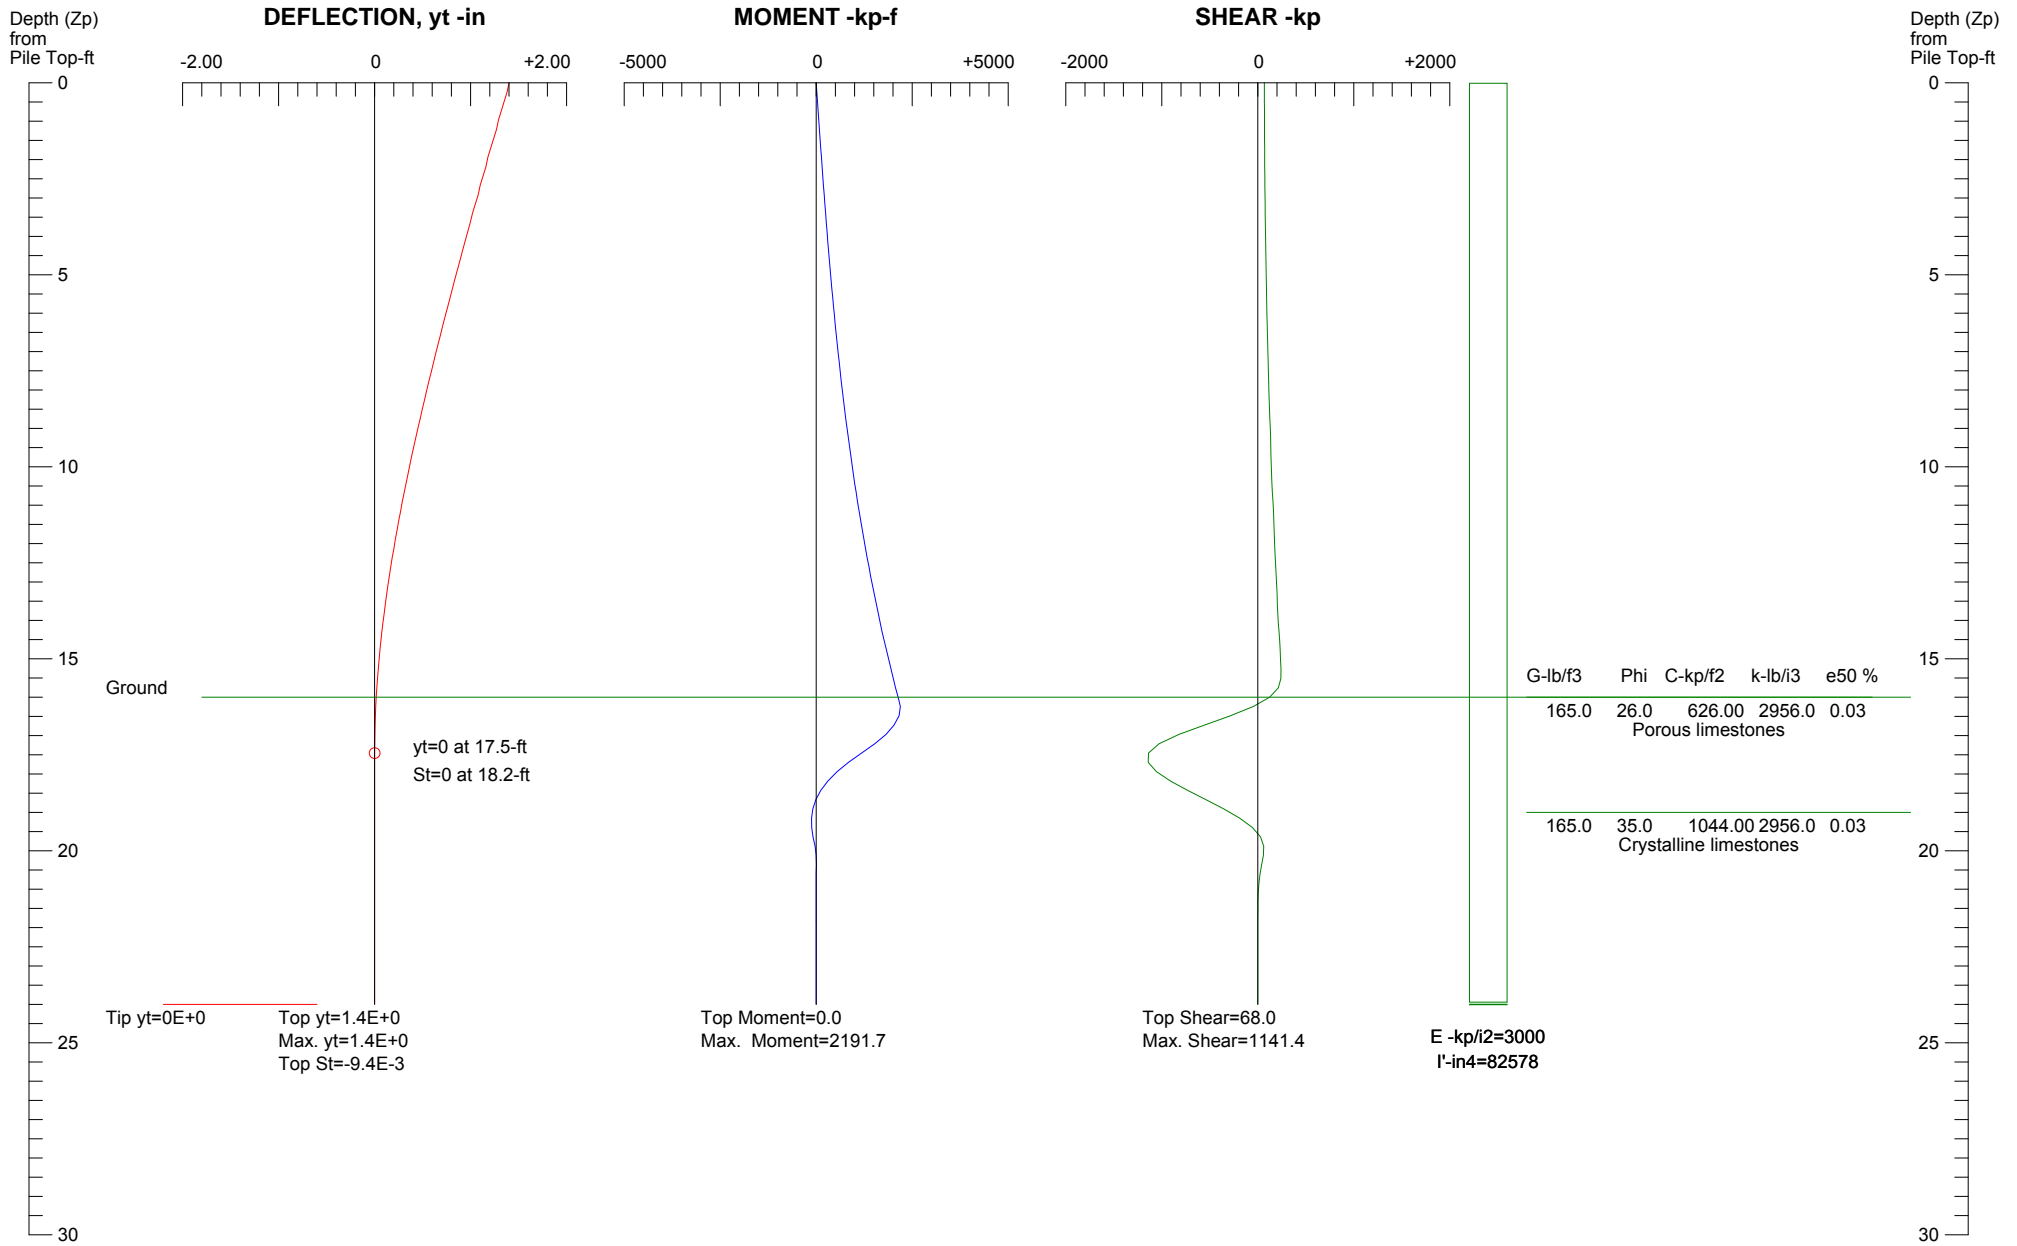
PILE DEFLECTION & FORCE vs DEPTH Single Pile, Khead=2, Kbc=1

Summit/Horizon Neighborhood
36" dia. Pier 16H Outside Pier

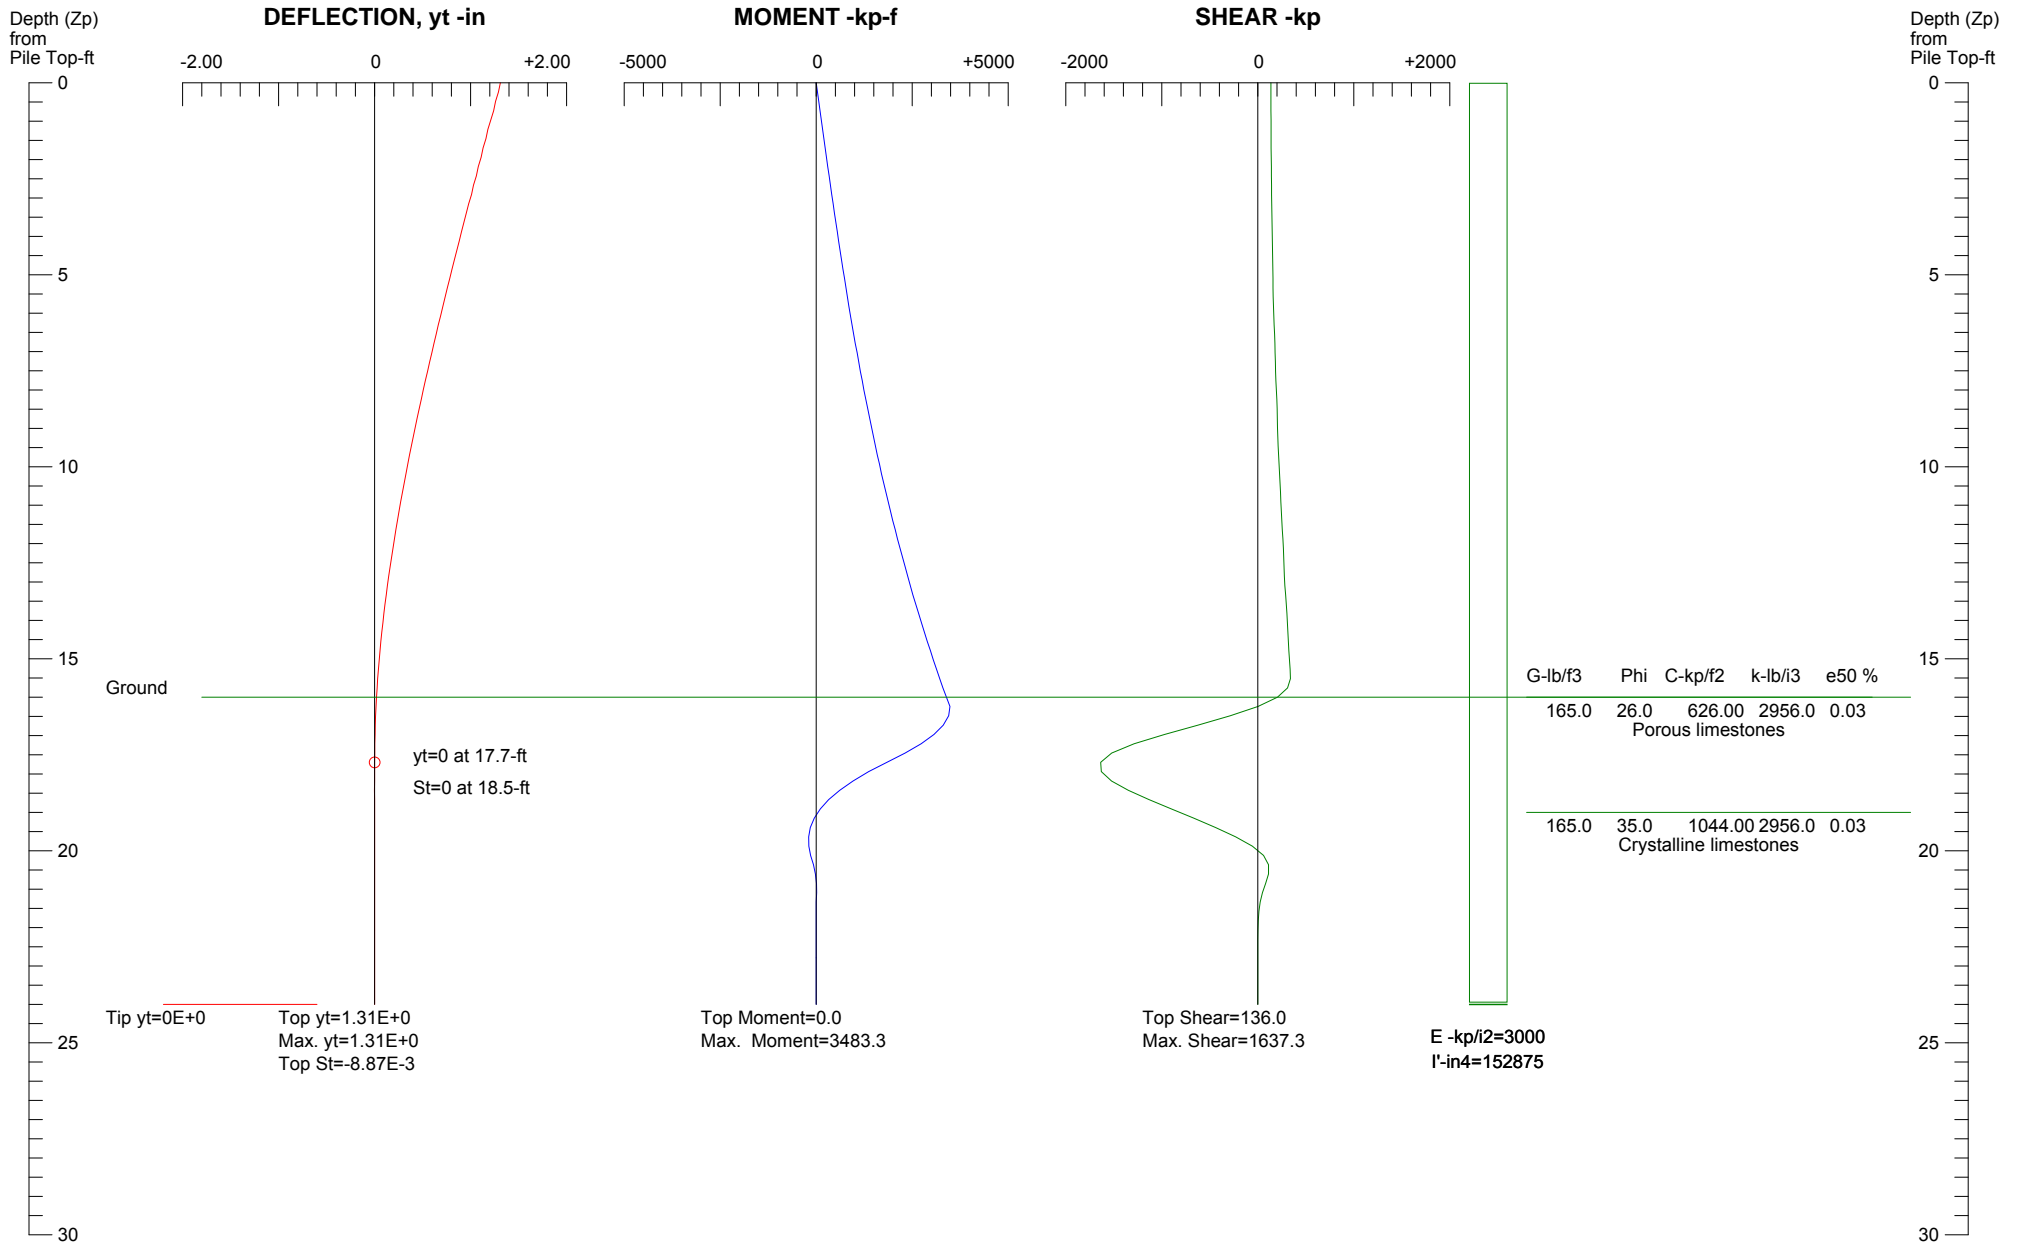
PILE DEFLECTION & FORCE vs DEPTH Single Pile, Khead=2, Kbc=1

Summit/Horizon Neighborhood
42" dia. Pier 16H Inside Pier
